API Inspection Report

1234 Anywhere Street

03/11/2022
2:30 PM

Occupancy status: Single-family occupied Date of Inspection: 2022-03-09
Year built: 1961 Start Time: 2:30 PM

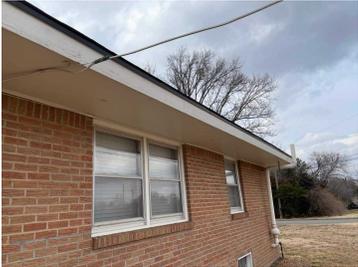
- 1. Material: Dimensional Asphalt Composition
- 2. Number of layers: 1
- 3. Approximate age: 2018
- 4. Flashing: Metal
- 5. Valleys: Asphalt shingle
- 6. Plumbing Vents: Metal
- 7. Attic Vents: Box Vents
- 8. Electrical Mast:
- 9. Gutters: Guttering at east side is missing. Adding guttering is recommended for improved drainage.

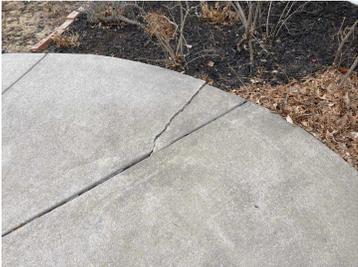
- 1. Driveway: Concrete
- 2. Walks: Concrete - Cracks and settling noted. Consider repair.

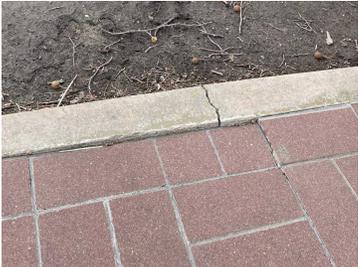
- 3. Patio: Paver, Concrete - Cracks and settling noted. Consider repair.

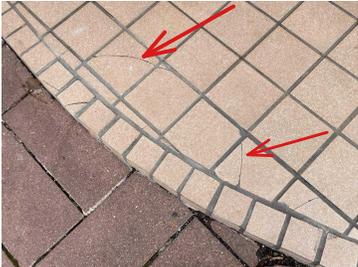
- 4. Steps: Concrete
- 5. Porch: Tile - Cracked tiles noted. Consider repair.

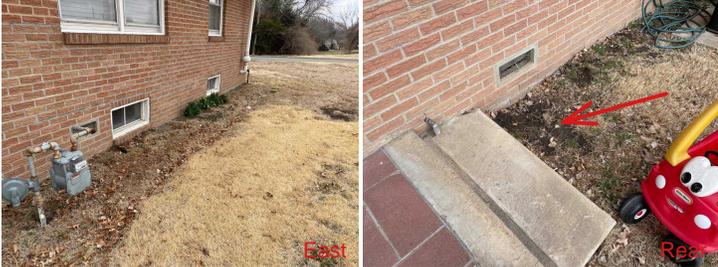
- 6. Drainage: Low areas noted. This may allow water to pool near the foundation. Recommend backfilling for proper drainage.

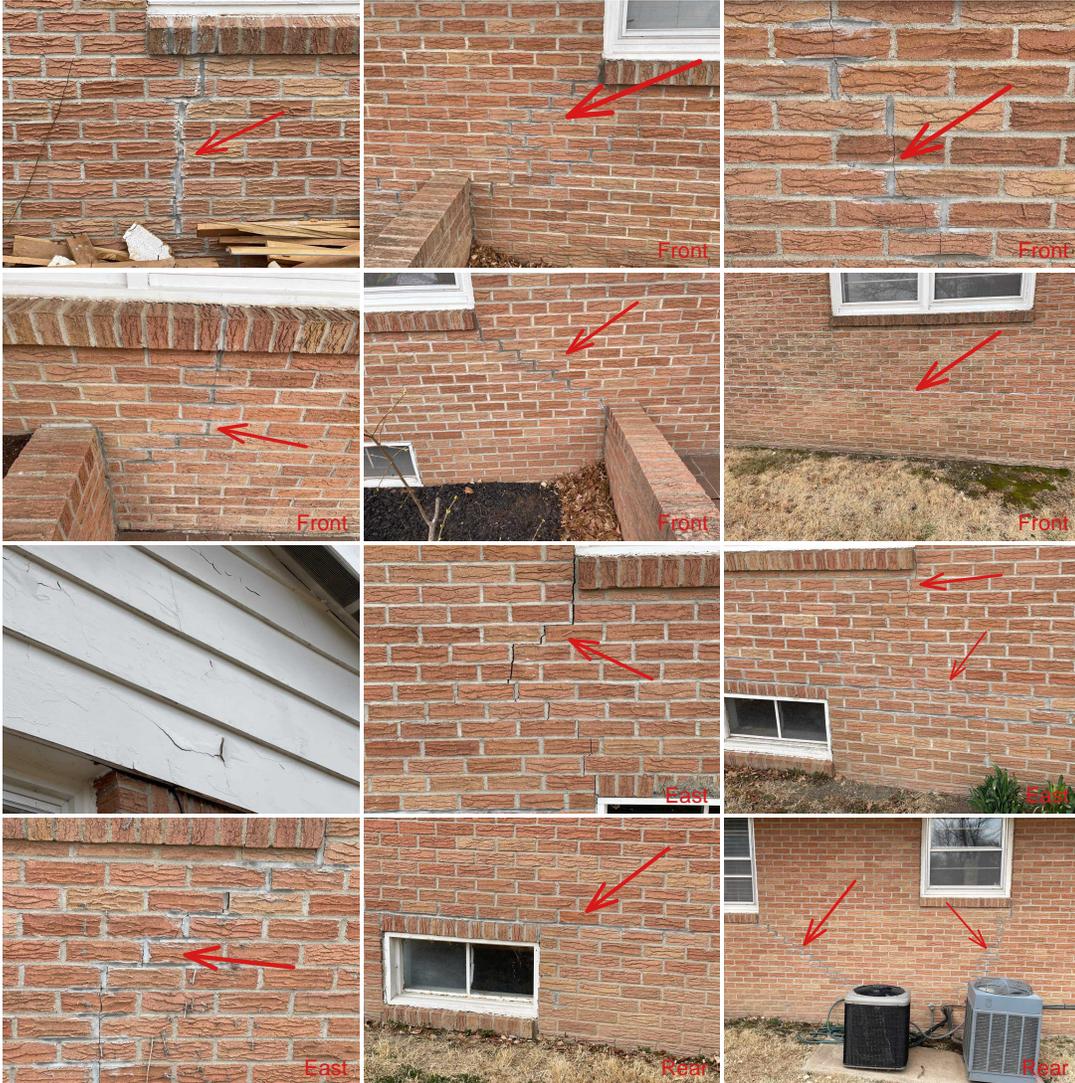
1. Wall Surface: Brick, Wood - Cracked bricks and mortar noted. Some cracks have been sealed. Recommend sealing cracks as needed.

Peeling paint noted. Paint maintenance is recommended.

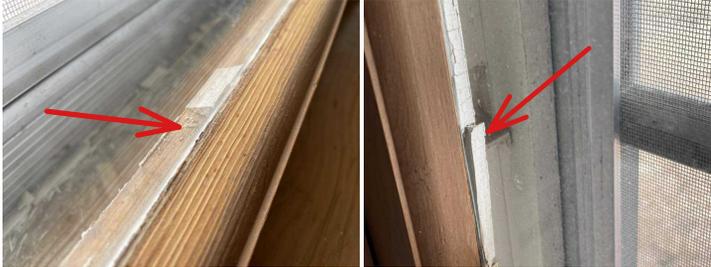
7. Windows: Cracked/missing glazing noted at some windows. Repair as needed is recommended.

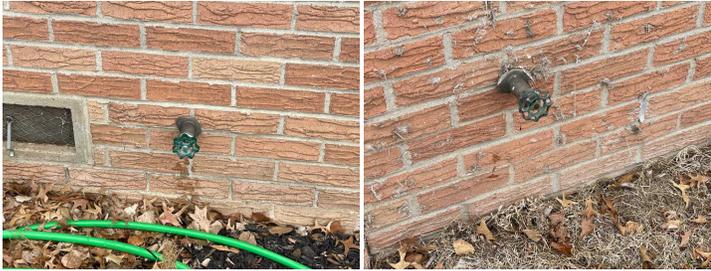
11. Hose Bibs: Hose bibs not connected to the house. This can allow for pipe movement when the valve is operated, and may lead to leaks due to stress on pipe joints. Recommend securing the hose bibs to the house.

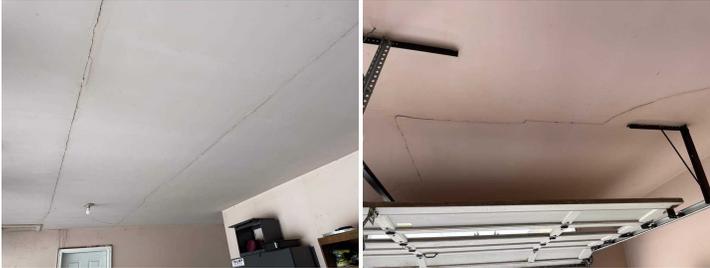
1. Ceiling: Cracks noted.

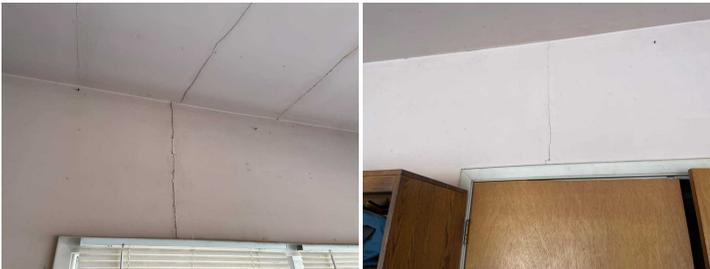
2. Interior Walls: Cracks noted.

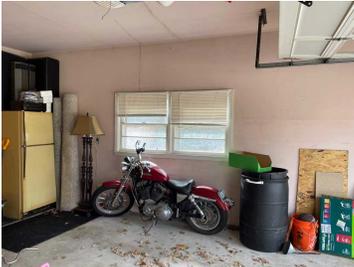
3. Windows: The windows will not open. Repair is recommended.

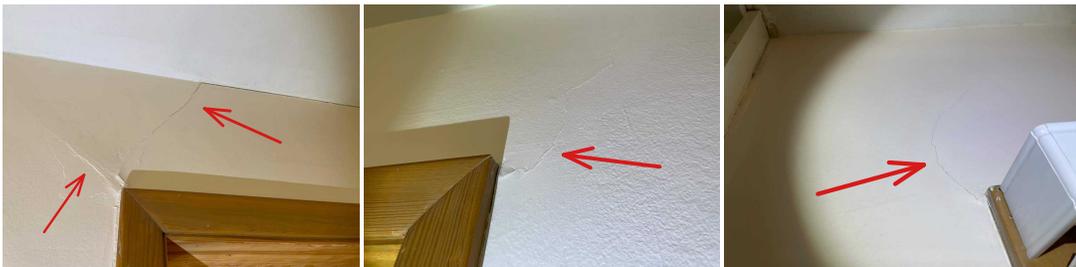
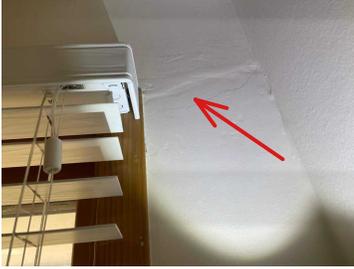
Cracks noted.

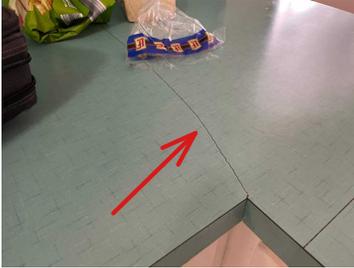
4. Counter Tops: Cracked countertop noted. Consider repair.

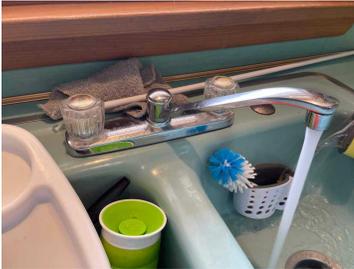
13. Plumbing/Fixtures: Faucet is loose. Repair is recommended.

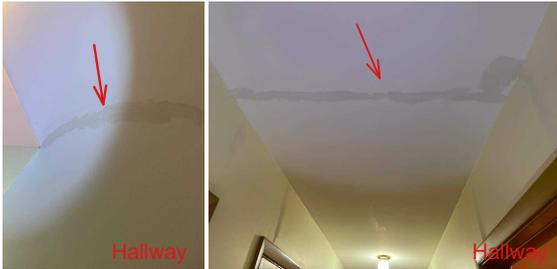
Cracks noted.

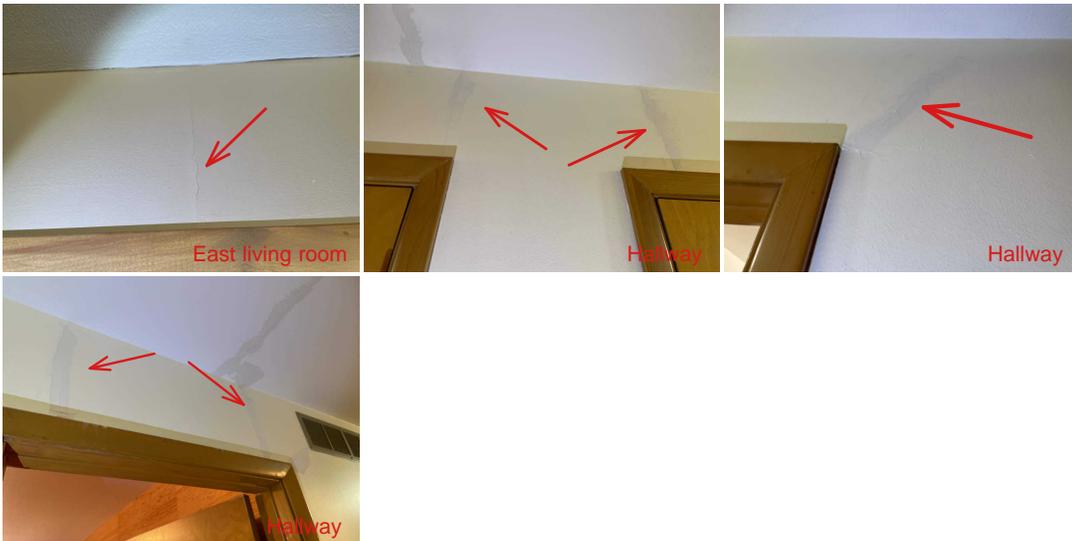
Cracks noted.

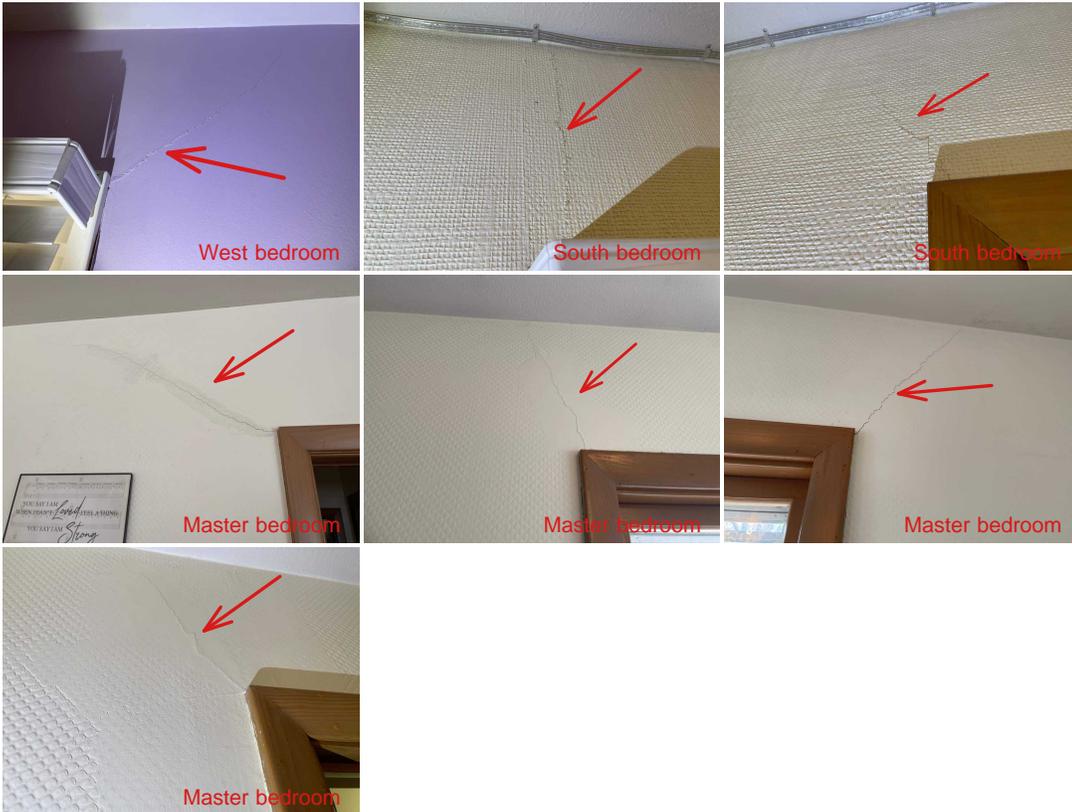
Cracks noted.

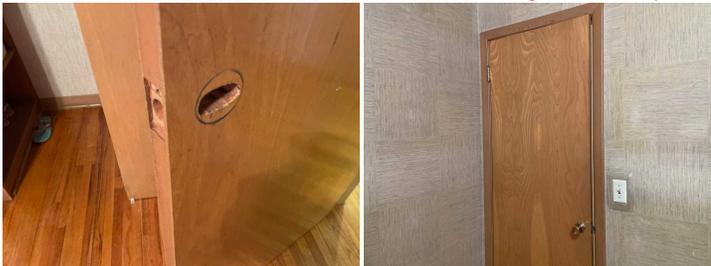
Missing hardware noted at door to center bedroom. Repair is recommended.

Door to north bedroom will not close (hits jamb). Repair is recommended.

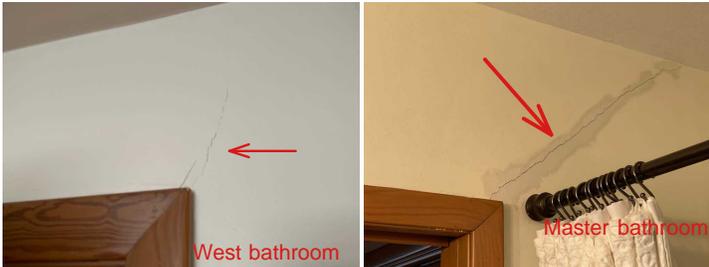
Cracks noted.

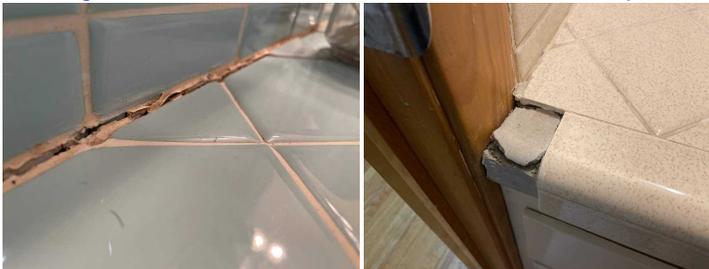
Caulking/sealant is cracked at vanity in master bathroom. Repair is recommended.

Damaged tile noted in hall bathroom. Consider repair.

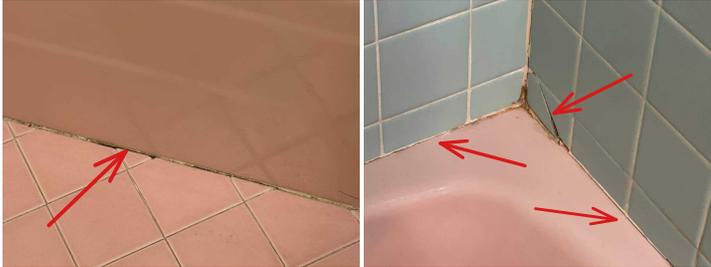
10. Tub: Sealant at the base of tub in master bathroom is worn, cracked or missing. Recommend sealant.

Cracked tile and sealant at tub surround noted. Recommend maintenance.

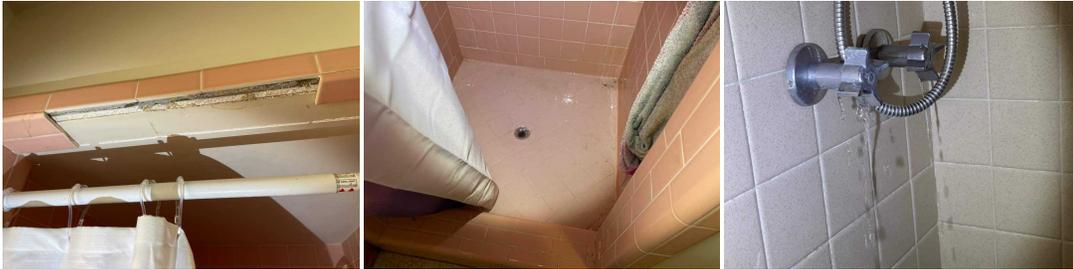
11. Shower: Damaged tile noted at shower in west bathroom. This shower also drains slowly. Consider repair.

Leaks noted at hot and cold valves in hall shower. Consider repair.

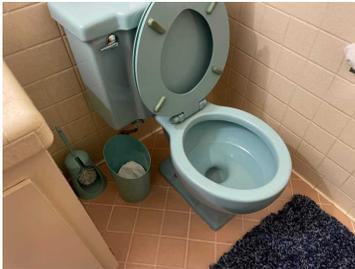
12. Toilets: Toilet in hall bathroom not flushing properly (must hold handle down during flush). Repair is recommended.

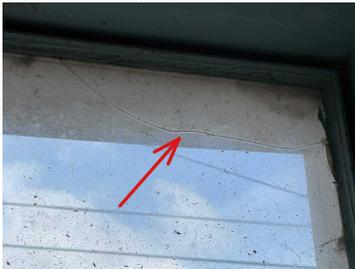
Broken glass noted at east window. Recommend replacing the broken glass.

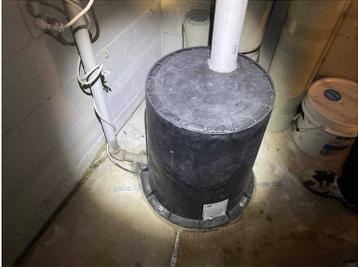
7. Sump Pump: Not tested due to sealed radon installation.

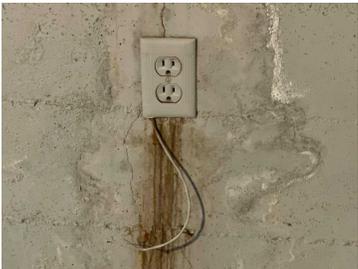
9. Electrical: Water was observed running through the outlet near the breaker panel. Evaluation of the electrical in this area should be performed by a qualified electrician.

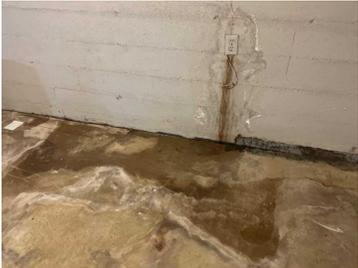
11. Moisture Present: Moisture at the east wall present at the time of inspection. Future evaluation and repair by a qualified basement waterproofing contractor is recommended.

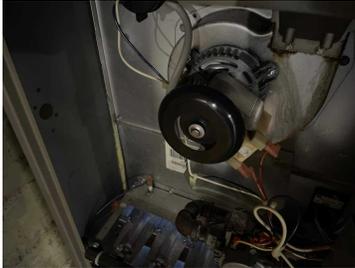
3. Cabinet:
4. System Operation: **Draft inducer is noisy. Service by a qualified HVAC technician is recommended.**

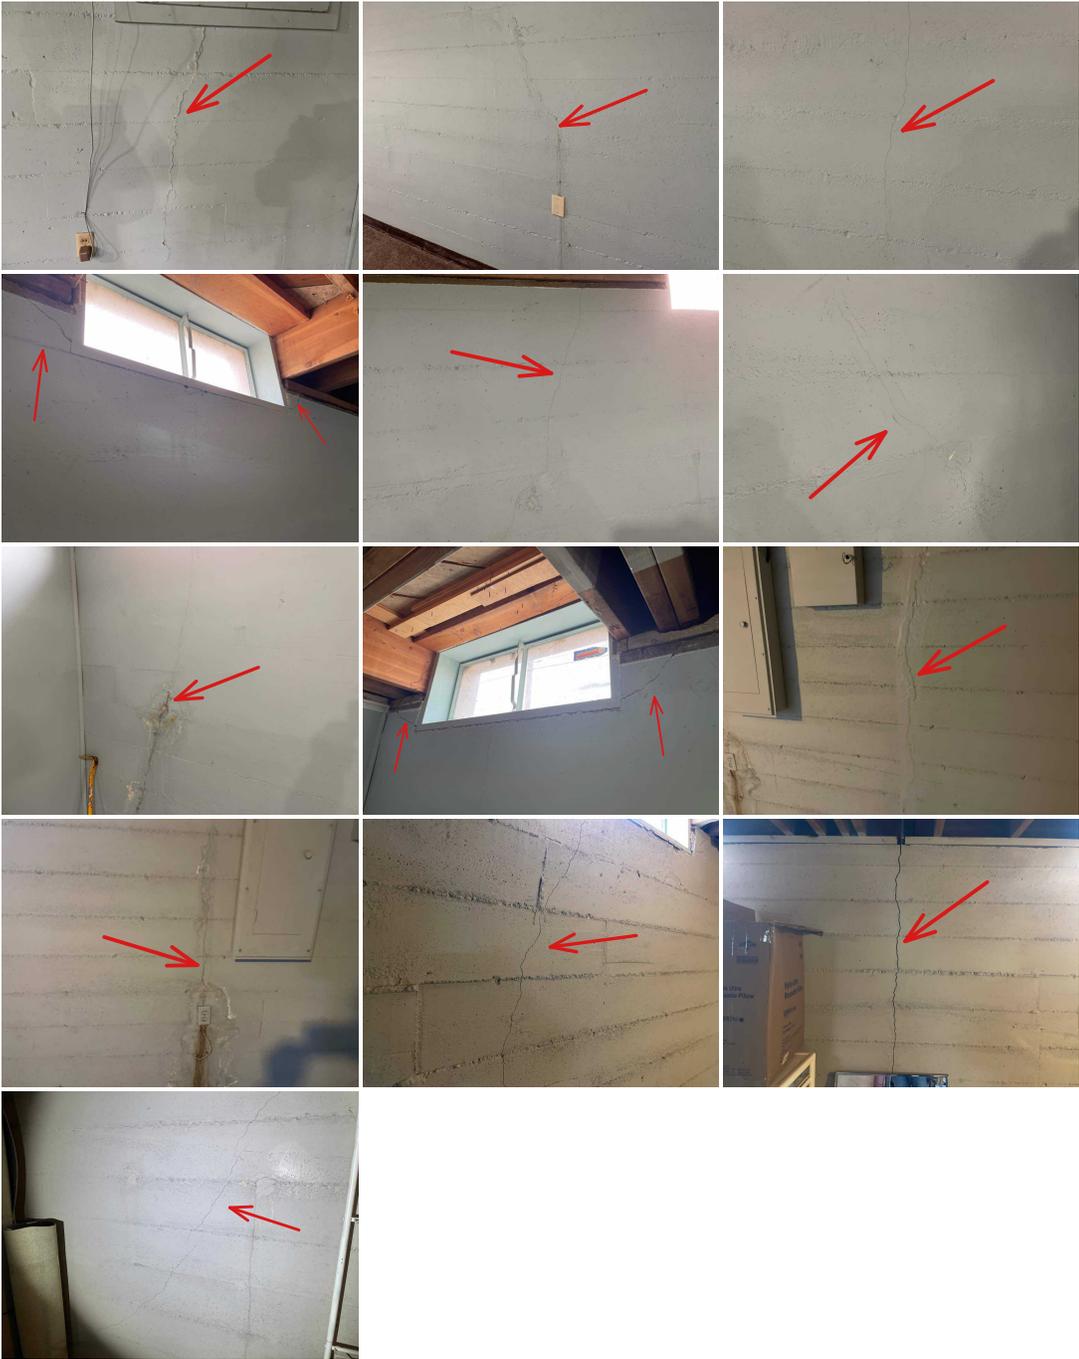
- 1. Structure Type: Wood frame
- 2. Foundation: Poured - Cracks noted. Consider further evaluation by a qualified foundation contractor.

3. Movement: Past structural movement is suspected. There are multiple exterior cracks, interior wall/ceiling cracks, and foundation cracks. Further evaluation by a qualified foundation contractor is recommended.
4. Beams:
5. Bearing Walls:
6. Joists/Trusses:
7. Floor/Slab:
8. Subfloor: Dimensional wood

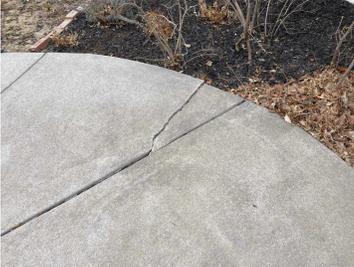
- 1. Walks: Concrete - Cracks and settling noted. Consider repair.

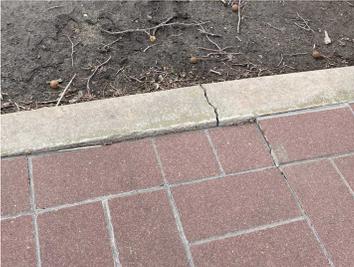
- 2. Patio: Paver, Concrete - Cracks and settling noted. Consider repair.

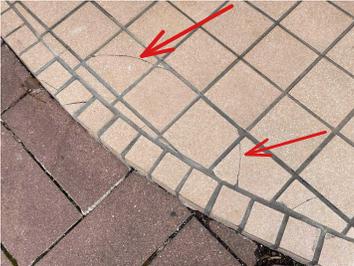
- 3. Porch: Tile - Cracked tiles noted. Consider repair.

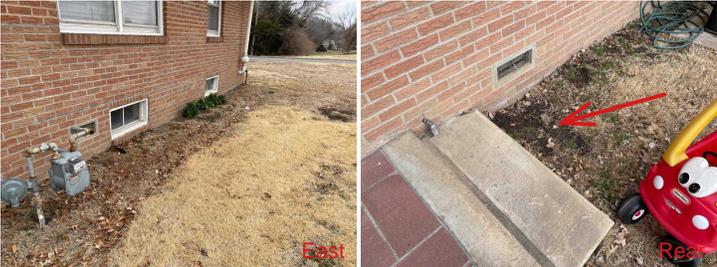
- 4. Drainage: Low areas noted. This may allow water to pool near the foundation. Recommend backfilling for proper drainage.

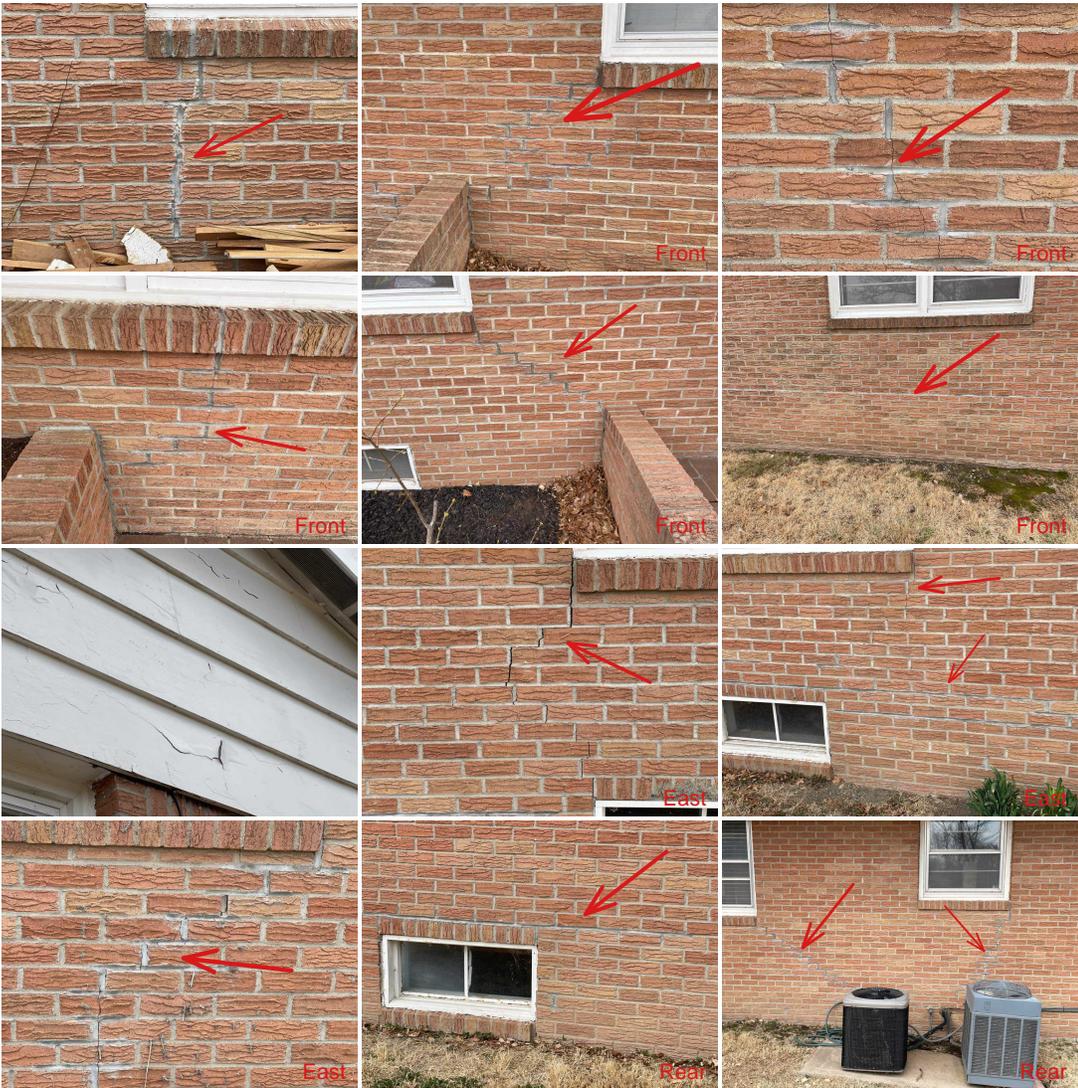
- 5. Wall Surface: Brick, Wood - Cracked bricks and mortar noted. Some cracks have been sealed. Recommend sealing cracks as needed.

Peeling paint noted. Paint maintenance is recommended.

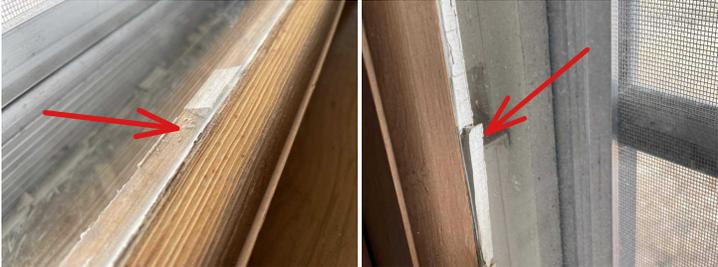
6. Windows: Cracked/missing glazing noted at some windows. Repair as needed is recommended.

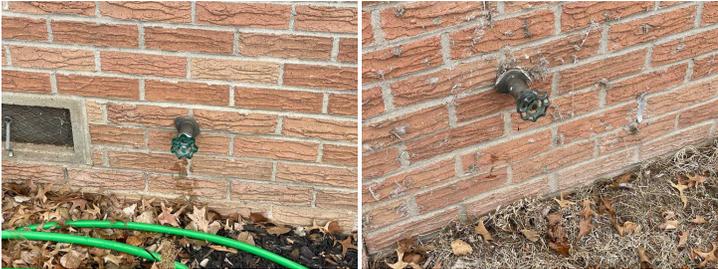
7. Hose Bibs: Hose bibs not connected to the house. This can allow for pipe movement when the valve is operated, and may lead to leaks due to stress on pipe joints. Recommend securing the hose bibs to the house.

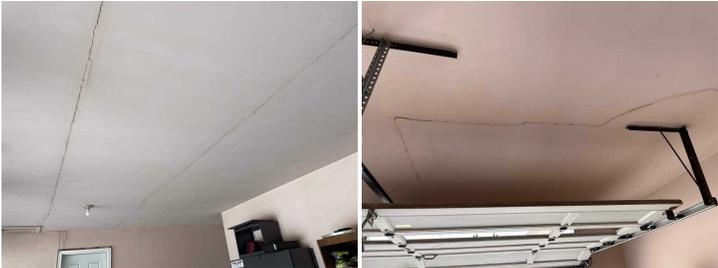
8. Ceiling: Cracks noted.

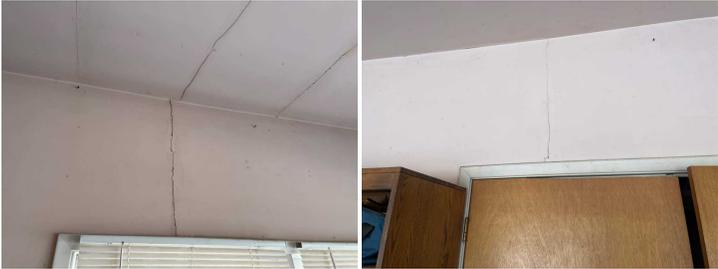
9. Interior Walls: Cracks noted.

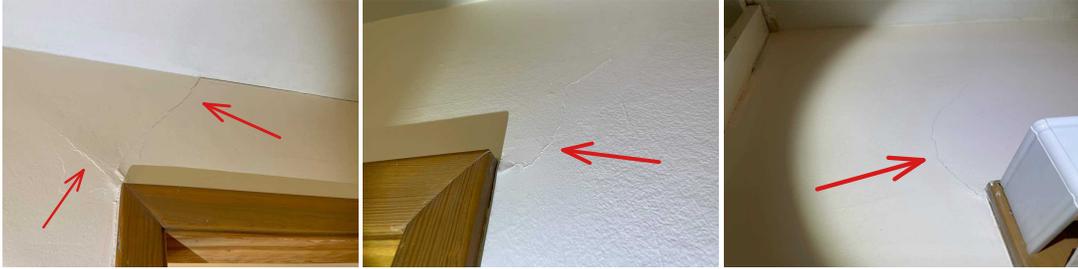
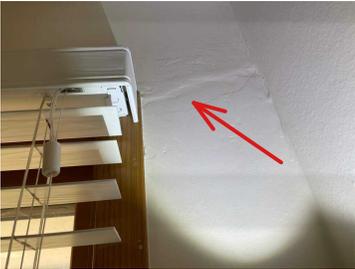
11. Walls: Cracks noted.

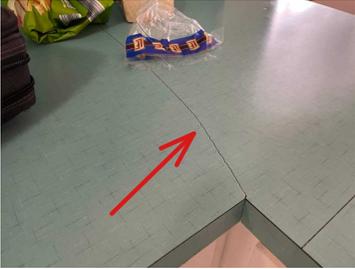
12. Counter Tops: Cracked countertop noted. Consider repair.

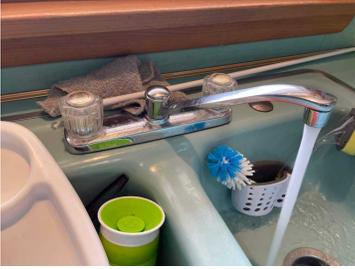
13. Plumbing/Fixtures: Faucet is loose. Repair is recommended.

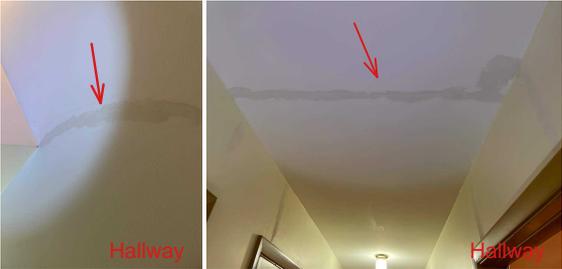
14. Living Space Ceiling: Cracks noted.

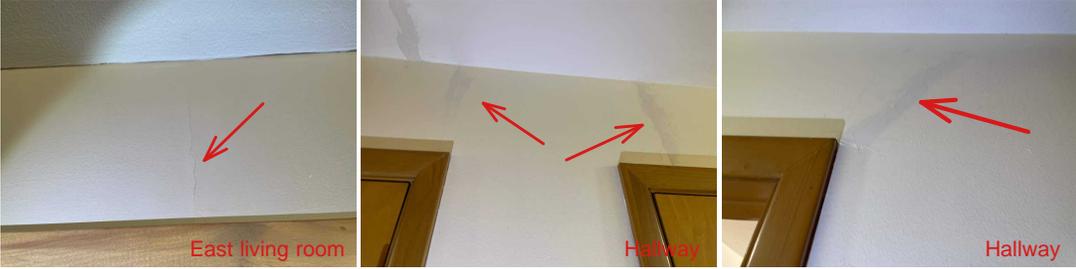
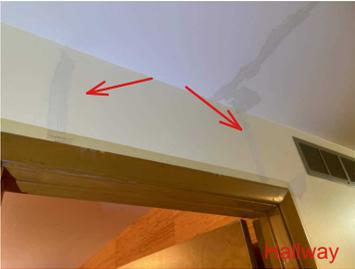
15. Living Space Walls: Cracks noted.

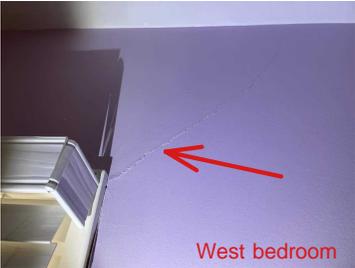
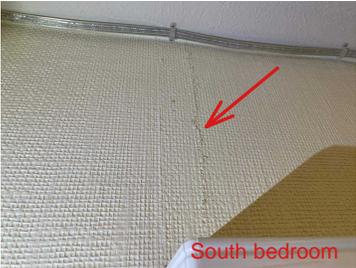
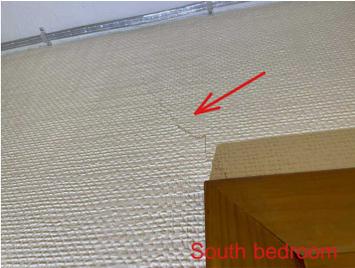
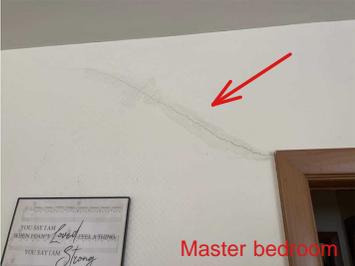
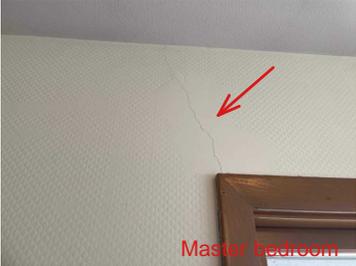
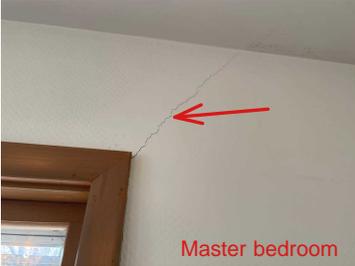
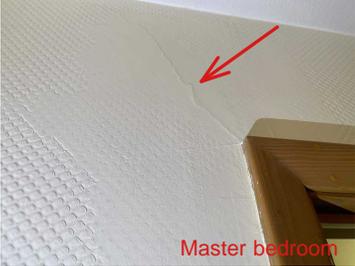
16. Bedroom Walls: Cracks noted.

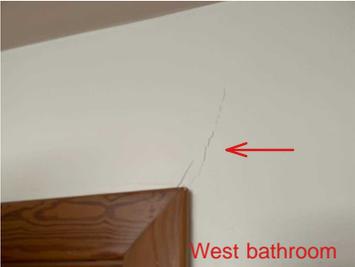
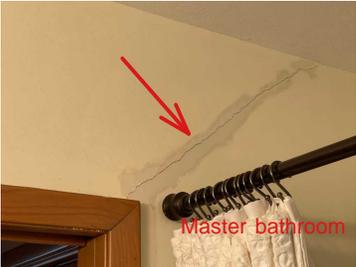
17. Bathroom Walls: Cracks noted.

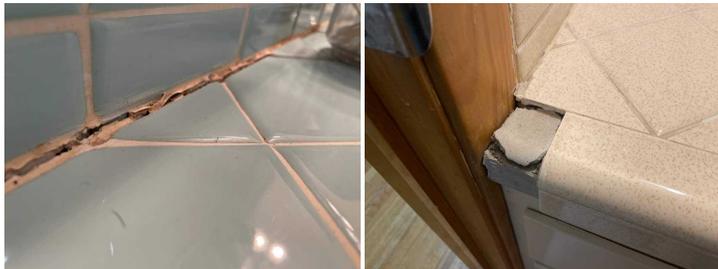
18. Bathroom Counter/Cabinet: Caulking/sealant is cracked at vanity in master bathroom. Repair is recommended.

Damaged tile noted in hall bathroom. Consider repair.

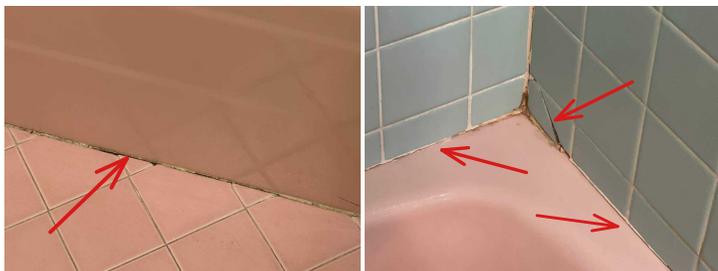
19. Bathroom Tub: Sealant at the base of tub in master bathroom is worn, cracked or missing. Recommend sealant.

Cracked tile and sealant at tub surround noted. Recommend maintenance.

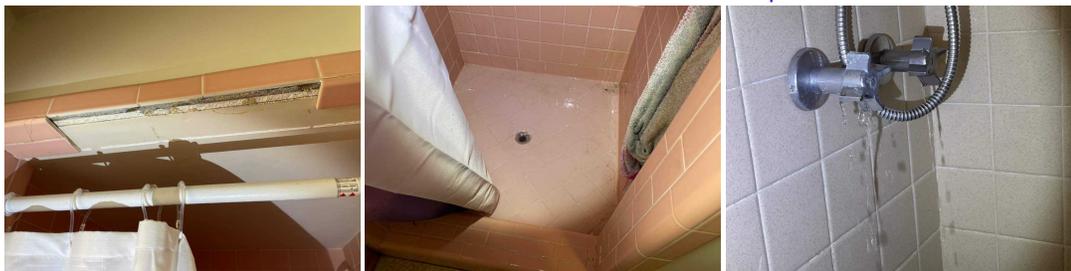
20. Bathroom Shower: Damaged tile noted at shower in west bathroom. This shower also drains slowly. Consider repair.

Leaks noted at hot and cold valves in hall shower. Consider repair.

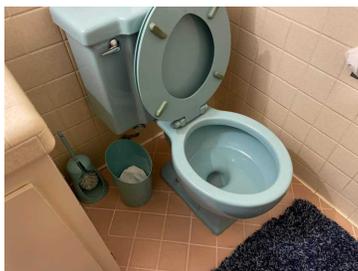
21. Bathroom Toilets: Toilet in hall bathroom not flushing properly (must hold handle down during flush). Repair is recommended.

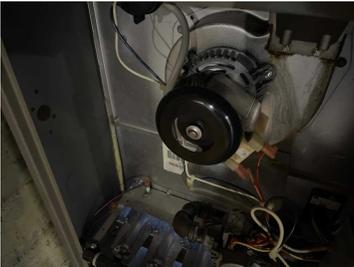
23. Heating System System Operation: Draft inducer is noisy. Service by a qualified HVAC technician is recommended.

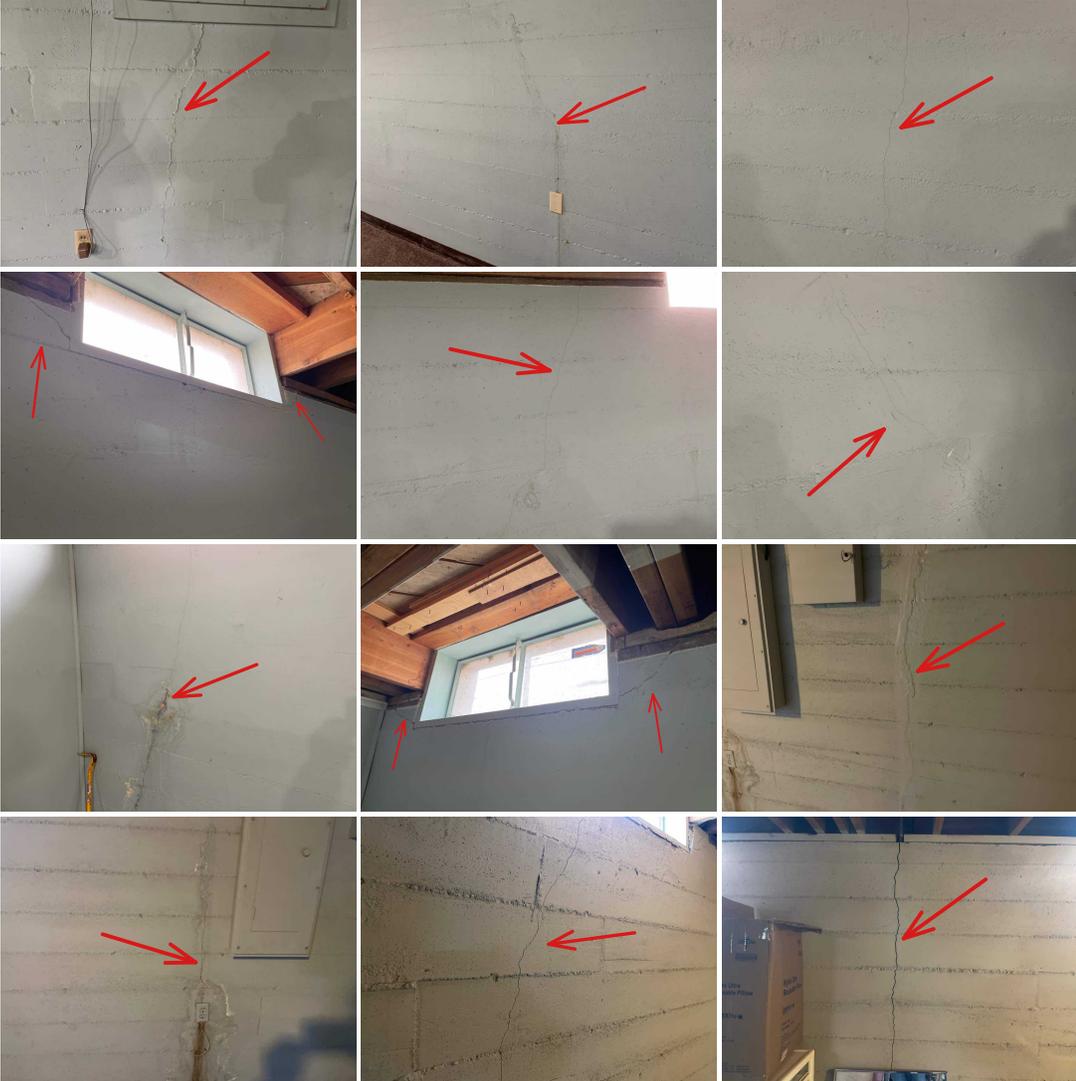
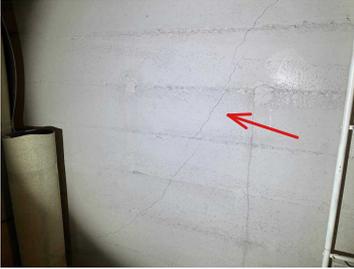
24. Foundation: Poured - Cracks noted. Consider further evaluation by a qualified foundation contractor.

25. Movement: Past structural movement is suspected. There are multiple exterior cracks, interior wall/ceiling cracks, and foundation cracks. Further evaluation by a qualified foundation contractor is recommended.

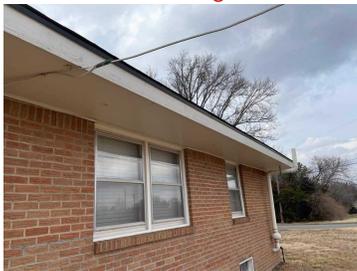
1. Gutters: **Guttering at east side is missing. Adding guttering is recommended for improved drainage.**

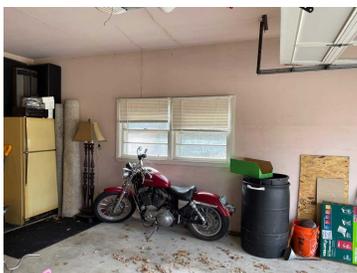
2. Windows: **The windows will not open. Repair is recommended.**

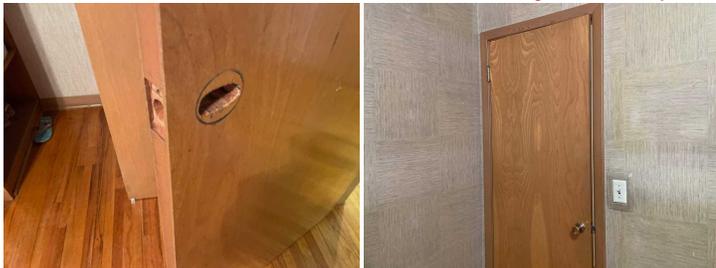
4. Bedroom Doors: **Missing hardware noted at door to center bedroom. Repair is recommended.**

Door to north bedroom will not close (hits jamb). Repair is recommended.

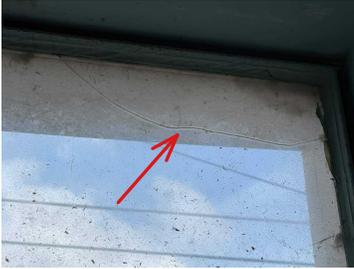
5. Windows: **Broken glass noted at east window. Recommend replacing the broken glass.**

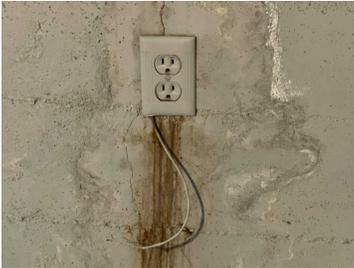
6. Smoke Detector: No smoke detector present. Recommend adding smoke detector.
7. Electrical: Water was observed running through the outlet near the breaker panel. Evaluation of the electrical in this area should be performed by a qualified electrician.

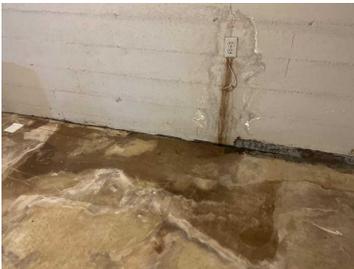
8. Moisture Present: Moisture at the east wall present at the time of inspection. Future evaluation and repair by a qualified basement waterproofing contractor is recommended.
