Topeka Electric Motor Repair Inc. 605 S.W. Lane st. Topeka, Ks. 66606

This test was done to confirm the existence of circulating shaft currents.

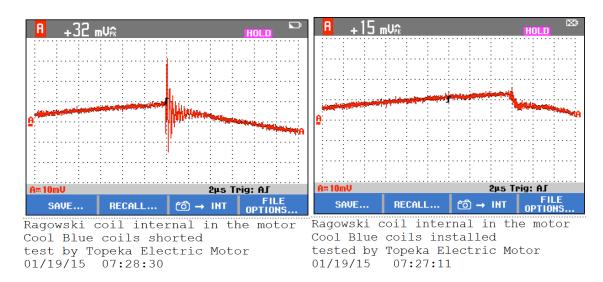
The Ragowski coil was installed around the rotor shaft between the bearing and the rotor.

In test # 1 the Cool Blue coils were shorted out to simulate that the motor was being powered from the VFD only. Note 32 mv

In test # 2 the Cool blue coils were not shorted, to show the effect reducing the internal shaft currents. Note 15 mv.
