FORENSIC ENGINEERING REPORT

Regarding: Adams Landing Association
3444 Adams Shore Dr.
Waterford, MI 48329-4202

Client: Farmers Insurance Exchange
Reference Number: 7001953401-1
Nederveld File Number: 20805347
December 3, 2020

The purpose of our investigation was to determine the cause of the third-floor sagging.

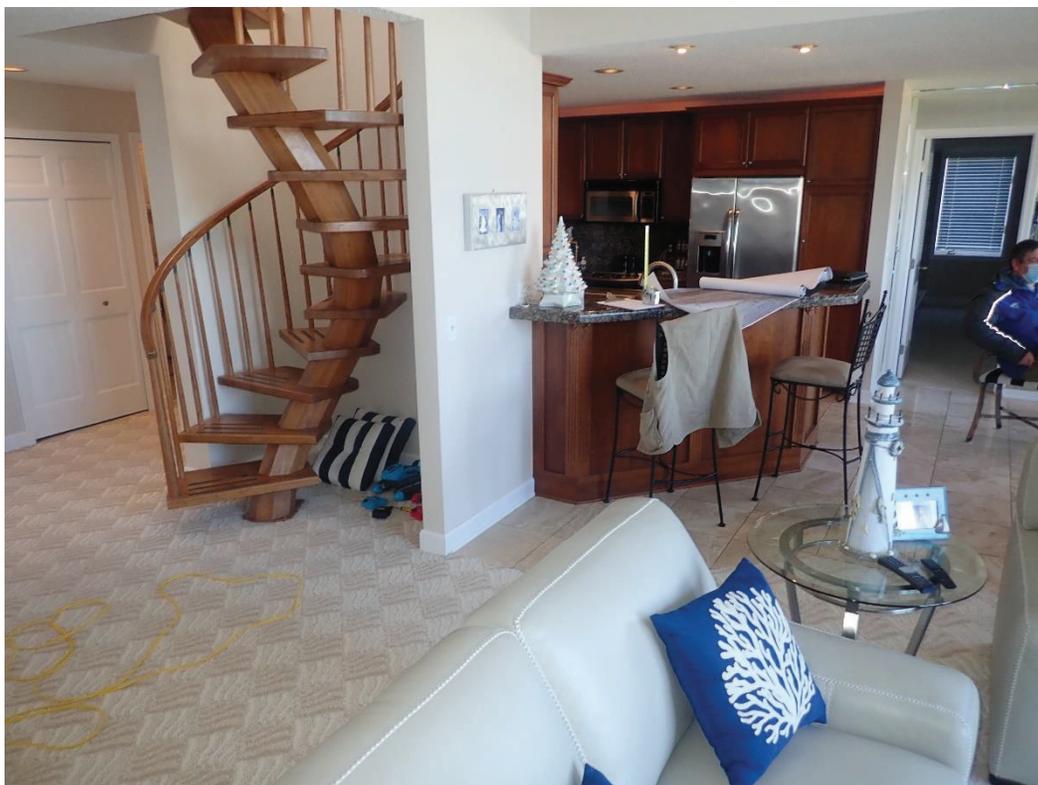
Photo #2 – Unit 3444: Spiral stair, northwest corner of stair walls on right side of stair.

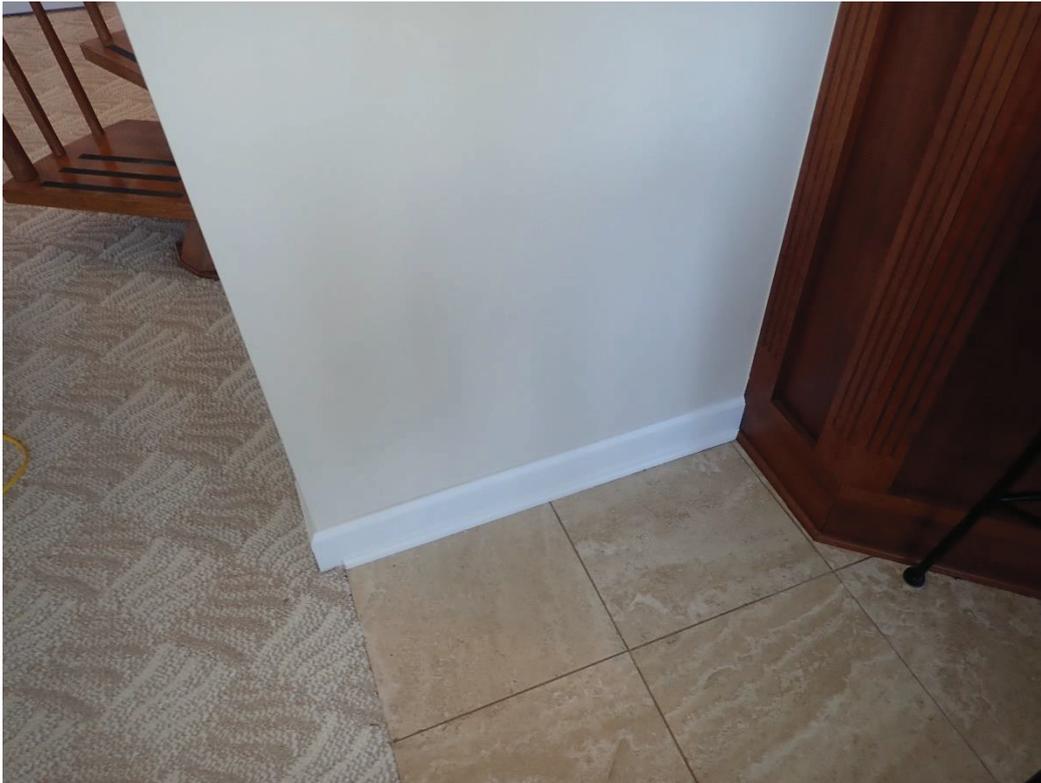
- l) We observed no evidence of gypsum board cracking in the walls or ceiling in the vicinity of the northwest corner of the spiral stair walls.
 - m) We observed no evidence of gypsum board or floor finishes (ceramic tile) cracking in the vicinity of the northwest corner of the spiral stairs.

Photo #3 – Unit 3444: Wall and floor tile in vicinity of northwest corner of spiral stair walls; no wall or floor finish cracks evident.

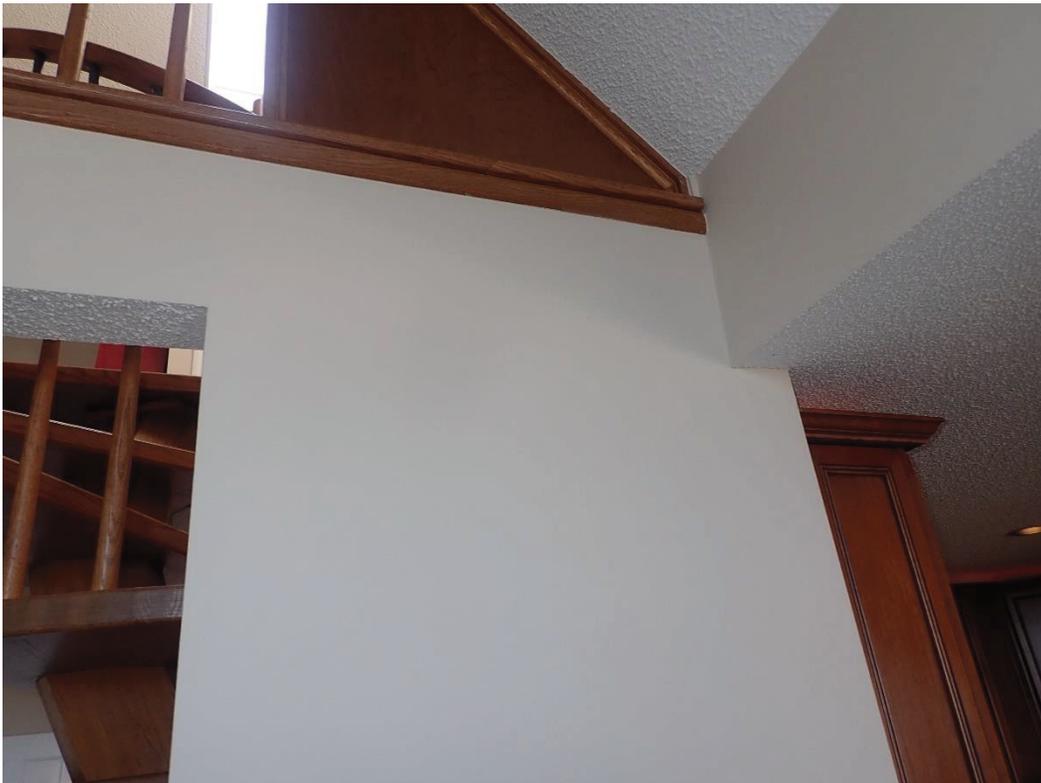
Photo #4 – Unit 3444: Wall and wall openings in vicinity of northwest corner of spiral stair walls; no significant gypsum board cracks evident.

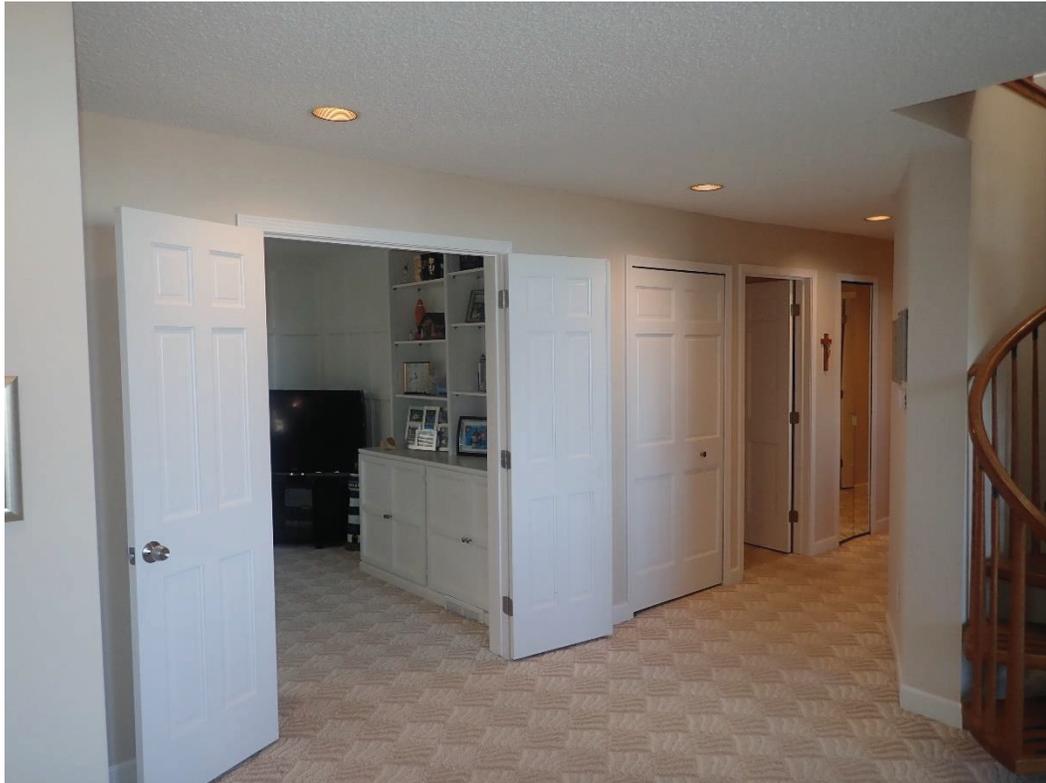
- v) The doors to rooms in the south hallway operated without difficulty.
 - w) We observed no evidence of significant finish cracks in the ceiling or walls in the south hallway.

Photo #5 – Unit 3444: No gypsum board cracks in walls or wall opening in south hallway.

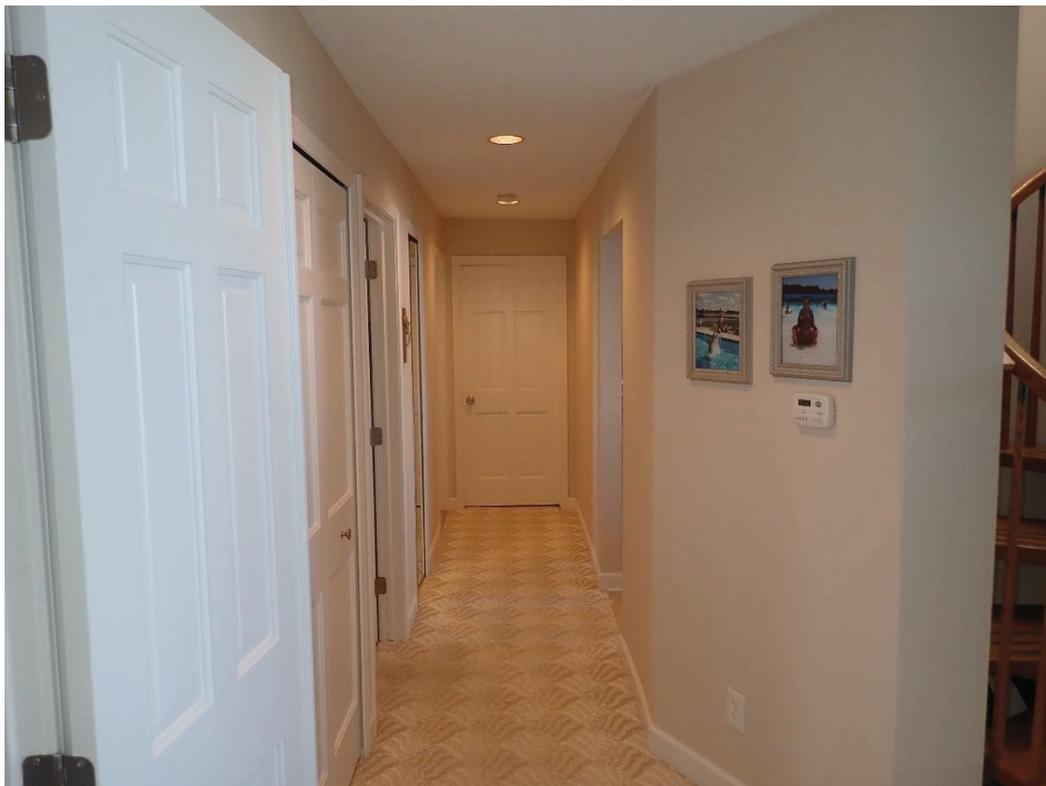
Photo #6 – Unit 3444: South hallway, door to southwest bedroom at west end of hallway (background).

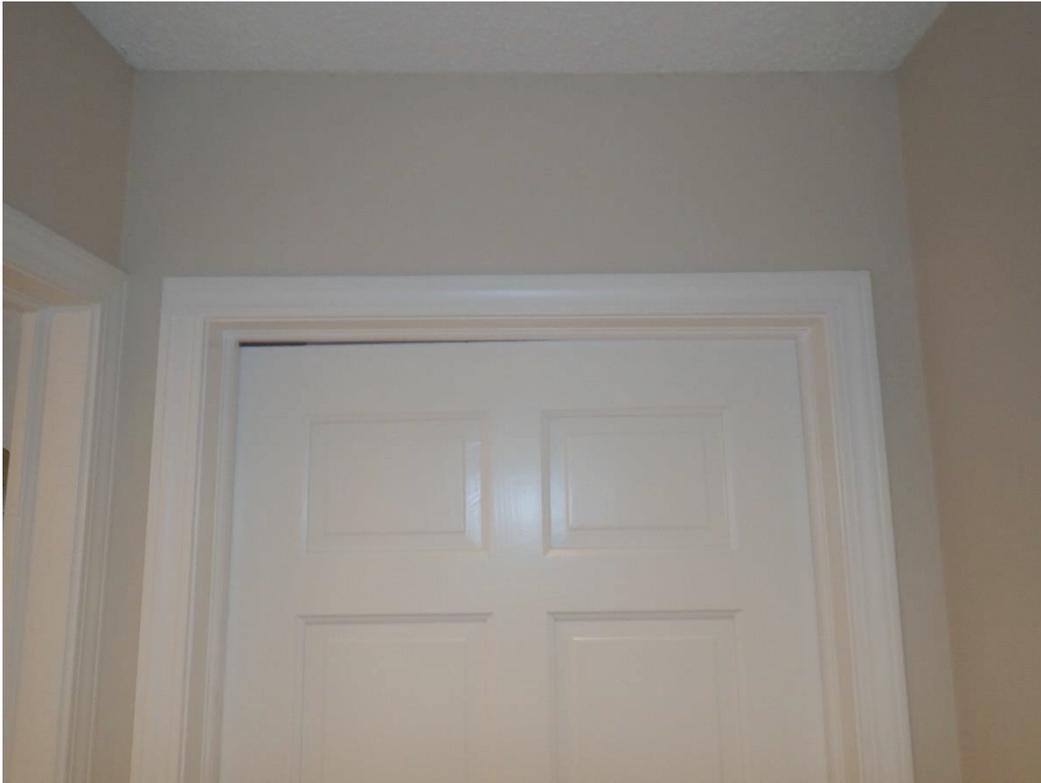
- o) The door to the southwest bedroom is at the west end of the hallway.
 - p) The door to the southwest bedroom operated without difficulty.
 - q) There is a gap on the south side of the door to the southwest bedroom, between the top of the door and the door trim.

- u) There are no gypsum board or paint cracks around the door opening to the southwest bedroom or ceiling indicating no recent displacement. The tapered gypsum board above the door was present when the walls were painted and predate the loss event.

Photo #7 – Unit 3444: Gap at top of door to southwest bedroom, west end of south hallway; no gypsum board cracks.

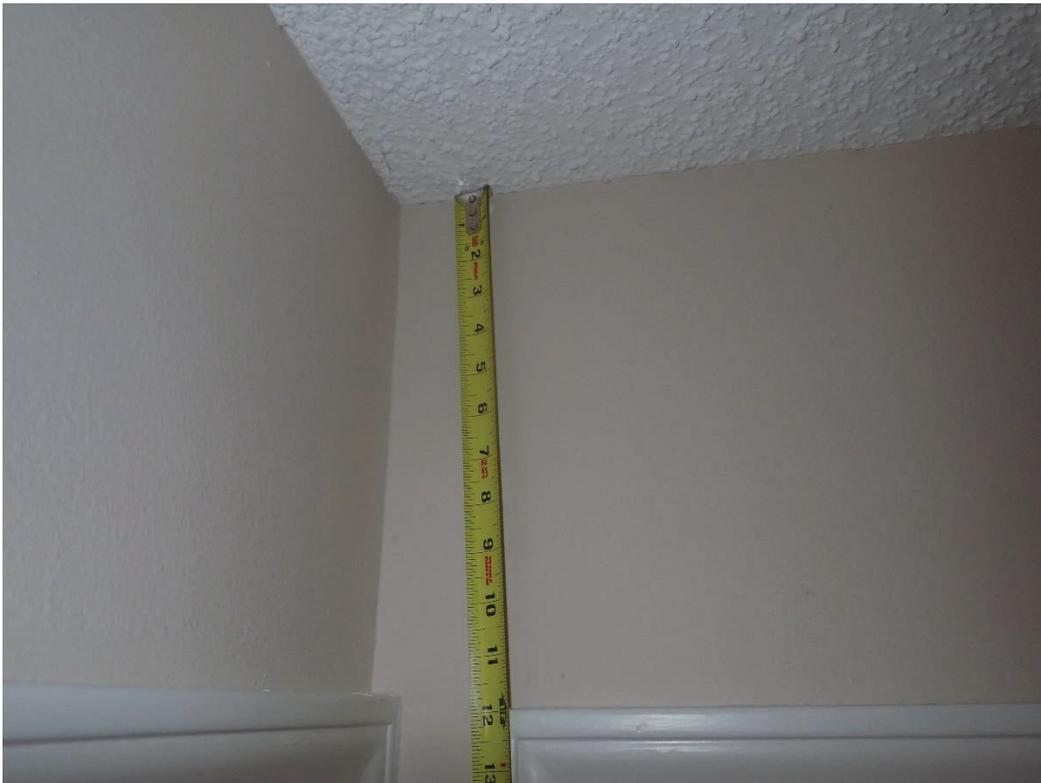
- r) The door head trim measured level.
 - s) The ceiling above the door to the southwest bedroom is sloping downward approximately 1/4" in 12".
 - t) The gypsum board above the door to the southwest bedroom is tapered. The top of the door head trim is 12" below the ceiling on the south side of the door and 11-1/2" below the ceiling on the north side of the door.

Photo #8 – Unit 3444: Door to southwest bedroom, south edge of top of trim 12" below ceiling.

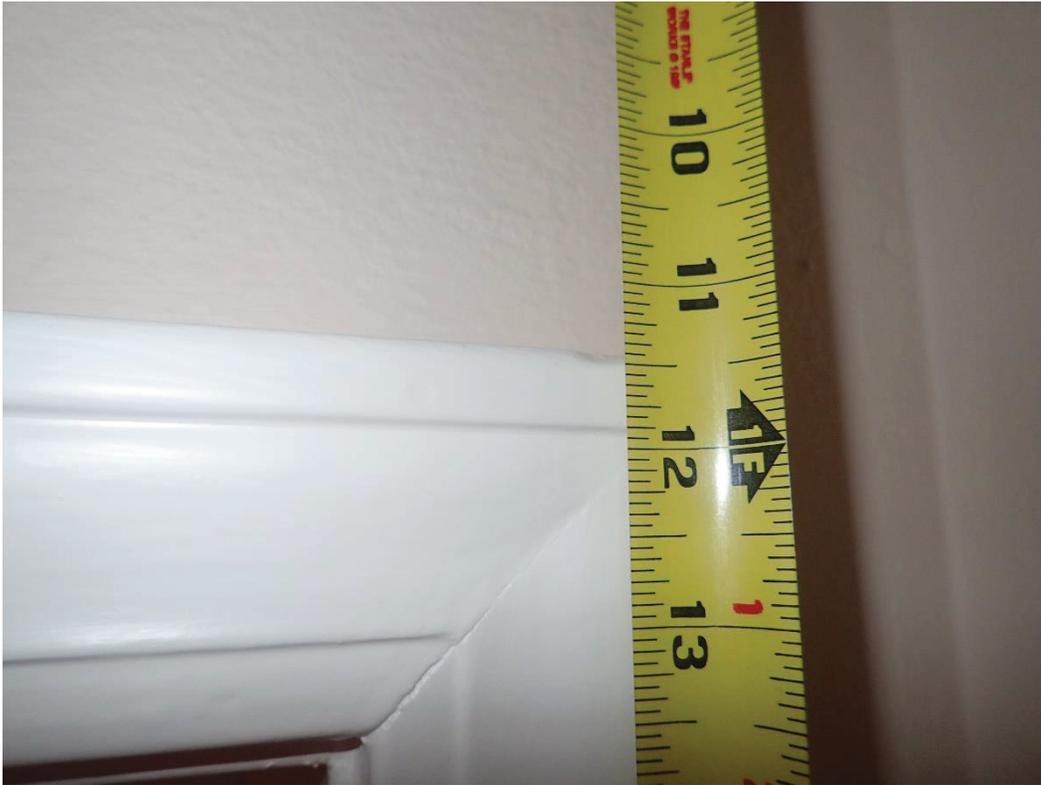
Photo #9 – Unit 3444: Door to southwest bedroom, north edge of top of trim 11-1/2" below ceiling.

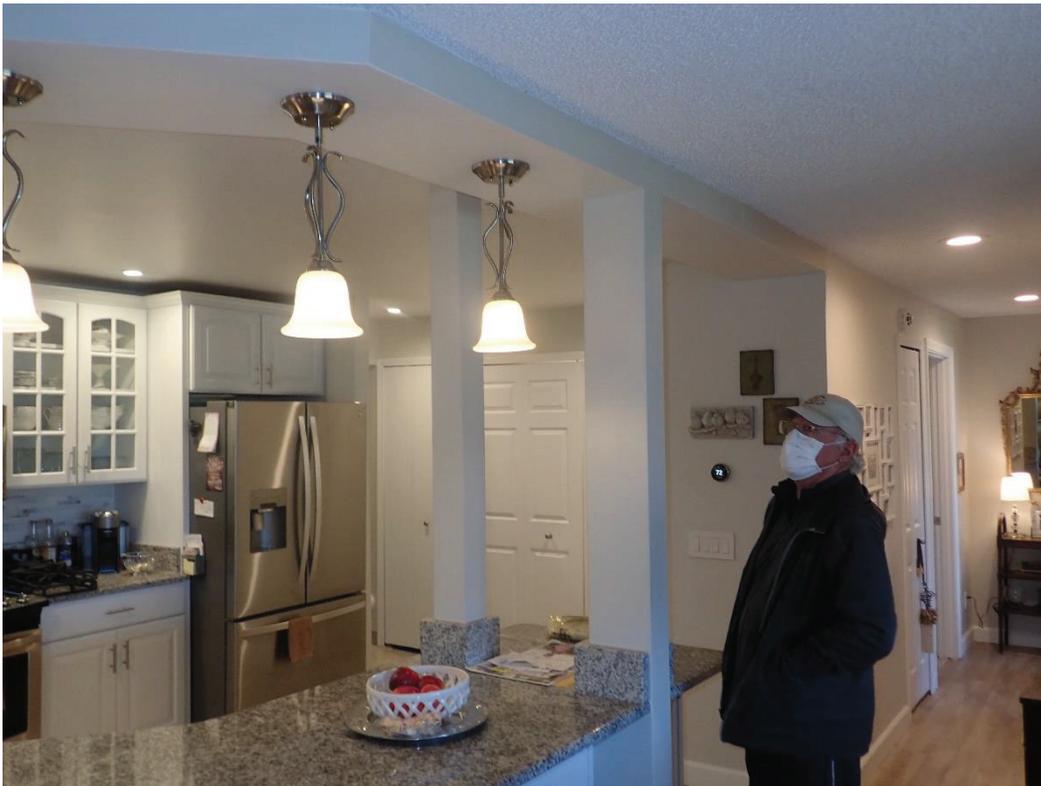
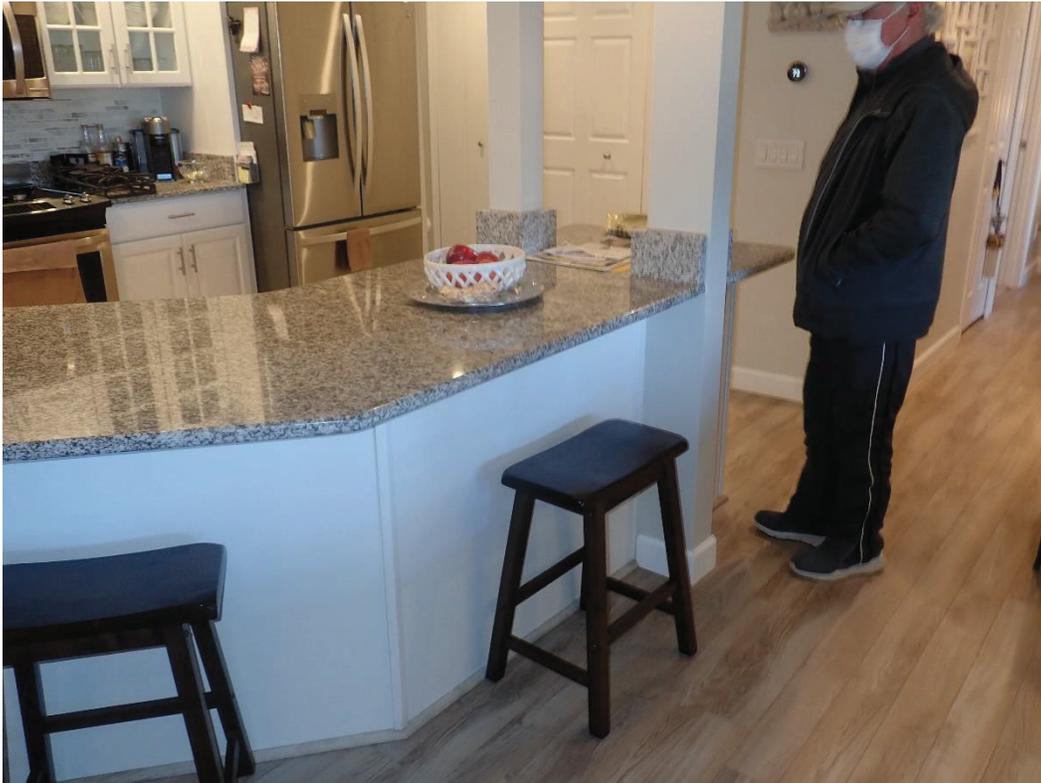
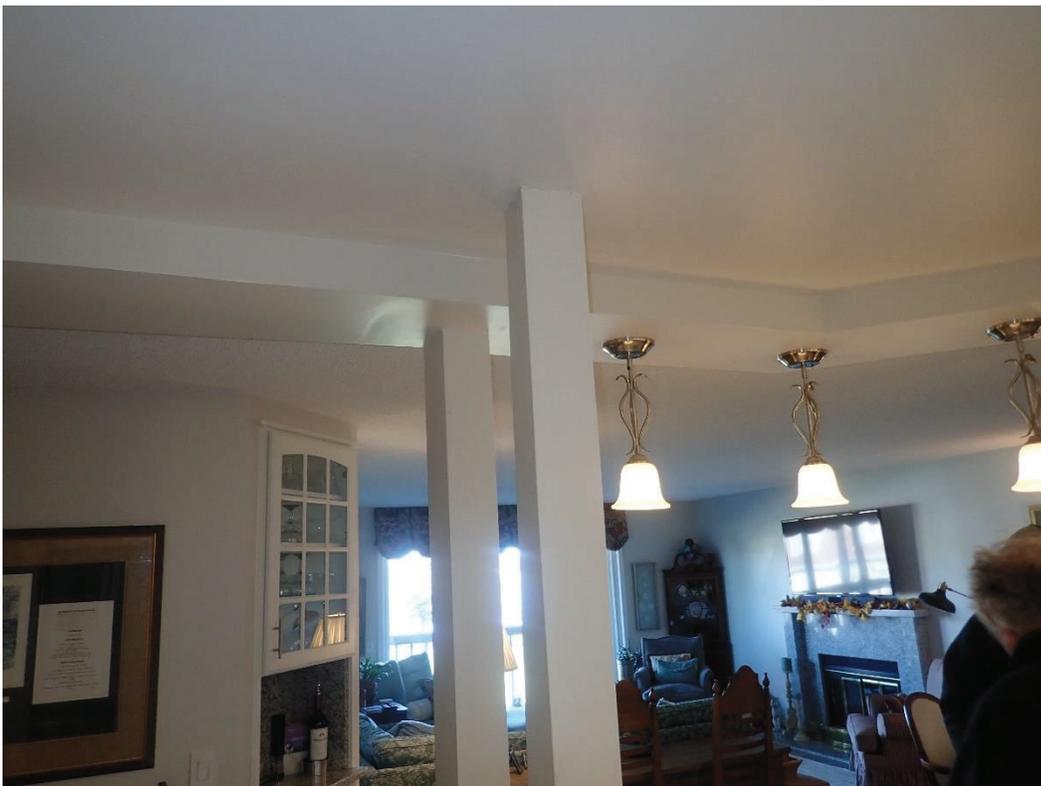
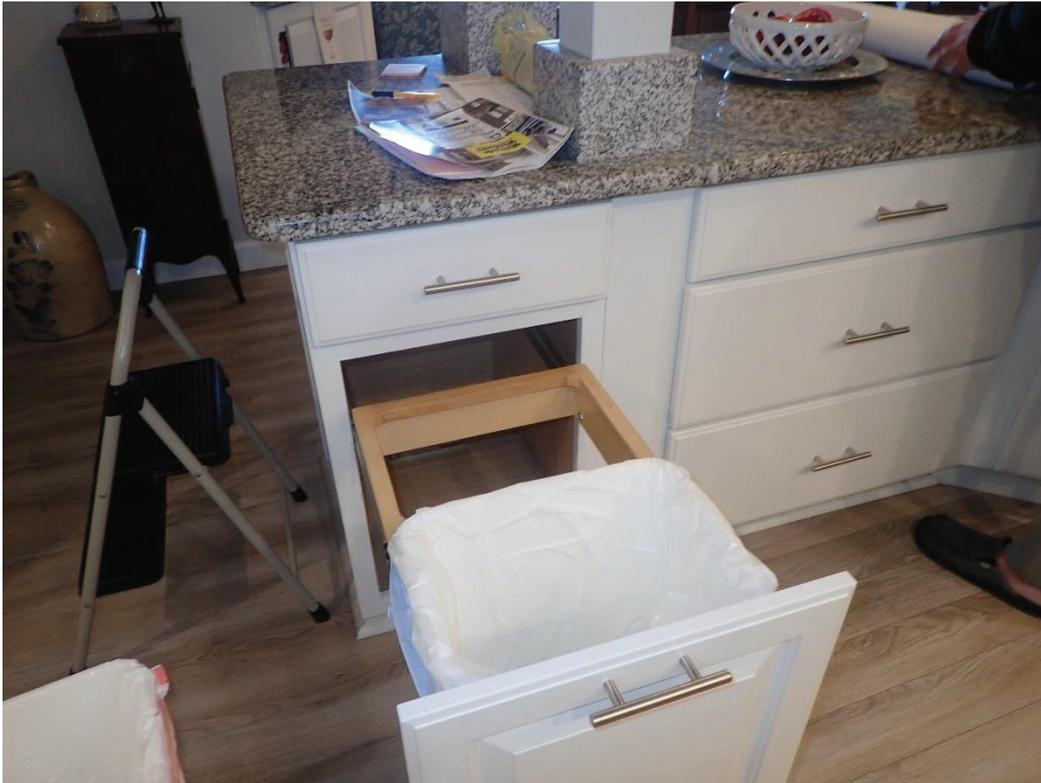
- b) Posts at former pantry corners:
 - i) There are posts, covered with painted gypsum board, located at the northeast and southeast corners of the former kitchen pantry, as shown on the plans.

- ii) It appears the south post supports the south 3-1/8"x10-1/2" Glulam floor beam over the kitchen and the north post supports the north 3-1/8"x10-1/2" Glulam floor beam over the hallway opening.

- 1) It is our opinion that it is unlikely the floor framing (the north and south 3-1/8"x10-1/2" Glulam floor beams) for Unit 3444 was left unsupported, as reported, when the pantry walls were removed by the previous owner at the west end of the kitchen counter in Unit 3442. We estimate that the reaction at the ends of those beams, which are now supported by post assemblies, is approximately 2,500 pounds each for the self-weight (dead load) of the floor and roof girder truss for Unit 3444. The floor framing would have failed, and significant downward displacement would have occurred at that location if left unsupported for even a short period of time. However, this opinion does not attempt to validate that the framing installed is structurally adequate since we did not have the opportunity to inspect and evaluate (requires destructive examination).

Photo #10 – Unit 3442: Posts supporting floor beams above; formerly in east wall of pantry that was removed.

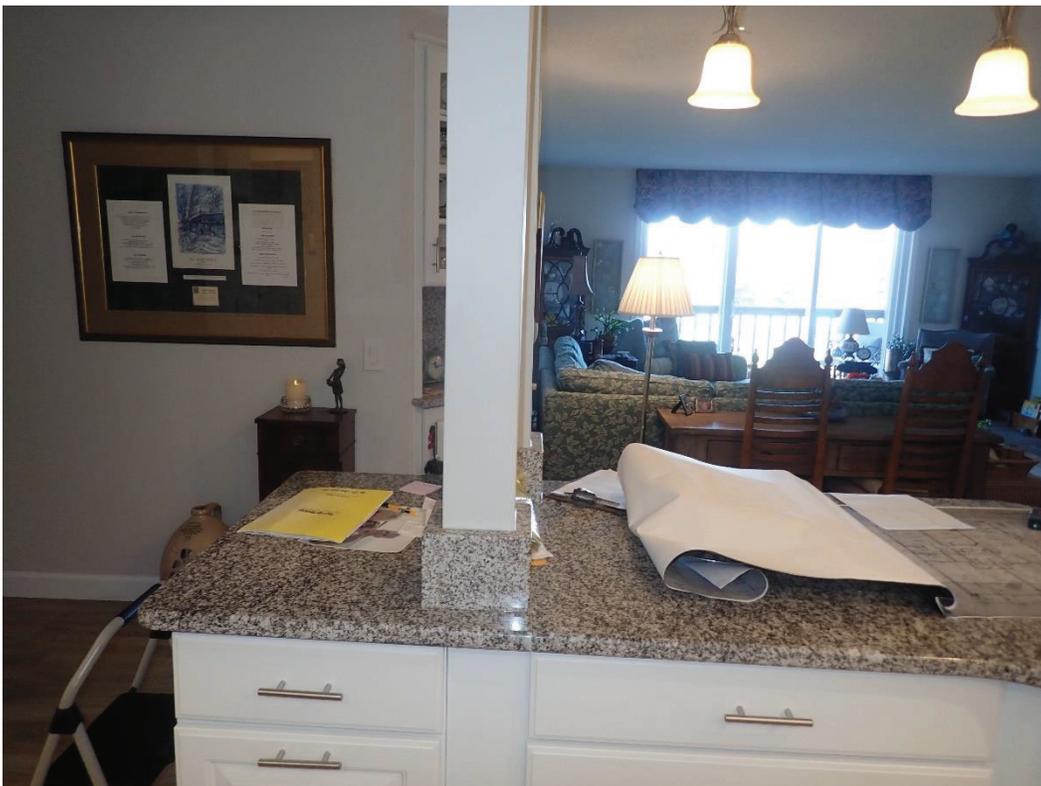
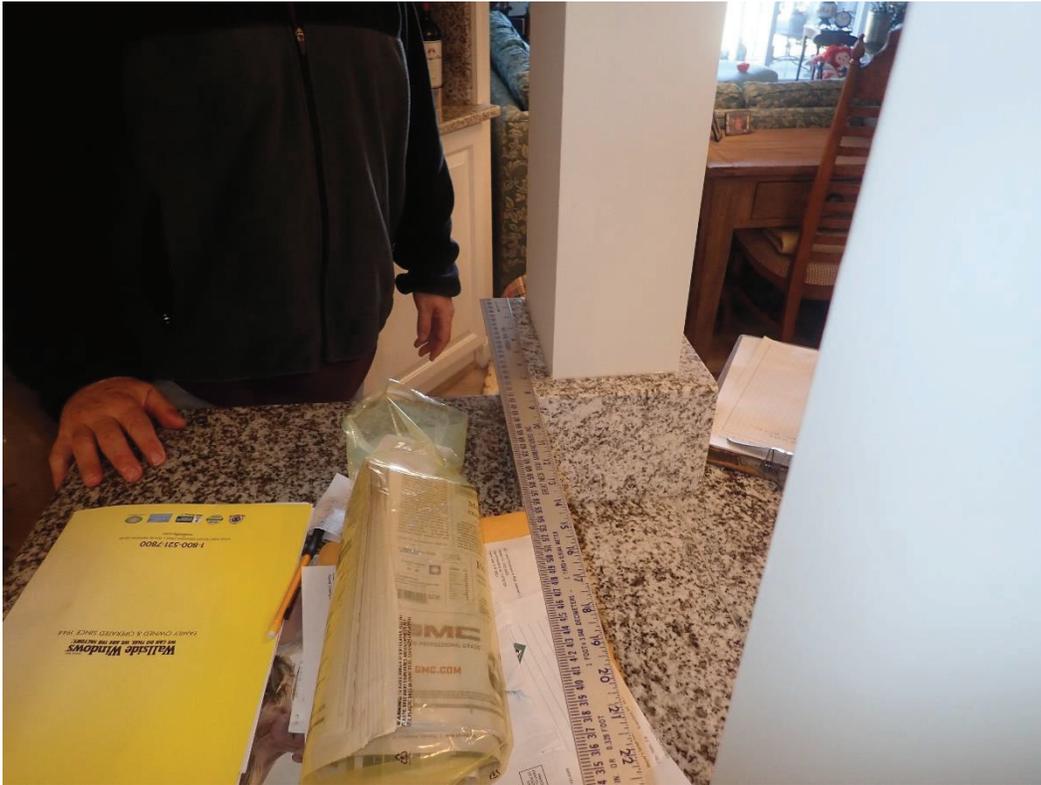
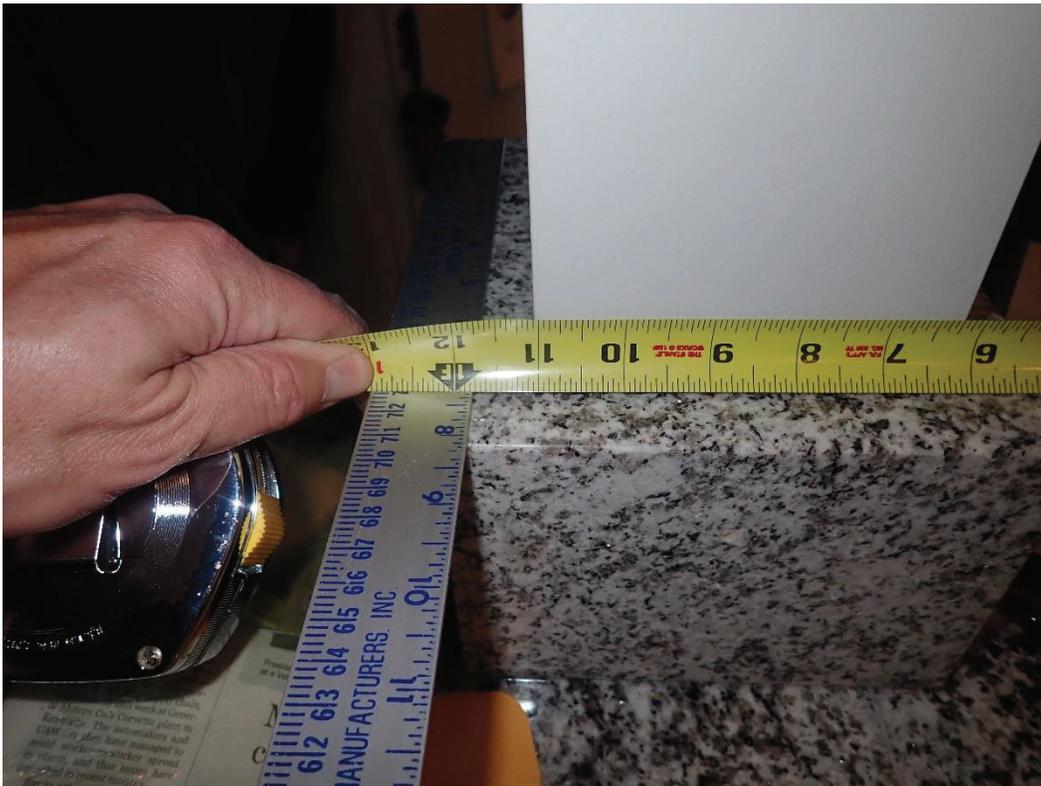
Photo #14 – Unit 3442: South post out-of-alignment with north post, 3/4" toward west.

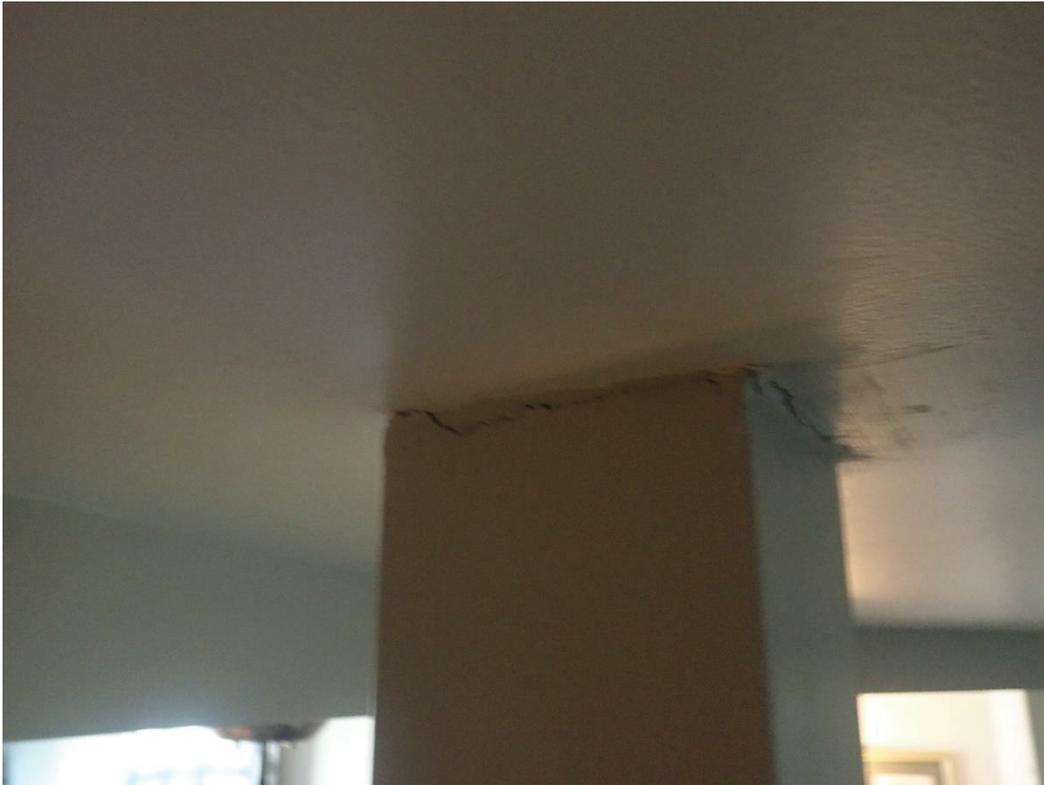
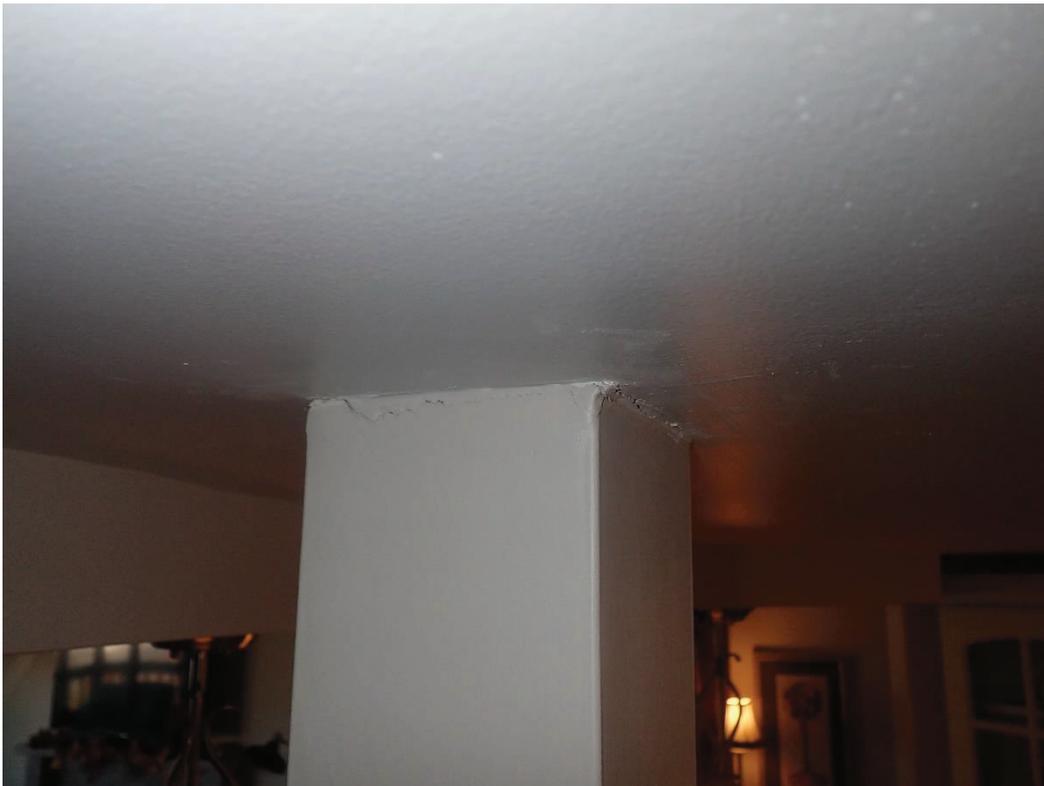
- iv) There are gypsum board finish cracks at the top of the south post. The cracks and surrounding region of the ceiling present as poorly finished by the previous owner.

- 2) The finish cracks in the ceiling gypsum board around the top of the south post assembly and the west end of the kitchen counter in Unit 3442 presents as poor finishing by the previous owner and do not indicate adverse structural conditions.

Photo #17 – Unit 3442: Gypsum board finish cracks at top of south post.

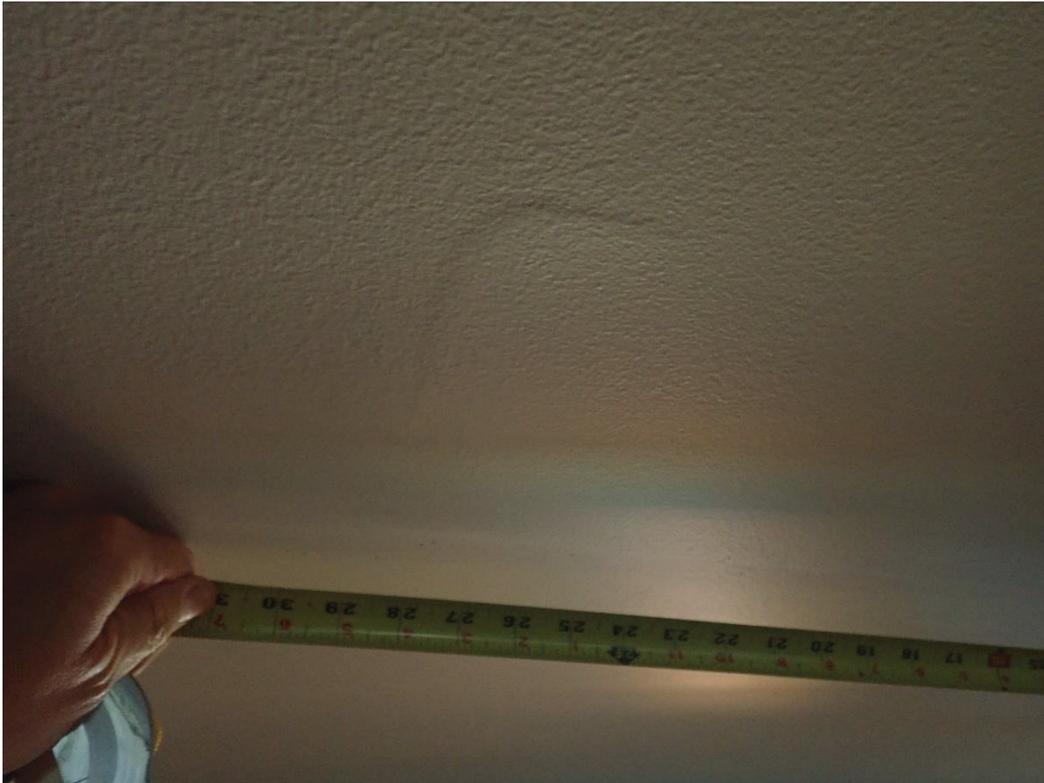
- c) We did not observe evidence of significant gypsum board cracks in the ceiling or walls in other regions of the unit.
 - d) There is an "L-shaped" bump or raised area in the ceiling gypsum board finishes approximately 26" west of the top of the south post.

- 3) The L-shaped raised area in the ceiling gypsum board finishes, approximately 26" west of the top of the south post, is located at the southwest corner of the previous pantry and presents as poorly finished by the previous owner and does not indicate adverse structural conditions.

Photo #19 – Unit 3442: Bump in ceiling gypsum board finishes approximately 26" west of south post, formerly southwest corner pantry that was removed.

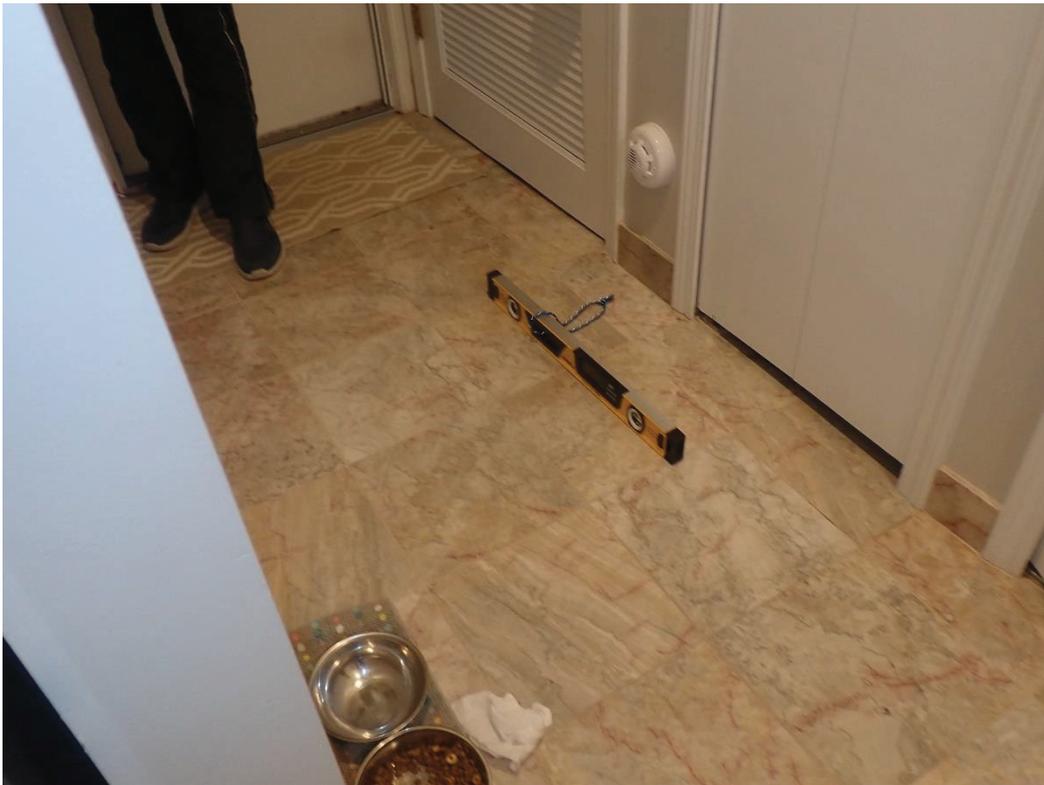
- j) The kitchen/laundry floor in the vicinity of the door to the garage on the north side of the bearing/foundation wall, is sloping up to the garage entry area approximately 3/8" on 12". That is, the southwest region of the kitchen/laundry floor is sloping up to the floor on the south foundation wall and on the south side of the foundation wall.

- c) The floor framing in Unit 3442 is similarly displaced downward as evidenced by the kitchen/laundry floor sloping up to the south foundation/grade beam wall at the garage entry area on the south side of the south foundation wall.

Photo #20 – Unit 3442: Southwest region of kitchen/laundry floor sloping up to garage entry floor on upper left.

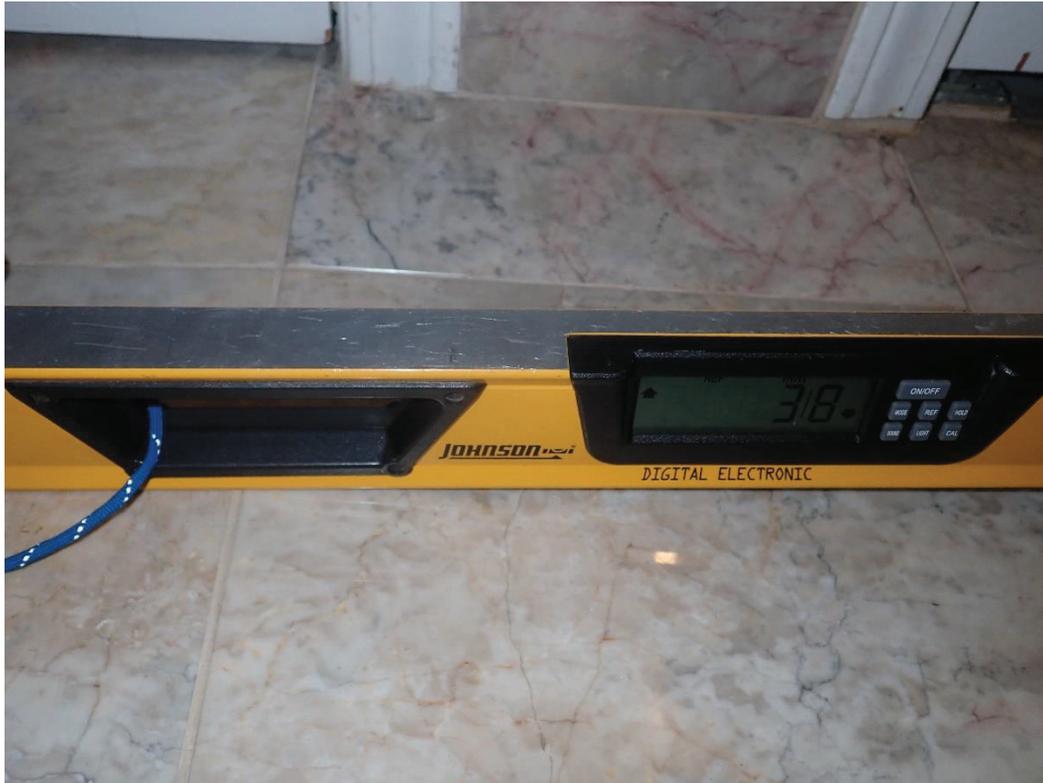
- k) The floor finishes and wall finishes are cut to fit, indicating the sloping floor is an as-built condition and pre-dates the loss.
 - l) We observed the east-west partition wall (parallel below the floor trusses) in the laundry closet, on the west side of the kitchen, was removed by the previous owner; this wall is not a bearing wall.

Photo #21 – Unit 3442: Floor sloping up to garage entry, wall finishes/tile cut to fit.
