Building Condition Report

Norton Wagon Shops

38 NANTICOKE ROAD, MAINE NY

APRIL 24, 2019

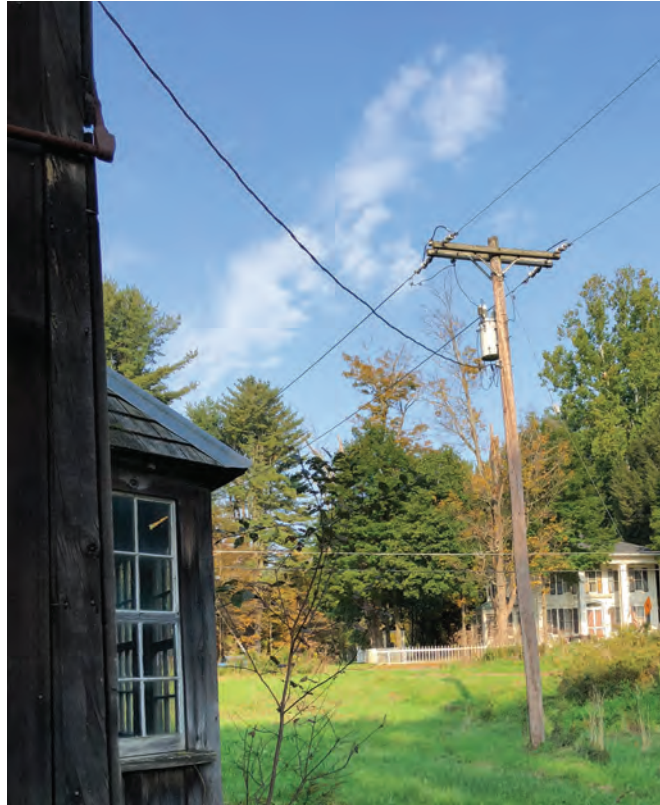
Figure 7 - Overhead Electric Service

- e. Bury the overhead electrical service to be less obtrusive to the historic nature of the site. By burying the wiring below ground, the electric service is also less prone to damage by high wind events. Consider relocating interior equipment to be less visible/obtrusive.

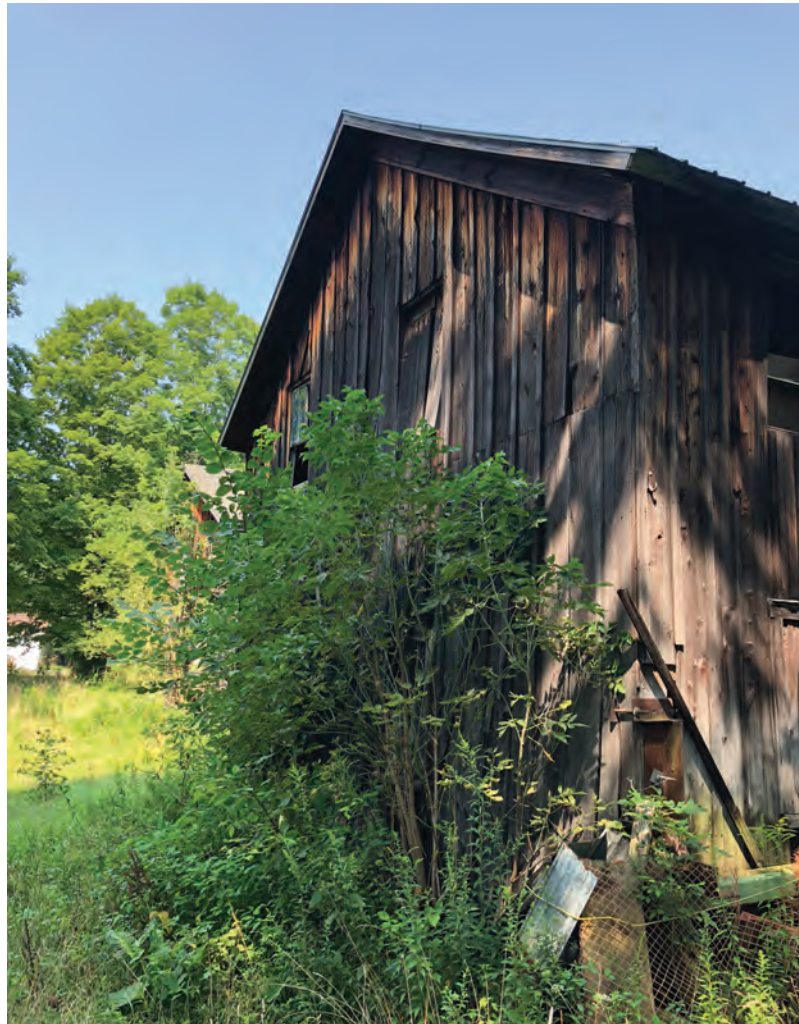
Figure 10 - description

Stockpiled materials susceptible to damage by moisture should be stored under cover. Other stored materials should not be in contact with the building's exterior as they create areas of decay much like that of organic material (refer to Fig 10 and 11).

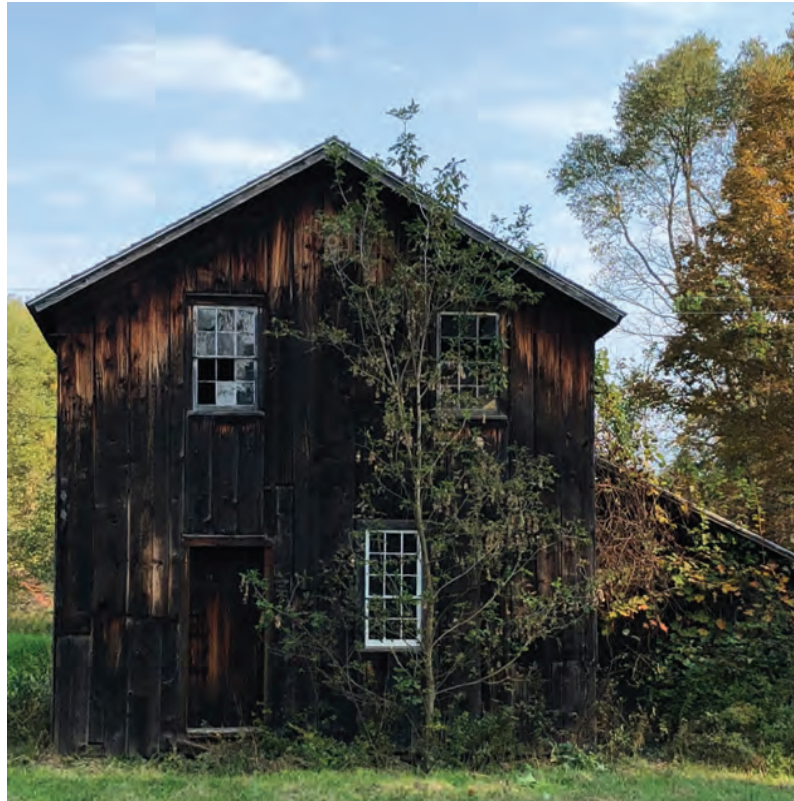
Figure 13 - South Elevation

This side of the building is the 'two story' addition that was added as noted above. It is sided with vertical wood boards. The joints between the boards are not covered with battens (refer to Fig 13). The upper boards are continuous and of a long length. Lower portions of the boards are spliced. This may be due to limited length of the boards or portions of the boards may have been replaced due to damage (refer to Fig 13 – Fig 15).

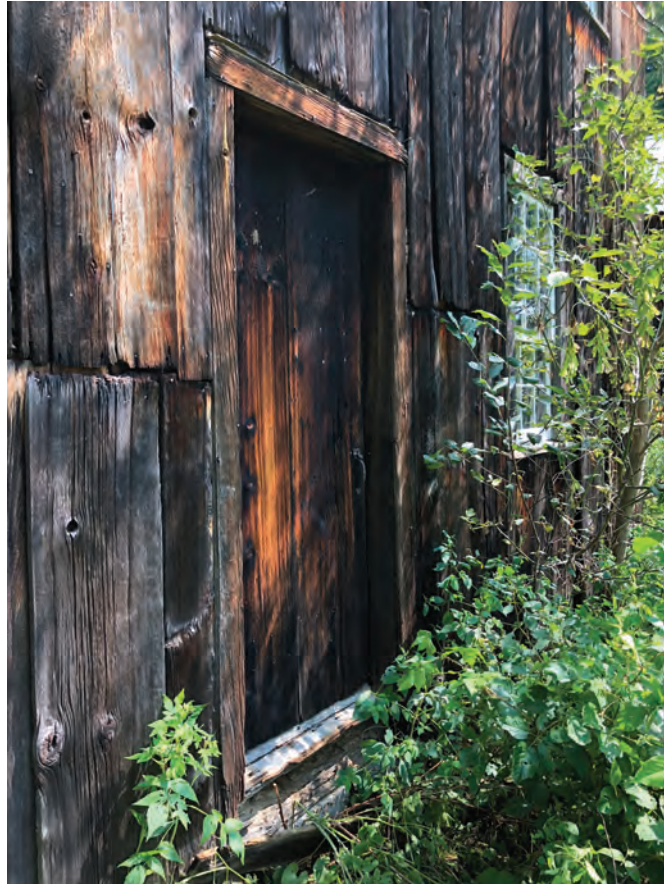
Figure 15 - South Door

There is also a single door at grade level. It consists of solid vertical wood boards. The door opens inwards and is operated with a metal door pull with thumb latch. Its wooden head flashing and adjacent siding are weathered and no longer protecting the door. The wood threshold has deteriorated such that it no longer protects the sill beam below (refer to Fig 15).

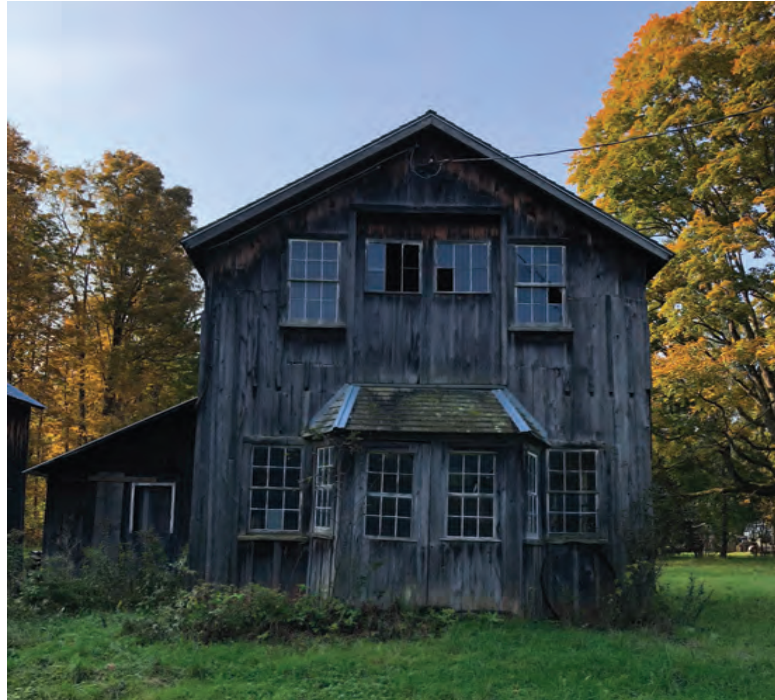
Figure 17 - North Elevation

The Shop building elevation has 2 upper and 2 lower window openings. The 2 upper windows appear to have been moved vertically as the wood siding below show signs of regular shaped infill consistent with the windows locations (refer to Fig 18). A one-story lean-to is attached to the west side of the Shop. The endwall of the lean-to is set back from the gabled end of the Shop and does not have window openings. The bayed entrance has a single window on each side. The bayed windows are of a shorter height. All window sashes are intact. Many panes of glass are missing, and there is wood and paint deterioration throughout. The window head flashing and sills show signs of severe weathering and are no longer protecting the window openings (refer to Fig 17 and Fig 18).

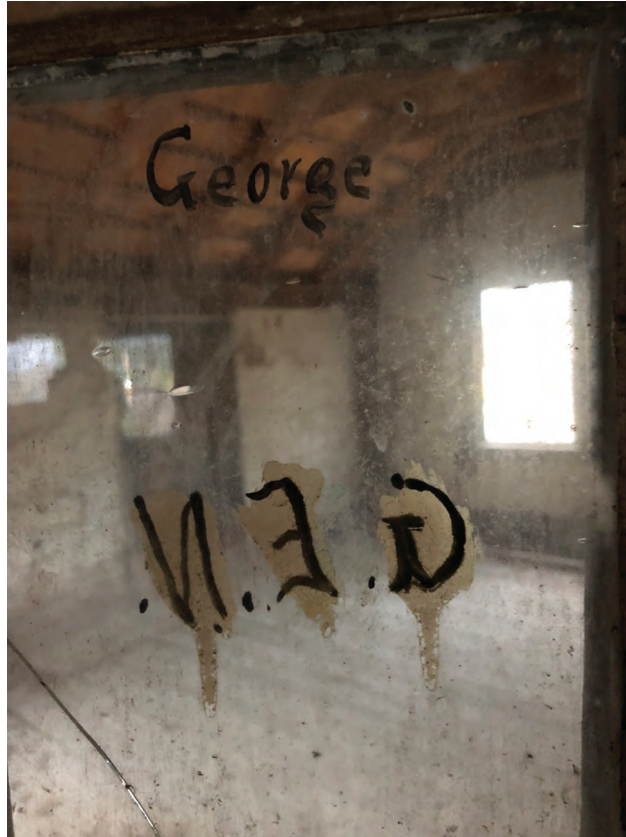
Figure 47 - Norton Graffiti Interior Second Level Door

The second level of the addition is finished with plaster on wooden lath. The plaster on the walls is mostly intact. The ceiling was removed as part of the 1970's roofing project (refer to Fig 43 to 46). Evidence of Norton graffiti can be found on the walls and on a glass pane in a door into the addition (see Fig 47).

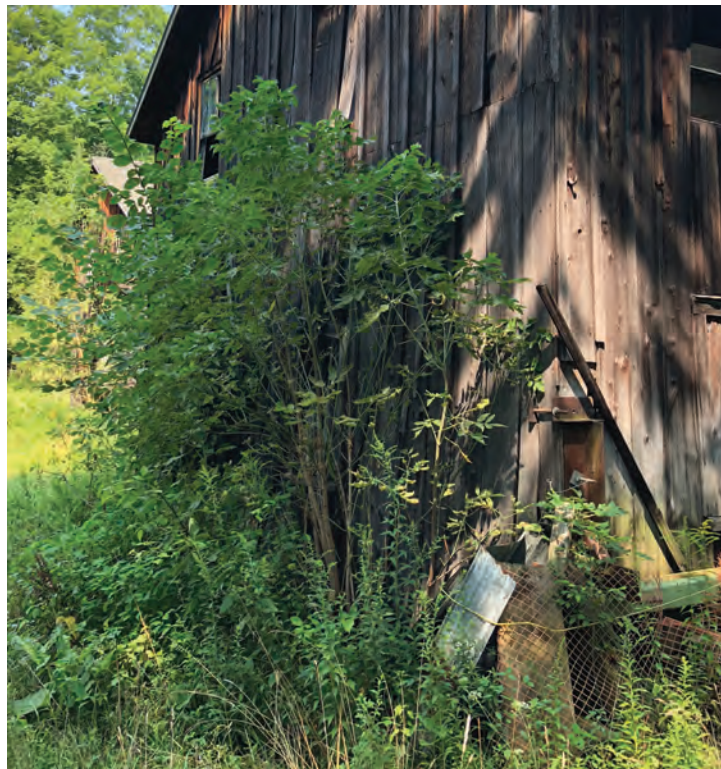
Figure 48 - description

Stored and/or loose materials should not be in contact with the building's exterior as they create areas of decay much like that of organic material. Stored materials that are susceptible to damage and rot when exposed to weather should be stored under cover (refer to Fig 48 and 50).

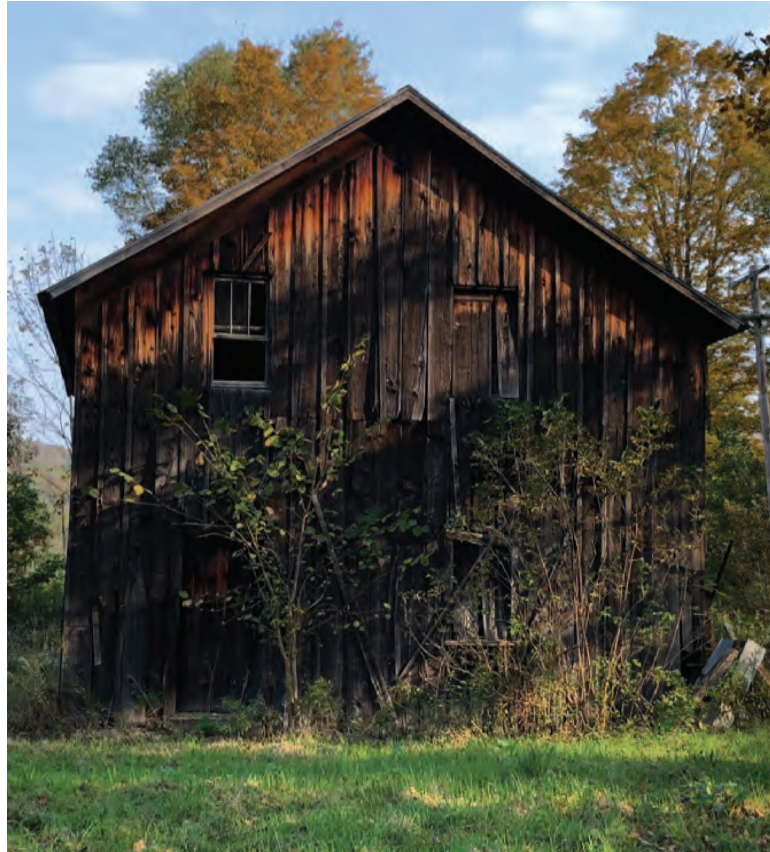
Figure 51 - South Building Elevation

This side of the building is sided with vertical wood boards and battens. Some battens are missing, and some boards are curled (see Fig 51). The boards are regularly spliced at the approximate second floor line (see Fig 52).

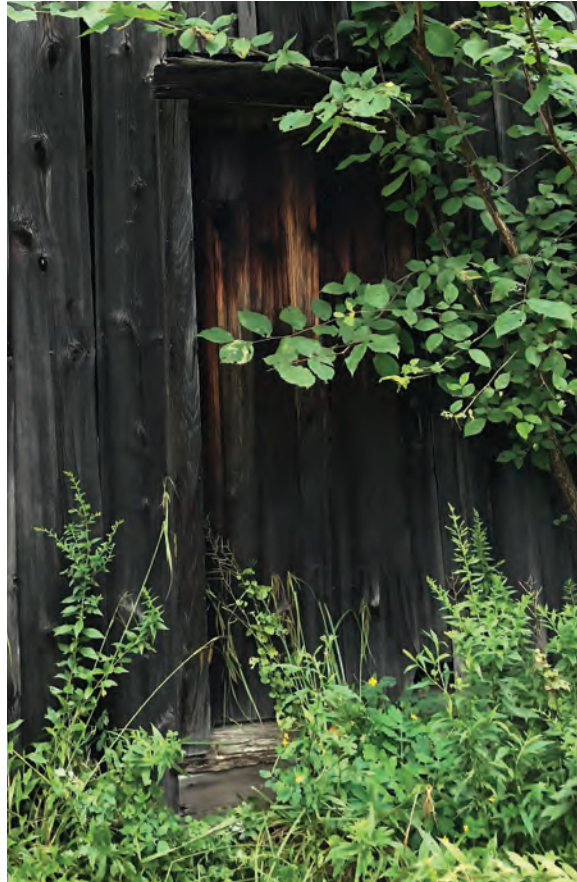
Figure 53 - description

There is also a single door at grade level. It consists of solid vertical wood boards. The door opens inwards and is operated with a metal door pull with thumb latch. Its wooden head flashing and adjacent siding are weathered and no longer protecting the door. The wood threshold has deteriorated such that it no longer protects the sill beam below (refer to Fig 53). The door has a hole in it at lower latch side.

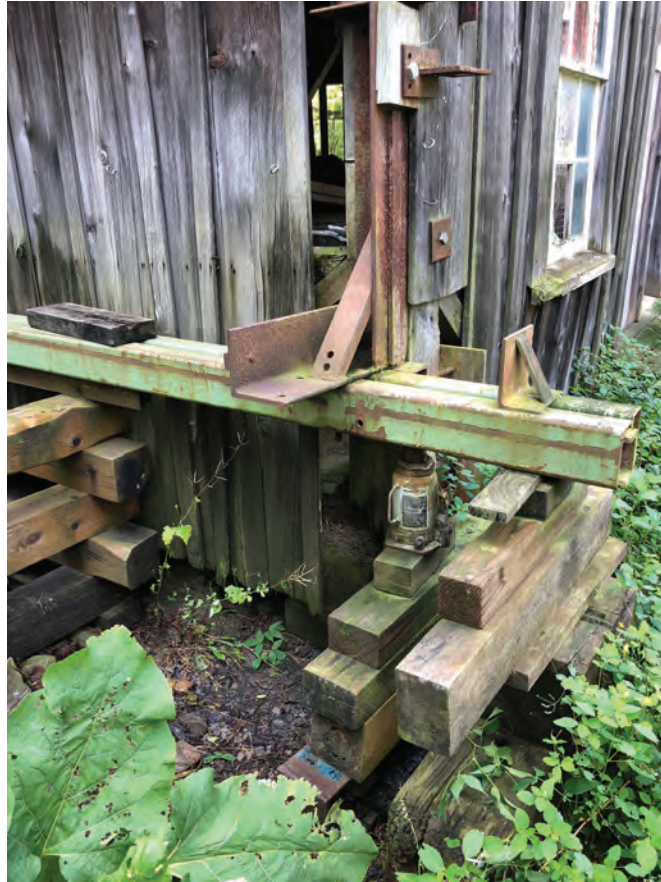
Figure 55 - description

This side of the building has evidence of temporary building stabilization measures including wood cribbing, tensile cabling and steel shoring. This building is sided with vertical wood boards with batten strips. Some battens are missing. The boards are mostly of one continuous piece. (see Fig 54). Deterioration of foundation piers, wood sill beams and wood posts are extensive. This side of the building faces Nanticoke Creek. Along this side of the building, some building foundation structure is visible. A more recent cinder block pier is noticeable at the northeast corner of the building (see Fig 55).

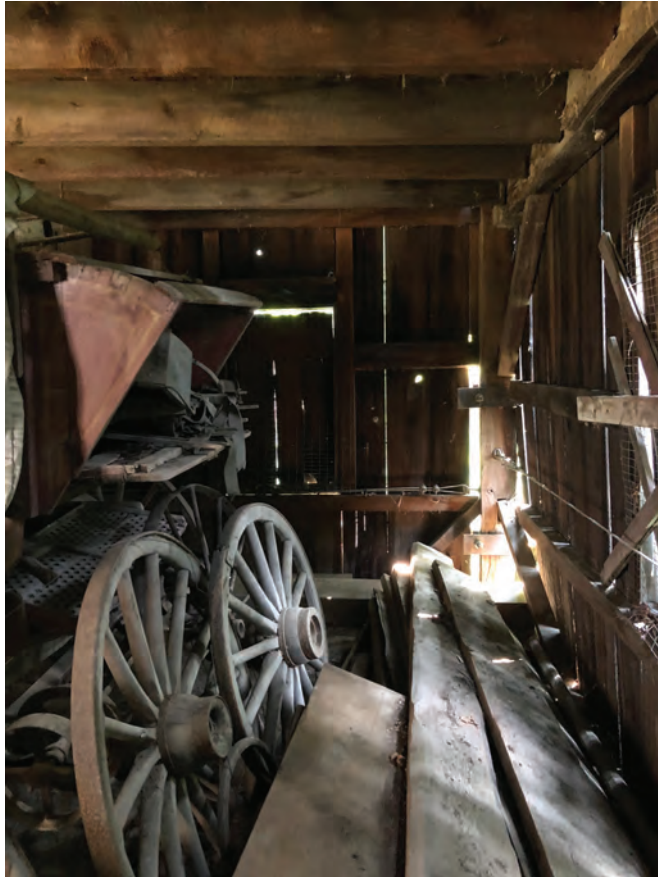
More evidence of temporary building stabilization measures including tensile cabling can be seen along the south wall (see Fig 65 and 66). These stabilization measures appear to have slowed the building collapse but not stopped or reversed it. There is evidence of settling or continued wood beam rot in the building's interior foundation system. The foundation system was not visible during the site survey but there is a noticeable drop in floor level; high point northeast corner low point north wall center (see Fig 69). Deterioration of subfloor and wood posts is extensive along the eastern wall (see Fig 70 to Fig 72). A portion of the subfloor also show signs of sagging which may be further deterioration of floor support/wood beneath (see Fig 73). This area is a low spot in the entire floor and may be subject to ponding when the building is flooded.

Figure 65 - Interior Grade Level View – Southeast Corner

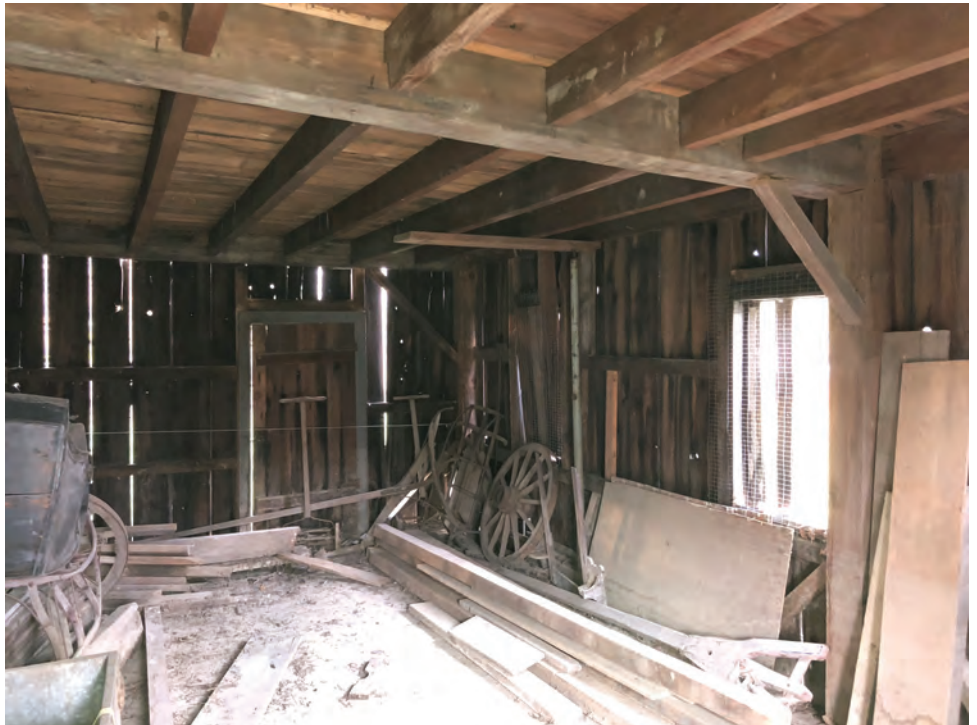
Figure 66 - Interior Grade Level View – Southwest Corner

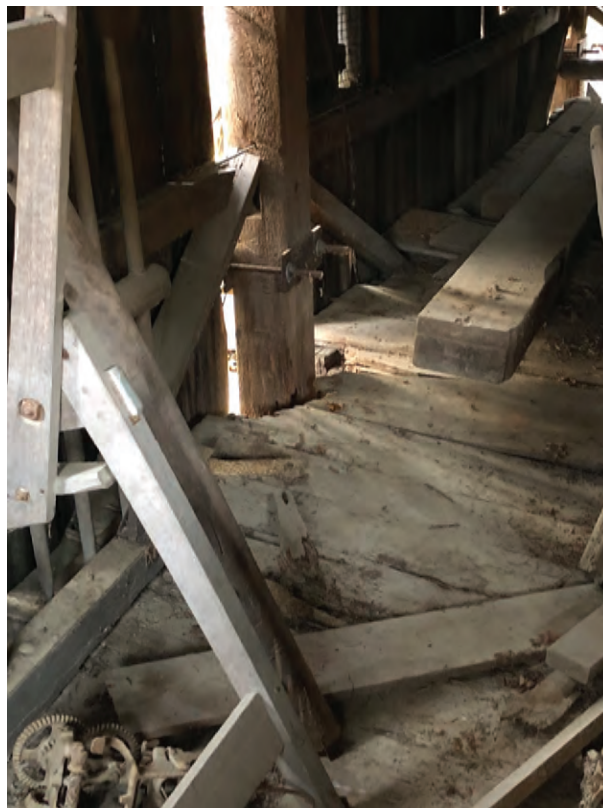
Figure 70 - Stabilization Measure at Missing Floor and Sill Beam Building Perimeter

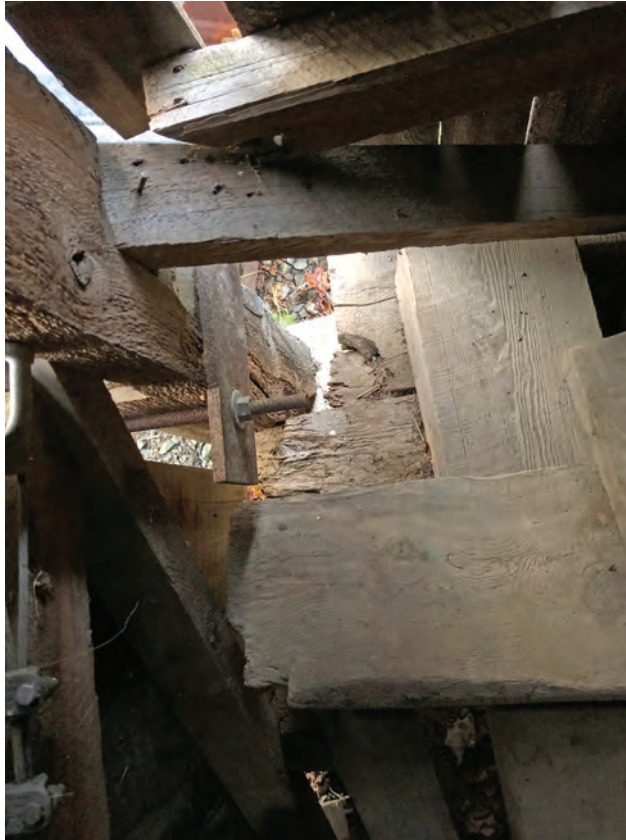
Figure 71 - Stabilization Measure at Missing Floor and Sill Beam Building Perimeter

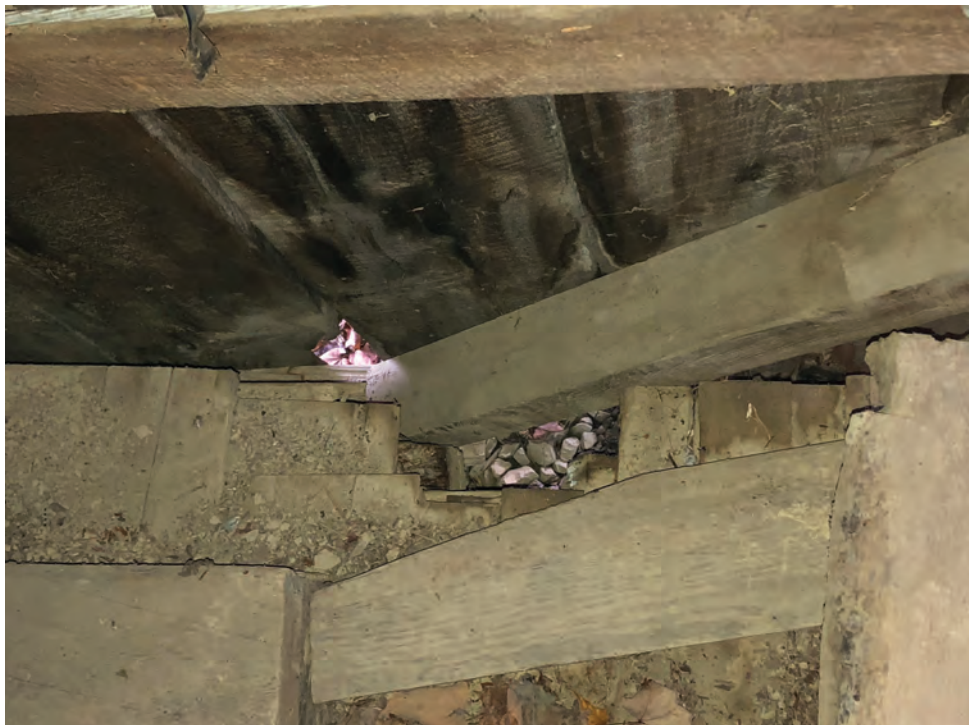
Figure 72 - Stabilization Measure at Missing Floor and Sill Beam Building Perimeter

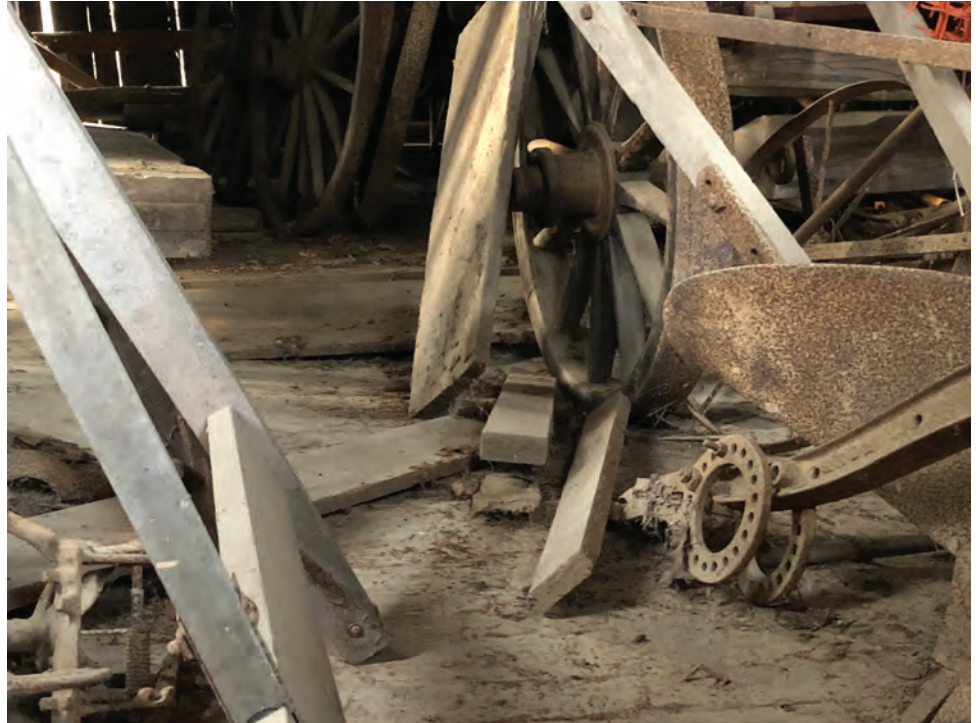
Figure 73 - Sagging Subfloor at Interior Floor Span

- VI. Structural
- a. As part of the elevation process, rotten wooden components beneath the first floor ie: floor boards, floor joists, posts and beams should be replaced in kind or repaired as necessary.

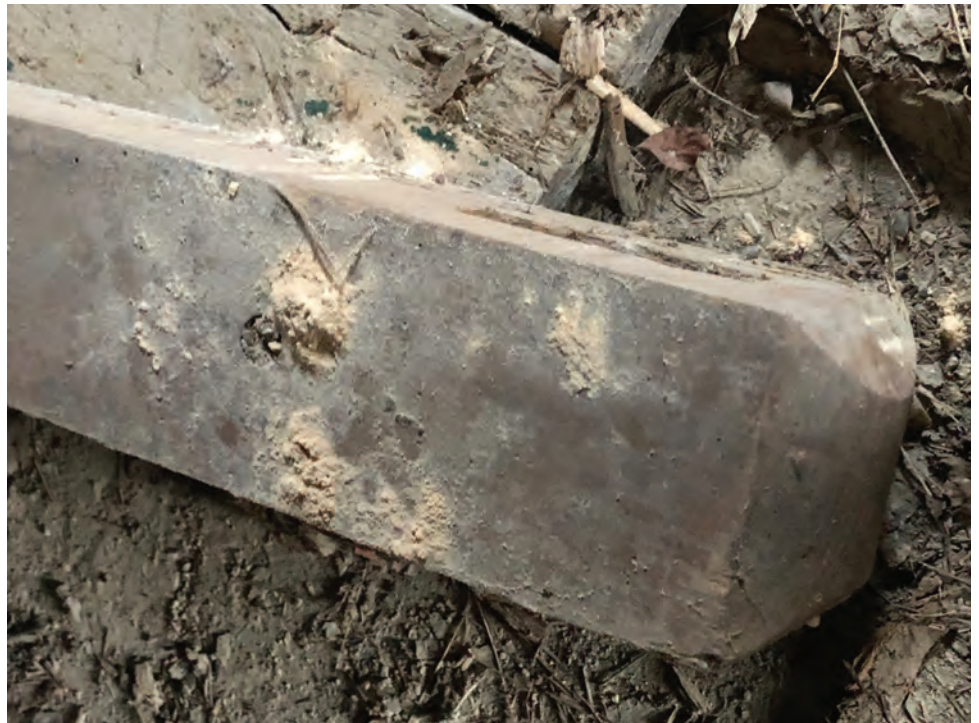
It should be understood that these wood structures have been affected by wood damaging insects throughout their lifespan. Evidence of current beetle damage was observed at the grade level (see Fig 74).

Figure 74 - Evidence of Powder Post Beetle Activity

- a. Implement a program for routine monitoring and treatment. Regular inspection is the first line of defense for prevention or early infestation of insects.
- b. Judicious use of a liquid applied borate-based insecticide, fungicide, miticide, moldicide should be considered. Utilize a product that does not change the appearance of the wood and does not interfere with future treatment (restoration, repair, replacement) of the material.
