GeorgiaHomePros.com

Home Inspection Report

1234 Candy Circle

Inspected on Mon, Jul 15 2019 at 3:30 PM

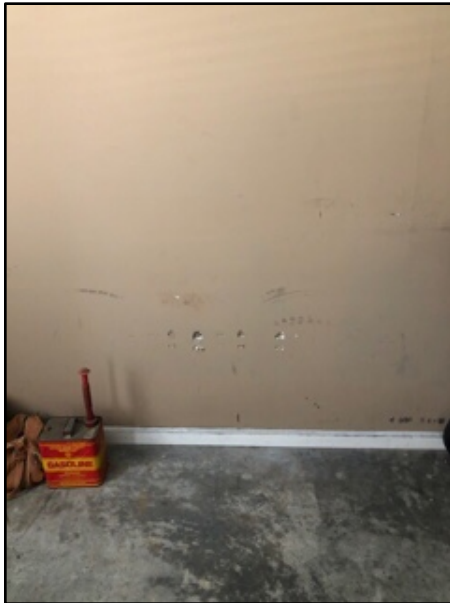
Figure 1-1

1) There is damage/holes in the garage drywall that need repair to maintain the required 20 minute fire barrier between the garage and living space.

There is damage/holes in the garage drywall that need repair to maintain the required 20 minute fire barrier between the garage and living space.
Recommend a paint professional repair or replace the damaged drywall.

Recommend a paint professional repair or replace the damaged drywall.

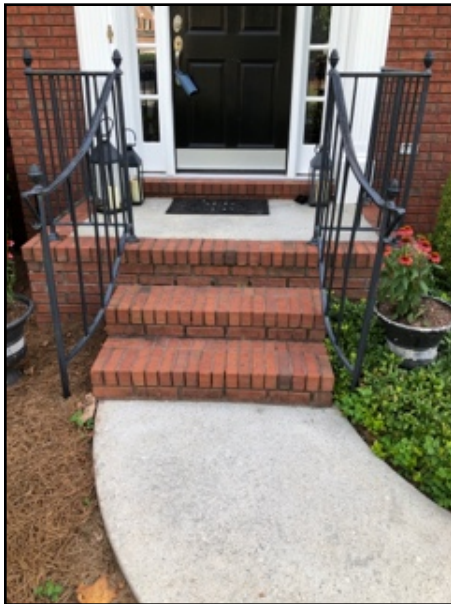
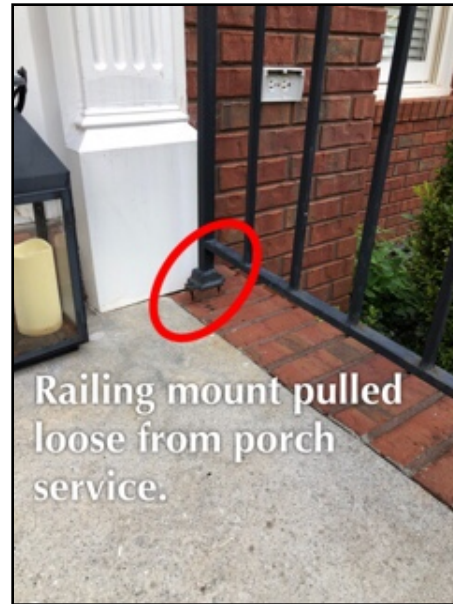
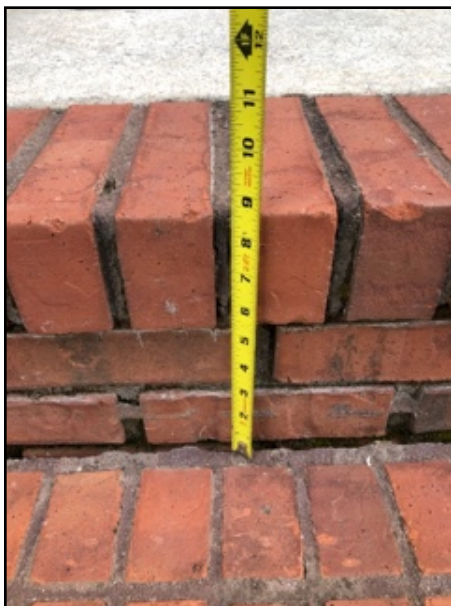
2) The sidewalk and porch steps have settled which has pulled the railing loose from the porch surface and now has a greater than the maximum 8 inches of riser between the top step and porch surface which is considered to be a trip hazard.

The sidewalk and porch steps have settled which has pulled the railing loose from the porch surface and now has a greater than the maximum 8 inches of riser between the top step and porch surface which is considered to be a trip hazard. Recommend further inspection and corrections be done by a concrete leveling professional and a qualified professional re-secure the railing as needed.

Recommend further inspection and corrections be done by a concrete leveling professional and a qualified professional re-secure the railing as needed.

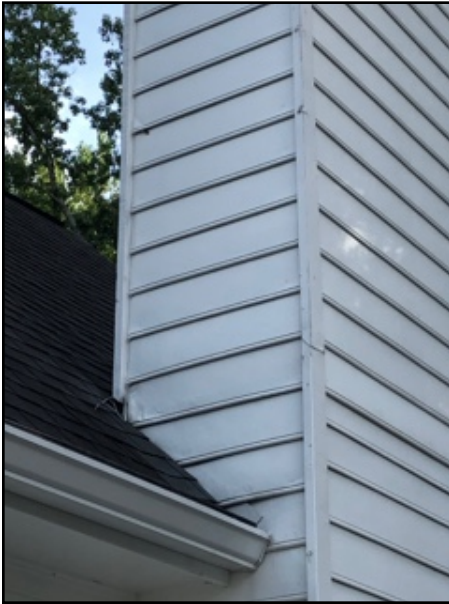
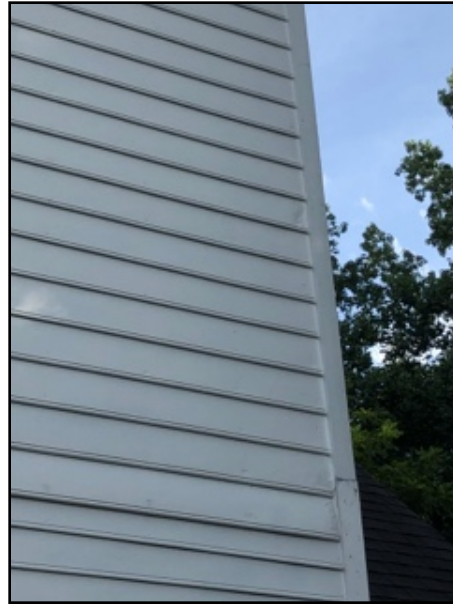
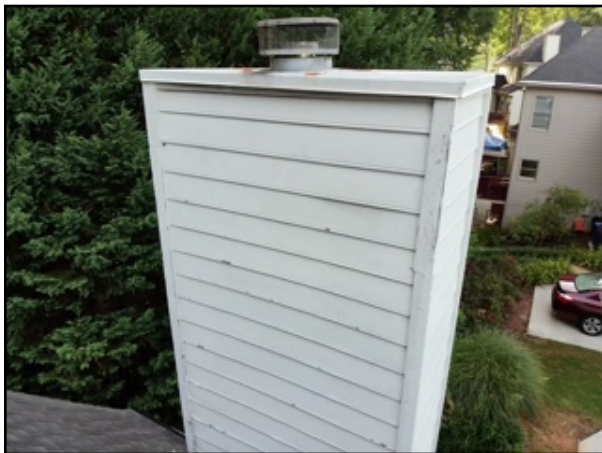
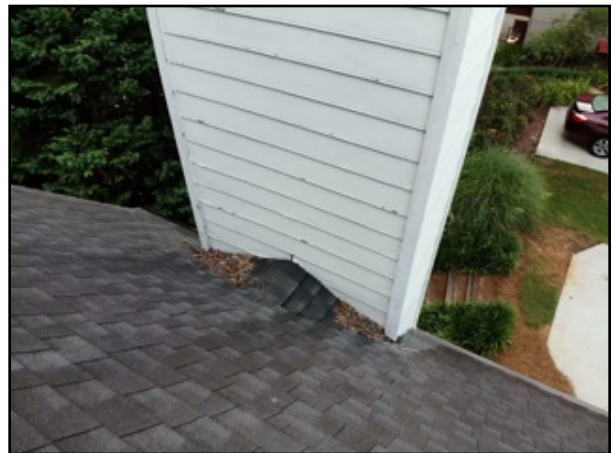
3) A portion of the chimney siding has been replaced, however the remaining siding on the chimney is moisture damaged and in need of replacement.

A portion of the chimney siding has been replaced, however the remaining siding on the chimney is moisture damaged and in need of replacement. Recommend further inspection and replacement of the damaged siding be done by a siding and trim professional.

Recommend further inspection and replacement of the damaged siding be done by a siding and trim professional.

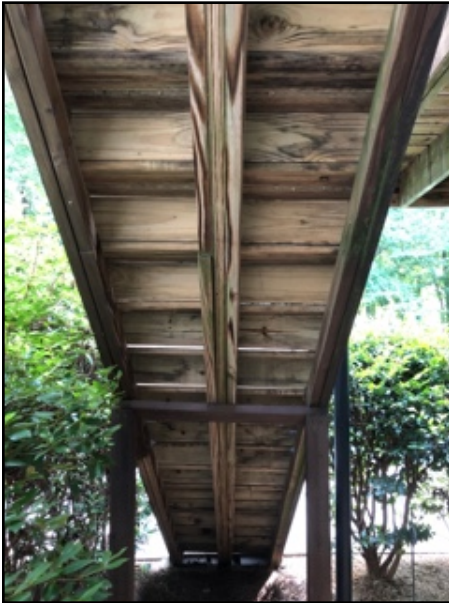
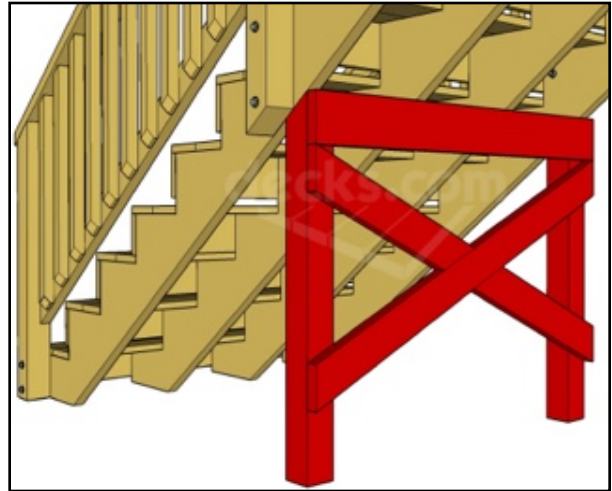
The deck stairs has lateral movement under normal foot traffic. Recommend a professional carpenter install additional bracing to prevent side to side movement.

Recommend a professional carpenter install additional bracing to prevent side to side movement.

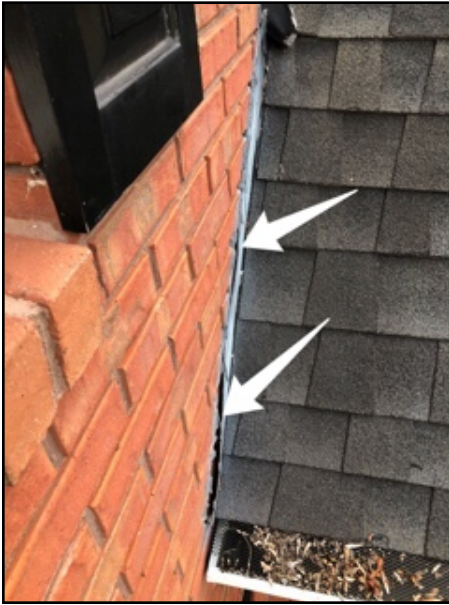
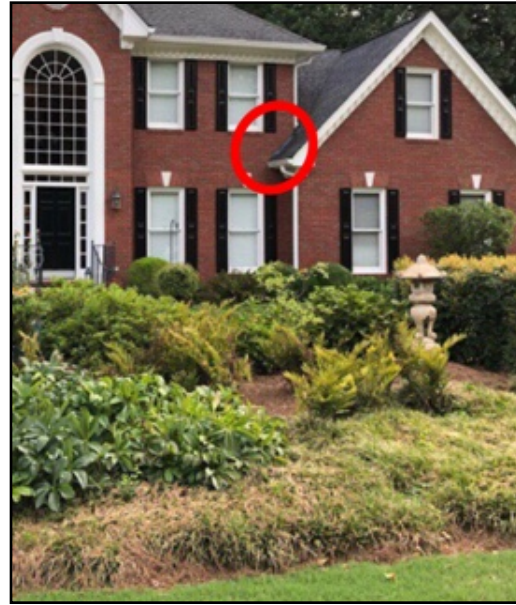
5) The roofing counter metal flashing has come loose from the brick at the garage roof gable to front wall junction. (see pictures for location)

The roofing counter metal flashing has come loose from the brick at the garage roof gable to front wall junction. (see pictures for location)
Recommend further inspection and corrections be done by a roofing professional to prevent possible water entry during times of heavy blowing rains.

Recommend further inspection and corrections be done by a roofing professional to prevent possible water entry during times of heavy blowing rains.

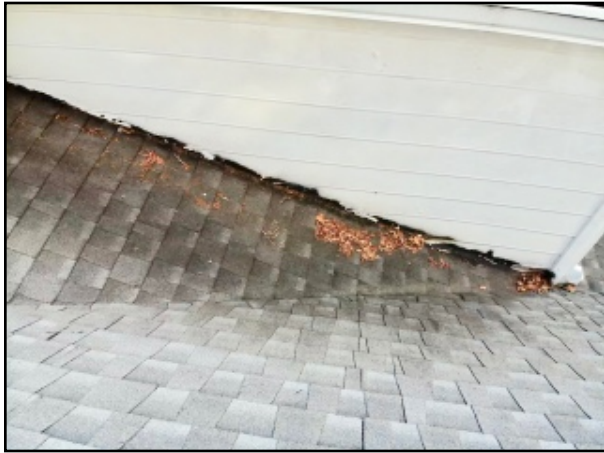
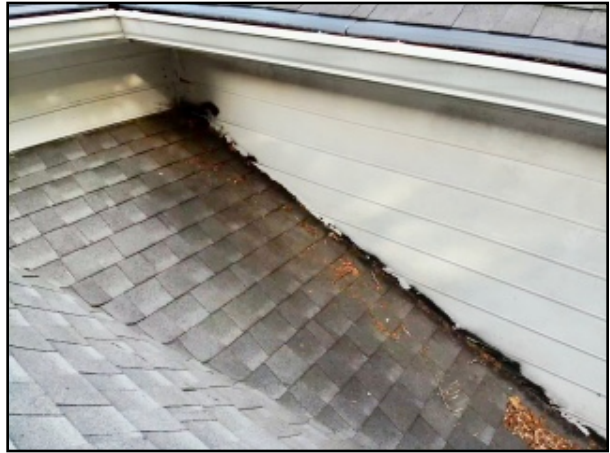
6) It appears that a spray sealant has been applied on the roofing shingles to wall junction above the kitchen eating area and family room. Spray sealant is not considered a permanent fix and appears to have been applied due to leaking. No active leaking was found in this area, however stains/repairs were visible on the ceiling below.

It appears that a spray sealant has been applied on the roofing shingles to wall junction above the kitchen eating area and family room. Spray sealant is not considered a permanent fix and appears to have been applied due to leaking. No active leaking was found in this area, however stains/repairs were visible on the ceiling below.

Recommend further inspection and permanent corrections be done by a roofing professional.

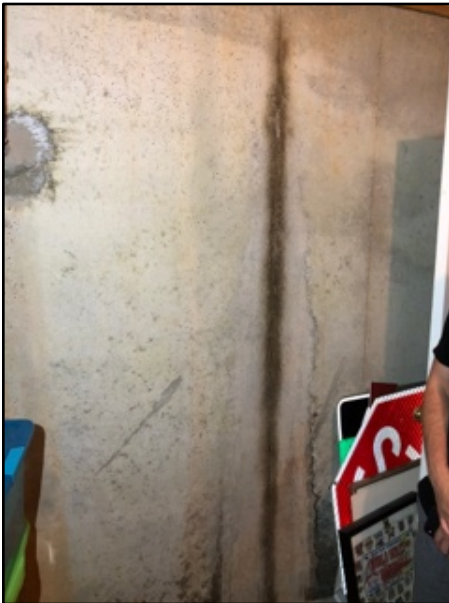
Figure 7-1

7) Water has leaked into the unfinished portion of the basement through a common shrinkage crack along the front poured concrete foundation wall.

Water has leaked into the unfinished portion of the basement through a common shrinkage crack along the front poured concrete foundation wall. Recommend a qualified professional perform an epoxy injection repair to prevent any water/moisture entry.

Recommend a qualified professional perform an epoxy injection repair to prevent any water/moisture entry.

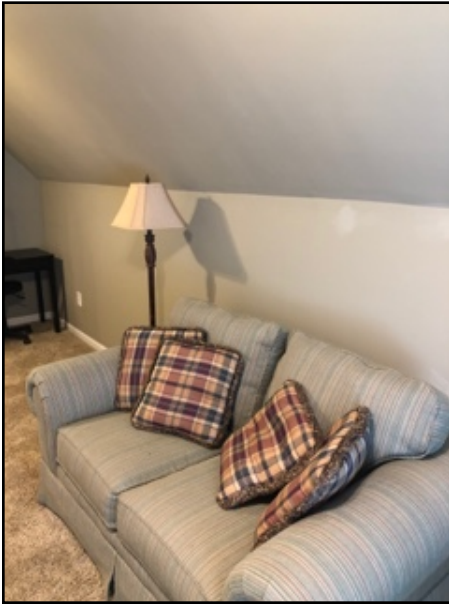
Figure 8-1

Comment 8:
There is no access to the side attic space above the garage. Access is required to any enclosed space larger than 50 ft.².
Recommend a professional carpenter create an attic access in either the garage ceiling below or knee wall in the room above the garage.

Recommend a professional carpenter create an attic access in either the garage ceiling below or knee wall in the room above the garage.

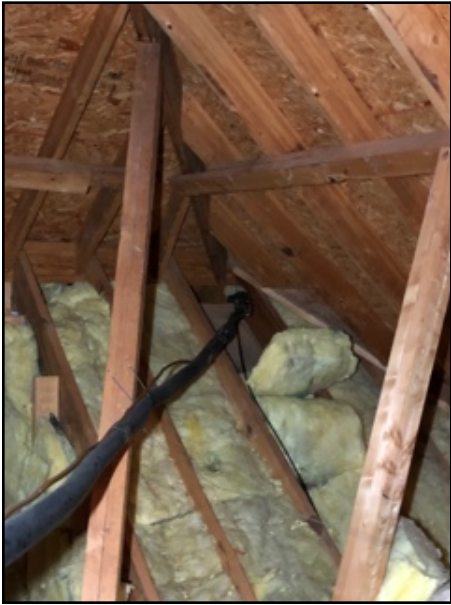
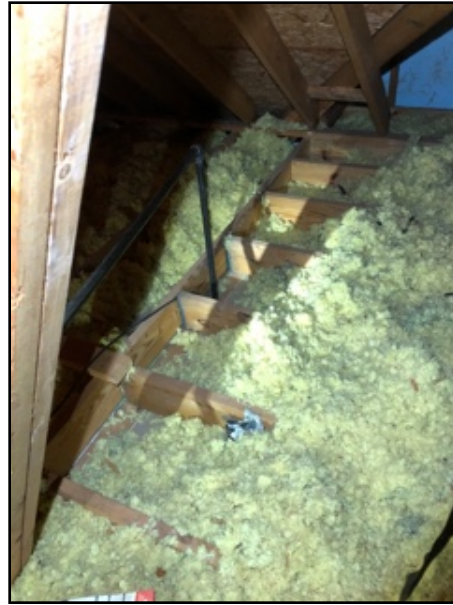
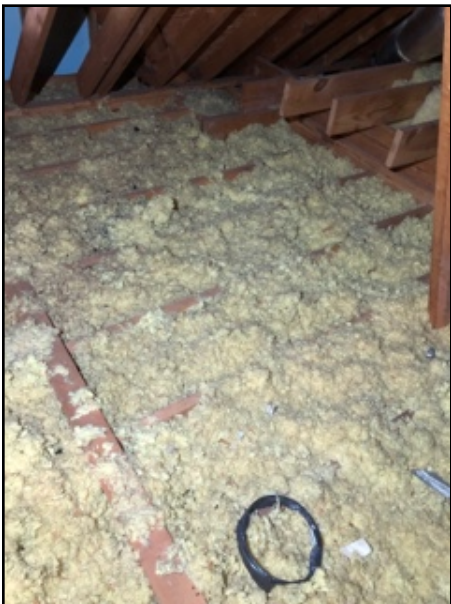
9) Signs of pests in the attic was found. It could not be determined the exact size or nesting of the infestation. Recommend further inspection of the entire house be done by a pest control professional. There is also compressed and displaced insulation in the attic due to pest.

Signs of pests in the attic was found. It could not be determined the exact size or nesting of the infestation. Recommend further inspection of the entire house be done by a pest control professional. There is also compressed and displaced insulation in the attic due to pest.

Recommend an insulation contractor restore the insulation to an R30+ after the pest have been removed. Removal of some of the existing insulation may be needed due to pest feces and urine.

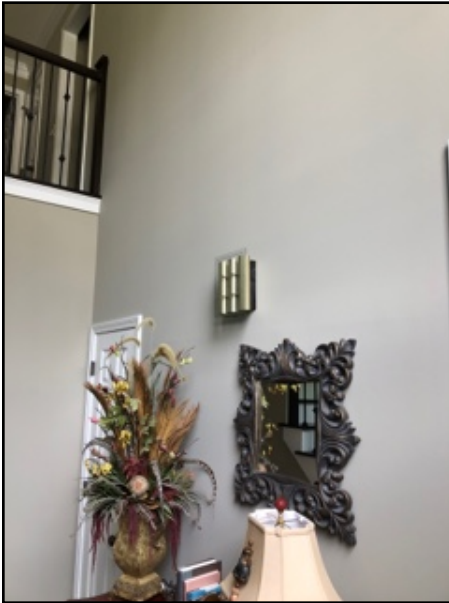
Figure 10-1

The doorbell was not operational at the time of the inspection.

Recommend further inspection and repair/replacement of the doorbell be done by a licensed electrician.

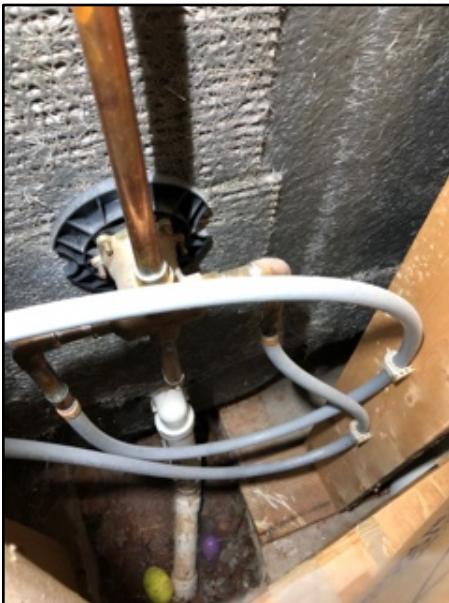
Figure 12-1

12) Polybutylene water supply pipes have been used thru out the house, this type of pipe has had documented problems and is no longer used for water supply. Due to the polybutylene plumbing it is recommended that a licensed plumber inspect further.

Polybutylene water supply pipes have been used thru out the house, this type of pipe has had documented problems and is no longer used for water supply. Due to the polybutylene plumbing it is recommended that a licensed plumber inspect further.

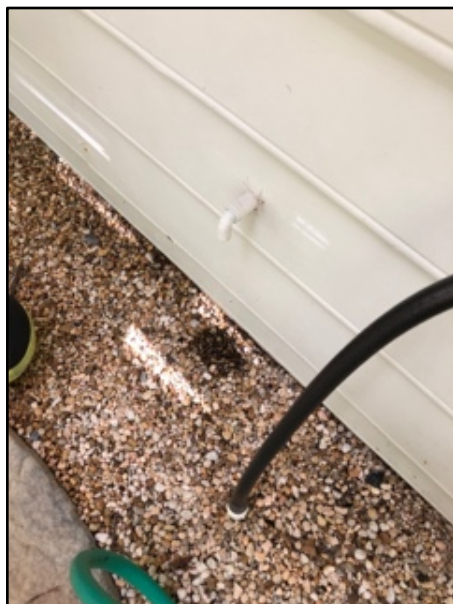
Figure 13-1

Water was dripping from the temperature pressure relief valve drain line at the time of the inspection. This dripping water may be an indication of a bad valve or temperature/pressure problems.

Recommend further inspection and corrections be done by a licensed plumber.

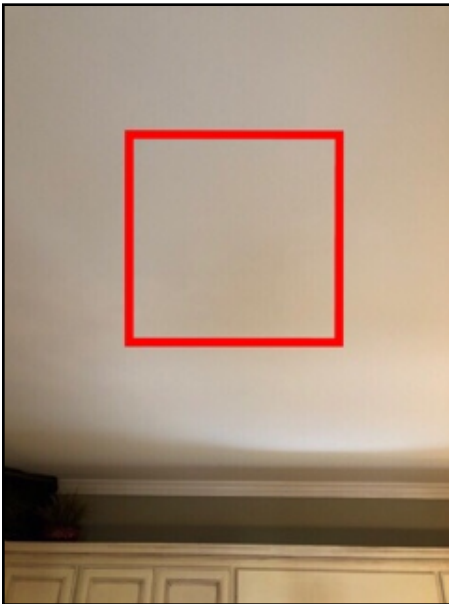
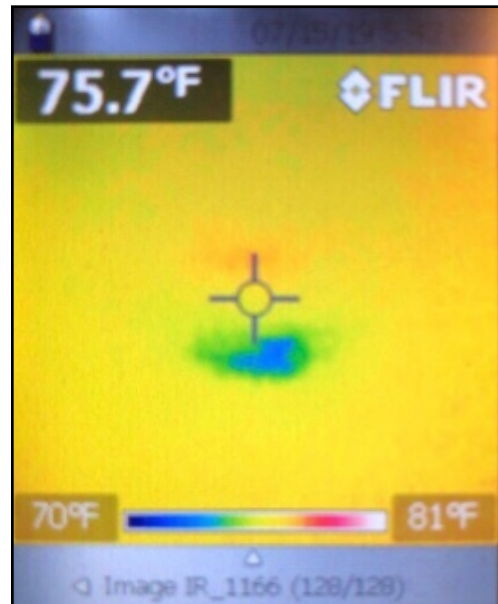
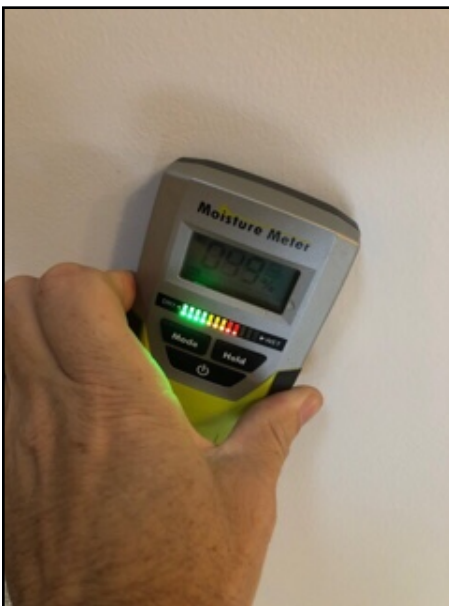
14) Infrared thermal imaging revealed water leaking on the kitchen ceiling. This leak was confirmed active with a non-destructive moisture meter. The exact source of the water could not be determined, however the area is directly below the second-floor hall bathroom. It could not be determined if any wood decay or mold growth has occurred between the floor and ceiling without removing drywall from the kitchen ceiling.

Comment 14:
Infrared thermal imaging revealed water leaking on the kitchen ceiling. This leak was confirmed active with a non-destructive moisture meter. The exact source of the water could not be determined, however the area is directly below the second-floor hall bathroom. It could not be determined if any wood decay or mold growth has occurred between the floor and ceiling without removing drywall from the kitchen ceiling.
Recommend further inspection and corrections be done by a licensed plumber.

Recommend further inspection and corrections be done by a licensed plumber.

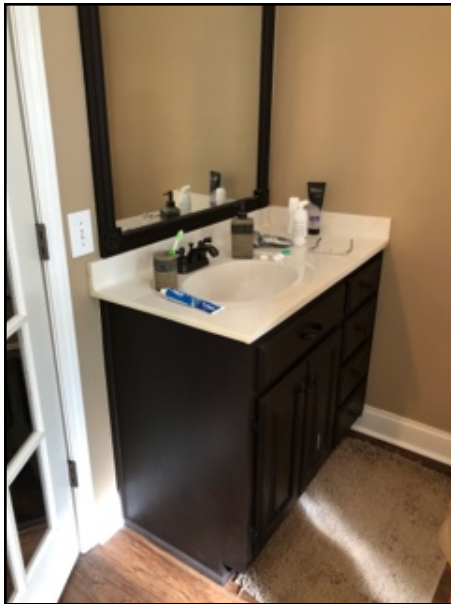
Figure 15-1

15) There is no outlet receptacle to service one of the master bathroom sink vanities. Recommend a licensed electrician install a GFCI protected receptacle within a 2 foot reach of the sink vanity countertop as required.

There is no outlet receptacle to service one of the master bathroom sink vanities. Recommend a licensed electrician install a GFCI protected receptacle within a 2 foot reach of the sink vanity countertop as required.

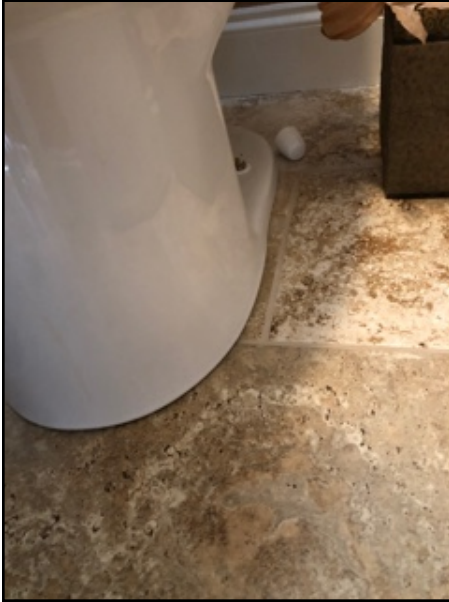
Figure 16-1

16) The master bathroom toilet is loose from the floor.

The master bathroom toilet is loose from the floor.

Recommend further evaluation and corrections be done by a licensed plumber.

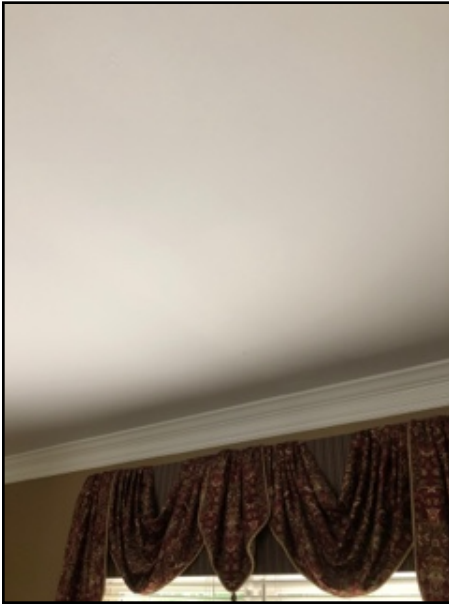
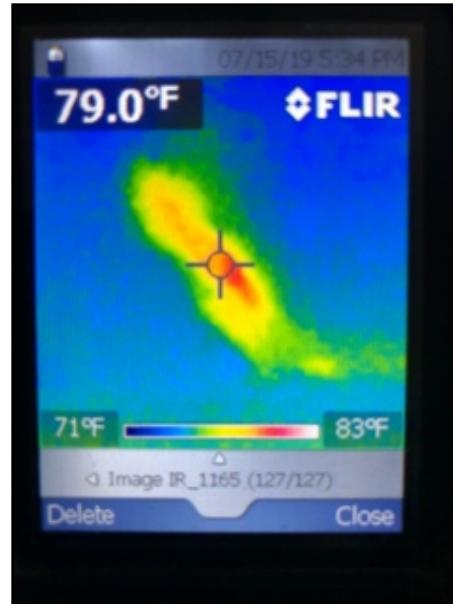
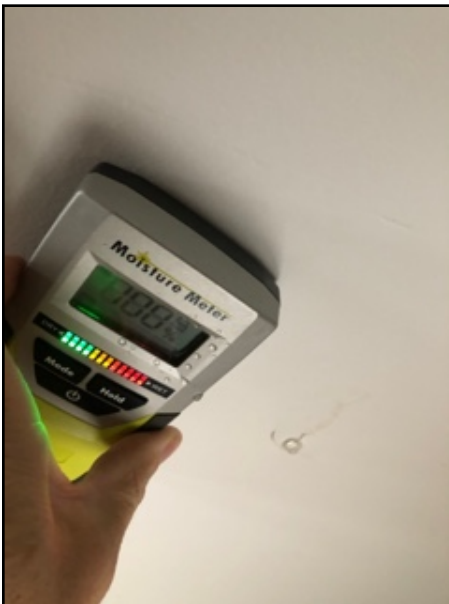
17) Water was visibly dripping from the ceiling of the dining room directly below the master bathroom at the time of the inspection. This leak was confirmed active with a nondestructive moisture meter and infrared thermal imaging. There was visible water damage to the drywall ceiling, however it could not be determined if any wood decay or mold growth has occurred within the wood framed cavity between the floor and ceiling. Recommend further inspection and corrections be done by a licensed plumber.

Recommend further inspection and corrections be done by a licensed plumber.

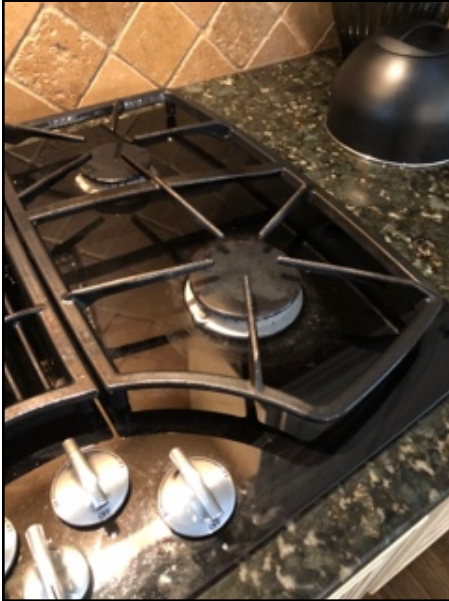
Figure 18-1

18) The right front burner would not ignite on the gas cooktop at the time of the inspection. Recommend further inspection and corrections be done by an appliance professional.

**Comment 18:**
The right front burner would not ignite on the gas cooktop at the time of the inspection. Recommend further inspection and corrections be done by an appliance professional.

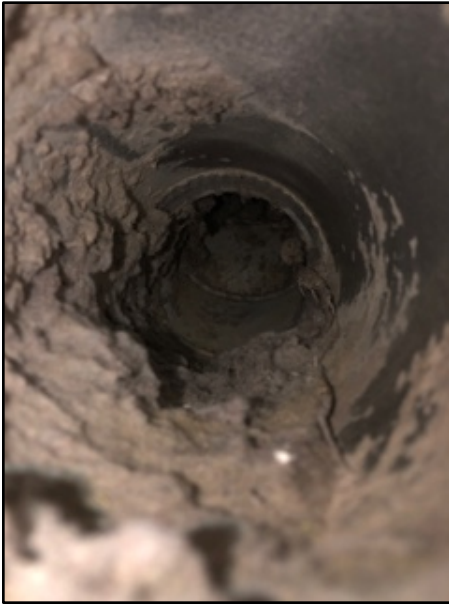
Figure 19-1

**Comment 19:**
The laundry dryer vent has a lint build up which needs to be cleaned for full efficiency and to prevent the possibility of a fire.
Recommend cleaning be done by a professional duct cleaning service.

Recommend cleaning be done by a professional duct cleaning service.

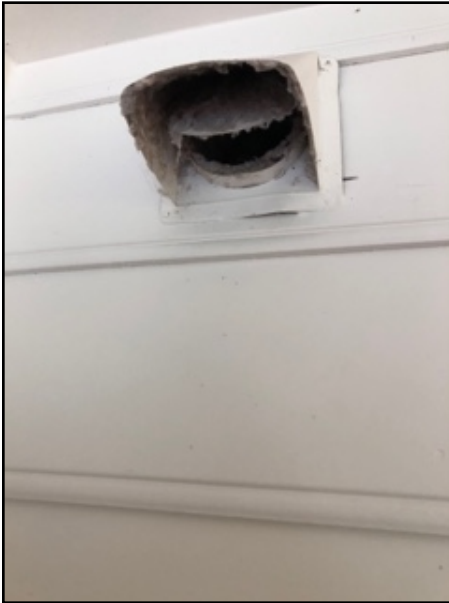
Figure 20-1

20) The dryer vent damper door will not completely close. Recommend a qualified person adjust the duct or damper so that the door will close when the dryer is not in use to avoid air movement and pest/insect entry.

The dryer vent damper door will not completely close. Recommend a qualified person adjust the duct or damper so that the door will close when the dryer is not in use to avoid air movement and pest/insect entry.

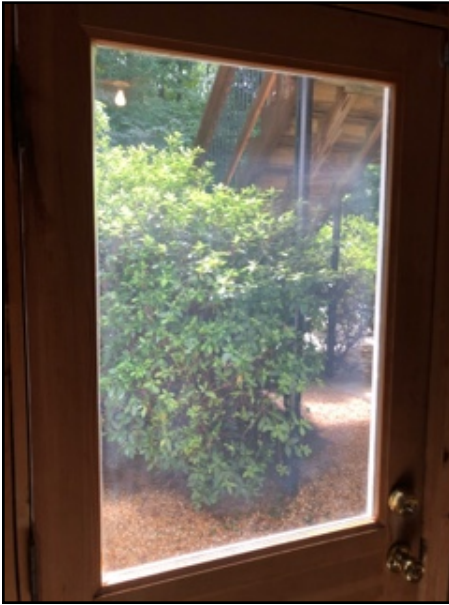
Figure 21-1

21) The single entry basement door and one of the master bedroom double pane window units have moisture/stains between the panes of glass. This is caused by the insulating gas leaking out which allows air to enter and condensation to form between the panes of glass, when the condensation evaporates a mineral deposit is left between the panes glass.

Recommend further inspection of the double pane window units be done by a professional window/glass contractor and replacement of the glass units be done where needed.

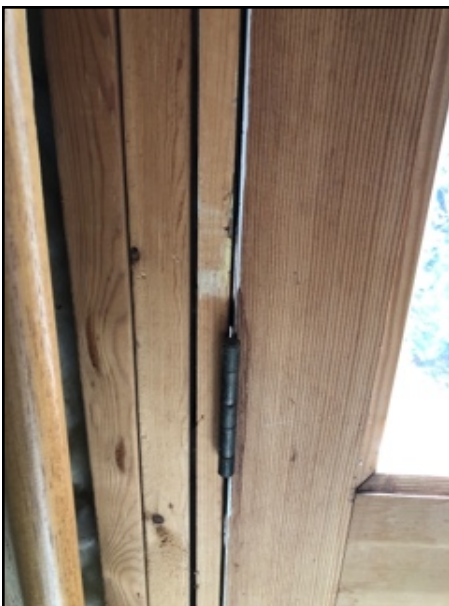
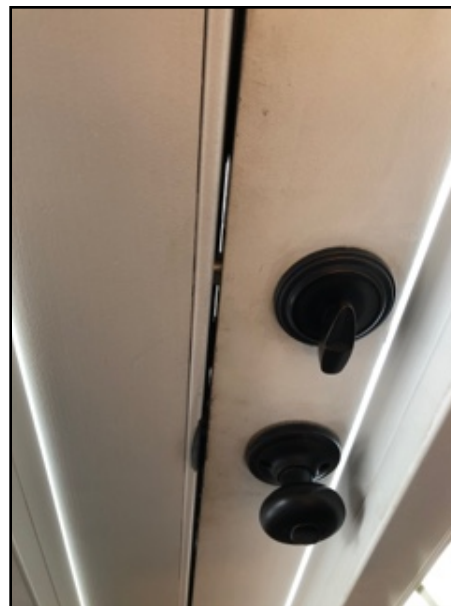
22) There are gaps between the door and door frames of the single entry basement door and double door from the rear deck. Recommend additional weatherstripping or adjustments be done by a qualified person.

There are gaps between the door and door frames of the single entry basement door and double door from the rear deck. Recommend additional weatherstripping or adjustments be done by a qualified person.

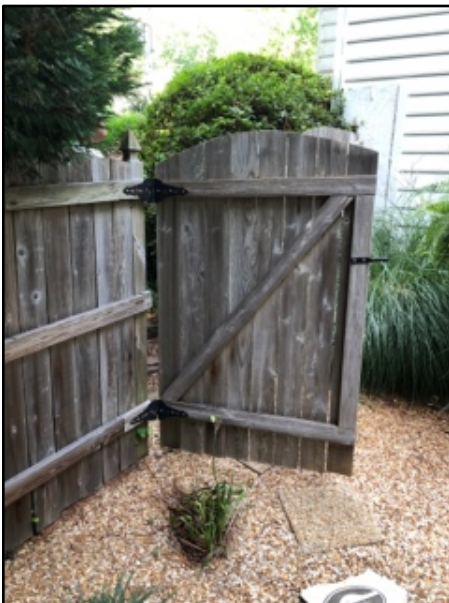
Figure 23-1

The gate does not have any self closing device installed as required for a pool surround.

Recommend a professional finish carpenter install some type of self-closing device on the gate.

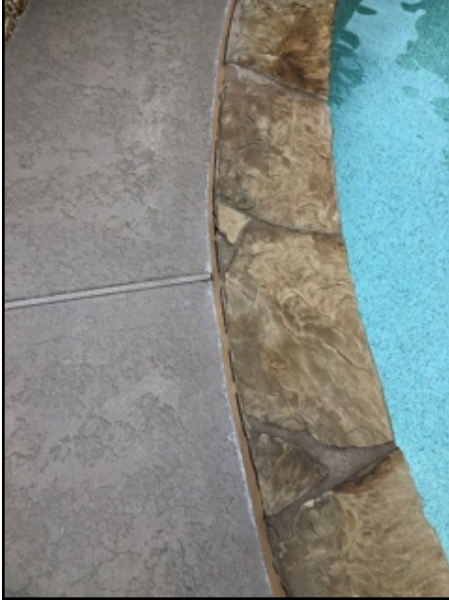
Figure 24-1

24) The coping sealant around the pool has deteriorated. Recommend a qualified person reseal the pool coping.

The coping sealant around the pool has deteriorated. Recommend a qualified person reseal the pool coping.
