Re: Massey's Ice Climbing Accident: March 11th, 2019

You have asked me to provide a summary of my investigations into the Massey's ice climbing accident that occurred on March 11, 2019 in Field, BC. This letter summarizes the investigation completed. This report does not provide an opinion on this matter at this time.

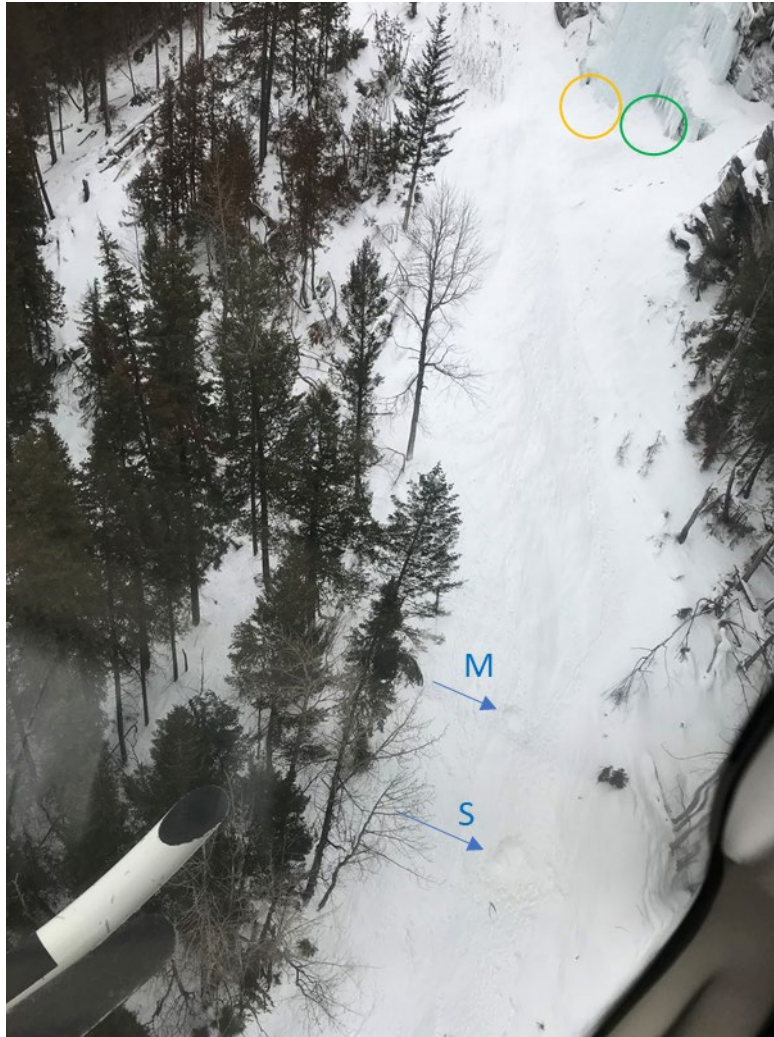
When the avalanche came to rest, two participants were buried within approximately 10 m of each other, 50 to 60 m (estimated) downslope of the base of the ice climb (Figure 4-1). One of the buried participants was visible to those on the surface (Michelle), while the other (Sonja) was not. A rescue was initiated by the guides at site; however, all packs with rescue gear were also buried. Michelle was uncovered within minutes, and Sonja was uncovered after being buried for approximately 30 minutes. Michelle survived, and Sonja did not.

Figure 4-1: Accident site from above taken March 11th showing base of ice climb (orange circle) and two excavated burial sites as blue arrows with initials of those buried. Green circle is estimated location of lead guide when the avalanche occurred (Parks Canada photo).

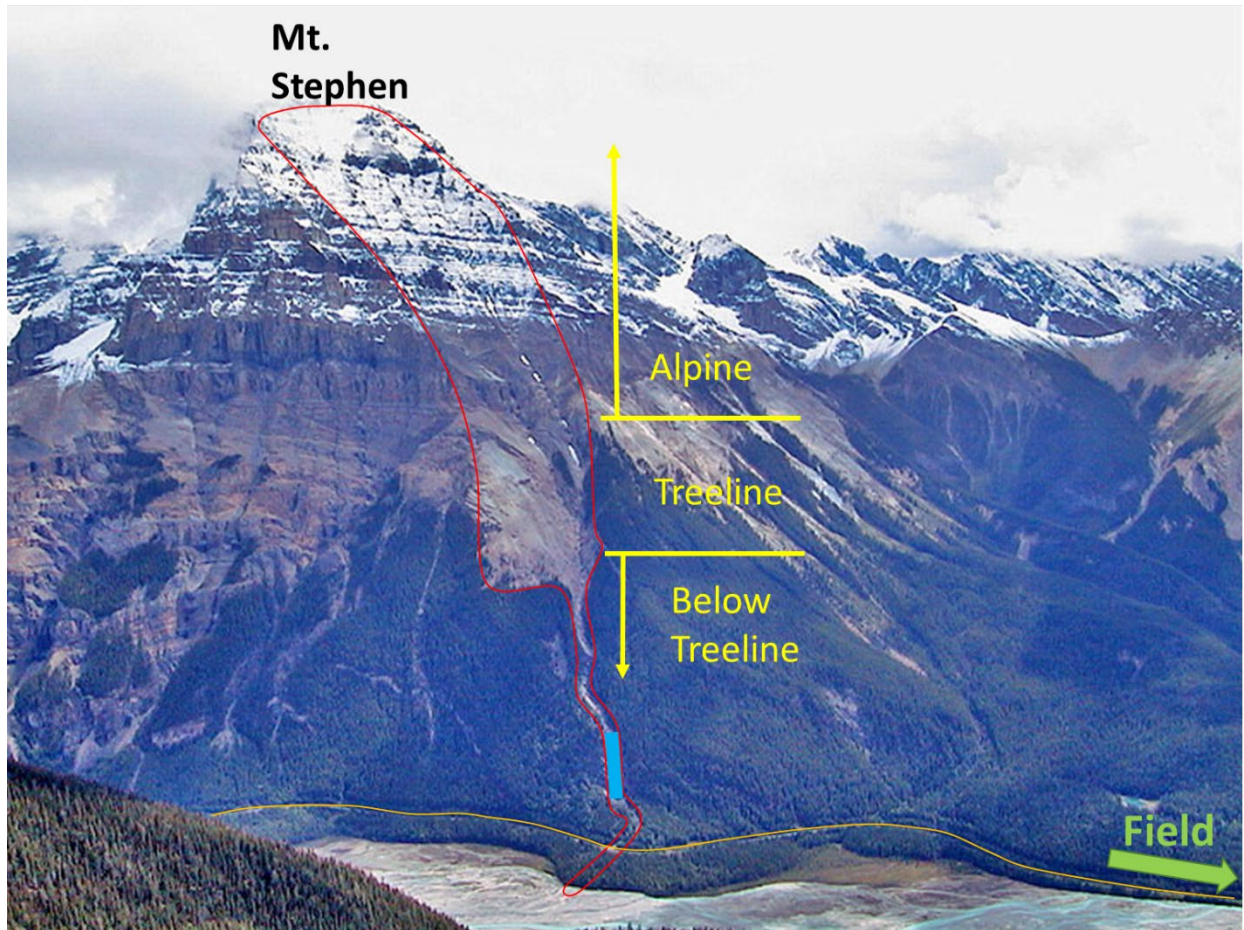
The avalanche path that affects Massey's ranges from 3150 m elevation, near the summit of Mt. Stephen, to approximately 1250 m at the Kicking Horse River valley bottom (Figure 6-1). The path encompasses all three elevation bands that are normally associated with avalanche hazard – alpine, treeline, and below treeline.

The starting zone of the avalanche path is a large west facing alpine bowl with several small gully systems that converge into a single channeled track in the 'below treeline' elevation band, at approximately 1700 m. The slope incline of the starting zone ranges between 35° and 45° on average.

Figure 6-1: Massey's ice climb (blue). Avalanche path outline in red, CP Rail line in orange. Approximate elevation bands referenced by avalanche forecasts in yellow.

Although the starting zone is large (up to 700 m wide near the top), vegetation patterns suggest that most avalanches terminate above the convergence point at 1700 m. This is estimated to be partly due to the disconnected nature of the start zone, resulting in the vast majority of avalanches releasing with only a small segment of the start zone. This is consistent with long term observations of this avalanche path by Parks Canada.

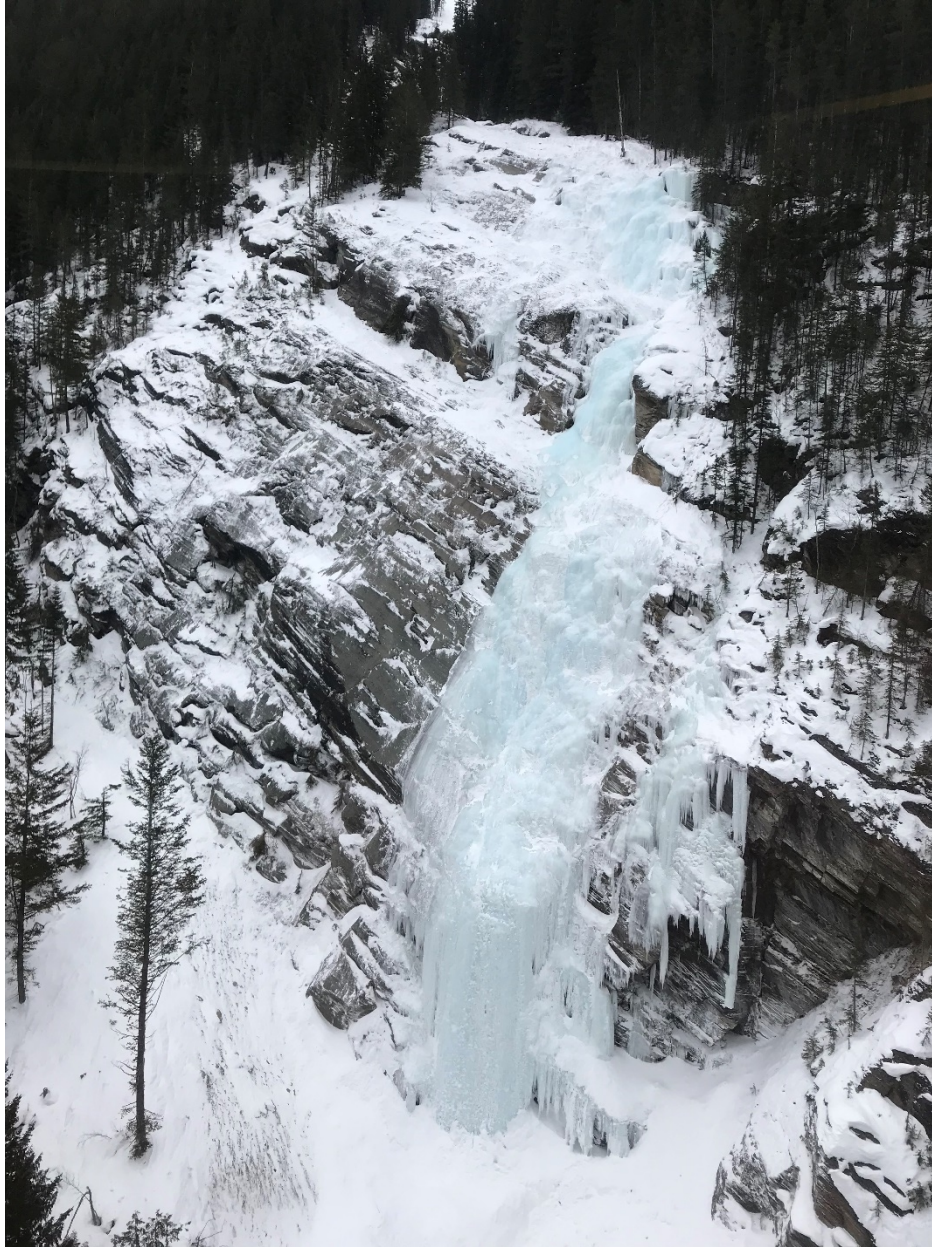
The ice climb is located at the lower end of the track between approximately 1350 and 1450 m elevation (Figure 6-2). The track becomes steep and is stepped through this segment, with a near vertical cliff at the bottom providing the most challenging climbing section. Below the ice climb the runout zone of the avalanche path appears to follow a low incline clearing through the forest to the CP Rail tracks.

Figure 6-2: Massey's ice climb (Parks Canada photo)

Although an analysis of frequency of avalanches reaching the ice climb was not completed for this report, it is estimated that the Massey's ice climb is impacted by avalanches much less frequently than other exposed ice climbs in Field. Parks Canada Visitor Safety staff suggest it is an exceptional event for an avalanche to reach the ice climb, and it occurs with return frequency in the order of five to 10 years.

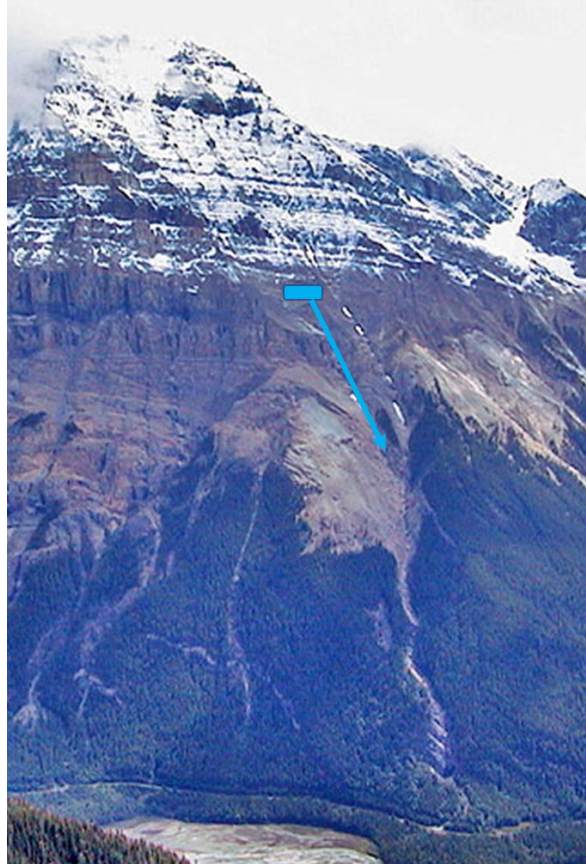
Avalanche size was difficult to determine since the fracture line of the avalanche was no longer visible during the investigation and helicopter flight, due to the snowfall and wind that occurred between March 11th, and March 13th. However, the avalanche was reported by the guides involved to be a Size 2 to Size 2.5 (Table 9-1) avalanche based on the extent of debris in the runout zone. The deposit depth was estimated by guides to be 2.5 to 3.0 m. These estimates are consistent with helicopter-based observations of the runout zone on March 13th, as well as photographs of the start zone area taken by Parks Canada on March 11th, illustrating a small shallow fracture estimated to be in the order of 50 m to 100 m wide, and 50 cm deep in the lower starting zone. The estimated aerial extent of the release area is illustrated in Figure 9-1.

Figure 9-1: Estimated avalanche release area (blue square).
