SUBJECT: Final Letter Report of Product Improvement Test of Truck
Utility, 1/4 Ton, 4X4, M151A1 (Rear Suspension Retrofit).
USATECOM ~~Project No. 1-VG-120-151-055~~ USAADC AG No. N/A,
Report No. APG-MT-4087

*Final letter rept.
27 Jan - 9 May 72*

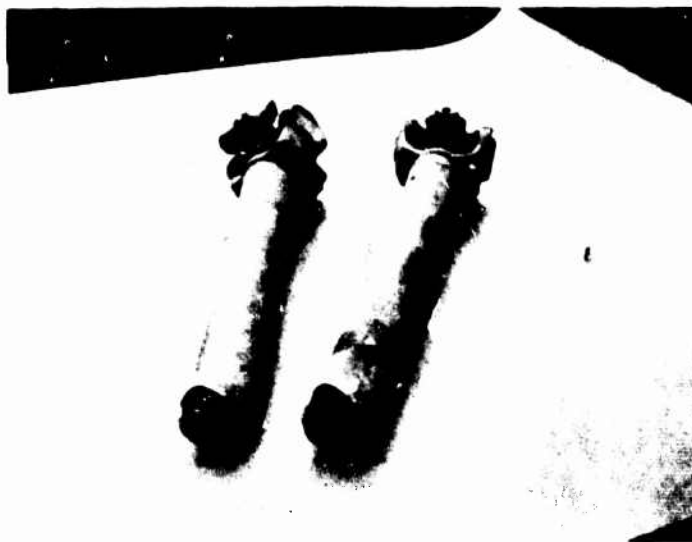
(13) Two front propeller shafts fractured, one at 5954 test miles and the second at 15,220 test miles (9266 part life miles) (Figure I-2).

Failure of the three front propeller shafts is attributed to increased torque forces imposed by drive line wrap up during operation on secondary roads and Belgian block in four-wheel drive and to shock forces imposed by service brake lock-up reported by drivers of both vehicles on several occasions.

Figure I-2: Front Prop Shaft of Vehicle 02CV5569, 5954 Miles.

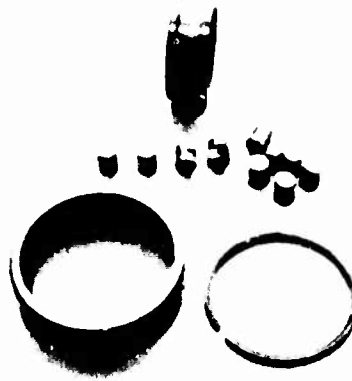
(12) The annular bearing on the rear output shaft of the transfer assembly failed at 19,197 test miles (Figure I-5, 6, 7, and 8).

Figure I-5: Transfer Case Rear Output Shaft Bearing Failure on Veh. No. V55 at 19,197 Test Miles.

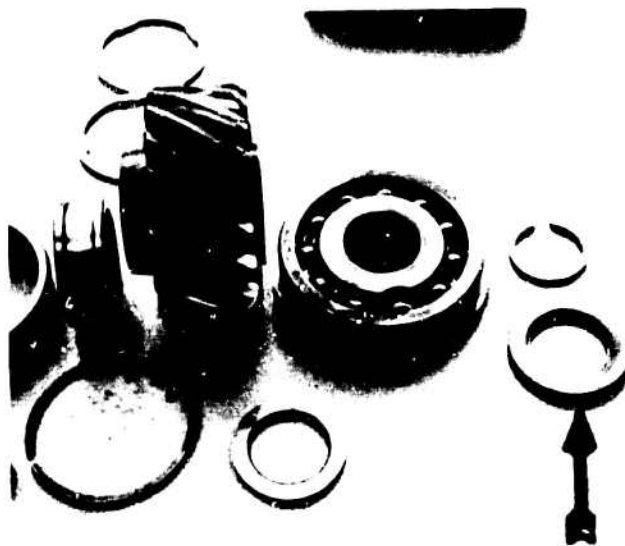
Figure I-8: Transfer Output Shaft Snap Ring Retainer after 19,197 Part Life Miles (Veh. No. V55).

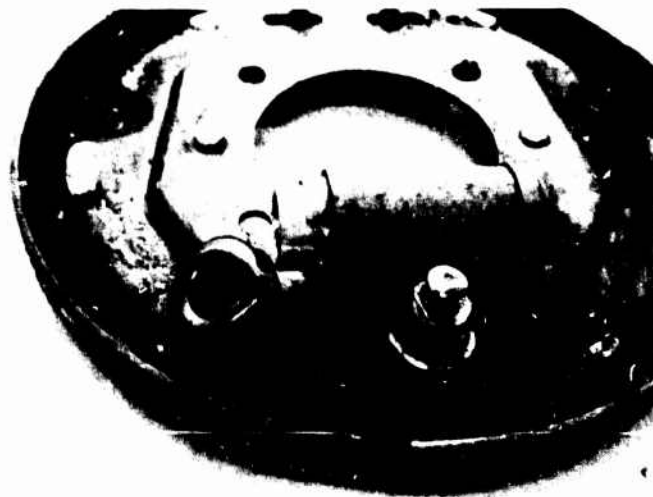
(21) The secondary brake shoe on the left front wheel failed after 6264 test miles and the backing plate anchor pin and wheel cylinder were damaged (Figures I-15 and I-16).

Figure I-15: Broken Wheel Cylinder and Damaged Anchor Pin on Veh. No. W07 after 6234 Test Miles (Caused by Shoe Failure Shown in Figure I-13 Below).

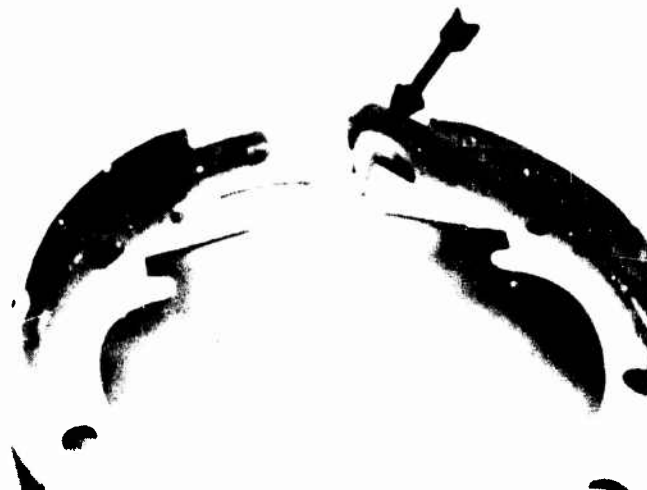
Figure I-16: Shoe Failure on Left Front Wheel of Veh. No. W07 after 6234 Test Miles (Arrow Indicates Failure of Weld Securing Shoe Web to Platform).
