Internal Ultrasonic Gauging Survey
Of
Aboveground Fuel Storage Tank One

Report Number: EXMNDTRF0000 **SAMPLE**

This report has been written in support of the recent inspection undertaken on xx/xx/xxxx at
****ADDRESS**** by EX Mechina on behalf of ****CLIENT****.

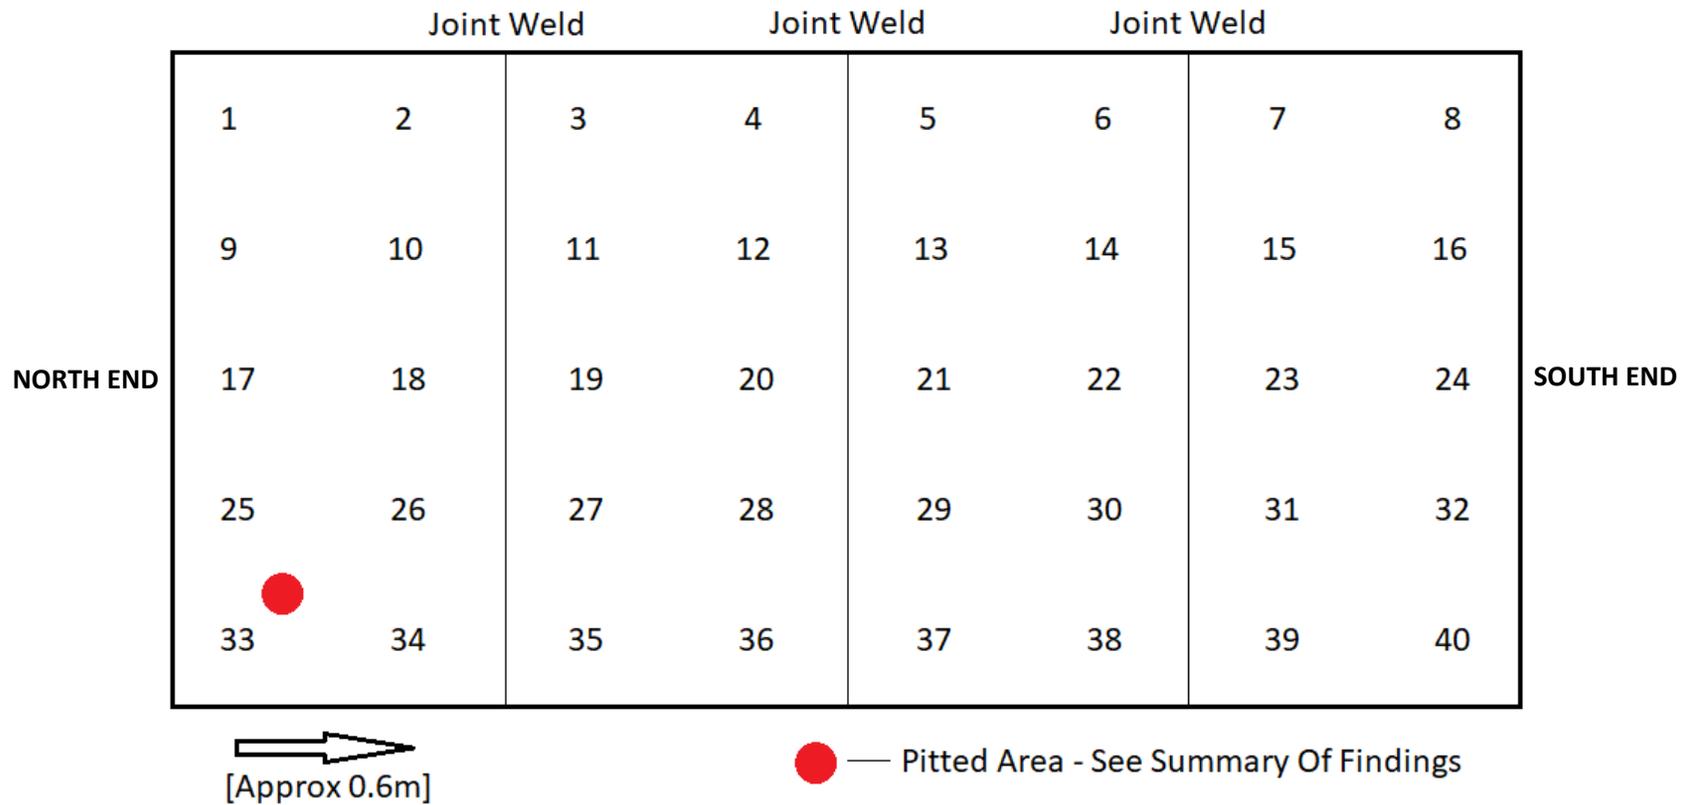
**THICKNESS MEASUREMENT LOCATION DIAGRAM
FUEL TANK ONE - FLOOR PLATING**

The floor of this tank has one area of pitting corrosion and corresponding skin loss [see figures 30 and 31]. The location is marked with a red dot on the diagram found on page six of this report. In the north-west corner of the tank floor corrosion pitting was found, measured at 1.82mm in depth. This is an approximate loss (from original floor thickness of circa 5.2mm) of 35%. This does not meet the 40% level of loss that industry standards would describe for remedial action but owing to the closeness of the loss level it is suggestable that remedial works are advisable here. It is also noted that despite the highest risk of corrosion and metal thickness loss occurring on the tank floor, the four steel plates used to construct this section are thinner than those of the rest of the tank. The junction welds between this plate and the neighbouring sidewall and end-wall plates are fully welded only on the exterior side [within the bund] and the interior is only tac welded. This does not confirm to the current British Standard set out for the construction of double-skinned fuel storage tanks of this type and construction; it is a weaker design and consequently presents a higher possibility of eventual failure. The inner welds joining the four floor plates together is in good condition with no signs of cracking, seepage, or delamination.

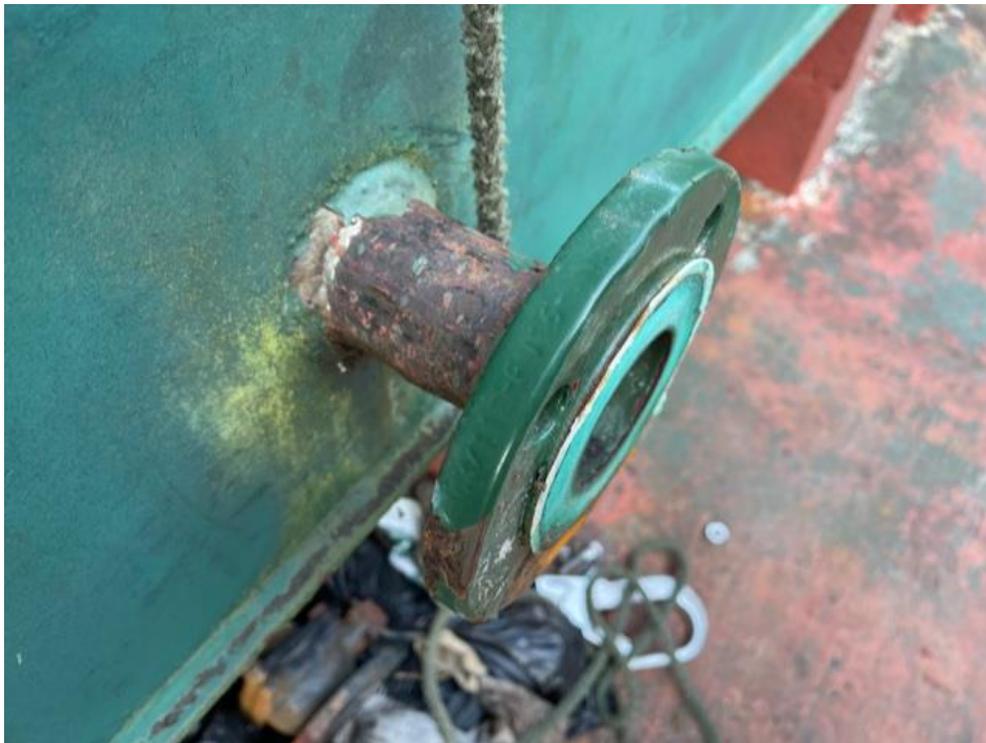
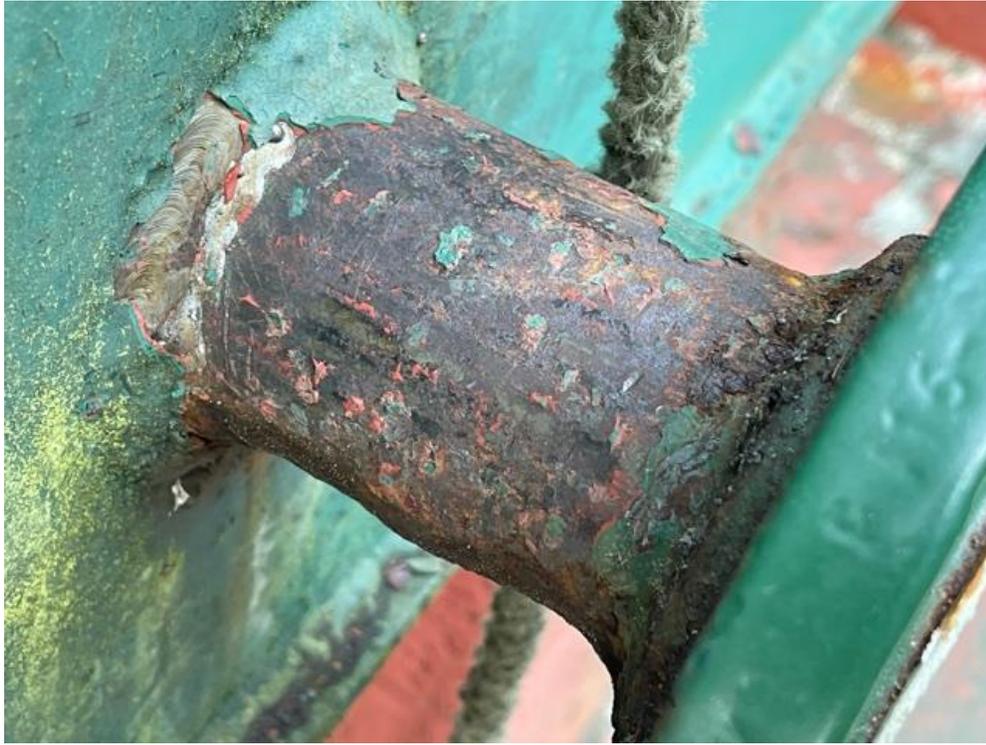
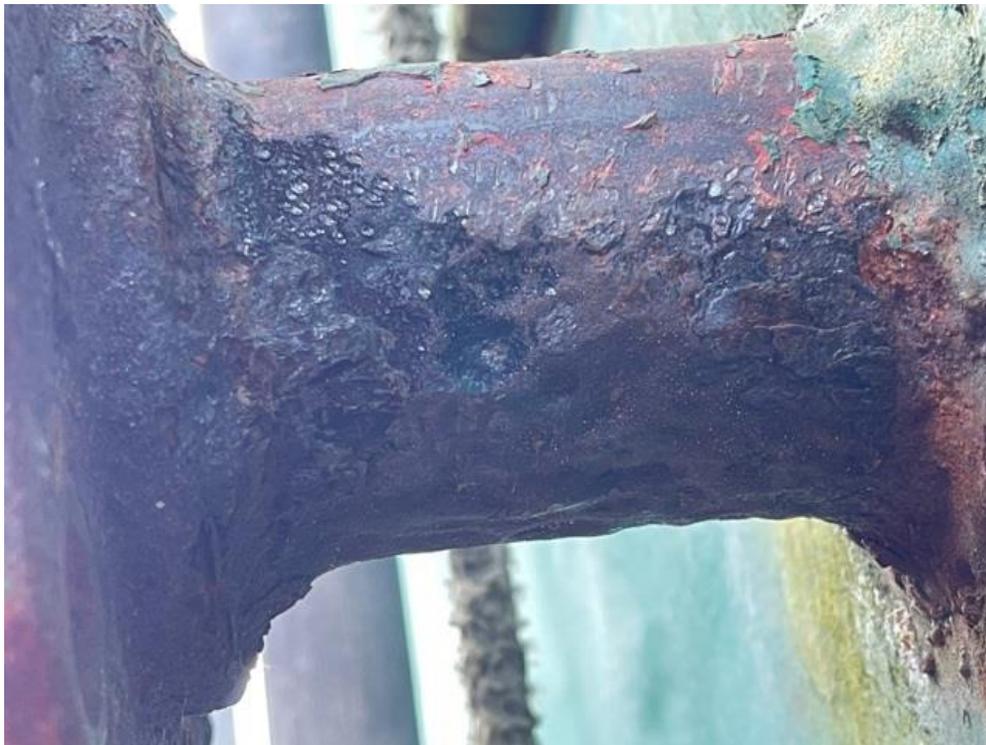
Fig 8. Outlet Nozzle

Fig 9. Outlet Nozzle Close-Up

Fig 10. Outlet Nozzle Corrosion

The pre-flange exterior outlet nozzle pipework was found to be severely corroded with heavy pitting and skin loss to the pipe [see figures 8 to 10]. There is evidence of pinhole leakage on the bottom of the pipe and if the tank is to be returned to use, then this will require suitable prior rectification.

- Corrosion and pinhole leakage in the fuel outlet nozzle.

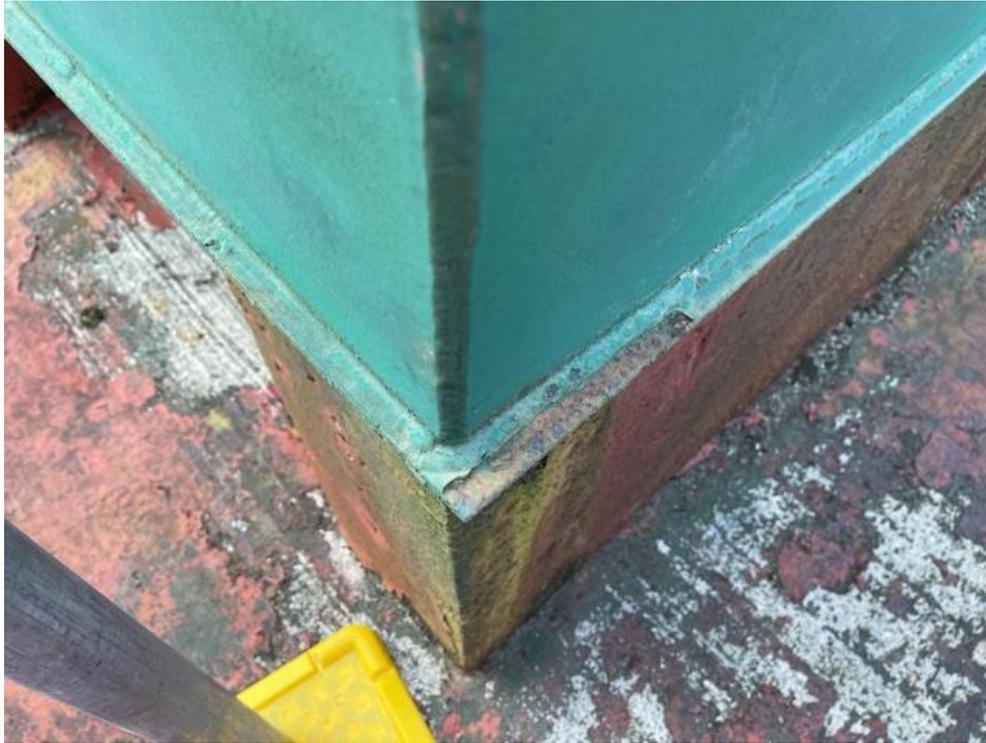
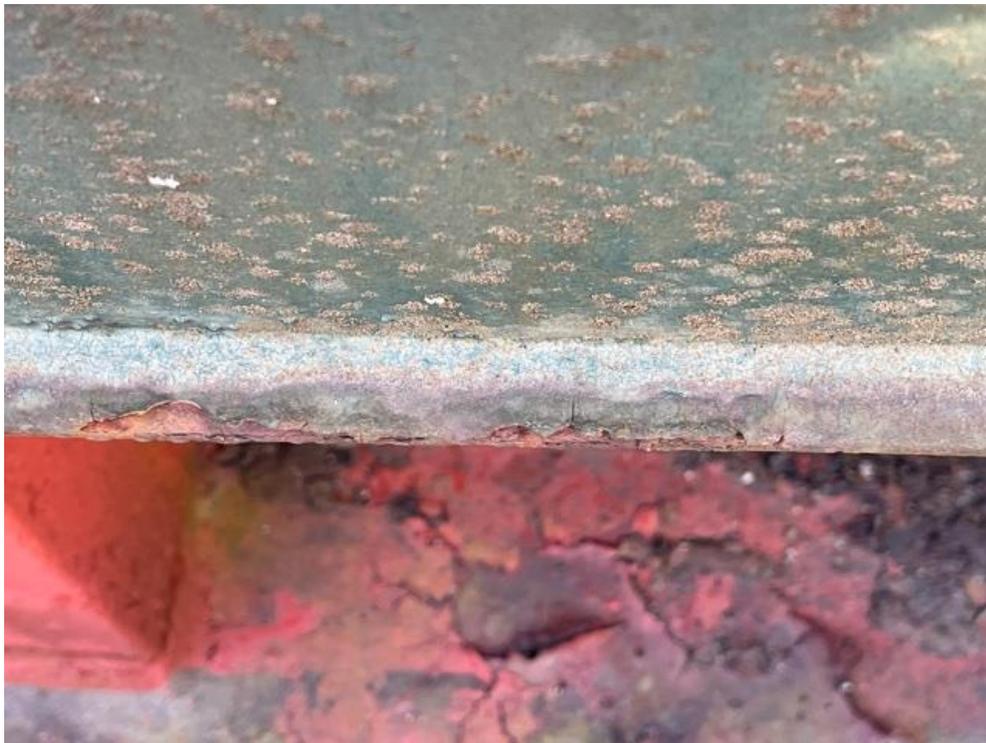
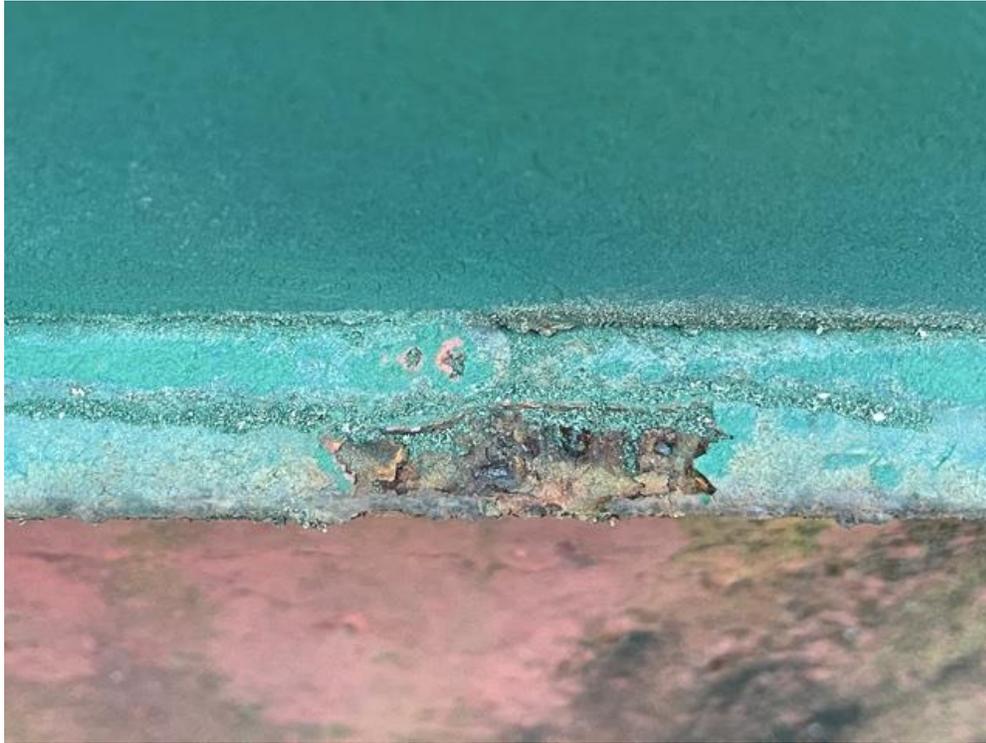
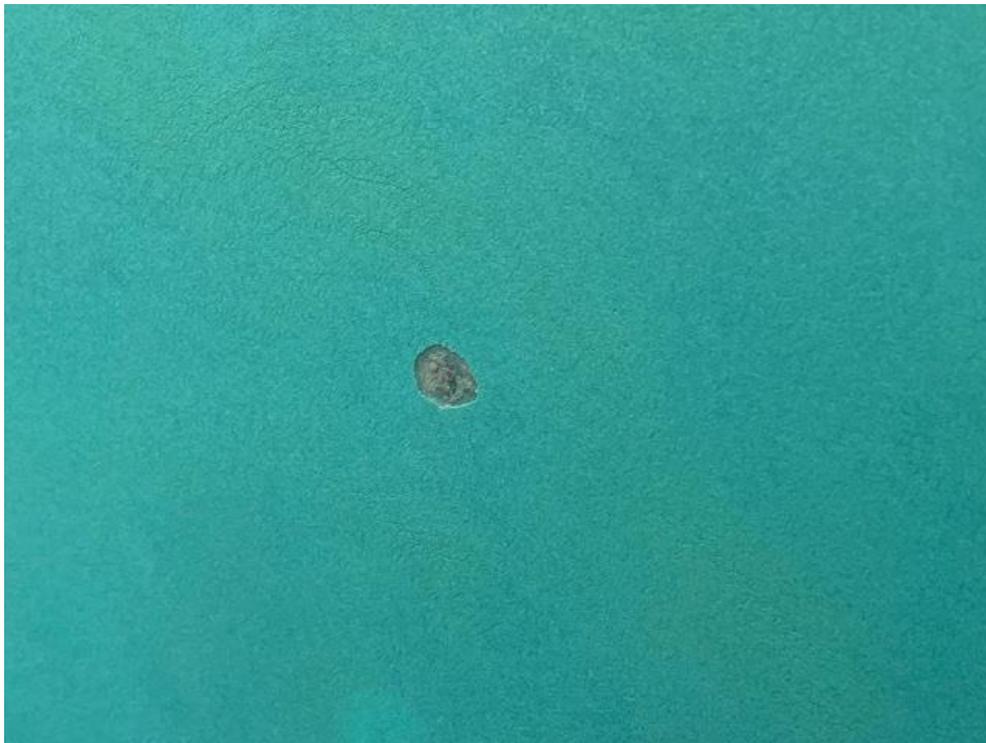
Fig 11. Protrusion Corrosion

Fig 12. Protrusion Corrosion

Fig 13. Protrusion Corrosion

Fig 14. Exterior Bund Corrosion

The exterior shell of this tank shows signs of minor corrosion. There are a small number of surface-corroded areas due to paintwork damage and subsequent water entrapment on the floor protrusion and north wall [see figures 11 to 14].

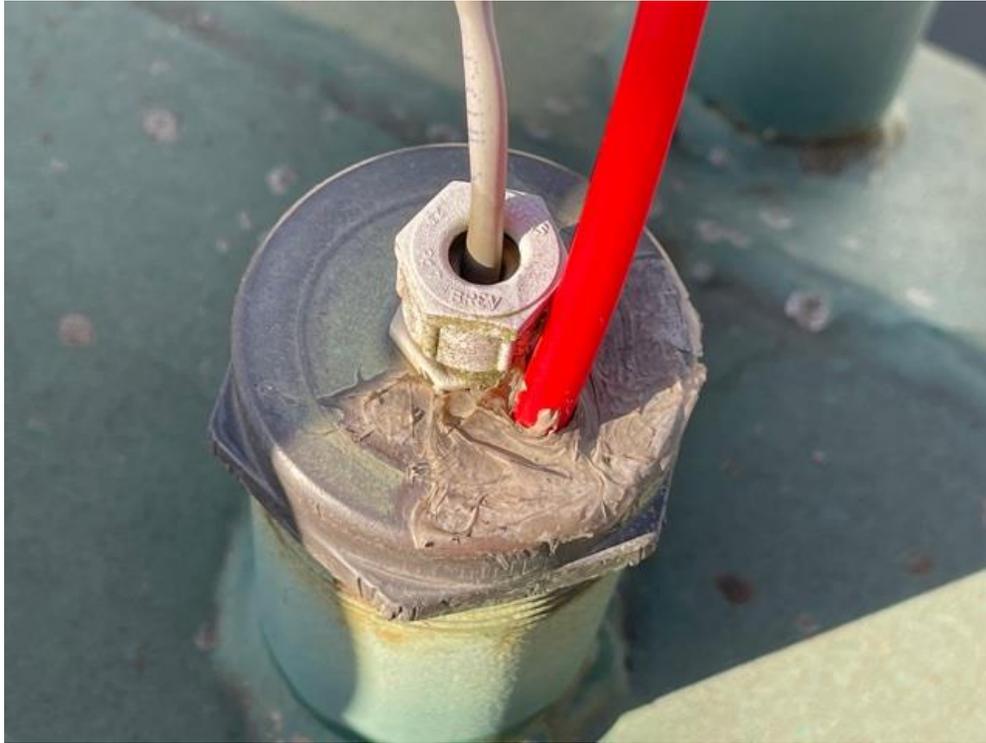
Fig 15. Gauge Pipe Inlet

The OCIO tank product level gauge's PU tube enters the tank through a drilled hole in a screwed cap fitted to a nozzle on the tank roof. An attempt has been made to seal the surrounding hole with a type of putty, but this is ineffective, and no seal has been made. Consequently, there is a chance of water ingress to the main body of the tank around the edges of the tubing at this point [see figure 15].

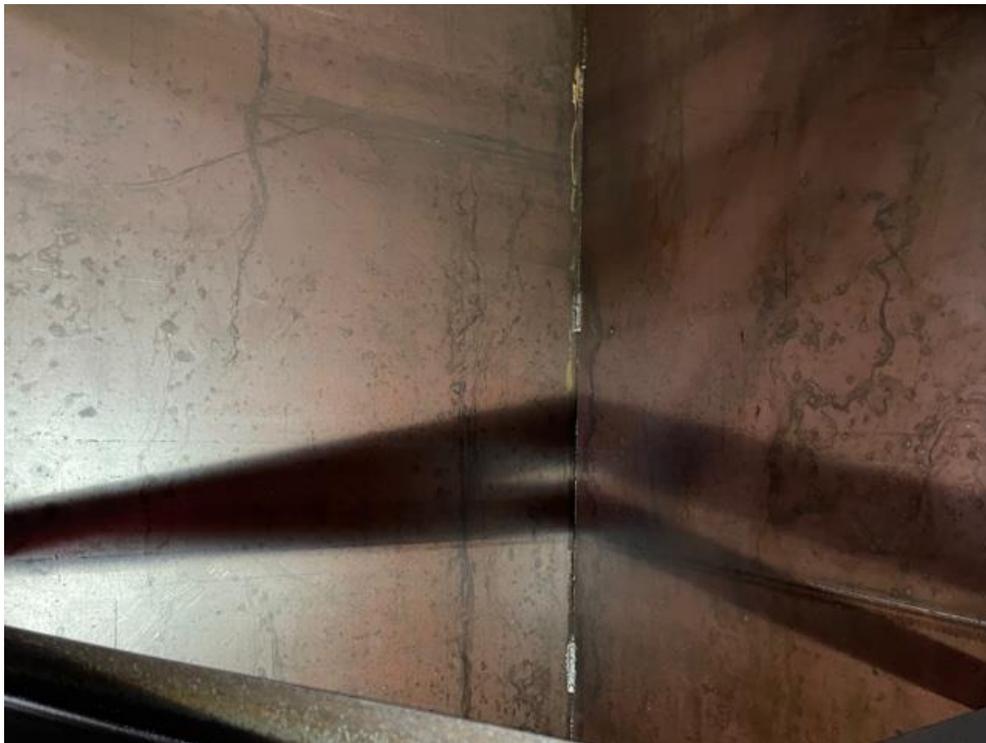
Fig 27. Internal Tac Welds

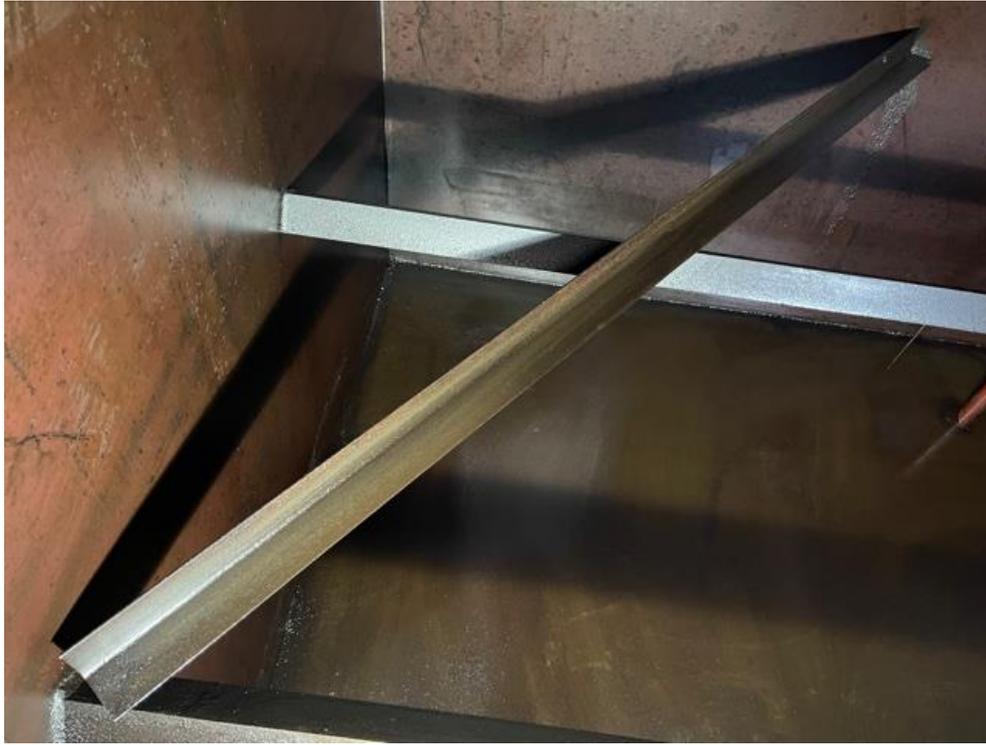
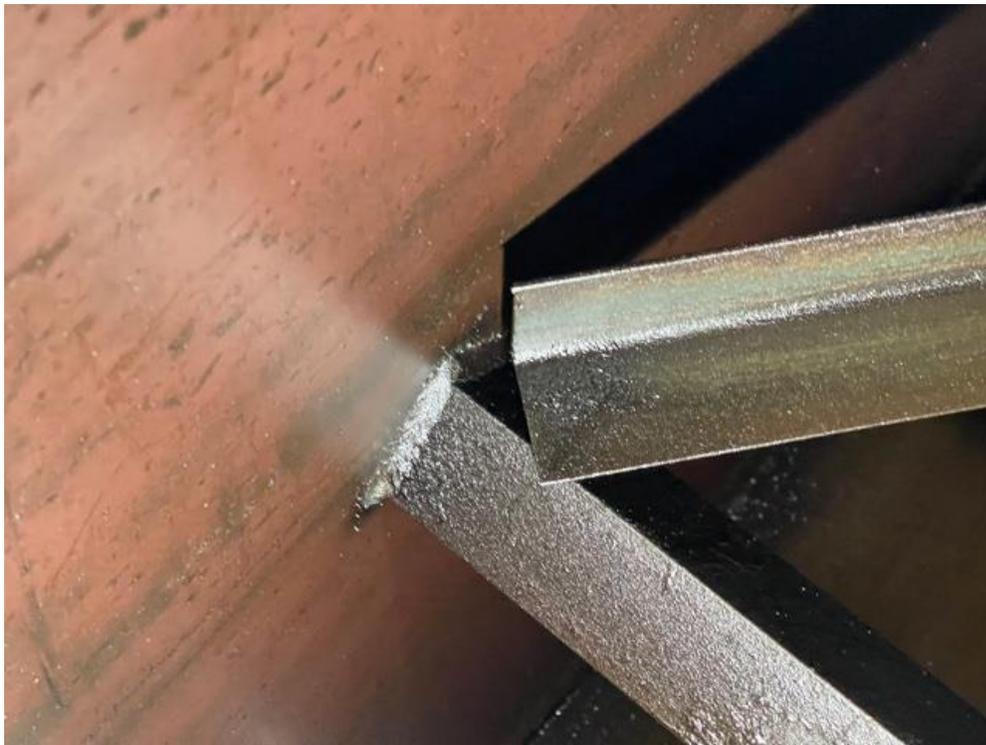
Fig 28. Unwelded Bracing

Fig 29. Bracing Close-Up

cracking to the welding or floor plates was found to have occurred from this, but it presents a point of note to be referenced when inspecting for damage or deterioration in any subsequent inspections. The lowest corner bracing bar in the northwest corner of the tank is only partially attached to the shell walls; one end is welded to the north end-wall, but the opposing end is not attached to any part of the tank. There is no indication that this has been caused by damage or deterioration, rather there is no evidence that this was ever welded together during the manufacture stage. This presents a small potential weak spot in the structural rigidity of the tank [see figures 28 and 29].

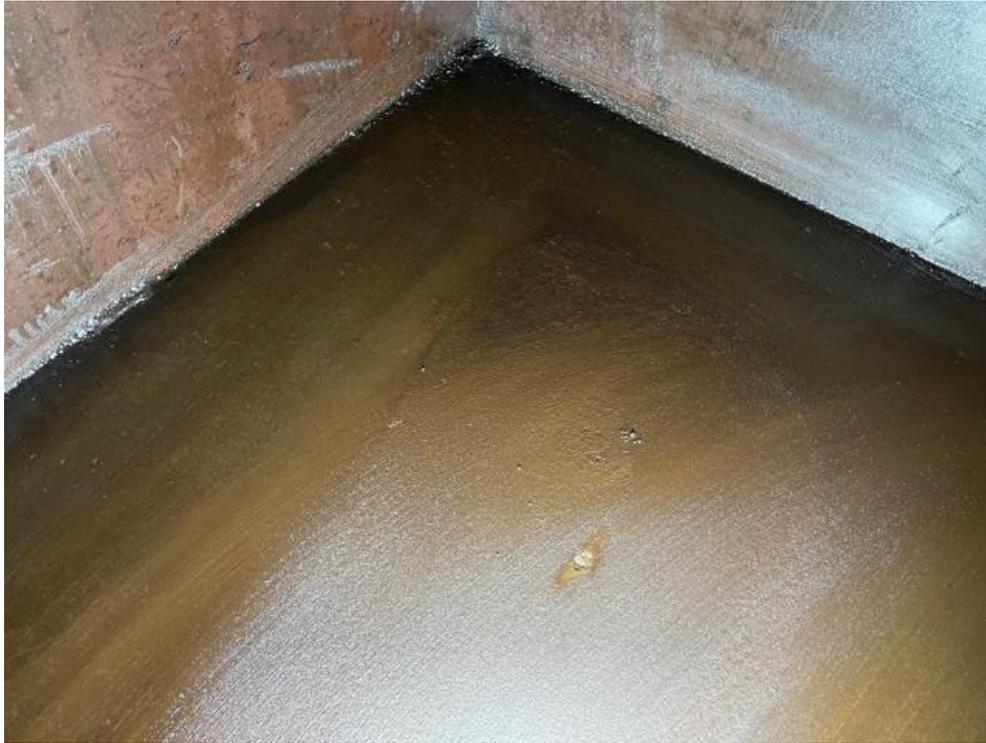
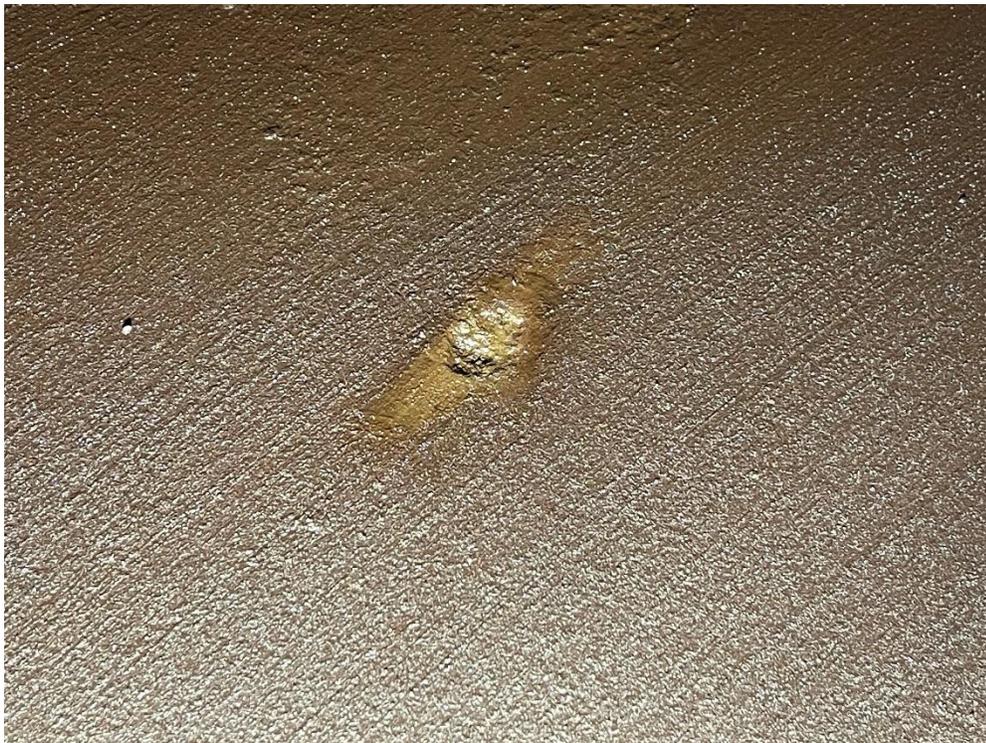
Fig 30. N/W Floor Pitting

Fig 31. Pitting Close-Up
