Home Inspection Report

Prepared for: John & Jane Doe

1234 Your Street
Your Town, TN 37001

Inspected by:
William Carmichael TN License #2190
BeSure1st Home Inspections, Inc.
615-944-6999

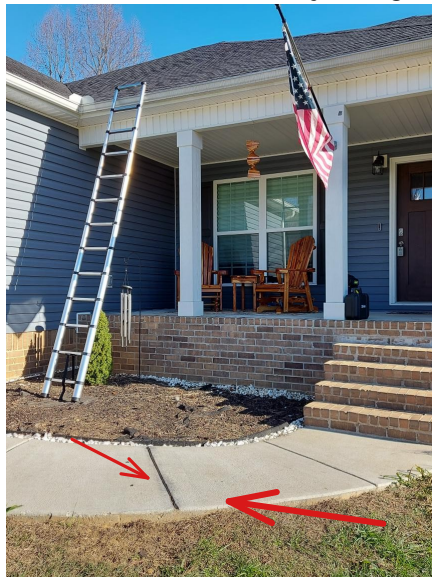
Walks: Concrete. The walkway has settled and a section of concrete has lifted, presenting a small trip hazard of about 1 inch. This may or may not get worse but based on what was observed at the brick steps it should be monitored. If it worsens I recommend a qualified contractor stabilize it. Several options are available, such as foam jacking.

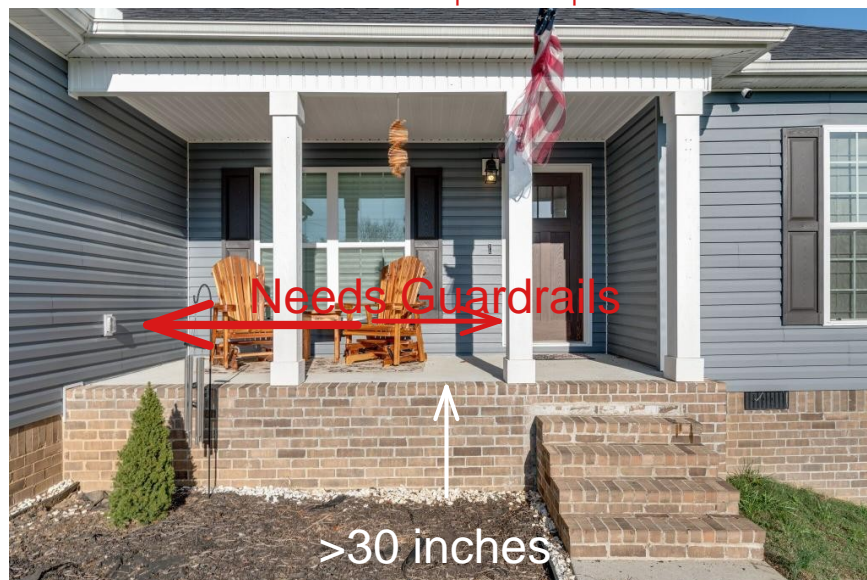
Front Porch: Bricks and concrete. The porch elevation was more than thirty inches from the grade. The International Residential Code, which this jurisdiction adheres to, requires handrails for steps and porches that are more than 30 inches higher than grade. They are required to have no more than a four inch separation between the balusters which is a safety feature to prevent small children from becoming trapped between the balusters and to provide pedestrian stability during use. The TN Standards of Practice for Home Inspections requires that missing handrails be noted in the Home Inspection Report as a potential safety hazard. The inspector recommends that a qualified contractor install a handrail on the porch steps.

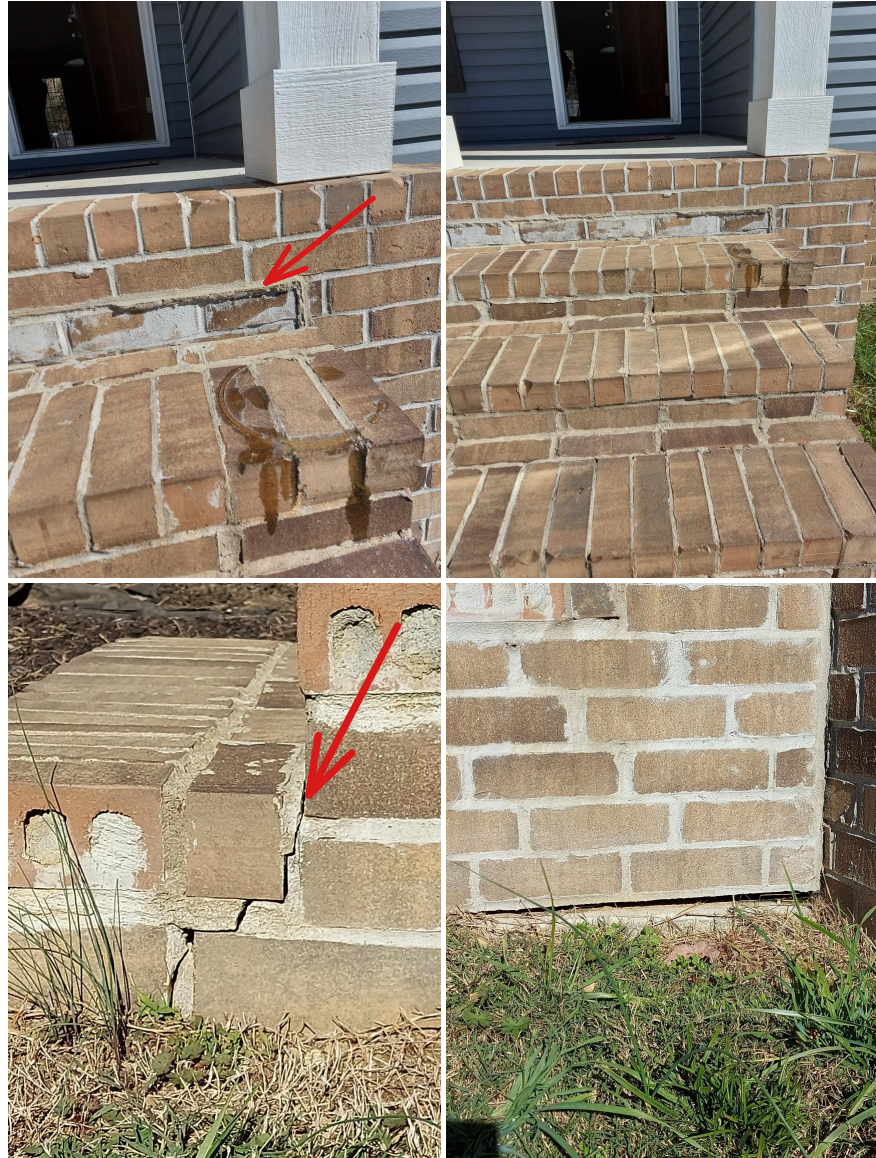
Steps to Front Porch: Brick ---- The brick steps were built on top of the sidewalk which appears to have settled. The tread of the top step has displaced downward on the right side about four inches. This has increased the height of the top riser to about 10 inches and presents an non-standard step which could be a potential tripping hazard. Also, steps of this height should have a railing with a grippable handrail and balusters spaced no more than four inches apart. It is recommended that a qualified contractor install a set of handrails on the steps.

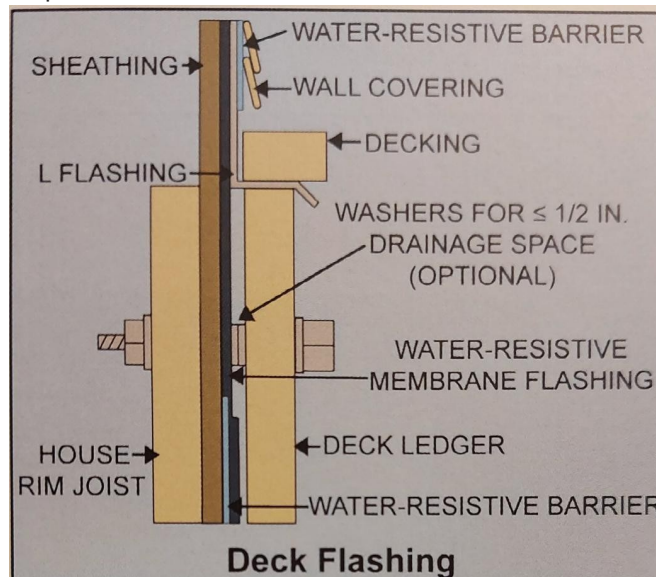
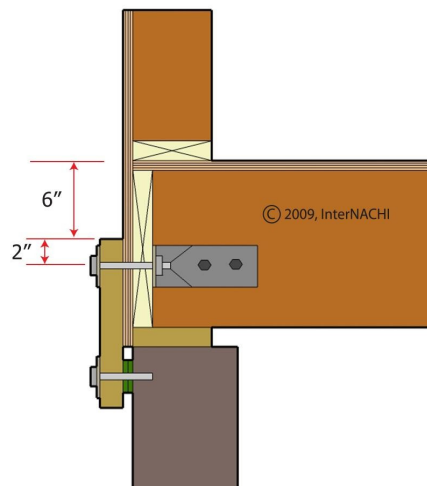
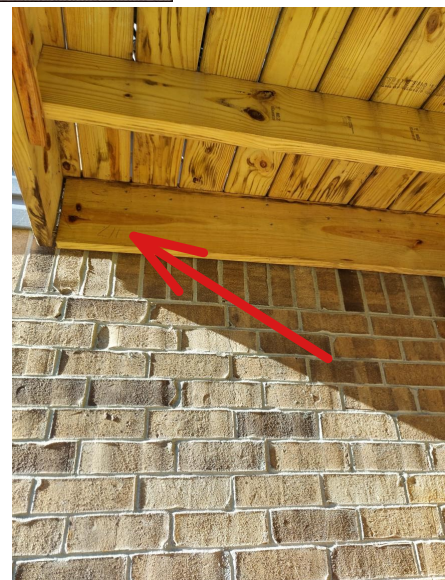
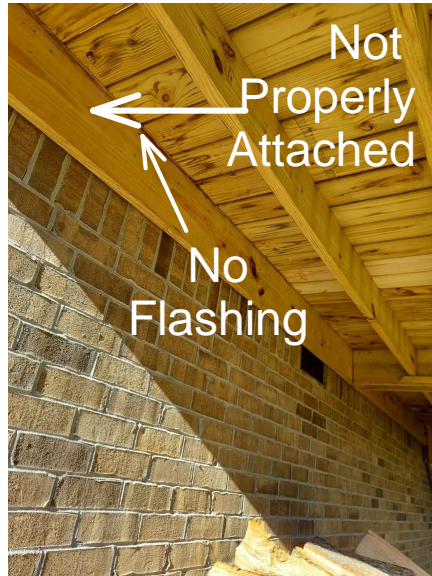
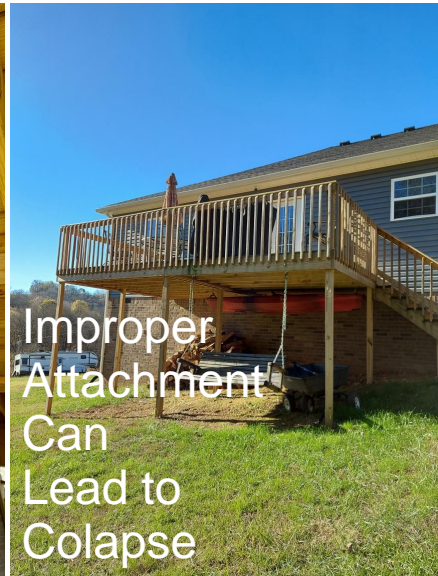
Deck Ledger to House Connection

Deck: Treated wood ---- The deck was improperly attached to the home. Decks are required to be bolted to the home and the bolts are required to have washers. The International Residential Code requires the ledger board to be attached to the house with 1/2 inch by 4 inch lag bolts with washers. The top of the ledger board should be protected with a metal drip edge. This deck does not meet that standard and may become unstable with heavy loading. It is recommended that a qualified tradesman provide a solution that meets the requirements.

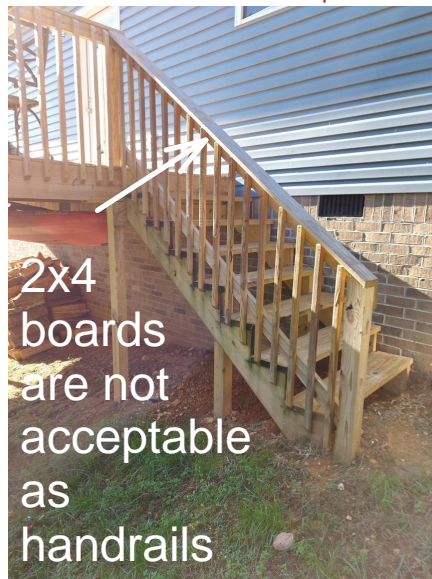
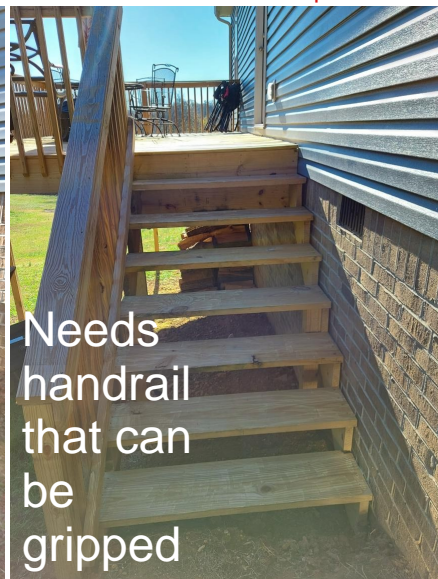
Deck Handrails: Treated Wood ---- An acceptable handrail was not observed. The International Residential Code does not consider 2x6 or 2x4 boards to be acceptable handrails. Handrails should be shaped so that they can be gripped. It is recommended that a qualified contractor install an acceptable handrail.

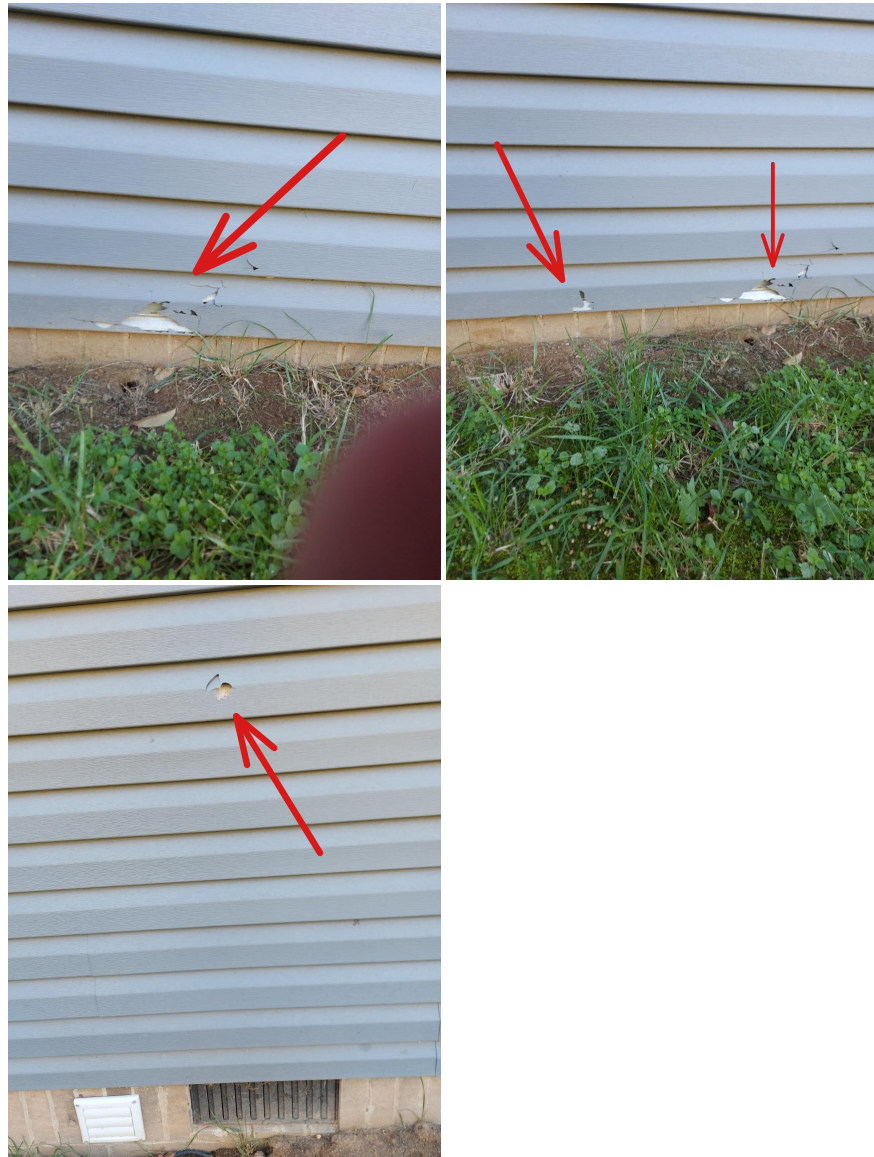
Type: Vinyl siding ---- Holes in the vinyl siding were observed. This type of damage typically occurs when the mower propels small rocks. The breaks in the siding can allow water intrusion behind the siding and has the potential for inducing rot or mold issues. Bees have also been known to nest their hives in such places. The repairs to the siding can be effected by the client by sealing with a backing of spray foam and a top coating of silicone sealant. This suggested repair may not be considered permanent and it is recommended that a qualified contractor be consulted for repairs or replacement of the broken siding.

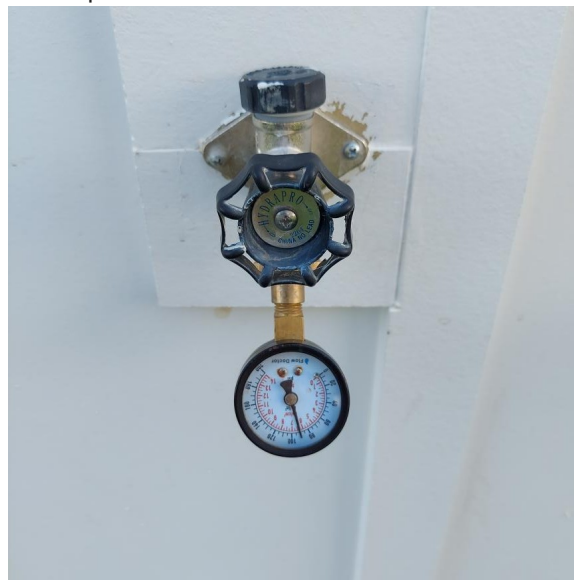
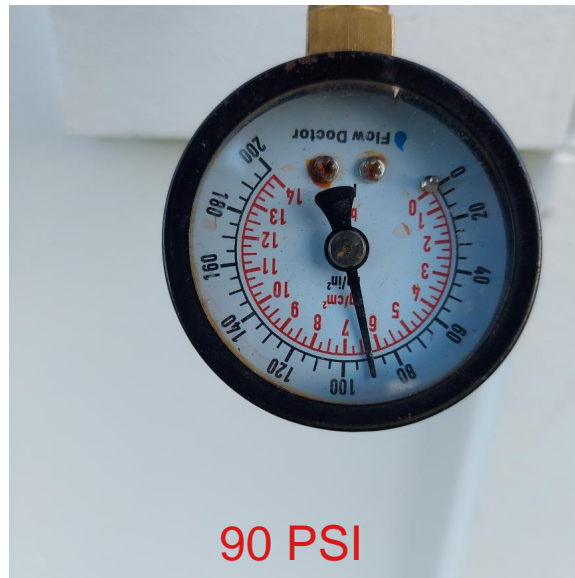
Hose Bibbs: - Gate valve type ---- - Water pressure was measured at 90 PSI. 70 PSI is the upper limit of the recommended water pressure for residential homes. While too much pressure probably won't cause an immediate leak, it can stress pipe joints and faucet seals which can increase the chances of leaks or failure in the future. Additionally, showers and spigots may be uncomfortable to use. High water pressure is typical in new homes. Plumbing systems are often stress tested to ensure that all joints and seals are working well and no leaks appear. It is recommended that a qualified handyman reduce the water pressure. Normal water pressure between 40 and 70 PSI.

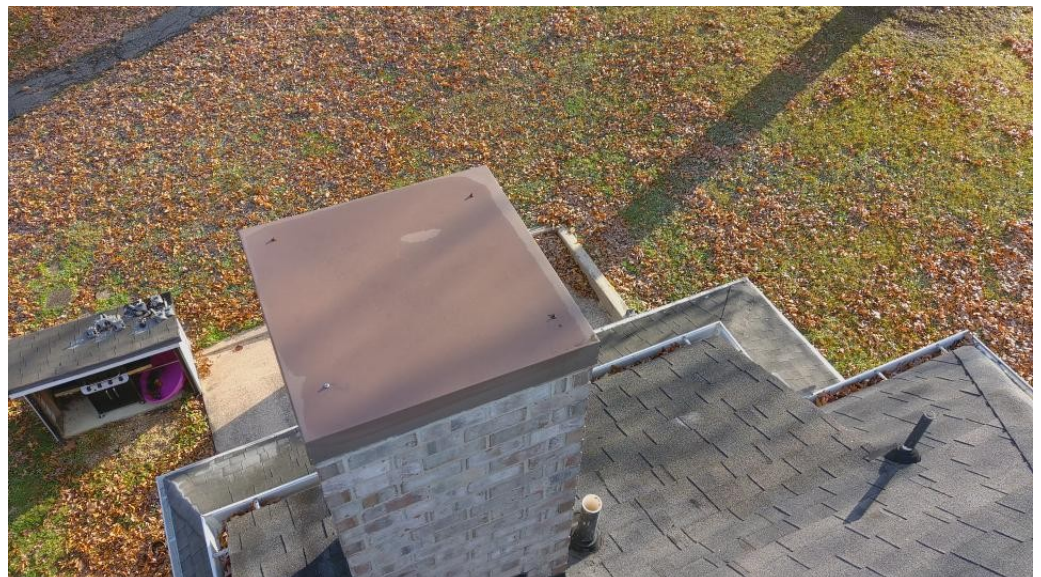
Flue/Flue Cap: Metal ---- Non-functional chimney. This chimney has been capped off and the fireplace is no longer useable. A professional chimney sweep should be consulted before re-commissioning the fireplace and chimney.

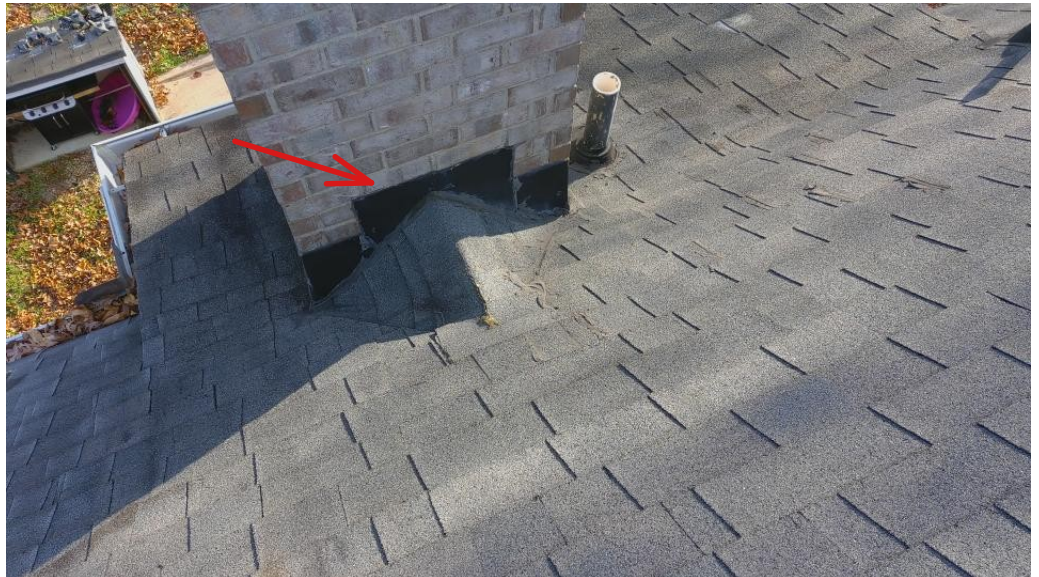
Chimney Flashing: Rubberized asphalt ---- Deteriorating sealant. Needs to be resealed to prevent the potential of future leaks.

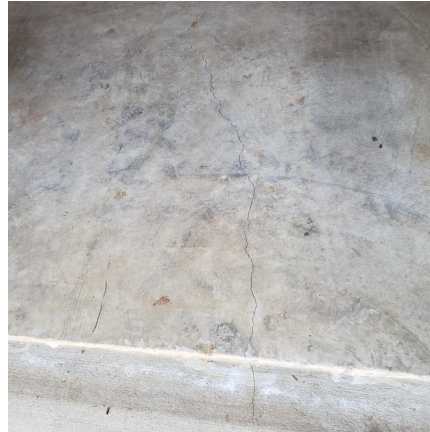
Cracks on the exterior should be sealed, however. It was noted that a small portion of the water-stop edge of the floor has broken and was repaired. This crack should be sealed since it is subject to water intrusion and freeze/thaw damage.

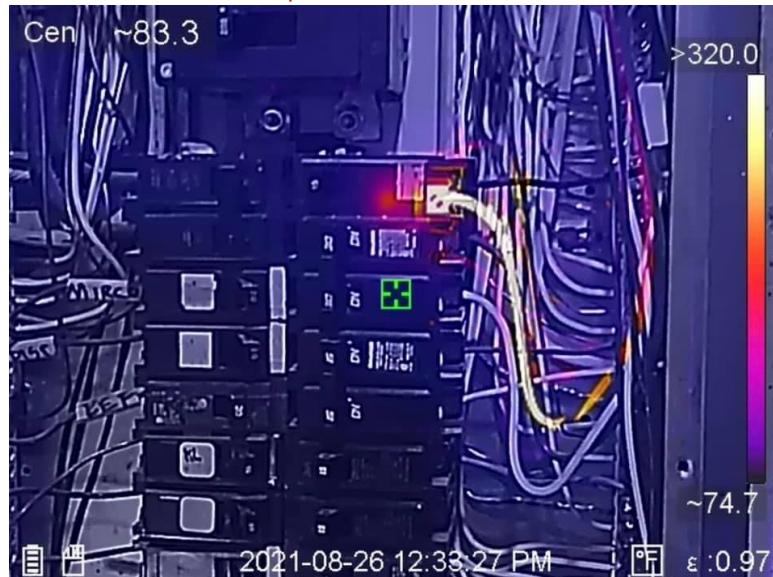
Breakers: Copper ---- While scanning the electrical panel with my Infrared Thermal Imaging Camera I observed a breaker that was overheating. This would not have been observed without the use of an IR camera. The temperature was 320 F. Due to the possible safety issues I deactivated this breaker. This is a potential electrical fire hazard. I recommend that a licensed electrician further evaluate and affect repairs.

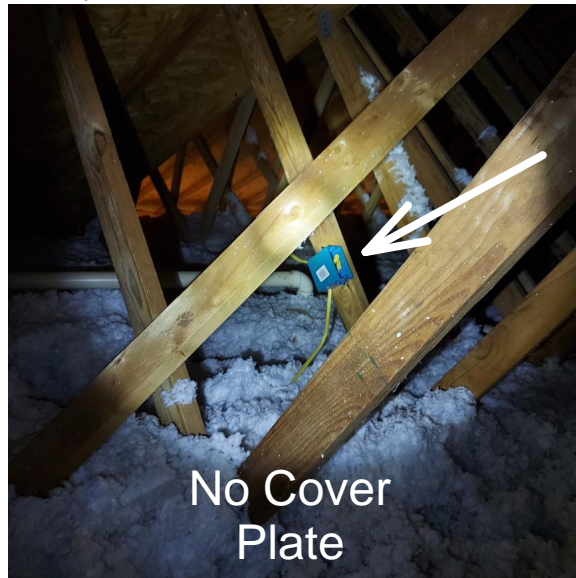
Wiring/Lighting: 110 VAC and lighting circuit ---- Open junction boxes, Exposed wire splices

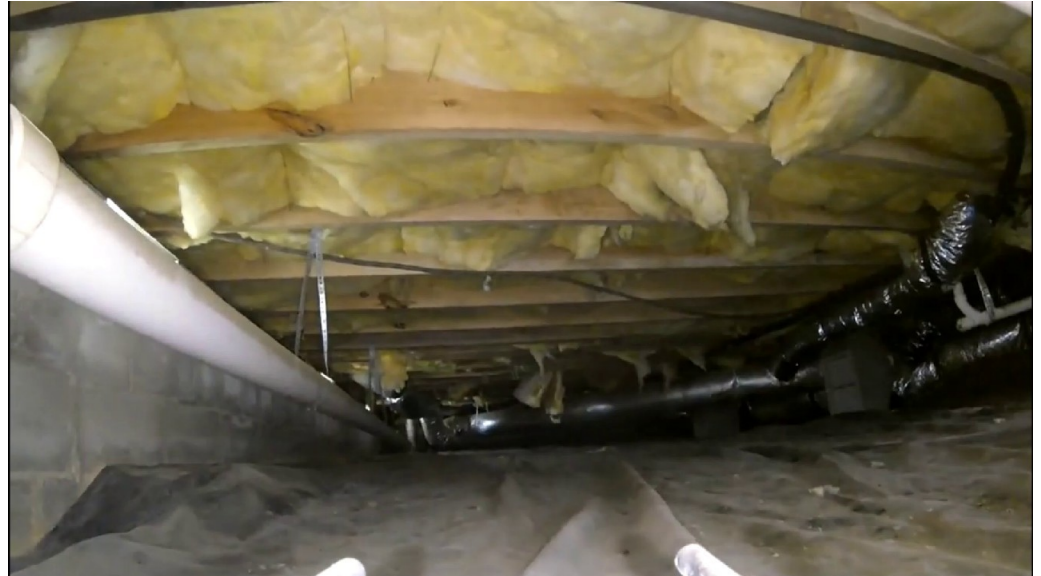
Functional	Percentage Inspected: 100%
Functional	Vapor Barrier: --- 6 mil polyethylene
Functional	Moisture Penetration: No moisture present at time of inspection
Functional	Ventilation: Vents in block wall - properly spaced
Functional	Subfloor: OSB Plywood
Functional	Foundation Walls --- Block on poured concrete footers
Functional	Joists and Beams: 2x10 Joists and three bonded 2x10s for beams.
Functional	Piers/Posts: Block Piers
Minor Concern	Insulation: Fiberglass ---- This is a periodic maintenance item. Over time fiberglass insulation that is suspended between floor joists can sag or fall. It is a simple matter to affix sagging insulation. Large hardware outlets sell flexible wire rods that are cut to length and are wedged between the joists to support the insulation. This should be checked once a year.

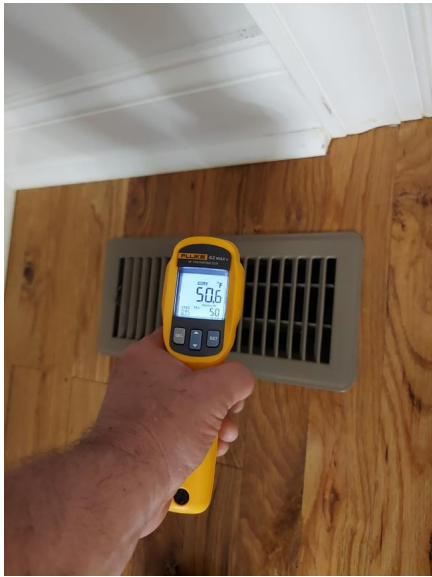
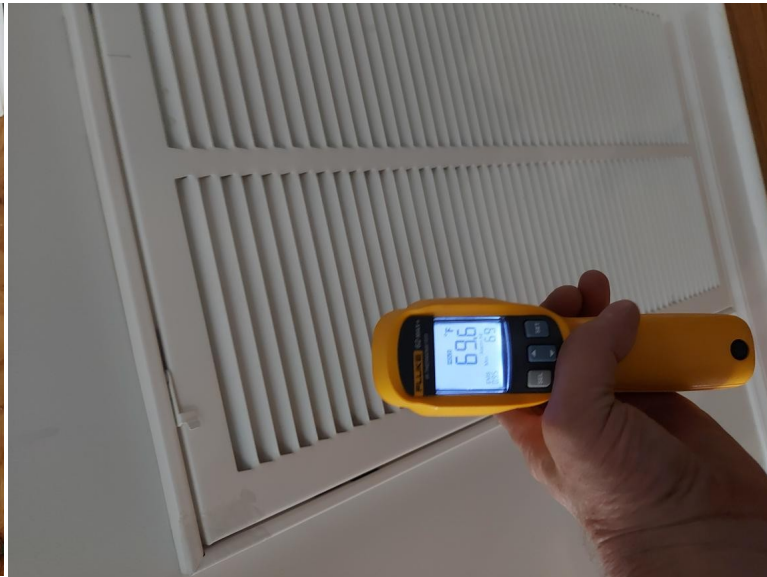
Temperature Differential in Cooling Mode 20 F ---- A properly functioning air conditioning unit should have a differential between 14 and 22 F. When the temperature is below 65 degrees F Home Inspectors do not operate the HVAC system in the cooling mode. Tennessee Standard Operating Procedures specifies that the system should not be operated in the cooling mode because the refrigerant may not vaporize completely and liquid refrigerant can damage the compressor. However, the heating mode was tested and found to be adequate.

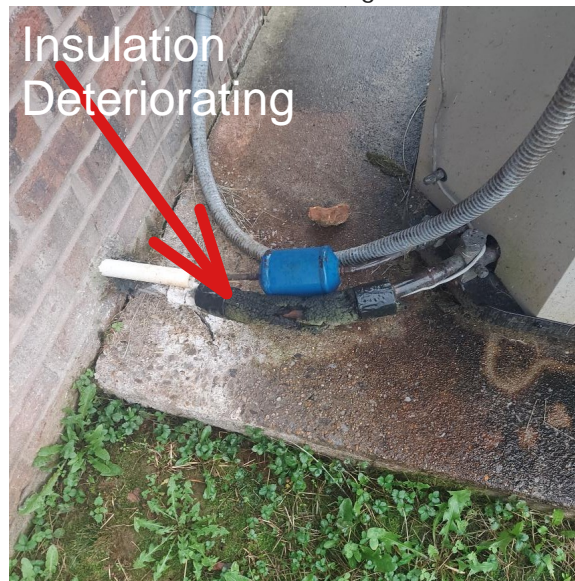
Refrigerant Lines: Insulation on pressure lines ---- Deteriorating insulation on the refrigerant lines can reduce the efficiency and has the potential of freezing. It is recommended that the refrigerant line insulation be replaced.

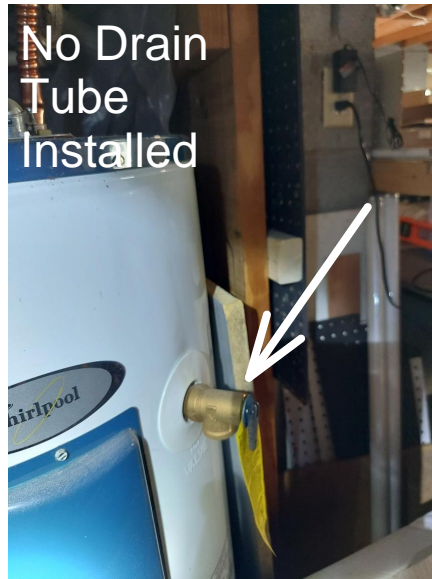
Drain Tube Not installed ---- Drain tube is missing. Drain tubes on the Temperature/pressure relief valve direct hot water to the floor if the TPR activates due to high pressure or temperature in the tank. This is designed to prevent explosions of the tank and by directing the water to the floor the likelihood of scalding is reduced when the system's problem is being investigated or shut down. It is recommended that a qualified contractor install a drain tube in accordance with best practices and code requirements.

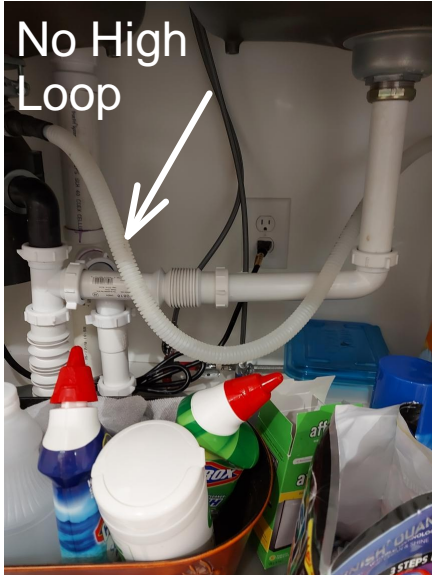
Air Gap Present? No - No high loop in the discharge drain was observed. A high loop in the discharge hose creates an air gap and prevents contaminated dishwater from siphoning back into the dishwasher. This is a safety feature to prevent sickness due to polluted water. The inspector recommends that a qualified handyman or plumber adjust the discharge hose to create a high loop.

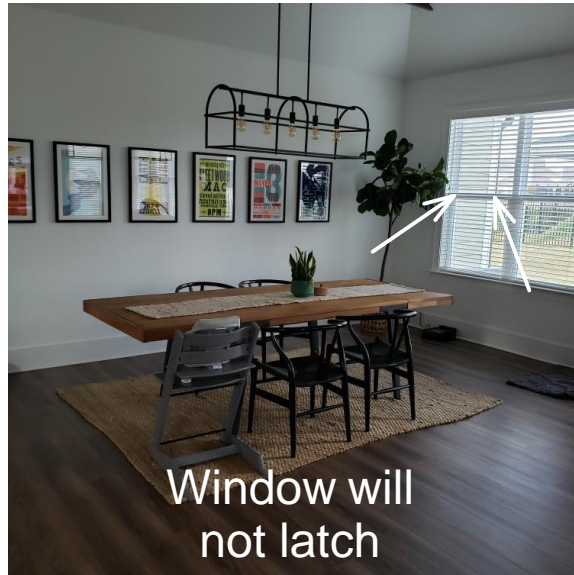
Windows: Vinyl double hung ---- The locks do not align and will not lock. This is a security issue. Doors and windows of a home should be lockable to prevent break-ins. It is recommended that a professional window installer assess and repair.

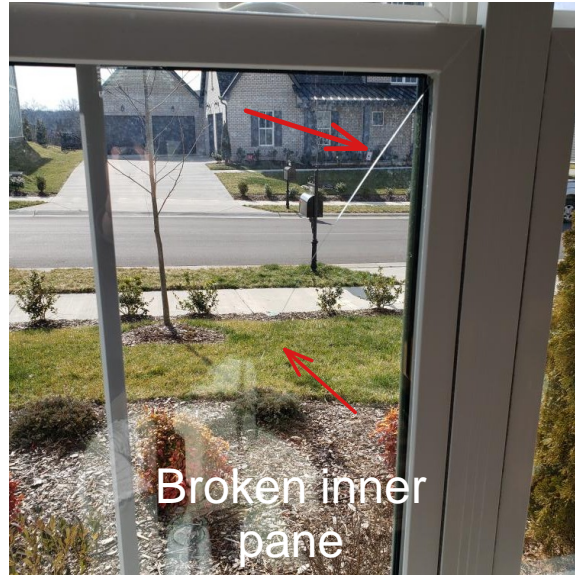
Windows: Vinyl double hung ---- Cracked glass, A qualified glazier is recommended to evaluate and estimate repairs

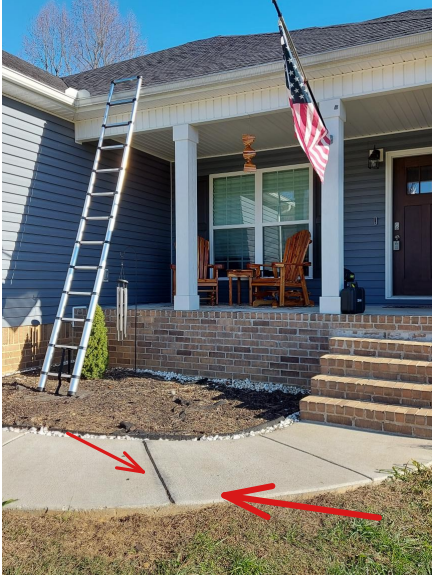
Walks: Concrete. The walkway has settled and a section of concrete has lifted, presenting a small trip hazard of about 1 inch. This may or may not get worse but based on what was observed at the brick steps it should be monitored. If it worsens I recommend a qualified contractor stabilize it. Several options are available, such as foam jacking.

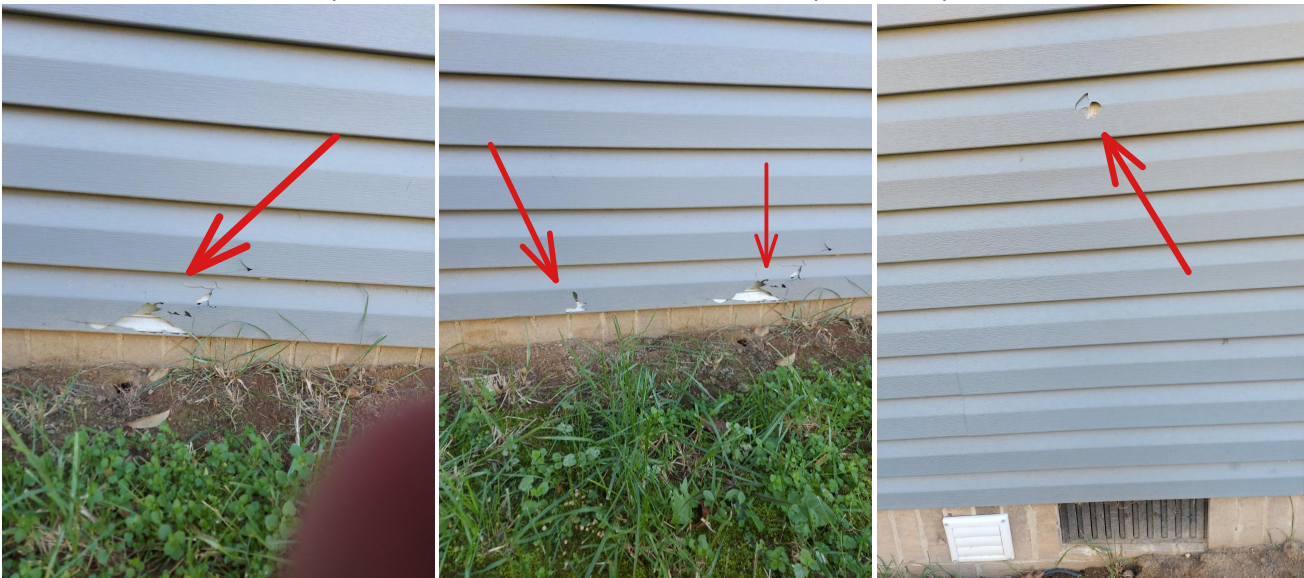
All Sides unless noted in comment Exterior Surface Type: Vinyl siding ---- Holes in the vinyl siding were observed. This type of damage typically occurs when the mower propels small rocks. The breaks in the siding can allow water intrusion behind the siding and has the potential for inducing rot or mold issues. Bees have also been known to nest their hives in such places. The repairs to the siding can be effected by the client by sealing with a backing of spray foam and a top coating of silicone sealant. This suggested repair may not be considered permanent and it is recommended that a qualified contractor be consulted for repairs or replacement of the broken siding.

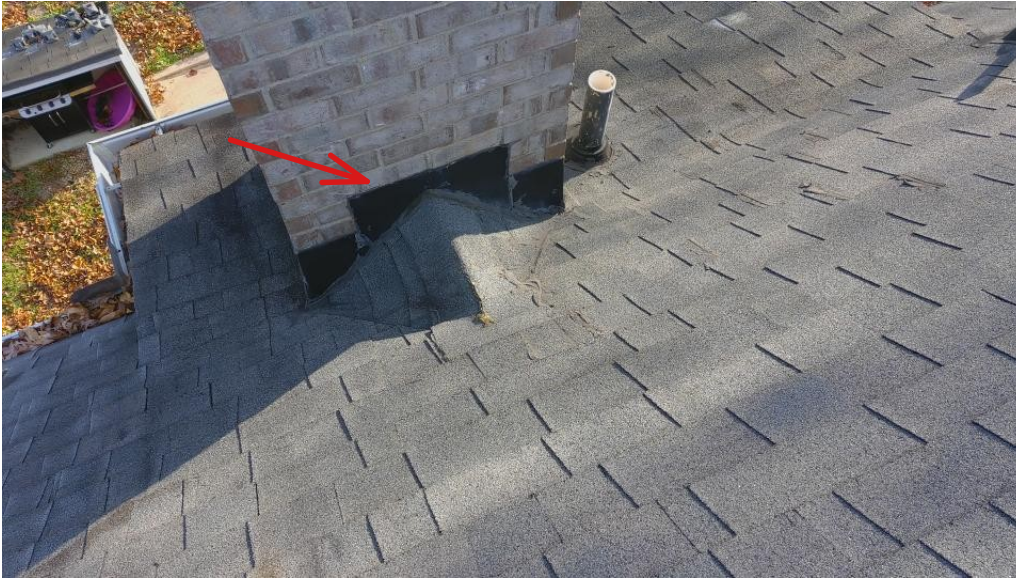
Flashing: Rubberized asphalt ---- Deteriorating sealant. Needs to be resealed to prevent the potential of future leaks.

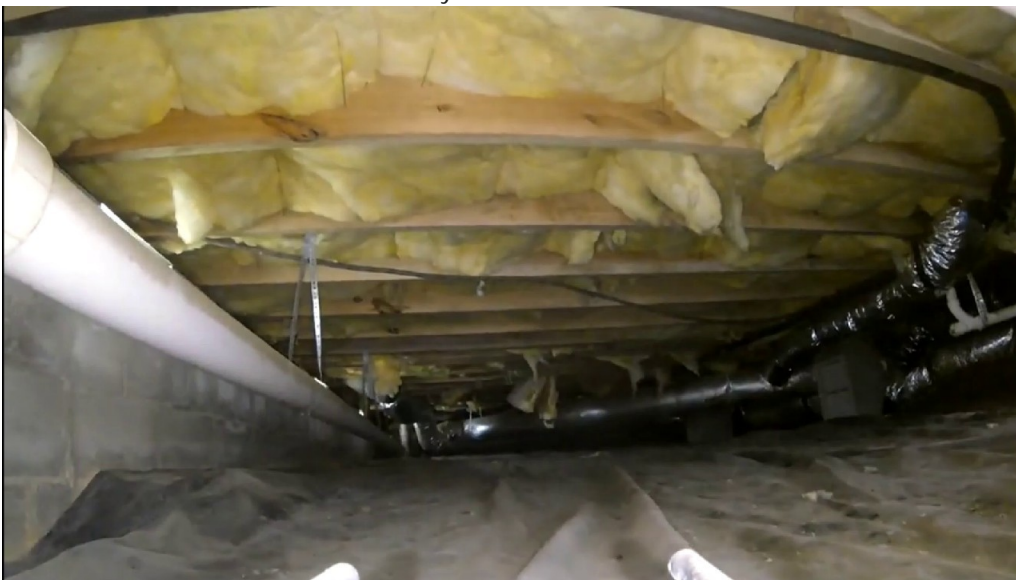
Crawl Space Insulation: Fiberglass ---- This is a periodic maintenance item. Over time fiberglass insulation that is suspended between floor joists can sag or fall. It is a simple matter to affix sagging insulation. Large hardware outlets sell flexible wire rods that are cut to length and are wedged between the joists to support the insulation. This should be checked once a year.

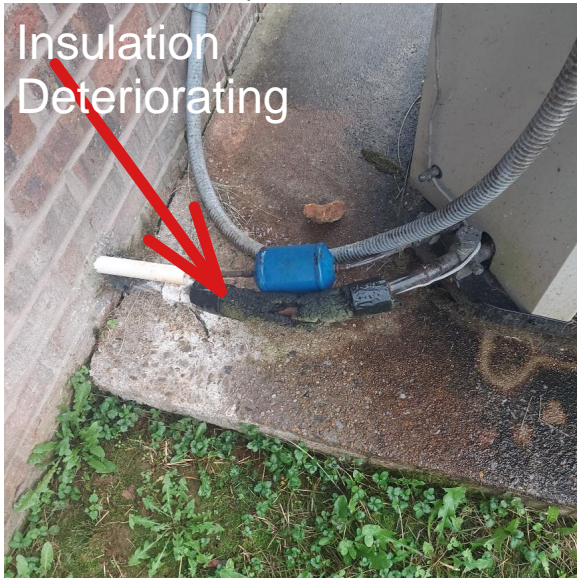
Back of House AC System Refrigerant Lines: Insulation on pressure lines ---- Deteriorating insulation on the refrigerant lines can reduce the efficiency and has the potential of freezing. It is recommended that the refrigerant line insulation be replaced.

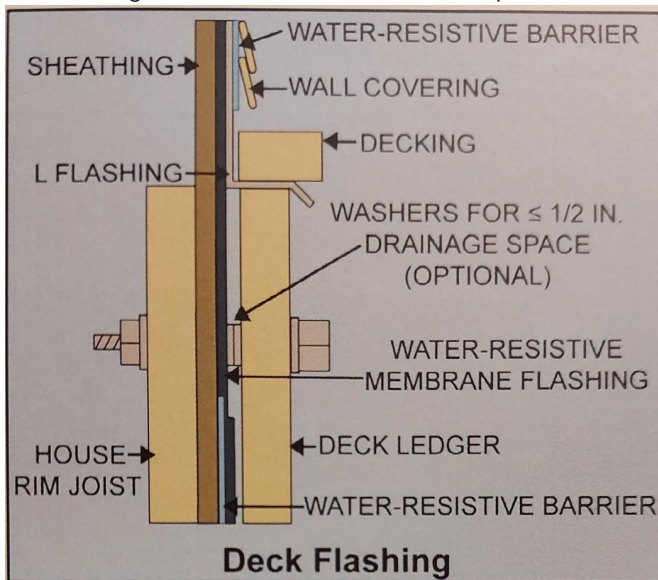
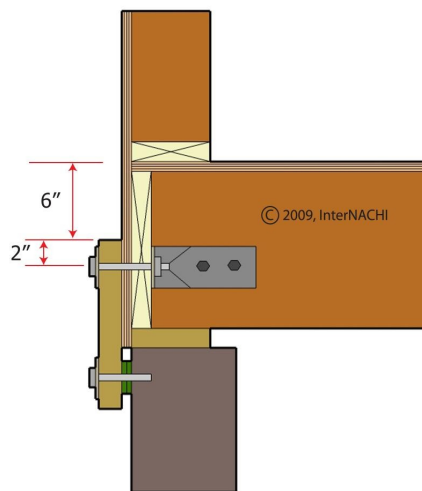
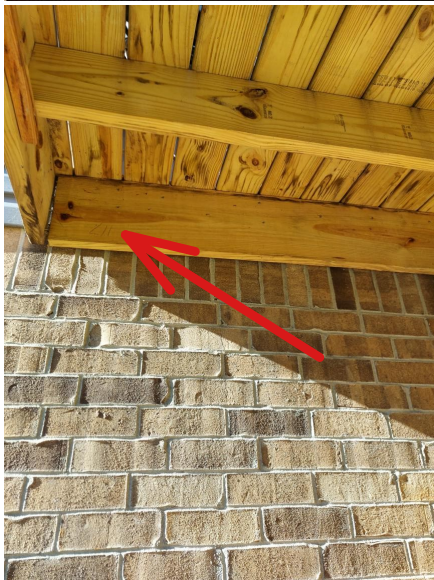
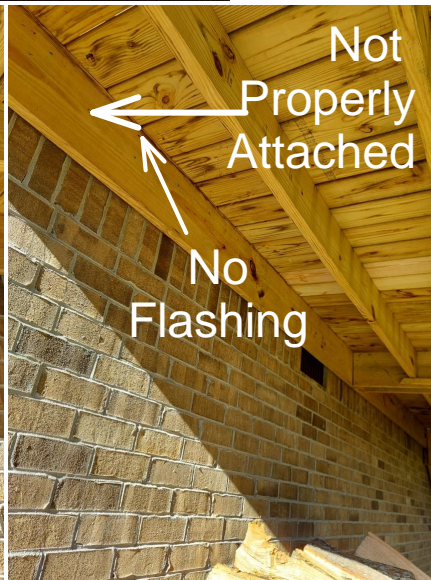
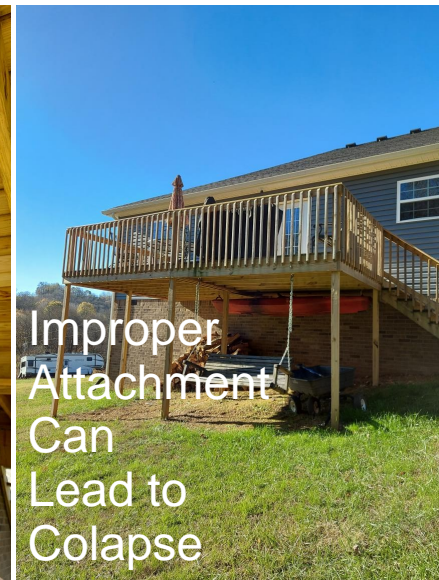
Deck Ledger to House Connection

Deck: Treated wood ---- The deck was improperly attached to the home. Decks are required to be bolted to the home and the bolts are required to have washers. The International Residential Code requires the ledger board to be attached to the house with 1/2 inch by 4 inch lag bolts with washers. The top of the ledger board should be protected with a metal drip edge. This deck does not meet that standard and may become unstable with heavy loading. It is recommended that a qualified tradesman provide a solution that meets the requirements.

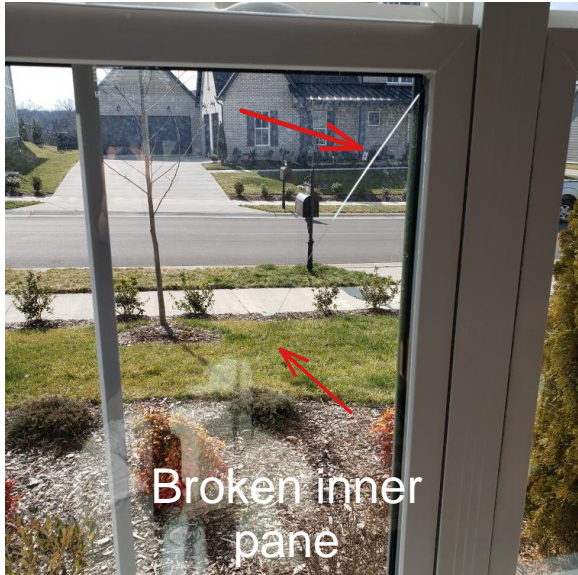
1st Floor Front Bedroom Windows: Vinyl double hung ---- Cracked glass, A qualified glazier is recommended to evaluate and estimate repairs

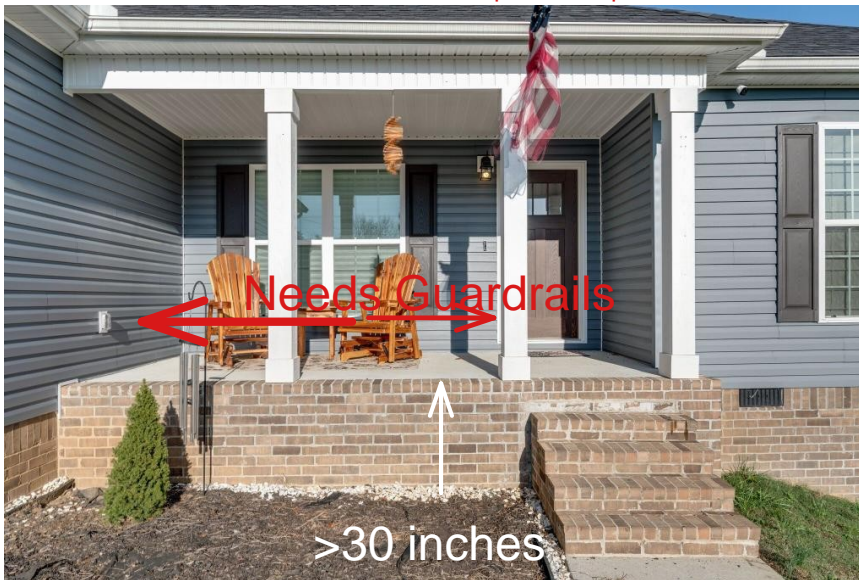
Front Porch: Bricks and concrete. The porch elevation was more than thirty inches from the grade. The International Residential Code, which this jurisdiction adheres to, requires handrails for steps and porches that are more than 30 inches higher than grade. They are required to have no more than a four inch separation between the balusters which is a safety feature to prevent small children from becoming trapped between the balusters and to provide pedestrian stability during use. The TN Standards of Practice for Home Inspections requires that missing handrails be noted in the Home Inspection Report as a potential safety hazard. The inspector recommends that a qualified contractor install a handrail on the porch steps.

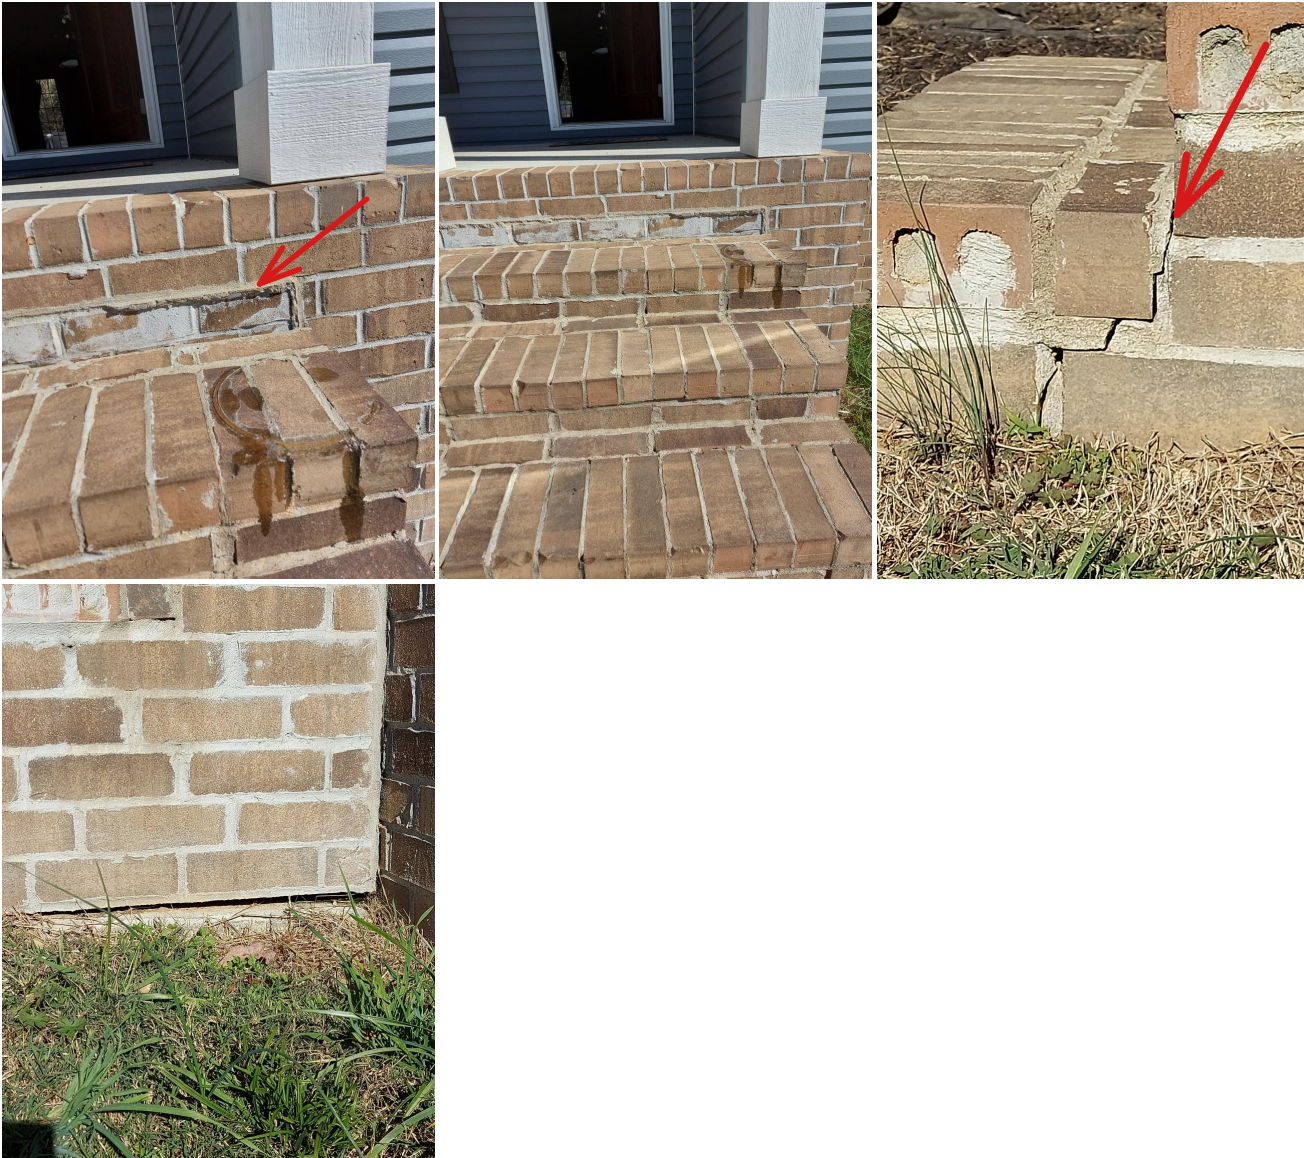
Steps to Front Porch: Brick ---- The brick steps were built on top of the sidewalk which appears to have settled. The tread of the top step has displaced downward on the right side about four inches. This has increased the height of the top riser to about 10 inches and presents a non-standard step which could be a potential tripping hazard. Also, steps of this height should have a railing with a grippable handrail and balusters spaced no more than four inches apart. It is recommended that a qualified contractor install a set of handrails on the steps.

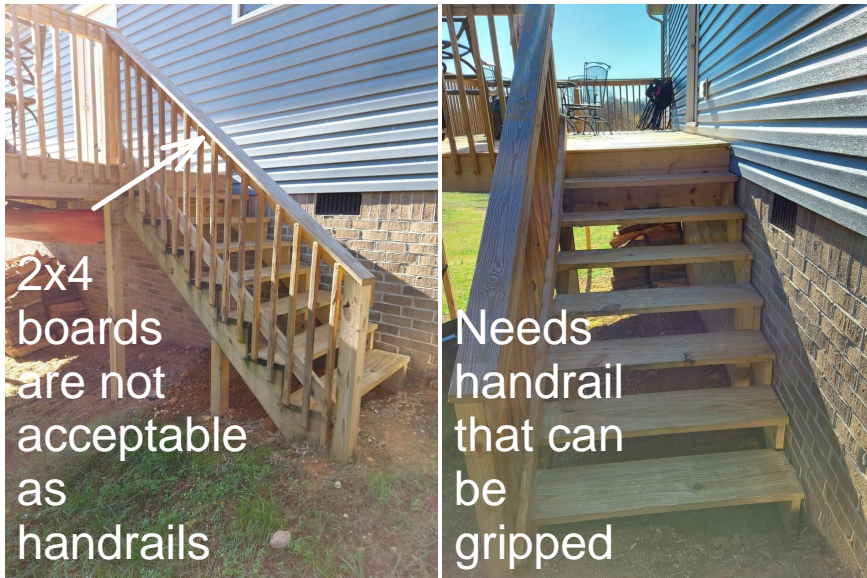
Deck Handrails: Treated Wood ---- An acceptable handrail was not observed. The International Residential Code does not consider 2x6 or 2x4 boards to be acceptable handrails. Handrails should be shaped so that they can be gripped. It is recommended that a qualified contractor install an acceptable handrail.

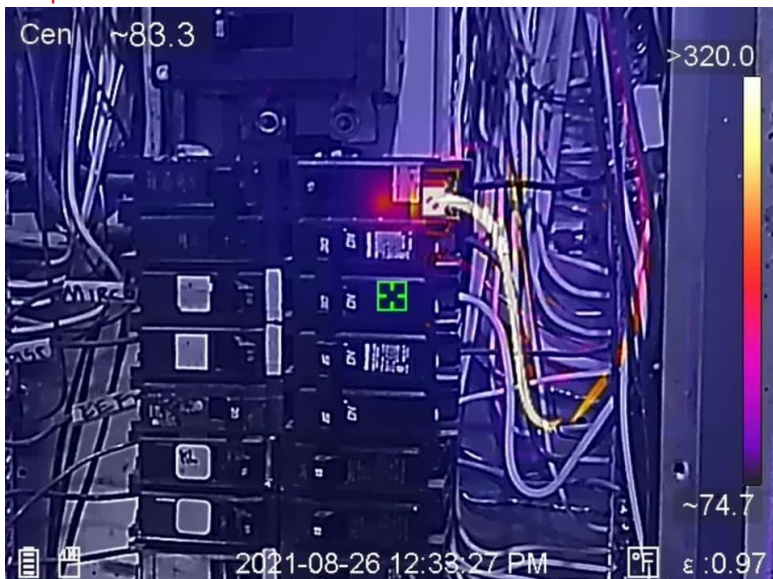
Garage Electric Panel Breakers: Copper ---- While scanning the electrical panel with my Infrared Thermal Imaging Camera I observed a breaker that was overheating. This would not have been observed without the use of an IR camera. The temperature was 320 F. Due to the possible safety issues I deactivated this breaker. This is a potential electrical fire hazard. I recommend that a licensed electrician further evaluate and affect repairs.

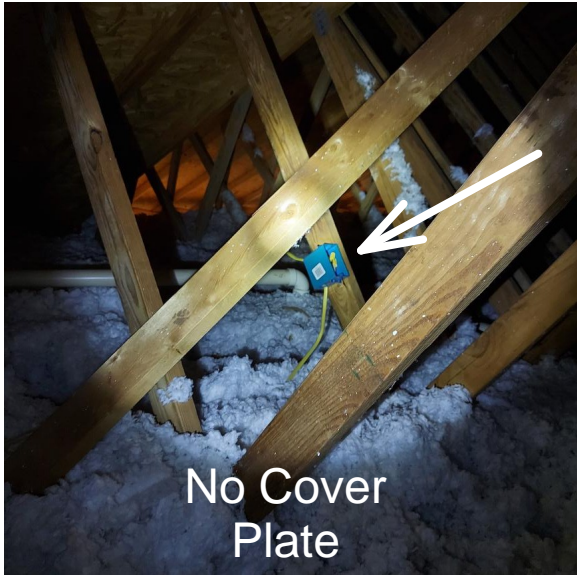
Entry at top of stairs on second floor Attic Wiring/Lighting: 110 VAC and lighting circuit ---- Open junction boxes, Exposed wire splices

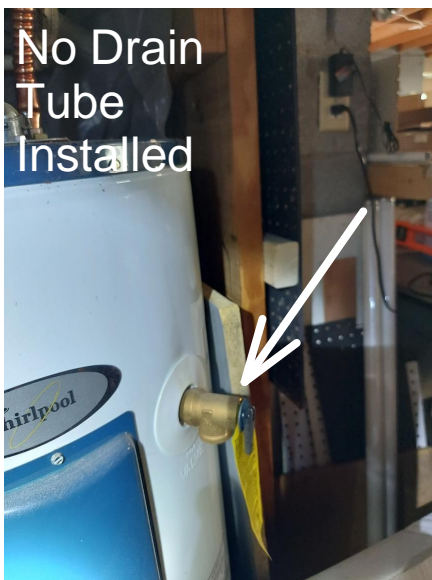
Garage Water Heater Drain Tube Not installed ---- Drain tube is missing. Drain tubes on the Temperature/pressure relief valve direct hot water to the floor if the TPR activates due to high pressure or temperature in the tank. This is designed to prevent explosions of the tank and by directing the water to the floor the likelihood of scalding is reduced when the system's problem is being investigated or shut down. It is recommended that a qualified contractor install a drain tube in accordance with best practices and code requirements.

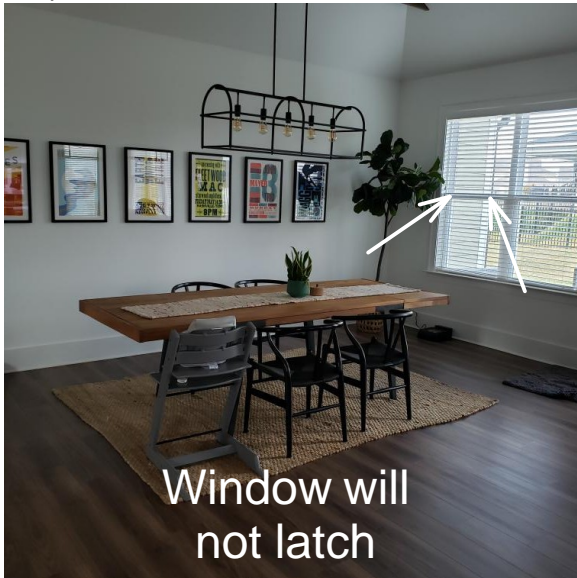
Dining Area Living Space Windows: Vinyl double hung ---- The locks do not align and will not lock. This is a security issue. Doors and windows of a home should be lockable to prevent break-ins. It is recommended that a professional window installer assess and repair.
