# Sample Home Inspection Report

Prepared for: John and Jill Doe

1234 Sample Street  
Sample Town, TN 37001

Inspected by:  
William Carmichael TN License #2190  
BeSure1st Home Inspections, Inc.

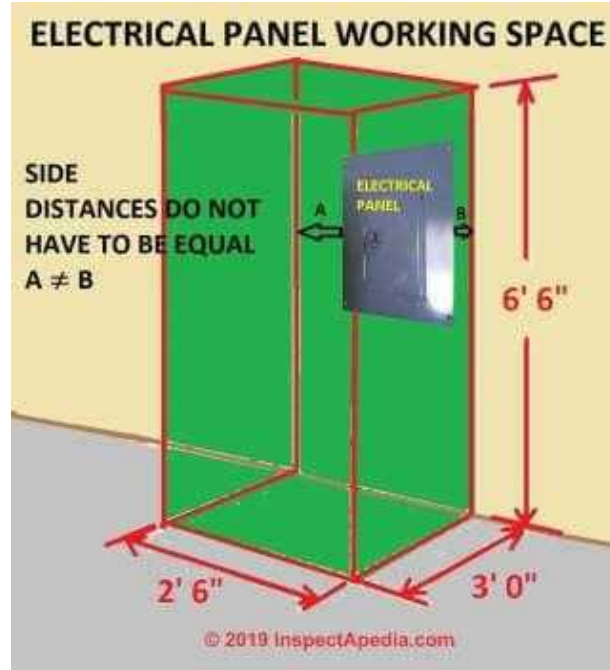
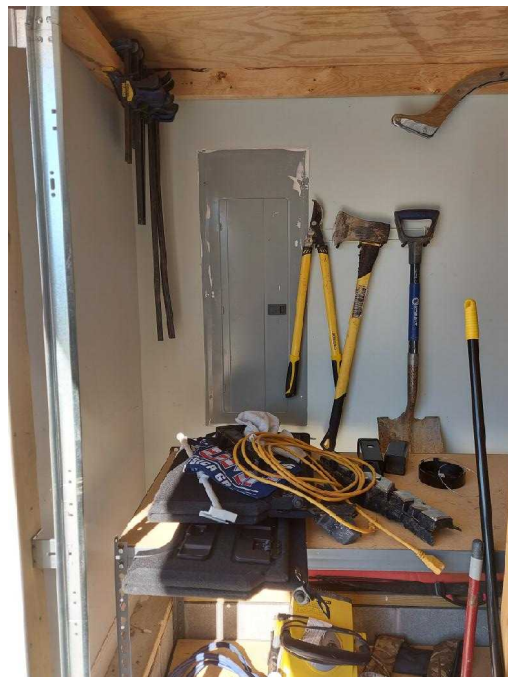
Main Electric Breaker Located on the Left side of garage interior -- Storage in front of panel -- No clear access. Electrical panels should have three feet of clear space in front of panel and a width of 30 inches. Local codes and good safety practices require that the Electrical Panel be easily accessible in the event that electrical power is interrupted or needs to be shut off. The Inspector recommends clearing thae area around the panel to provide proper access.

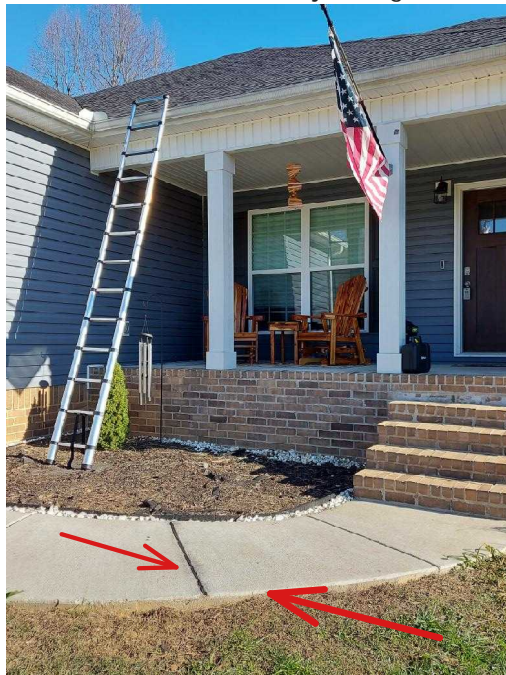
Walks: Concrete -- The walkway has settled and a section of concrete has lifted, presenting a small trip hazard of about 1 inch. This may or may not get worse but based on what was observed at the brick steps it should be monitored. If it worsens I recommend a qualified contractor stabilize it. Several options are available, such as foam jacking.

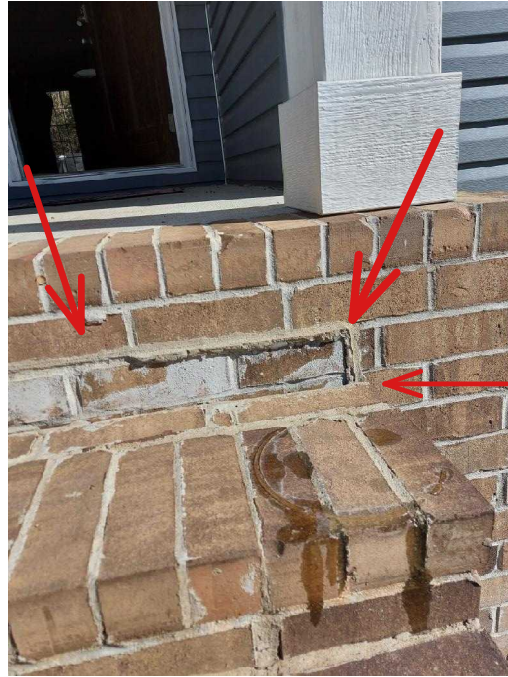
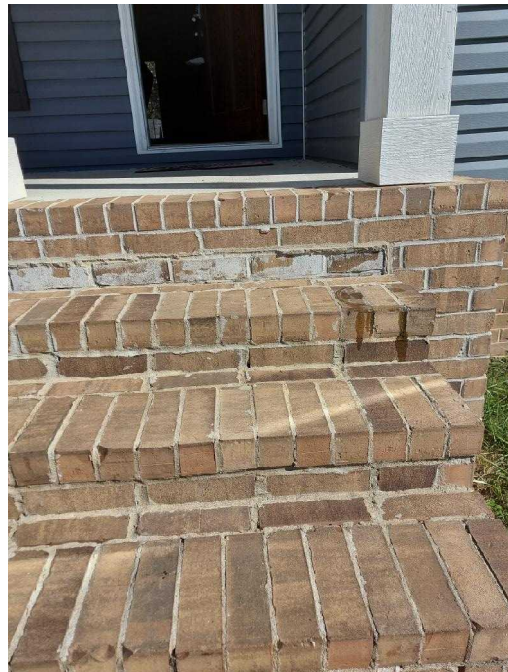
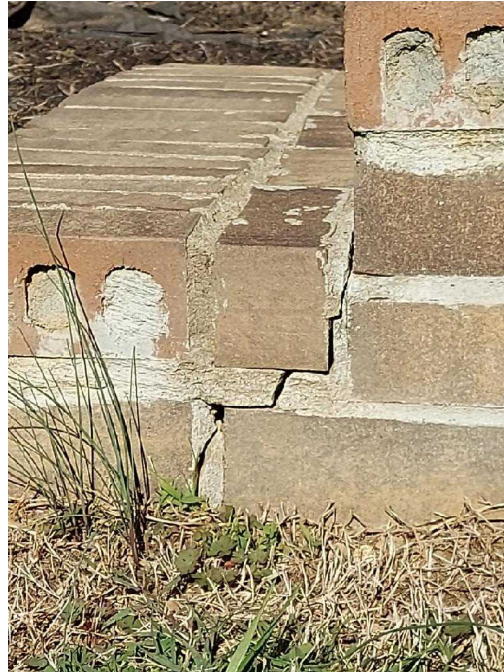
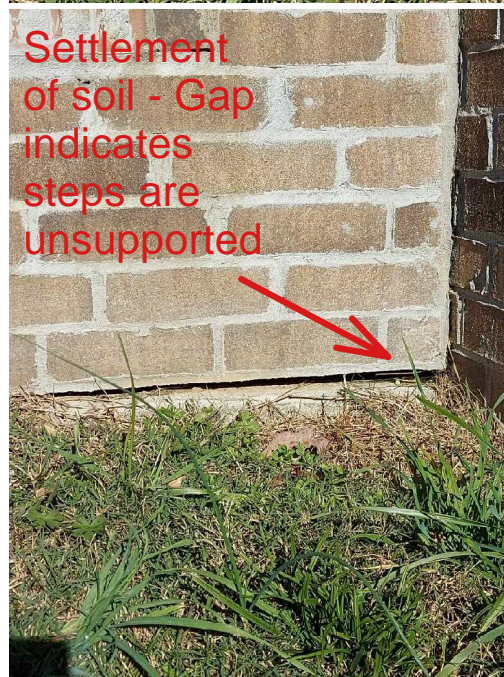
Steps -- Brick -- The brick steps were built on top of the sidewalk which appears to have settled. The tread of the top step has displaced downward on the right side about four inches. This has increased the height of the top riser to about 10 inches and presents an non-standard step which could be a potential gripping hazard. Also, Steps of this height should have a railing with a grippable handrail and balusters spaced no more than four inches apart. It is recommended that a qualified contractor install a set of handrails on the steps.

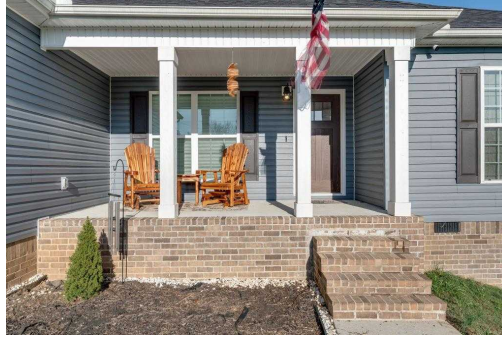
Porch: -- Concrete, Brick -- Missing handrails, A qualified contractor is recommended to evaluate and estimate installation of railing. Porches of this height should have a railing installed that is at least 32 inches high. Balusters should be no more than four inches apart and handrails should be grippable.

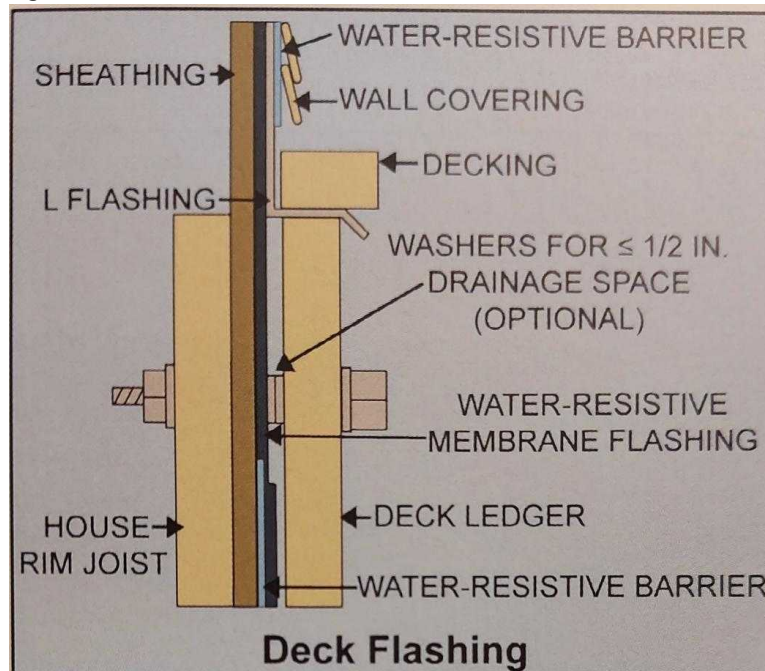
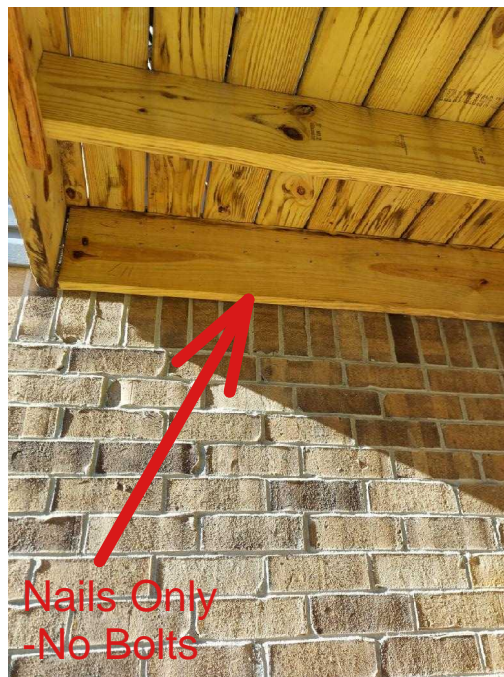
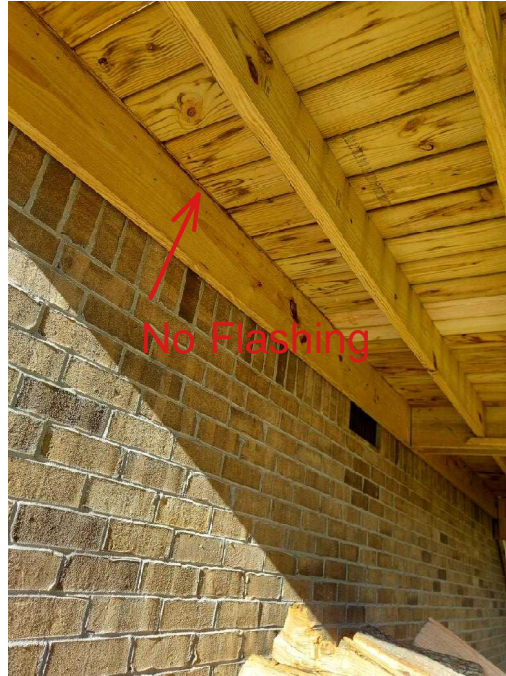
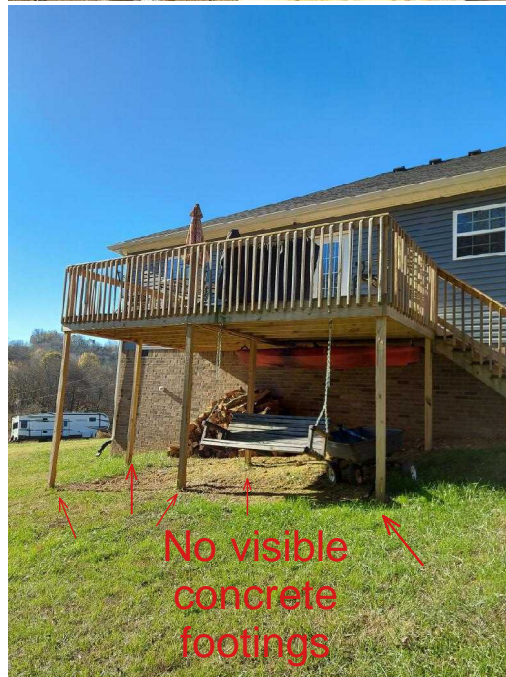
### Deck Ledger to House Connection

Deck: -- Treated wood -- The deck attachment to the home was improperly done. No ledger was used to connect deck floor joists to the home structure. Instead, joists were fastened directly to the home exterior wall with nails only. Nails are not considered adequate for long term stability. Elevated decks should be bolted securely with washers so that the bolts do not pull through. This connection may be structurally insufficient and may result in detachment and collapse of the deck. There were no visible concrete footings for the post. The posts may be set on footings and properly attached below grade but this was not observable. No flashing was observed on the deck band against the house wall. The Inspector recommends further evaluation and correction by a qualified contractor. While it may seem secure for the moment if the deck were loaded with numerous people it has the potential for collapse, especially as the wood ages.

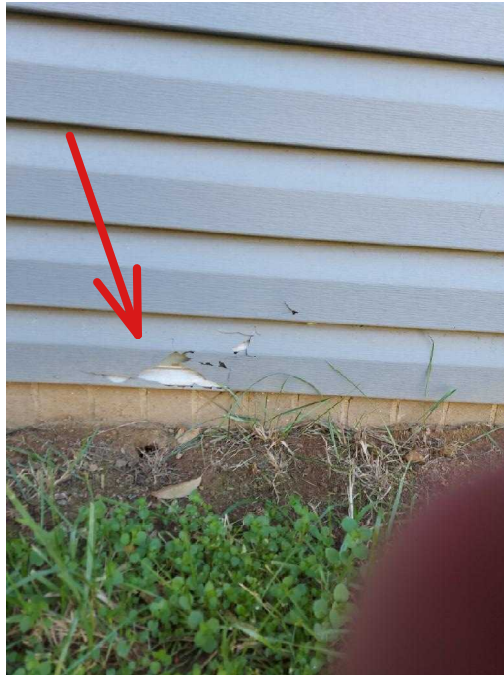
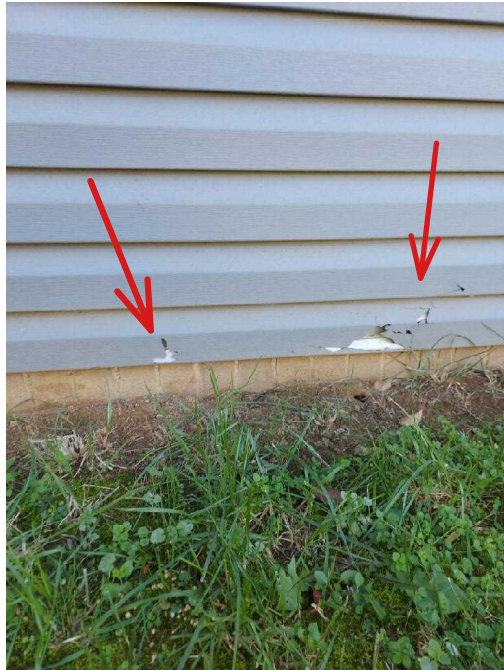
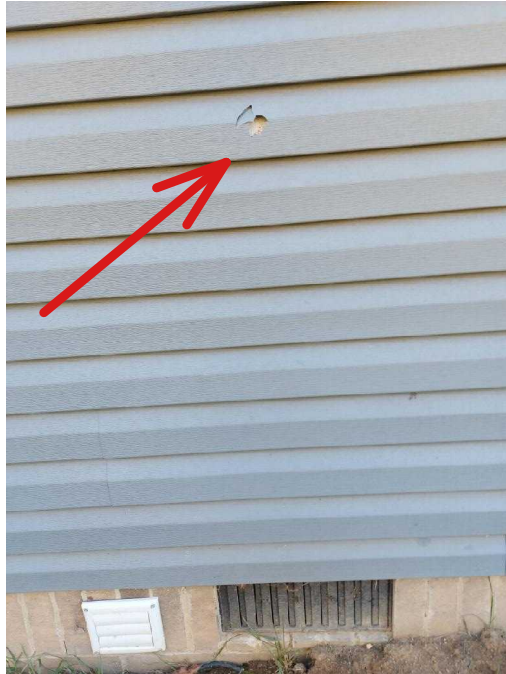
Type: Vinyl siding -- Holes noted left side on the northwest side (on the exterior wall of the garage) in the vinyl siding. These holes usually are caused by a lawn mower that has thrown a rock. Vinyl siding can be brittle when cold and rocks can damage it if propelled with enough force. The damage that is close to the foundation is of less concern than the hole that is higher on the surface. Holes in the siding can allow water intrusion resulting in mold or rot to structural components. It is recommended that the holes be sealed or the vinyl siding repaired by a qualified contractor.

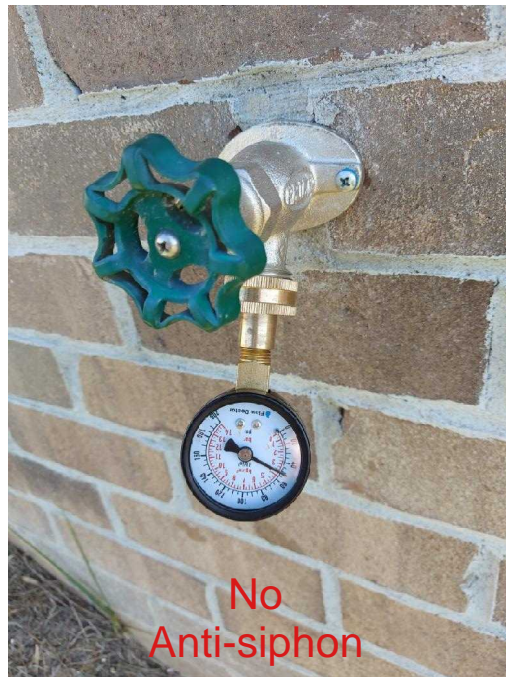
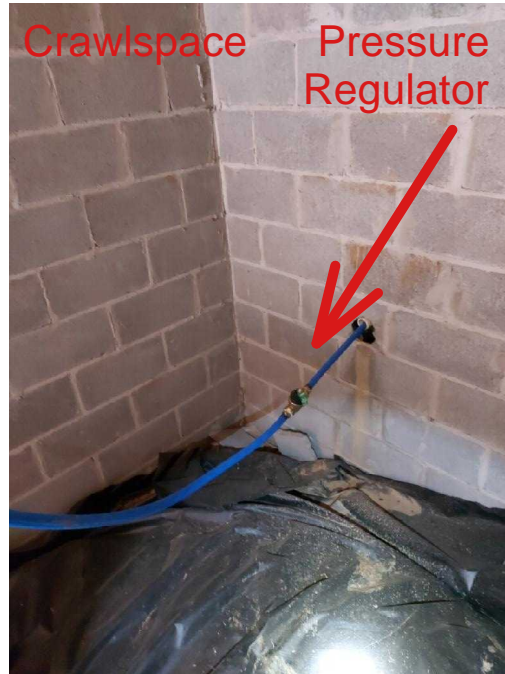
Patio Door: Metal sliding and glass  
Exterior Lighting: Surface mount  
Exterior Electric Outlets: 110 VAC GFCI  
Hose Bibs: Gate valve -- Missing anti-siphon valves at front and back of house. Anti-siphon valves prevent contaminated water from being siphoned into the drinking water supply of the house and prevents the potential for backflow into the public water supply. It is recommended that anti-siphon valves be installed on the exterior hose bibs. Water pressure was observed at 50 psi. The water pressure regulator is located in the crawlspace behind the wall where the hose bib on the front of the house is located.

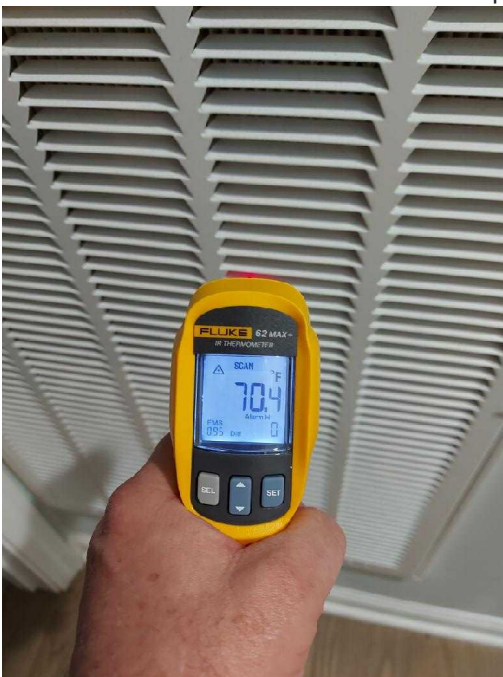
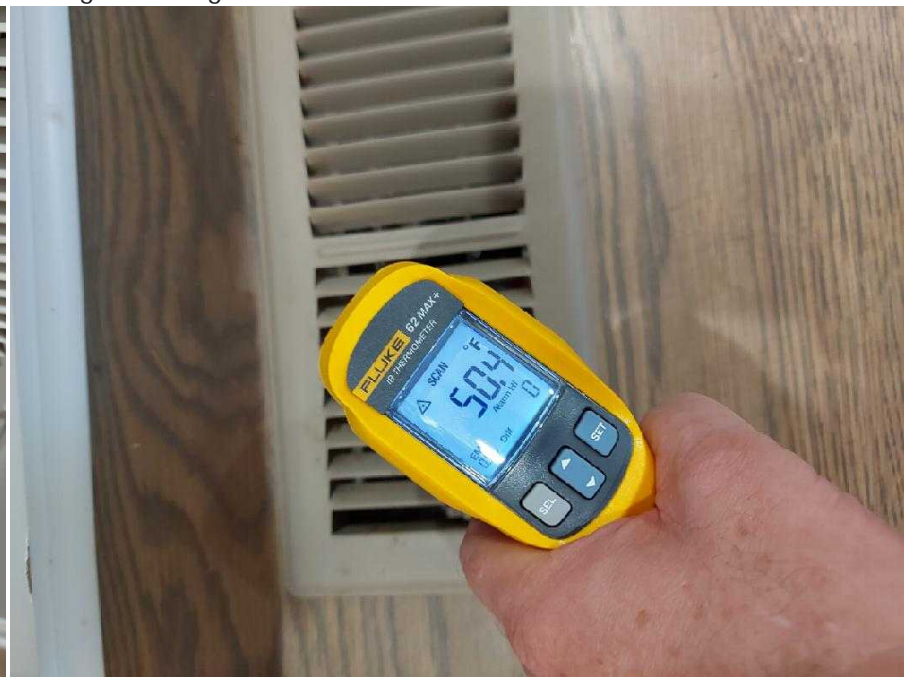
Temperature Differential in Cooling Mode 20° F -- Temperature difference between return air and the register should be between 14F and 22F. This unit is operating at the high end of the standard.

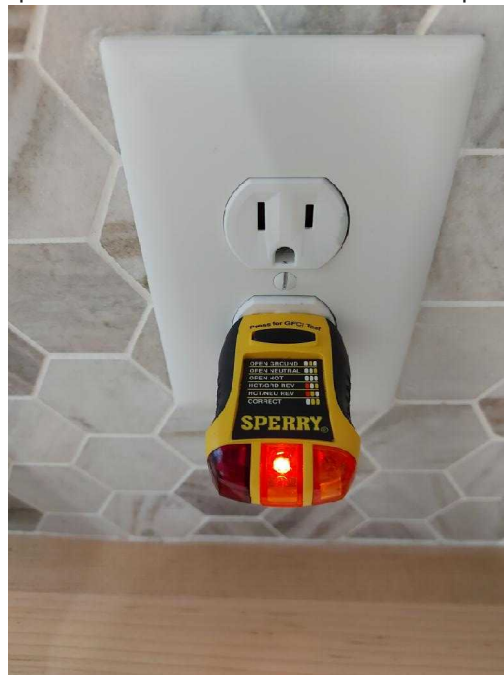
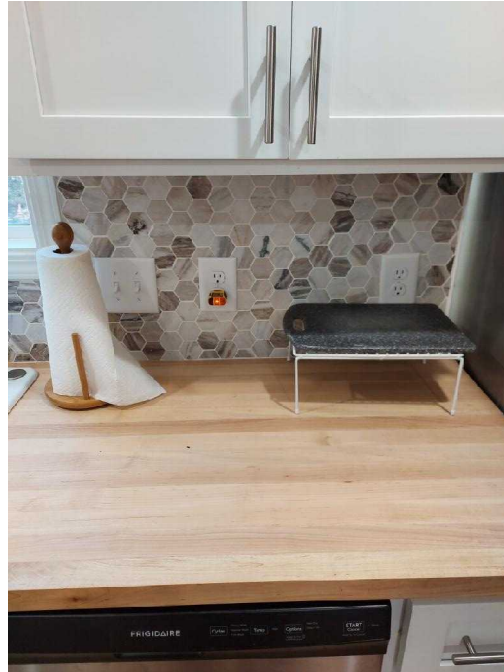
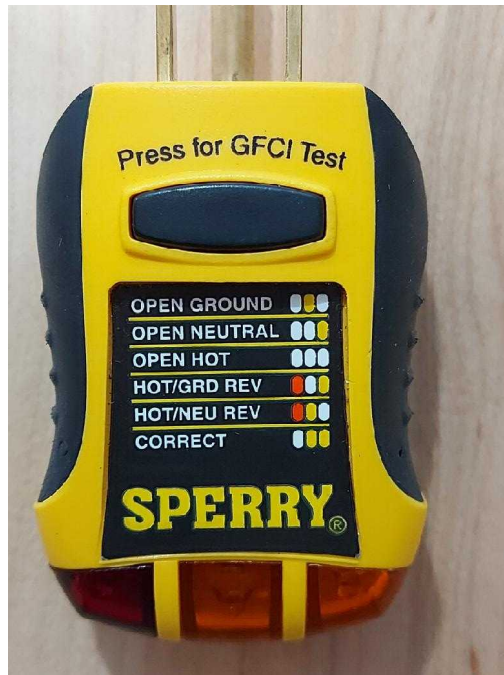
Electrical: -- 110 VAC GFCI -- Open or missing ground. The NEC mandates GFCI protection when located within 6 ft. of water. GFCIs were first required in 1971 and have reduced electric shocks hazards significantly. It is recommended that a qualified contractor evaluate and repair.
