Prepared at the request of:

**Jennifer Christoffersen
Chestnut Creek HOA Treasurer
PO Box 670431
Marietta, GA 30066**

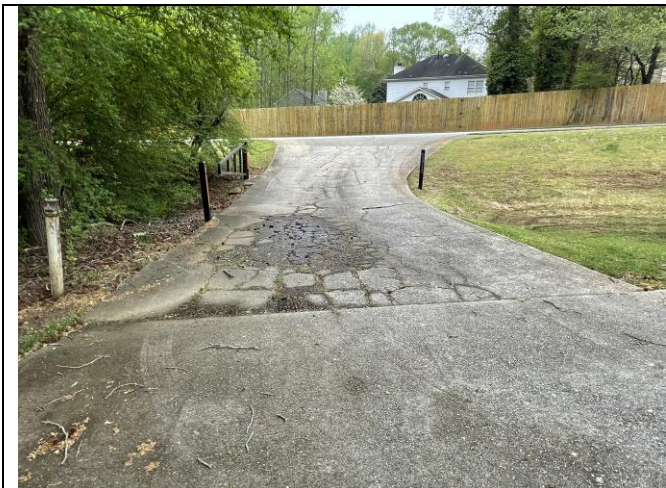
Damaged driveway to parking lot

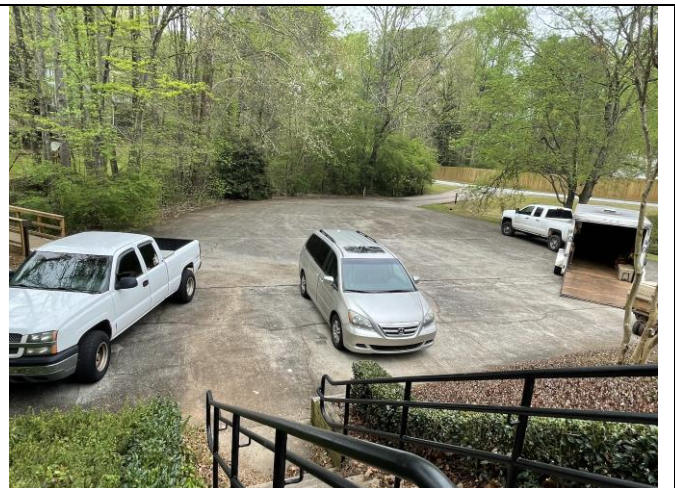
Cracks visible in the parking lot

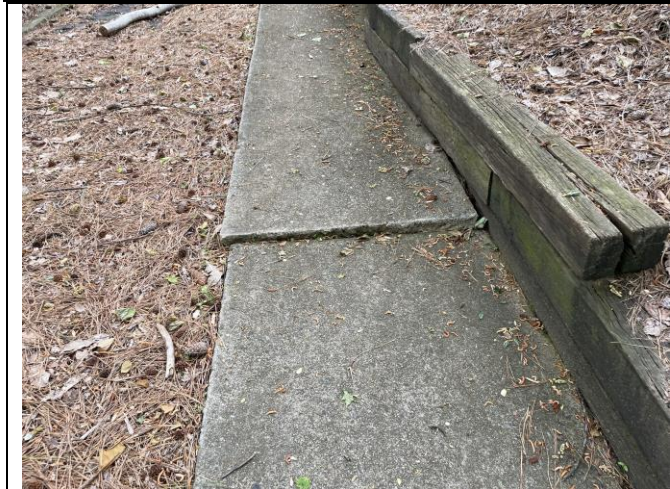
Example of shifted/settled sidewalk (trip hazard)

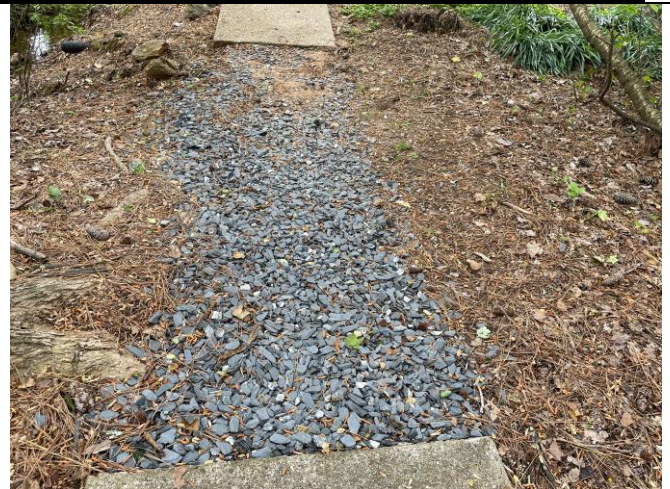
Section of sidewalk missing

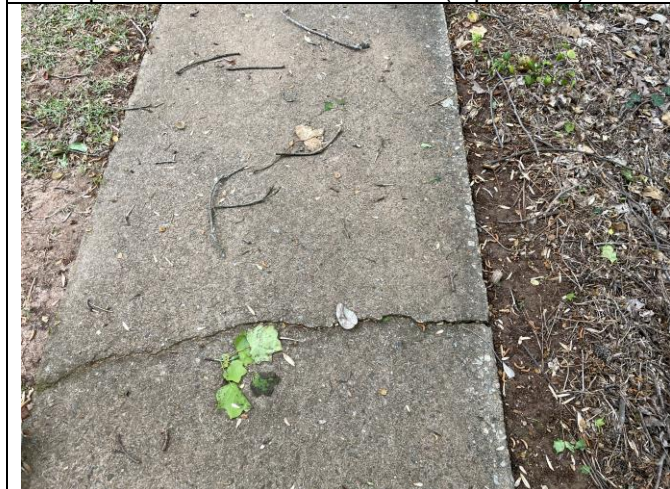
Cracked sidewalk example

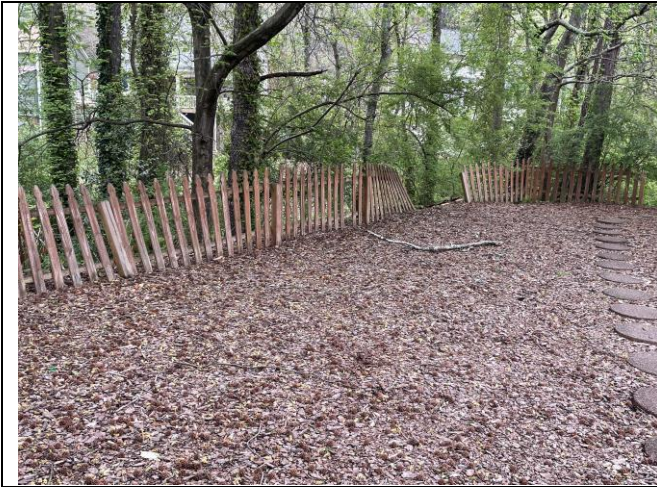
Picket fence on ridge

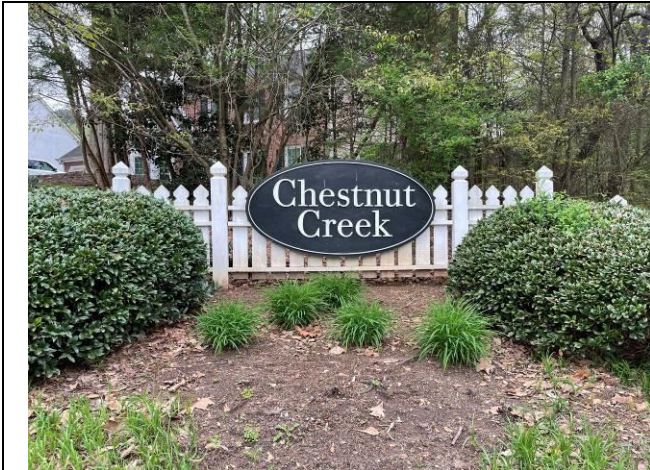
Monument and sign at Running Cedar Drive

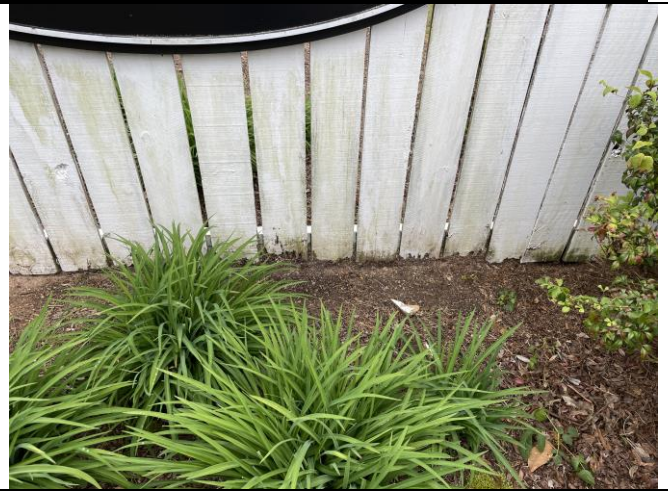
Signs of deterioration at the base of the pickets

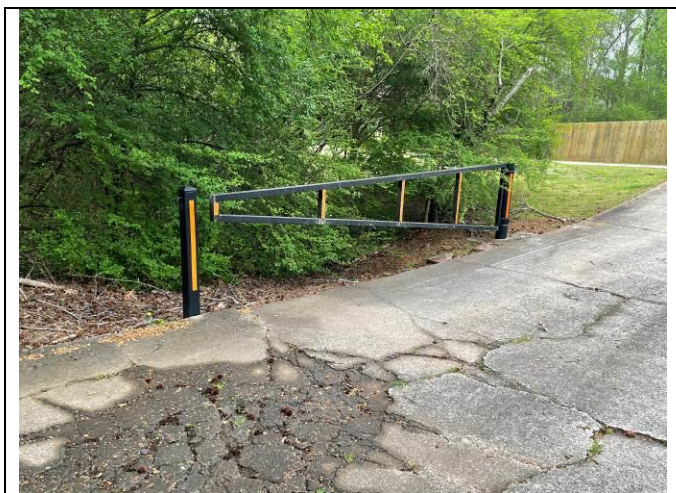
Manual vehicle restriction gate

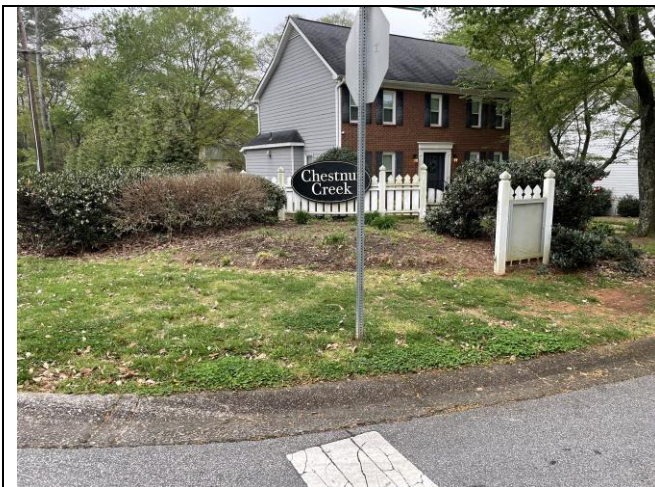
Example of landscaping at entry.

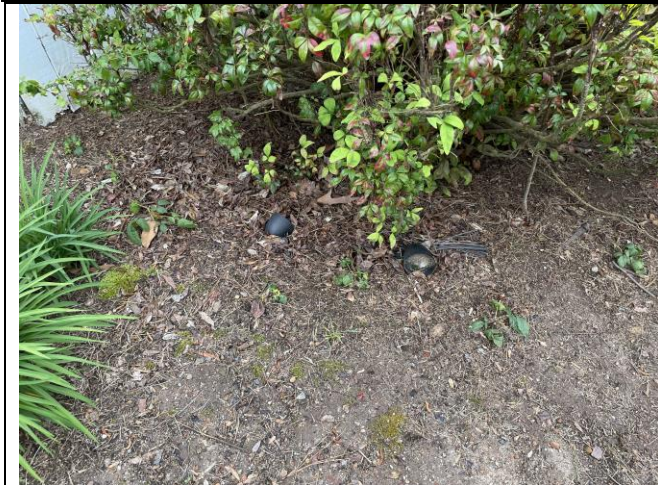
Landscaping lighting damaged

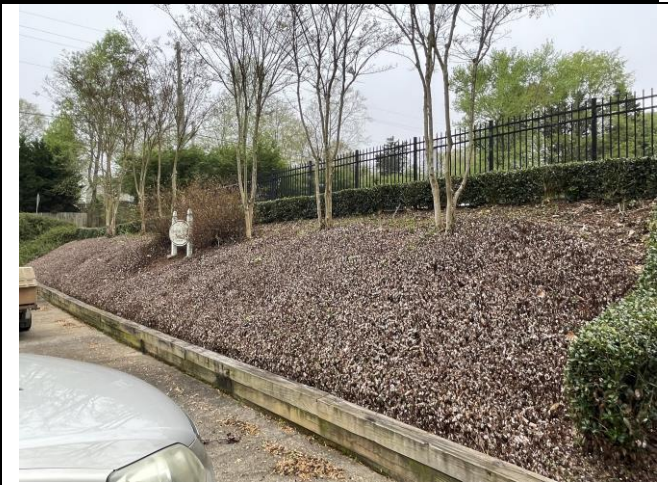
Example of landscaping

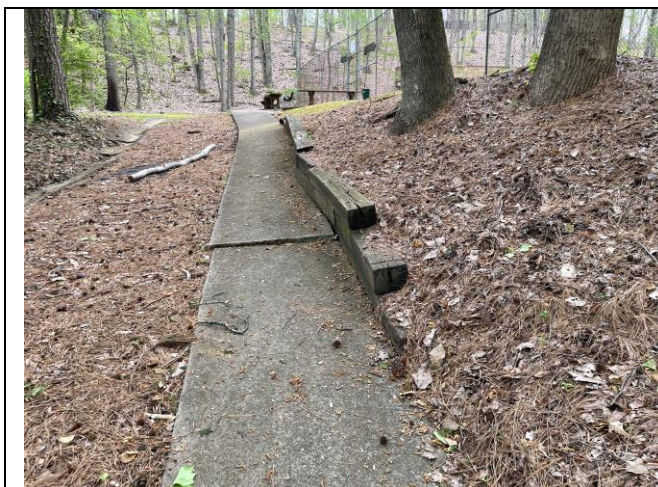
Wall bowing and leaning

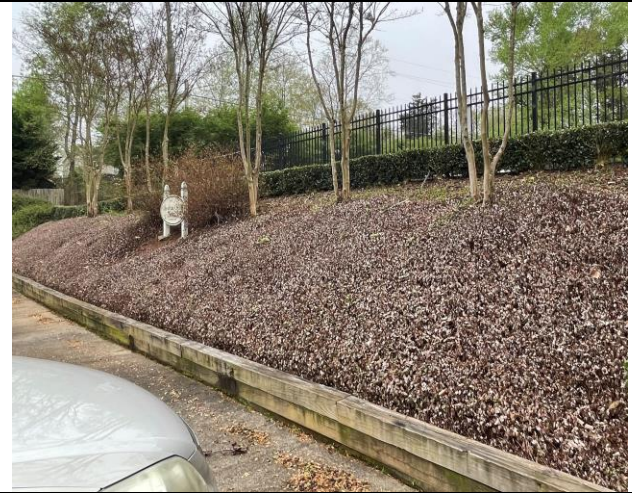
Wall at parking area

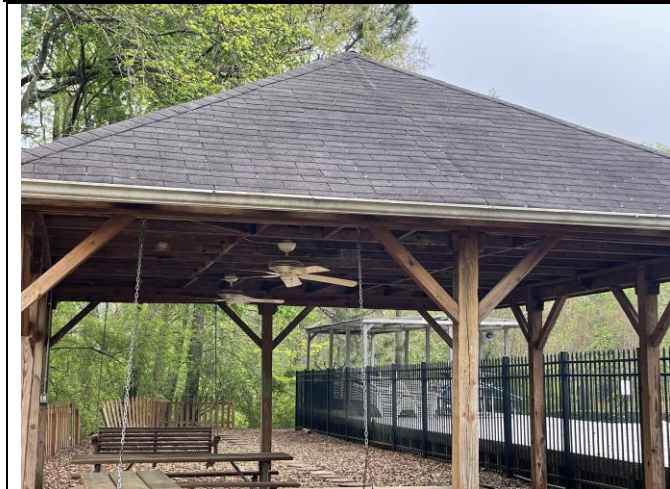
Pavilion with missing shingles

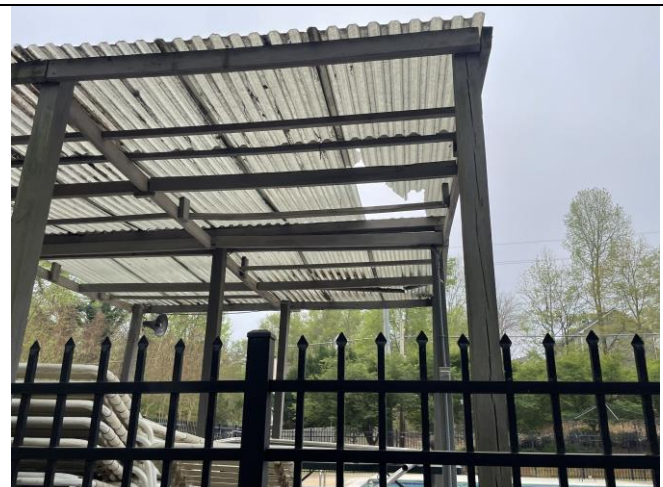
Damage to the Gazebo roof

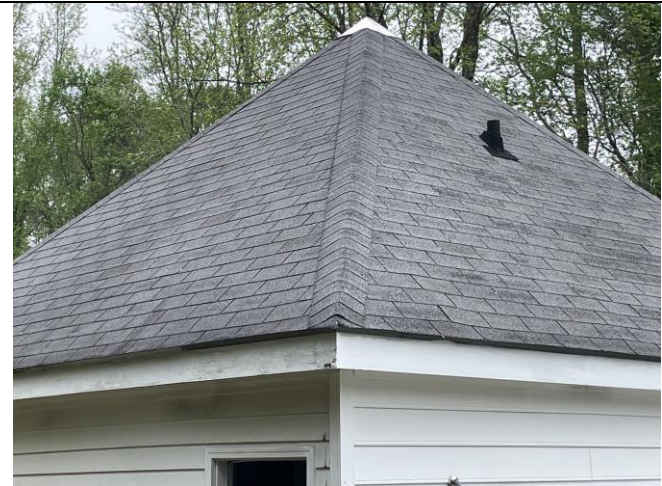
Poolhouse roofing. Note: no gutters

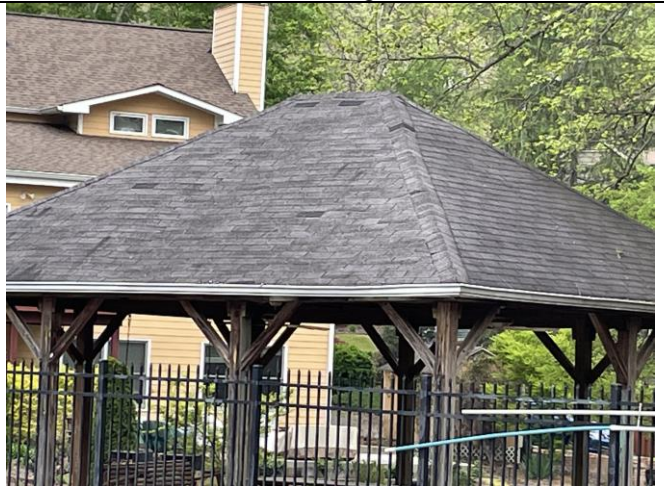
Pavilion roof with several damaged shingles

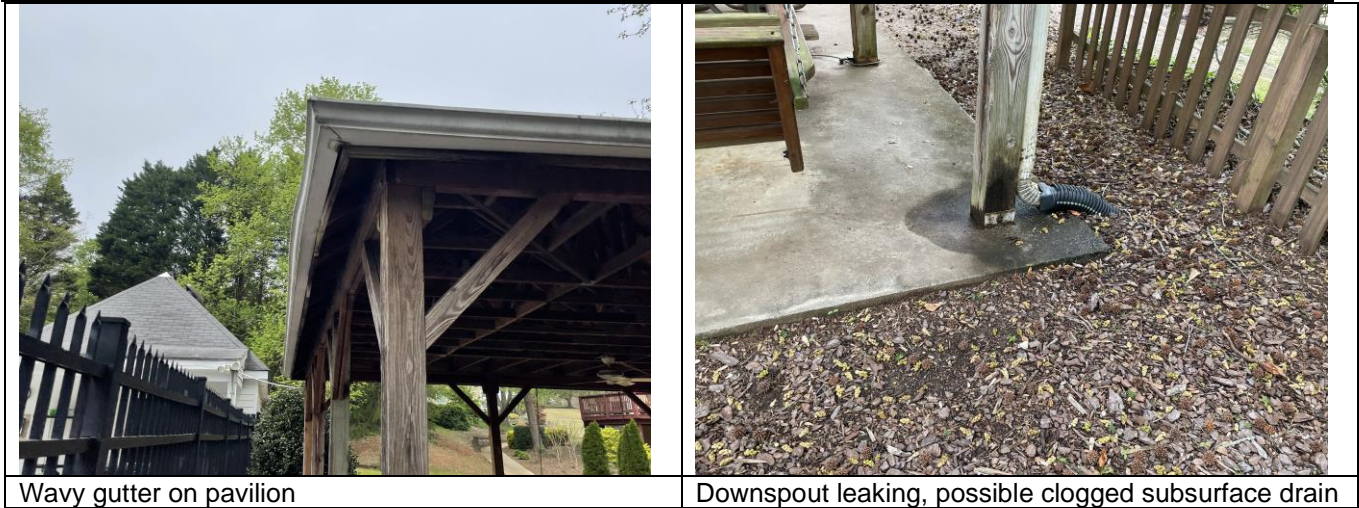
Wavy gutter on pavilion

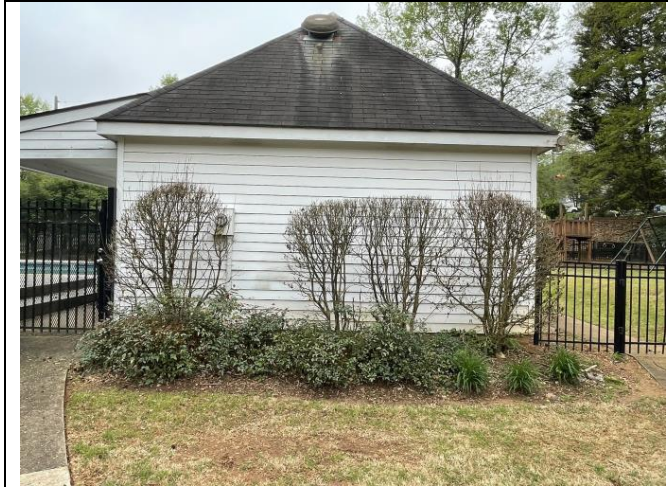
Example of the siding

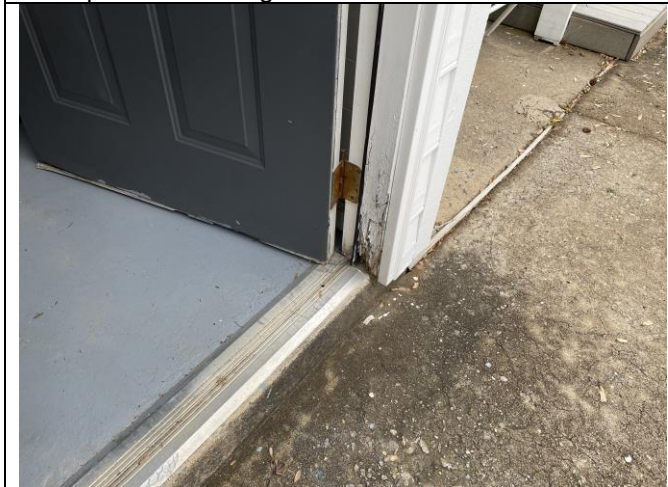
Example of damage at door trim

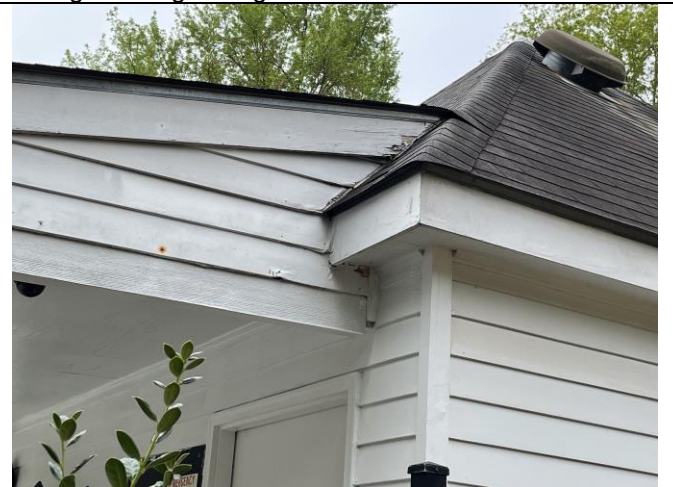
Example of siding and trim damage

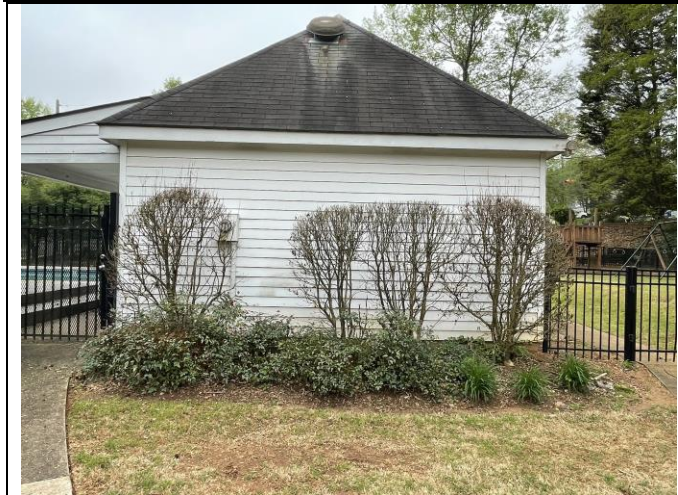
Poolhouse siding require routine painting

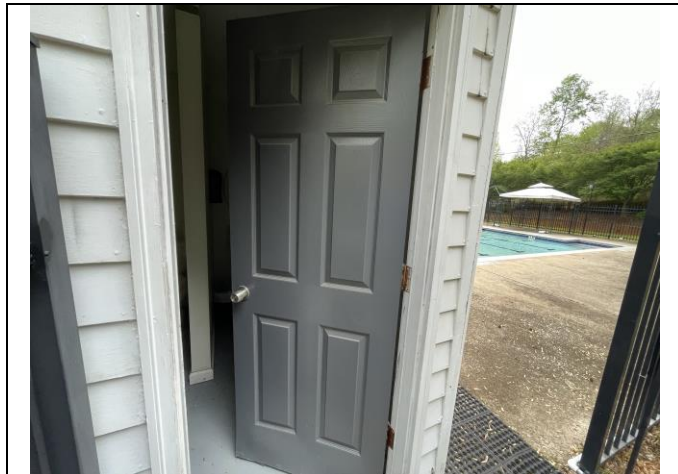
Ladies bathroom door is interior rated hollow core

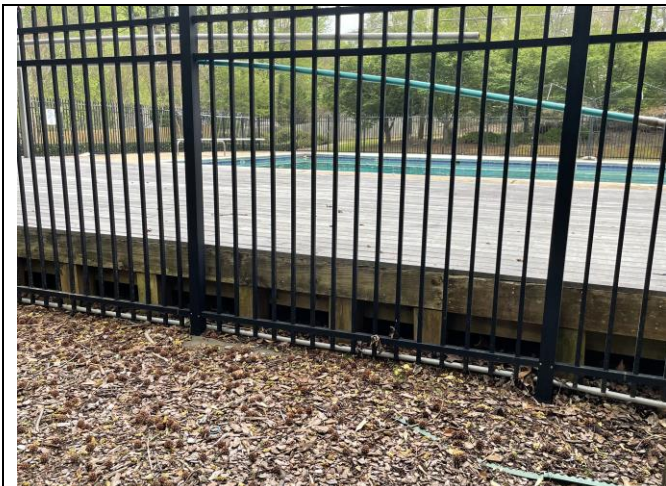
Some of the synthetic board decking at the pool deck is showing signs of ageing. The following photos illustrate examples of the elements in this category and any observed deficiencies:

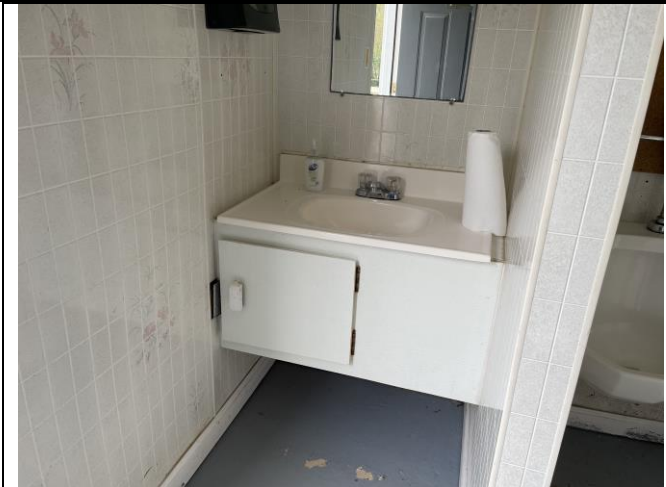
The bathrooms are functional but are aged and in poor condition. Walls are stained, pieced together like patchwork, and not consistent in décor. The following photos illustrate examples of the elements in this category and any observed deficiencies:

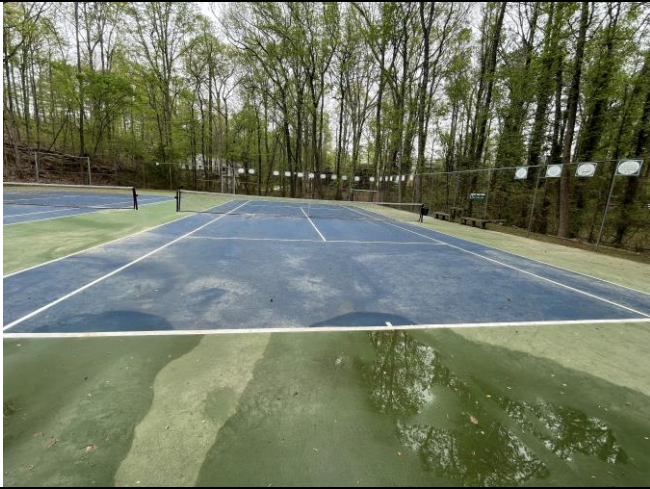
One of the two courts. Note standing water.

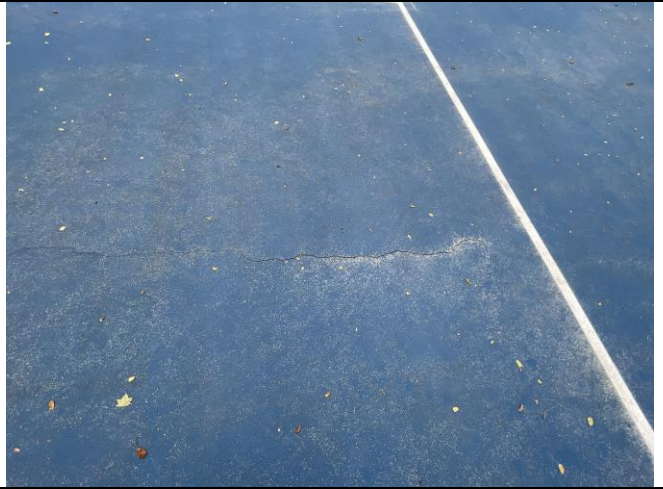
Small crack in the court area

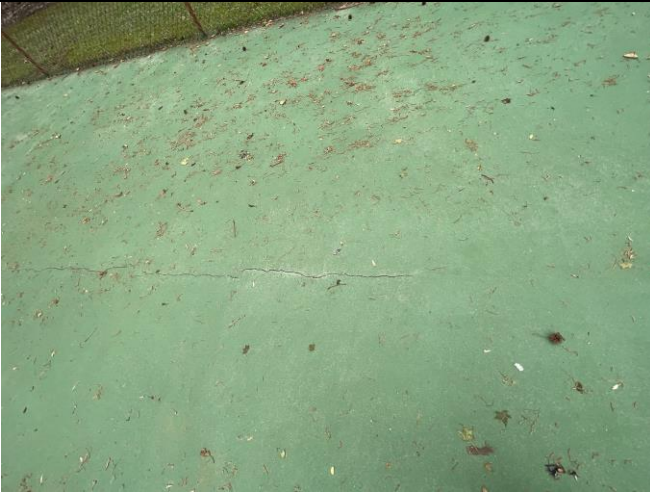
Small crack at a perimeter

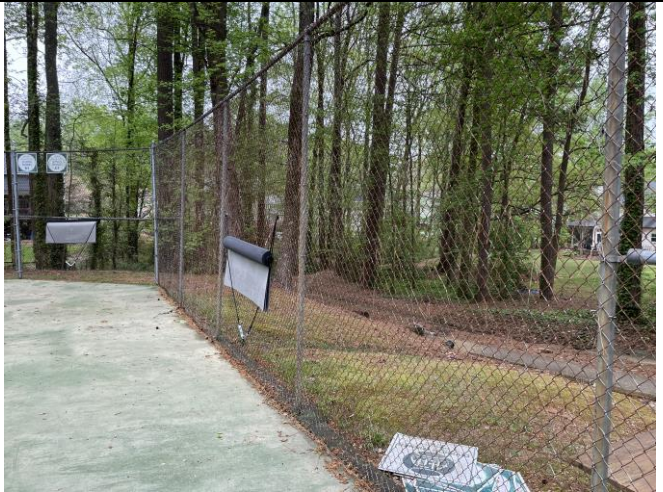
Example of the corroding fence

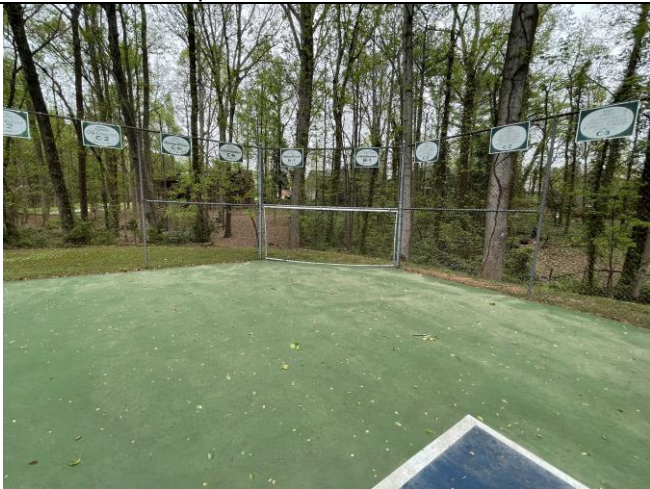
A section of the fence has been replaced

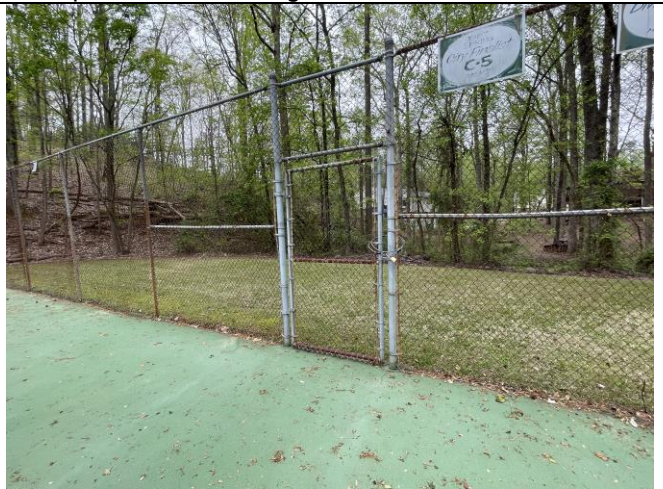
Corroding of galvanized post and fence evident

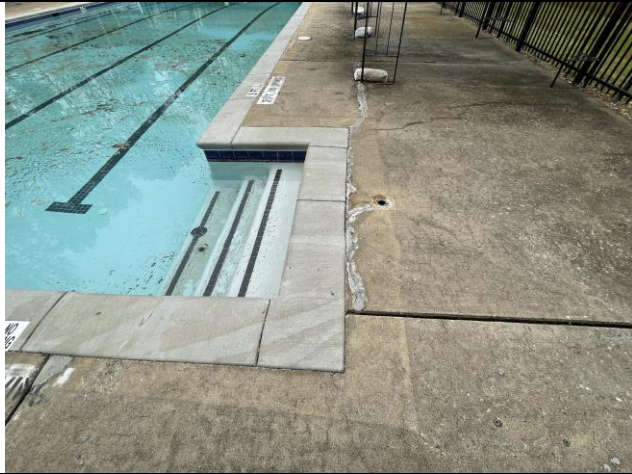
View of the pool with new edge and pool surface

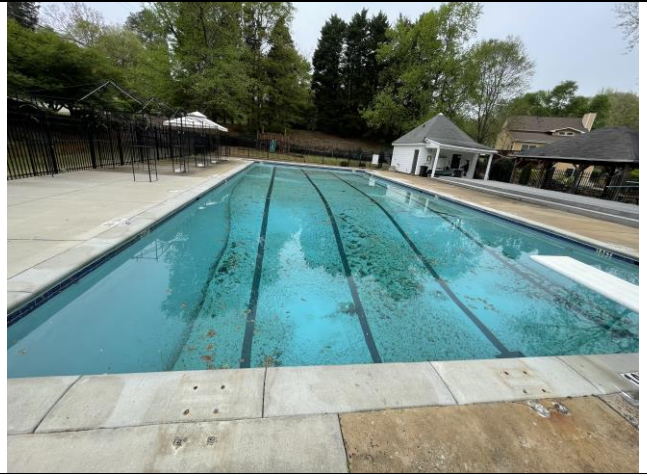
Another pool shot with replaced decking at left

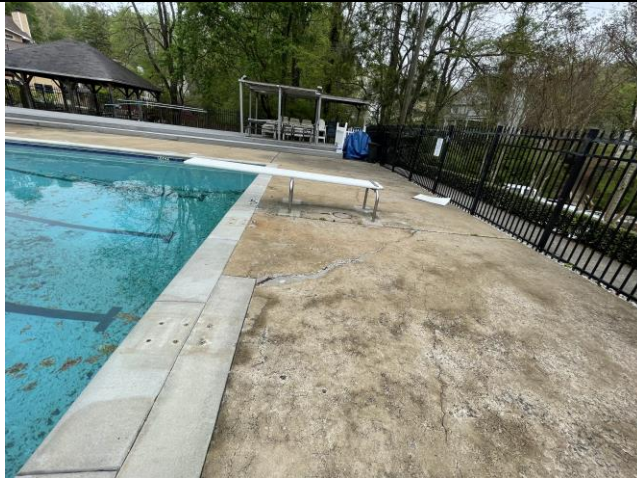
Pool decking with recent pool edge repairs

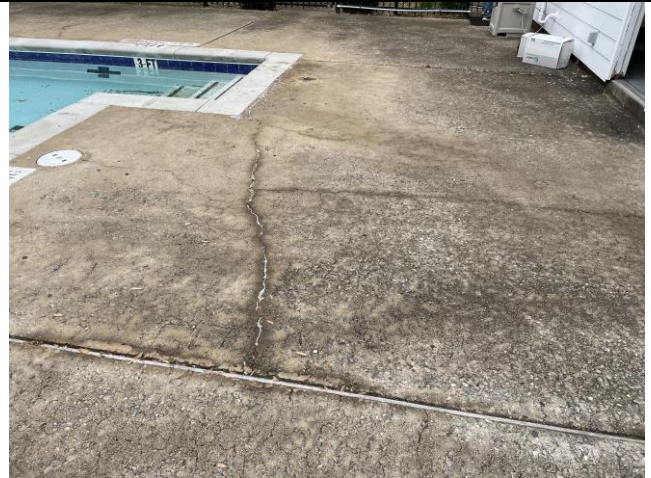
Cracks in the pool side decking

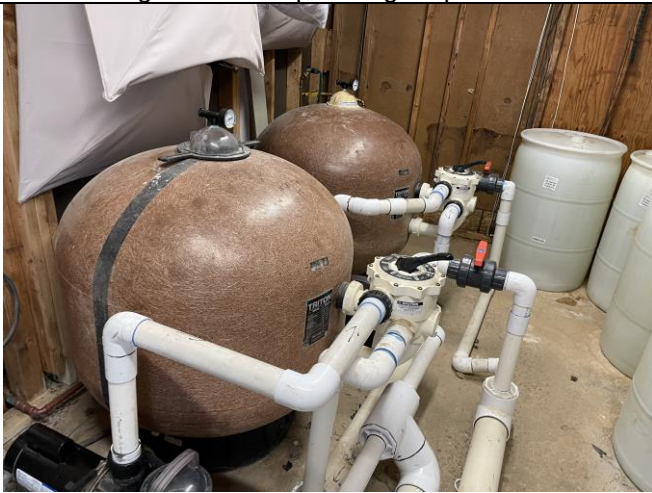
Two filters with two pumps

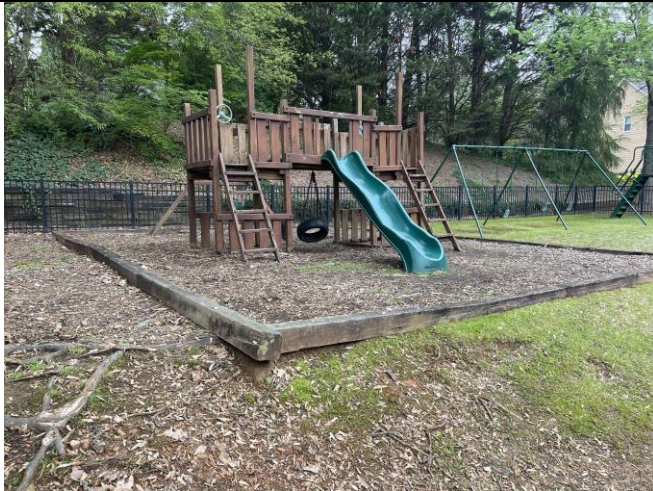
Areas of the wood modular set are showing some decay. The tire swing on the wood modular set is damaged. The following photos illustrate examples of the elements in this category and any observed deficiencies:

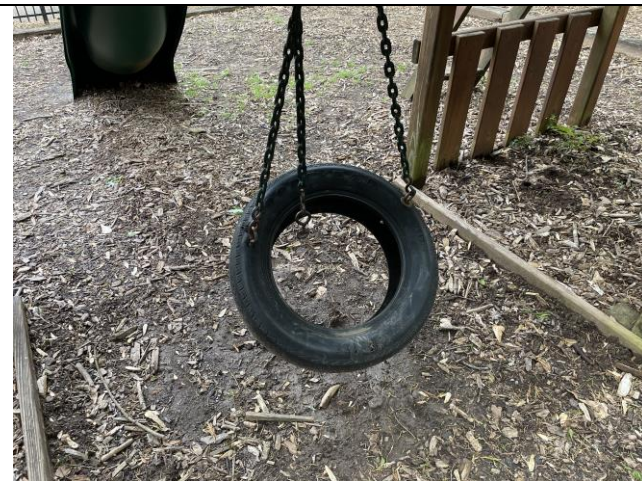
Damaged tire swing on modular set

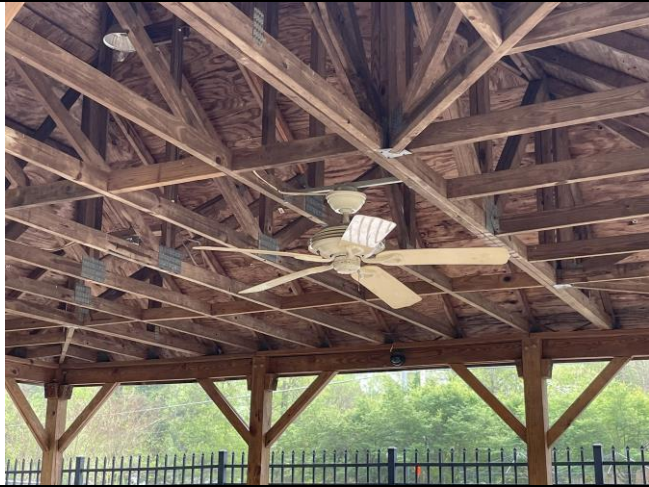
The following photos illustrate examples of the elements in this category and any observed deficiencies:
