**G & M Engineering, Inc.**  
Consulting and Design Engineers

**REFERENCE: Chestnut Creek Homeowners Association, Marietta, Georgia**  
Swimming Pool and Pool Deck Review

At your request, Kelvin D. Garmon, P.E., of G&M Engineering, Inc., conducted an inspection of the swimming pool and concrete pool deck area at the Chestnut Creek Subdivision, Marietta, Georgia. The purpose of our review was to evaluate the structural integrity of the swimming pool shell, evaluate the concrete pool deck and provide our opinion of the swimming pool amenity area as a whole.

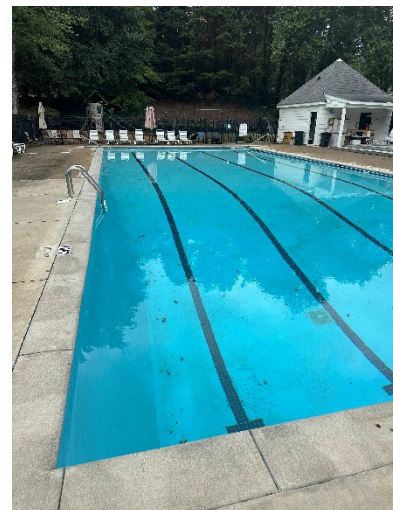
Upon reviewing the swimming pool, we observed cracks in the surface of the pool that would indicate settlement of the pool shell is occurring and it is critical to eliminate the settlement. Given the age of the pool structure consideration should be given to complete removal and replacement of the pool. The

- Chipping all existing plaster from the interior surface of the pool.

- Installation of 22 foundation piles to support the pool shell that is currently experiencing settlement. This is done by cutting holes through the bottom of the pool shell to allow the helical piles to be installed and then new steel reinforcement installed within the holes and new concrete installed.
- Restoration of the cracks in the pool shell with staples.
- Installation of new plaster which will need to include new water line tiles.

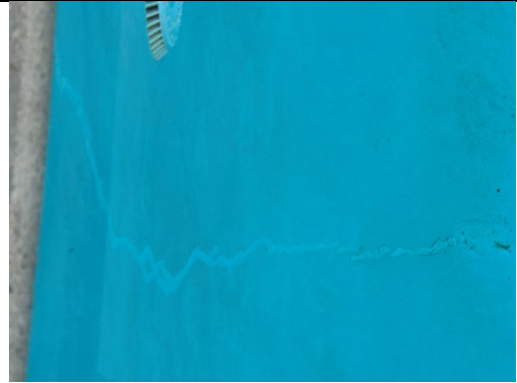
remediation of a settlement issue at any swimming pool is costly and there are unknowns with how the actual pool shell was constructed originally in approximately 1980 that can cause other frustrations when attempting to install foundation piles to support the pool shell. During our review, we also observed very uneven surfaces (walls) within the pool shell that would indicate a poor plaster project or projects over the years. This would require the entire surface of the pool to be chipped to expose the original concrete pool walls

and allow a new coat of plaster to be installed. This process can reveal other issues such as underlying cracks or damage to the walls within the pool. Given the age and condition of this pool, in our opinion great consideration should be given to complete demolition and replacement of the pool.

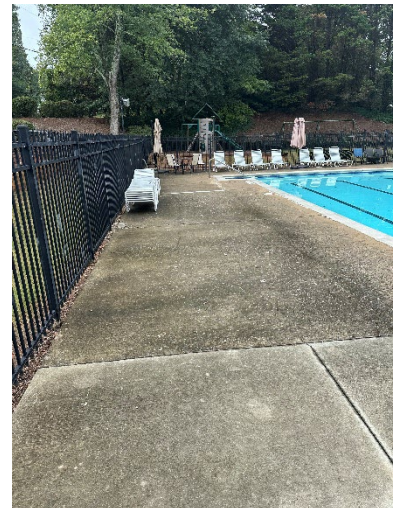
The concrete pool deck typically has a service life of approximately 40 years and since this pool deck is 45 years of age and the surface is in poor condition, we have concluded that the pool deck has reached the end of its useful life. The spalling of the concrete surface to reveal the gravel within the original concrete is not a safe walking surface and the continued spalling of the concrete will only increase in severity as the concrete continues to age. This deterioration of the concrete is based upon age, exposure to chemicals from the pool water, etc. Continuing with our review of the pool deck, we observed some locations where patches were performed. We also observed some cracks in the concrete pool deck that allow water direct access to the soils under the concrete and this will result in further movement of the concrete and more cracks.

The restoration of the concrete pool deck in our opinion is required due to condition and age. The work should include a land disturbance permit from Cobb County. This will require engineering drawings for the concrete pool deck removal and replacement.
