THE SALLADE'S INSPECTION SERVICES

DRAW INSPECTION

101 America Drive
Lakeworth, TX 76082

Bill Sallade
AUGUST 9, 2023

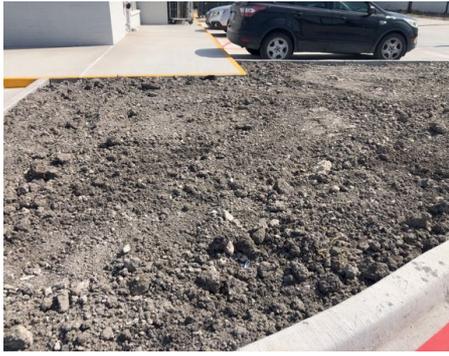
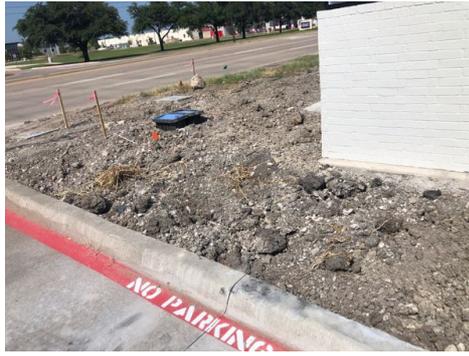
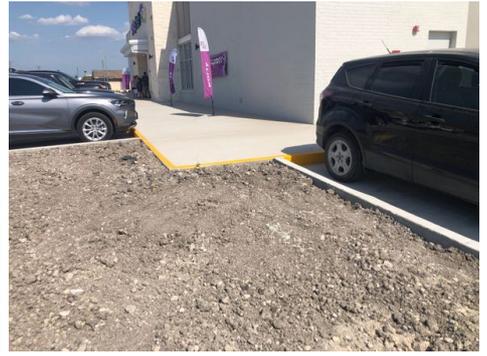
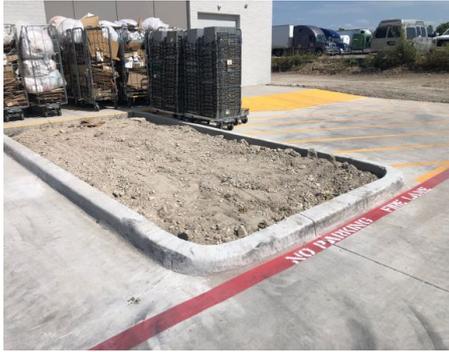
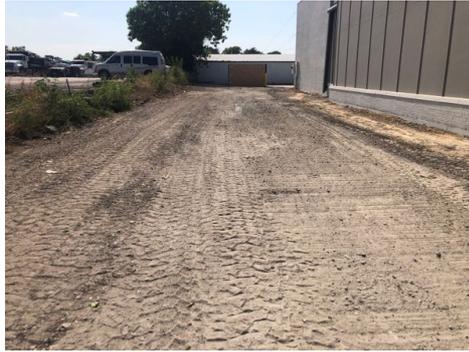
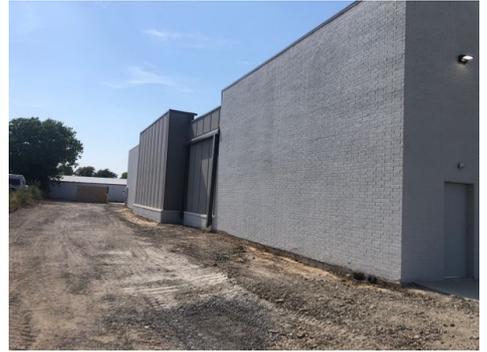
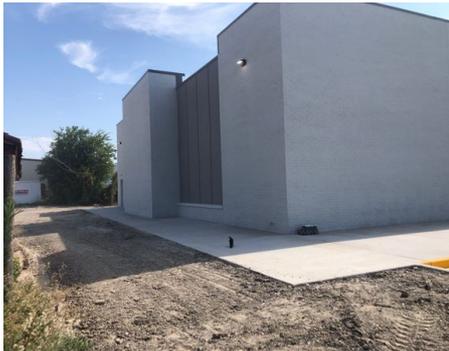
Final grade incomplete

- The final grade around the property was incomplete at the time of inspection.

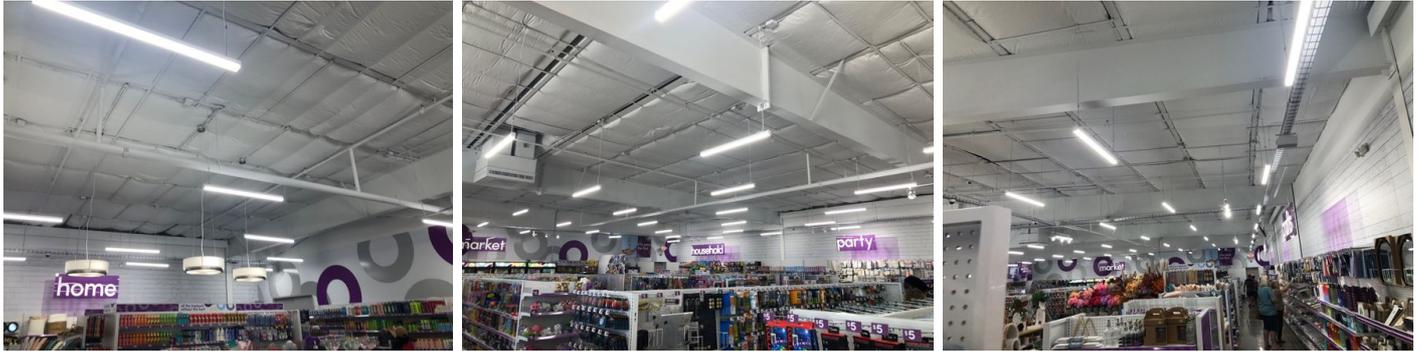
Building Insulated

- The buildings insulation was observed to be in place or already installed at the time of inspection.

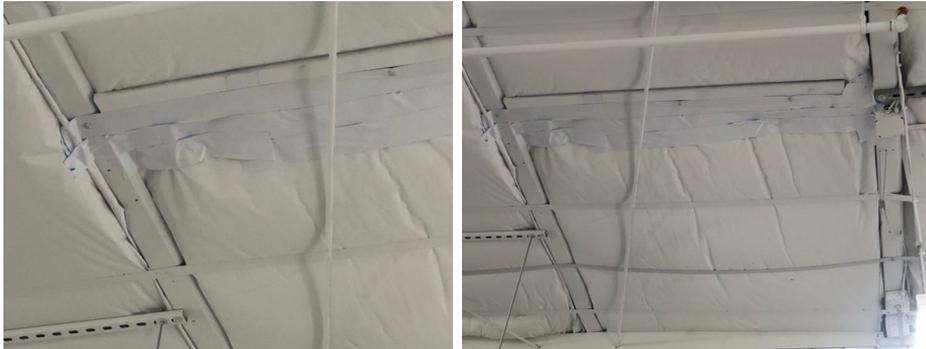
Patch observed

The insulation sheathing was observed to be patched at the left rear corner inside the building. The patch appeared to have been done with blue painters tape spray paint.

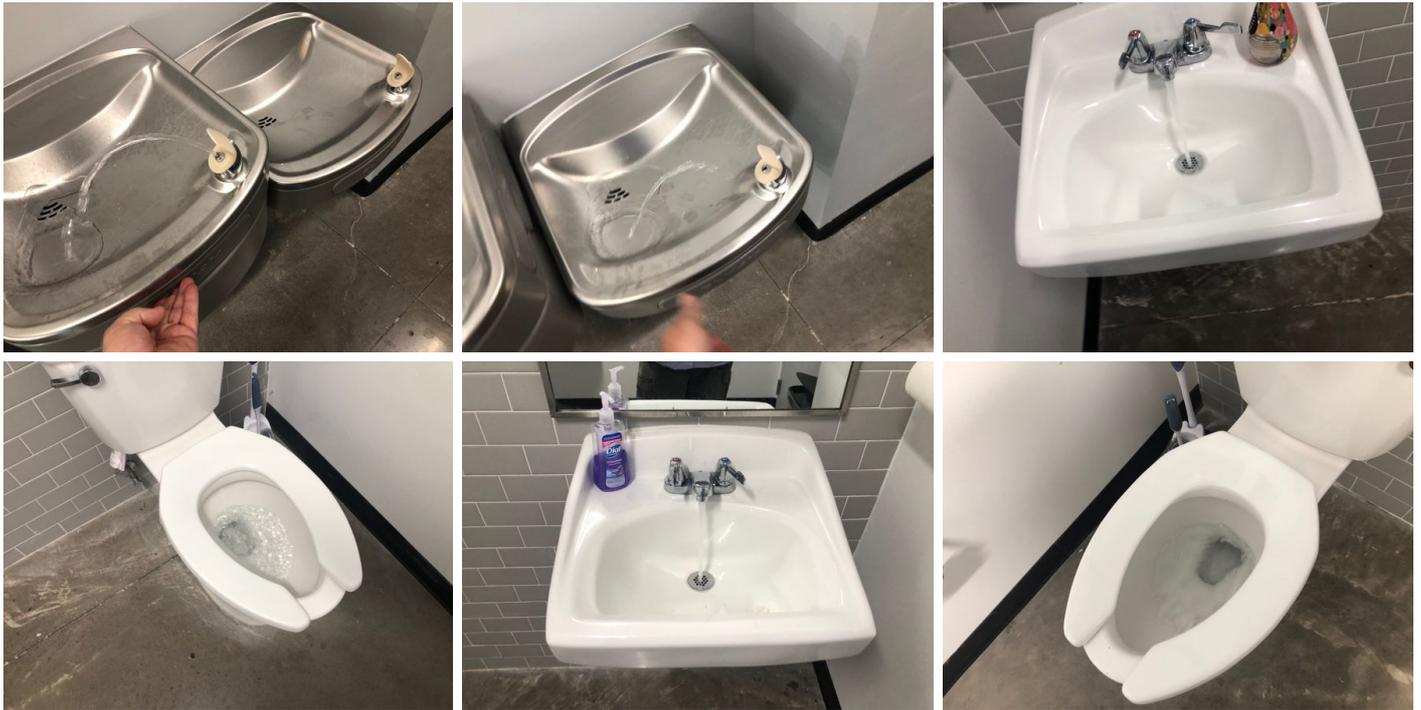
Plumbing Trim complete

- The plumbing trim appeared to be complete. Toilets, urinals & sinks were installed and appeared to be working at the time of inspection.

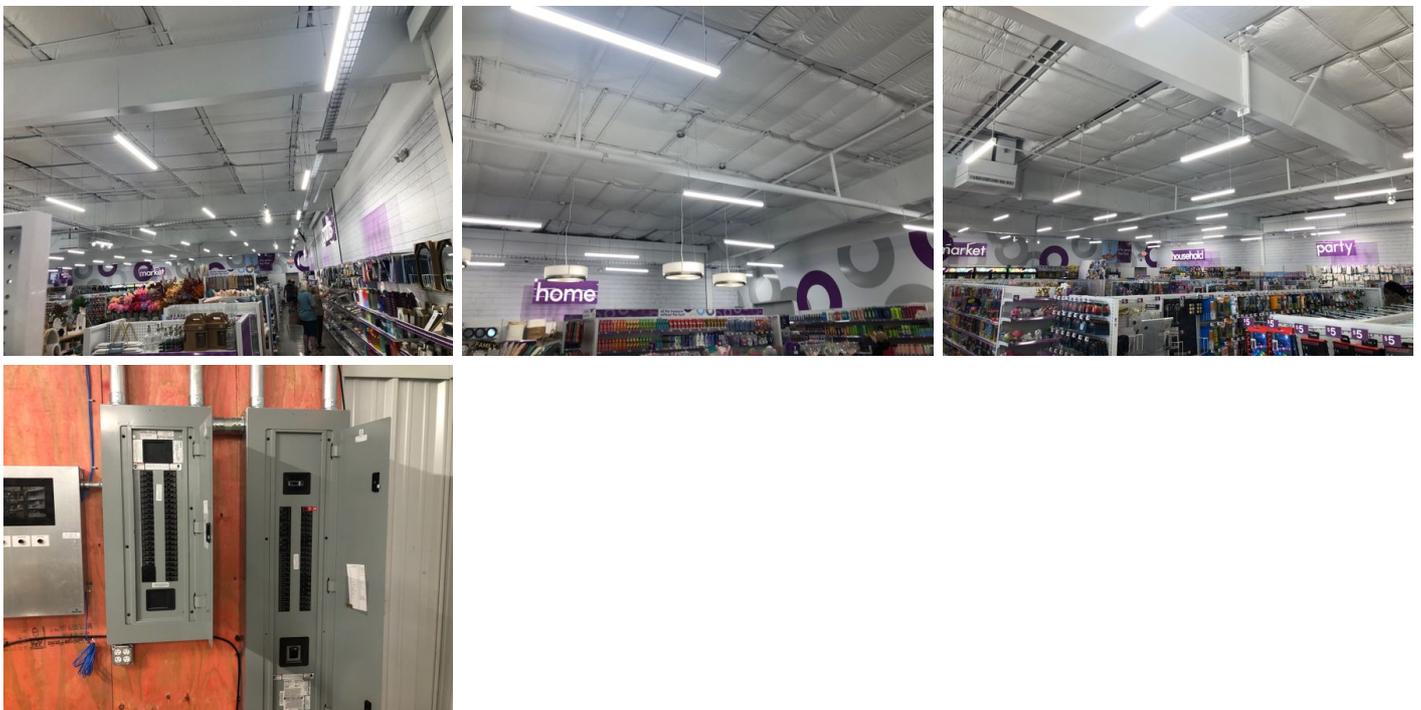
Electrical Trim Complete

- The electrical trim appeared to be complete at the time of inspection. Switches, switch plates, outlets and outlet plates were installed. Light fixtures were installed and the electrical panels were installed, labelled and the covers were secured in place.

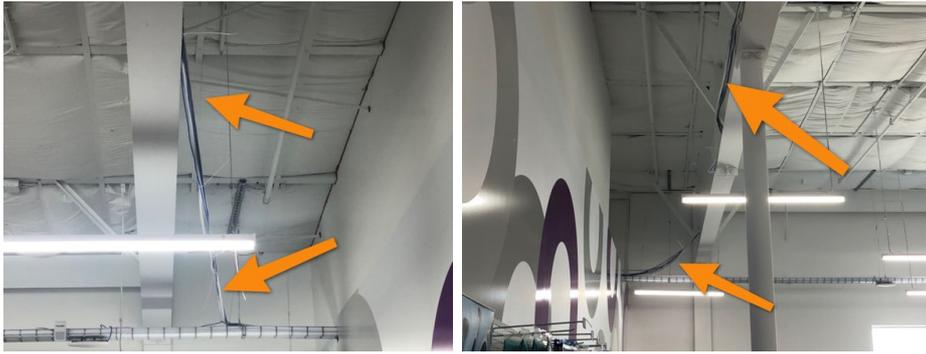
Low voltage wires hung temporarily

The low-voltage wires were observed to be hung in a temporary manner on the right side interior of the building.

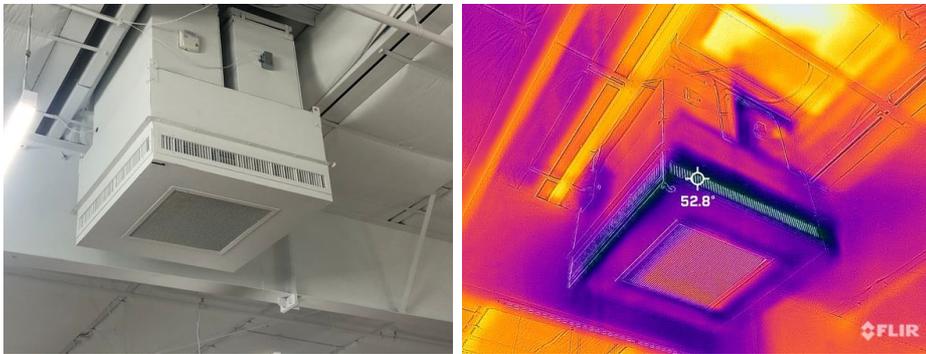
right side

HVAC Trim Complete

- The HVAC contractor appears to have finished with the HVAC Trim. The grills were installed and the air inside of the building was being conditioned at the time of inspection.

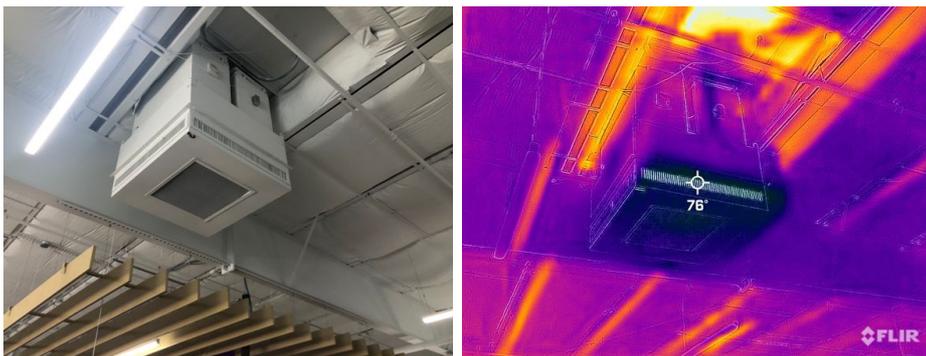
left side

HVAC not cooling Properly

- The HVAC system was not cooling properly at time of inspection. It could be hard to be running, but the temperatures coming out of the supply grill appeared to be warmer than they should be.
