JOHNSON WILBUR ADAMS, INC.

May 3, 2024

**Re: Palatine Stables – Palatine, IL
Structural Condition Assessment
JWA Project No. 2024201**

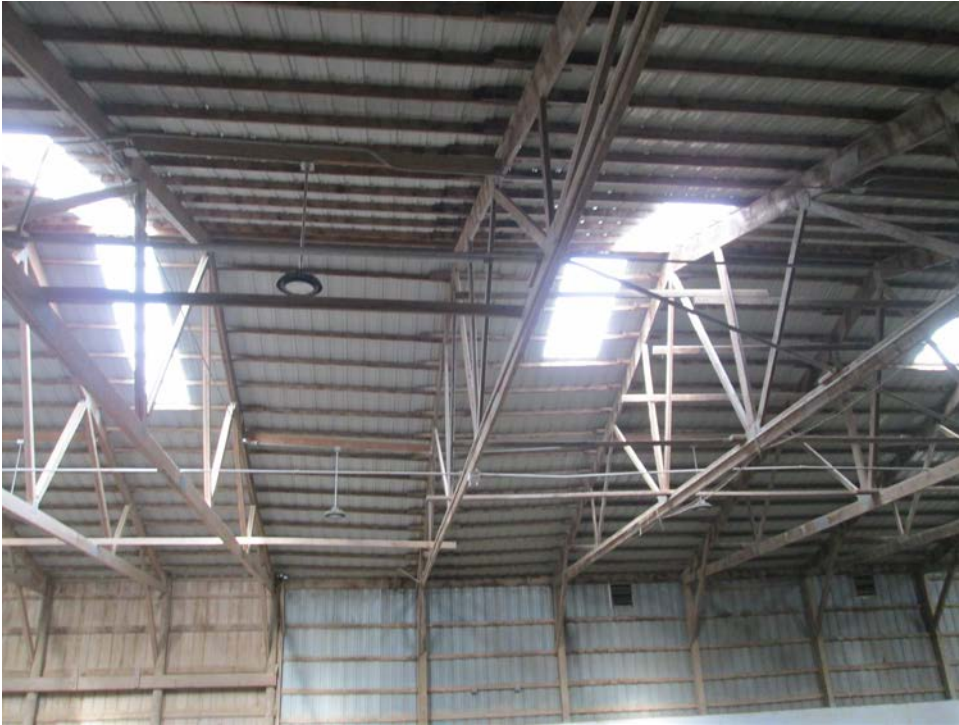
1. At the west barn building the arena roof purlins were observed to be sloping down to the supporting roof truss on the east side of the building. The supporting truss was observed to be in good condition and did not show any signs of excessive deflection or stress. *It is my opinion that the existing condition of the roof structure in this area is not an immediate structural concern at this time. However, further investigation should be performed to determine the cause of the deflection and any potential repairs that may be required.*

Photo 1 Sloping Roof at West Barn

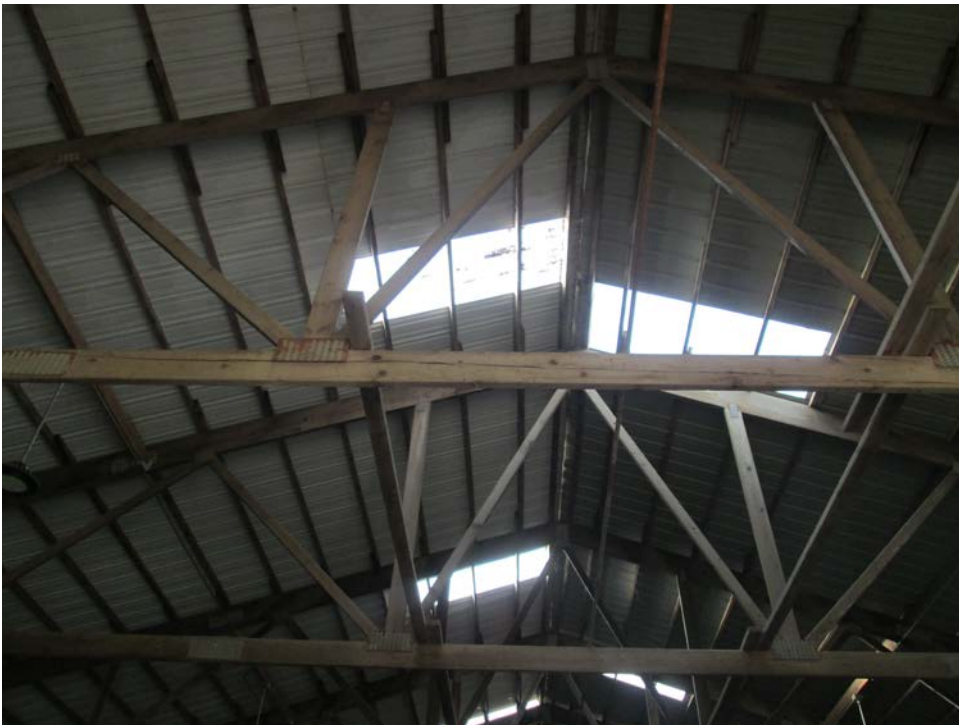
Photo 2 Cracked Truss Bottom Chord at West Barn

2. At the west barn building a wood roof truss on the south side of the building was observed to have a horizontal crack in the bottom chord of the truss. *The truss bottom chord should be repaired as soon as practical preferably prior to the next winter season. The repair will likely consist of sistering new 2x6 members on each side of the bottom chord at the location of the crack.*

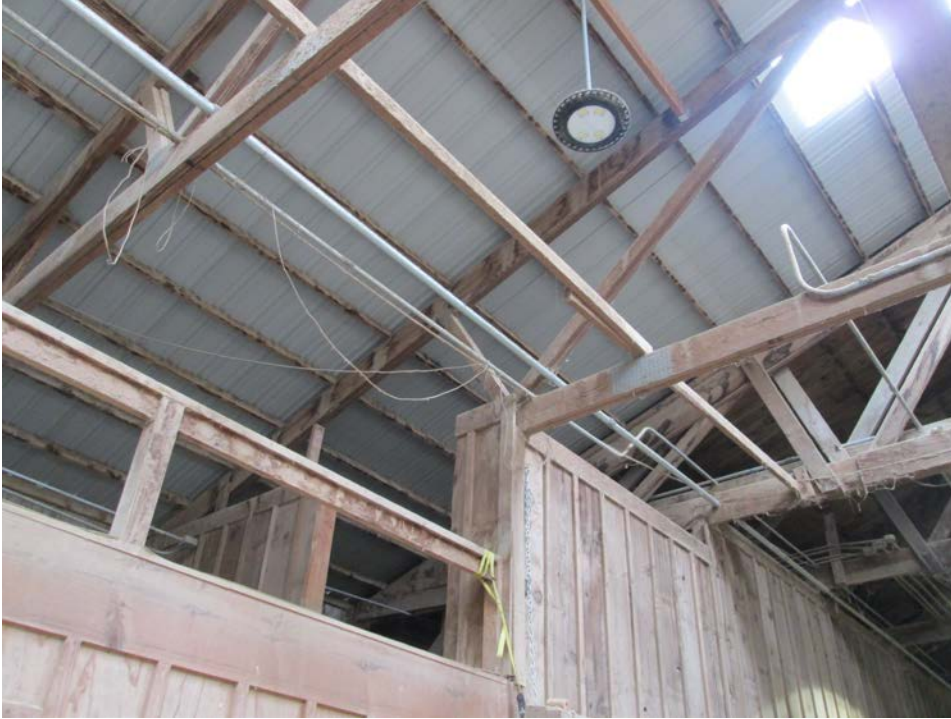
3. At the west barn building the bottom chord of a roof truss above the arena judging platform was observed to be cut and removed. No significant distress or deflections were

observed in the truss at this location that would indicate that a load capacity issue currently exists. *However, it is my opinion that the truss should be repaired or properly supported as soon as practical to restore continuity back to the truss bottom chord.*

Photo 3 Cut Truss Bottom Chord Adjacent to Arena Judging Platform

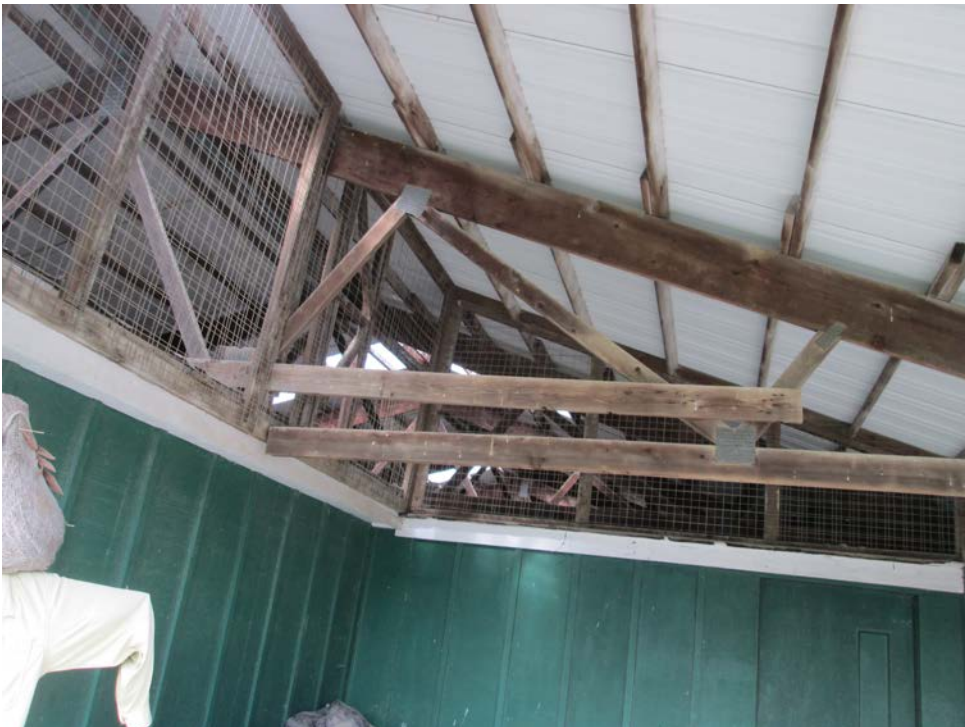
4. At the west barn building the bottom chord of a roof truss at the cross-gable roof on the east side of the building was observed to be cut and removed to accommodate a higher ceiling structure. No significant distress or deflections were observed in the truss at this location that would indicate that a load capacity issue currently exists. *However, it is my opinion that the truss should be repaired or properly supported as soon as practical to restore some continuity back to the truss bottom chord.*
5. At the west barn building arena judging platform the wood guard rail was observed to be shorter than the building code required 42" height for a safety railing. *If the platform will still be used for judging events the existing railing shall be modified or replaced with a code compliant railing system prior to the next use.*

Photo 4 Cut Truss Bottom Chord at West Barn Cross Gable Roof

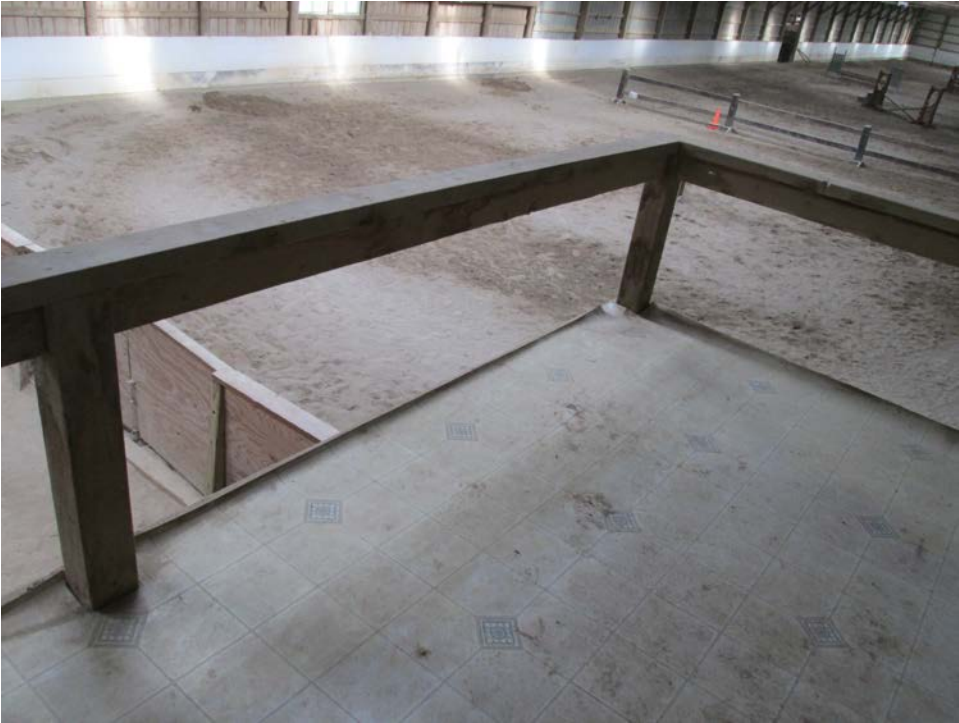
Photo 5 Non-Code Compliant Railing at Judging Platform

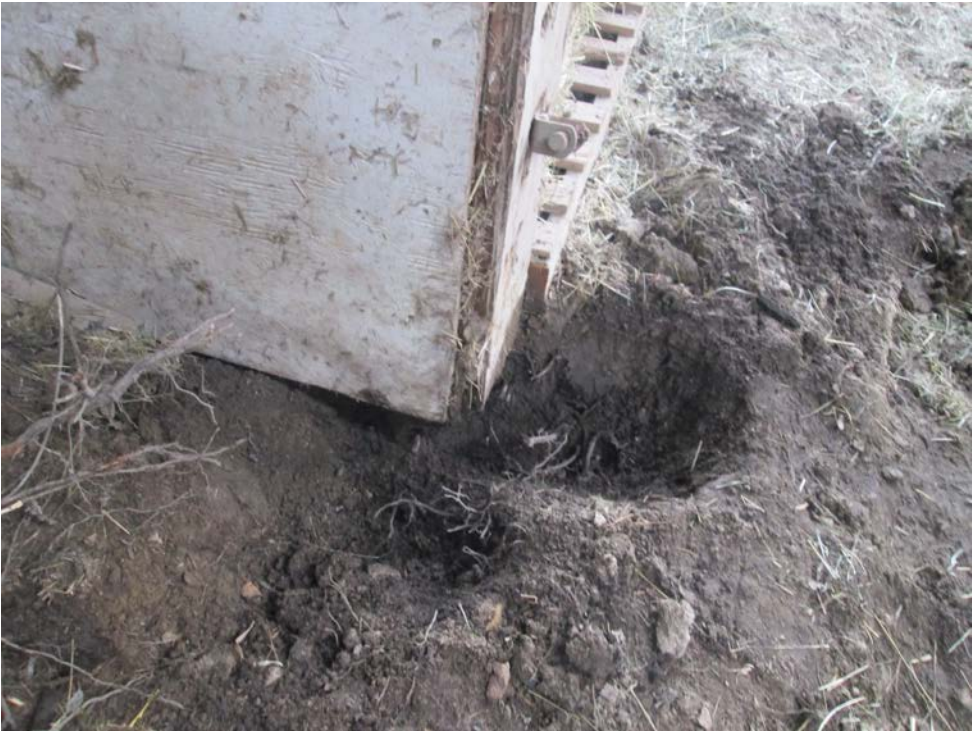
2. At both the east and west barn buildings rot was observed at the bases of numerous columns as a result of the long-term exposure to moisture below grade. Of the columns exposed at the time of the site visit 4 columns at the east barn building and 9 columns on the east side of the west barn building were observed to be rotted to the point that repairs are required. The exposed columns observed on the west side of the west barn building had either been previously repaired in 2014 or were in fair structural condition due to a sheet metal cover added to the exterior base of the wall. *It is my opinion that the current condition of the column bases at both barn buildings does not present an immediate life safety issue for continued use. However, the columns do contribute to the overall stability of the structure for both gravity and lateral loads. As a result, it is my opinion that the rotted column bases should be repaired as soon as possible to prevent any further damage to the barn structures over time. Since all of the column bases were not exposed at the time of my site visit it is my recommendation that all column bases be reviewed at the time of the repairs to determine the full quantity of repairs required. For reference refer to the attached Sketch SK1 of 1 dated 10/06/2014 for the repair detail used in 2014. In addition, refer to the attached sketches SK-1 and 2 of 2 dated 05/03/2024 for approximate locations of the columns observed to be rotted.*

Photo 6 Rotting Interior Column Base at East Barn Building

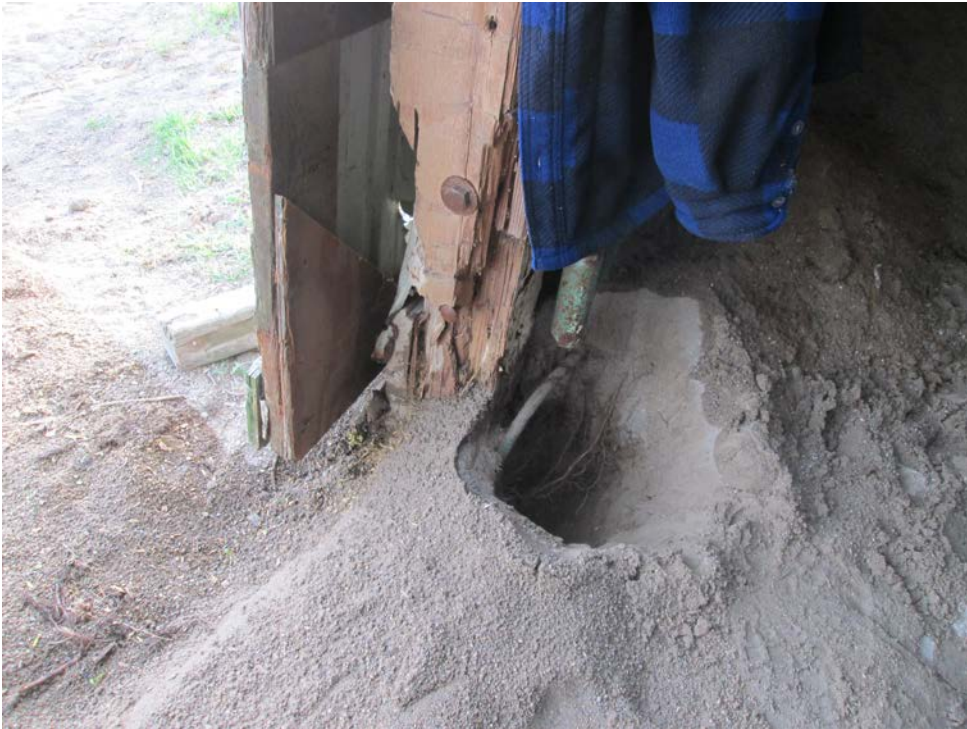
Photo 7 Deteriorated Jamb Column at North Wall of West Barn Building

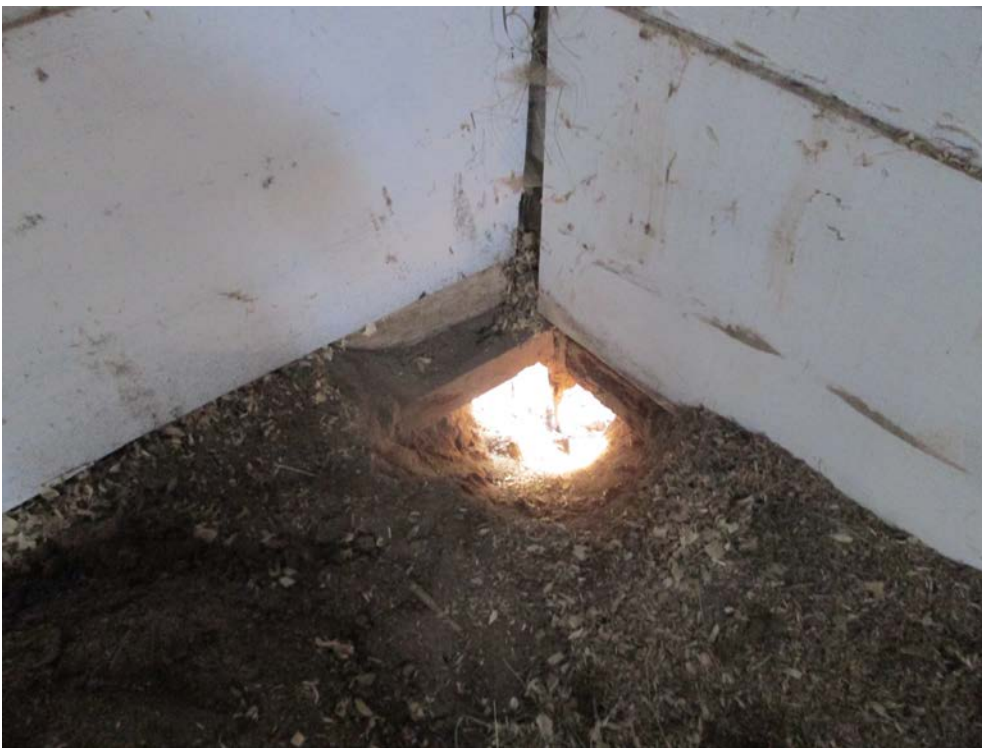
Photo 8 Deteriorated/Missing Column Base at East Barn Building

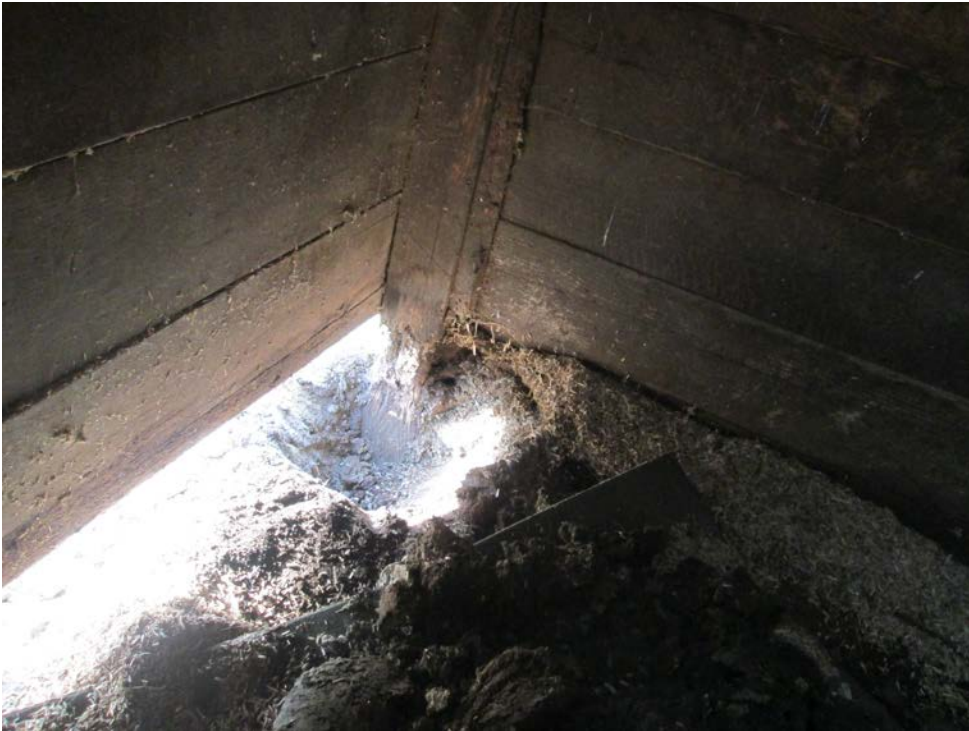
Photo 9 Deteriorated/ Missing Column Base at East Barn Building

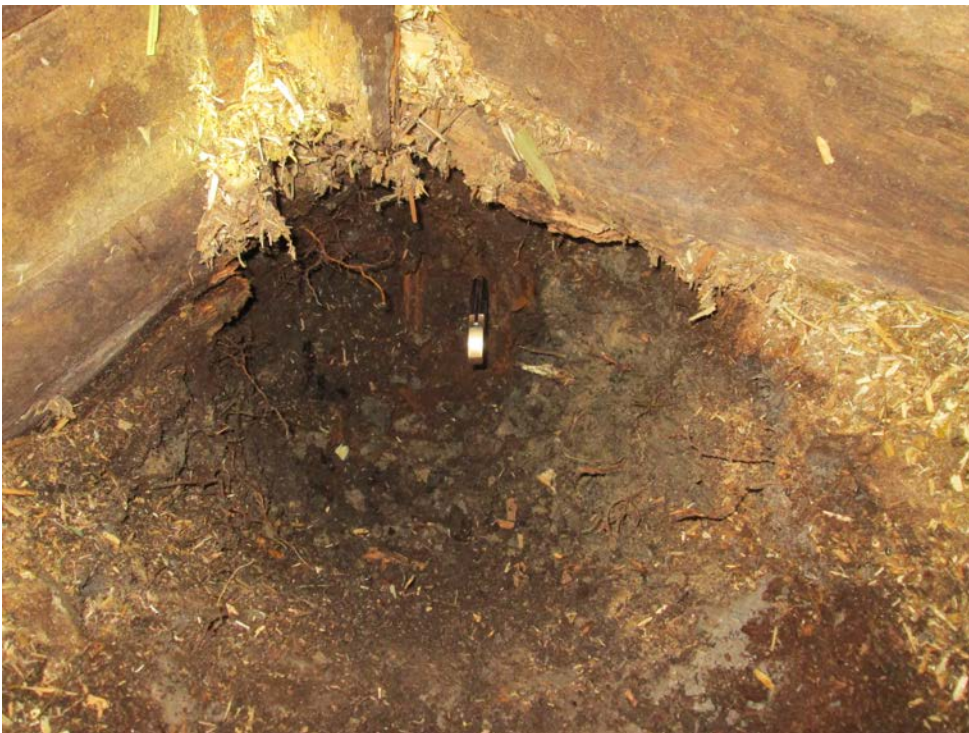
Photo 10 Rotted Column Base on East Wall of West Barn Building

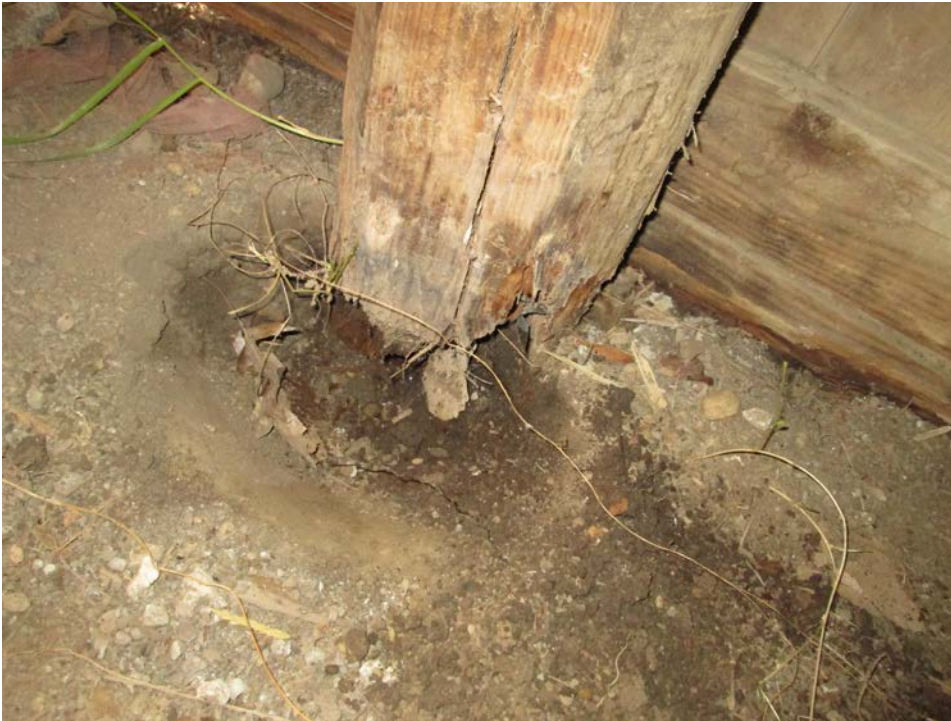
Photo 11 Rotted Column Base on East Wall of West Barn Building

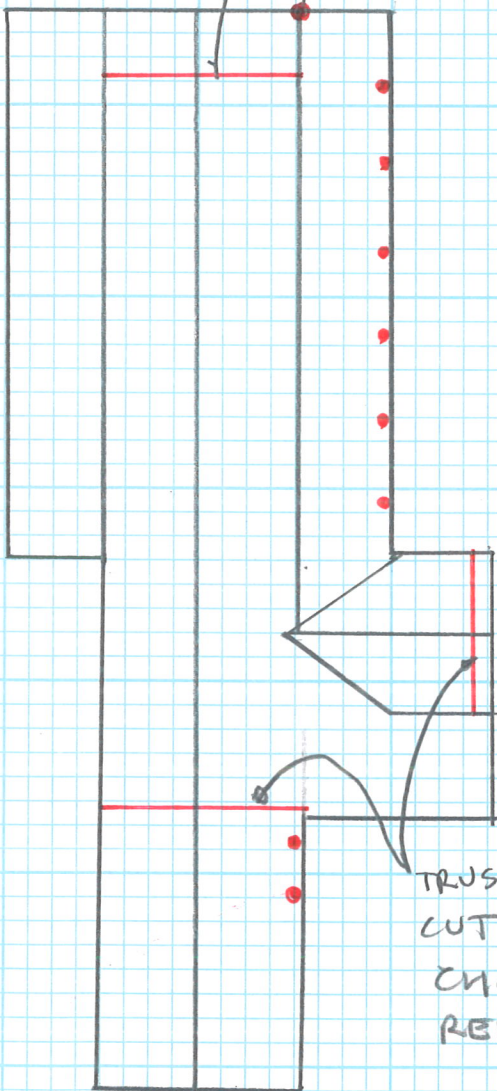
JOB PPD STABLES NO. 2024201
SHEET NO. SK-1 OF 2
CALCULATED BY KLA DATE 5/3/24
CHECKED BY _____ DATE _____
DESCRIPTION WEST BARN PLAN

CRACKED TRUSS
BOTTOM CHORD

INDICATES APPROXIMATE
LOCATION OF ROTTEN
COLUMN TO BE REPAIRED

TRUSS WITH
CUT BOTTOM
CHORD TO BE
REPAIRED

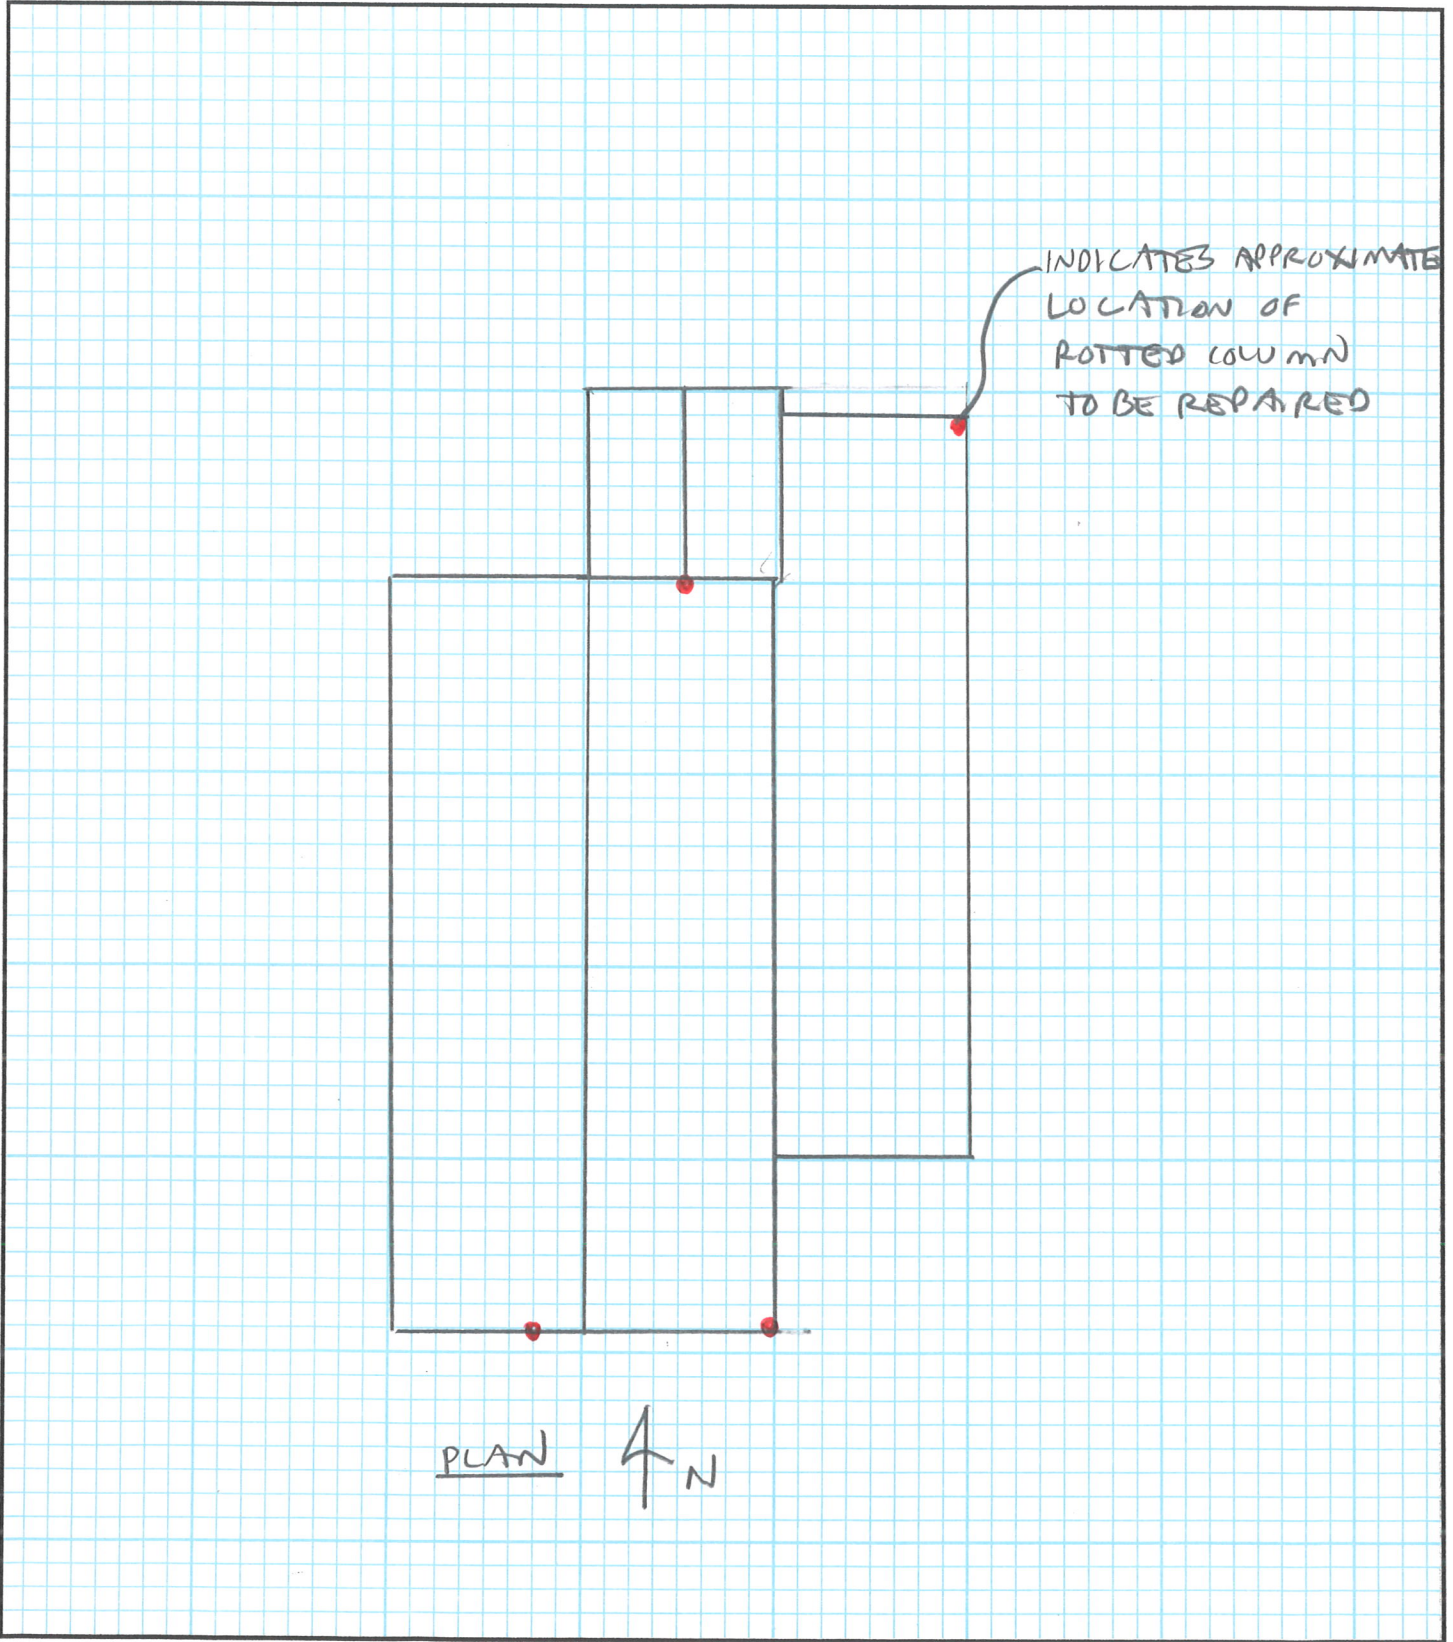
SHEET NO. SK2 OF 2

INDICATES APPROXIMATE
LOCATION OF
ROTTED COLUMN
TO BE REPAIRED
