JOHNSON WILBUR ADAMS, INC.

**Re: Palatine Stables – Palatine, IL
Structural Condition Assessment Supplemental Report
JWA Project No. 2024201**

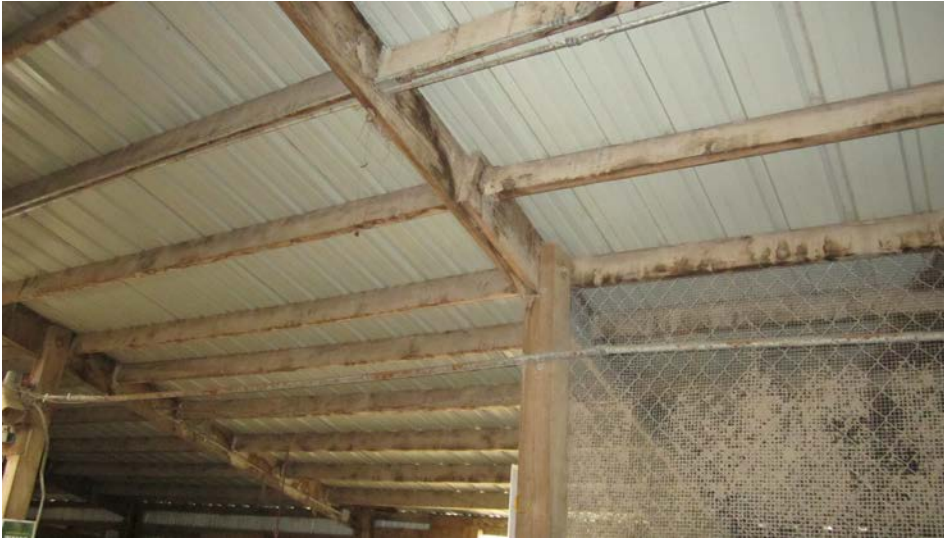
However, based on preliminary calculations, the existing single 2x10 roof beams do not have the capacity to support the minimum building code required dead and live loads for a barn structure. As a result, it is my opinion that, as part of any renovation to the stable portions of the buildings, the beams be reinforced as required to meet the minimum loads required.

Photo 1 2x10 Roof Beam at Stable Area

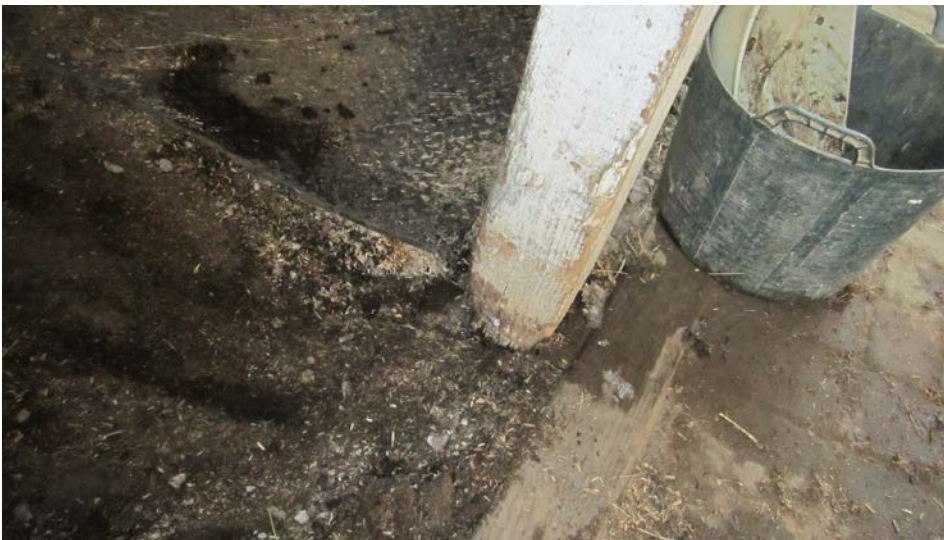
As indicated above all accessible columns of both the Upper and Lower Barns were visually observed to determine the existing structural condition of the columns. Rot was observed at the bases of a significant number of columns at both the Upper and Lower Barns. Approximately 48% of the Lower Barn columns (40/83) and 55% of the Upper Barn columns (102/187) were

Photo 2 Rotted Interior Post at Stable

As previously indicated in my initial report it is my opinion that the rotted column bases should be repaired as soon as possible to prevent any further damage to the barn structures over time. In addition, it is also my recommendation that the repairs to the interior columns and roof beams in the stable areas of both buildings be completely prior to this coming winter.

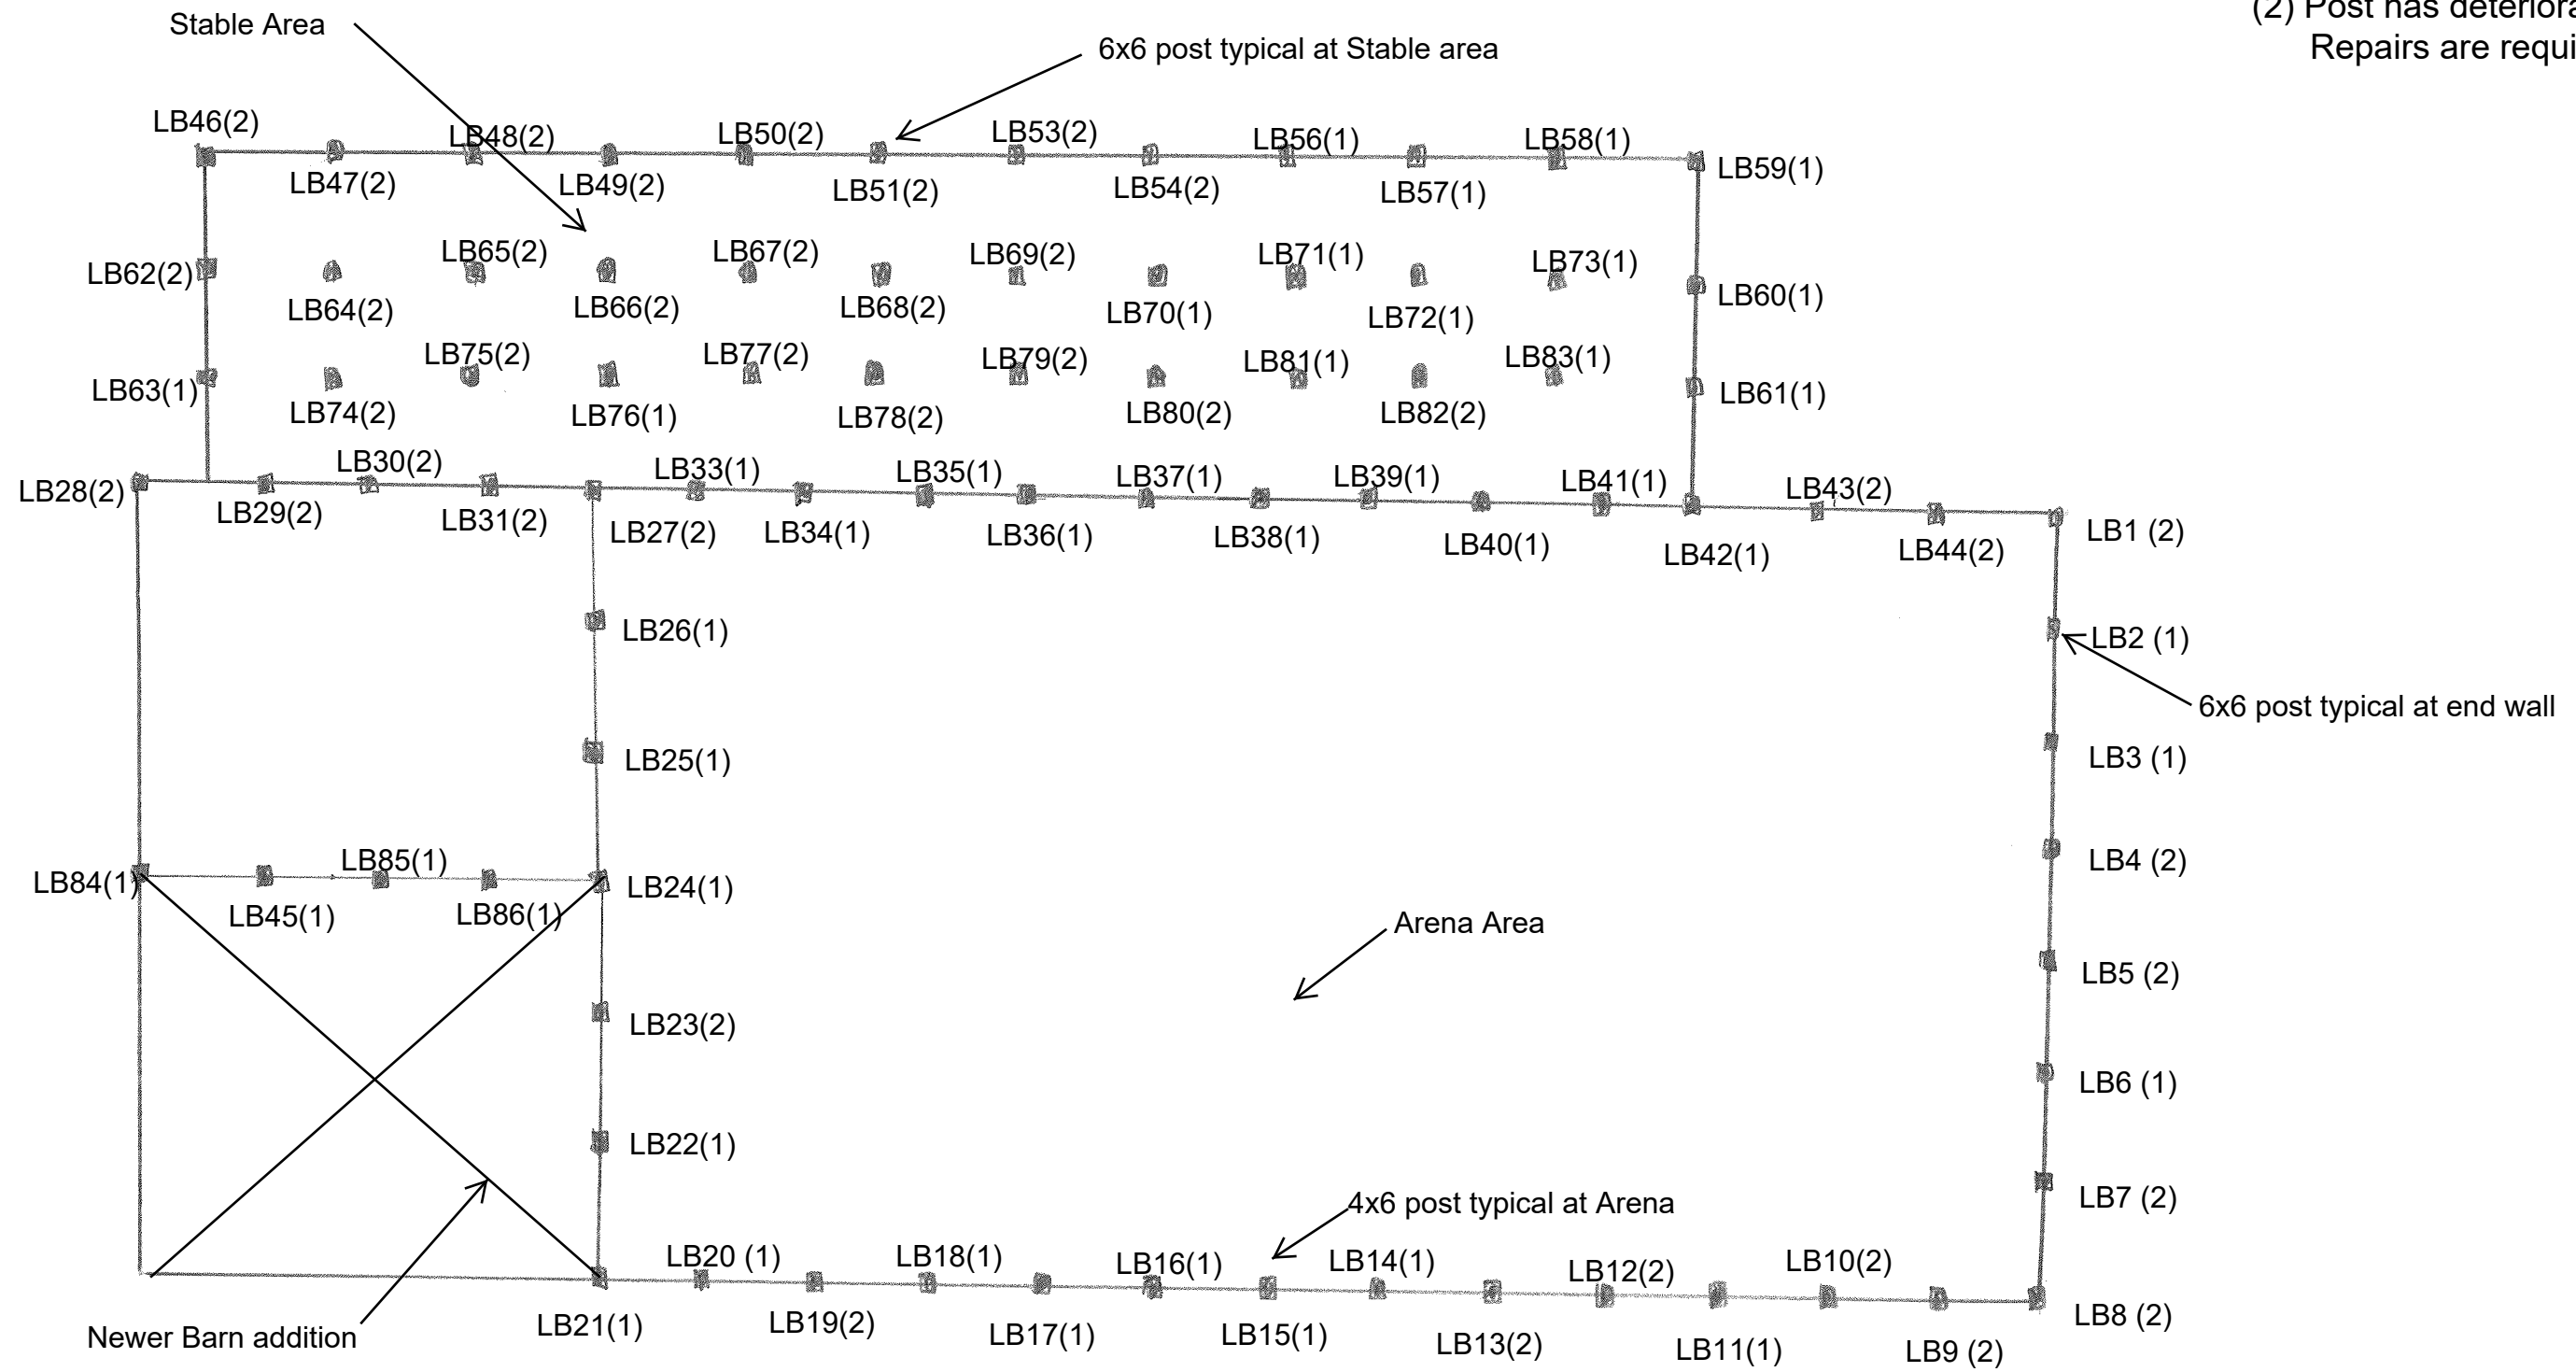
Lower Barn Post Plan

observed to have varying degrees of deterioration. See Attachments A and B for a summary of the column locations and conditions.
