DOUGLAS J. BURGASSER, P.E.  
THOMAS D. WURDER, P.E.

**Inspection:**

Date: [REDACTED]  
Property [REDACTED]  
Address: Spencerport, NY 14559  
Inspector: **Michael P. Yun, P.E.**

This is a two-story house with mostly vinyl sided exterior walls and an asphalt shingle roof surfacing.

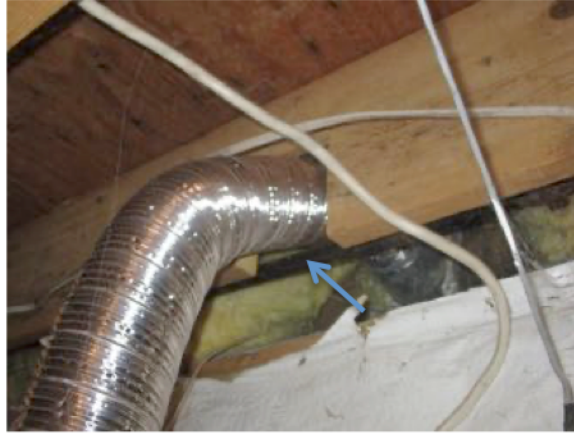
In the basement there is a cut in one of the floor joist, approximately above the laundry area. This may be long-standing and might have been done at the time of construction to provide adequate clearance for the exhaust ductwork for the dryer. Sistering or reinforcing the cut floor joist would be recommended if significant floor slopes or large cracks in wall and ceiling surfaces were to occur in the living room in the future.

*Cut in floor joint above the laundry area in the basement*

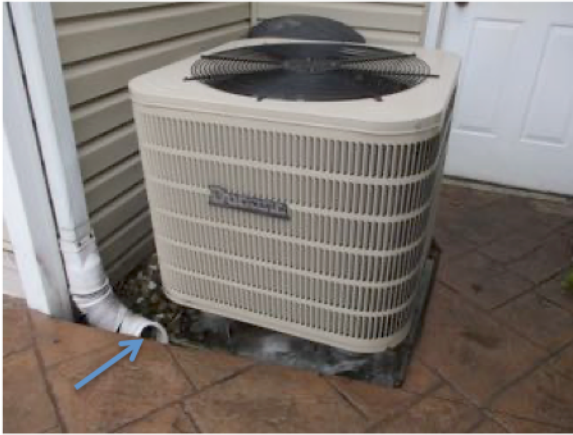
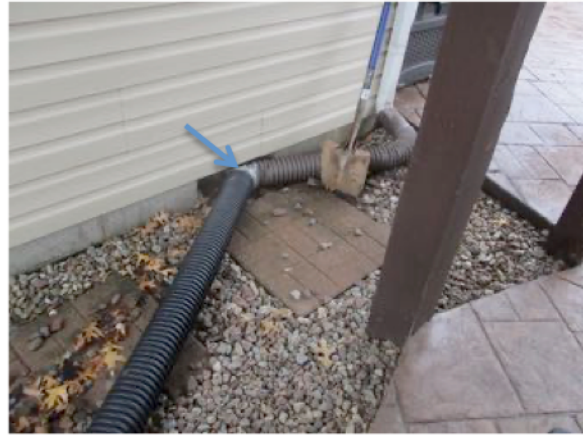
At the rear of the house, near the heat pump unit, there is a relative low spot in the grading along with gutters that drain to this area. Piping or extending the downspout away from this area better and improving the grading away from the house at this corner can help to minimize the chances of seepage in this basement corner in the future.

*Revise downspouts to discharge further away from the house*

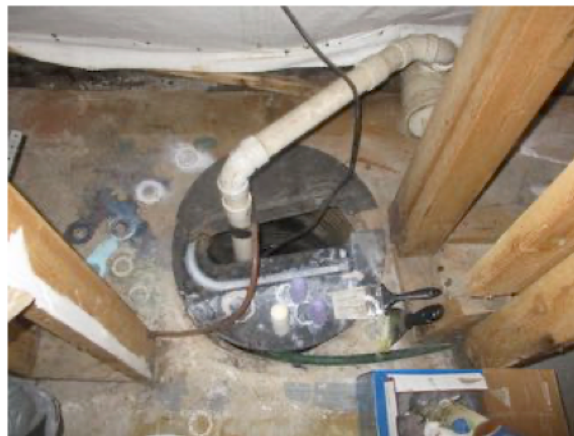
This house has a floating slab type basement floor with a crock and sump pump. The pump was working at the time of inspection. Systems of this type are usually effective in controlling moisture when installed and working properly. However, one cannot determine conclusively by visual examination, that the perimeter system is in fact working adequately. Past experience is usually the best indicator of what can be expected. We therefore recommend discussing with the owner, the extent to which there has been any uncontrolled leakage in the past.

*Crock and sump pump*

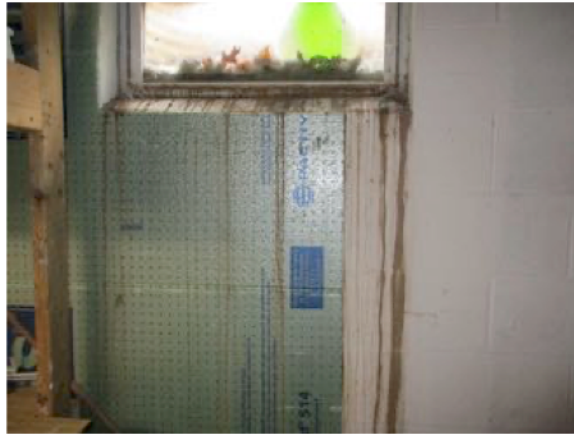
There is evidence of leakage at one of the rear basement windows. Keeping the window well on the exterior clean and clear of debris along with maintaining the plastic cover on the window well is recommended.

*Evidence of leakage at rear basement window*

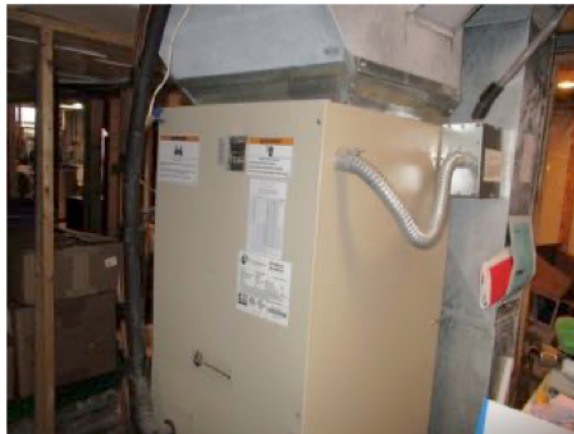
Heat is provided by a forced air electric heat pump system with electric resistance back-up. This system was put into operation in both modes at the time of inspection, and at that time it was found to be operable.

*Electric furnace*

It is recommended that the heating/cooling system be fully cleaned and serviced once yearly. This servicing should include the motor-blower unit, the filter, all electrical controls and devices for starting and operating, etc.

The filter for the heating and cooling system is relatively dirty. Filter replacement is recommended at this time. Typically, replacing the filter on a monthly basis is recommended as maintenance.

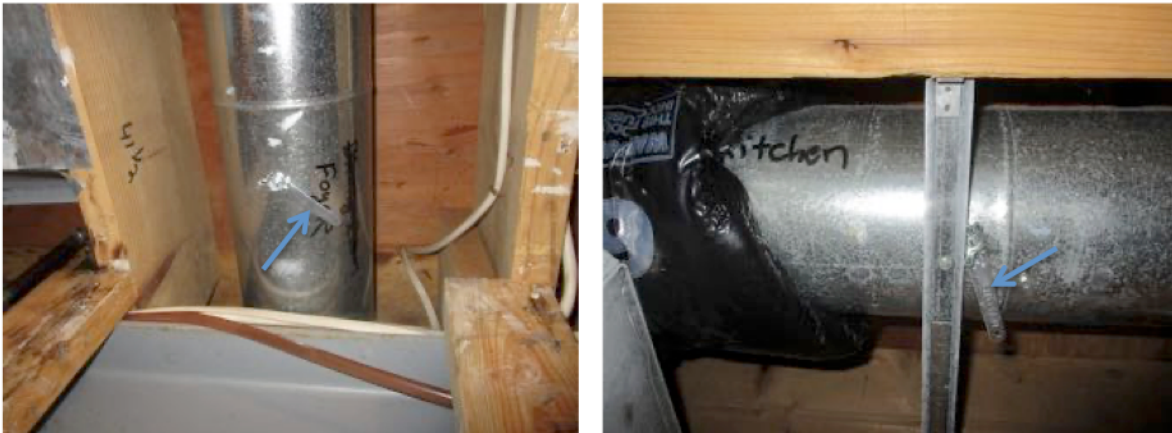
In the basement, we noted closed dampers in supply ductwork feeding areas such as the foyer, kitchen, family room, etc. This is not uncommon. The dampers can be adjusted to provide uniform airflow throughout the house.

*Examples of closed dampers in the basement*

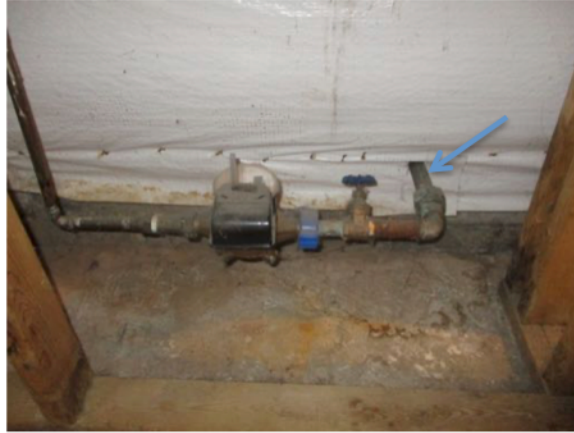
The public water service is plastic and enters at the front of the basement. The plumbing supply is copper and drains are PVC. Where visible, supply and drain lines appeared to be in serviceable condition. Water pressures in the various plumbing fixtures were normal. All interior fixtures were tested and found to be in working order, with one exception. We did note that the kitchen sink sprayer does not fully divert all water to the spray handle when the sprayer is in use. This unit can be repaired or replaced in the interest of water conservation.

*Public water service*

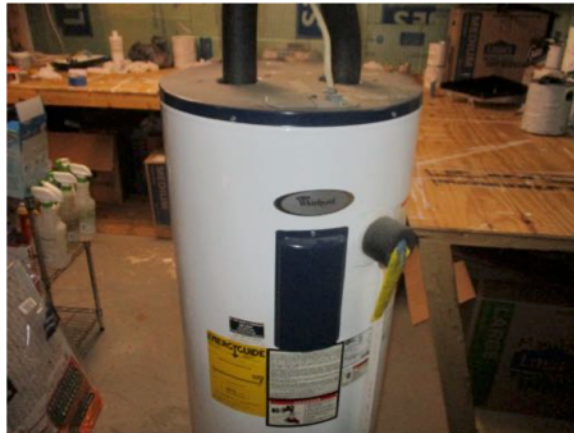
The separate hot water heater was in operation and its size appeared adequate for the normal needs of this size house. The water heater is relatively old. Near term replacement may be necessary.

*Electric hot water heater*

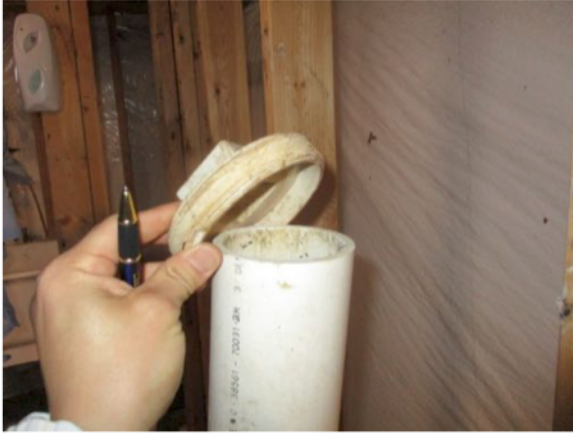
There is a loosely capped waste pipe at the front of the basement. We recommend properly securing the pipe cap to help prevent sewage odors from leaking into the basement. This is a simple job to perform.

*Uncapped waste pipe in the basement*

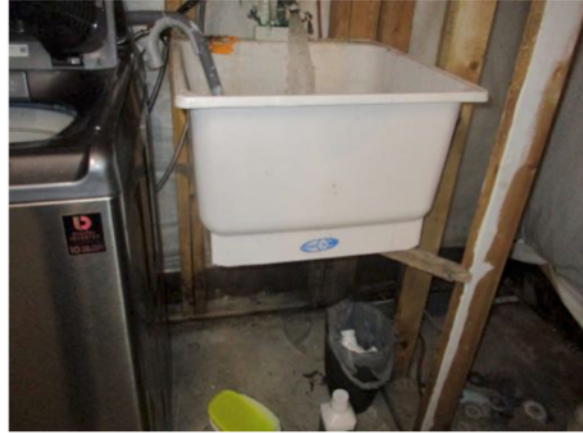
In the basement, the legs for the laundry sink have been removed and the sink is mounted on top some trim. Better supporting and securing the laundry sink is recommended.

*Laundry sink*

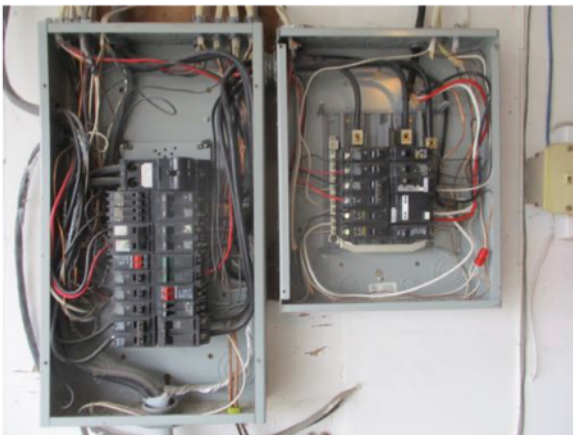
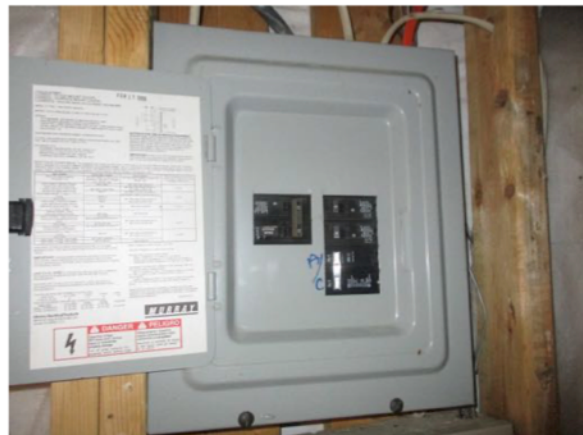
The electrical power entering these premises consisting of a three-wire service, 120/240 voltage and with 200 amperes available, is adequate in capacity to serve the needs of this house as it now stands. There are two subpanels. One of the subpanels is located in the garage adjacent to the main electric panel, and the other subpanel is located in the basement.

*Electric panels*

We noted a number of circuit breakers in the main electric panel that are double-tapped; meaning that two wires are attached to the terminals of these circuit breakers. This is a very common condition, but it does not fully comply with standards. This should eventually be corrected by your electrician.

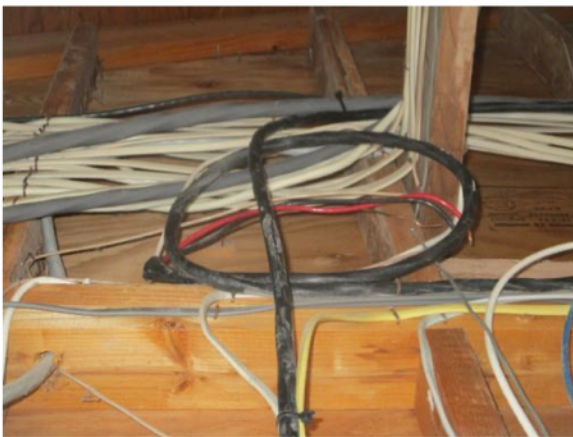
We did note the need for a small degree of electrical clean up in the house. Conditions include some poorly supported wires in the basement, an open junction box above the pool storage room, a loose wire above the panels in the garage, a loose wire connection above the shop area in the basement, etc. A closer examination by an electrician may reveal the need for additional repair.

*Loose wire above the electric panels in the garage*

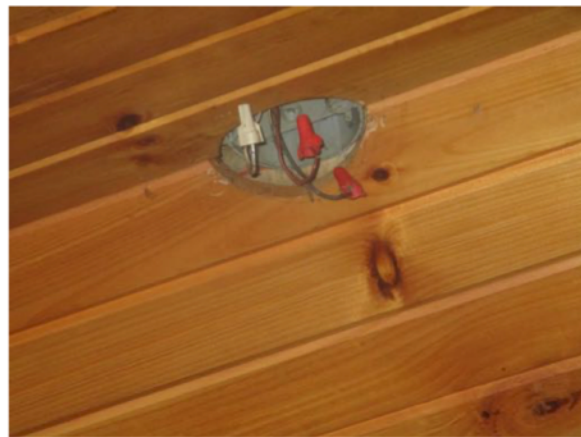
*Open junction box above the pool house*

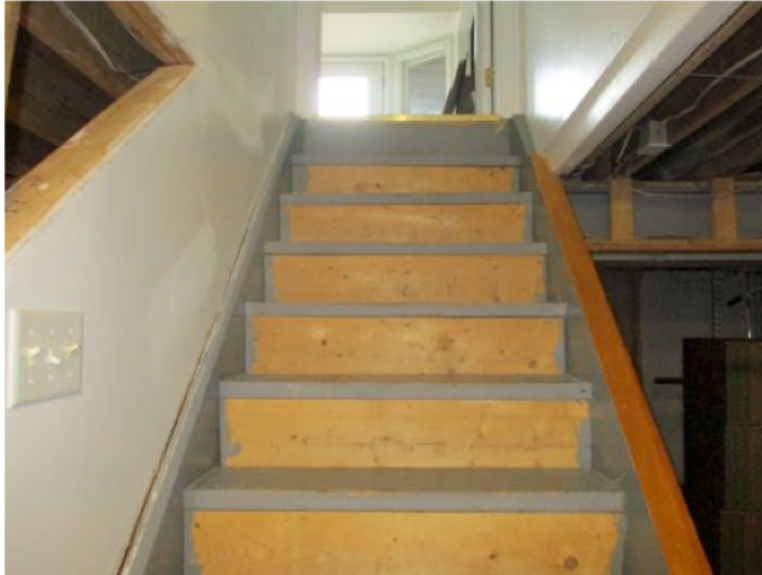
The basement stairs lack a handrail and the open side of the basement stairs lacks a guardrail. Proper guards and railings should be installed at all stairways and landings.

*Basement stairs lacks a handrail and a guardrail*

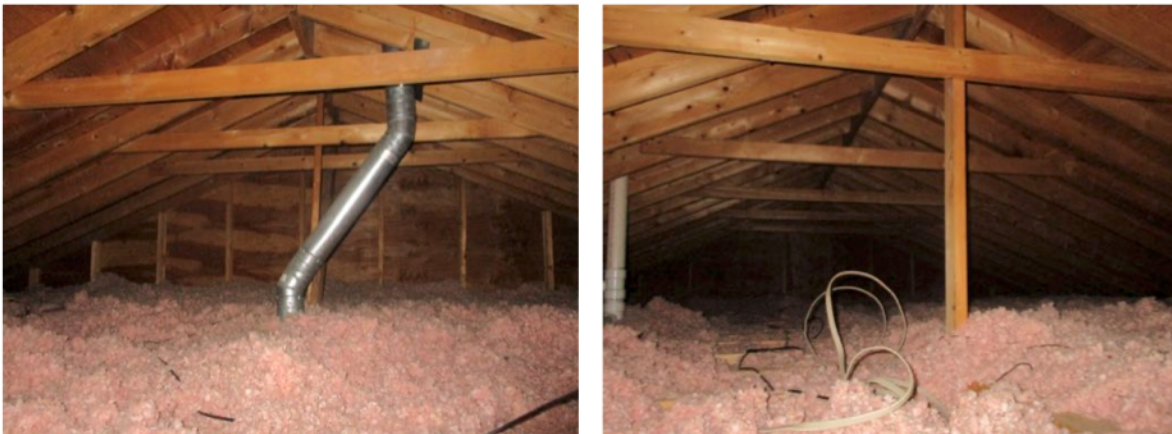
In the attic space, there is insulation in the attic floor, and the amount of insulation is considered to be adequate for the most part. We recommend insulating and weather stripping the attic access hatch to help prevent heat loss.

*Attic space*

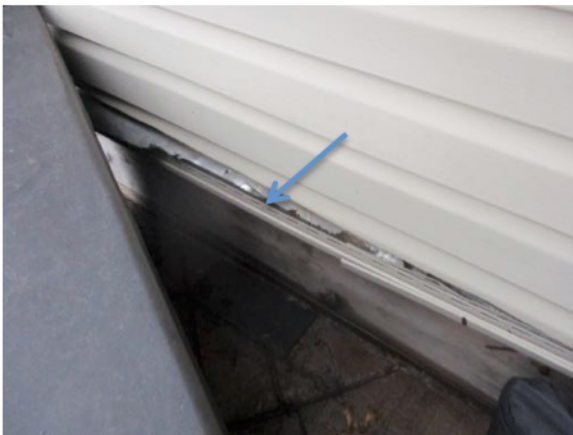
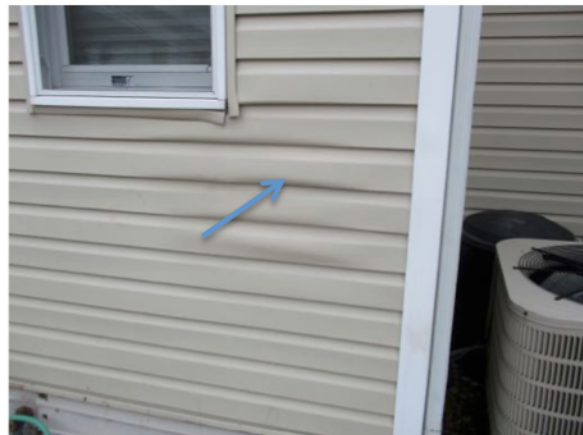
The exterior walls and siding are in generally serviceable condition. Some of the siding and trim at the rear lower portions of the house are damaged and sloppy. There is also small area of warped siding and trim. We suspect that this is due to placing a hot grill too close to the house. Siding and trim repairs are recommended. Minor weathering or slight damage on exterior wood trim was found in spots. There are also several areas where cracked and chipped trim paint exists. Rotted trim should be removed and replaced. Regular trim paint maintenance will be necessary for this house.

*Examples of siding and trim damage at the rear of the house*

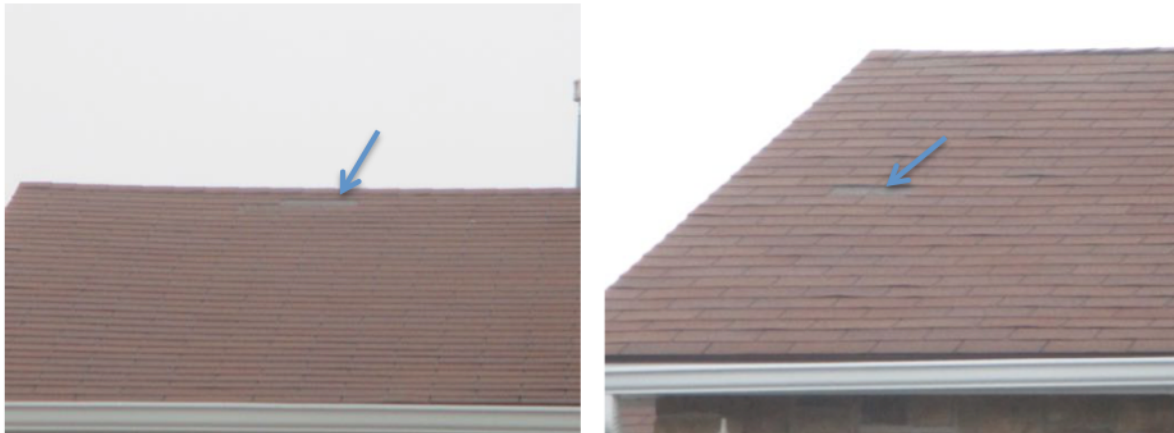
The roof was inspected from the ground with the aid of binoculars. The roof is asphalt shingle. It is original, which makes it approximately 23 years old. As discussed, a roof of this age is considered to be relatively old. In fact, there are a small number of missing shingles and several nail pops. These conditions are not uncommon for a roof of this age. Replacement of missing shingles is recommended. It should be understood that many roofers would rather replace the entire roof than make small repairs. Complete replacement should be considered, at least if you choose a more cautious approach.

*Few missing roof shingles*

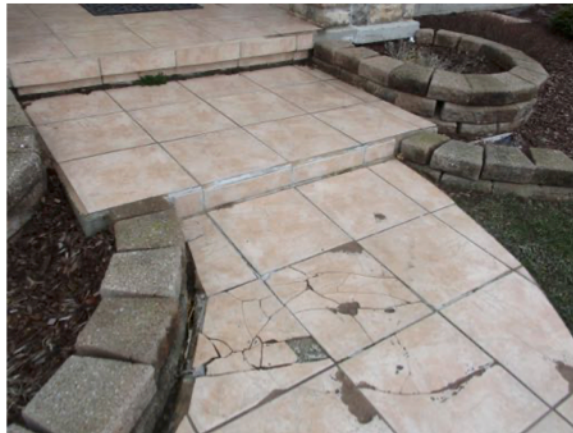
The front walkway consists of ceramic tiles that have been installed in a less than professional manner. Some of the tiles are cracked, broken, loose, etc. Also, the tiles might be slippery in the winter. Replacement of the front walkway is recommended for safety reasons.

*Ceramic tile front walkway*
