SHIVER ME TIMBERS, INC.
MARINE SURVEYOR AND CONSULTANT

1979 Morgan 415 Ketch Rigged Sailing Vessel

Report of Marine Survey

August 06, 2017

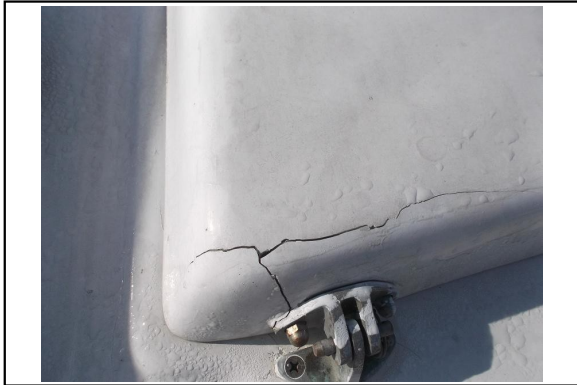
Forward FRP hatch is cracked at hinge.

Forward Deck Hatch

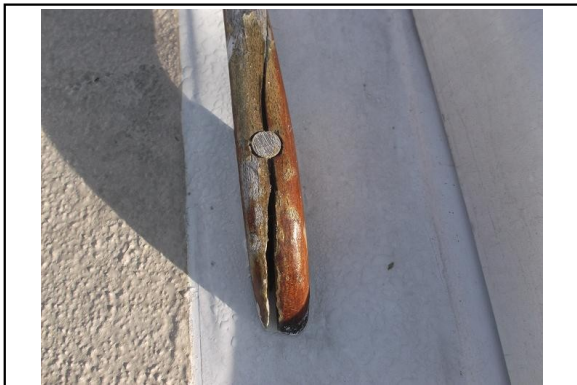
- * **GRAB RAIL: [B2]** Teak grab rails on cabin house. Starboard teak handrail on main cabintop is split and not secure.

Handrail

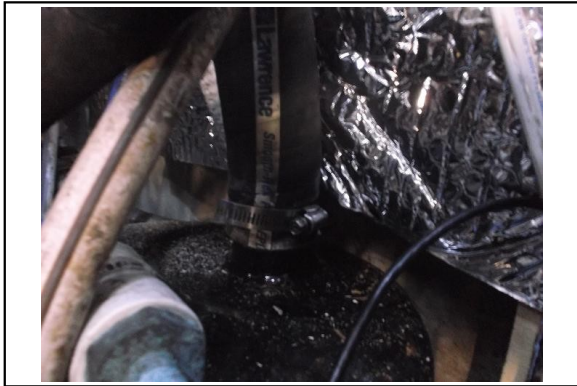
- * **EXHAUST SYSTEM:[A1]** Wet exhaust type system with water lift muffler with flexible exhaust hose. A siphon break was sighted in cooling water piping. Flexible exhaust hose is not double clamped and cooling water leak sighted at muffler leaking onto engine mount.

Single Clamped Exhaust Hose

<p>Flexible exhaust hose is not double clamped and cooling water leak sighted near muffler leaking onto engine mount.</p>	<p><i>Clamp Exhaust as per ABYC P-1. Flexible Exhaust Hose Connections: P-1.7.1.10.1 Every exhaust hose connection shall be secured with at least two non-overlapping clamps at each end to produce a secure, liquid and vapor-tight joint. Further investigate exhaust cooling water leak and repair as necessary.</i></p>
--	--

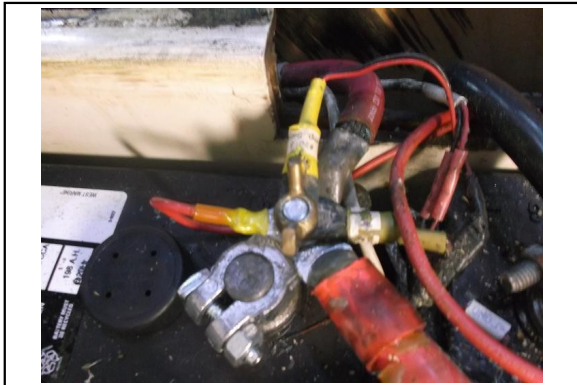
- * **DC OVERCURRENT PROTECTION:**[A4, A5] All ABYC standards recommended overcurrent protection **is not** in place. Wires were sighted connected directly to the battery positive terminals without overcurrent protection. High amperage fuse sighted installed in negative battery cable.

No Overcurrent Protection

<p>All ABYC standards recommended overcurrent protection is not in place.</p>	<p><i>Further investigate and provide overcurrent to comply with ABYC E-11. 11.10 OVERCURRENT PROTECTION</i></p> <p><i>11.10.1 LOCATION OF OVERCURRENT PROTECTION - DC CIRCUITS</i></p> <p><i>11.10.1.1 General Requirements</i></p> <p><i>11.10.1.1.1 Overcurrent Protection Device Location</i></p> <p><i>Ungrounded conductors shall be provided with overcurrent protection within a distance of seven inches of the point at which the conductor is connected to the source of power measured along the conductor.</i></p> <p>EXCEPTIONS:</p> <ol style="list-style-type: none"> <i>1. Cranking motor conductors.</i> <i>2. If the conductor is connected directly to the battery terminal and is contained throughout its entire distance in a sheath or enclosure such as a conduit, junction box, control box or enclosed panel, the overcurrent protection shall be placed as close as practicable to the battery, but not to exceed 72 inches.</i> <i>3. If the conductor is connected to a source of power other than a battery terminal and is contained throughout its entire distance in a sheath or enclosure such as a conduit, junction box, control box or enclosed panel, the overcurrent protection shall be placed as close as practicable to the point of connection to the source of power, but not to exceed 40 inches.</i>

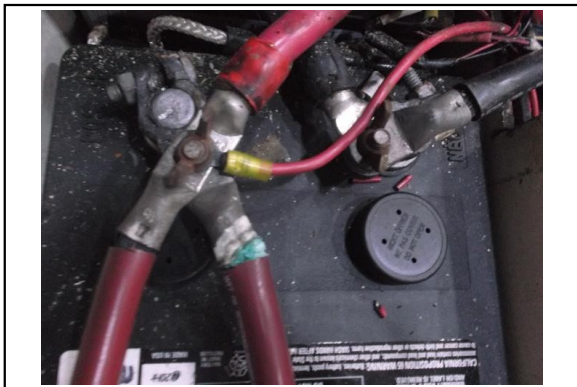
- * **DC WIRING CONNECTORS:** [A6] Wing nuts were sighted connecting large gauge battery cable to batteries.

Wing Nuts

<p>Wing nuts were sighted connecting large gauge battery cable to batteries.</p>	<p><i>Replace wing nuts with standard nuts to comply with ABYC E-10.8.3 Battery cables and other conductors size 6 AWG and larger shall not be connected to the battery with wing nuts.</i></p>
---	---

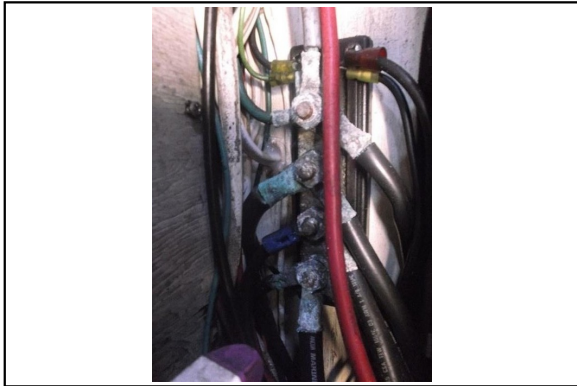
- * **NOTE:** [C3] There are many electrical connections in the engine room with corrosion.

Terminal Corrosion

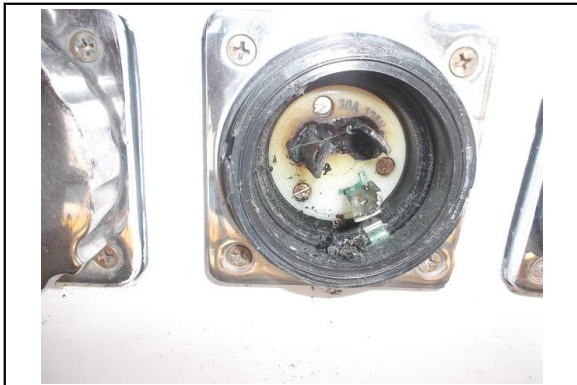
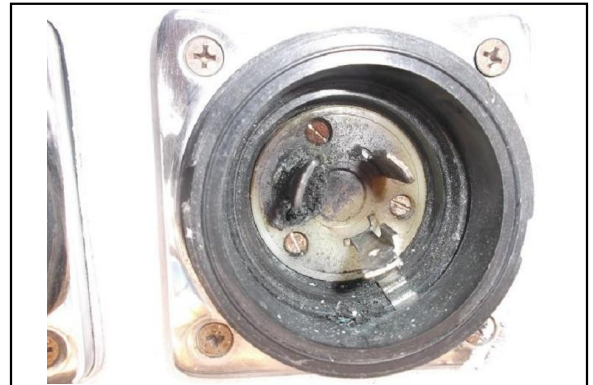
* **SHORE POWER INLET: [A7]** Two 30 amp, 120 volt shore power inlets were sighted. Both shore power inlets and cords had burned terminals and pins and were not connected to shore power at time of survey.

Shore Power Inlet 1

Shore Power Inlet 2

FINDINGS	RECOMMENDATIONS
A.7 (PAGE 8) SHORE POWER INLET:	
Both shore power inlets and cords had burned terminals and pins.	<i>Replace shore power inlets and cords.</i>
A.8 (PAGE 9) MANUAL OR ELECTRIC TYPE:	
The heads did not flush.	<i>Repair or renew as necessary.</i>
A.9 (PAGE 12) THRU-HULL VALVE OPERATION:	
No thru-hull valve operated with normal force with the exception of the forward air conditioning unit intake valve.	<i>It is the surveyors recommendation that all seacocks be serviced. I would also like to add that wooden plugs of the appropriate size be readily accessible for emergency use at each seacock location.</i>
A.10 (PAGE 12) MATERIAL/TYPE/INSTALLATION:	
The seacocks are installed on thru-hull fittings that are too long to allow the seacock flanges to be secured to the hull.	<i>Install seacocks to comply with ABYC H-27 Seacocks and Thru-Hull Fittings. H-27.6.3 If a flanged seacock is used, its flange shall be securely mounted to the hull structure.</i>

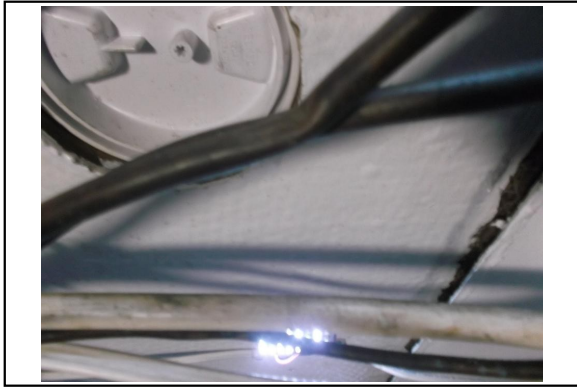
* **LINES AND FITTINGS: [C5]** Copper hydraulic fluid steering line damaged/kinked in engine room.

Steering Hydraulic Line

Copper hydraulic fluid steering line damaged/kinked in engine room.	<i>Renew or repair as necessary.</i>
---	--------------------------------------

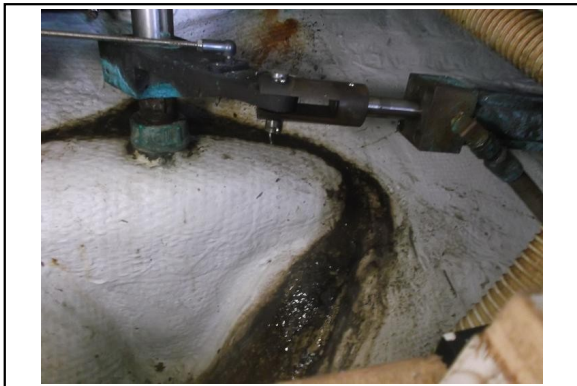
* **RUDDER SHAFT PACKING GLAND: [C6]** Rudder shaft seal is a traditional type bronze packing gland. The seal was leaking at time of inspection.

Leaking Rudder Post

The rudder shaft seal was leaking at time of inspection.	<i>Adjust packing nut tension and/or replace packing material as needed to stop shaft seal leak.</i>
--	--

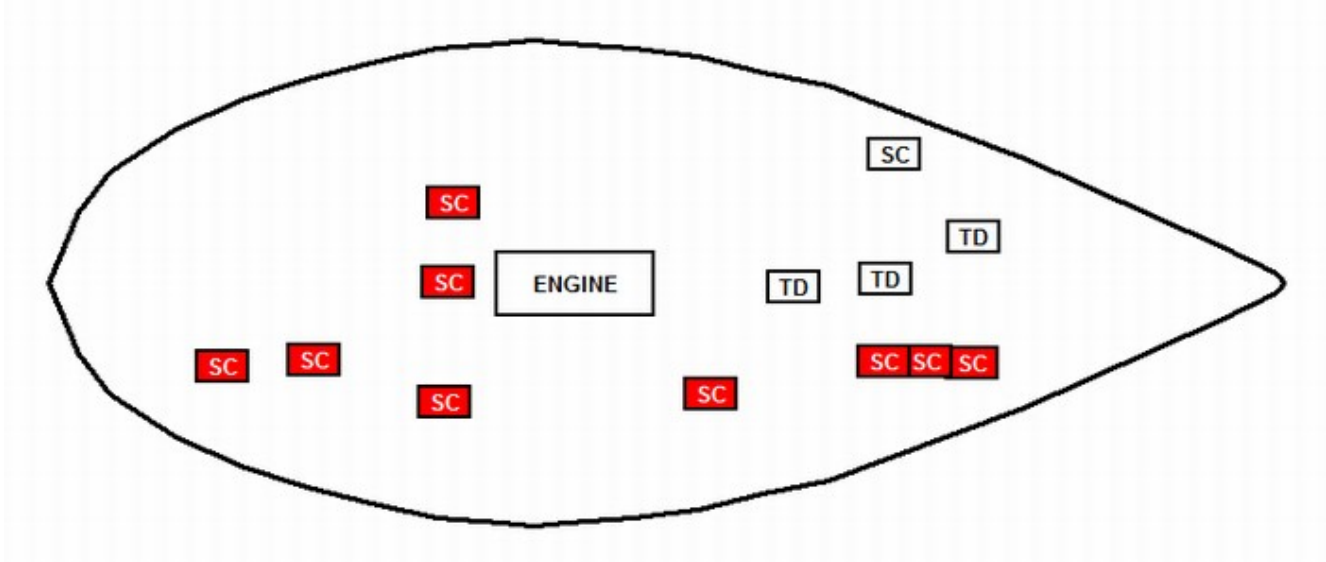
THRU-HULLS BELOW WATER LINE (DIAGRAM):

** Red Icon(s) with white text indicates inoperable item.

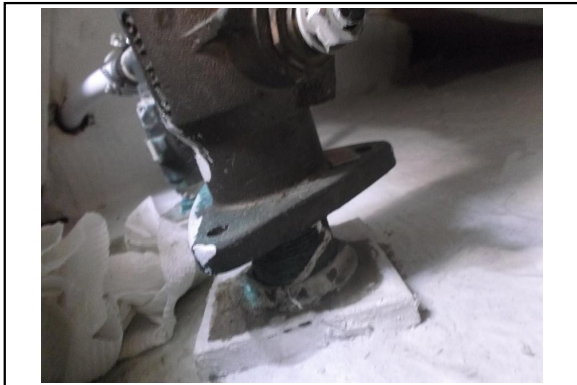
- * **THRU-HULL VALVE OPERATION: [A9]** No thru-hull valve operated with normal force with the exception of the forward air conditioning unit intake valve.
- * **MATERIAL/TYPE/INSTALLATION: [A10]** Flanged bronze ball valve seacocks. The seacocks are installed on thru-hull fittings that are too long to allow the seacock flanges to be secured to the hull.

Seacock Installation

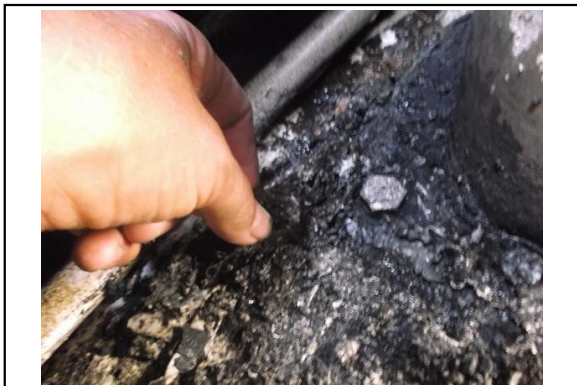
- * **MAST STEP: [A18]**
- 1 - Main mast stepped on keel. A mild steel (magnetic) plate used to distribute the load has deteriorated due to corrosion (rust).
 - 2 - Mizzen mast stepped on the sole of the head in aft cabin is supported by bulkhead glassed in hull in bilge. Good condition. (Access for inspection is limited and was done with a mirror and light on one side only)

Main Mast Step

FINDINGS	RECOMMENDATIONS
A.15 (PAGE 13) NAVIGATION LIGHTS:	
All USCG required navigation lights not operational. Anchor and steaming lights not operable.	<i>Renew or repair navigation lights to comply with USCG regulations for navigation light requirements.</i>
A.16 (PAGE 13) INLAND NAVIGATION RULE BOOK (12M-39'4" OR LONGER):	
No navigation rule book sighted.	<i>USCG regulations require all vessels over 12 meters (39 feet) to carry onboard a copy of the Inland Navigation Rule Book.</i>
A.17 (PAGE 13) LIST:	
The aft bilge pump discharge hose is kinked due to the weight of a bronze in-line check valve.	<i>Replace and support aft bilge pump hose to avoid kinks.</i>
A.18 (PAGE 15) MAST STEP:	
A mild steel (magnetic) plate used to distribute the main mast load on the keel has deteriorated due to corrosion.	<i>Further investigate and repair as needed. Un-stepping the mast will likely be needed to complete this repair.</i>

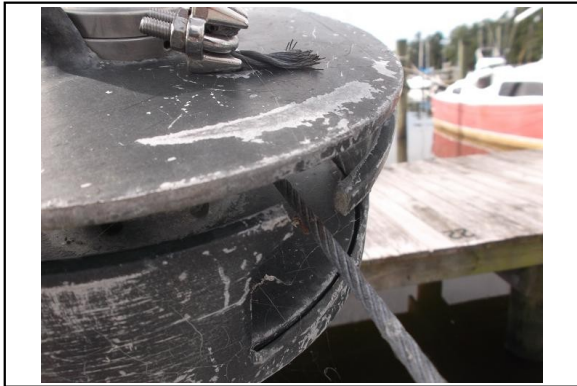
- * **WINCHES:** [C13] All sail handling winches are Lewmar. The jib sheet winches are Lewmar #54 self-tailing two speed winches. The other winches are not self tailing. One mast winch drum is not secure and falls off. All winches are in need of service.
- REEFING SYSTEM:** Jiffy reefing system appeared serviceable.
- * **RUNNING RIGGING:** [B12] All running rigging is worn and UV/weather degraded.
- * **ROLLER FURLING GEAR:** [A19] Roller furling gear is of unknown manufacturer. The aluminum drum on furling gear is damaged in two places. The electric wire reel winch mounted below decks to operate the furling gear is inoperable.

Furling Drum

A.19 (PAGE 16) ROLLER FURLING GEAR:	
Roller furling gear damaged and inoperable.	<i>Further investigate and repair or replace as needed.</i>
