SHIVER ME TIMBERS, INC.
MARINE SURVEYORS AND CONSULTANTS

1996 Fishing Machine 67

Report of Marine Survey

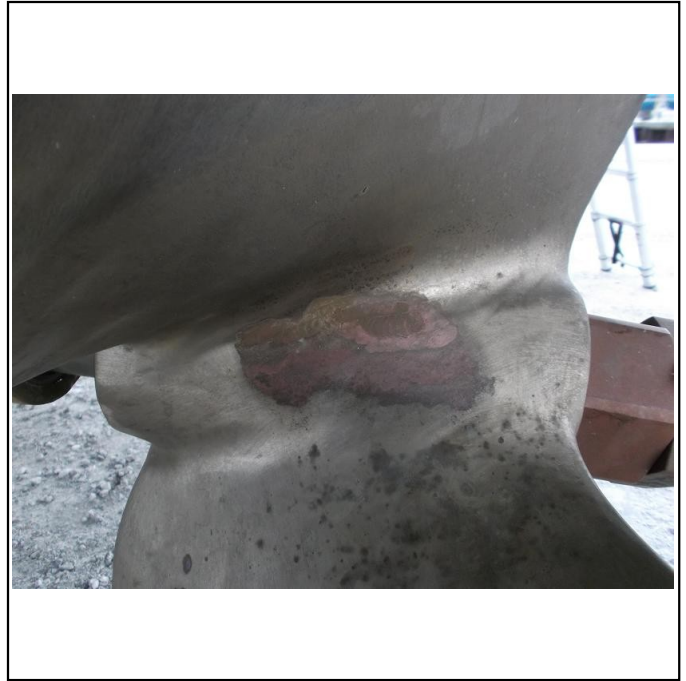
Note; Minor corrosion was sighted on each propeller.

Propeller Corrosion

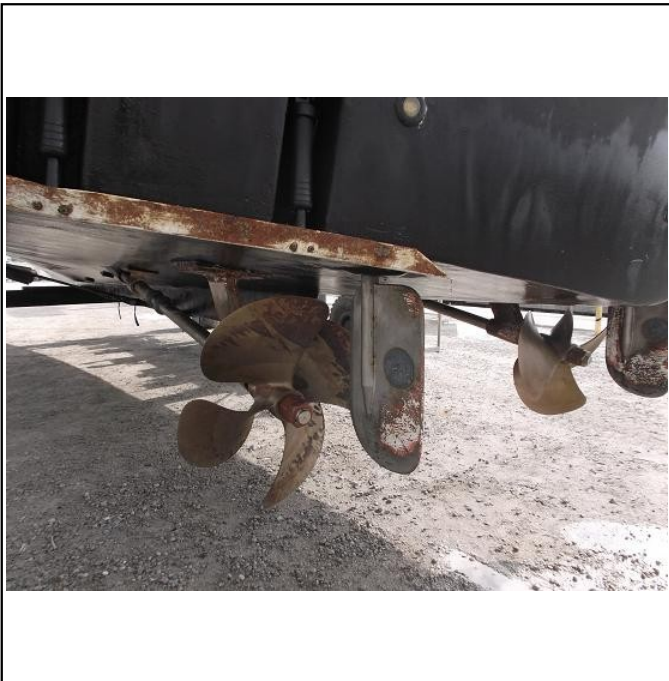
Running Gear

PROPELLER SHAFT LOG/STRUT/CUTLESS BEARINGS Good condition.

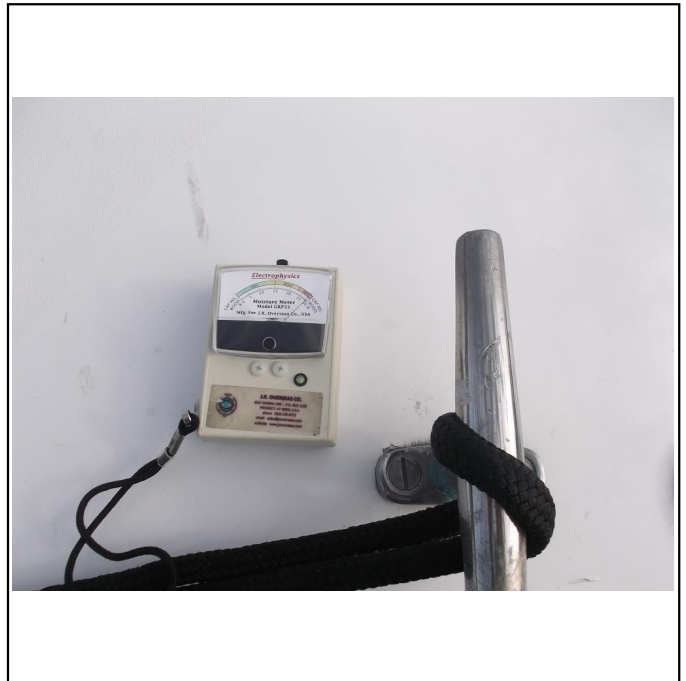
DECK/MOISTURE METER READINGS: Elevated moisture meter readings were detected on foredeck in area near mooring clats and windlass.

Moisture Meter At Foredeck

Note; Consideration should be given to including re-bedding of foredeck hardware in a maintenance schedule.

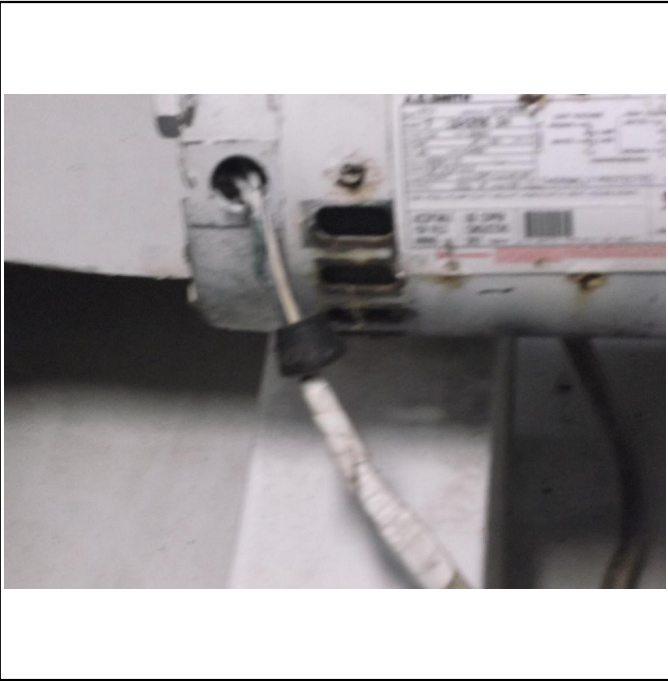
- * **RAW WATER COOLING PUMP: [B1]** Wiring to raw water cooling pump mounted to stringer aft of port engine not protected against chafe at pump motor.

A/C Pump Wiring

FINDINGS	RECOMMENDATIONS
B.1 (PAGE 9) RAW WATER COOLING PUMP:	
Pump wiring not protected against chafe at pump motor.	<i>Provide chafe protection at wire entry point to motor.</i>
B.2 (PAGE 12) LIST:	
One bilge pump did not operate from it's float switch when tested. Two bilge pumps were reported to be not operating. No bilge pump was tested for its ability to perform it's designed function, which is to pump water.	<i>Repair or replace non functioning bilge pumps. Periodic testing of bilge pumps ability to pump water should be included in a maintenance schedule.</i>
