Re: Warning Letter
Site No. 337974 / Project No. 418829
Complaint No. 41067
Interceptor Lagoon, Class III Waters
Unnamed Wetlands, Class III Waters
Parcel No. 412126103010
Charlotte County – SLERC

Florida Department of Environmental Protection
 SOUTH DISTRICT COMPLIANCE ASSURANCE PROGRAM
 ERP Inspection Report

Inspection Date: 5/17/2024

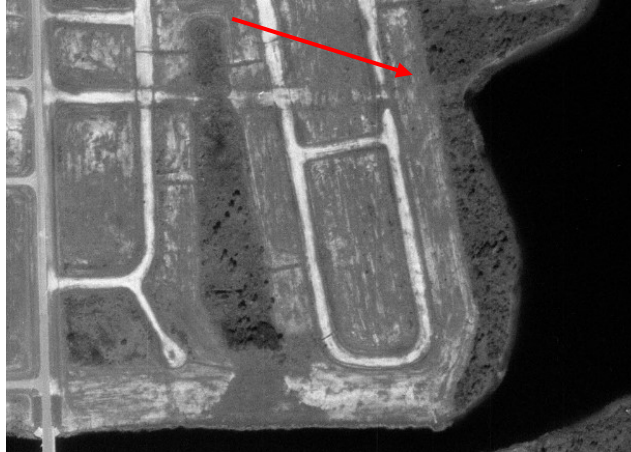
Figure 1: Aerial photograph dated 12/20/1985 showing the historically filled area. Property 2 location shown by red arrow. Source: Florida Department of Transportation.

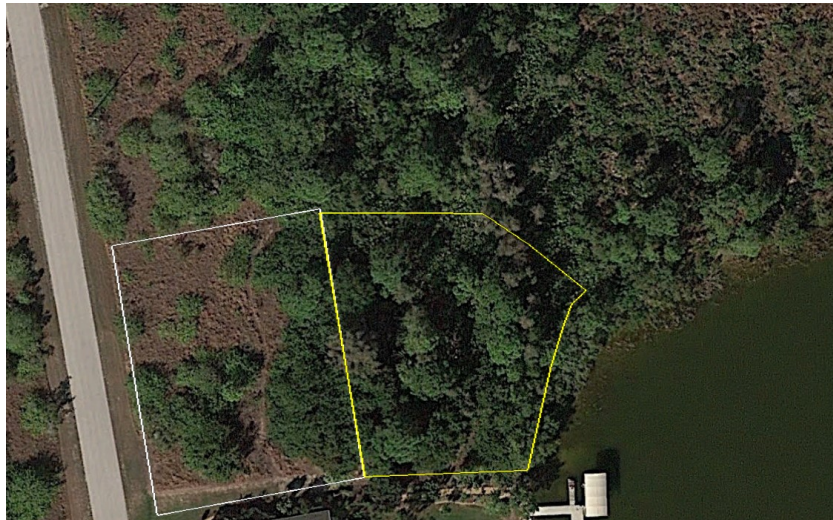
Per aerial review, the first wetland impacts occurred sometime between 1/23/2013 and 2/17/2014 (Figures 2-3). On site observations included approximately 17,779 square feet (0.41 acres) of unauthorized impacts to wetlands via clearing of vegetation, placement of sod, and a brick pathway (Figure 7). Additionally, department staff observed boulders along the shoreline (Photos 3-4).

Figure 2: Aerial photograph dated 1/23/2013. The Greenbelt section is outlined in yellow, and Property 2 is outlined in white. Source: Google Earth.

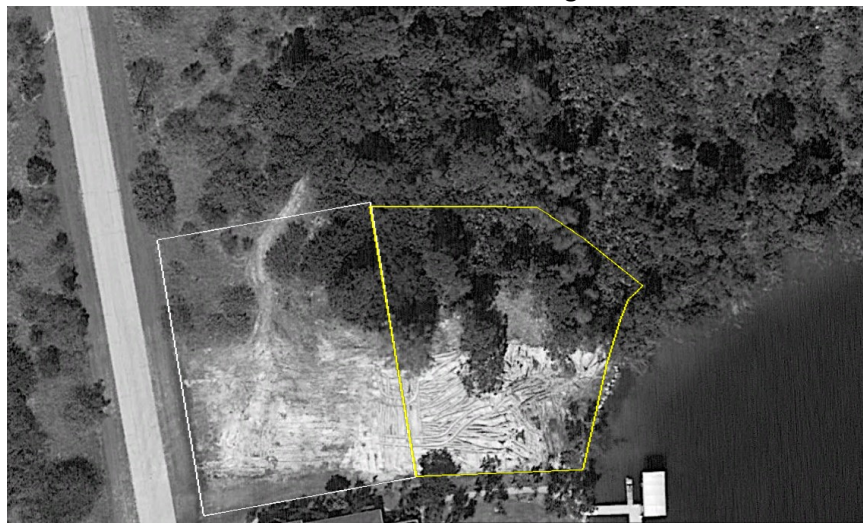
Figure 3: Aerial photograph dated 2/17/2014 showing first impacts to wetlands via clearing of vegetation. The Greenbelt section is outlined in yellow, and Property 2 is outlined in white. Source: Google Earth.

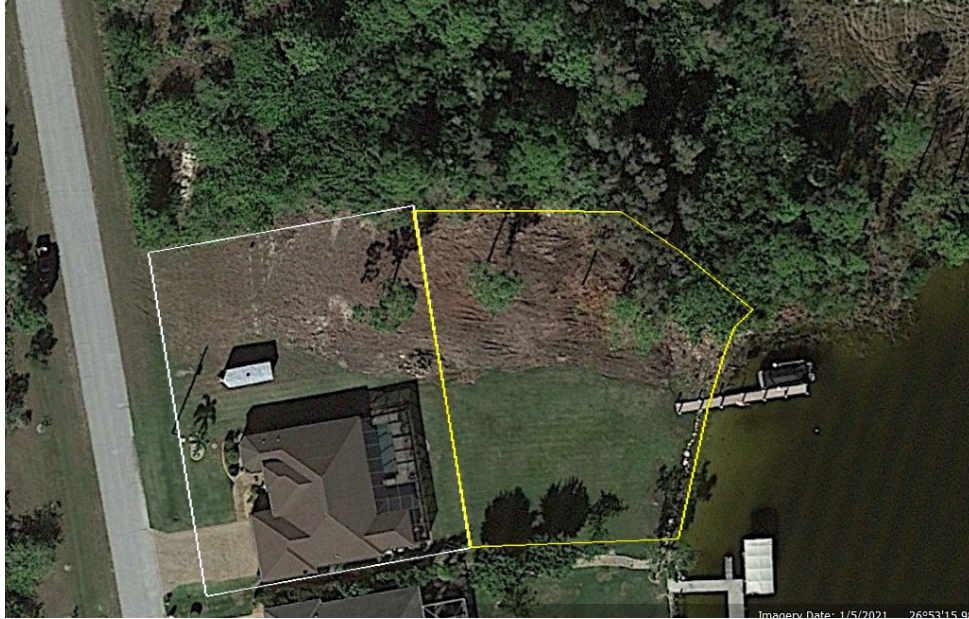
Figure 4: Aerial photograph dated 1/5/2021 showing further impacts to wetlands via clearing and placement of sod. A dock with a boatlift can also be observed. The Greenbelt section is outlined in yellow, and Property 2 is outlined in white. Source: Google Earth.

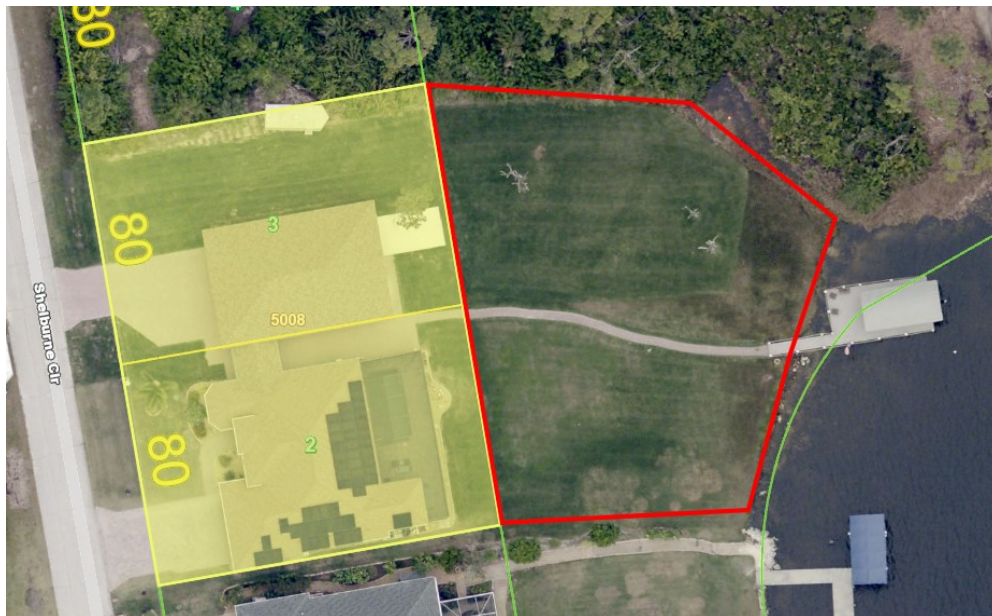
Figure 5: 2024 aerial photograph showing impacts to wetlands via clearing, sodding, and a brick pathway to the dock. The Greenbelt section is outlined in red, and Property 2 is outlined in yellow. Source: Charlotte County Property Appraiser.

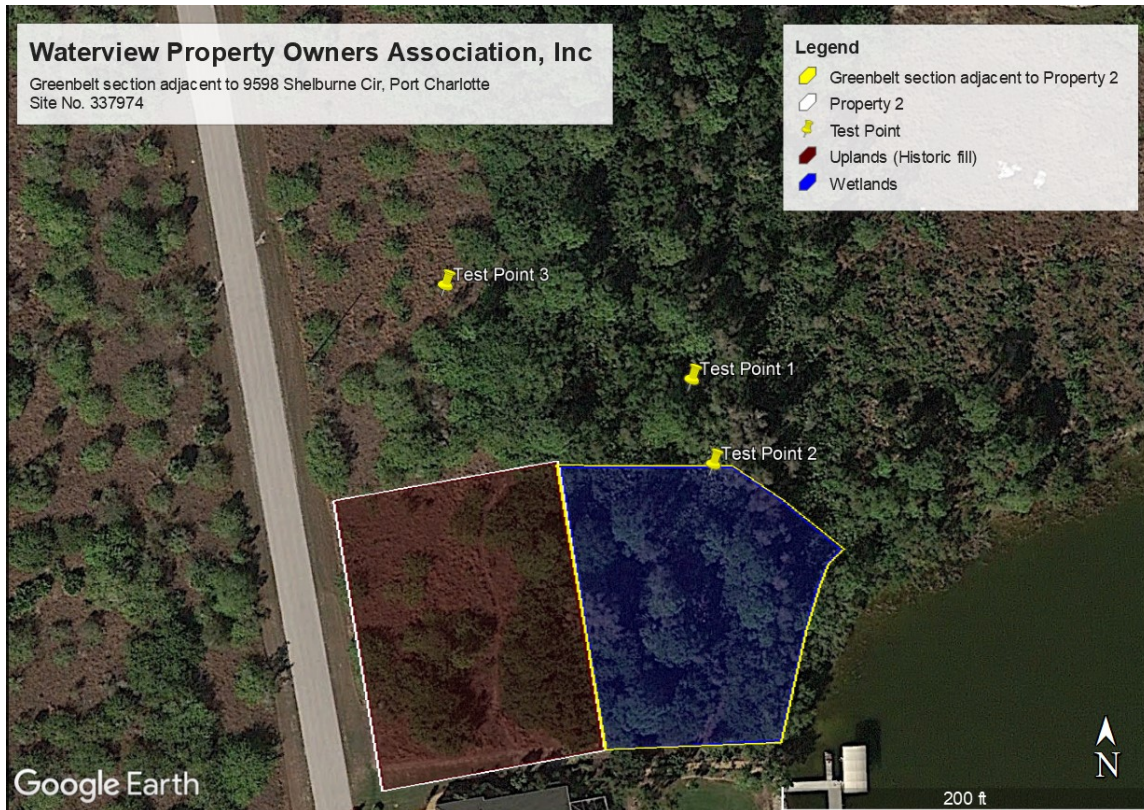
Test Point 1 is a location where the vegetation was undisturbed, and the ground surface was left at original grade. Test Point 1 met the wetland definition, and D test requirements for wetlands under the guidelines provided by Chapter 62-340, F.A.C. Test Point 2 is a location that was cleared of vegetation and sodded. Immediately prior to impacts, Test Point 2 would have met the wetland definition, and D test as referenced by Test Point 1. Test Point 3 is a location within a historically filled area (pre-1994) and was found to be uplands under the guidelines provided by Chapter 62-340, F.A.C. Additional information on how this delineation was made is attached. The approximate location where the Test Points were taken is shown in Figure 6 below.

Figure 6: Aerial photography dated 1/23/2013 showing the approximate location of the test points taken. The Greenbelt section adjacent to Property 2 was determined to contain wetlands (blue). Property 2 was determined to be uplands (brown).

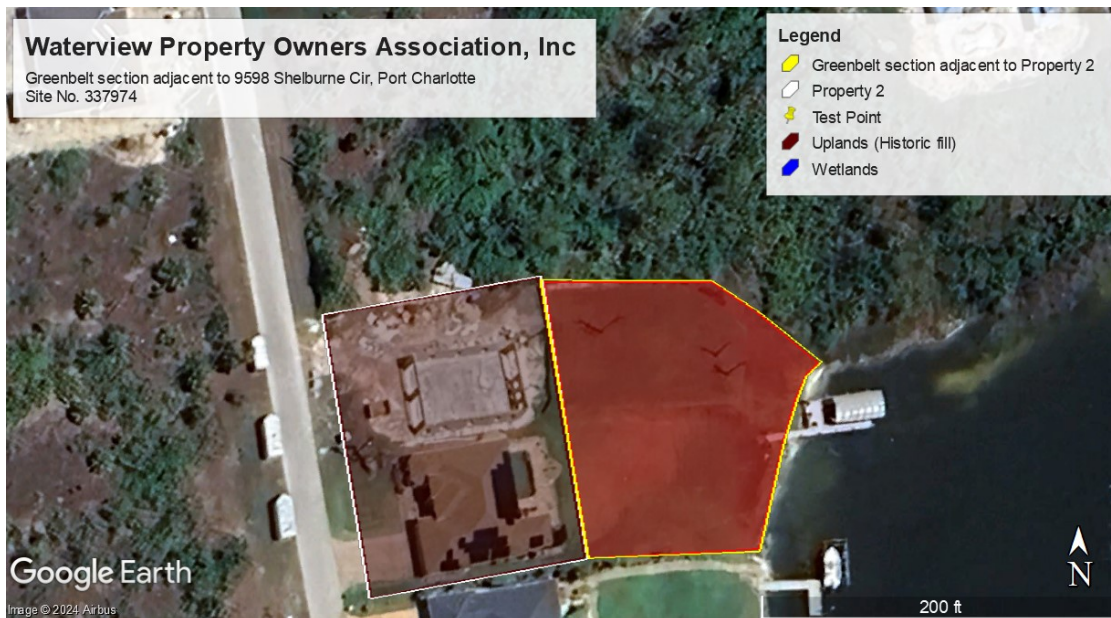
The dredge and fill activities on the Greenbelt section adjacent to Property 2 occurred entirely in wetlands and therefore requires an Environmental Resource Permit prior to activity commencement pursuant to 62-330.020, F.A.C. Record of an Environmental Resource Permit for the activities observed on the Greenbelt section could not be located in the department’s files.

Figure 7: 2023 Aerial photograph showing the unauthorized fill in wetlands (red).

- 1. Cease any further unauthorized activities, construction, and discharge of fill materials in wetlands; and**
- 2. Enter into a Consent Order with the department to resolve the unauthorized wetland dredge and fill on the Greenbelt section adjacent to Property 2; and**
- 3. Obtain the appropriate regulatory authorization from the department for any future construction in wetlands, pursuant to Chapter 62-330, F.A.C.**

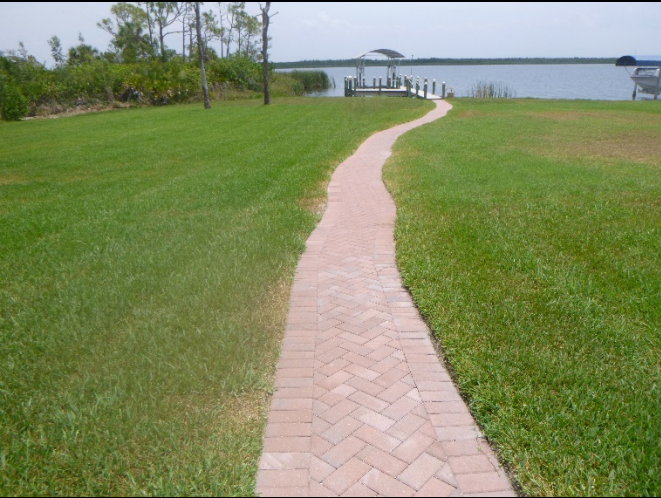
Photo 1: Facing East, view of sod and brick pathway on wetlands.

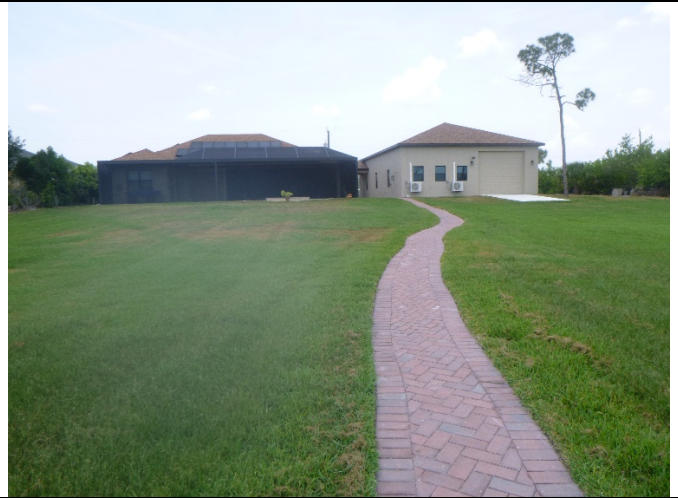
Photo 2: Facing West, view of sod and brick pathway on wetlands.

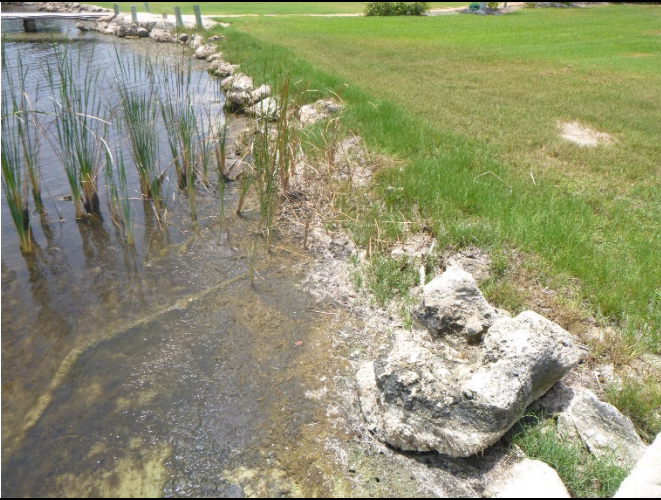
Photo 3: Facing South, view of boulders along the shoreline.

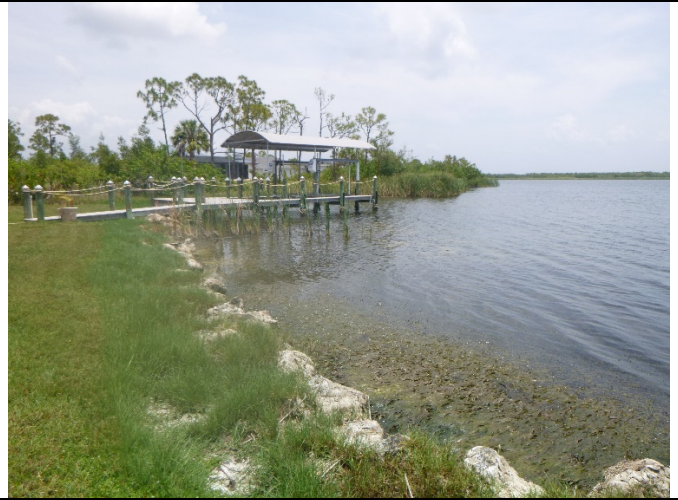
Photo 4: Facing North, view of boulders along the shoreline and dock.

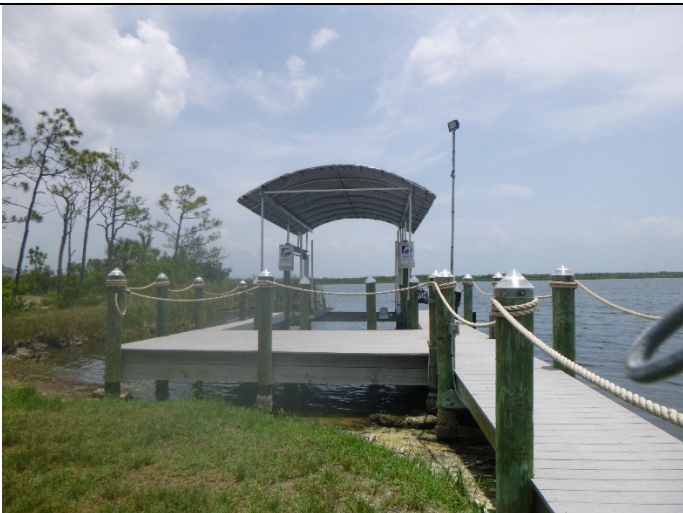
During the inspection, department staff observed a dock with a covered boatlift. The overwater surface area of the dock and the covered boatlift combined was measured to be approximately 847 square feet. Per aerial review, the dock is located 65 feet from the neighboring dock.

Photo 5: Facing East, view of dock and covered canopy.

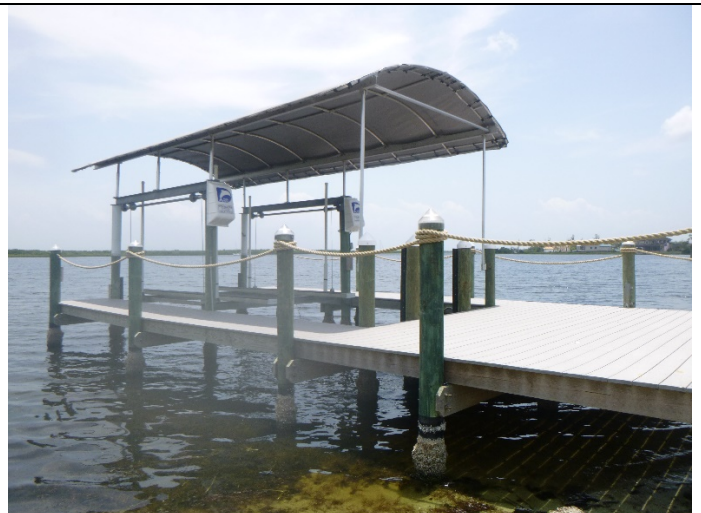
Photo 6: Facing Southeast, view of dock and covered canopy.

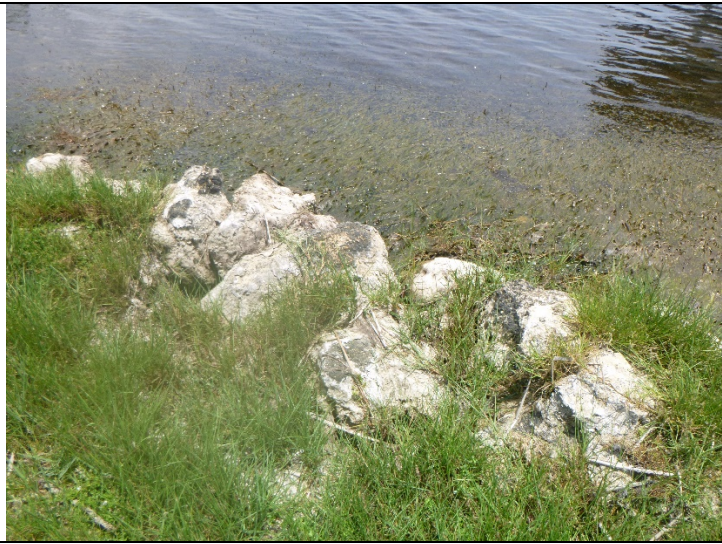
Photo 7: View of boulders along the shoreline. Note presence of submerged aquatic vegetation.

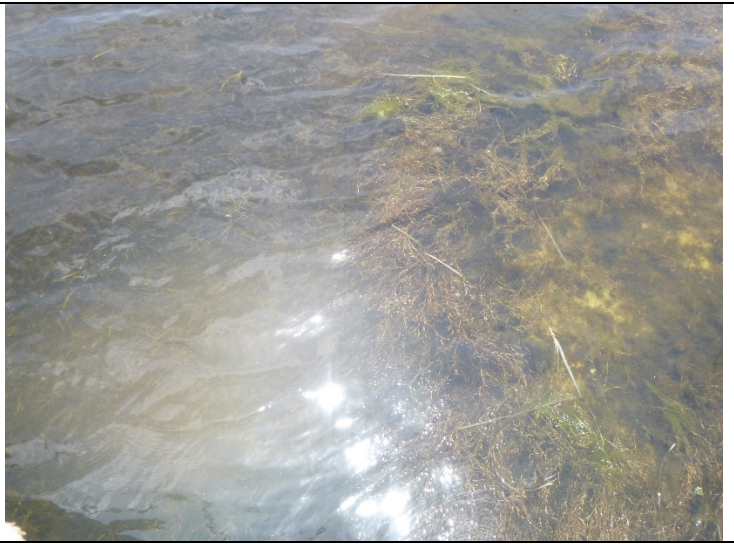
Photo 8: View of submerged aquatic vegetation on site.

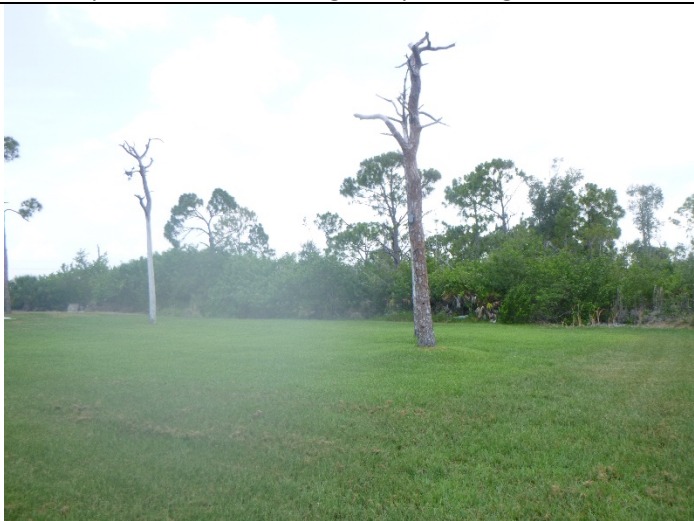
Photo 9: Facing North, view of impacted wetlands via placement of sod. Unimpacted wetlands can be observed in the background.
