## Qualitative On-Roof Moisture Survey Report

Inspection Date: 1/1/2025

**Project Name:** Your Commercial Roof

**Address:** 123 Main Street

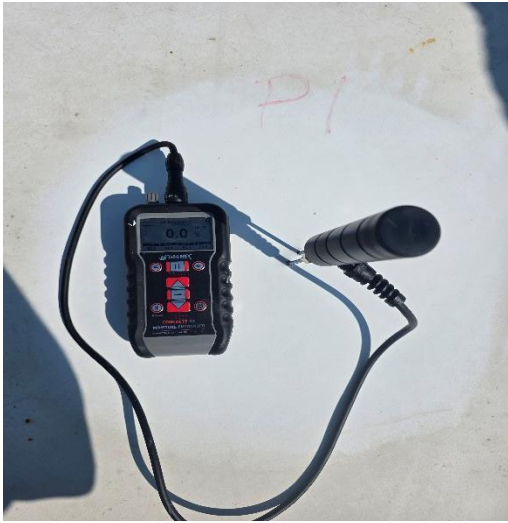
**Exhibit A**

**Description:** Pin probes to determine baseline moisture content.

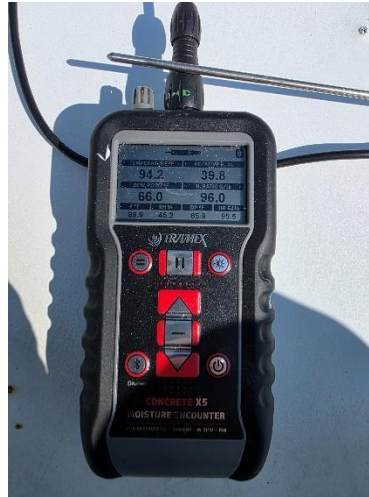
**Exhibit B**

**Description:** Baseline Relative Humidity showing 39.8% at the probe

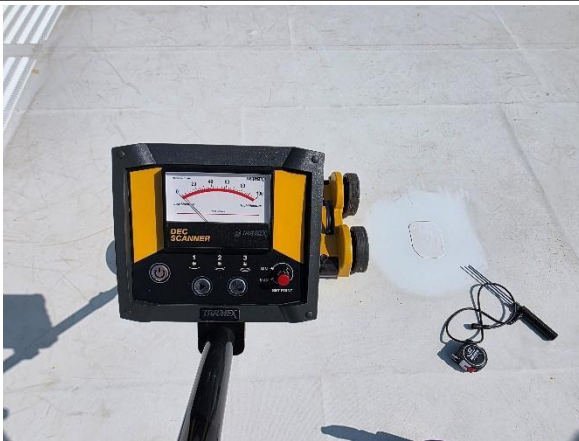
**Exhibit C**

**Description:** Setting the Tramex Deck Scanner to the "on the relative moisture scale at P1

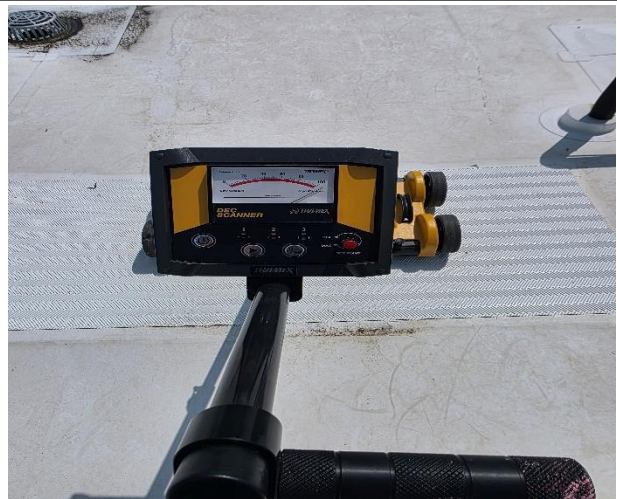
Deck Scanner always reads high moisture content over the walk paths. This could be due to residual moisture left in the treads of the actual composition of the walk mats.

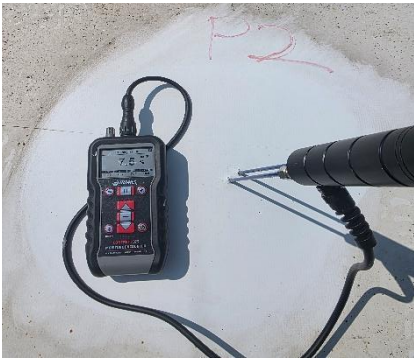
| | <p><b>Probe Point #2</b><br/>Moisture anomaly was only present in the top ½" of roof assembly. Pin probes registered at 7.5 No moisture was detected in the insulation. Relative humidity (RH) at the location was 25.4%, inside the roof structure was 30.6%.</p> <p>7.5 on the pins and a RH of 30.6% are considered Air Dry and not at risk</p> |

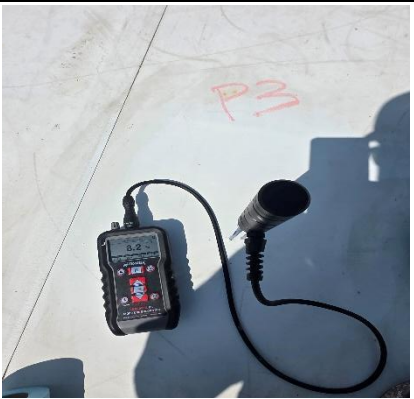
| | <p><b>Probe Point #3</b><br/>Moisture anomaly was only present in the top ½" of roof assembly. Pin probes registered at 8.5 No moisture was detected in the insulation. Relative humidity (RH) at the location was 26.3%, inside the roof structure was 40.2%.</p> <p>8.5 on the pins and a RH of 40.2% are considered Air Dry and not at risk</p> |

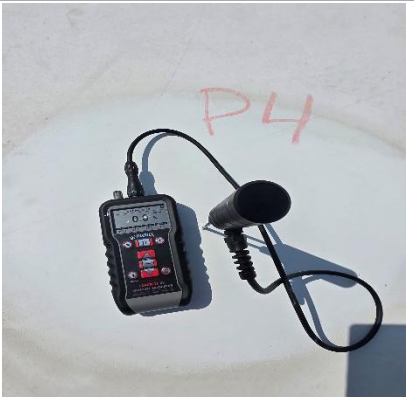
| | <p><b>Probe Point #4</b><br/>Moisture anomaly was only present in the top ½" of roof assembly. Pin probes registered at 9.2 No moisture was detected in the insulation. Relative humidity (RH) at the location was 25.6%, inside the roof structure was 43.8%.</p> <p>9.5 on the pins and a RH of 43.8% are considered Air Dry and not at risk</p> |

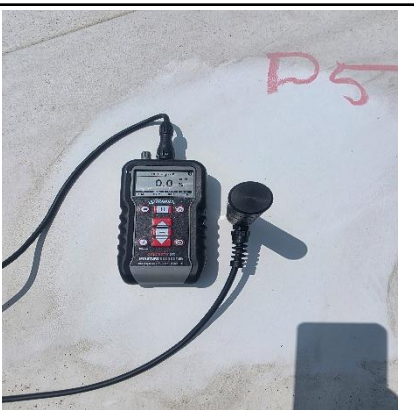
| | <p><b>Probe Point #5</b><br/>Moisture anomaly was only present in the top ½" of roof assembly. Pin probes registered at 8.0 No moisture was detected in the insulation. Relative humidity (RH) at the location was 32.1%, inside the roof structure was 43.1%.</p> <p>8.0 on the pins and a RH of 43.1% are considered Air Dry and not at risk</p> |
