INSPECTION OF DAM AND RESERVOIR IN CERTIFIED STATUS

Name of Dam Sinaloa Dam No. 1760 County Ventura
 Type of Dam Earth Type of Spillway Concrete drop inlet and auxiliary channel
 Water is 0.5 feet below spillway crest and 4.5 feet below dam crest.

Name of Dam Sinaloa

Dam No. 1760

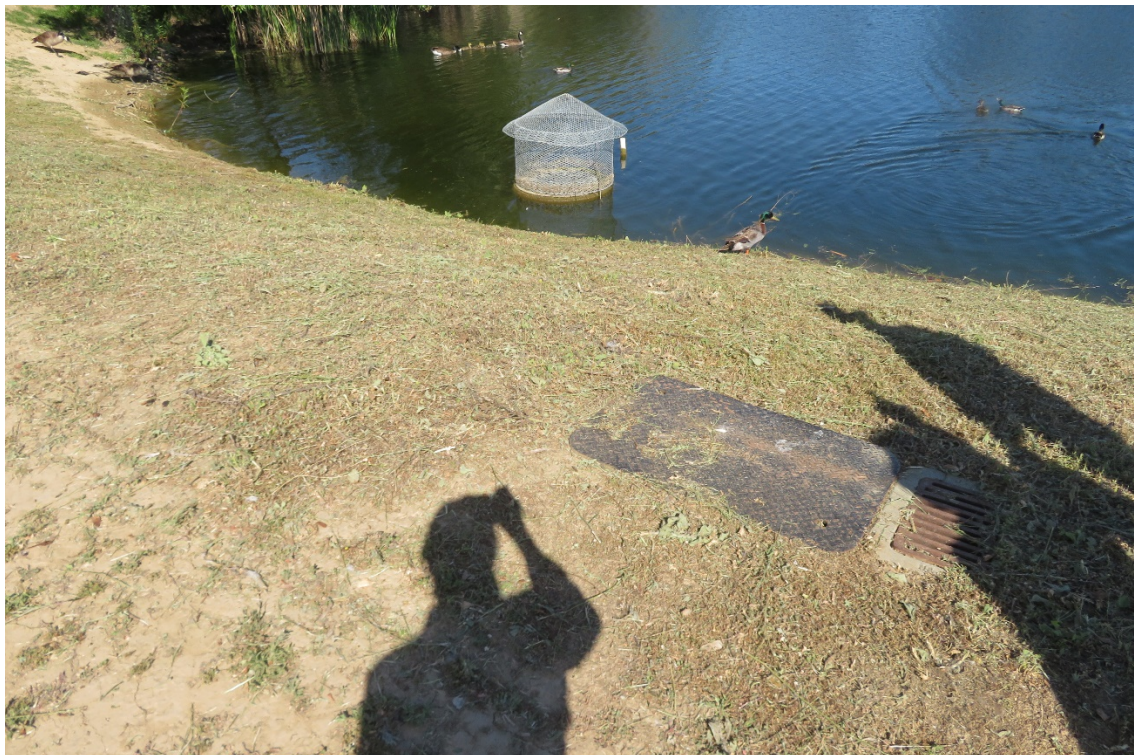
<u>Outlet</u>	The 12-inch outlet valve was fully cycled satisfactorily. The grate adjacent to the valve control box houses the vent pipe. It was clear of debris.
<u>Seepage</u>	There was no sign of seepage on the downstream slope, the groins, and toe of the dam.
<u>Instr.</u>	There is no instrumentation at this dam and none is judged necessary at this time.

Drop inlet spillway, outlet valve control box, and vent.
