Office of Transport Safety Investigations

TECHNICAL INSPECTION FINDINGS

WHEEL DETACHED FROM BUSABOUT BUS MO5184

14 JANUARY 2014

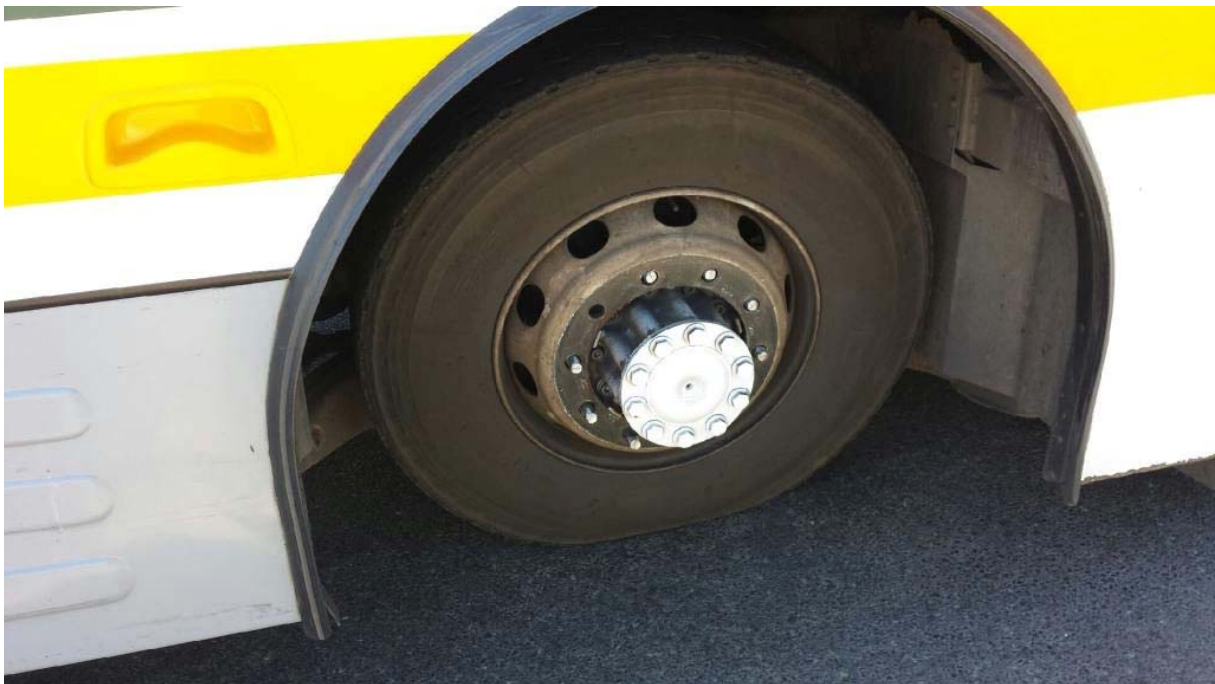
The driver stopped and alighted from the bus, and found that the outer left rear wheel was no longer on the bus, leaving the left rear of the bus supported only by the inner wheel. He also noticed that all ten of the wheel nuts were missing and one of the studs could not be seen. A photograph taken by the driver using his mobile phone appears below as *Photograph 1*.

Photograph 1: What the driver saw

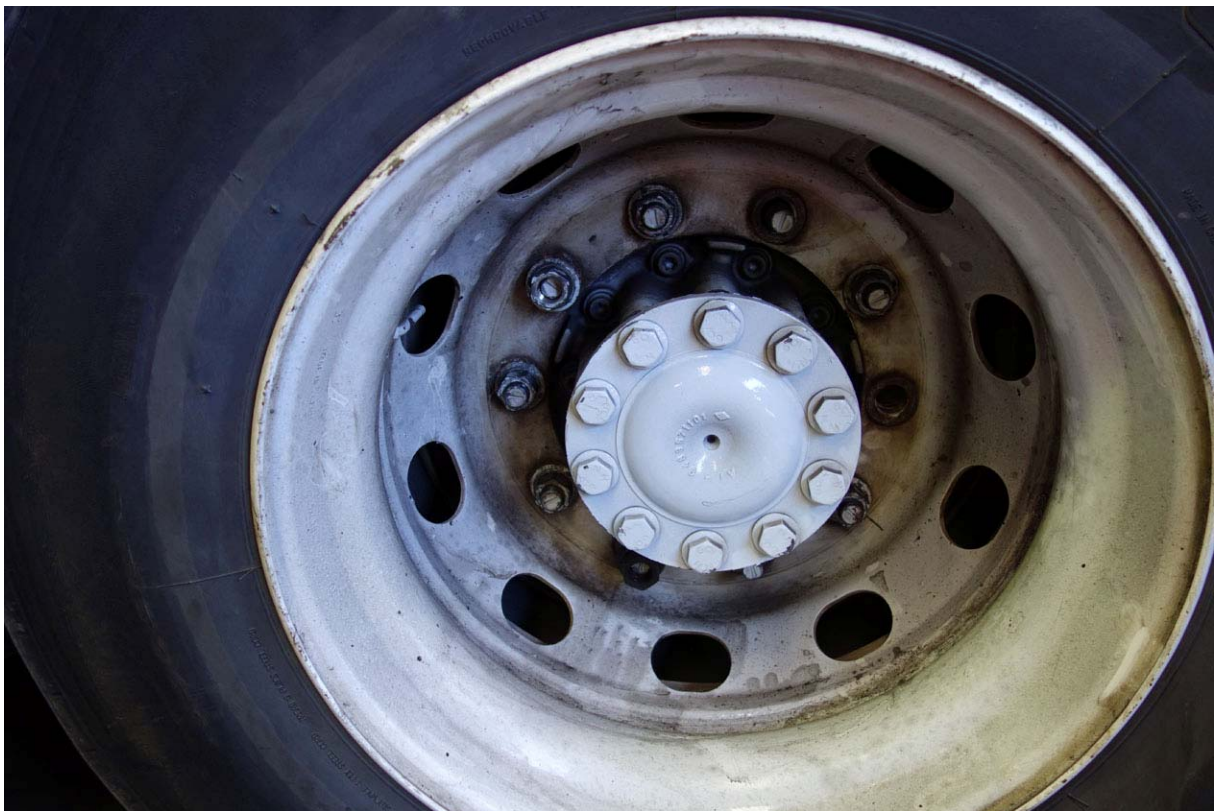
In order for the bus to be moved to the operator's depot from the incident location, replacement wheels had been temporarily fitted, as seen in *Photograph 2*. These wheels remained in place throughout the initial inspection of the bus as no jacking equipment was available to facilitate their removal.

Photograph 2: Left rear wheels temporarily fitted

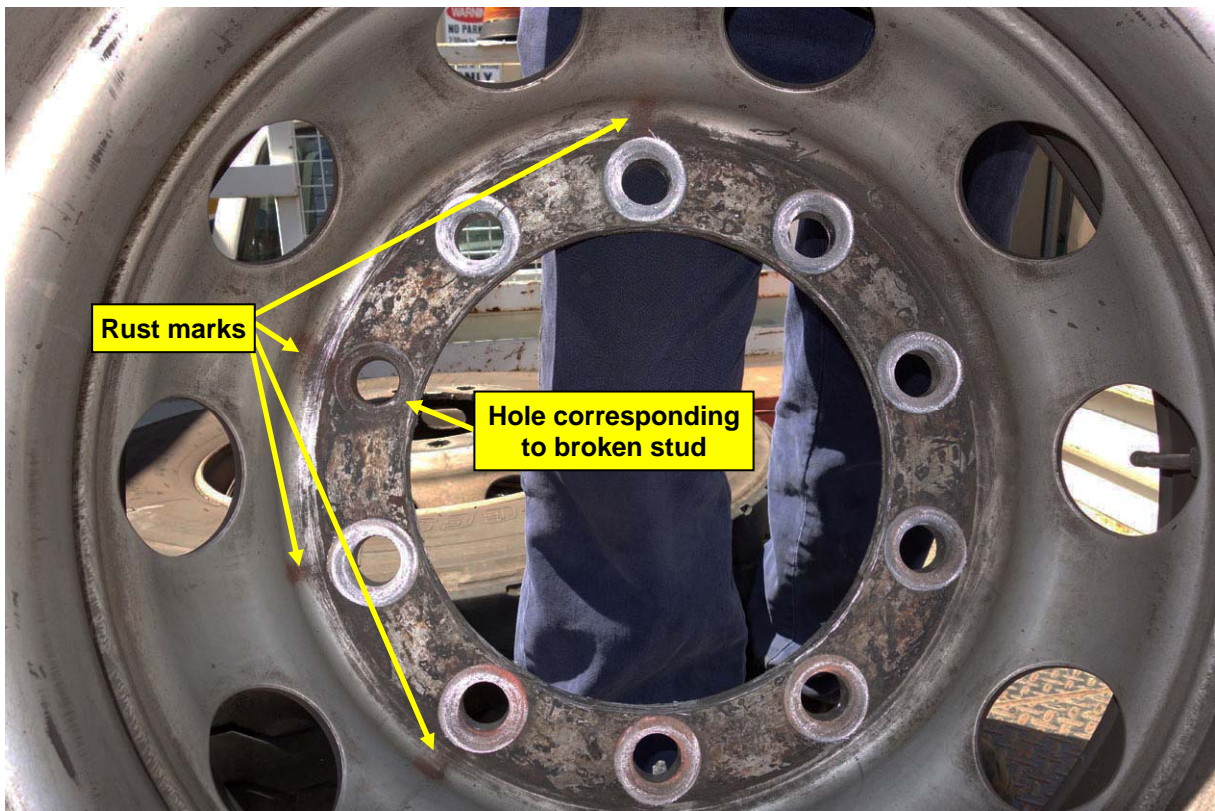
The detached wheel and the inner left rear wheel were examined at the depot. With the exception of the stud hole associated with the broken stud, all stud holes in the outer wheel exhibited severe scuffing on the surrounding face as seen in *Photograph 3*. There were also rust marks radiating outwards from some of the stud holes.

Photograph 3: Condition of detached wheel

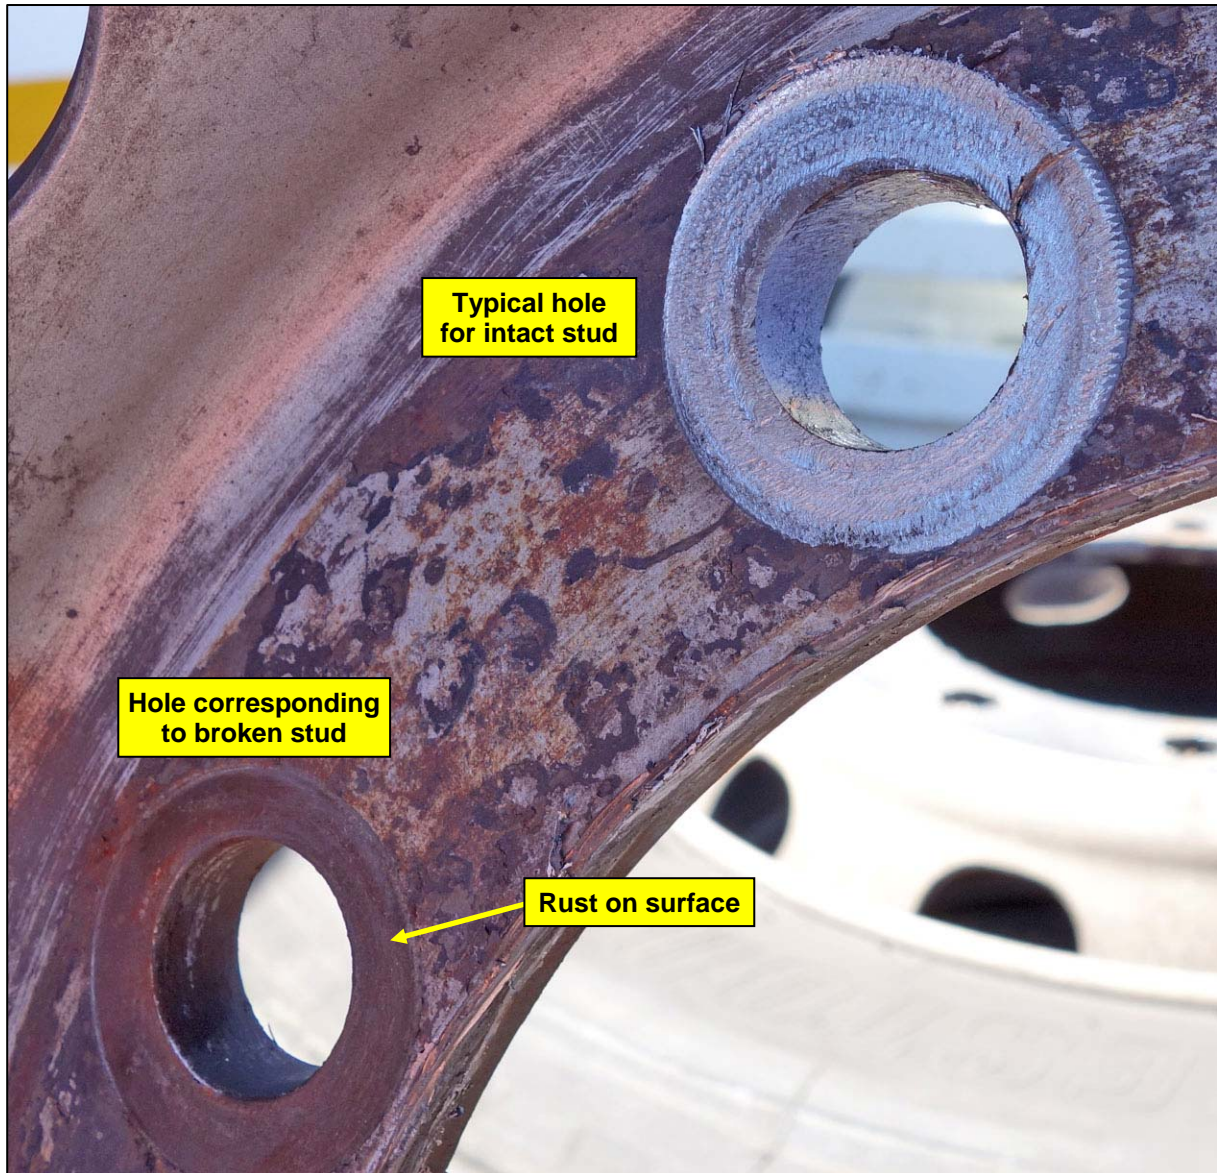
The inner surfaces of these holes were similarly scuffed, the contrast between the hole associated with the broken stud and the other holes being as seen in *Photograph 4*. Rust was visible on the face surrounding the hole associated with the broken stud.

Photograph 4: Contrast between stud holes

The absence of any witness marks on the wheel at the position of the broken stud to indicate movement between the wheel and this stud prior to its failure suggests that its flange nut remained tight as all the other nuts loosened, subjecting it to excessive load and consequent fatigue failure. However, the rust marks observed in *Photograph 4* show that there was sufficient movement for surface rust on the wheel to be expelled from the interface and thrown radially out onto the wheel prior to failure of the stud.

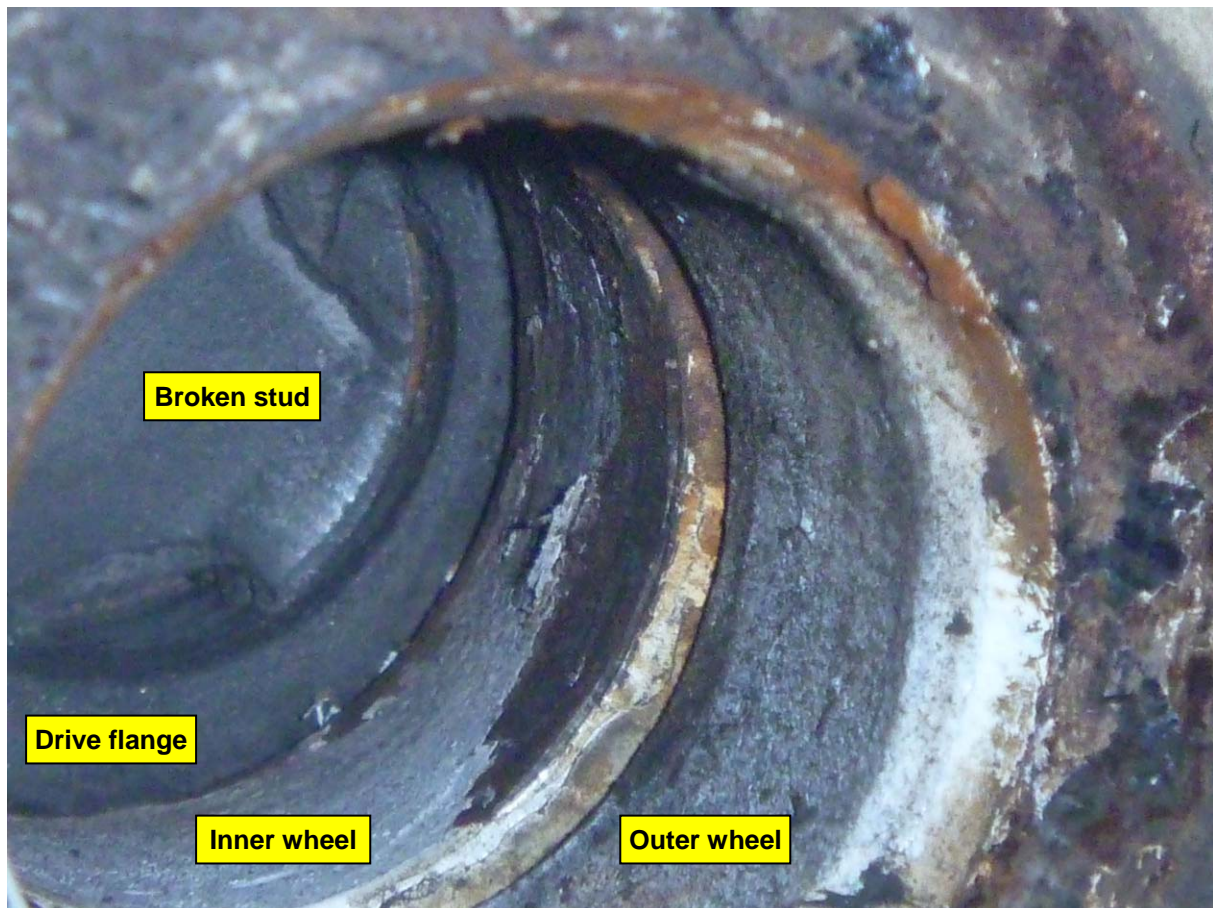
When the bus was examined at the depot, nine of the wheel securing studs were intact although damaged. The tenth stud was broken off just inside the surface of the drive flange, the remainder being retained in the hub as seen in *Photograph 5*. The outer part of the broken stud could not be located after the incident.

Photograph 5: Broken stud in situ

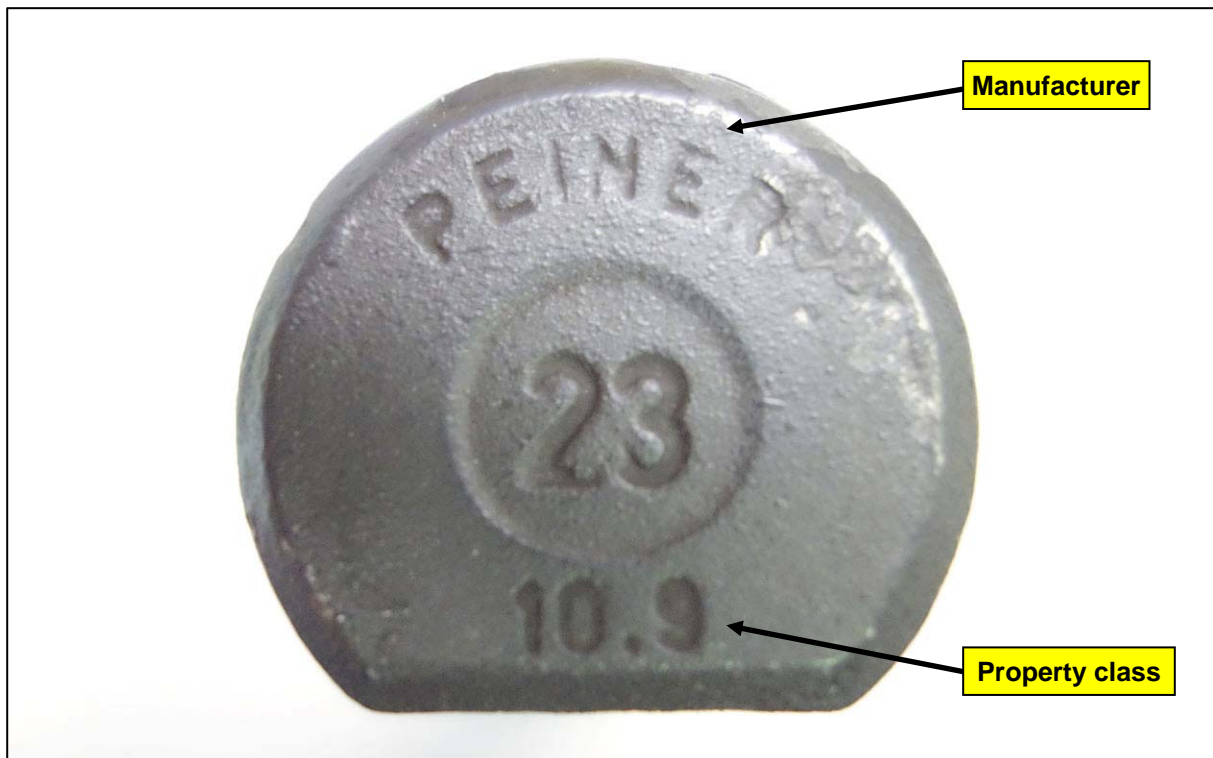
The head of each stud bore the markings shown in *Photograph 6*. The identity of the manufacturer (Peiner) was shown, and the code 10.9 refers to a property class defined in International Standard ISO 898-1¹. In summary, property class 10.9 specifies a carbon or alloy steel, quenched and tempered, with a minimum tensile strength of 1040 MPa.

Photograph 6: Identification marks on studs

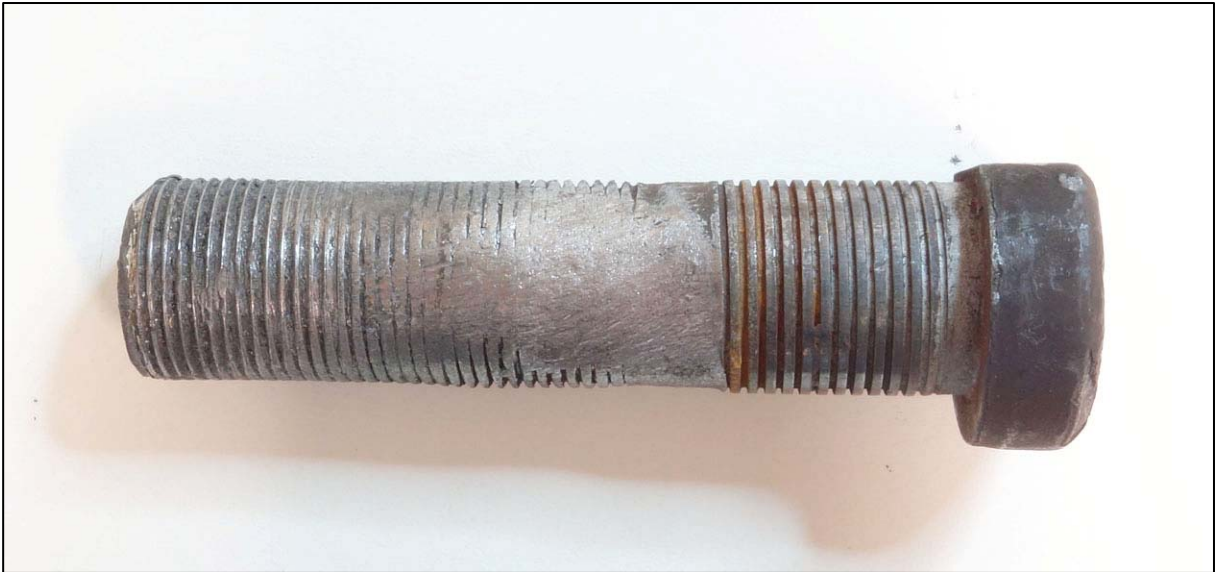
One of the unbroken wheel studs is shown in *Photograph 7*, and the broken stud in *Photograph 8*.

Photograph 7: Unbroken wheel stud

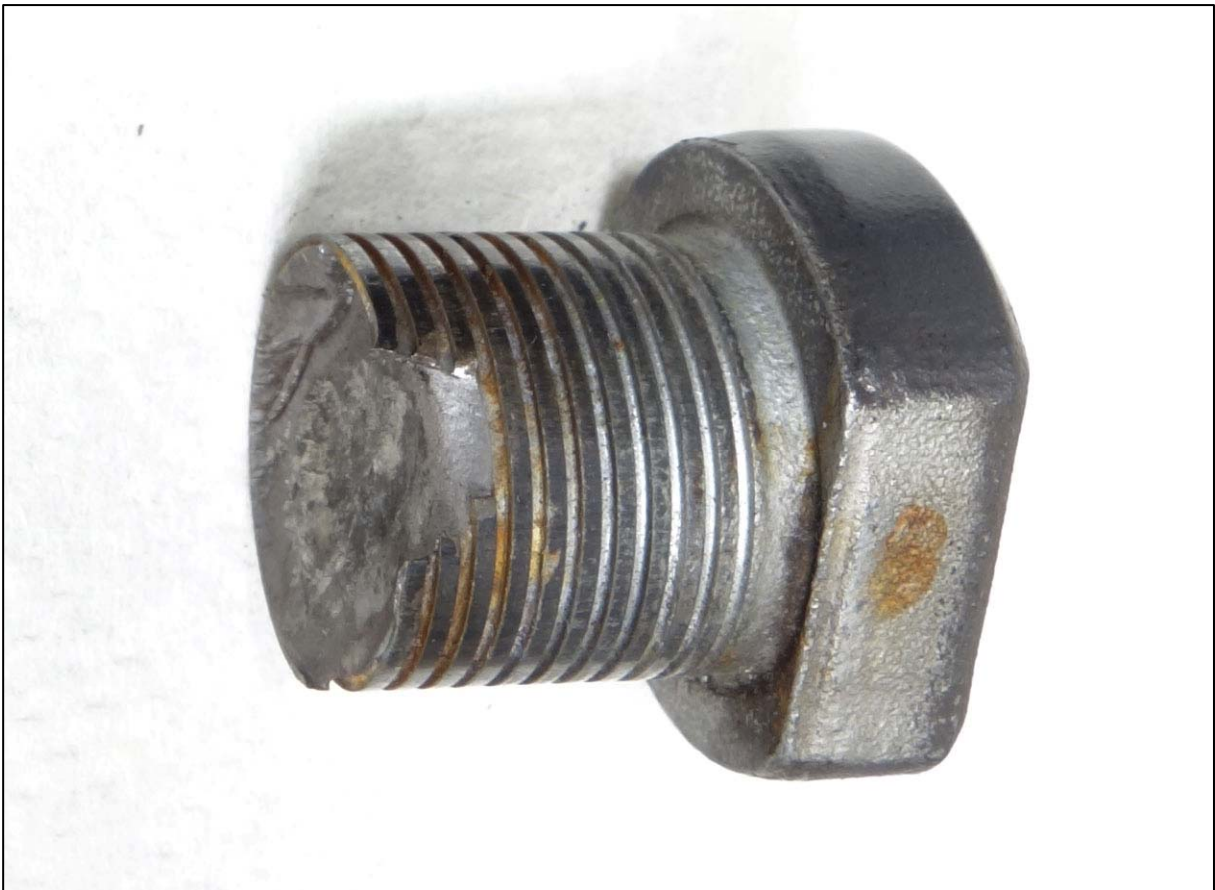
Photograph 8: Broken wheel stud

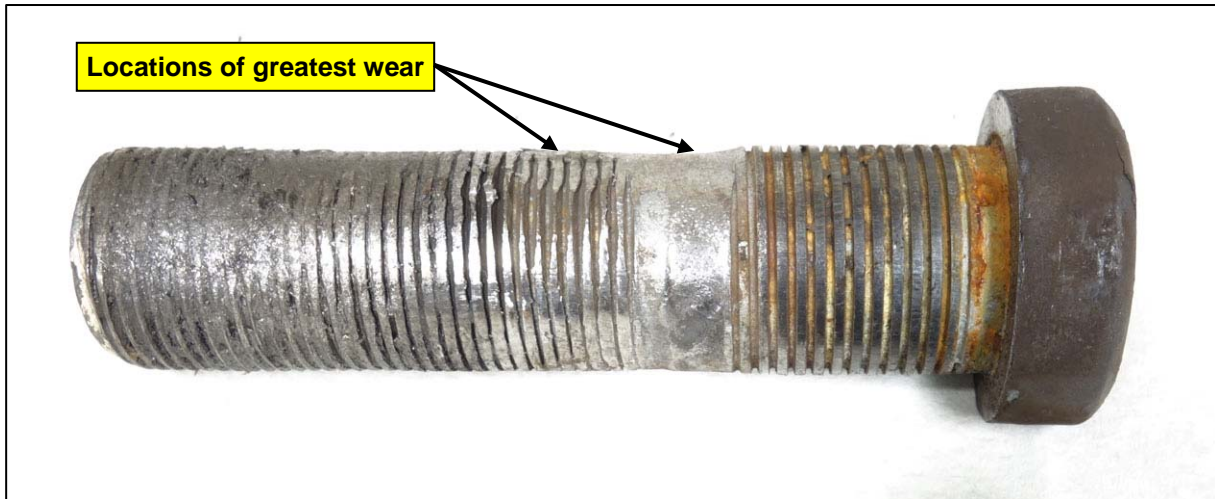
The section of the stud labelled “**B**” was the transition from the diameter of section “**A**” to the slightly smaller diameter of sections “**C**” and “**D**”. It was also the section of the stud that passed through the inner wheel. As stated earlier, in normal operation the inner wheel would be clamped sufficiently tightly between the outer wheel and the drive flange for driving and braking torques to be transferred by friction. However, significant wear marks were seen on section “**B**” of all intact studs, indicating that movement had occurred between the wheel and the drive flange. Marking was greater on the face that would have been in contact with the wheel when the engine was under power rather than when the bus was braking (see *Photograph 11*). This is to be expected, as during normal use a far greater proportion of time is spent with the engine under power than with the vehicle coasting or the brakes being applied.

Photograph 11: Wear on stud due to wheel movement

Section “C” of the stud, corresponding to the position of the outer wheel, showed evidence of wear adjacent and similar to that on section “B”.

The damage to the thread on section “D” of the stud was more evenly distributed around the circumference of the stud, and would have occurred as the wheel nuts loosened and allowed both wheels to move progressively further out on the studs.

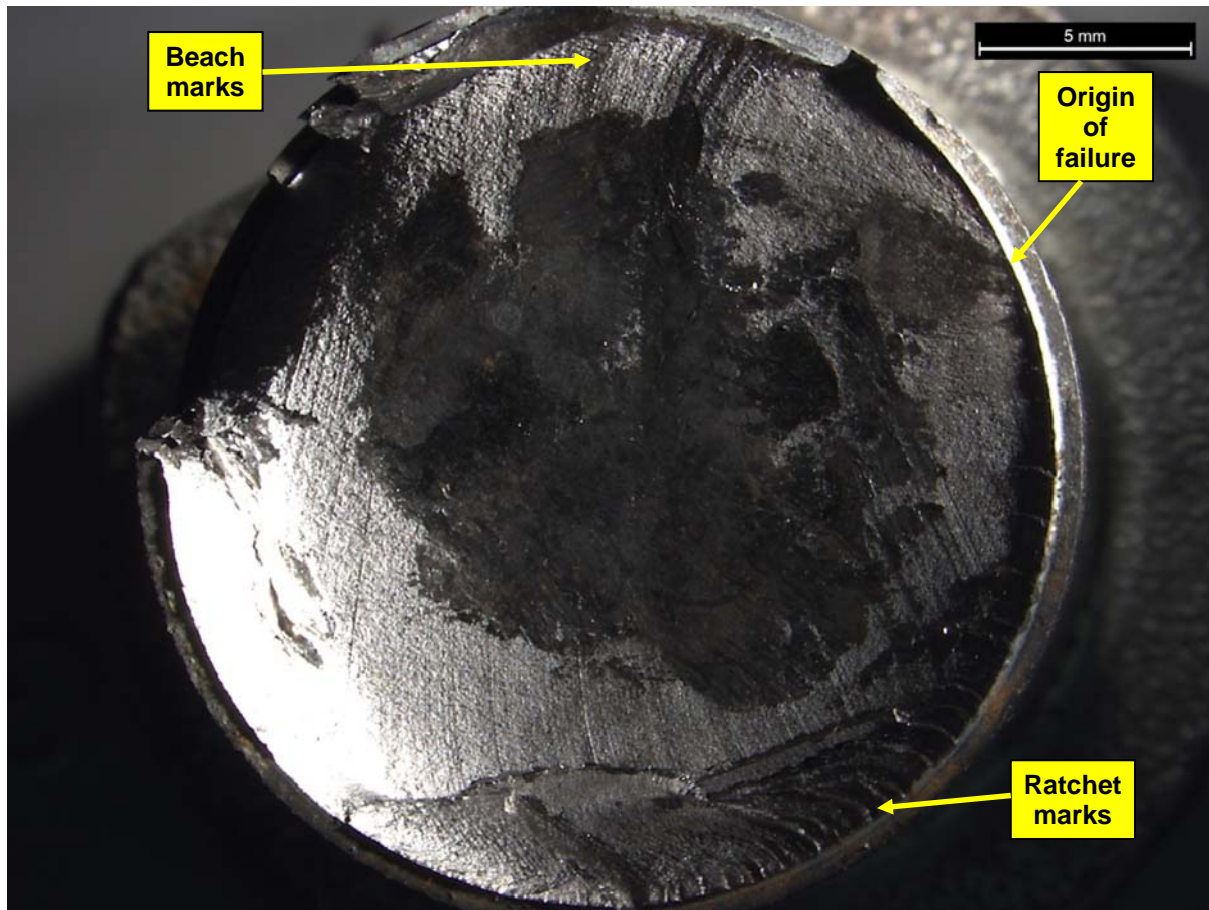
The broken stud and an intact stud were examined microscopically by the Australian Transport Safety Bureau (ATSB) to assist in determination of the cause of the stud failure. The ATSB’s report described the presence of beach marks and ratchet marks on the fracture surface of the broken stud, indicating a fatigue failure with fractures on multiple planes (*Photograph 12*). The origin of the fatigue failure could also be seen.

The darkened central area on the fracture surface was due to damage that occurred during removal of the stud, obliterating the beach marks in this area.

Photograph 12: Fracture surface of stud (Photograph by ATSB)

This movement was limited initially by the remaining nut that maintained sufficient stud tension to retain the wheel, as evidenced by the lack of scuffing in and around the corresponding wheel stud hole. As a consequence, this stud was subjected to a high level of rotational fatigue loading until it rapidly suffered a fatigue fracture as indicated in the ATSB analysis reported earlier.
