# Wheel Separations from Commercial Vehicles: Experiences in Ontario

R. F. Monster, P.Eng.  
Ministry of Transportation, Ontario

## Abstract

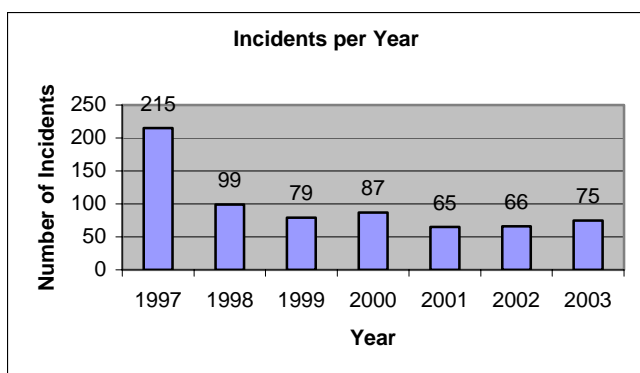
**Figure 1**

Figure 1 shows the total number of wheel separations per year. There is a dramatic 54% decrease in the number of wheel separation occurrences in 1998 compared to 1997. This decrease can be attributed to the actions that were being taken by both industry and government in 1996 and 1997 as described in the previous section, *Government and Industry Response*. The two main influences being the wheel installers certification program and the new wheel separation legislation.

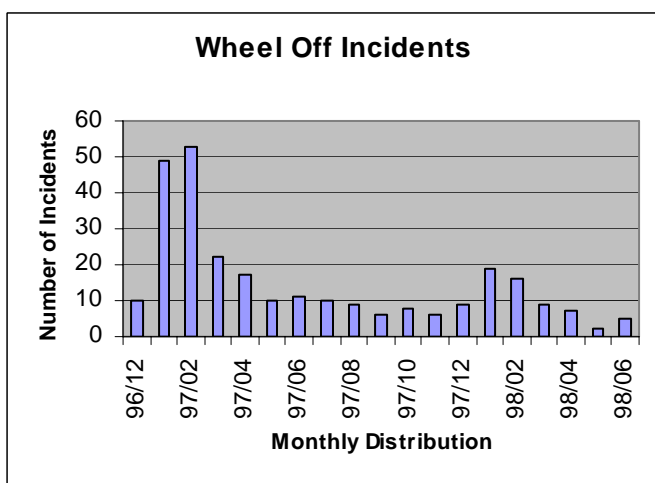
**Figure 2**

The month-to-month distribution of incidents as shown in Figure 2 indicates a dramatic increase of wheel separations in the winter months of January and February for 1997 and 1998. This trend is consistent throughout the range of data up to the present.

The rise of incidents in winter could be attributed to two possible factors. The effect of low temperatures on wheel components is one possible factor. Less effective daily pre-trip inspections by the driver and roadside repairs, both of which are made more difficult by inclement weather, may also contribute to the increased number of wheel separations during the winter. Although some concern has been expressed that the colder temperatures of Canadian winters may affect components and contribute to wheel separations there is no evidence to support this. Yet there is repeated evidence in the incident reports that improper repairs or lack of maintenance was a contributing factor and very likely the cause of separation.

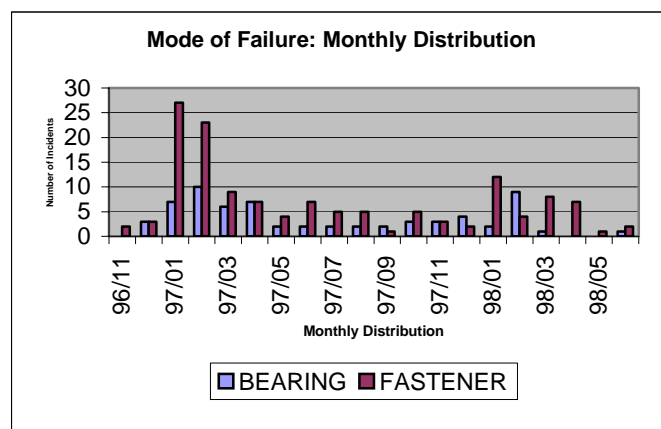
**Figure 3**

This seasonal trend in separations is not restricted to one mode of failure alone. Figure 3 plots the two major modes of wheel separations, fasteners and bearings during the same time period as Figure 2. The plot indicates that both of these modes of failure follow the general trend of increased incidents in winter.

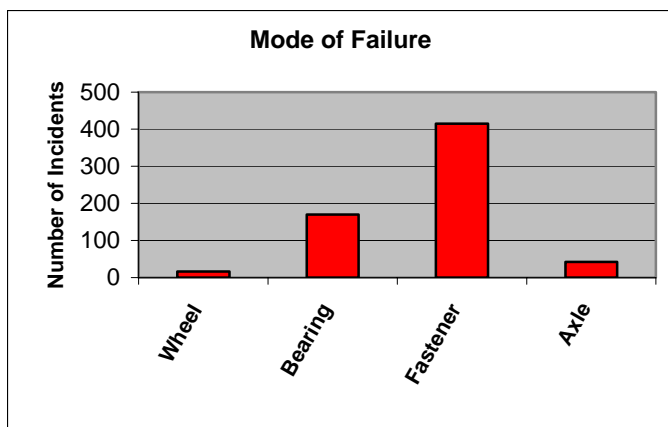
**Figure 4**

Figure 4 shows the distribution between the different types of failure modes in the 643 incidents where the mode of failure was reported. Failure of the wheel fasteners occurred in 65% of the incidents, while wheel bearings were the mode of failure in 26%. What is worthy to note is that these two modes of failure representing the vast majority of incidents involve the components that require the most amount of maintenance and therefore are most affected by poor maintenance and inspection practices. The other two modes of failure were only indicated in 9% of incidents.

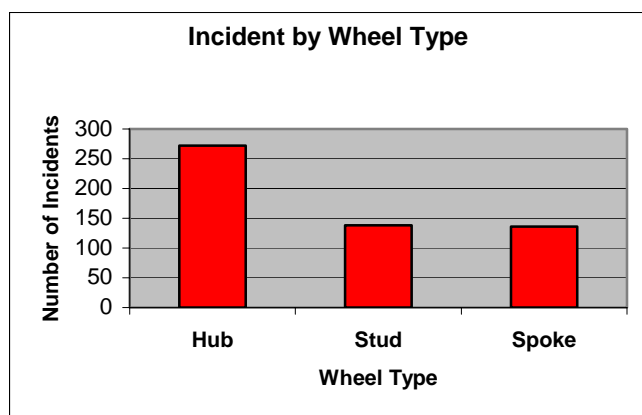
**Figure 7**

The chart shows that all wheel types are involved in wheel separation incidents. However there is a clear predominance of separations involving hub-piloted wheels. Although hub-piloted wheels were involved in 50% of the wheel separation incidents it cannot be assumed that these wheels are more problematic than the other wheel types.

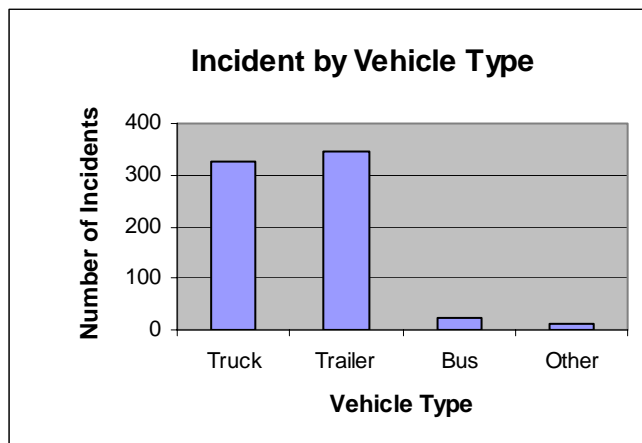
**Figure 8**

Figure 8 shows the distribution of vehicle types involved in the reported wheel separations. There is only a slightly higher number of incidents from trailers as compared to trucks. With regard to buses and “other”<sup>11</sup> vehicle types the numbers are relatively very small. These numbers of course

From the information regarding kilometers travelled compared with the information of Figure 8 we can see that trailers operate about 8% less kilometers per day than trucks yet are represented in about 6% more wheel separations than trucks. Although we can determine from this that wheel separations are more predominant with trailers than they are from trucks the difference is not large.
