Engineering Report V1.0

# Engineer's Foundation Evaluation

On 1/10/2025 a foundation evaluation was performed at the property located at address 123 Sample, Address, TX, 12345, which consists of a 2621 square-foot single family attached structure built in 1978 (47 years old) with a slab on grade foundation.

### **On-Site Inspection Report with Photos Dated 1/10/2025**

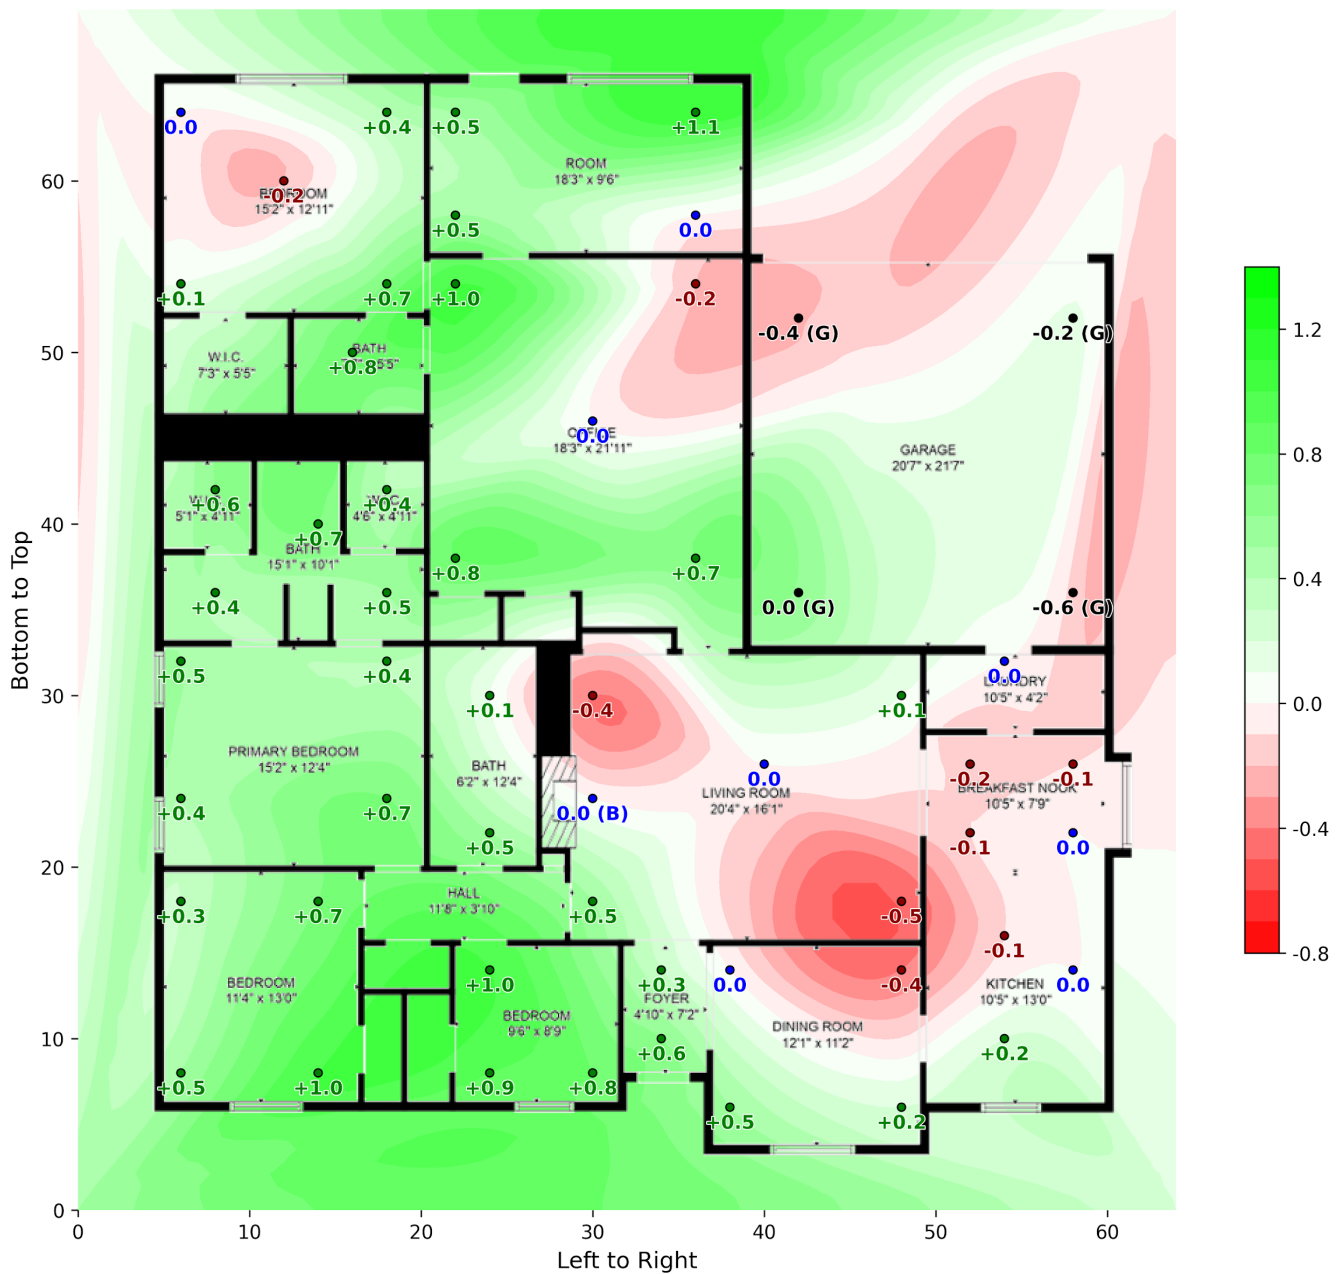
**Elevation Plot Graphic (Figure A)**

The elevation plot resulted in the graphic as depicted above in Figure A. The red-points and areas are elevation measurements that were lower than the base station elevation (0.0). The green-points and areas are elevation measurements that were higher than the base station elevation (0.0). The blue-points (and white areas) are equal to the base station elevation (0.0). The base station is depicted with a (B) symbol. The maximum elevation point was determined to be 1.1 inches and the minimum was -0.5 inches, resulting in an elevation difference of 1.6 inches of difference across the structure.

As documented above, the maximum elevation point of this structure was determined to be 1.1 inches and the minimum was -0.5 inches, resulting in an elevation difference of 1.6 inches of difference across the structure. The elevation deflection across an entire structure should remain within 0.5 to 1-inch depending on the age of the structure. Measured differences approaching 2-inches are a sign of foundation fatigue. The maximum allowable elevation difference is subjective, depending on other factors such as the visual condition and age of the structure (47 year(s) old).

Based on observed elevations of the foundation from the elevation plot, the structure should be considered currently stable. Elevation differences fall within industry standards and tolerable limits. These findings indicate that the foundation has consistent and uniform elevation demonstrating foundation settling that is within tolerable limits.

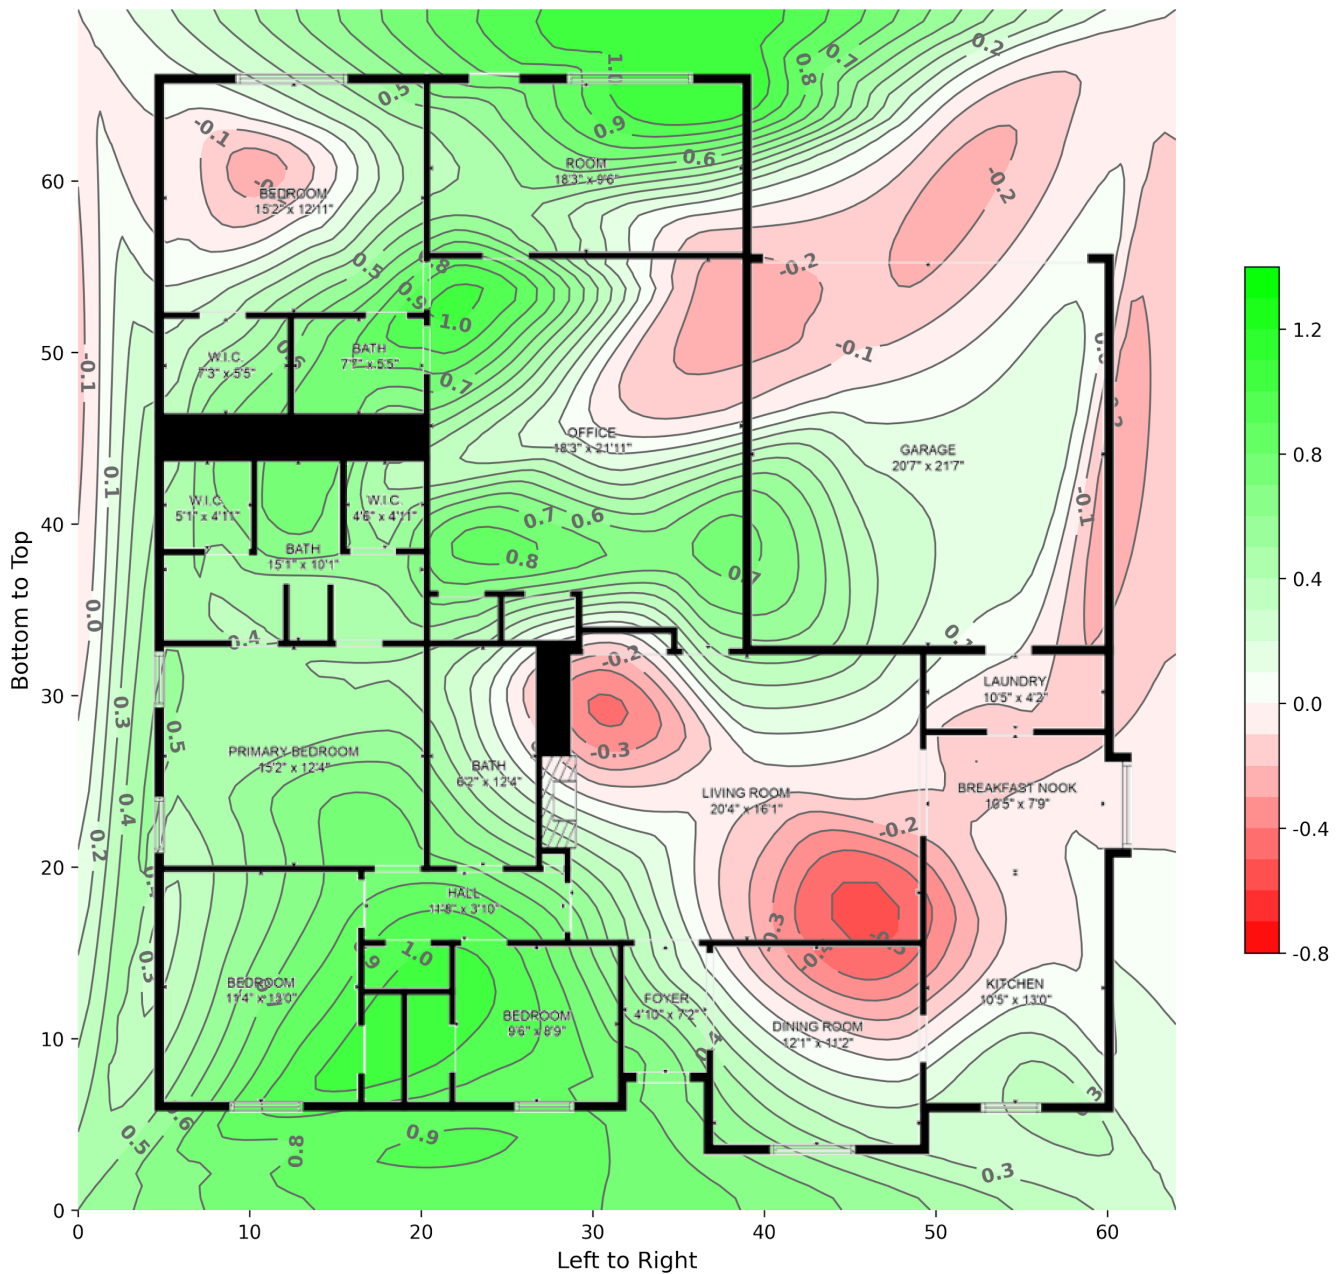
**Mesh Contour Graphic (Figure B)**

The mesh contours graphic depicted above in Figure B is similar to the elevation plot. The red, green, and white areas depict areas that are lower, higher, and equal to the base station elevation (0.0). The contour intervals are labeled.

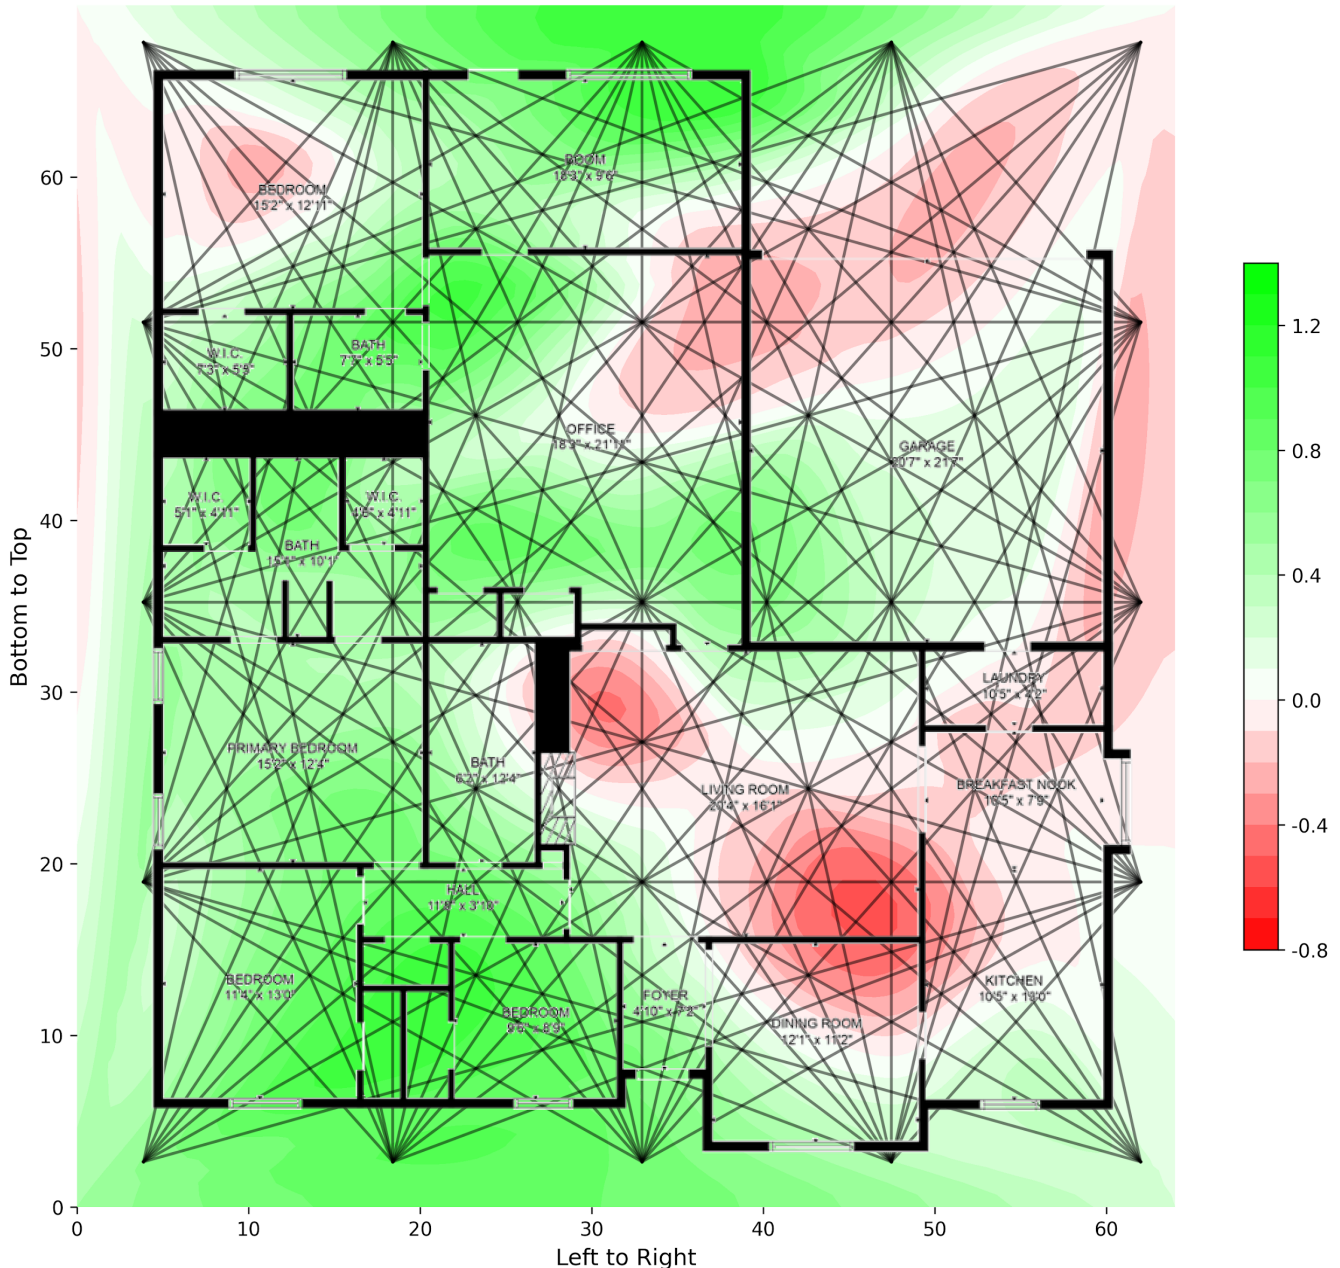
**All Profiles Graphic (Figure C)**

Below is a graphic that shows the locations of deflection and tilt profiles that were calculated. The total profiles calculated was 79 with a total usable profiles (above the effective length threshold) of 79.

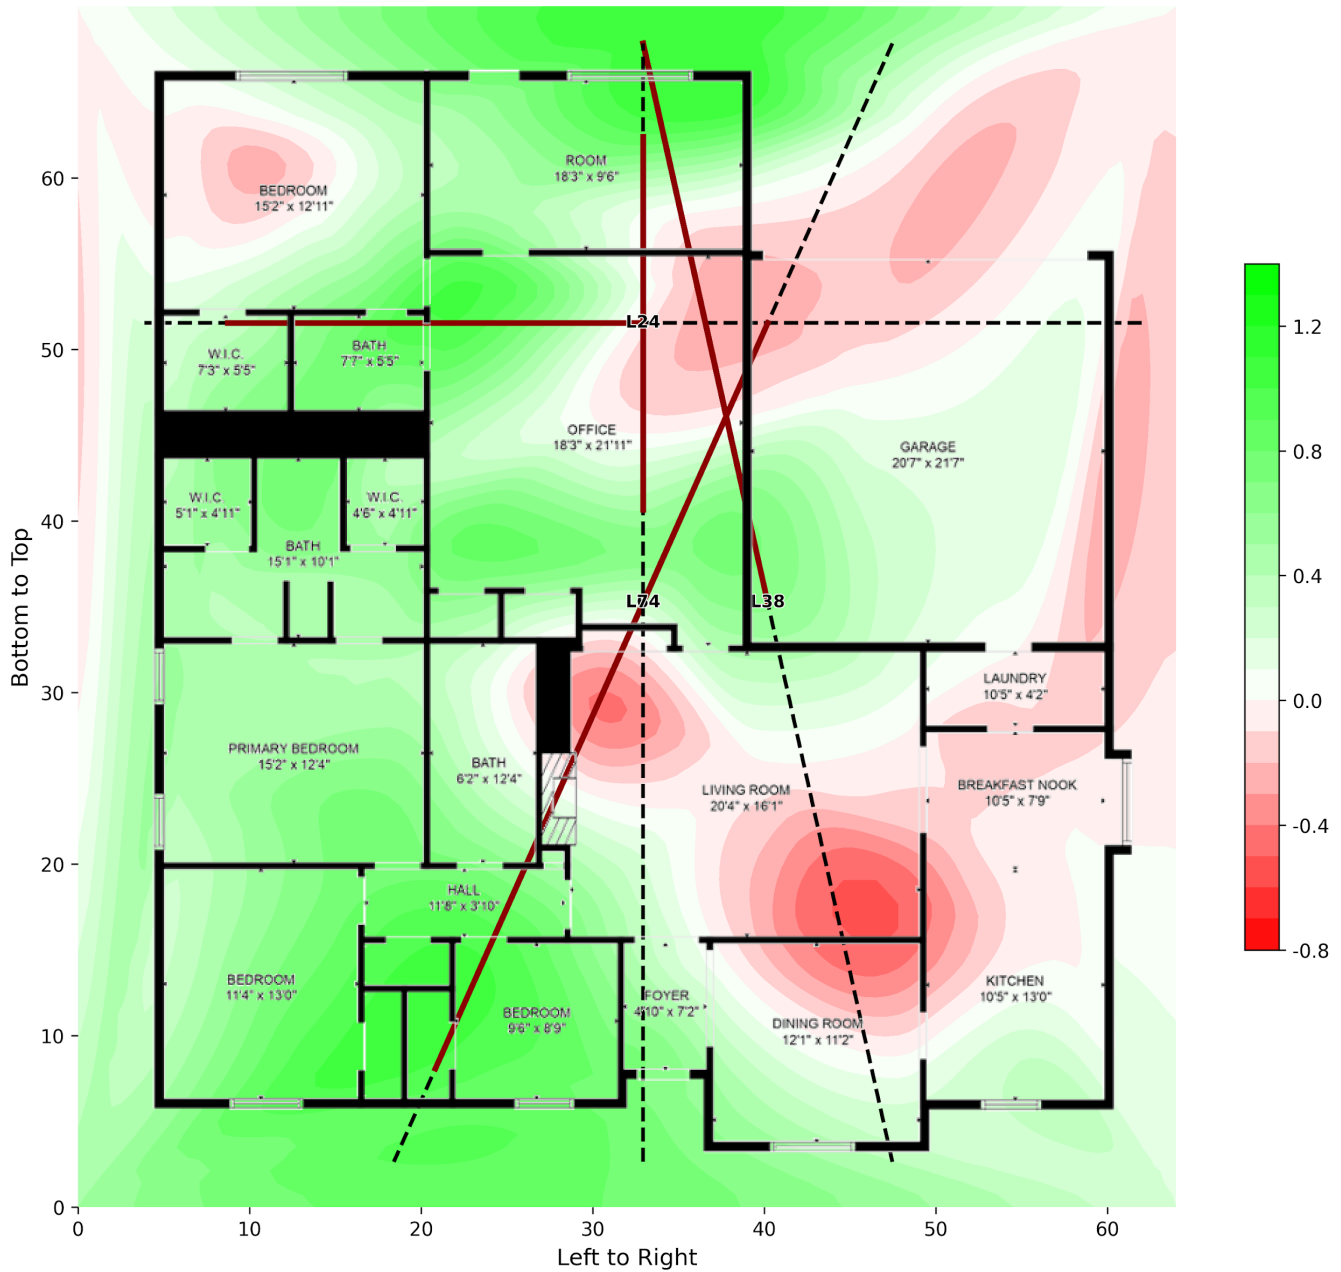
**Deflection Failures Graphic (Figure D)**

The above Figure D shows deflection failures along the foundation. Deflection failures can be considered localized failures in (sometimes) isolated portions of the foundation. The profile lines that were calculated are represented by a dashed black line and the areas that the deflection failures occur are represented by a dark red line segment. Of the 79 deflection profiles calculated, 4 profile failures were identified.

Deflection failures can be considered localized failures of the foundation in (sometimes) isolated portions of the foundation. Of the 79 deflection profiles calculated, 4 failures were identified.

Deflection failures are above standard acceptable limits; they exceed industry-standard thresholds and the structure should be considered actively moving/settling in areas where deflection failures are occurring.

This evaluation indicates few, but some, signs of possible impending foundation issues. Calculations were not found to be within industry standard thresholds, however, the foundation exceeds limitations only in some profiles and/or only some profiles are failing. The results do indicate the possibility of future foundation issues, but indications may be disguised as stabilized settlement. Foundation repair work is not recommended at this time, however these deficiencies should be monitored and it is not fully known nor determinable if foundation stabilization will be necessary in the future. We also recommend you perform another house elevation plot before 2 years. Visual deficiencies noted in this report are considered minor, possibly cosmetic, and should be resolved as preventive maintenance measures that may include:

- Patch and monitor visible foundation cracks
- Patch/cover exposed tension anchors
- Patch and monitor exterior brick or siding cracking
- Patch and monitor interior sheetrock cracking/separation
- Repair and monitor door misalignment
- Windows that won't open to resolve and monitor

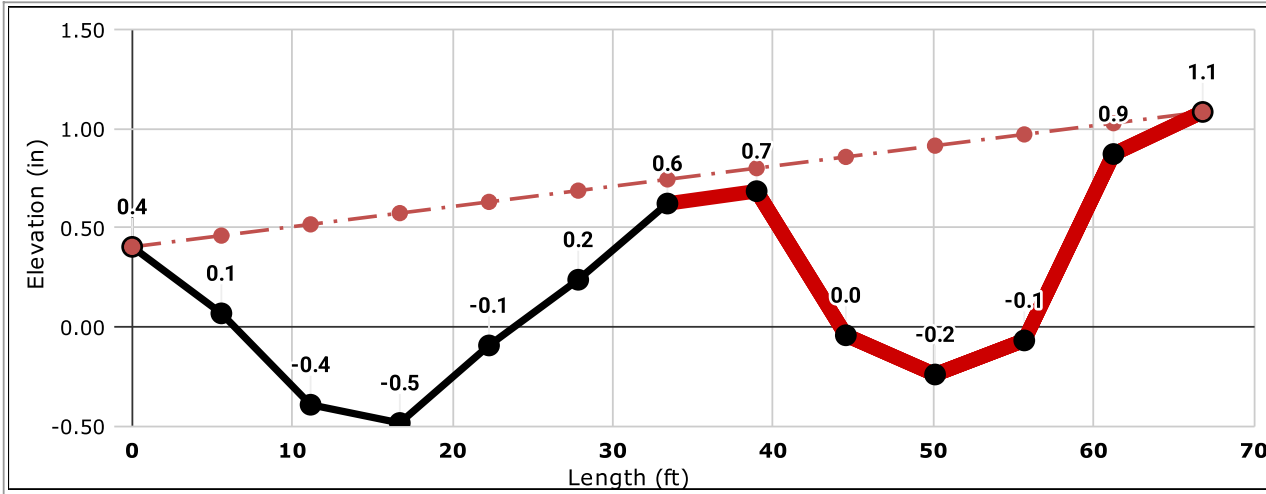
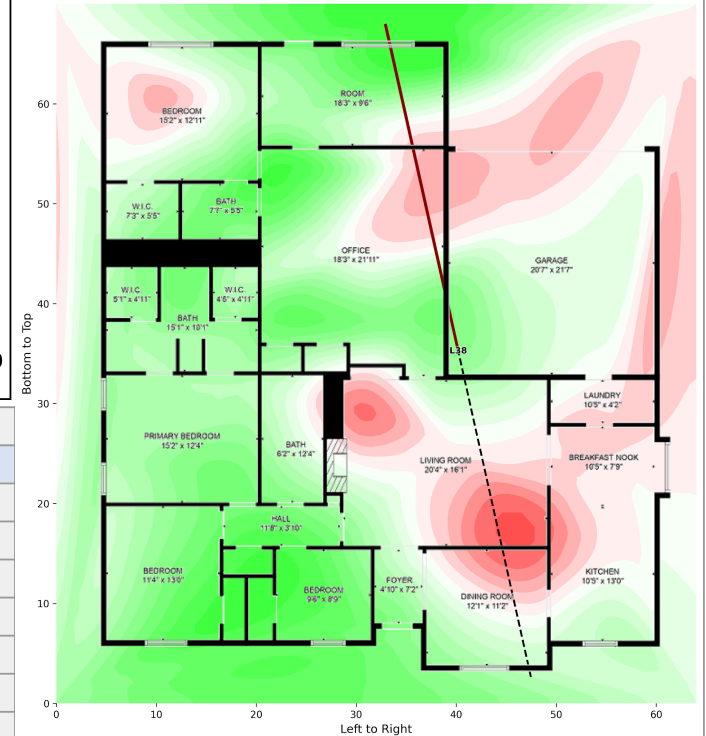
## Exhibit B: Identified Deflection/Tilt Failure (L38)

Performance Output							
Deflection & Tilt	Pass/Fail	Actual		Result Description	Point 1	Point 2	Point 3
Deflection 1 (using k)	FAIL	L /	262	EXCEEDS THE kL/360 (L/353) LIMIT BY 35%	8	10	12
Deflection 2 (using k)	FAIL	L /	299	EXCEEDS THE kL/360 (L/353) LIMIT BY 18%	8	11	12
Deflection 3 (using k)	FAIL	L /	308	EXCEEDS THE kL/360 (L/353) LIMIT BY 15%	8	10	13
Deflection 4 (using k)	FAIL	L /	330	EXCEEDS THE kL/360 (L/353) LIMIT BY 7%	7	11	13
Deflection 5 (using k)	FAIL	L /	336	EXCEEDS THE kL/360 (L/353) LIMIT BY 5%	10	12	13
Tilt	PASS	0.08 %		USING 8% OF THE ALLOWABLE 1% LIMIT

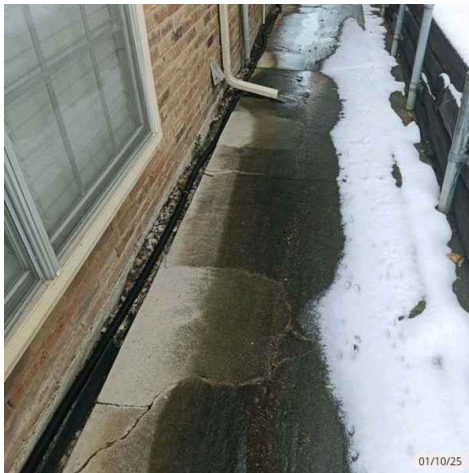
Right exterior.

#### PHOTO(S) OF POSSIBLE FOUNDATION REPAIR

Assessment of true and present foundation deficiencies is difficult when foundation repair has been completed because inspector is unable to determine the extent of the stabilization and resolution of present foundation issues. Common indicators of foundation problems may be resolved or may continue to exhibit failure. It is a difficult situation to fully understand without a timeline of events.

Recommend contacting the owner about the extent of the repairs to determine their validity as a true foundation stabilization, type of repair, and warranty. Recommend researching the previous foundation repair company to determine if they have quality reviews, have a long standing reputation, and if any warranty is transferable.

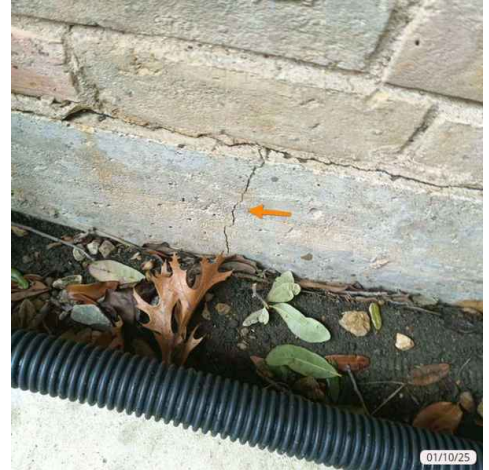
Right exterior. Garage.

#### **SLAB - FOUNDATION CRACKS - MINOR**

Minor cracking was noted at the foundation. This is common as concrete ages and shrinkage surface cracks are normal. Recommend patching the minor cracks to prevent moisture/pest intrusion. Also recommend monitoring for more serious shifting/displacement.

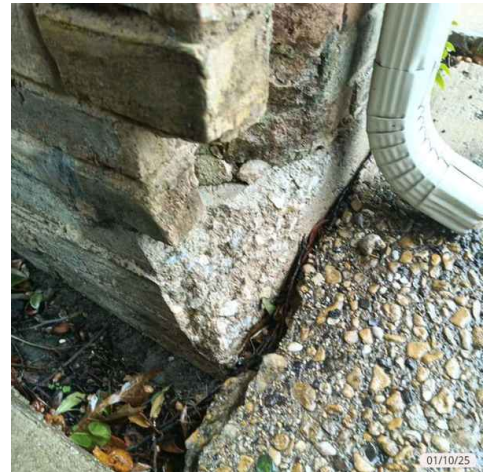
Back right. Garage.

#### **SLAB - FOUNDATION CRACKS - CORNERS**

Corner cracks are visible in the foundation slab but are of minimal structural concern. Shrinkage is a natural part of the curing process of concrete and cracks located in corners of structures are common. Recommend patching the corner cracks to prevent moisture/pest intrusion. Also recommend monitoring to confirm the cracking does not worsen.

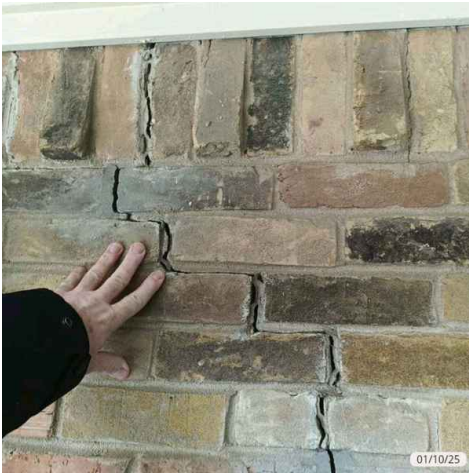
Right exterior. Garage.

#### **CRACKS MAJOR**

Major cracking observed in wall structure that is likely due to structural foundation issues and is considered evidence of a structural deficiency. Recommend a qualified foundation contractor evaluate and advise on course of action.

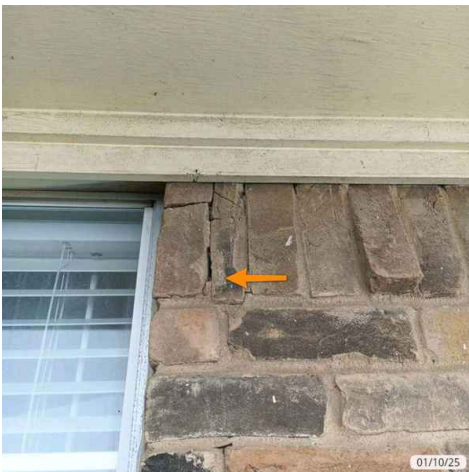
**CRACKS MINOR**

Minor cracking was observed in wall structure. This is common in structure this age and is often determined to be cosmetic. That said, cracking is a first sign of foundation failure and cracks can grow over time; recommend monitoring. The best way to monitor a crack is to patch it (with mortar or caulk) and repaint it, to see if the crack reappears.

Left exterior. Soldier bricks

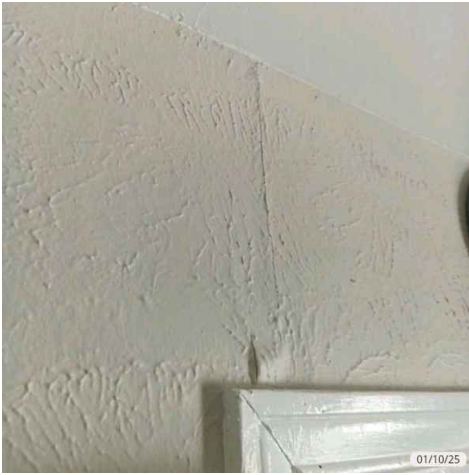
Dining room. Previous patching

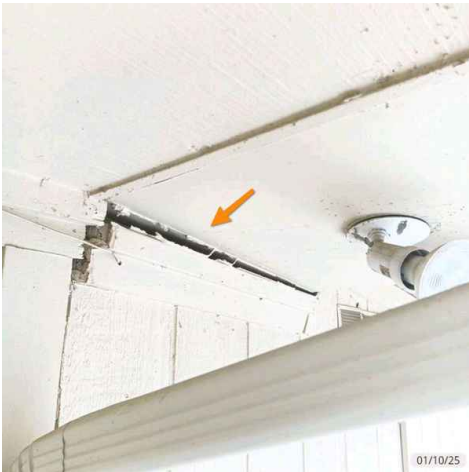
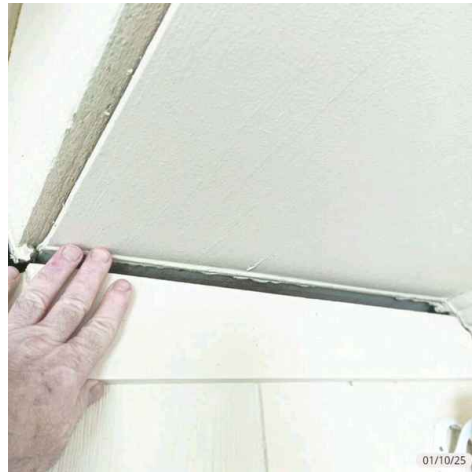
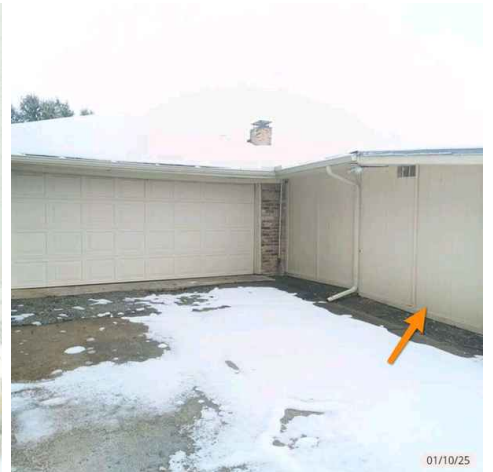
Floating patio. Attached storage closet

**SEPARATION - FLOATING PATIO**

Separations at attached storage closet on floating patio slab.

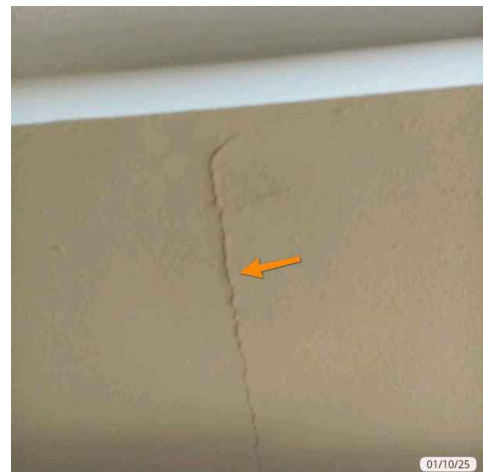
Office. Room addition

**CEILING - SHEETROCK CRACKS MINOR**

Minor sheetrock cracking was observed on the ceiling. This is common in structures this age and is often determined to be cosmetic, most often the separation of drywall tape joints. Recommend patching, repainting, monitoring these locations for further cracking.

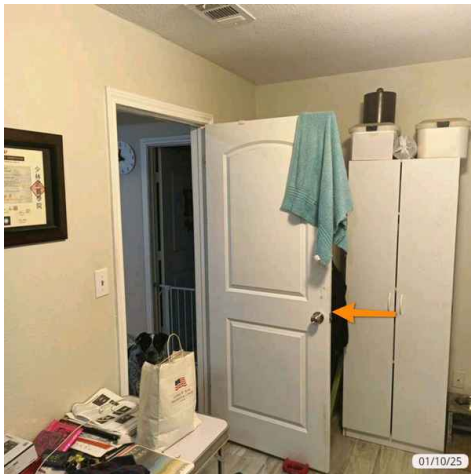
Back patio enclosed room.

**DOOR RUBS / STICKS AND IS MISALIGNED**

Door sticks, rubs the frame, and is tough or impossible to open and/or close. The door is not aligning with the frame. Recommend hiring a door repair and installation contractor to realign the door or sanding down offending sides.

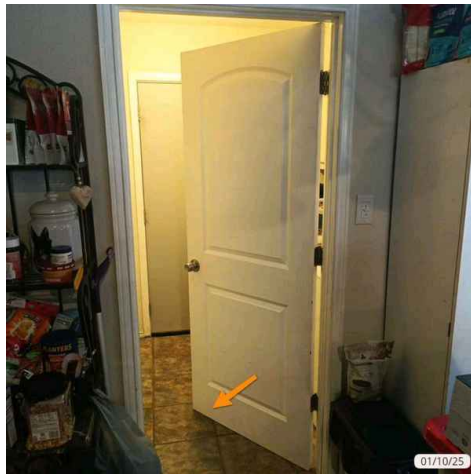
Utility room. Rubbing floor

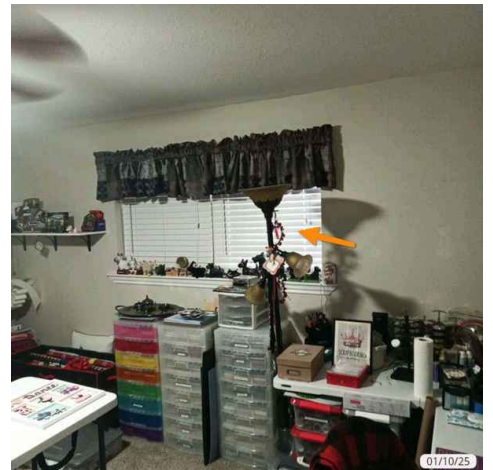
Back left bedroom. Room addition

**WINDOW WON'T OPEN**

One or more windows won't open. This could be caused by a number of reasons including structural deficiencies, windows that are locked, broken, or are painted shut. Recommend windows be restored to functional use by a window repair and installation contractor.
