Property Condition Assessment

Report Date: March 27, 2017

Property Address: 0000 Sample Inspection Way
Dallas, TX 75000

Report Number: 20170327-01

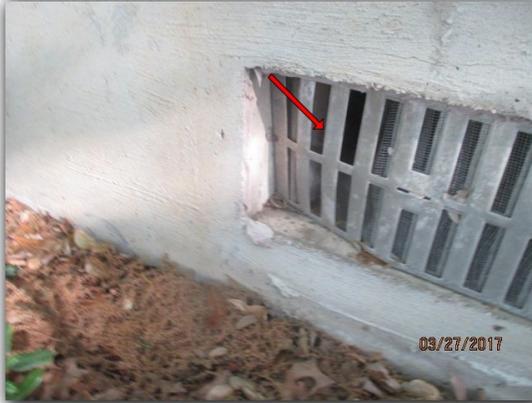
Observed damaged/missing foundation vent screens around property. These should be repaired to prevent pest entry into crawlspace. Evidence of previous pest activity was observed in crawlspace (i.e. droppings, traps, etc).

Torn vent screens.

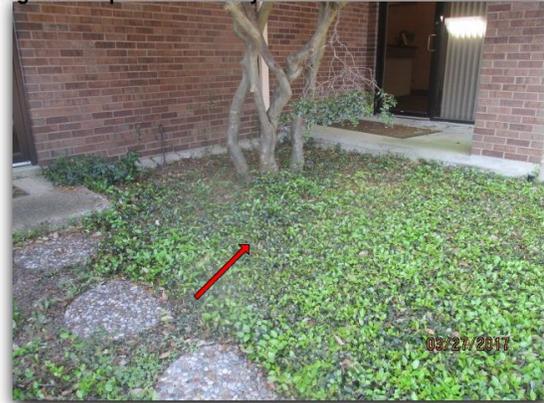
Observed negative drainage slope (moves water toward structure) at the front, back side of foundation area. This may cause water to drain toward property. Excessive moisture around foundation may affect foundation performance or cause high soil lines.

Negative slope at front entry.

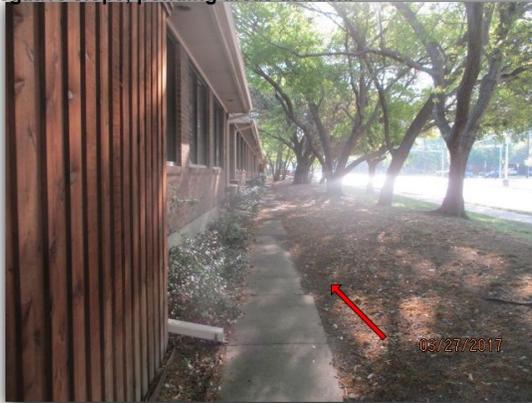
Negative slope, ponding areas at back.

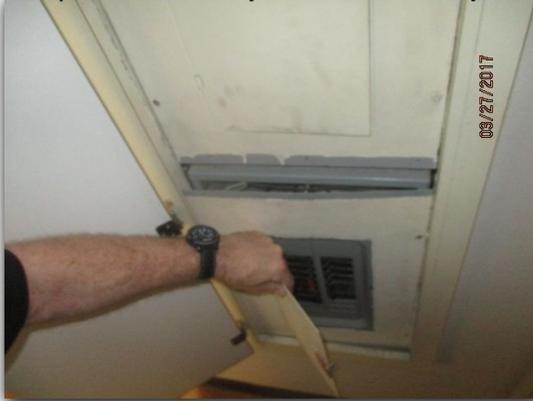
Interior panels obstructed by cabinet door assembly.

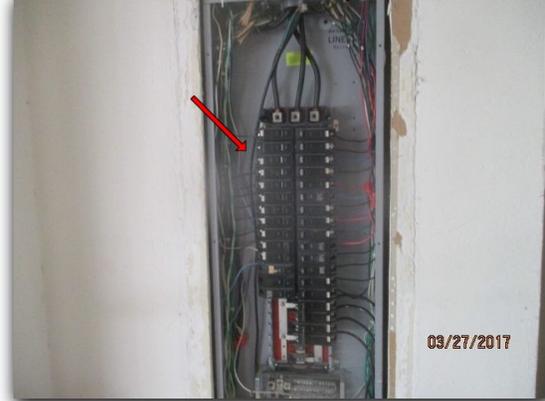
Disconnected breakers at accessible panel.

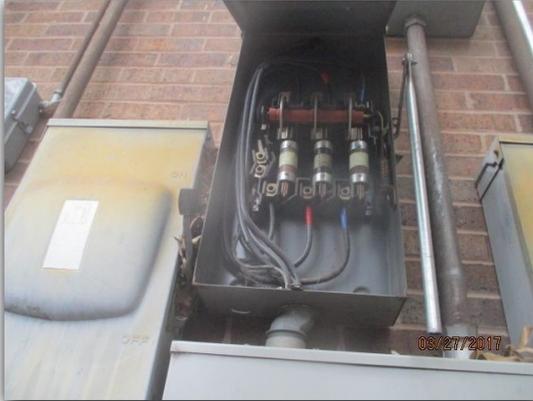
"Dead Front" cover was found missing from accessible shut off panel at end of building. Recommend consulting with owner/seller/HOA regarding responsibility for this equipment. Recommend cover be installed for safety reasons.

No "dead front" at exterior shut off.

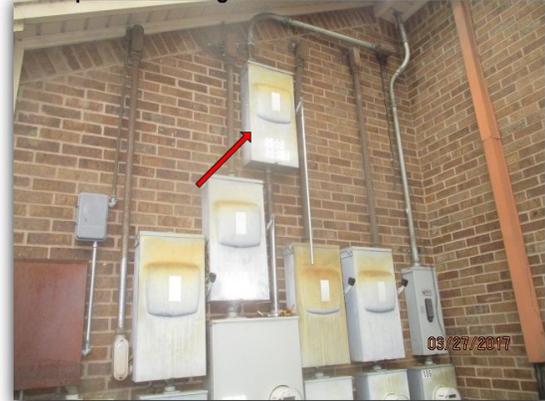
Shut off panel #2 too high.

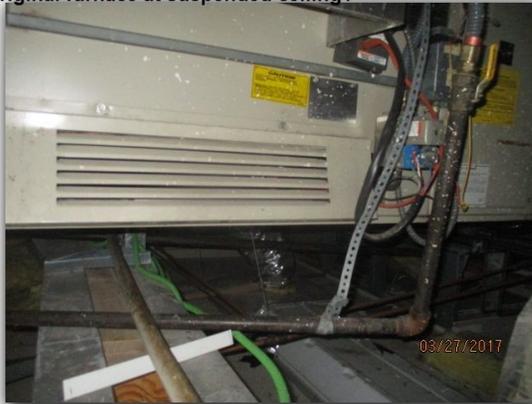
Observed furnace unit above suspended ceiling area that appears to be original by design of property.

Original furnace at suspended ceiling?

Recommend replacement of older (possible original) furnace unit at suspended ceiling area.
Estimated cost: \$4000.00

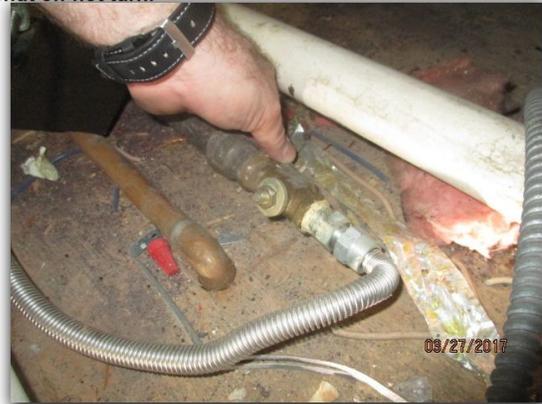
Observed one attic furnace unit with stuck gas shut off handle (not freely turn).

Shut off not turn.

Recommend service/repairs/general maintenance to units. Estimated cost: \$400.00

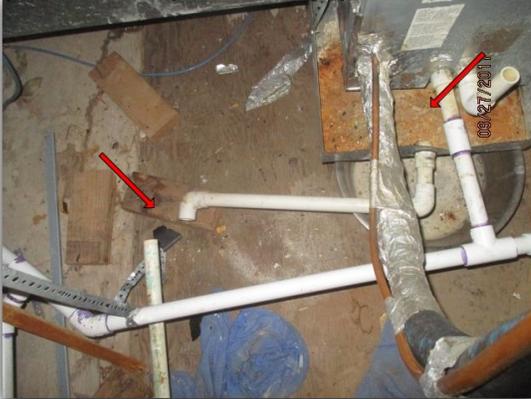
Observed separated secondary drain line at safety pan in attic area.

Safety pans have rust at various areas. This indicates previous back up's of condensation drain lines.

Separated secondary drain. Rust in pan.

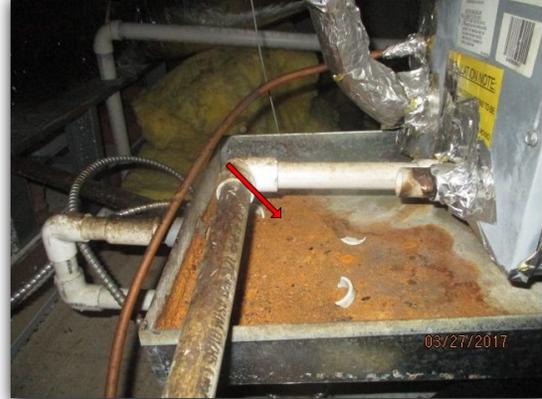
Rust in pan @ suspended ceiling unit.

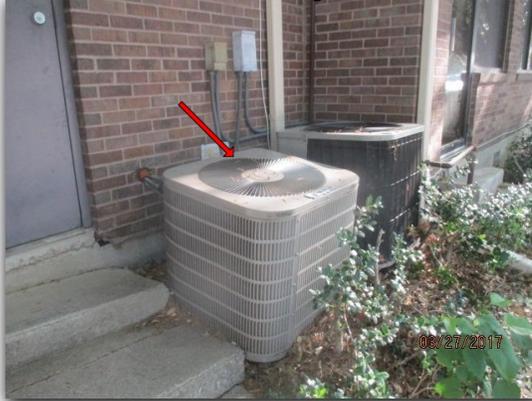
Exterior condenser units are in need of maintenance. Units have varying degrees of deterioration and wear. Units were found to be dirty, out of level, missing coolant line insulation, rust, in contact with ground, etc.

Units out of level. In contact with ground.

Recommend service/repairs/general maintenance to four (4) units. Estimated cost: \$1000.00

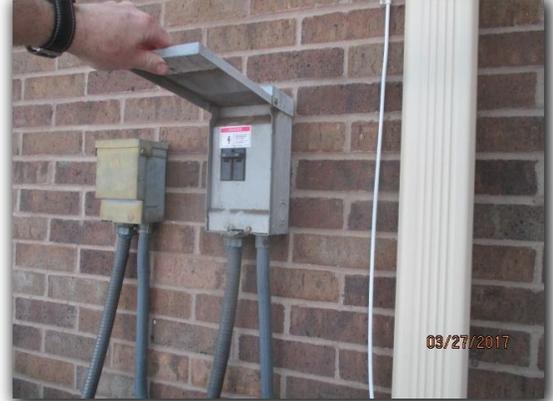
Service disconnects at the exterior were found to be loose to wall at some areas.

Service disconnect loose to wall.

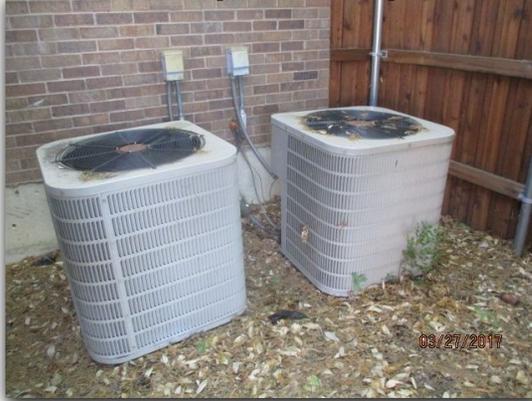
Units out of level, rusting, in contact with ground.

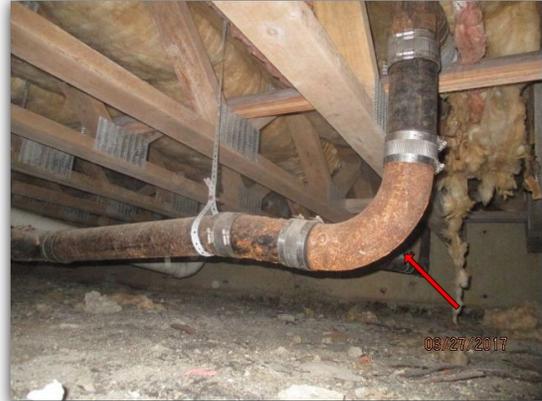
Drain lines are showing signs of routine age/deterioration.

Deterioration of drain lines. No active leaks found.

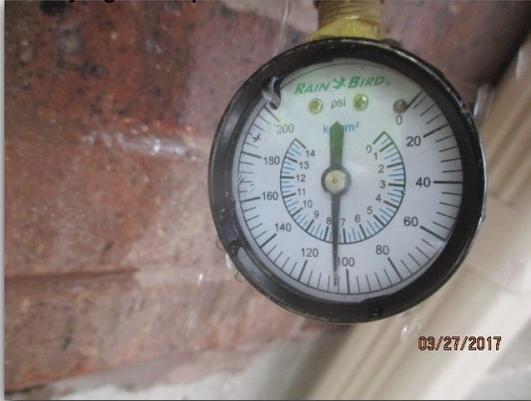
Water pressure at property at time of inspection was registered at 100-110 PSI at time of inspection. PSI above 80 psi can strain fixtures and fittings over time.

Unusually high water pressure.

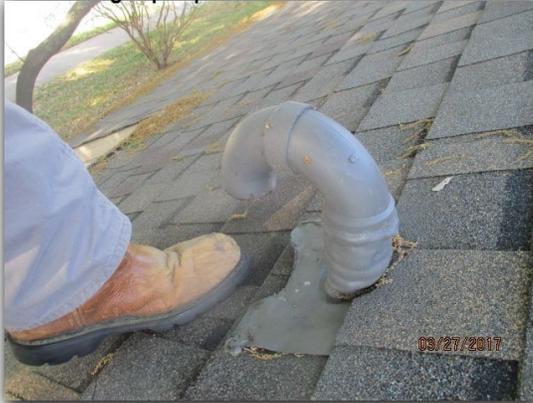
The roof has "soft" decking at roof exhaust. Property (dentist office) has high moisture exhaust venting directly onto roof surface at back of property. Vent is for compressor unit providing for air and suction for dentist needs.

"Soft" decking at pump exhaust.

Recommend consulting with a qualified roofing contractor to determine the type and extent of repairs that may be required.

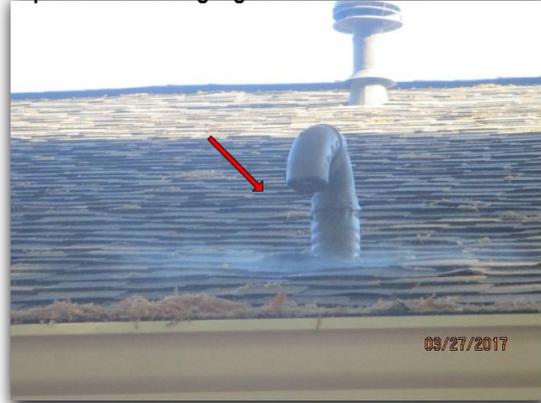
**Pump exhaust blowing high moisture on roof.**

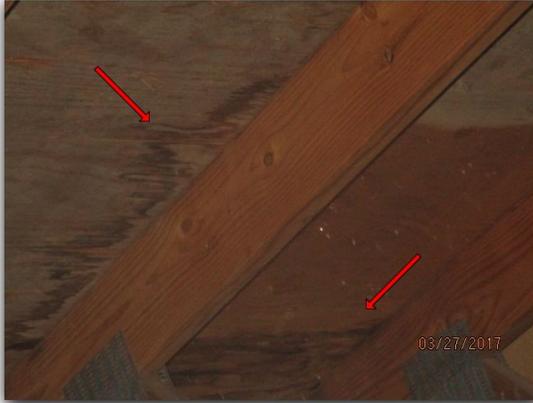
Observed signs of water penetration/staining at the roof decking at the back roofing area. It is unknown if this is from previous or ongoing leakage.

**Deck stains seen in attic.**

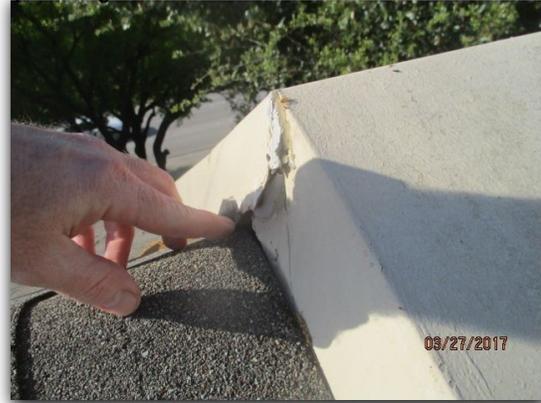
Flashing is lifting, raised, or not flush/pulling loose at some locations. These should be secured to prevent weather penetration.

**Cap flashings need sealant maintenance.**

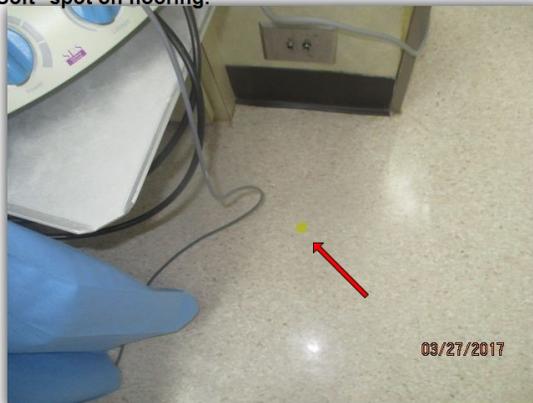
Flooring at far left exam room (adjacent to private office) had "soft" spot in flooring for unknown reason. Crawlspace at the area was not accessible due to being part of original Suite #106 location (see Foundation section for explanation).

"Soft" spot on flooring.

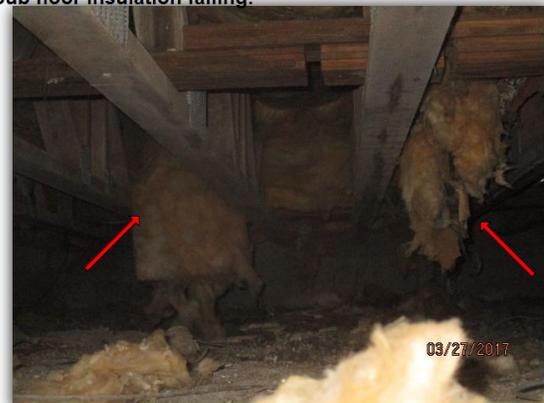
Sub floor insulation appears to be deteriorating/falling at some locations in crawlspace.

Sub floor insulation falling.

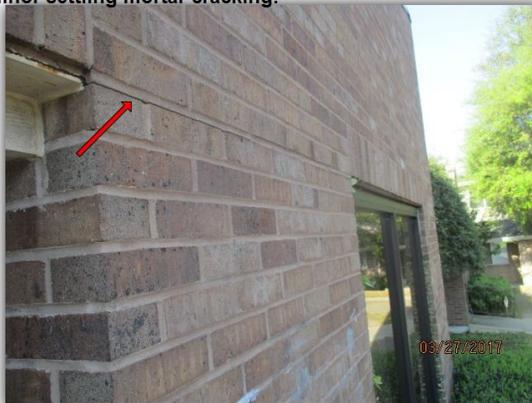
Exterior brick at property has some minor mortar cracking. This appears to be due to routine settling and seasonal movement.

Minor settling mortar cracking.

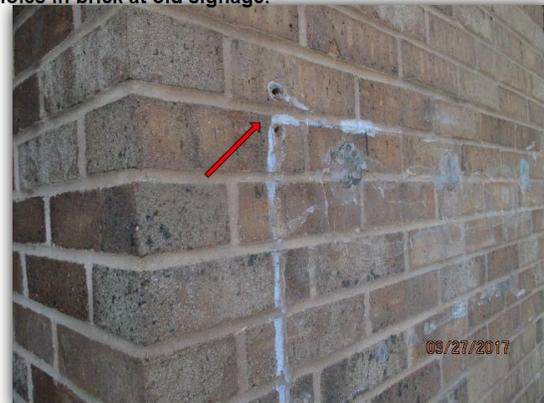
Holes in brick at old signage.
