### PROPERTY INSPECTION REPORT

Address: 0000 Sample Report Way, Dallas, TX, 75000

**Concerning:** 0000 Sample Report Way, Dallas, TX 75000  
(Address or Other Identification of Inspected Property)

**By:** Greg House, Lic #TREC #9986, SPCS #559963 10/23/2018  
(Name and License Number of Inspector) (Date)

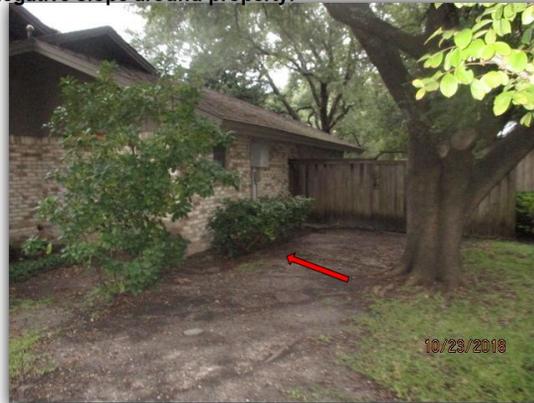
- Recommend further evaluation by drainage specialist to determine the type and extent of corrective measures needed.
- Observed negative drainage slope (moves water toward structure) at all sides side of foundation area. This may cause water to drain toward property, causing excessive moisture conditions in soil. Excessive moisture around foundation may affect foundation performance or cause high soil lines. In severe conditions, negative slope and high soil lines combined may allow for water intrusion into the property.

Negative slope around property.

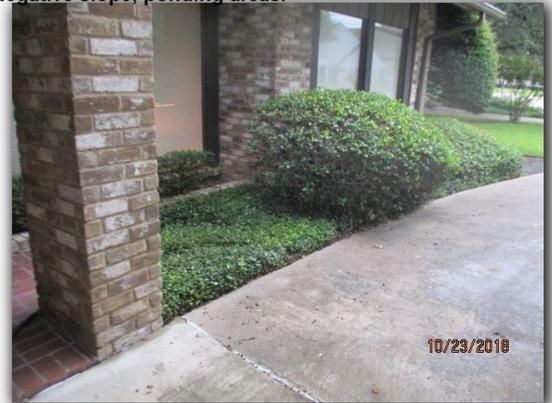
Negative slope, ponding areas.

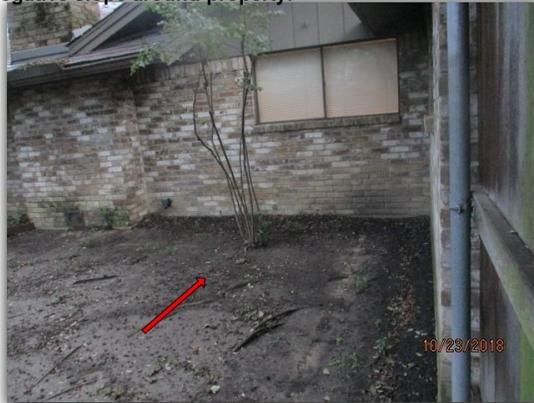
Negative slope around property.

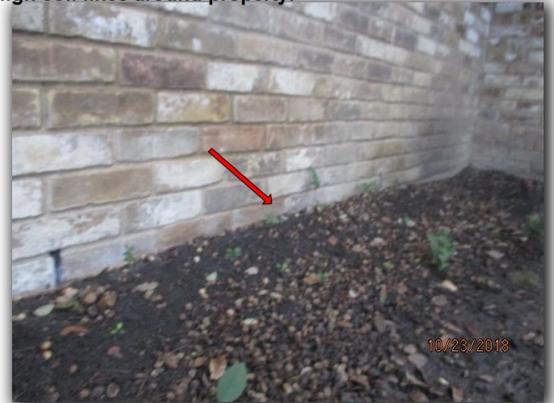
- The foundation soil line is too high at all sides of property. Current standards call for at least 6+ inches of foundation slab or beam wall exposed below bottom of exterior wall (brick, stone, etc.). High soil lines may cause moisture retention in exterior walls, and are conducive for possible WDI infestation if they are up to, or covering, exterior cladding (brick, siding, weep holes, etc)..

High soil lines around property.

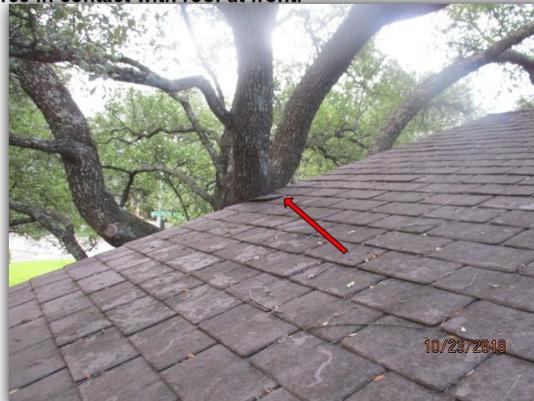
- Tree limbs are in contact, or are too close to roof surface. Trees should be trimmed at least 5 feet away from roof surface.
- No cricket (saddle) in place on chimney wider than 30 inches (small drainage roof now commonly installed behind chimney to move water around chimney).

Tree in contact with roof at front.

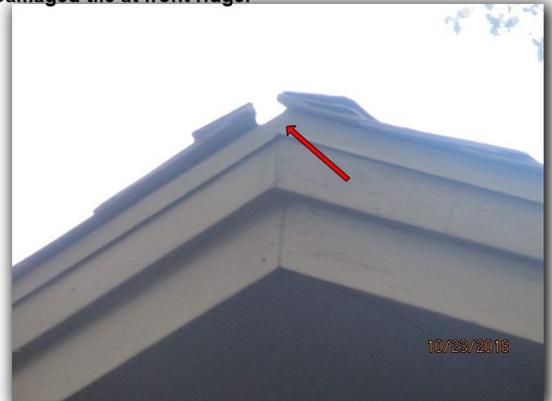
Damaged tile at front ridge.

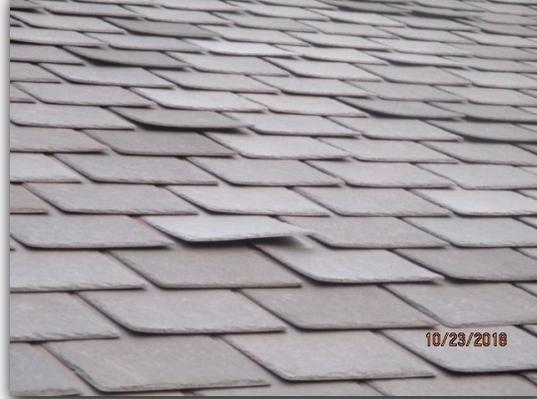
- The front roof ridge line edge appears to have damaged tiles.
- The faux (plastic) roof tile material has unusual curling and lifting at multiple locations around property. This may be due to roof heat load, and absence of upper attic ventilation (see Attic section of report).

Unusual warping, lifting of material.

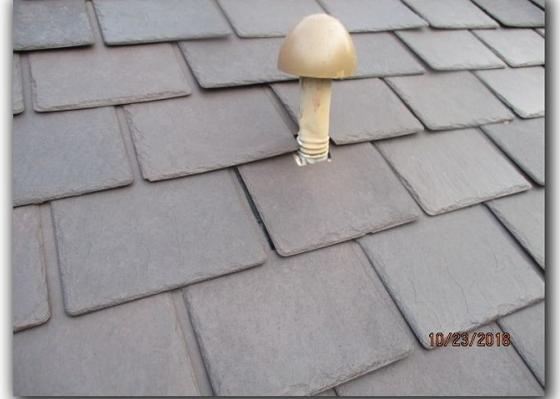
- Improper flashing installation observed. The flashing bottom edges should be free from shingles to allow water to properly run off. Shingles should cover the top and most of the sides only.

Improper installation at flashings.

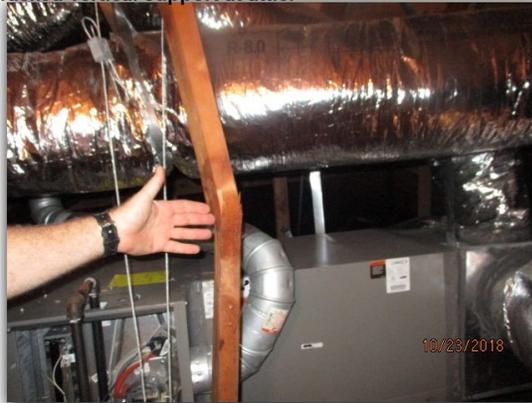
Cracked vertical support at attic.

- Recommend attic area be evaluated by qualified framing professional/general contractor.
- Recommend consulting with licensed and qualified attic ventilation and/or insulation specialist.
- The left property attic has cracked/damaged vertical roof support. This may be due to previous foundation movement..
- The attic has no high ventilation (turbines, static vents, ridge vents). This may decrease attic ventilation, and increase heat load during warmer months.
- Observed attic insulation in contact with exhaust flue at the water heater(s). Current standards would call for 2" clearance between metal exhaust flue and insulation materials.
- Observed evidence of pest entry/activity in attic area. Evidence includes presence of baits, traps. Pests have been known to damage attic components.

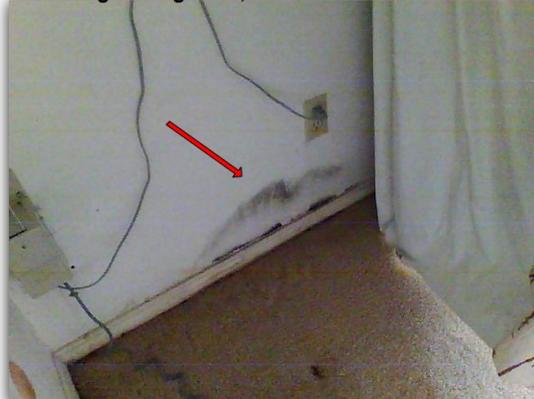
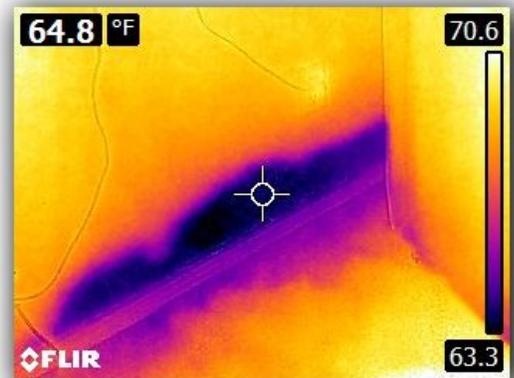
- Observed evidence of growth of unknown organism at the master bedroom wall. Infrared inspection at this area showed evidence of active moisture content in master bedroom wall and door area. Recommend this condition be evaluated by a licensed and qualified environmental services company (mold assessment technician) to determine the nature of this substance, and to advise regarding the correction of this condition.

Infrared- Organism growth, moisture at master bedroom wall

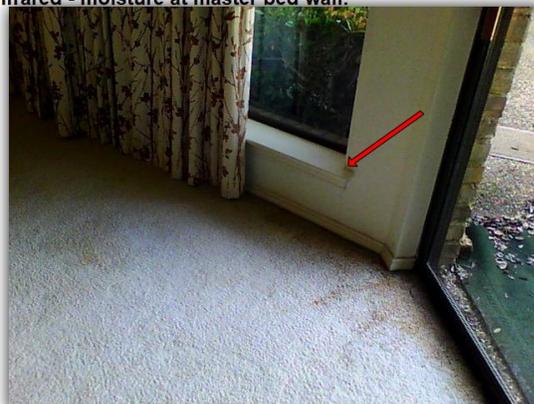
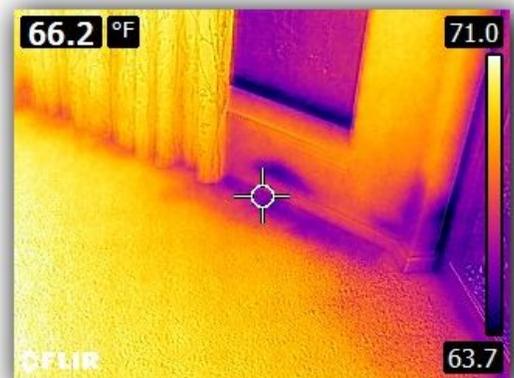
Infrared - moisture at master bed wall.

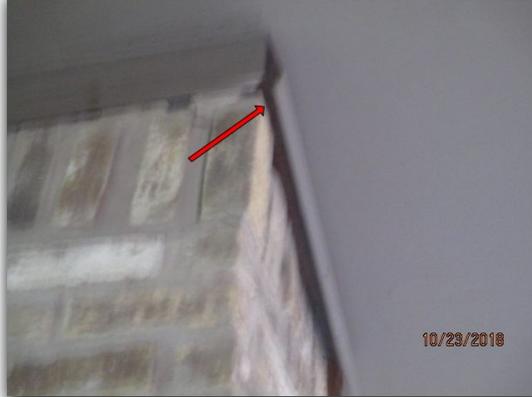
Separation at porte-cochere

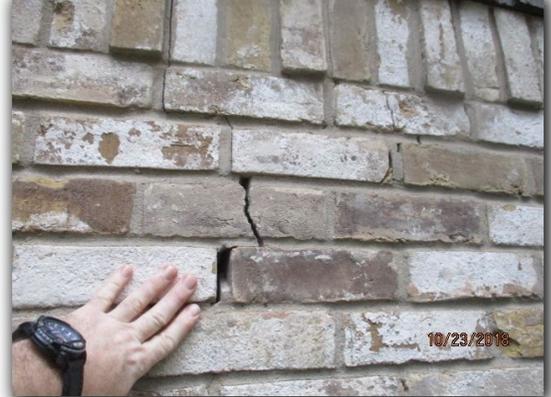
Cracking around property.

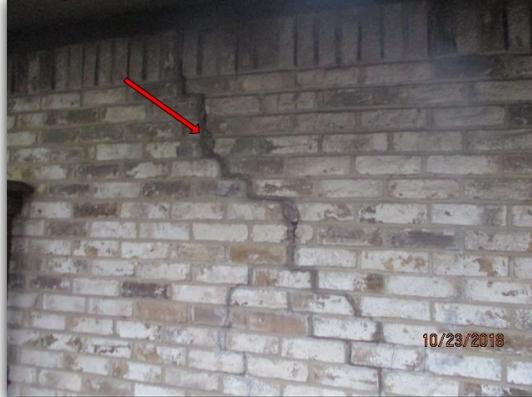
Cracking around property.

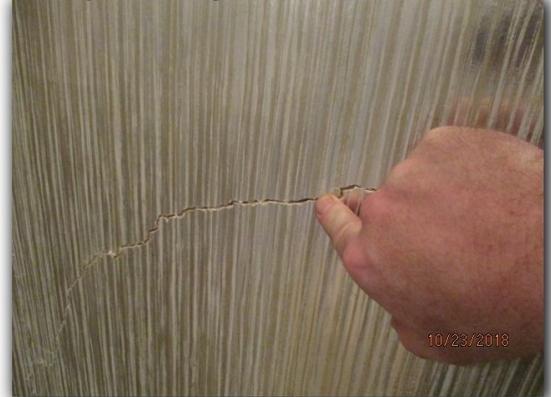
Interior drywall cracking.

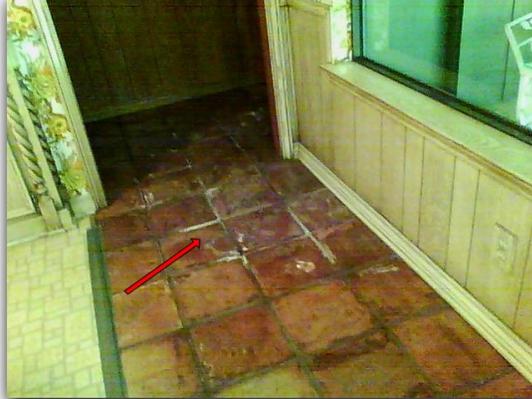
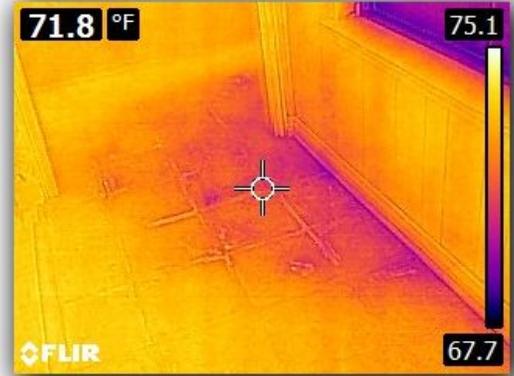
Infrared- Efflorescence. Evidence of active moisture.

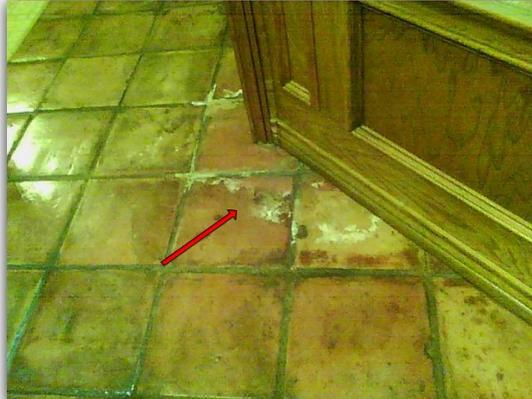
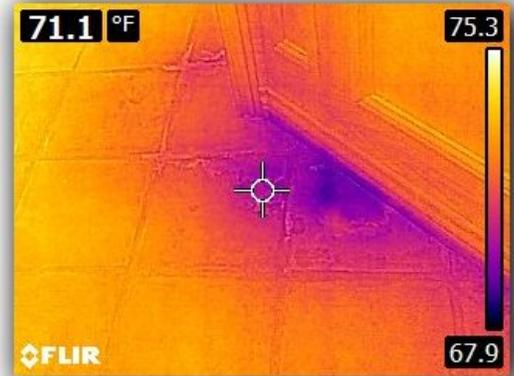
Infrared- Efflorescence. Evidence of active moisture.

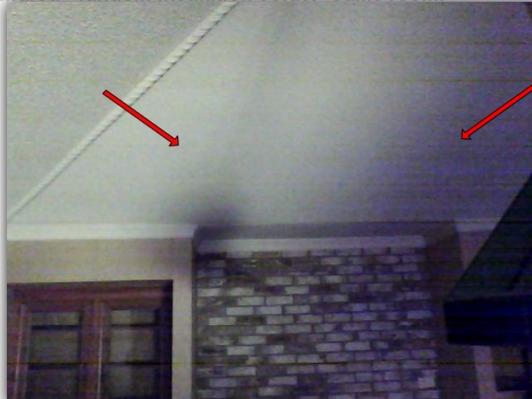
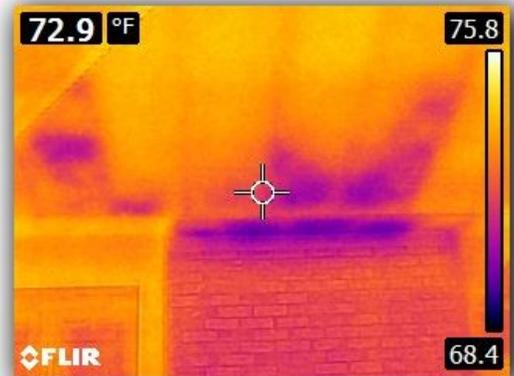
Infrared - random insulation voids. Game room.

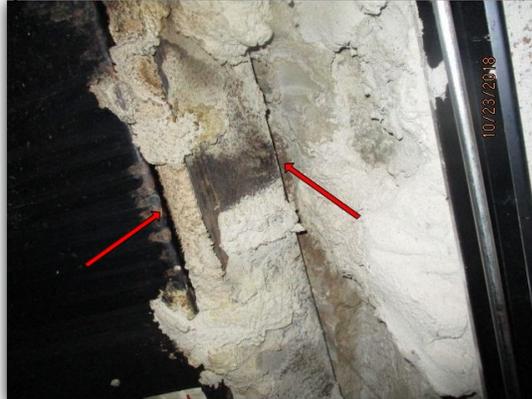
Gap at brick lintel.

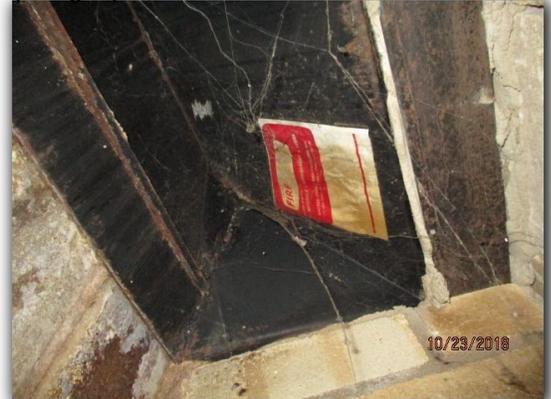
Paper tag in place.

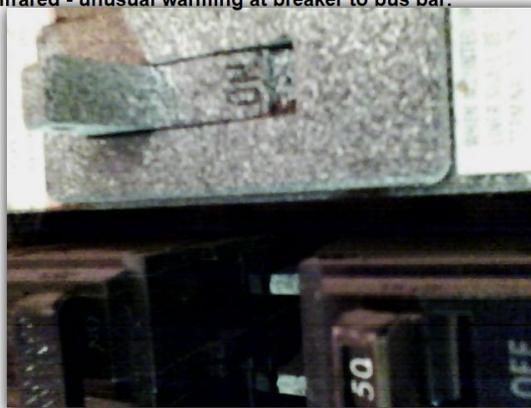
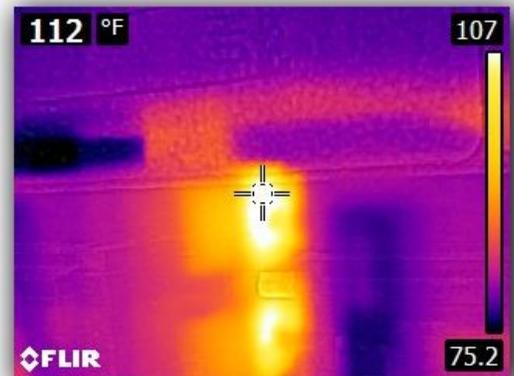
Infrared - unusual warming at breaker to bus bar.

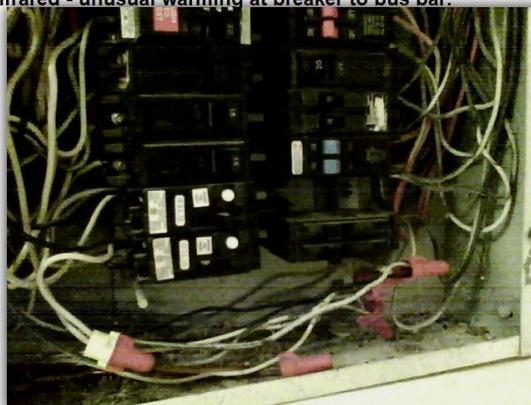
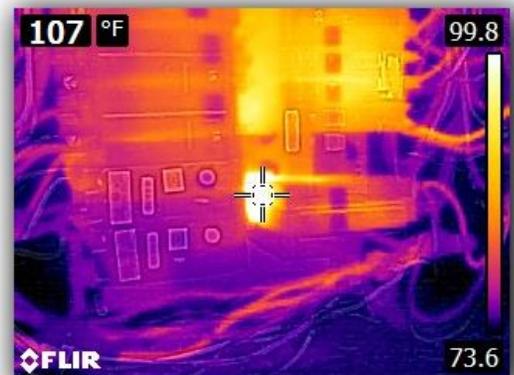
Infrared - unusual warming at breaker to bus bar.

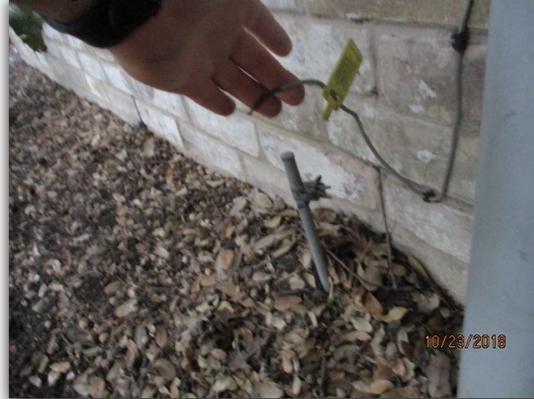
Exterior ground wire not connected.

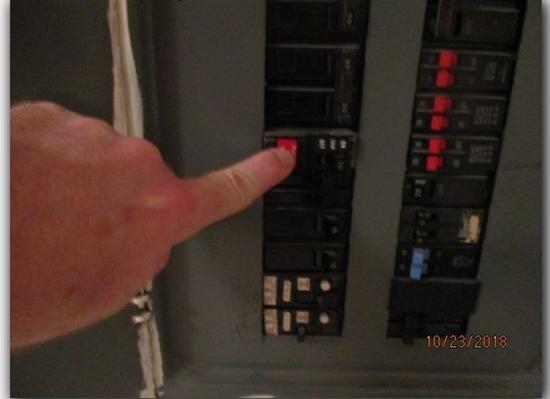
GFCI breaker not trip.

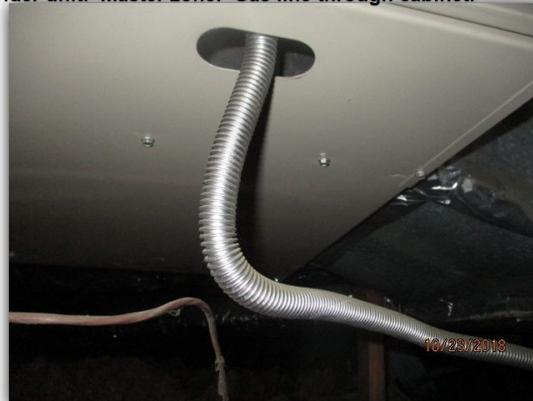
- The flexible gas supplying the furnace is not stubbed with black pipe into cabinet. It is possible for the vibration of the cabinet to slice or damage flexible gas lines. Also, current standards call for free/clear access to both ends of flex line connections.

Older unit. Master zone. Gas line through cabinet.

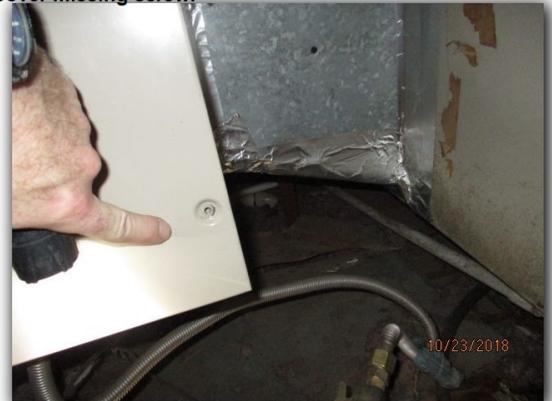
Cover missing screw.

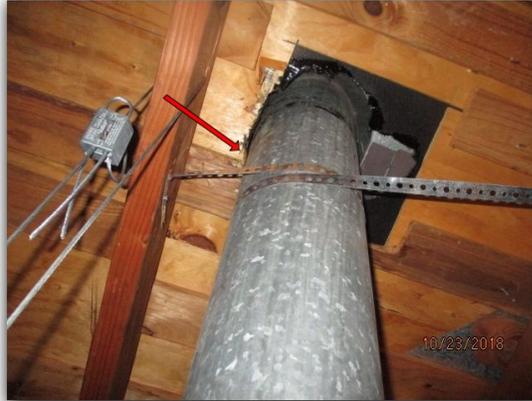
Exhaust touch roof.

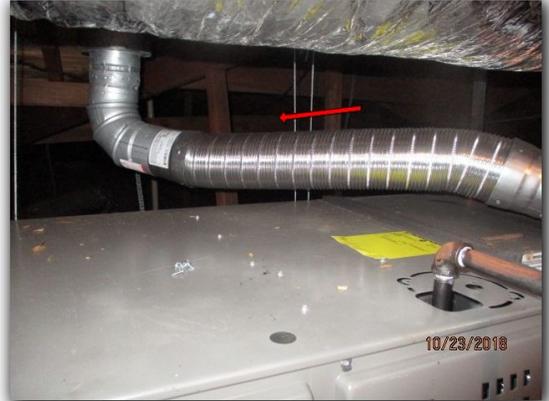
Left zone exhaust run downhill.

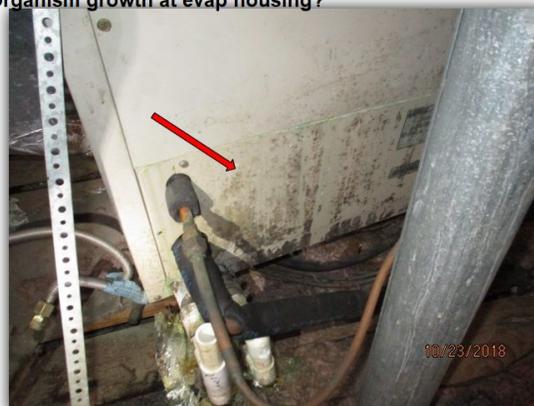
- Recommend that the HVAC system be fully inspected and evaluated by a licensed HVAC Technician.
- The master bedroom zone evaporator coil housing appears to be much older unit, and has evidence of organism or fungal type growth.

Organism growth at evap housing?

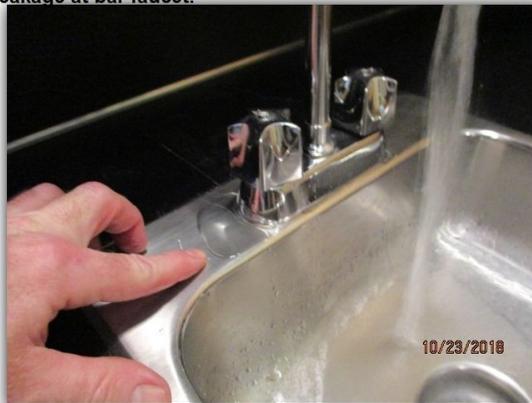
Leakage at bar faucet.

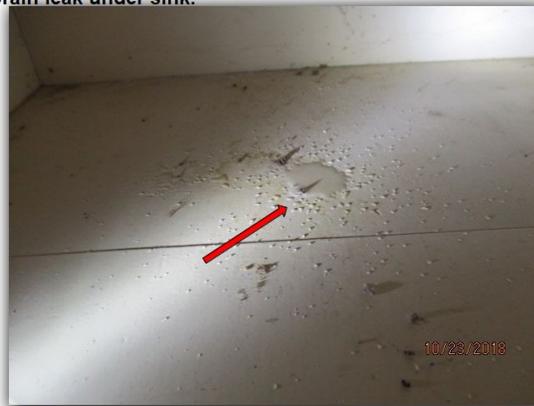
- **Recommend having the plumbing inspected/repaired by a qualified and licensed plumber.**
- Observed leak in the drain line at the jack-n-jill bath sink.

Drain leak under sink.

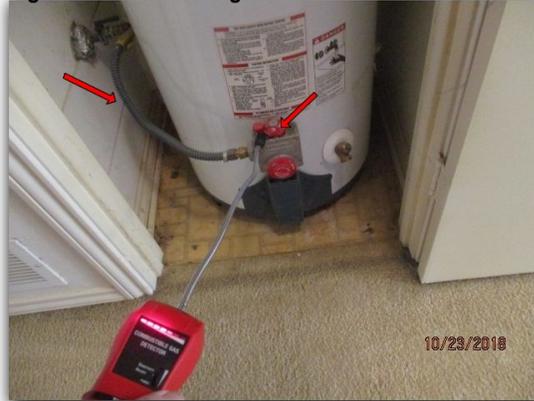
Old gas line. Gas leakage detected.

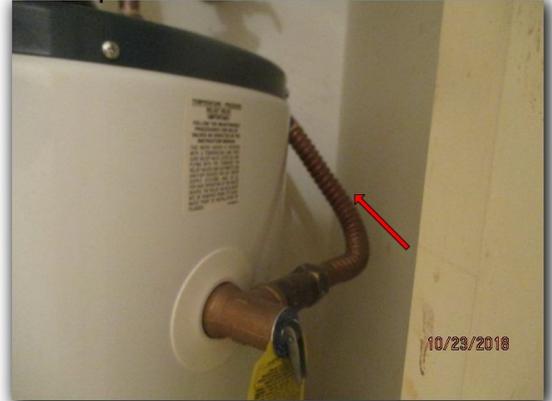
T&P runs uphill.

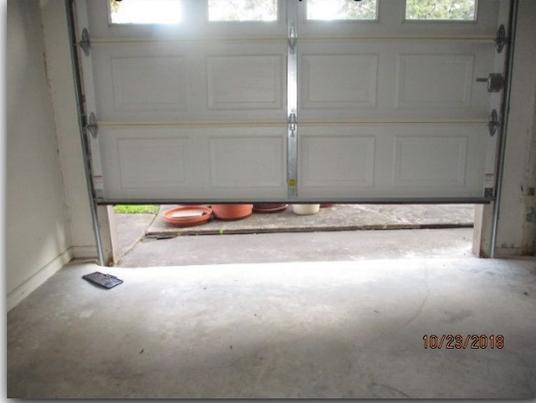
1-car door began to bind when opening.

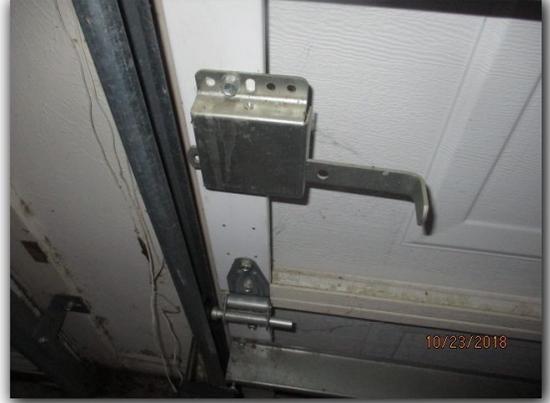
Manual lock.
