SEWER SCOPE CAMERA INSPECTION

1234 Main Street
Carrollton, TX 75007

Buyer Name
04/05/2023 9:00AM

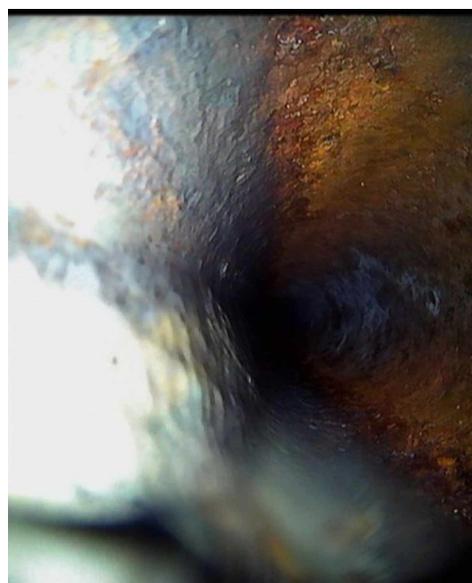
Cast Iron Drainpipes

Portions of main drain lines are cast iron. Cast iron waste lines are known to deteriorate and leak overtime. It is beyond the scope of this inspection to determine if there are leaks in the waste lines in non-visible areas. Most cast iron pipes today are over 40 years old and may be nearing the end of their life expectancy. Budgeting for future replacement is recommended. For a more detailed analysis of the cast iron waste lines, a licensed plumber should be consulted.

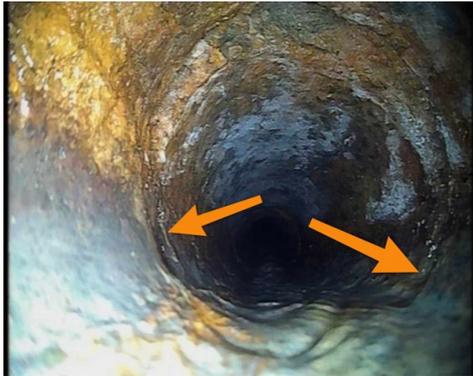
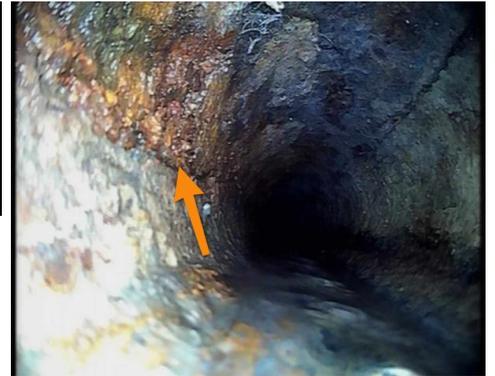
2.1.1 Deficiencies

PIPE CRACKS

There appeared to be one or more cracks observed in the drain lateral lines inspected. This can be the result of structural movement, improper installation and/or pipe manufacturers defects. If the cracks are leaking possible structural movement could occur. Leak detection is beyond the scope of this inspection. If leak detection is desired, a licensed plumber should be contracted to perform a hydrostatic leak test.

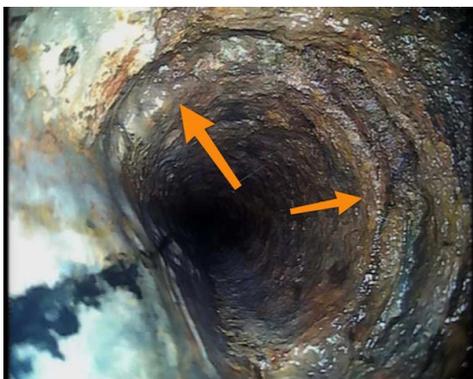
2.1.2 Deficiencies

PIPE OFFSET

There appears to be an offset in the drain pipe. An offset is a section of pipe that is separated, for one or more reasons, that leaves a gap in the drain. Offsets often occur at pipe joints due to movement or improper installation and can leak, accumulate debris, or allow roots to penetrate the drain line.

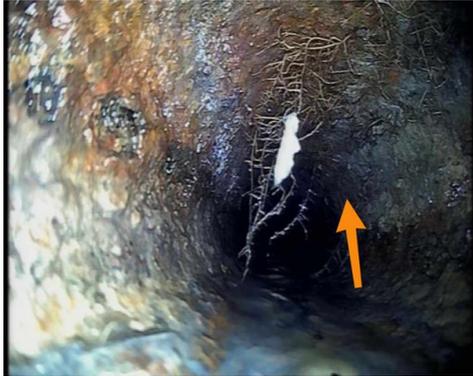
2.1.3 Deficiencies

ROOT INTRUSION

Roots were observed in the drain pipe. This may indicate a break in the line that allowed tree roots to infiltrate the line. A build up of debris in the line resulting in clogs and obstructions.

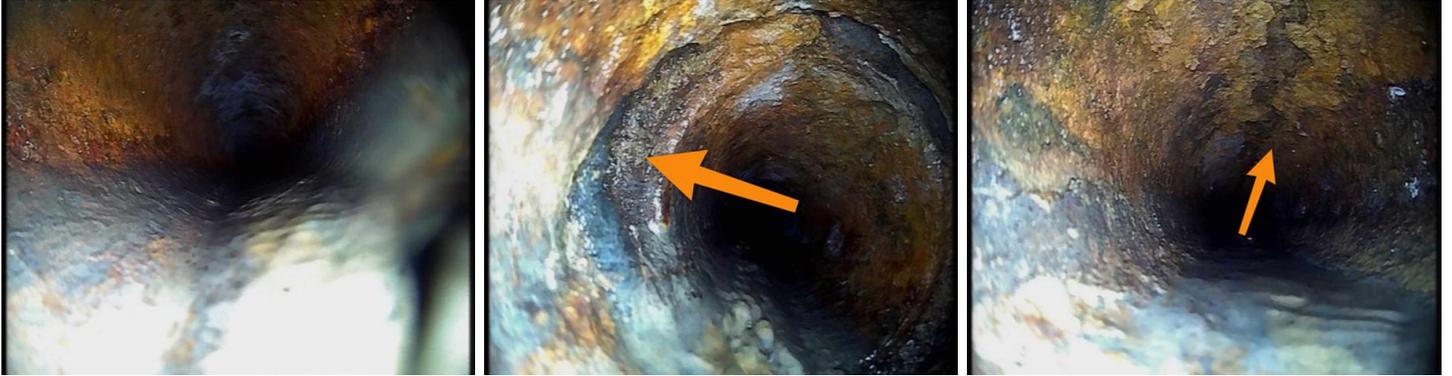
2.1.5 Deficiencies

SCALING

Scale build-up was observed on the interior walls of the drainpipe. This can result in debris build-up and potential clogging. Recommend monitoring of the condition and de-scaling or cleaning of the pipe by a licensed plumber as necessary.
