0000 Sample Inspection Way

1A. HOUSE INSPECTION SERVICES

3. 03/12/2019

4A. Sample Inspection Report

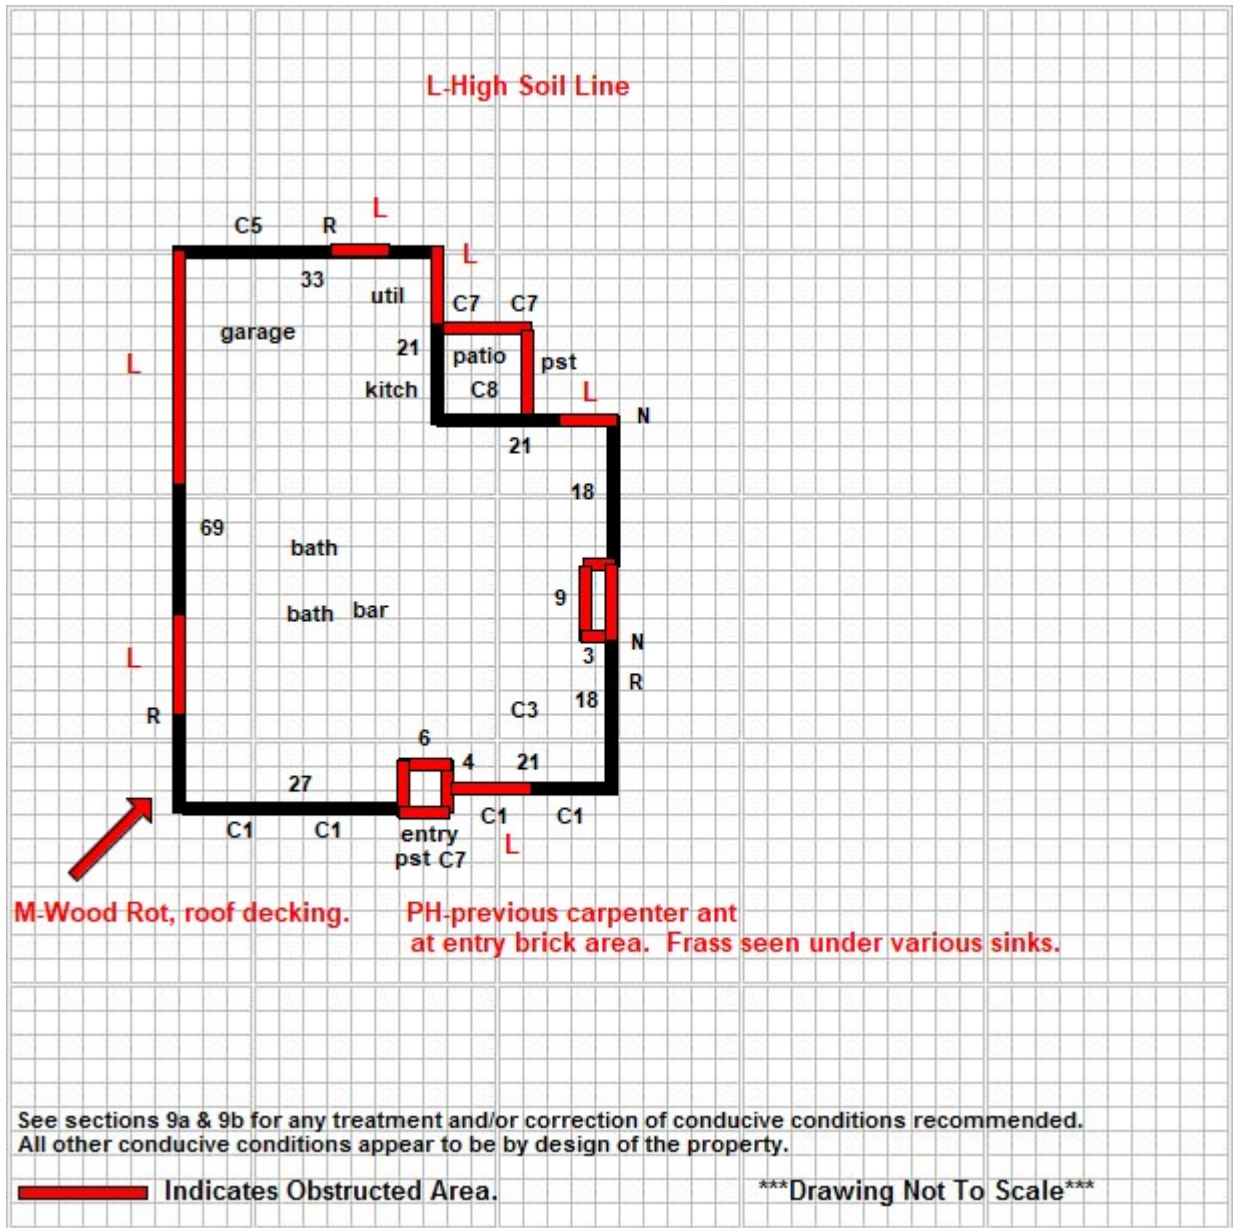
Diagram of Structure(s) Inspected

8G. Visible evidence of: Previous carpent ant infestation and/or damage has been observed in the following areas: Front exterior
If there is visible evidence of active or previous infestation, it must be noted. The type of insect(s) must be listed on the first blank and all identified infested areas of the property inspected must be noted in the second blank.

The inspector must draw a diagram including approximate perimeter measurements and indicate active or previous infestation and type of insect by using the following codes: E- Evidence of infestation; A-Active; P-Previous; D-Drywood Termites; S-Subterranean Termites; F-Formosan Termites; C-Conducive Conditions; B-Wood Boring Beetles; H-Carpenter Ants; Other(s) - Specify PH- Previous carpenter ant damage/evidence, PST- Previous treatment, M- Wood rot, L- High soil line, R- Wood fence, N- Heavy foliage, C1- Wood mulch, C3- Sunken room, C5- Garage trimmers, C7- Wood posts, C8- Wood trellis

Additional Comments Treatment is recommended because of evidence of previous infestation with no prior treatment. Recommend consulting with owner/seller of property regarding any history of WDI treatments.

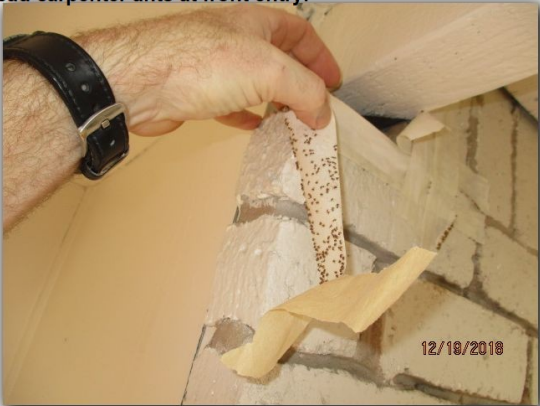
Dead carpenter ants at front entry.

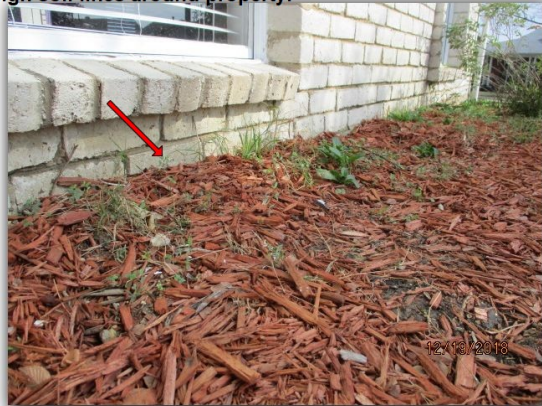
High soil lines around property.

9B. A preventive treatment and/or correction of conducive conditions as identified in 7A & 7B is recommended as follows: Yes [x] No [ ]
Specify reason: M- Wood Rot, L- High Soil Line
Refer to Scope of Inspection Part J

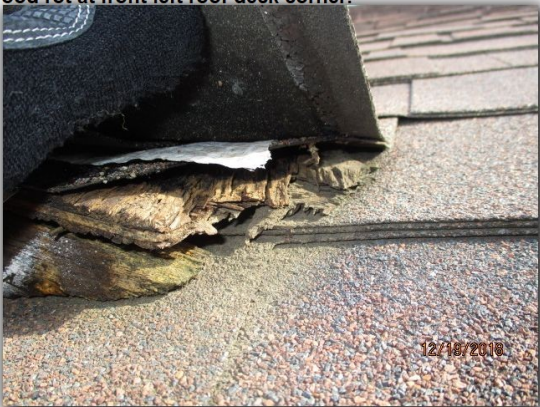
Wood rot at front left roof deck corner.
