Structural Engineering Report For **The Guild House** **62 South Swan Street Albany, NY**

Executive Summary:

On November 14, 2023 and January 18, 2024, Bryan Clapper, PE, from Clapper Structural Engineering, PLLC performed an inspection of the Guild House. The purpose of the inspections was to review the existing structural condition of the building.

The Guild house is an existing 3 story wood framed building with brick and clay tile masonry bearing walls. It is understood that the original building was built in 1902 and renovated/alterd in the late 1940s.

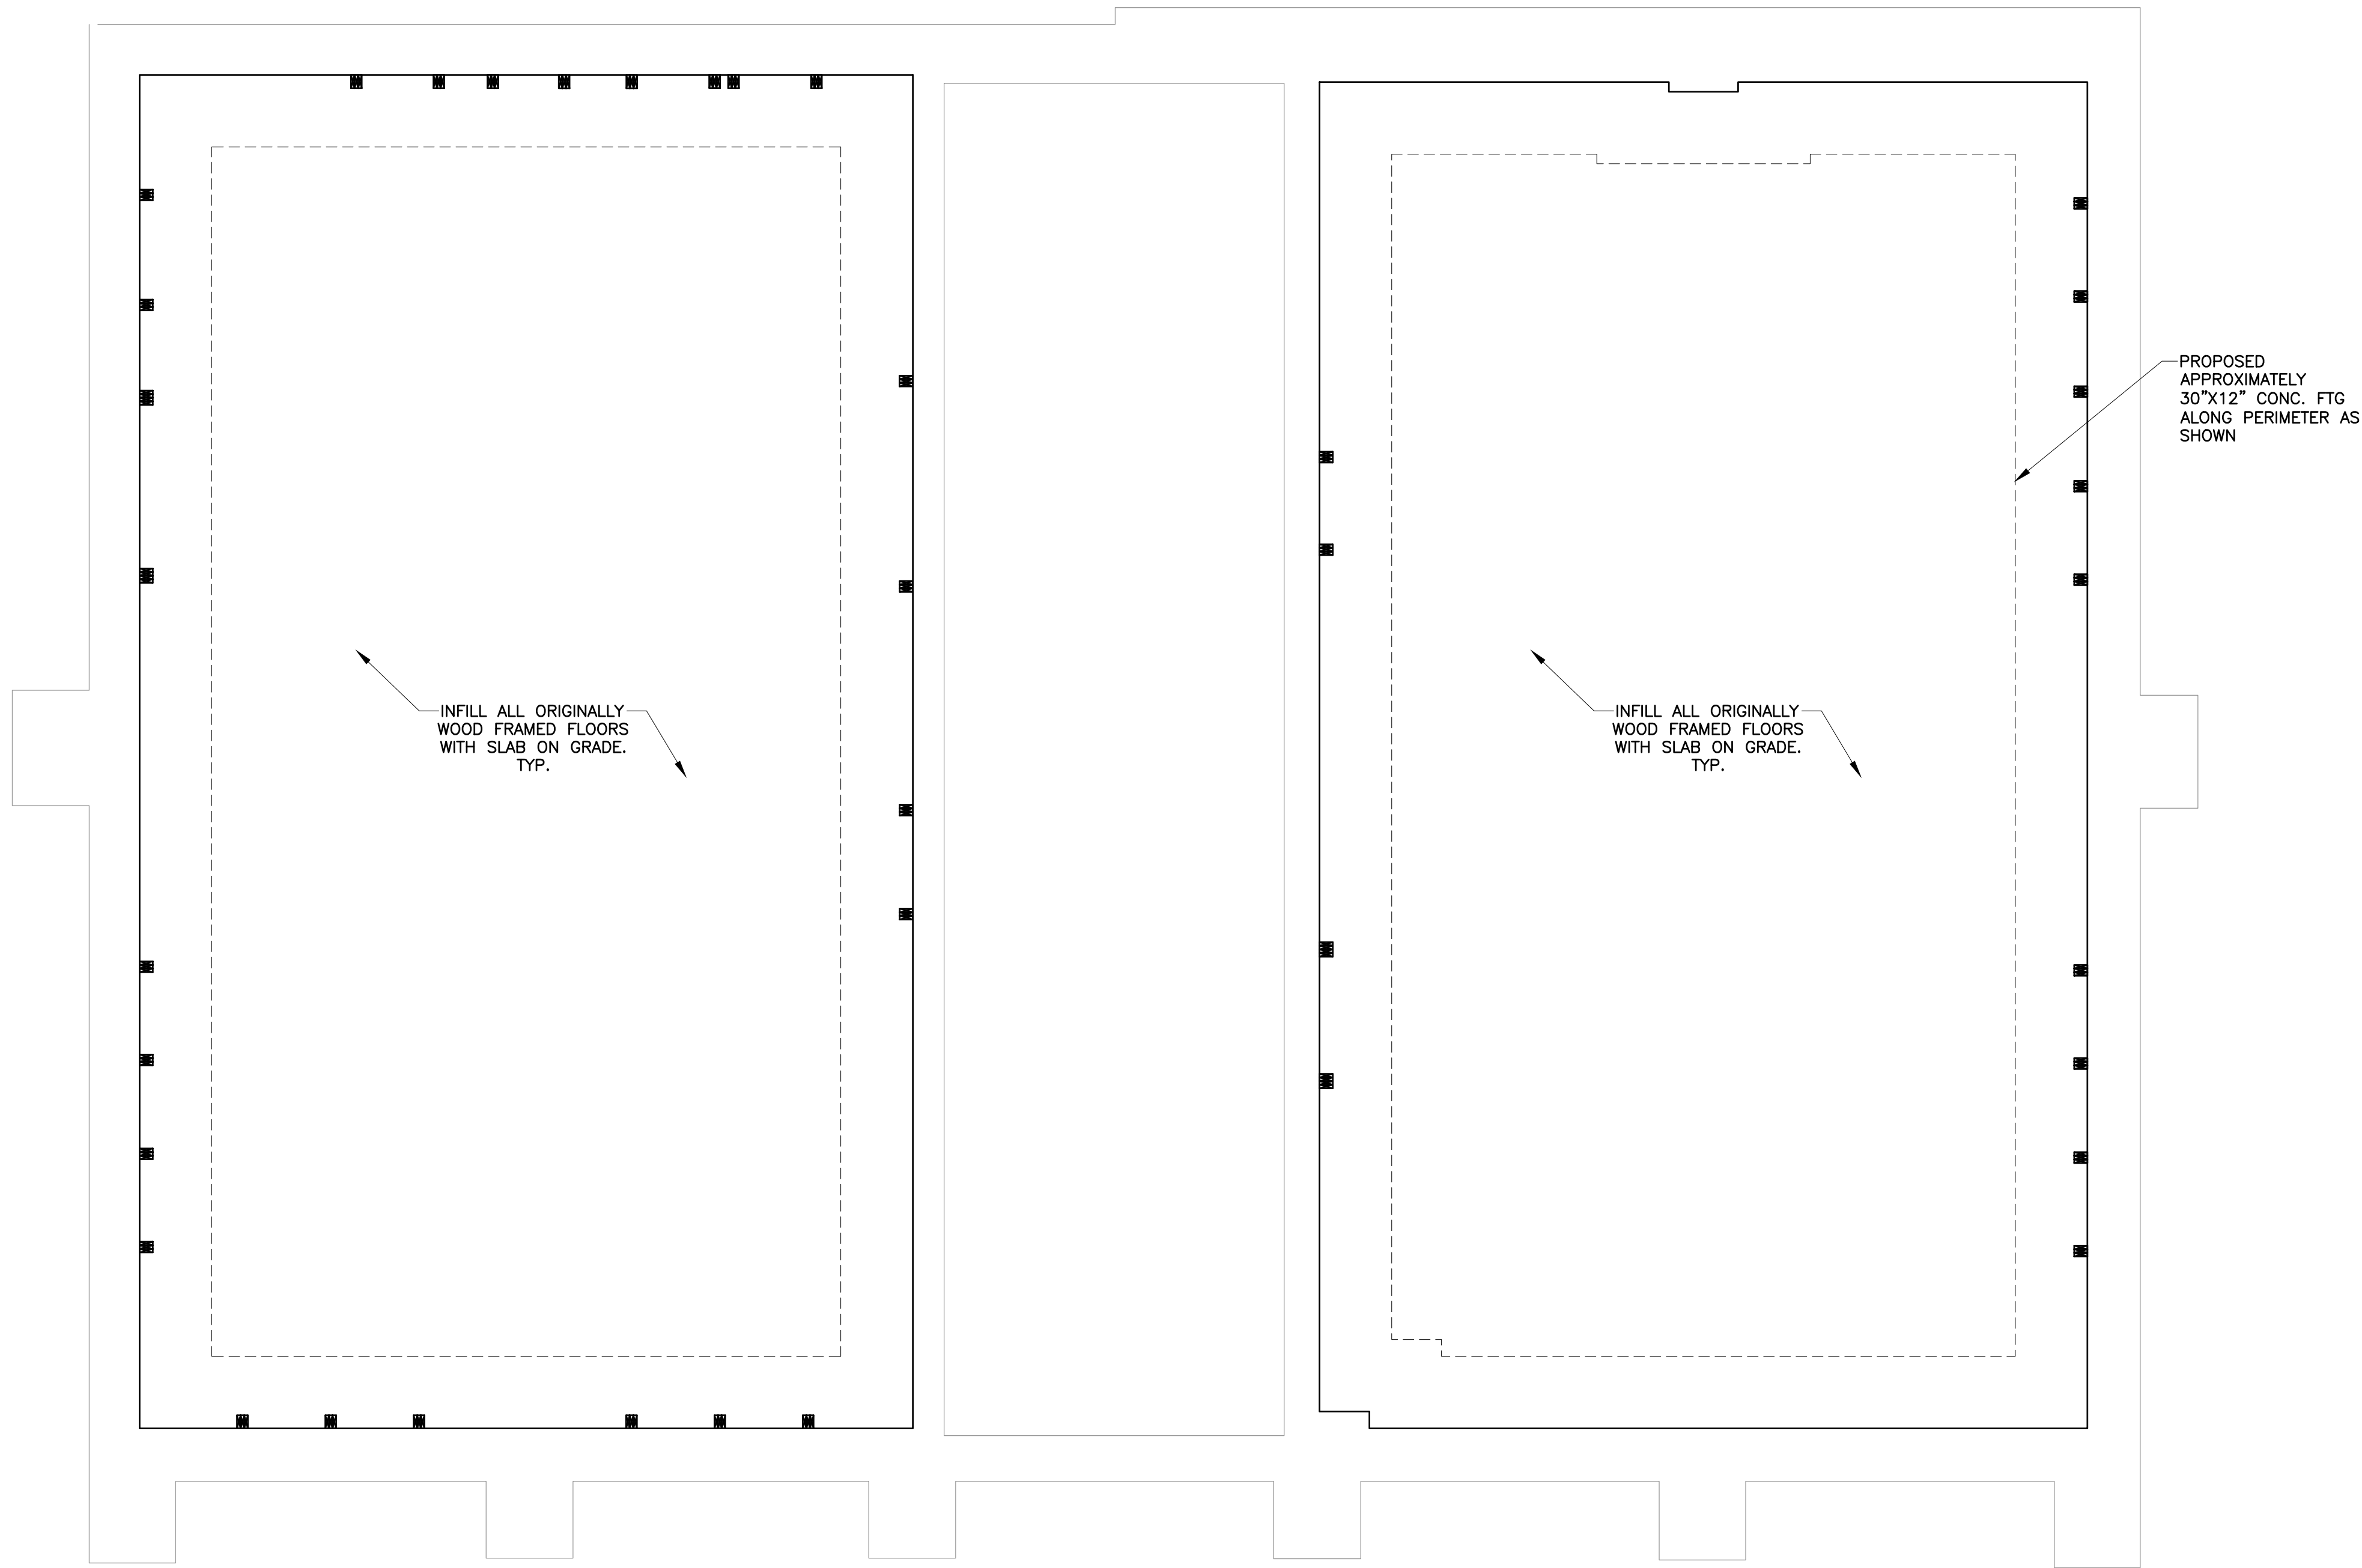
1 SCHEMATIC FOUNDATION PLAN
S-101 SCALE: 1/4"=1'-0"

The foundations were not exposed for visual inspection during the site visits. The majority of the floor and roof load will now be supported on the new wood framed bearing walls as described above. Beneath the bearing walls will need to be new footings. The new footings will support the majority of the floor and roof loading and will unload the existing foundation. Any areas in the existing foundation walls that are showing signs of settlement will need to be further reviewed and design for stabilization will be required.

- The first step of each sequence would be to build new foundation elements to support what will be the new wood framed bearing walls.
- The second step would be to remove the 2nd floor framing in the area, build new wood framed bearing walls, then replace the floor framing.

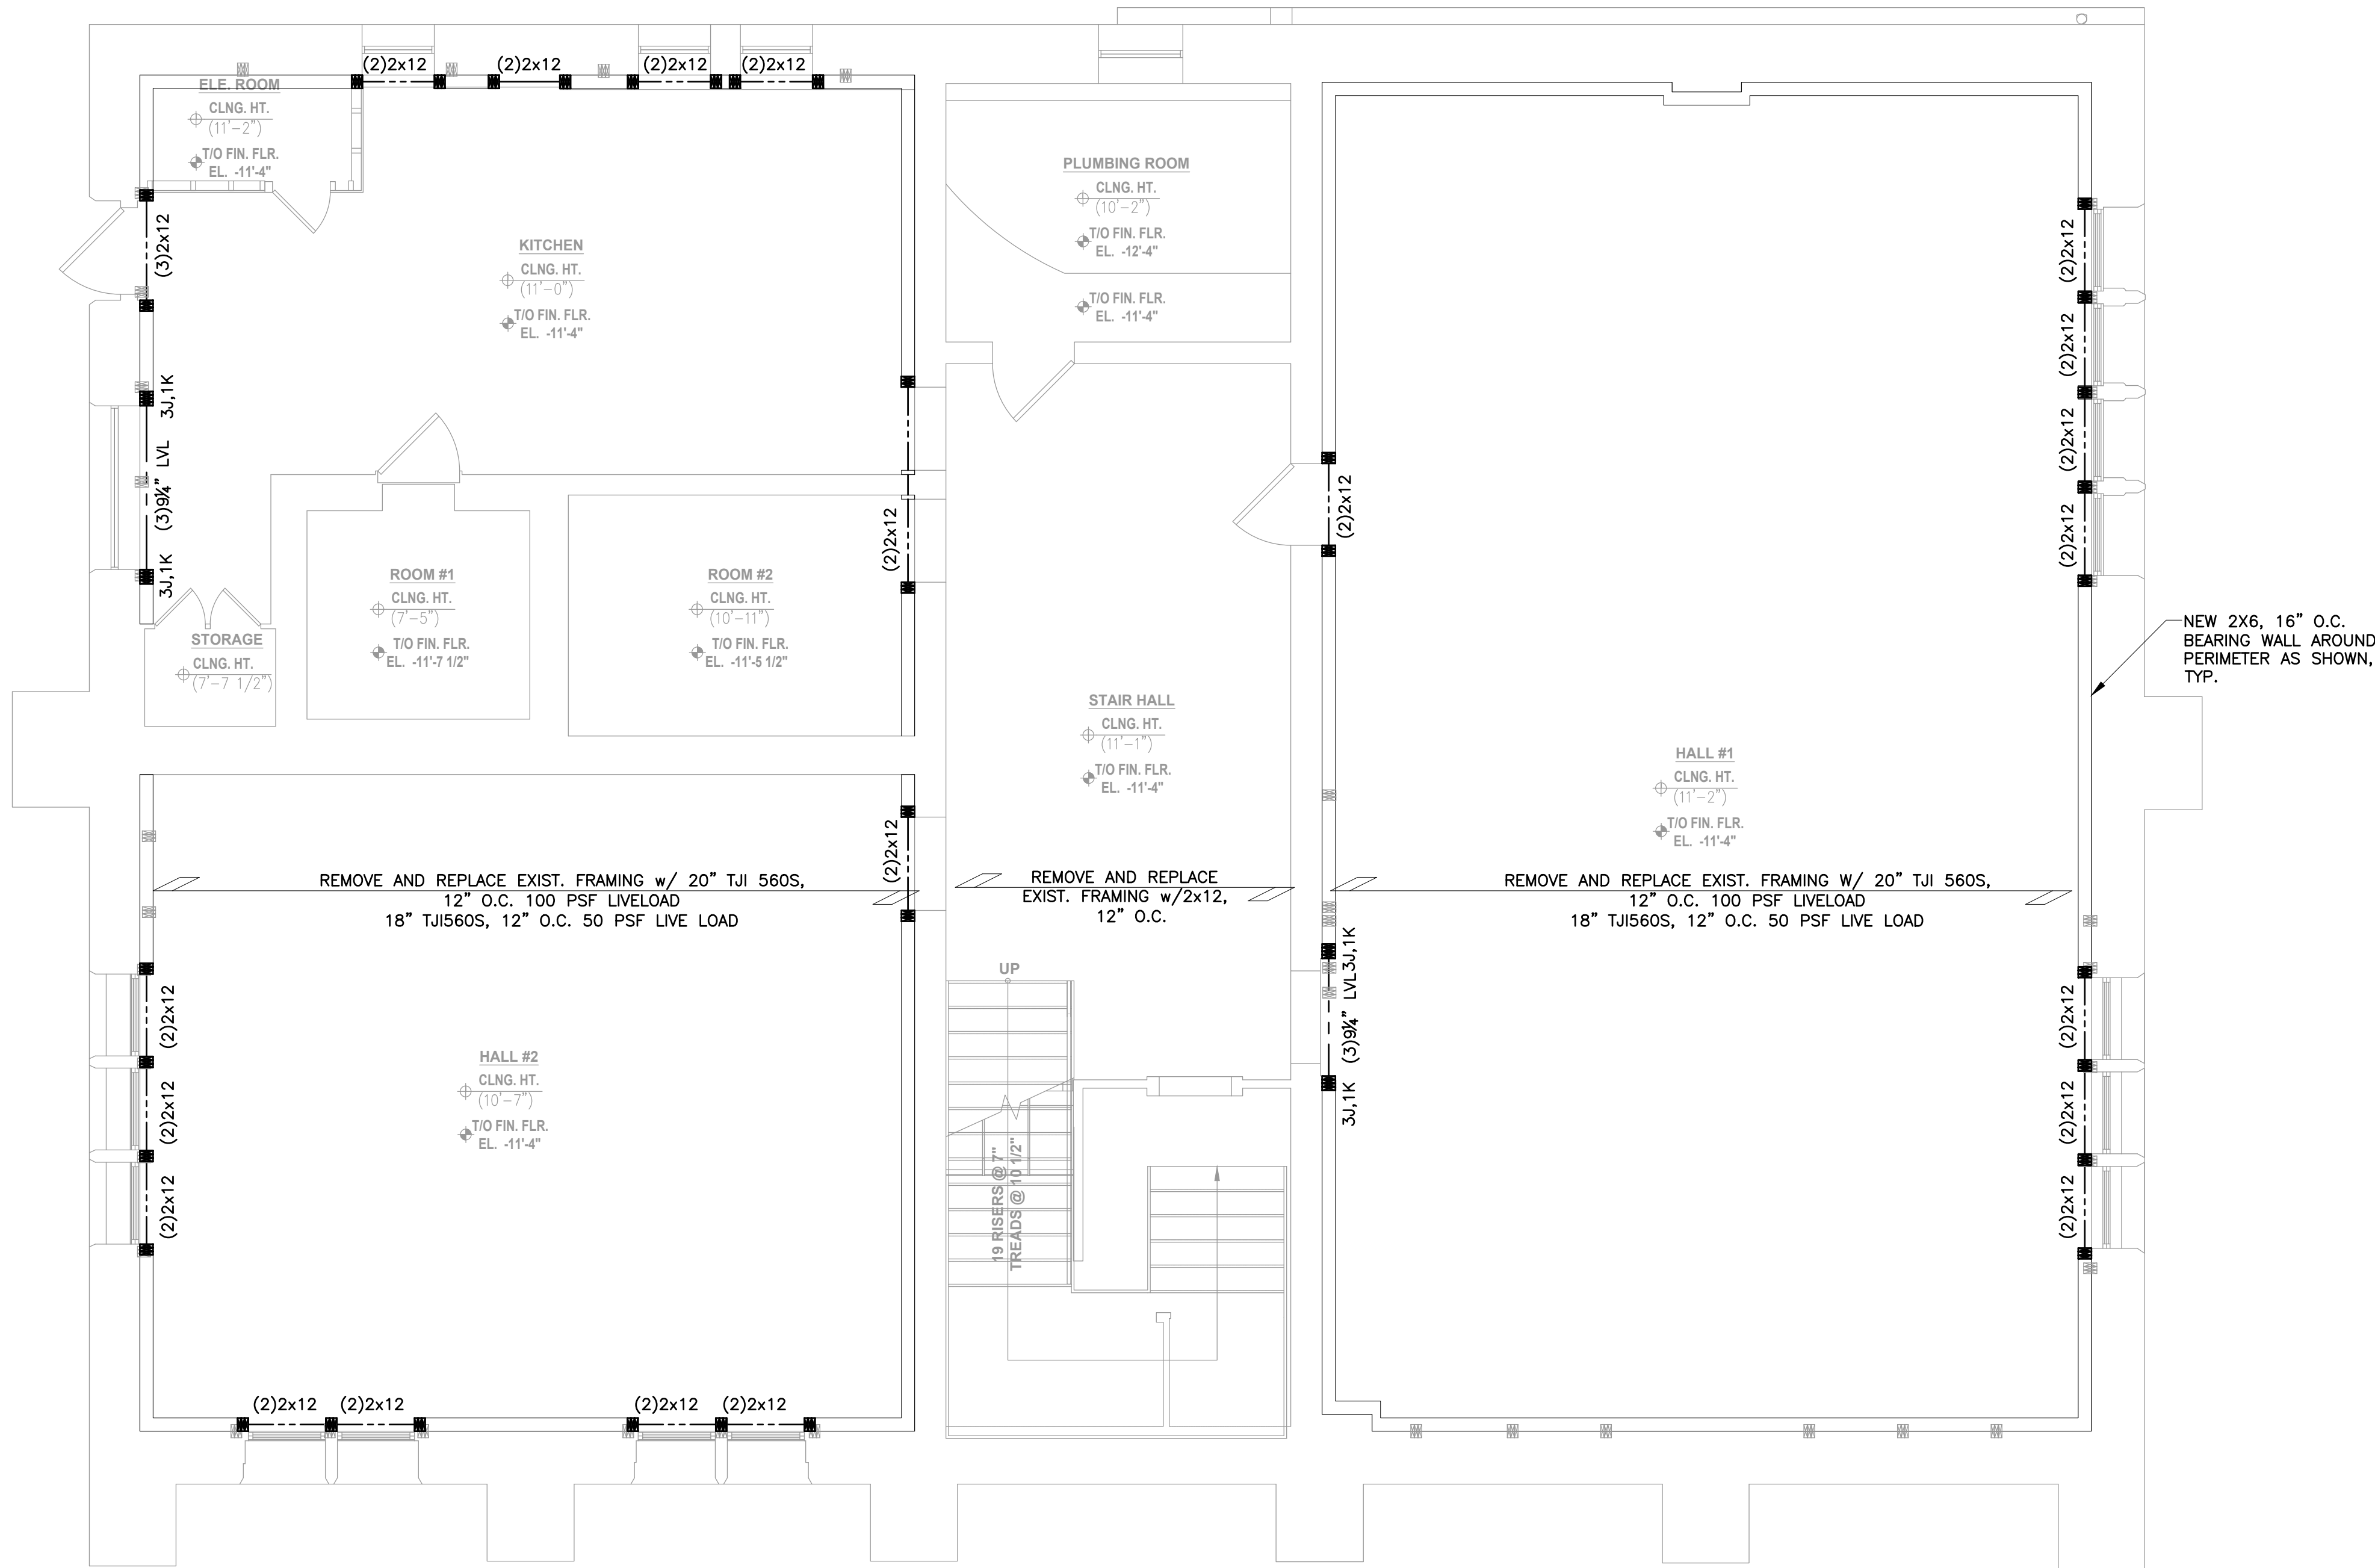
1 SCHEMATIC 2ND FLOOR FRAMING PLAN
S-102 SCALE: 1/4"=1'-0"

- The wood framing for the two upper floors is in poor condition; there are areas where the floor framing is collapsed. Where the wood meets the bearing walls, the ends of the joists are damaged beyond repair in several locations.
- The steel beams were not fully exposed at the time of inspection. Assuming they are in good condition it is recommended that they remain in place.
- Based on the condition of the wood framed joists for the upper floors it is recommended that all the floor joists be removed in their entirety and replaced. This is shown graphically in the schematic structural plans attached.
- In areas of the 1st floor where wood framing was originally installed, it is recommended from a structural perspective to remove the remainder of the wood framing, install a proper crushed stone subbase and vapor barrier, and provide a concrete slab on grade.

- The second priority is to reattach the floor diaphragms to the masonry exterior walls. This will need to be performed in a sequential manner. Our original concept is to perform this in approximately 8 sequences.

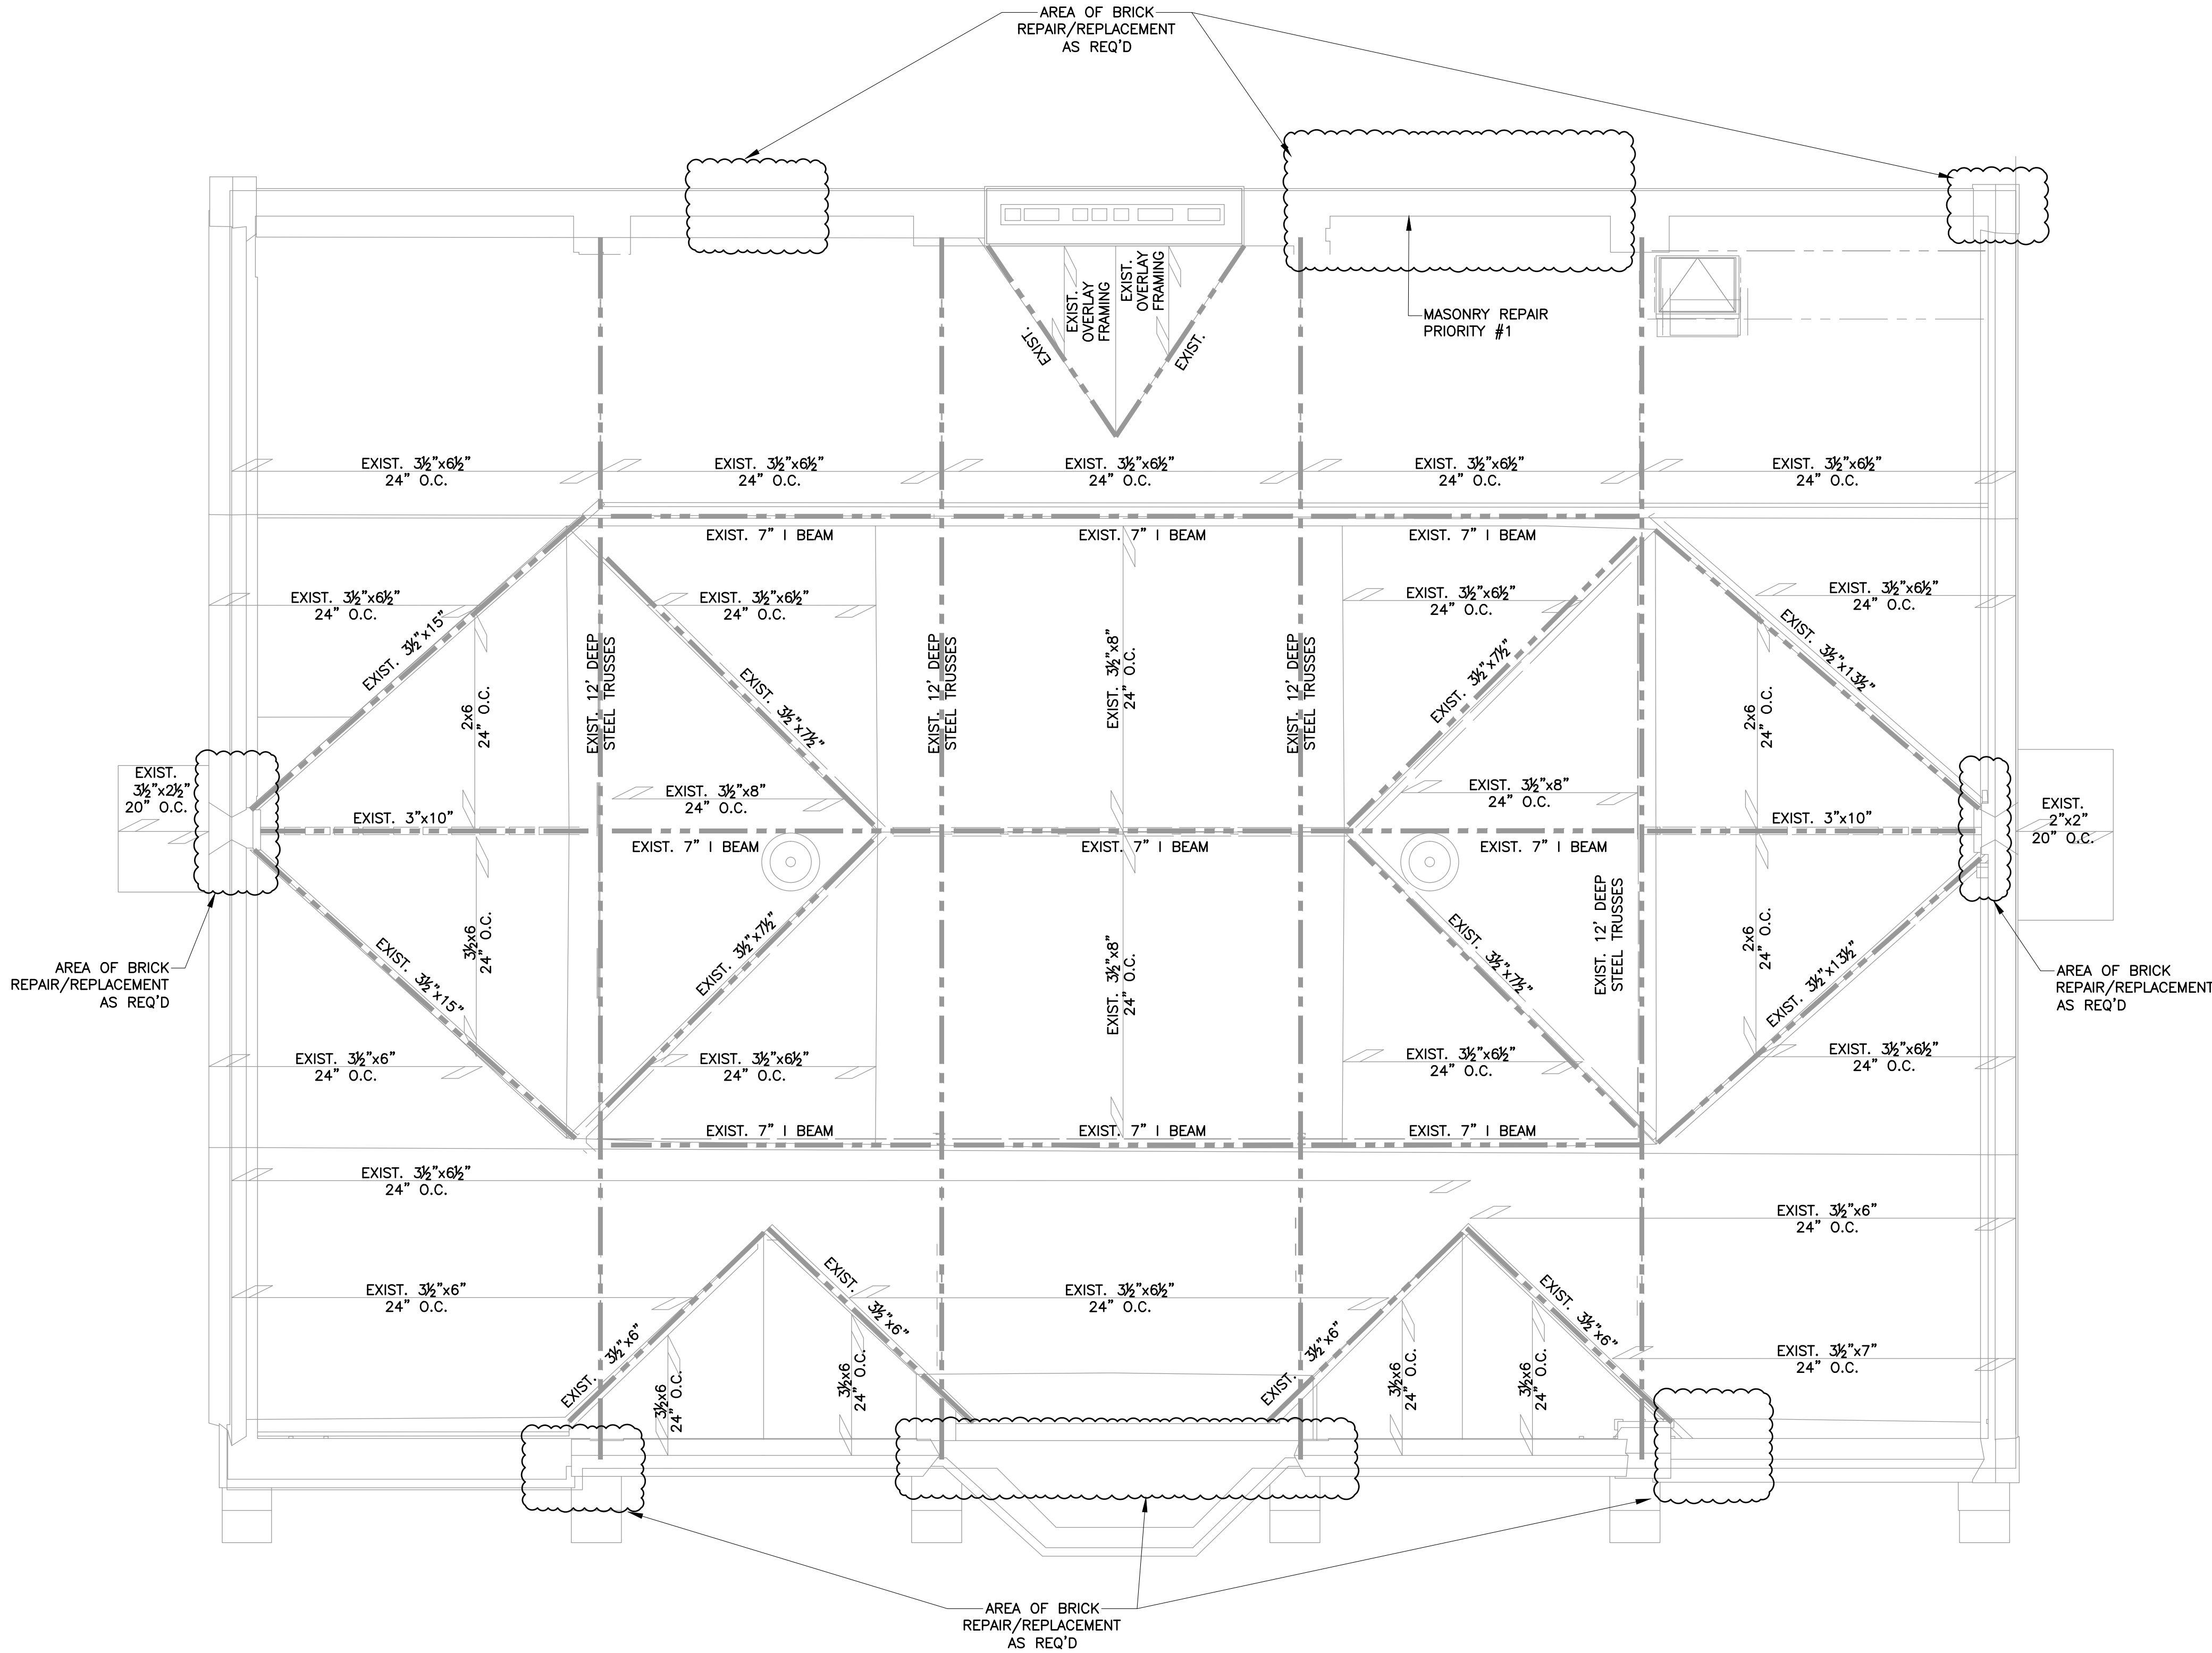
1 SCHEMATIC ROOF FRAMING PLAN
S-104 SCALE: 1/4"=1'-0"

- The purlins/rafters appeared to be in good condition at the time of inspection. The inspection was performed from the floor. A closer inspection will be needed after the floor framing is stabilized. Any damaged or rafters/purlins will need to be sistered or replaced. From our inspection it appears that minimal reinforcement will be needed, but this will need to be confirmed when safe access can be provided.

- In the locations where purlins/rafters are supported by the exterior masonry bearing walls, they are pocketed into the masonry. Each of these locations should be inspected when safe access can be provided. It is likely that these rafter ends have rot/deterioration. Any areas that have rot will need to be sistered and resupported.

- The valley rafters are damaged at the locations where they bear on the exterior masonry walls. In some locations these valleys are damaged beyond repair at the bearing location. It is recommended that these valleys be re-supported by adding supplemental steel supports and/or by replacing the valleys in their entirety. It is recommended that new wood framed walls be installed around the perimeter of the building. These walls will be used for support and columns can be placed in the locations of the valleys for support.

- The steel trusses were in fair condition at the time of inspection. It is recommended that surface rust be removed, and the steel be recoated with adequate paint. Where the ends of the trusses bear on the exterior masonry wall it is recommended that new supports are added. This can be done with new steel columns and site fabricated reinforcement plates.

- With the floor stabilized, all required roof framing repairs and reinforcement can take place.
- All masonry repairs from the interior can also take place from the 3rd floor to the roof.
- Finally new wood framed walls can be installed after the masonry repair is complete.
- Simultaneous to these repairs, exterior masonry repairs can be made.
