INSPECTION REPORT

Prepared for: .
Inspection Date: Wednesday, August 26, 2020
Prepared by: Marlon Burwell

BURWELL HOME INSPECTIONS, LLC

RE: Report No. 1006

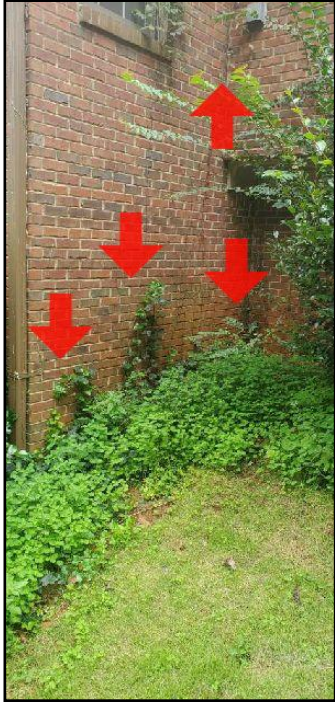
9. potential moisture intrusion

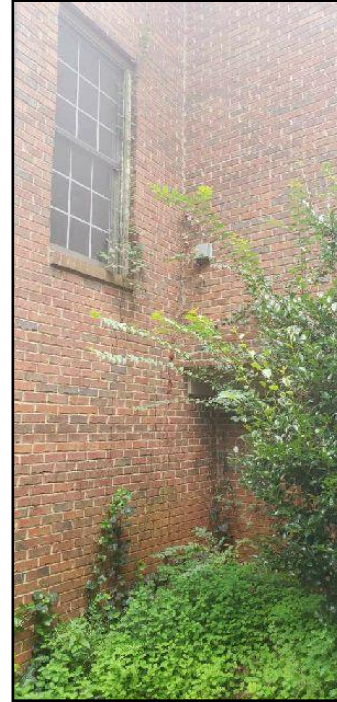
12. potential moisture intrusion

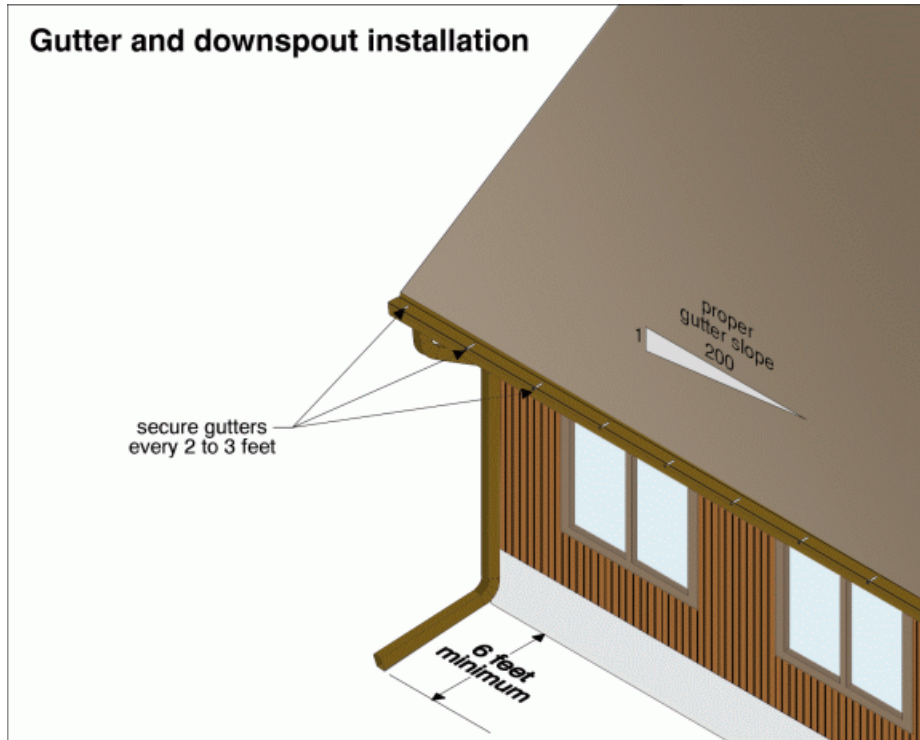
2. Condition: • [Should discharge 6 feet from building](#)

Implication(s): Chance of water damage to contents, finishes and/or structure

Location: Throughout Exterior

Task: Improve

Time: As soon as possible

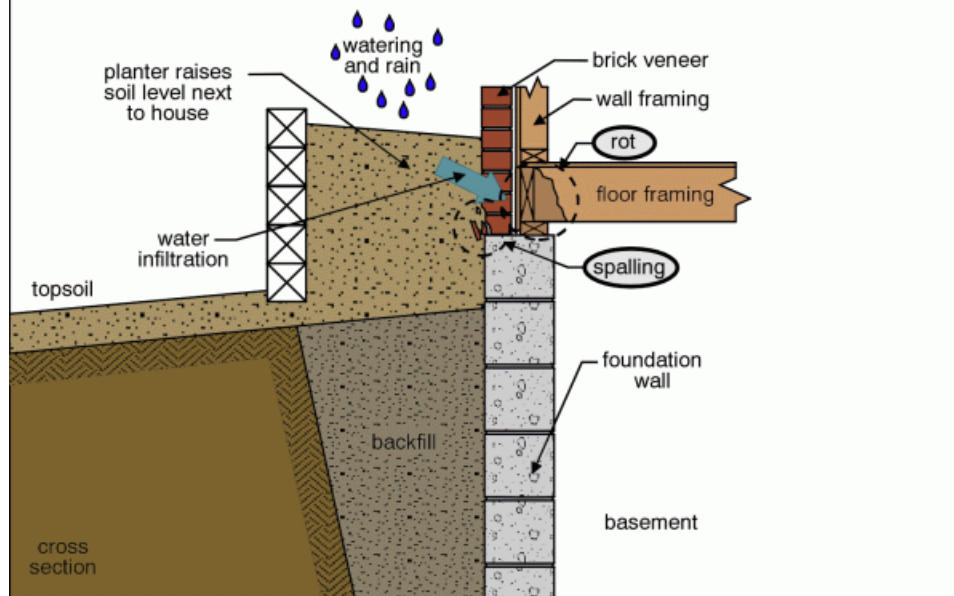
4. Condition: • [Planters and gardens against walls](#)

Implication(s): Chance of water entering building | Chance of damage to structure | Chance of structural movement

Location: Throughout Rear

Task: Improve

Watch for planters or gardens against walls

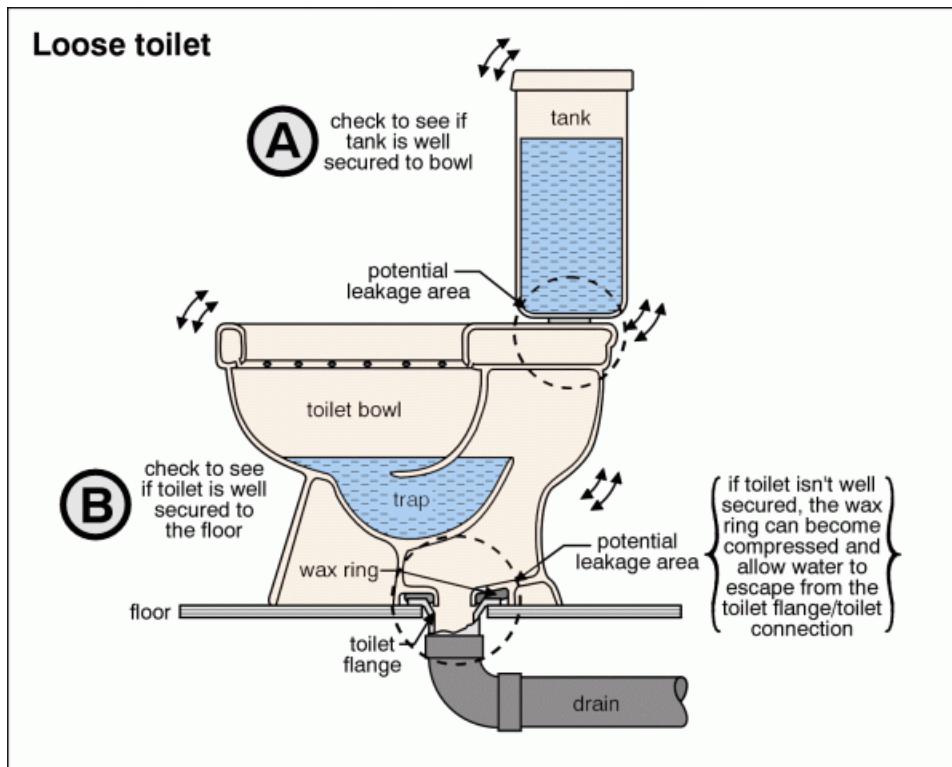
13. Condition: • [Loose](#)

Implication(s): Chance of water damage to contents, finishes and/or structure | Sewage entering the building | Possible hidden damage

Location: First Floor Second Floor Master Bathroom Hallway Bathroom

Task: Repair

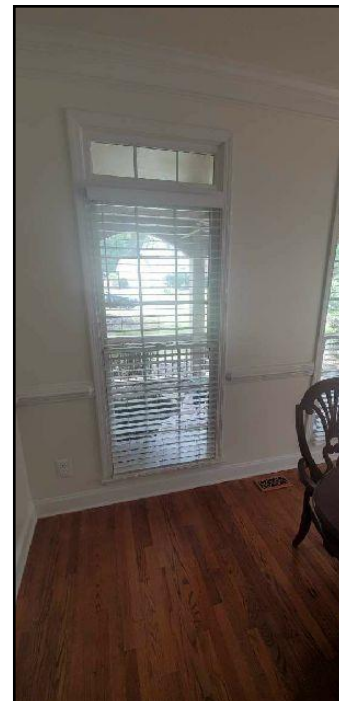
clogged vent. dining room

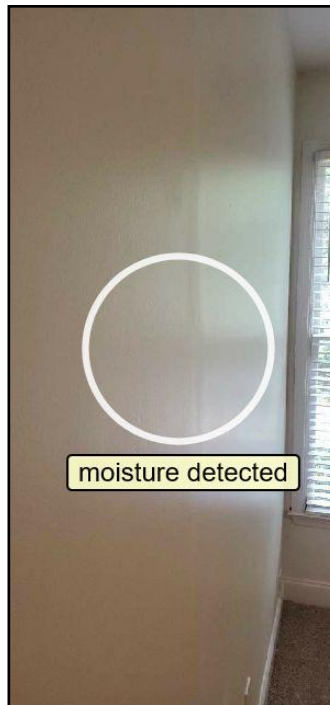
Moisture present

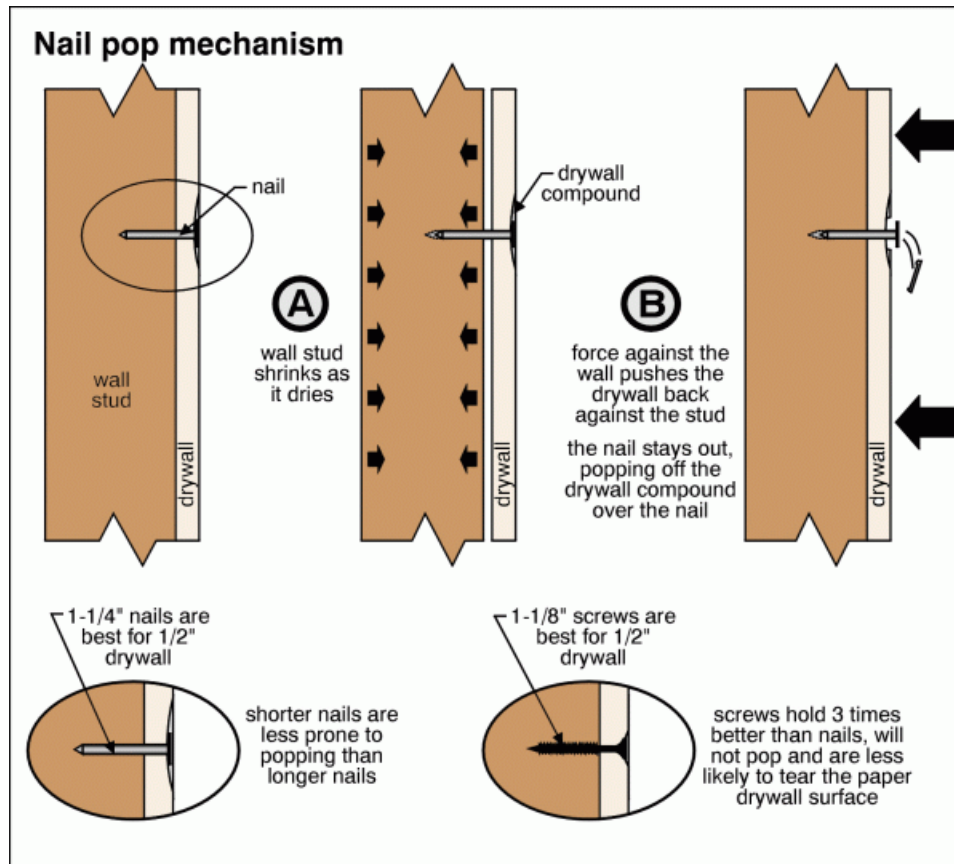
14. Condition: • [Nail pops](#)

Task: Repair

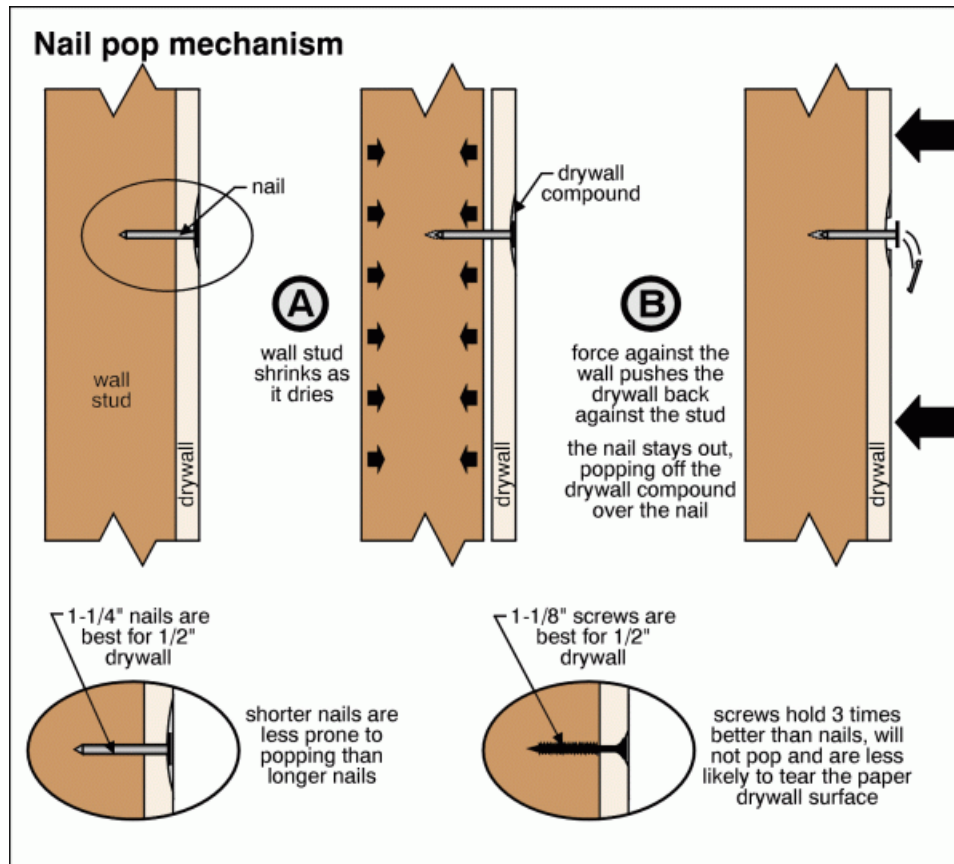
WALLS \ Plaster or drywall

15. Condition: • [Nail pops](#)

Task: Repair

Time: If necessary
