## TopHome Inspection LLC

## Home Inspection Report

**3520 Primrose Ave**

Inspected on Thu, Sep 23 2021 at 2:00 PM

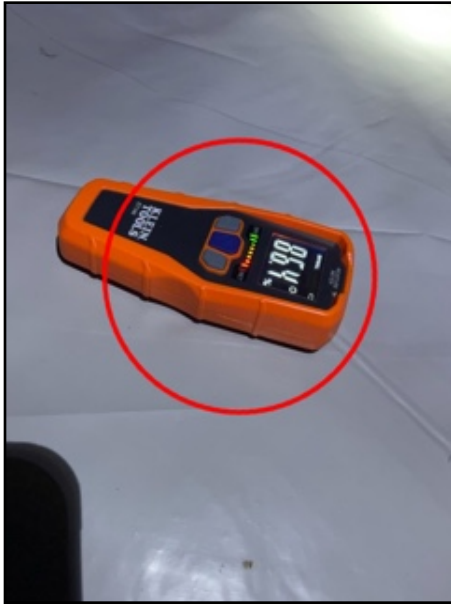
Figure 6-1

Comment 6:

There were several area inside the crawlspace that were wet and moist this indicates major water intrusion. This will cause damaged and problems to the foundation and the property. Recommend further evaluation and repairs by a qualified crawlspace specialist.

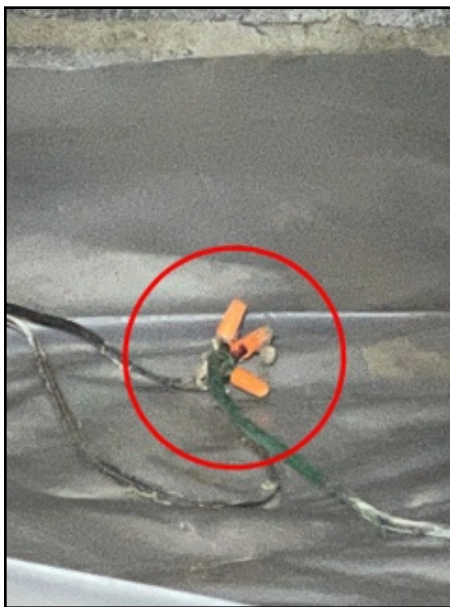
Figure 7-1

**Comment 7:**

I noticed improperly concealed electrical cables inside the crawl space, they should be properly concealed in a junction box. This is a safety hazard and all wires should be secure to the floor joists. Recommend further evaluation and repairs by a foundation specialist.

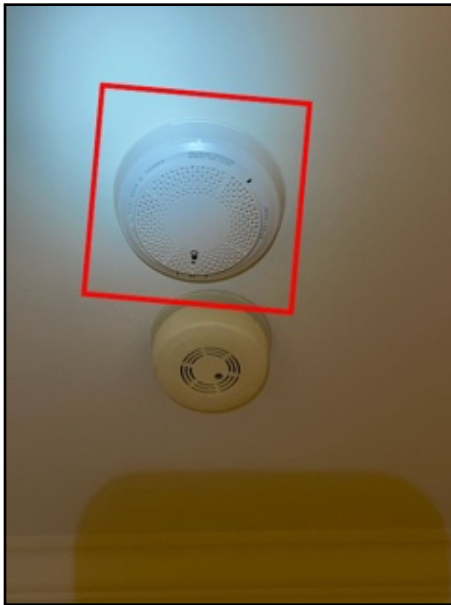
Figure 8-1

**Comment 8:**

I noticed several smoked detectors in the house but according to the National Fire Protection Association (NFPA), smoke alarms should be installed on every level of your home. Fire detectors should also be installed inside of every bedroom and outside of each sleeping area as well as at least 10ft away from the kitchen. This is a major safety concern as failure to properly detect fires will allow further damage to occur and put lives in danger. Recommend installing more fire detectors by a general contractor.

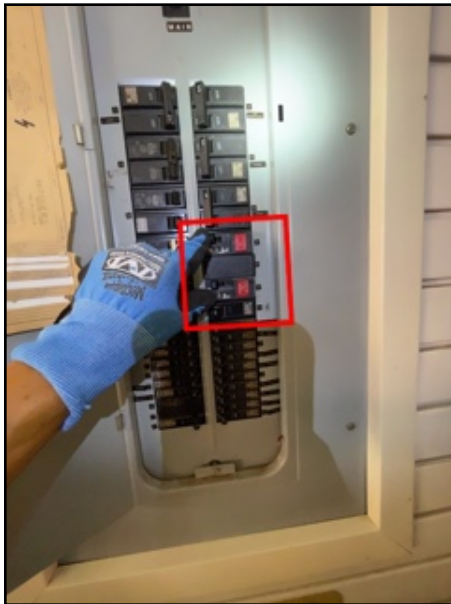
Figure 10-1

Comment 10:

I noticed loose breakers in the panel. Loose and disconnected wires can become hot enough to start fires or can create serious shock hazards because the breaker doesn't always trip and shut off the power. Recommend further evaluation by a liscense electrician.

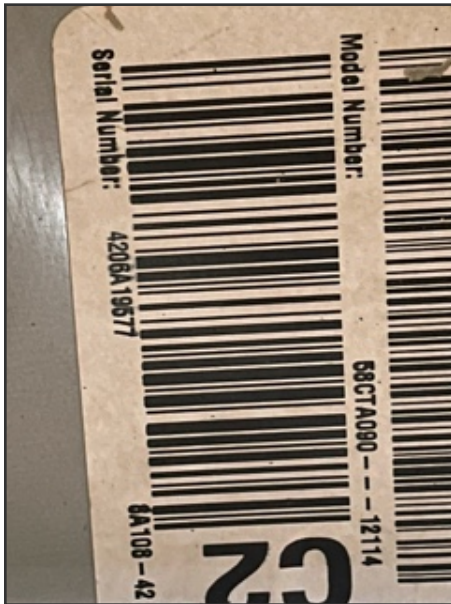
**Comment 11:**

I noticed that the heat pump didn't have a water pan. This will allow moisture intrusion into the foundation and cause further damages. Recommend further evaluation by an HVAC specialist.

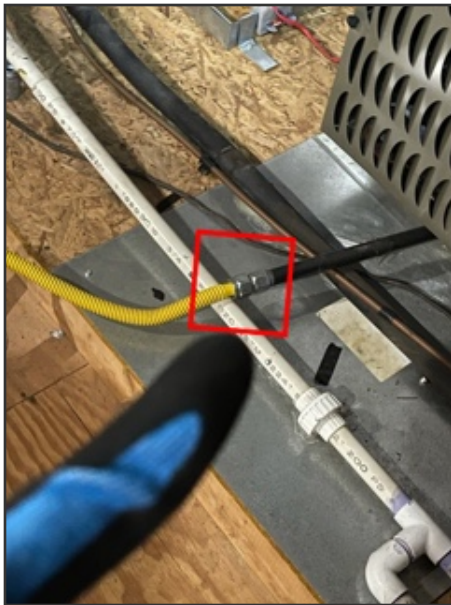
Figure 12-1

Comment 12:

At the time of the inspection a shut off valve was not visible near the heat pump. This is a safety hazard. Recommend further evaluation by a heater contractor.

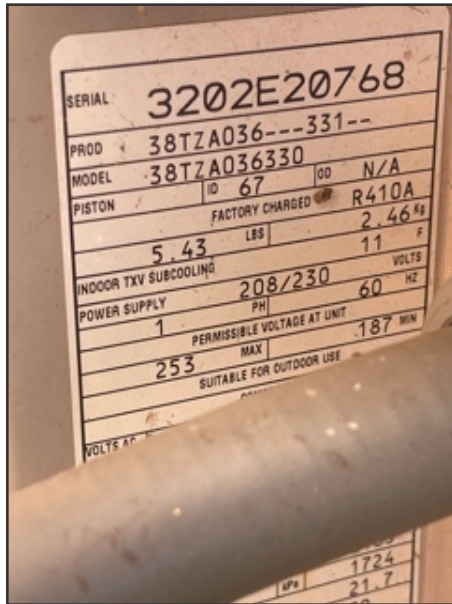
Figure 13-1

**Comment 13:**

The HVAC system is past the expected life expectancy. Recommend further evaluation by a qualified HVAC specialist.

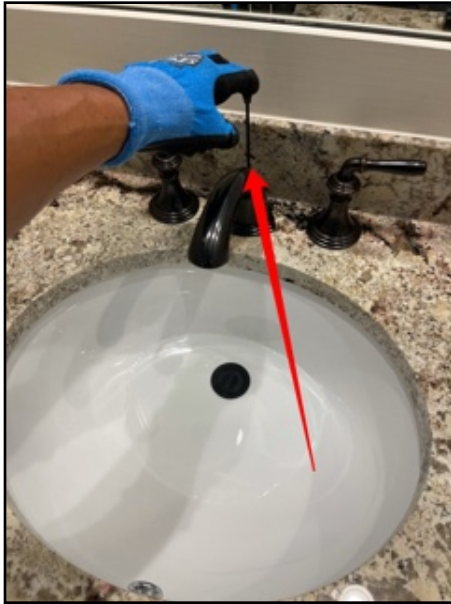
Figure 18-1

**Comment 18:**

I noticed a malfunctioning water stopper. This is necessary in order to keep pipes from clogging with debris or objects. This may cause excessive consumption of water and moisture intrusion. Recommend repairs and further evaluation by a qualified general contractor or plumber.

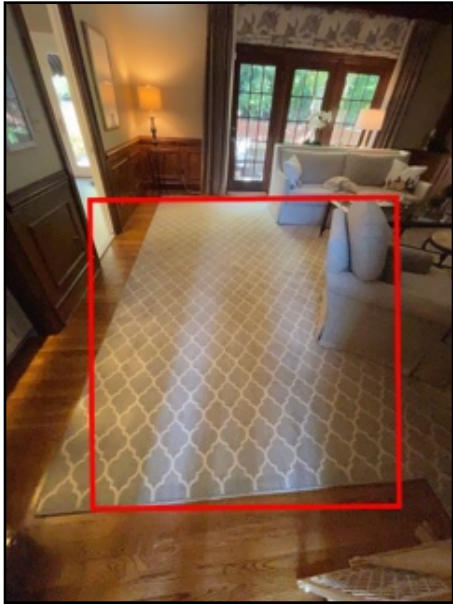
Figure 22-1

At the time of the inspection I could not fully inspected the flooring since a big carpet was covering most of it. Recommend further evaluation by a general contractor.

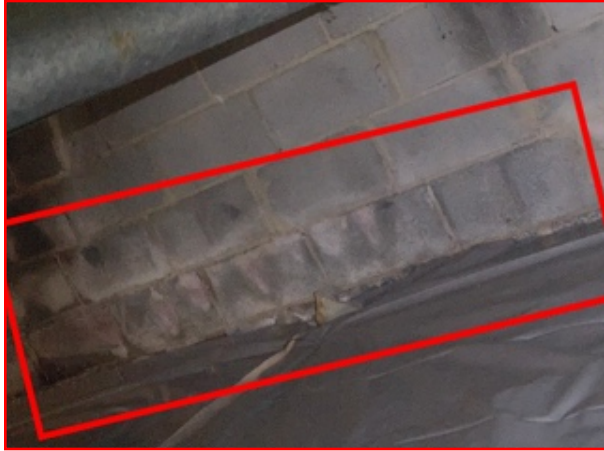
Figure 4-1

4) Efflorescence is a crystalline deposit of salts that can form when water is present in or on brick, concrete, stone, stucco or other building surfaces. It has a white or greyish tint and consists of salt deposits left behind when water evaporates. In addition, efflorescence can appear as a powdery substance on floors and walls and requires special care to treat. Moisture stains and high moisture readings were noticed inside the crawlspace, this is indication of major moisture intrusion. Recommend further evaluation by a foundation specialist.

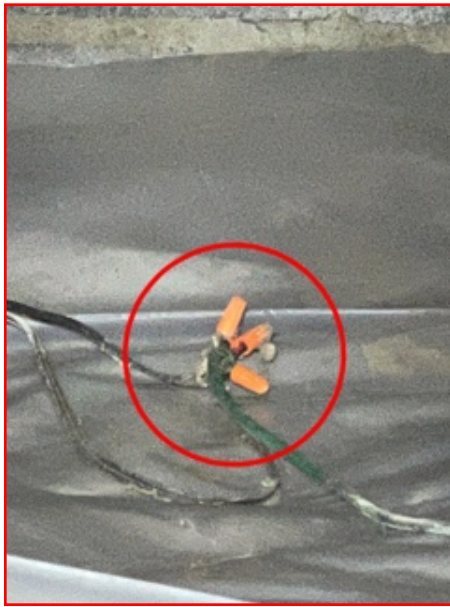
Figure 7-1

7) I noticed improperly concealed electrical cables inside the crawl space, they should be properly concealed in a junction box. This is a safety hazard and all wires should be secure to the floor joists. Recommend further evaluation and repairs by a foundation specialist.

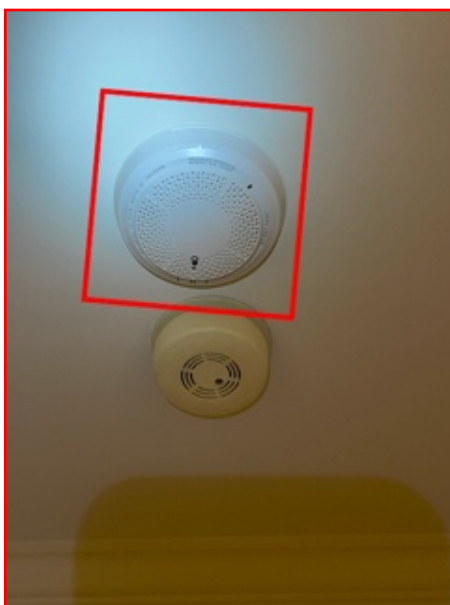
Figure 8-1

8) I noticed several smoked detectors in the house but according to the National Fire Protection Association (NFPA), smoke alarms should be installed on every level of your home. Fire detectors should also be installed inside of every bedroom and outside of each sleeping area as well as at least 10ft away from the kitchen. This is a major safety concern as failure to properly detect fires will allow further damage to occur and put lives in danger. Recommend installing more fire detectors by a general contractor.
