Top Home Inspection LLC

Home Inspection Report

6307 Ballybay Dr

Inspected on Sun, Nov 10 2019 at 1:00 PM

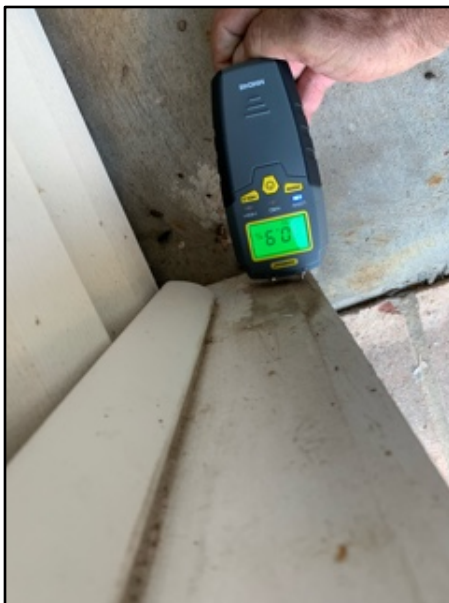
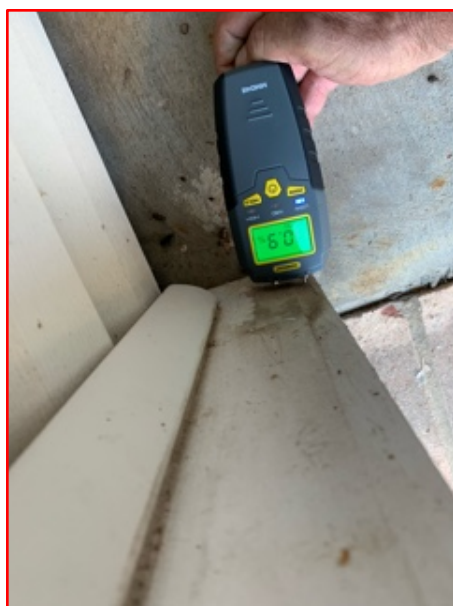
Figure 1-1

Wood trimming in the front entry moisture was detected. This will continue deteriorating. Recommend further evaluation by a qualified carpenter/general contractor.

1) Wood trimming in the front entry moisture was detected. This will continue deteriorating. Recommend further evaluation by a qualified carpenter/general contractor.

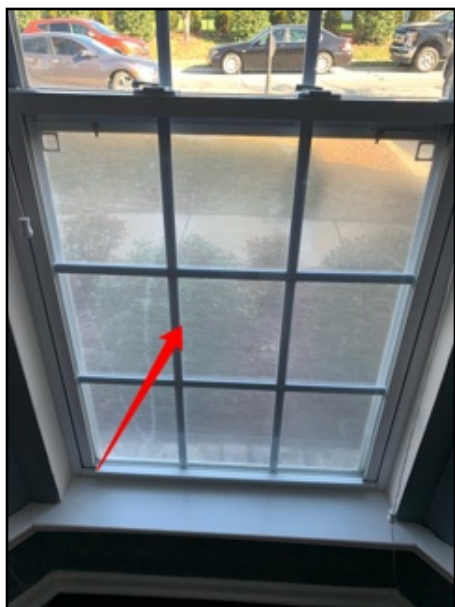
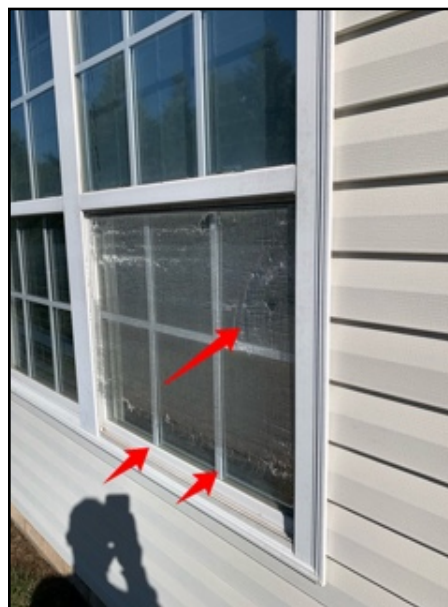
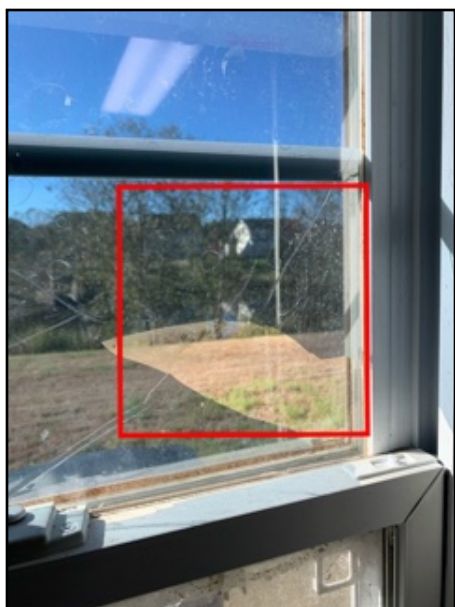
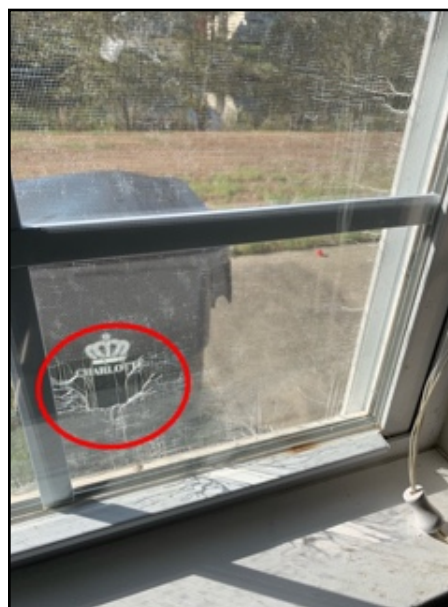
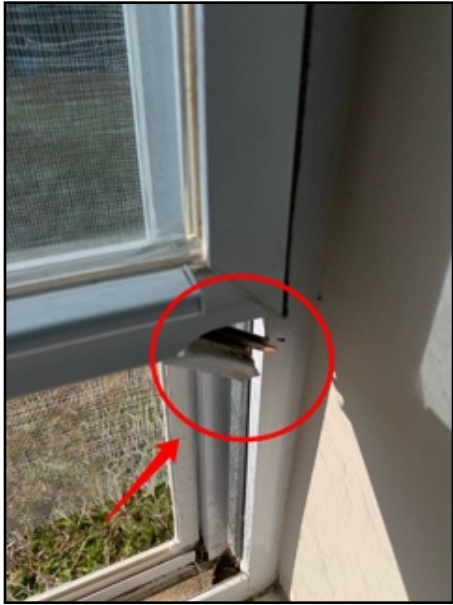
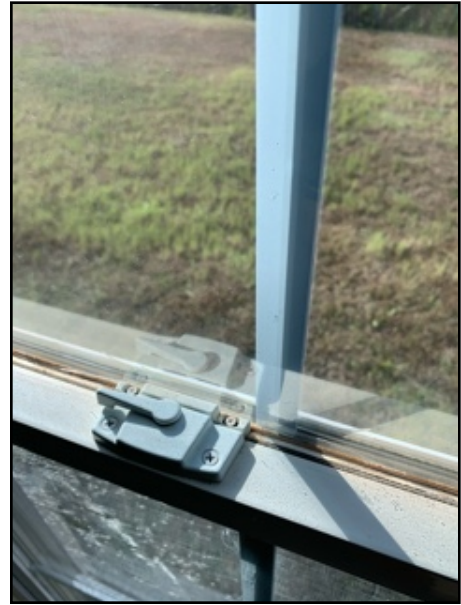
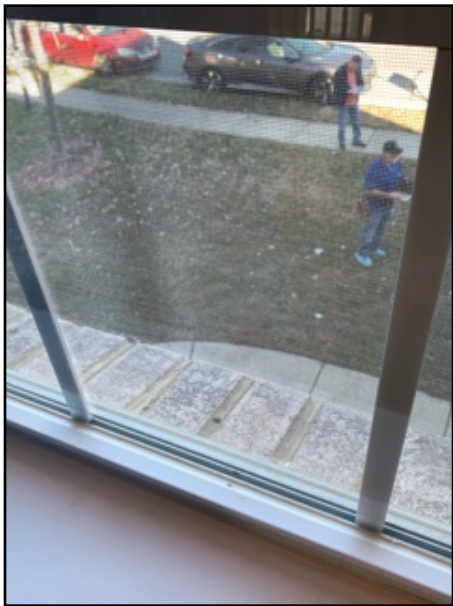
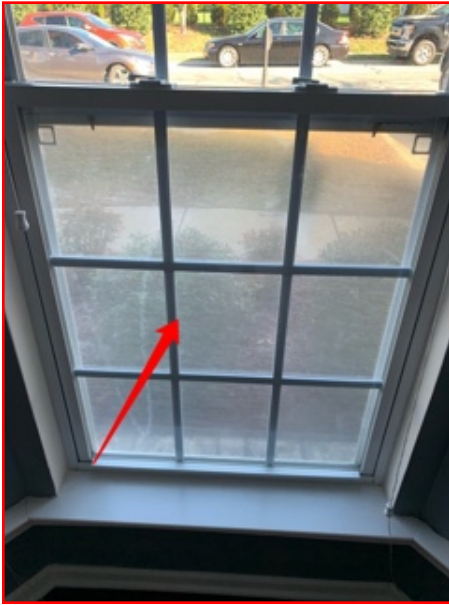
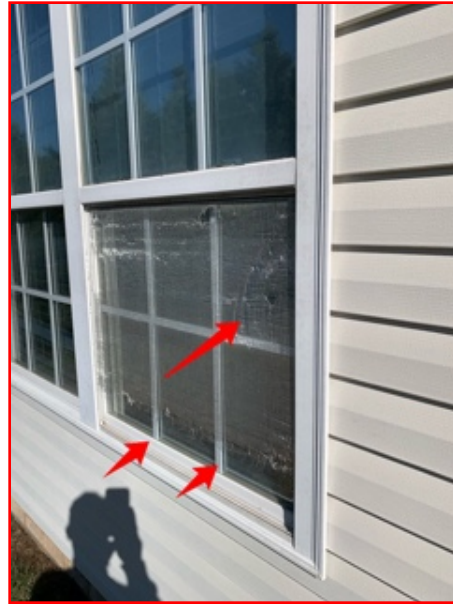
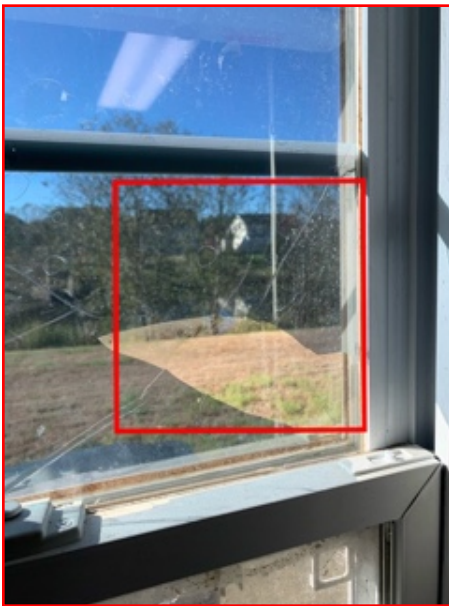
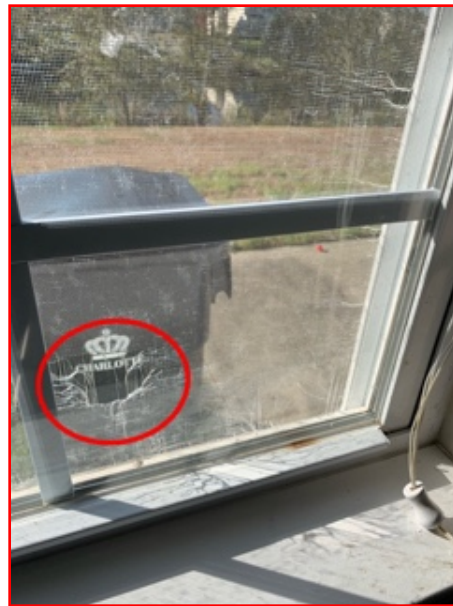
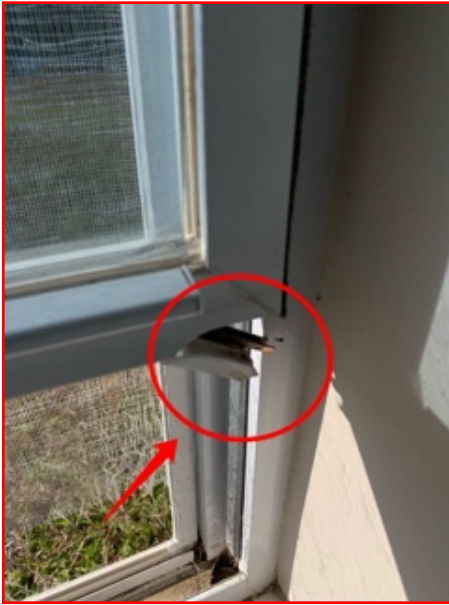
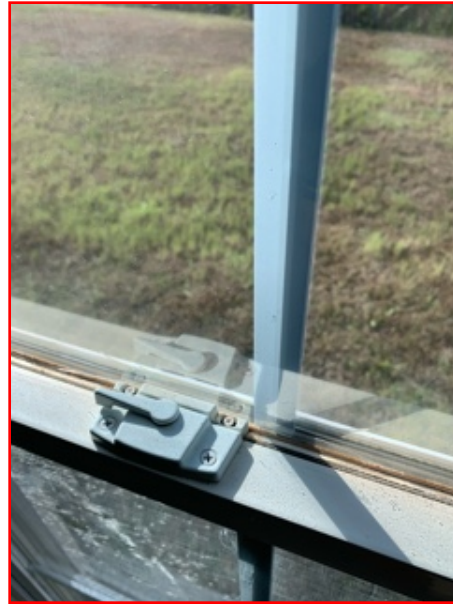
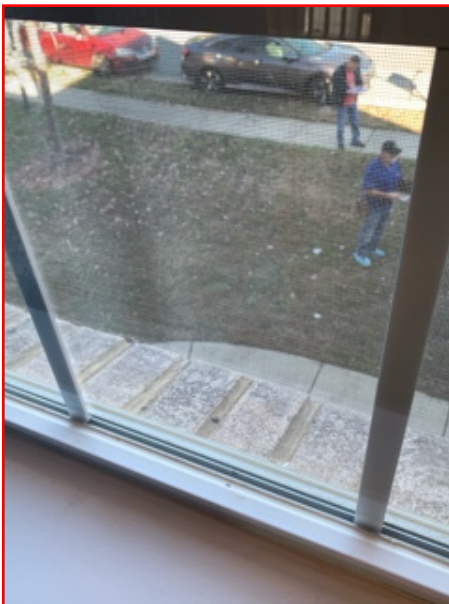
Most of the all the windows were either close shut. In the great room the bottom corner sash and balance were broken. Also most of the screens were broken and the window in the front bay window dinner was foggy this could be from moisture. Recommend repairs/replacement by a general contractor.

2) Most of the all the windows were either close shut. In the great room the bottom corner sash and balance were broken. Also most of the screens were broken and the window in the front bay window dinner was foggy this could be from moisture. Recommend repairs/replacement by a general contractor.

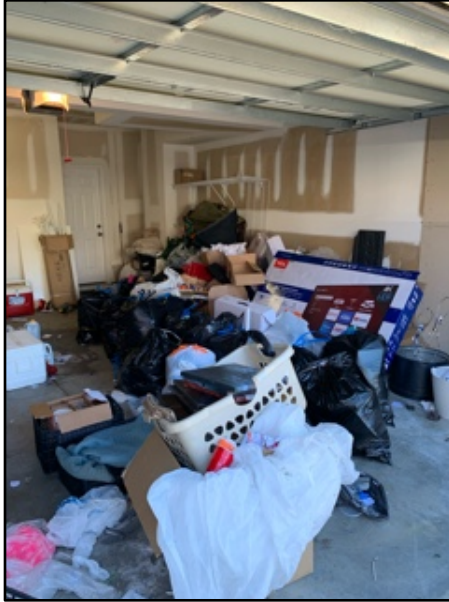
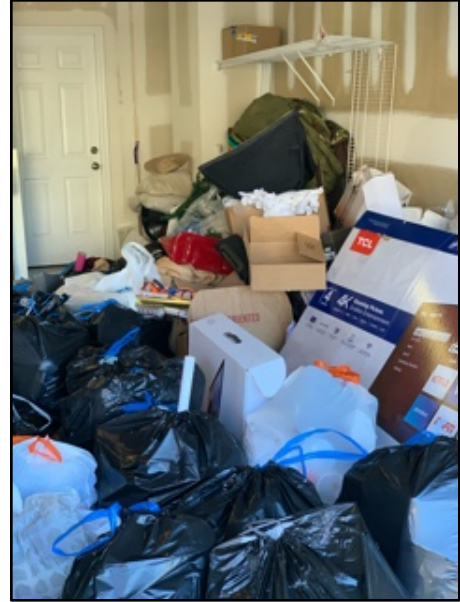
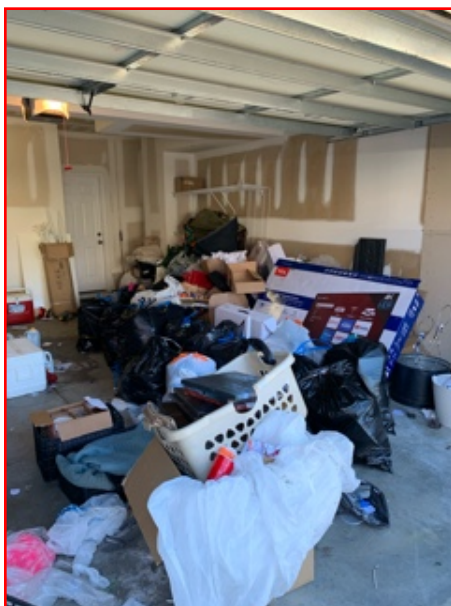
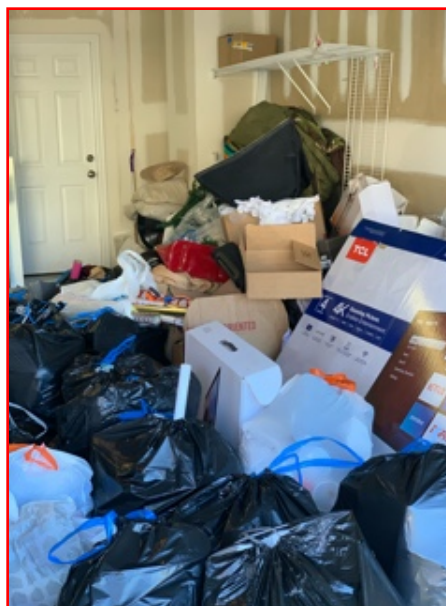
Garage was not fully inspected it had several obstruction. Attached photo.

3) Garage was not fully inspected it had several obstruction. Attached photo.

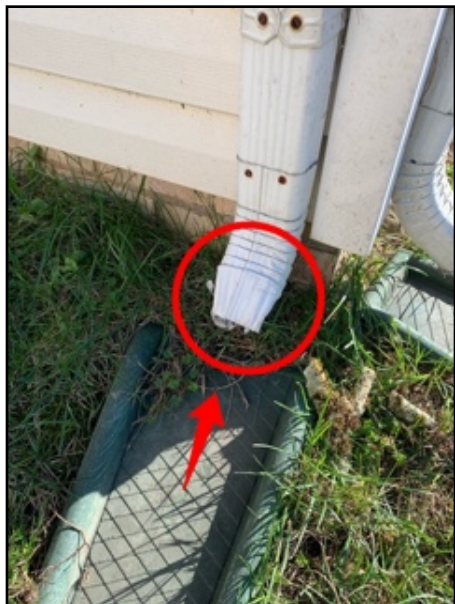
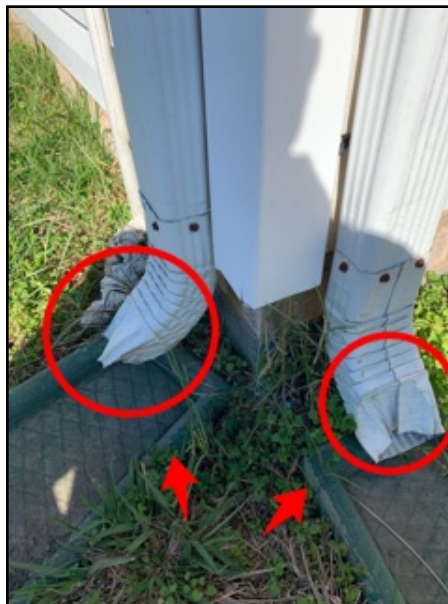
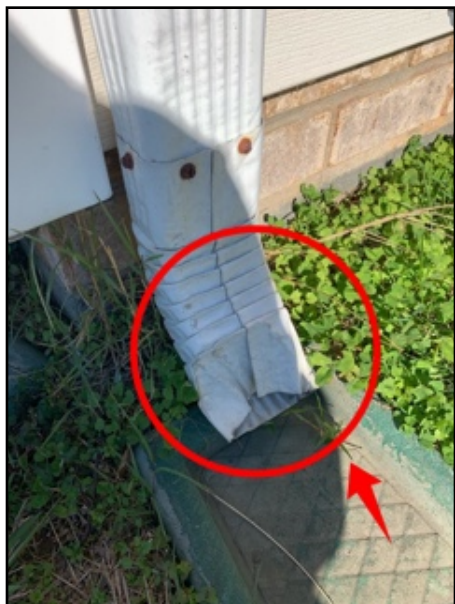
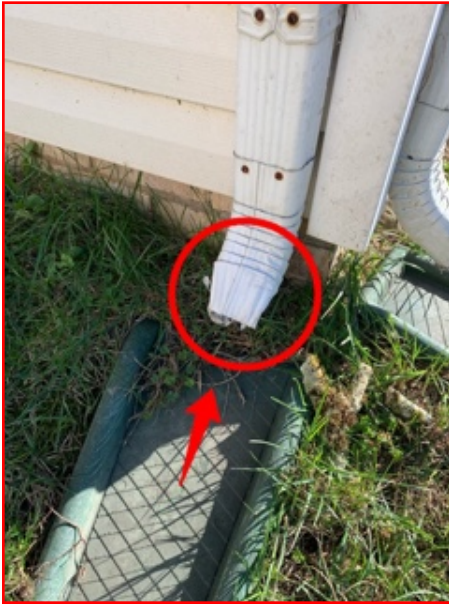
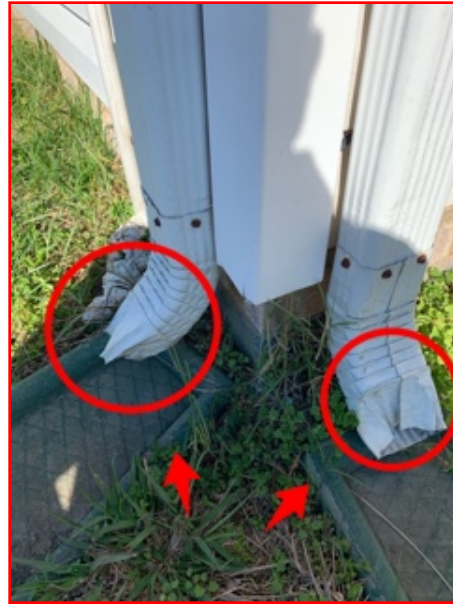
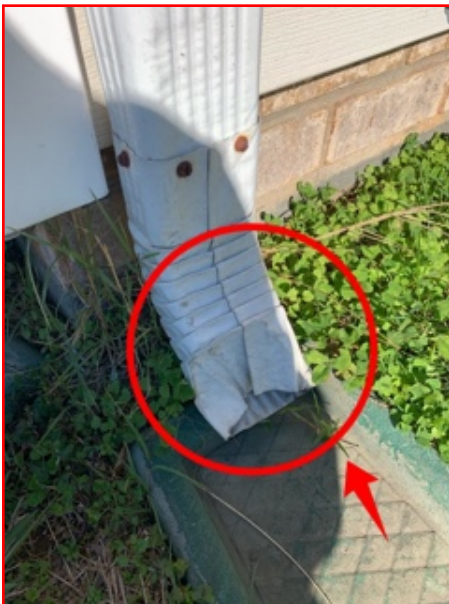
Several gutters were damaged and shut at the downspouts exits. This will hold debris and could clogged the drain therefore leading to damage siding and trim. Recommend repairs/replacement by a qualified gutters contractor.

5) Several gutters were damaged and shut at the downspouts exits. This will hold debris and could clogged the drain therefore leading to damage siding and trim. Recommend repairs/replacement by a qualified gutters contractor.

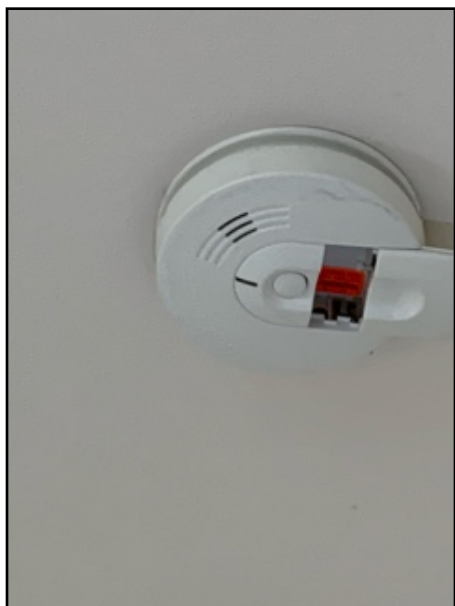
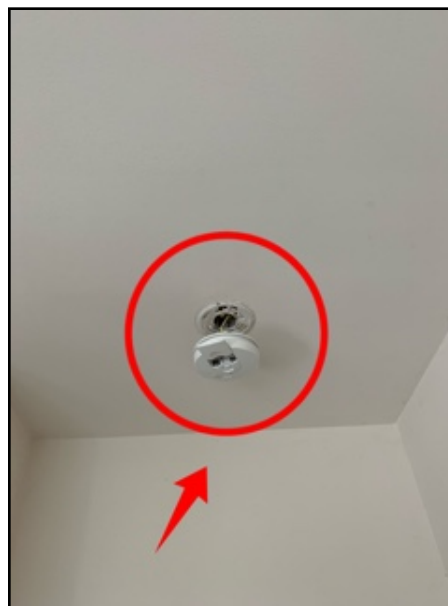
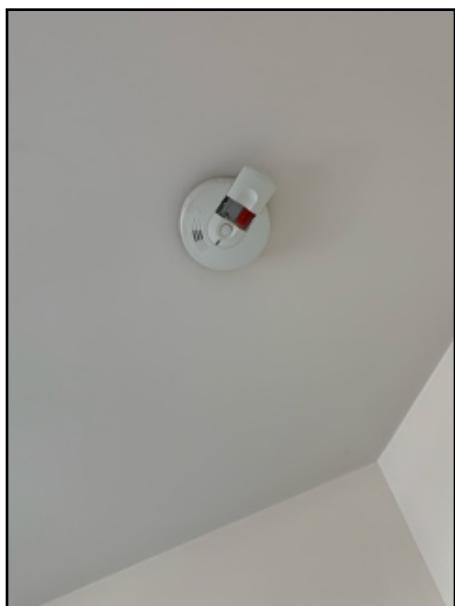
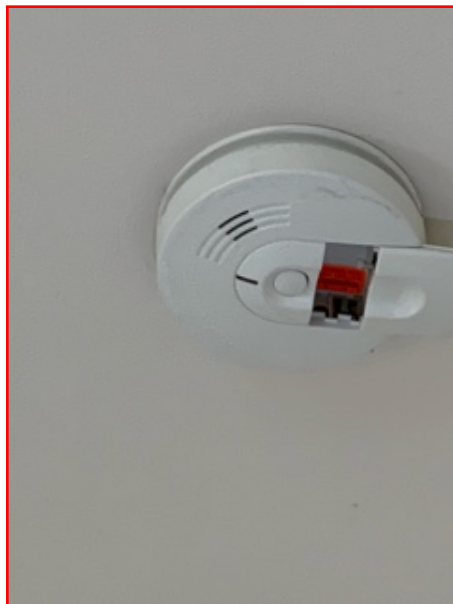
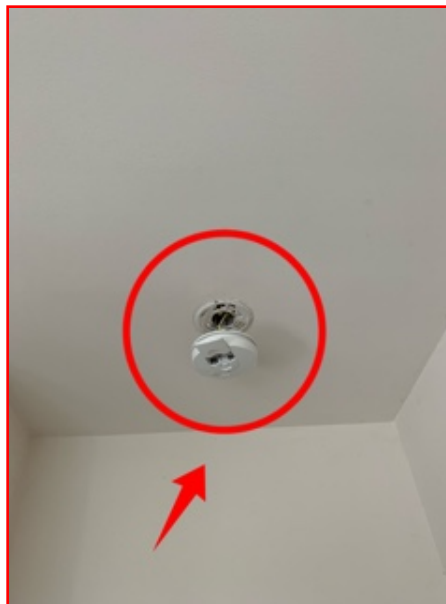
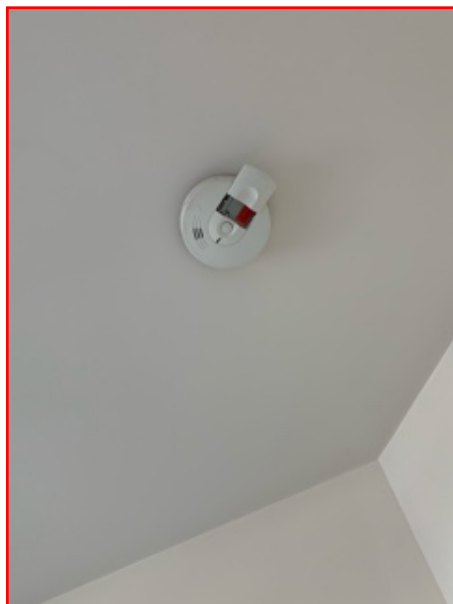
There were several smoke detectors with missing batteries, and one of them hanging down. Recommend install all batteries and repair or replace the damage smoke detector by a qualified handy man.

6) There were several smoke detectors with missing batteries, and one of them hanging down. Recommend install all batteries and repair or replace the damage smoke detector by a qualified handy man.

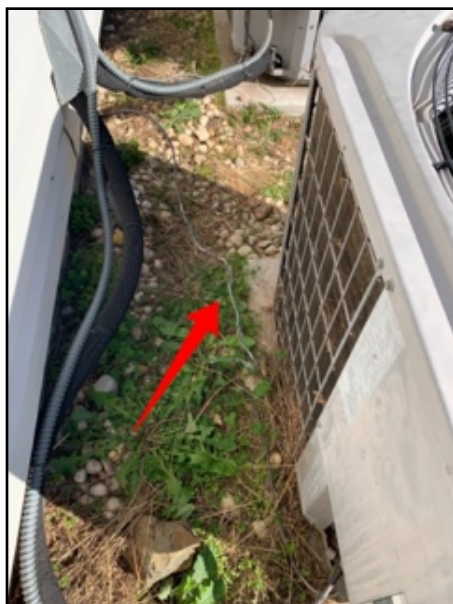
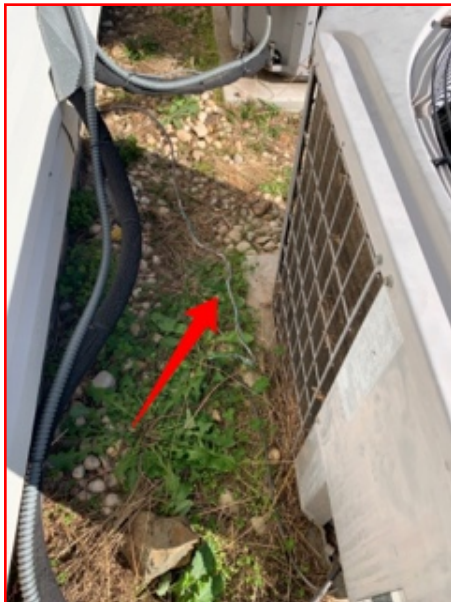
Figure 7-1

There were exposed electrical wires coming from the left outside unit. This is a safety hazard and should be corrected. Recommend repairs by a licensed HVAC contractor.

7) There were exposed electrical wires coming from the left outside unit. This is a safety hazard and should be corrected. Recommend repairs by a licensed HVAC contractor.

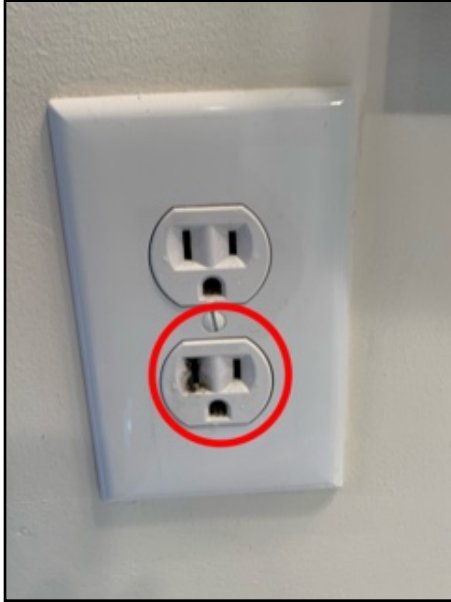
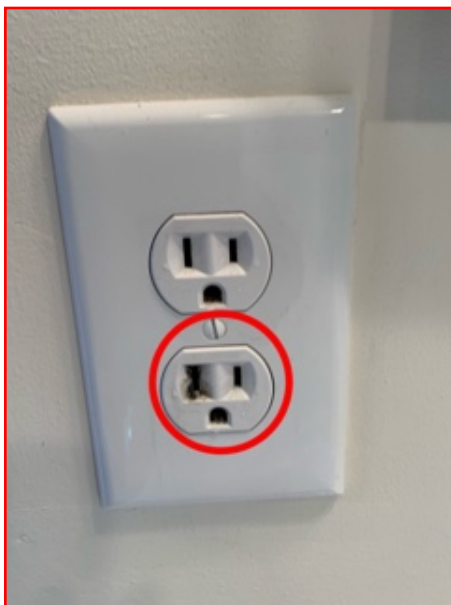
Figure 8-1

Receptacle in the bathroom did not work, it also was stain with black from probably power surge. Recommend a licensed electrician to repair.

8) Receptacle in the bathroom did not work, it also was stain with black from probably power surge. Recommend a licensed electrician to repair.

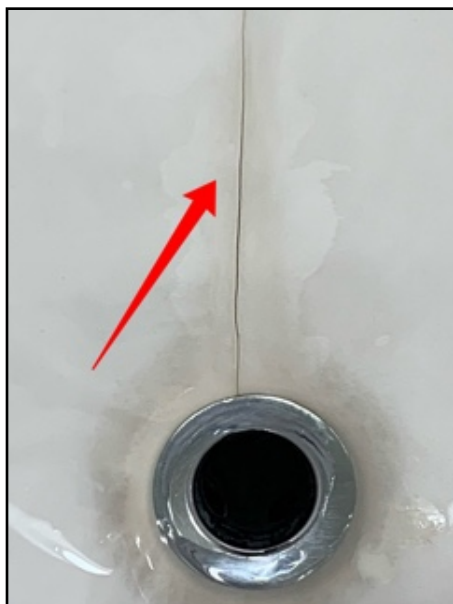
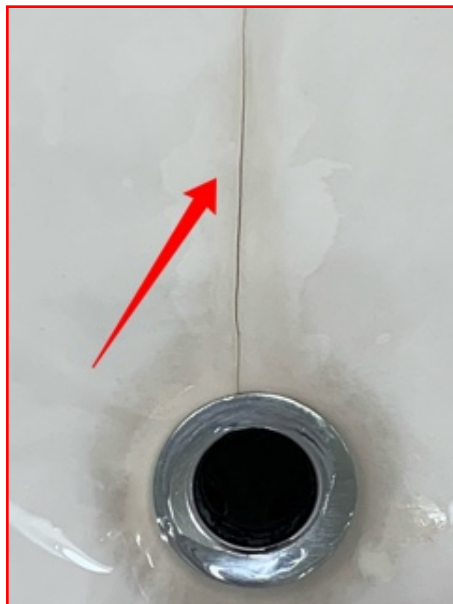
Figure 9-1

There was a visible vertical crack on the right vanity on the master bedroom. This could cause leak and moisture to the cabinets. Recommend replacement/repairs by a qualified general contractor.

9) There was a visible vertical crack on the right vanity on the master bedroom. This could cause leak and moisture to the cabinets. Recommend replacement/repairs by a qualified general contractor.

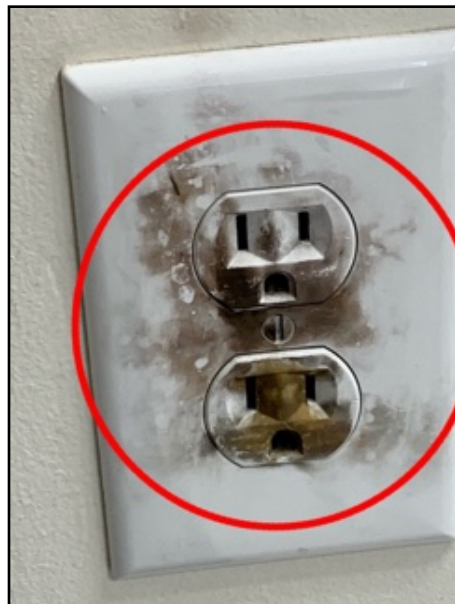
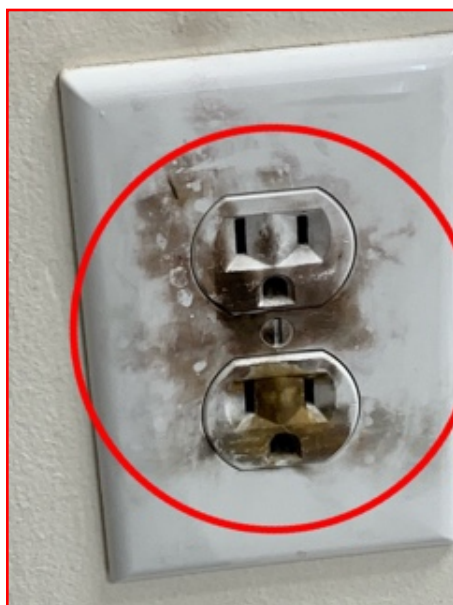
Figure 10-1

Receptacle in the bathroom did not work, it also was stain with black from probably power surge. Recommend a licensed electrician to repair.

10) Receptacle in the bathroom did not work, it also was stain with black from probably power surge. Recommend a licensed electrician to repair.

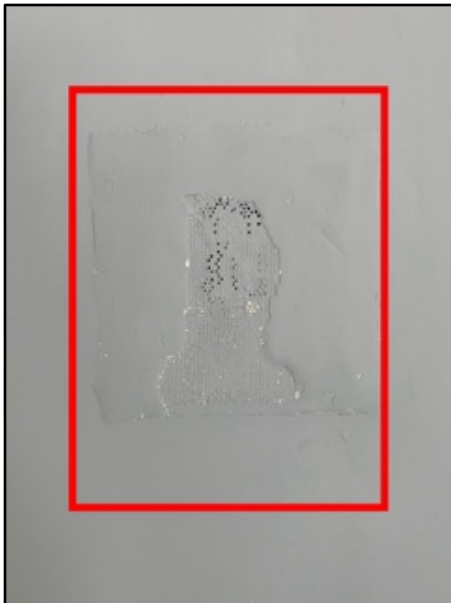
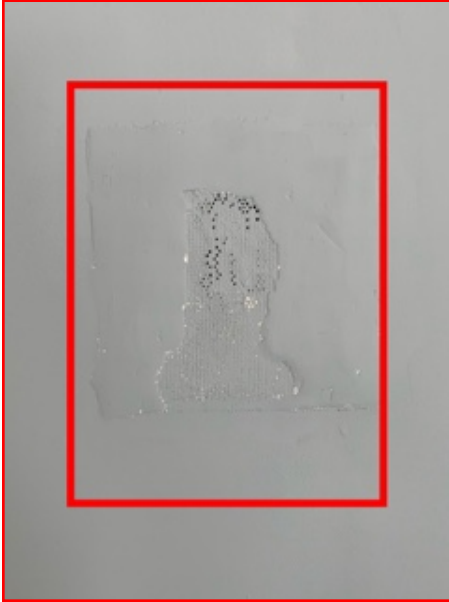
Figure 11-1

There was a noticeable patch. Recommend further evaluation by a qualified general contractor.

11) There was a noticeable patch. Recommend further evaluation by a qualified general contractor.

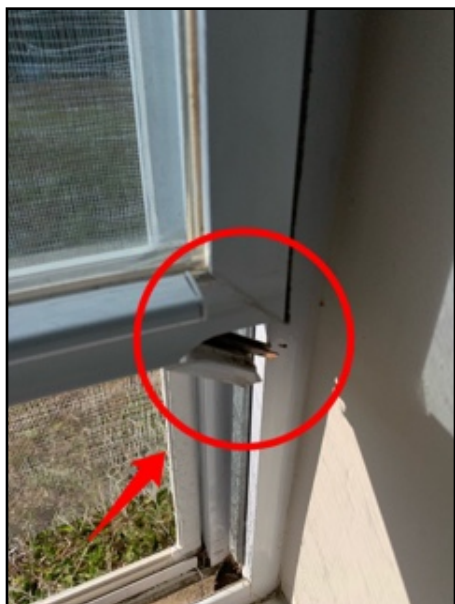
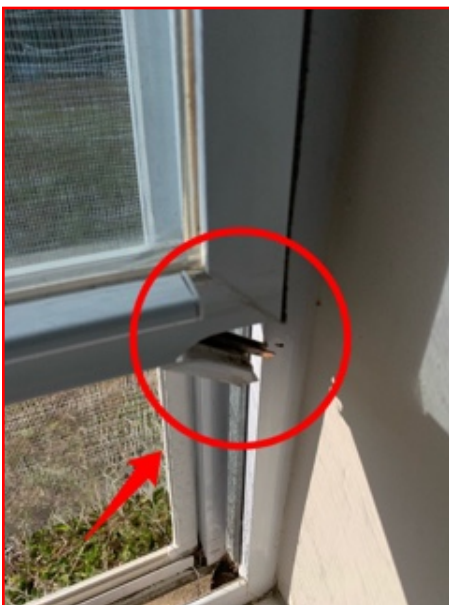
Figure 12-1

The far right hand window close to fireplace was damage. Latch is broken and balance. This is a safety hazard since all window must open and close for emergency exits. Recommend repairs by a qualified general contractor.

12) The far right hand window close to fireplace was damage. Latch is broken and balance. This is a safety hazard since all window must open and close for emergency exits. Recommend repairs by a qualified general contractor.

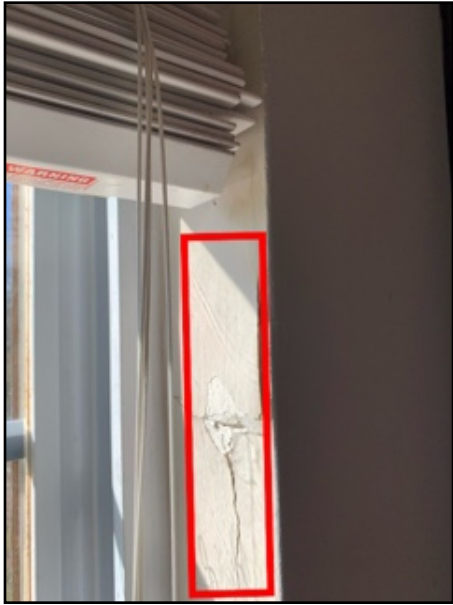
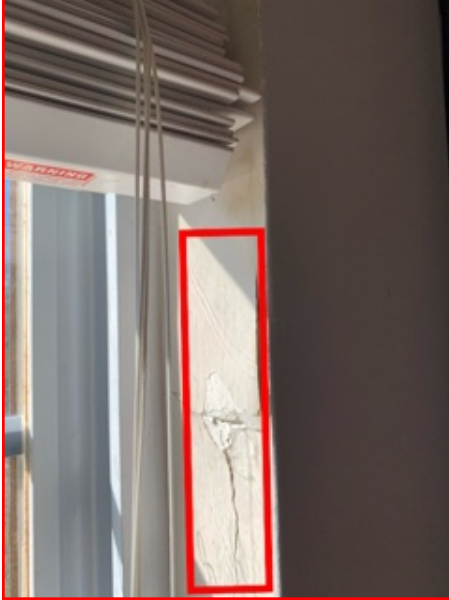
Figure 13-1

The kitchen window had crack trimming and siding. This could lead to moisture and deterioration. Recommend repairs by a general contractor.

13) The kitchen window had crack trimming and siding. This could lead to moisture and deterioration. Recommend repairs by a general contractor.
