CARSCION_ASIA TB1903-CS0011

Technical Bulletin

CARSCION engineers received recently several complaints about leakage of E90 radiators caused by aging of sealing rubber and deformation of plastic water hose joints. The OE references involved are:

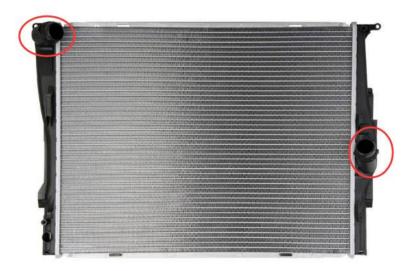
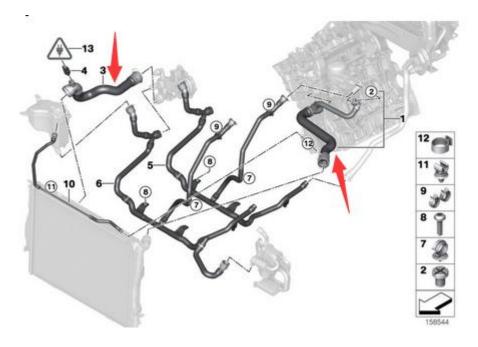
2. Leakage occurred at the inlet and outlet of the radiator.

CAUSE: When the water hoses have been used for a long time under high temperature on the car, aging corrosion and deformation of plastic water hose joints will occur (as shown in the

figure below), and the sealing rubber will also age, resulting in attenuation of the sealing effect and eventually leakage of the radiator. >>> Key in the "Failure mode of automotive rubber water hoses" in the Wechat account of CARSCION_ASIA to learn more.

Solution:

- 1). Change a new water hose;
- 2) . Change a new O-ring. Replacing the O-ring inside the water hose is relatively more economical than replacing the entire water hose. However, it is necessary to pay special attention to check whether the O-ring has been tightened correctly in the slot after replacement.

If the water hose joints deformed already (due to aging), the leakage situation won't change even after replacing a new O-ring, then the entire water hose needs to be replaced.
