RE: Bank of Everglades Historical Report

BANK OF EVERGLADES DRAFT REPORT

EXISTING CONDITION DOCUMENTS
 BANK OF EVERGLADES
 201 Broadway, Everglades City
 COLLIER COUNTY, FLORIDA

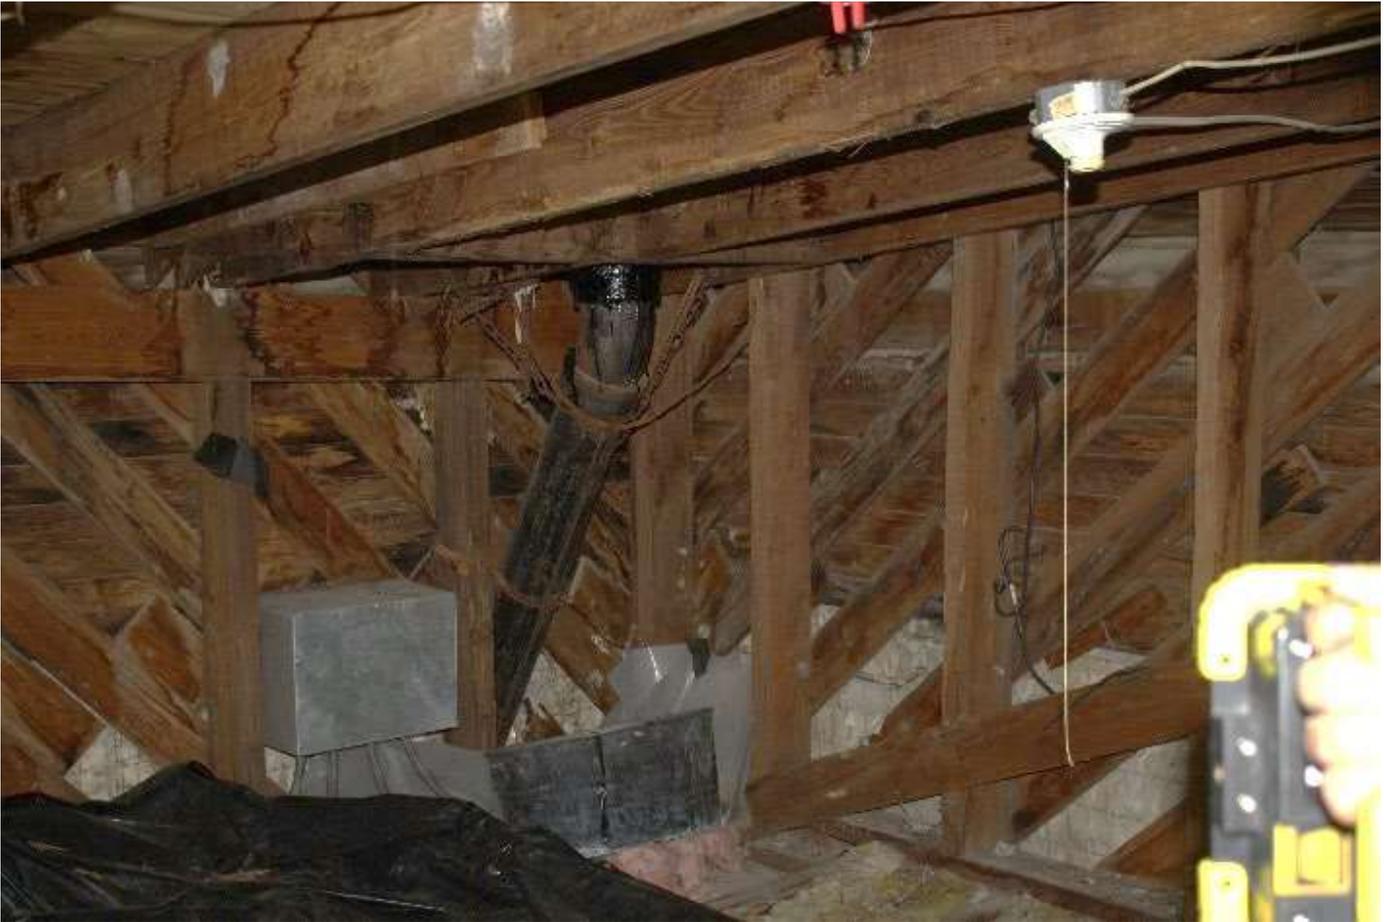
All roofs are framed in wood with the upper wall structures exposed. The materials are in good condition with no evidence of distress identified except where the roof leaks. The exterior siding was set at a 45-degree angle for structural stability. There was no evidence of damage to wall studs, sheathing, or roof joists in the attic. There were some roof leaks that needed repairs.

Attic area showing roof drain and plastic

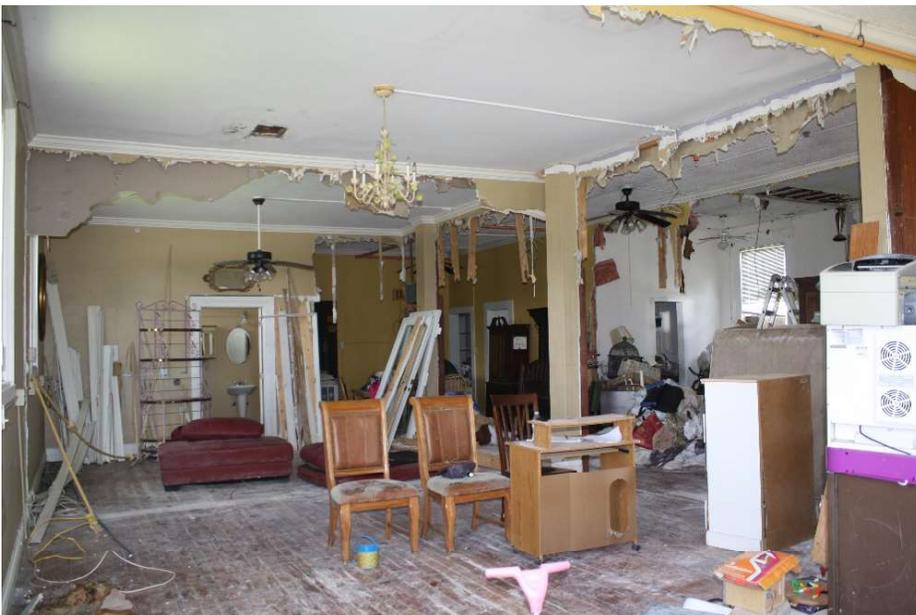
This photo shows the first floor with partitions partially demolished.

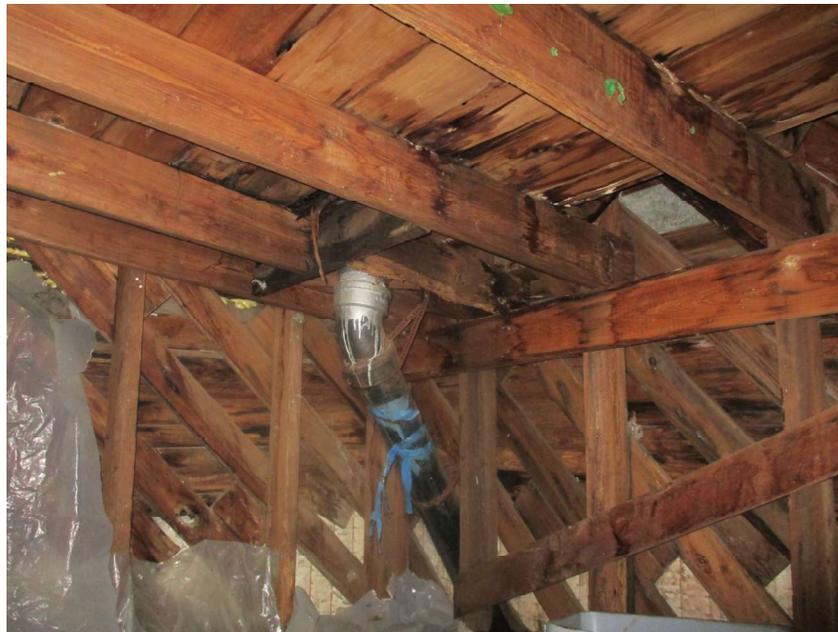
Photograph 4
Deteriorated Roof Framing at Drain

All roofs are in POOR condition due to the failing waterproofing membrane, and the roof drains which appear to have been leaking for several years. The original roof framing consisting of the decking and joists is severely deteriorated at the roof drains (see Photograph 4). Throughout, signs of active termites and termite damaged framing is evident. A plastic membrane was placed above the ceiling joists within the attic and is acting as a secondary roofing membrane. The plastic tarp is holding water within the attic space (see Photograph 5). The roof of the 1950s addition has a hole and allows rainwater and elements into the building to further deteriorate the existing roof, second, and first floor framing (see Photograph 6).

The structure located at 201 Broadway Avenue West in Everglades City, Florida, also known as the Bank of Everglades Building, is in FAIR condition overall, and requires repair and significant maintenance. The deteriorated roof joists require reinforcing with new 2X wood framing members and the deteriorated connections require repair. Roof sheathing, associated with the roof leaks, requires replacement. Once the necessary roof framing repairs have been completed, it is critical that a new roof be installed at both the high and low roofs to mitigate future water deterioration. The reviewed termite damaged framing did not appear to be severe, but the areas should be monitored. A termite expert should be consulted to determine the best solution for mitigating the insects and minimize the potential of any further termite damage to the framing.

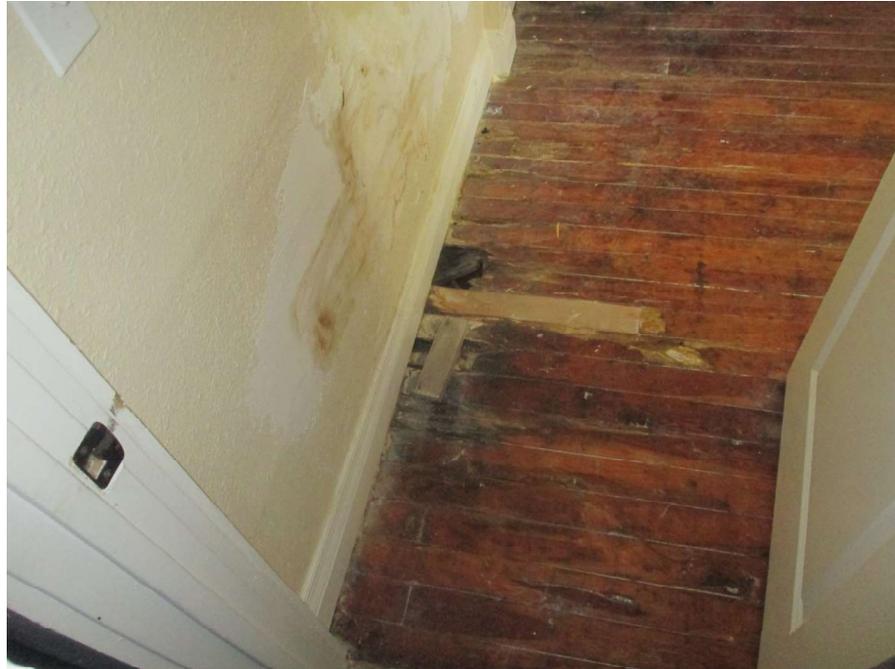
Photograph 7
Water Damage Due to Plumbing Leak

The second floor is in FAIR condition overall with the following exceptions noted; several areas of floor decking and floor joists are deteriorated due to water intrusion through windows and the roof with additional water damage due to leaking pipes (see Photographs 7, 8, & 9). Several floor joists have been coped for the existing plumbing, compromising the integrity of the floor joists (see Photograph 10). Additionally, the stairs linking the first floor to the second floor at the northeast corner are severely deteriorated and are structurally unstable, and the wood handrail has failed (see Photograph 11). These stairs replaced a previous stair, which provided access to the second-floor exterior door. There is no longer interior access to the second-floor exterior door.

Second floor framing members require 2 x 12 joists sistered to them. A review of plumbing should be conducted by a qualified consultant and necessary repairs should take place. The stairs at the northeast corner are damaged and require replacement.

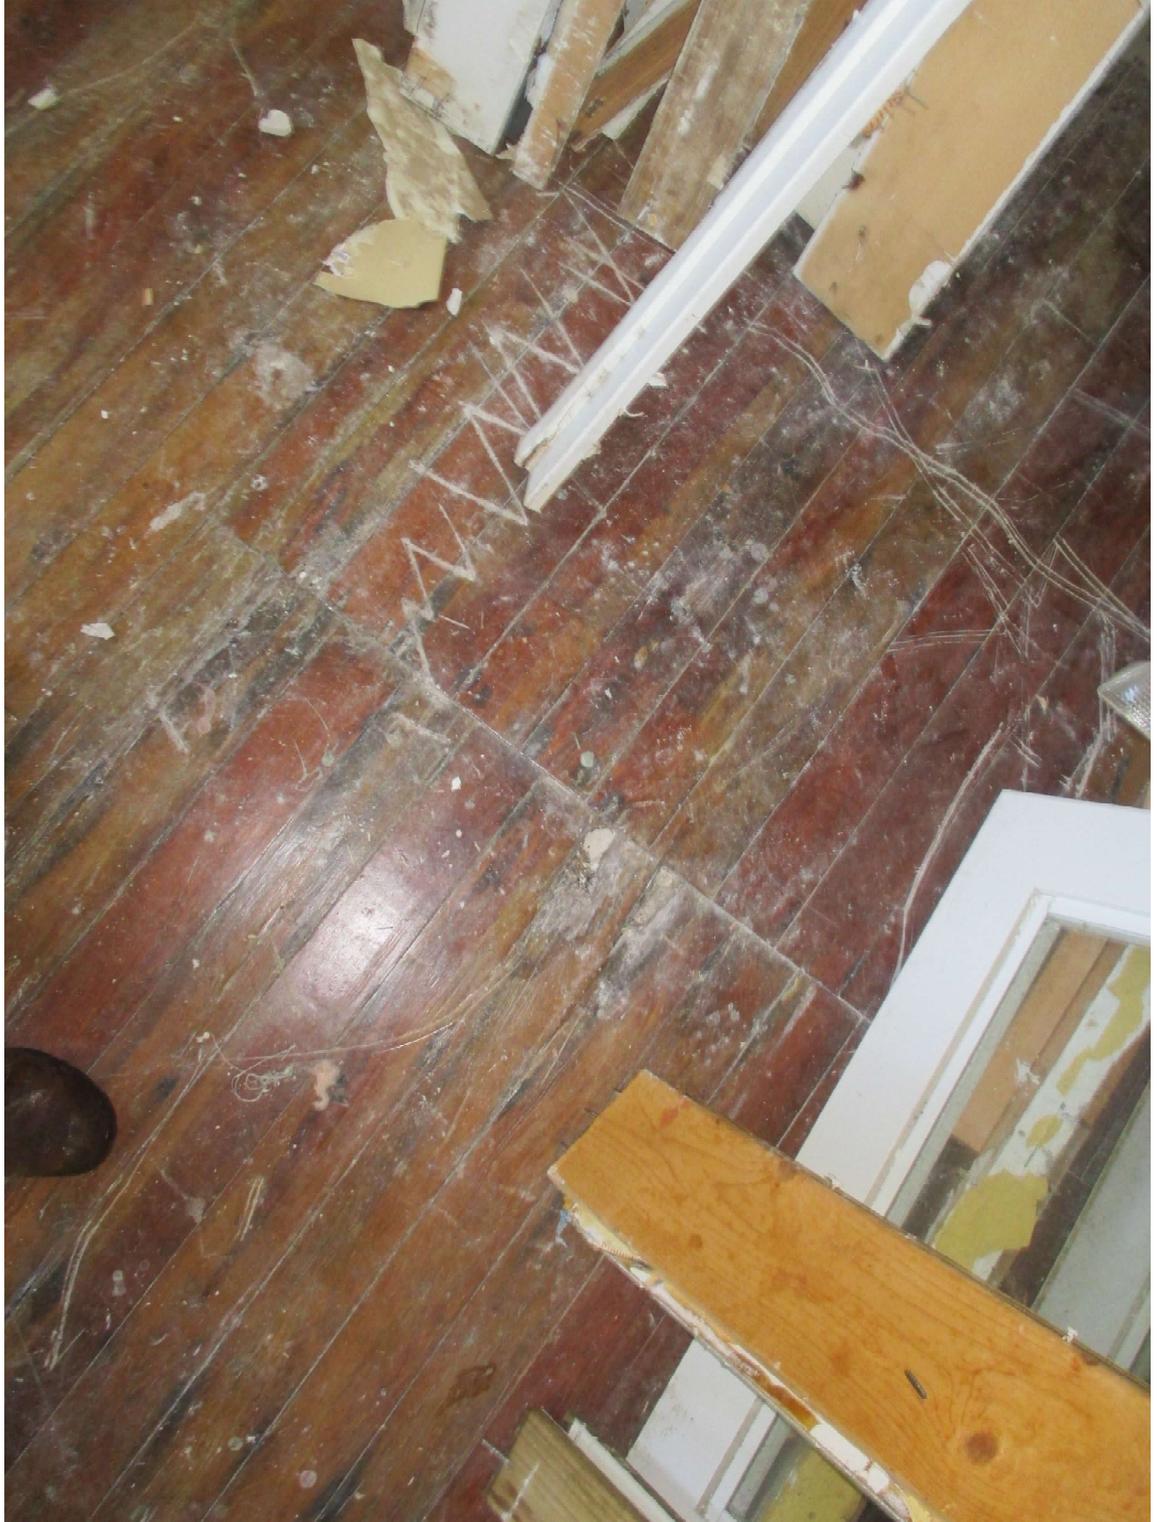
Photograph 12
Deteriorated First-Floor Decking

The first floor appears to be in FAIR condition with minor deteriorated tongue and groove floor decking (see Photograph 12). The first-floor framing and foundations were not observed from within the crawl space due to standing water, excessive mosquitoes, and debris found. However, a conduit access hole allowed viewing of the northeast section of the original 1926 structure. Upon review, it was noted that the northeast pier is severely cracked and damaged (see Photograph 13).

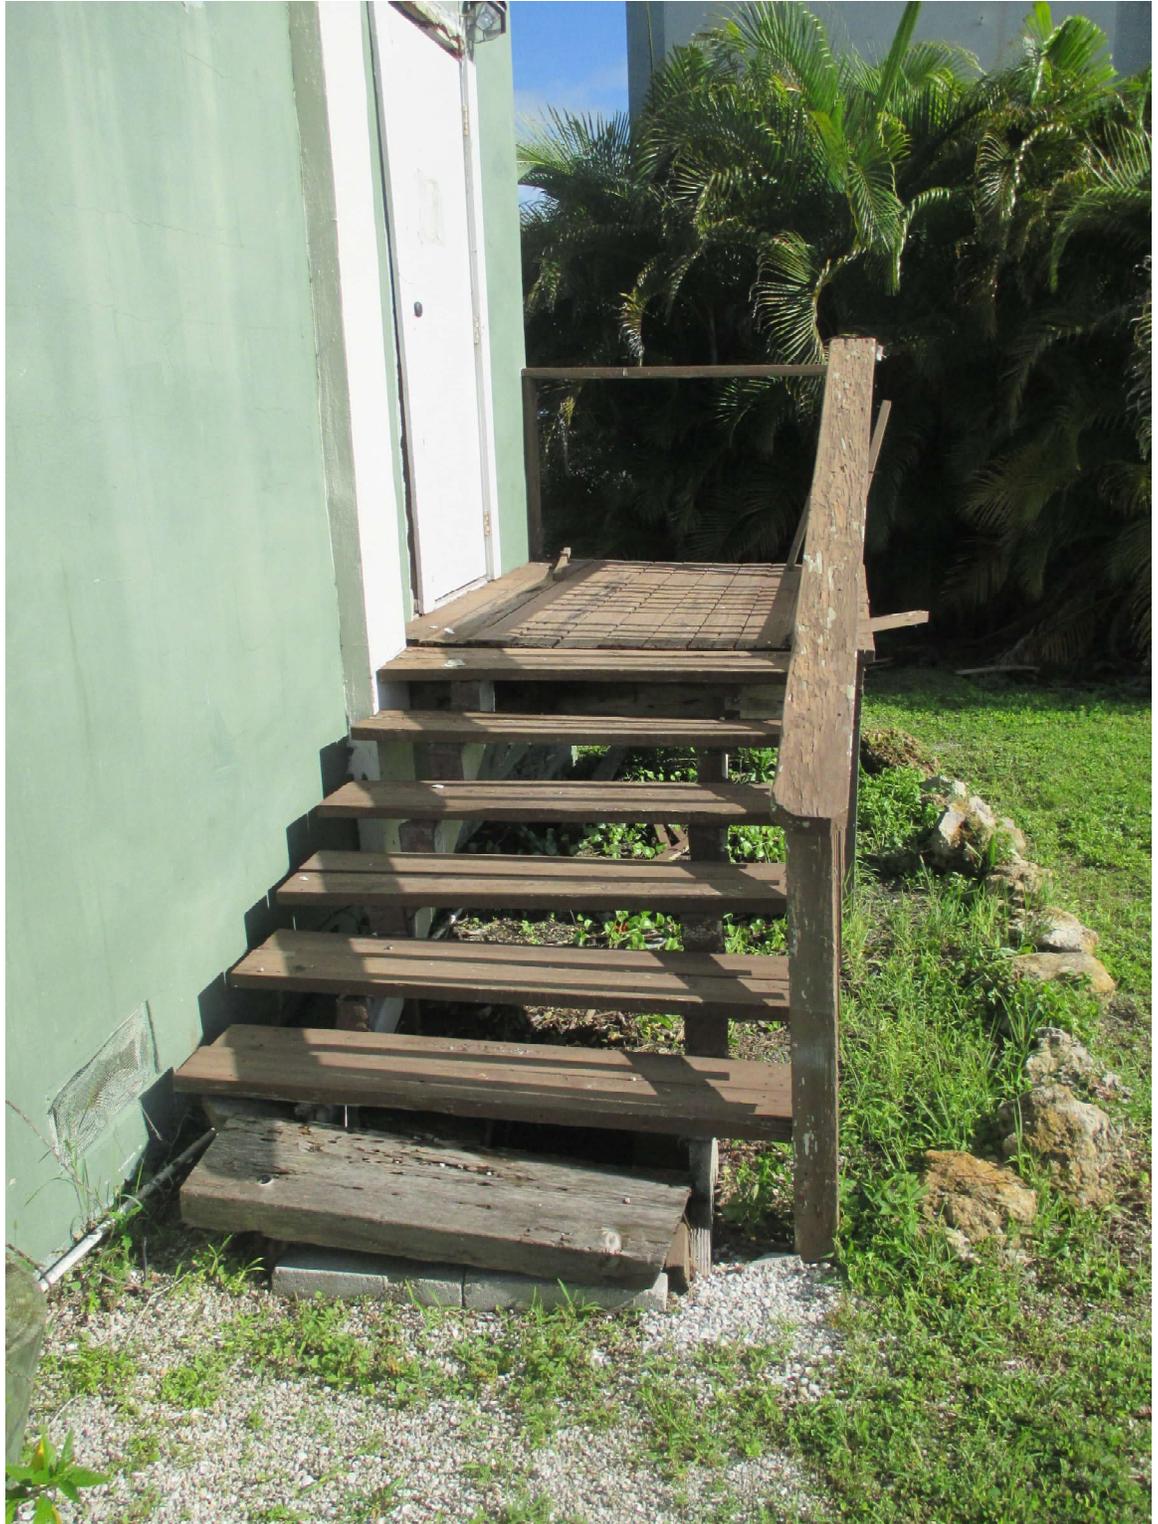
Photograph 14
East Facade Deteriorated Wood Stair Requiring Replacement on New Footings

The stairs and landing at the entry of the east façade building are severely deteriorated, unstable, and in POOR condition. It appears the framing is non-pressure treated lumber with several loose deck boards (see Photograph 14). The wooden handrail has failed and the structure bears directly on grade or on split CMU (see Photograph 15). Located at the west façade, the cast-in-place steps and perimeter walls appear to be in FAIR condition with minor topping cracks and spalls (see Photograph 16). The south façade entry is in FAIR condition; however, the wooden ramp is not ADA compliant. The southwest handrail post base at the ramp landing has deteriorated and caused the concrete topping to spall, exposing the metal base, and causing additional deterioration (see Photograph 17). At the north façade of the second-floor entry, the rear access steps have been removed and the wooden landing is severely deteriorated and beyond repair (see Photograph 18). The perimeter walls of the original 1926 structure have roughly 1-1/2-inch thick concrete cladding with a skim coat of smooth stucco. It appears the cladding has cracked at the base of the first floor to the foundation wall junction in several areas (see Photographs 19 and 20).

It is recommended, the access stairs located at the east façade be demolished and reconstructed with pressure treated lumber on solid foundations. The wooden ramp at the south façade did not appear to have any deficiencies, however, the ramp should be deconstructed and reconstructed if the building is to be ADA accessible. Located at the southwest corner of the south façade entry stoop, the deteriorated handrail base should be removed and replaced with a Simpson post base connector and the concrete topping should be repaired. It is recommended the west façade entry steps have the concrete topping patched and re-leveled. The north façade second-floor stair landing requires deconstruction and the associated second-floor exterior entry door should be removed and patched with either an architecturally approved window or a new wall section to match the existing wall.

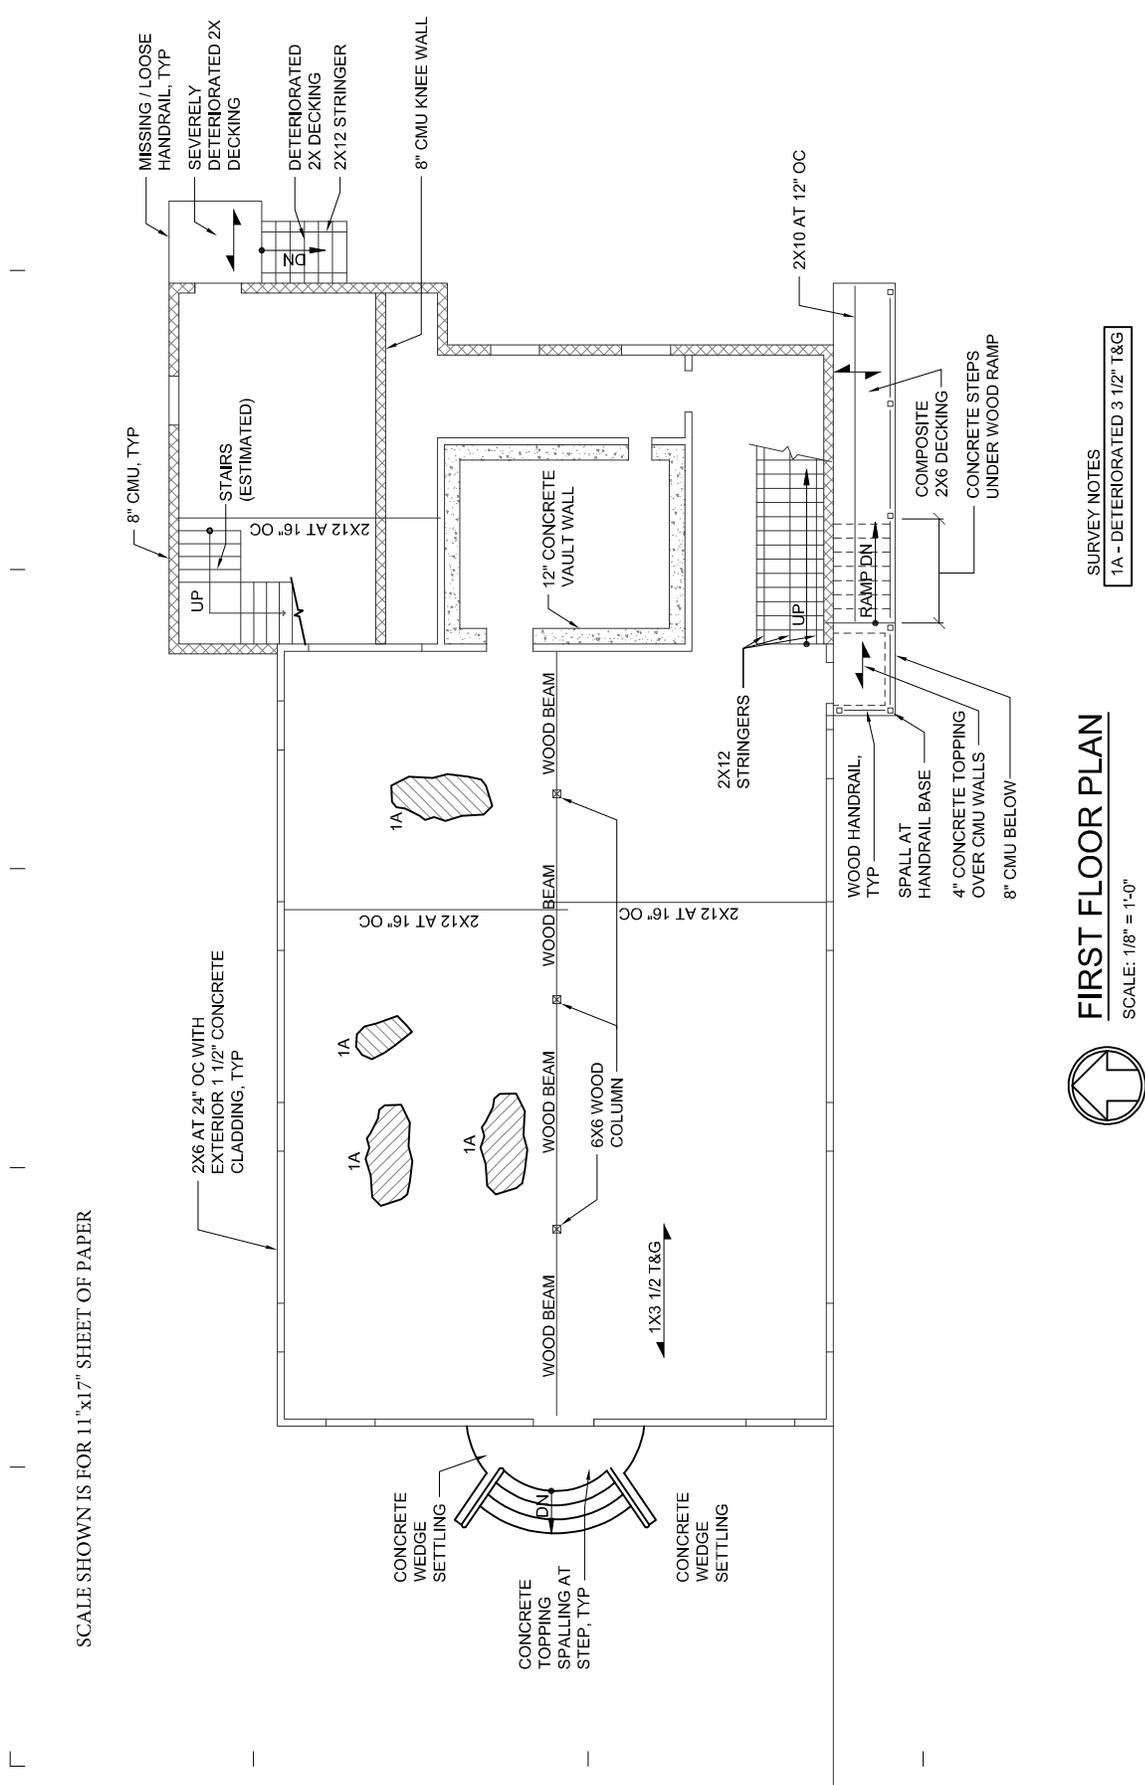
FIRST FLOOR PLAN
 SCALE: 1/8" = 1'-0"

SURVEY NOTES
 1A - DETERIORATED 3 1/2" T&G

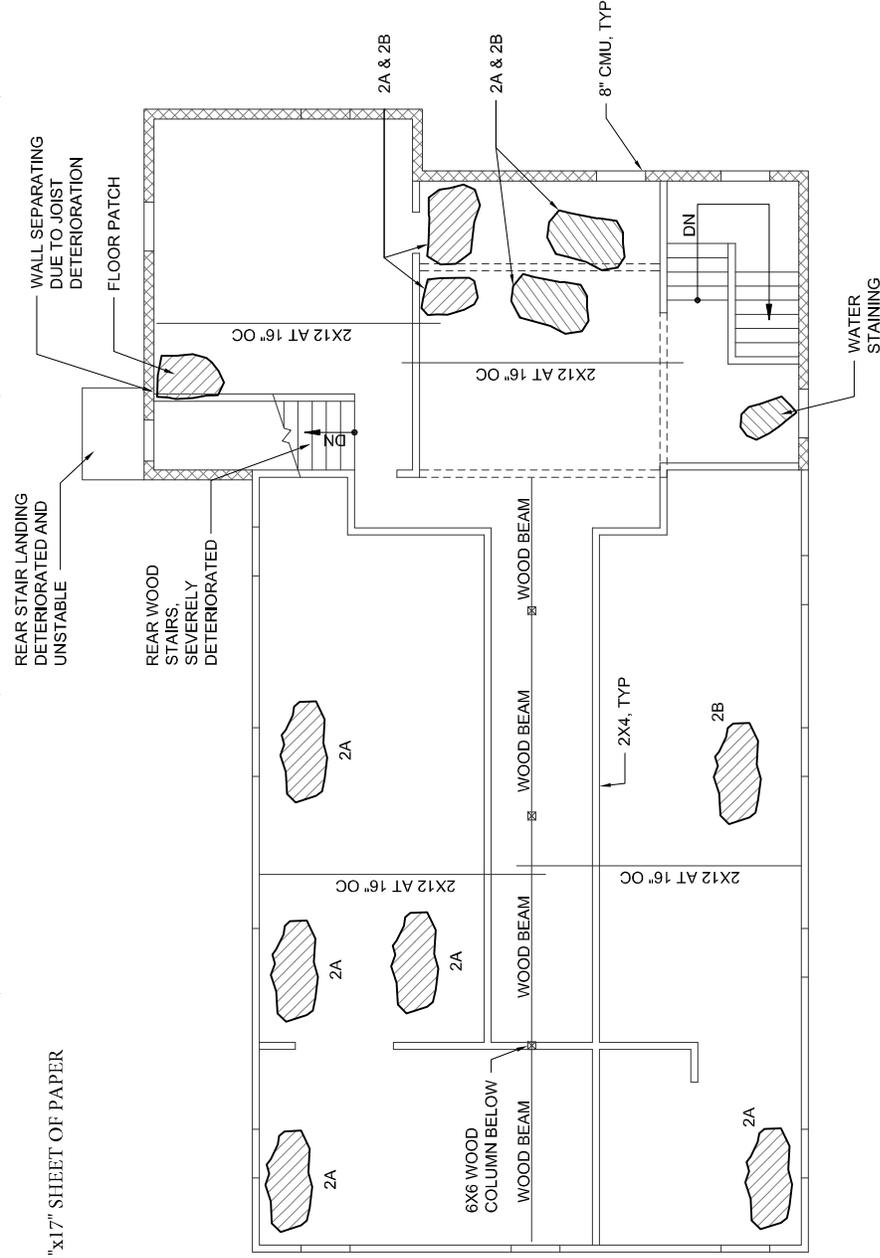
SECOND FLOOR PLAN

- 2A - DETERIORATED DECKING
- 2B - DETERIORATED JOIST

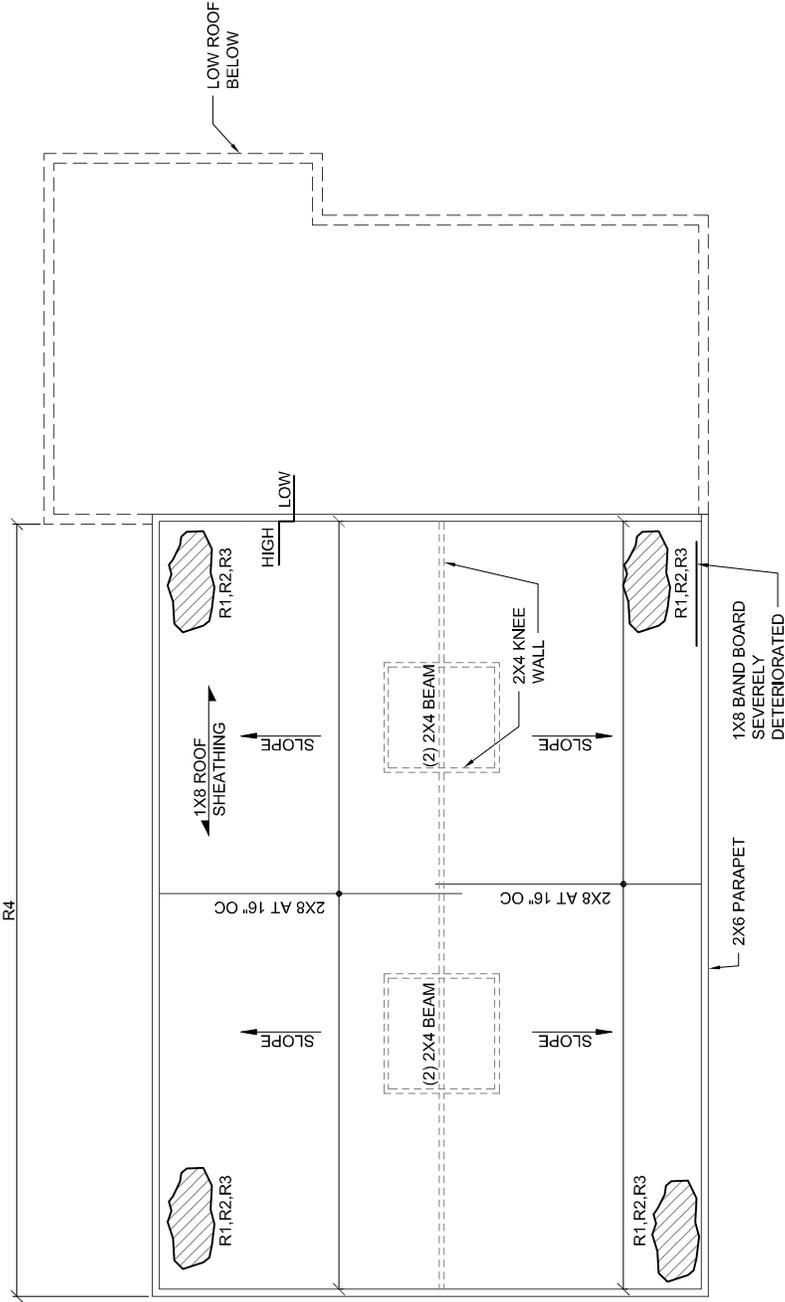
HIGH ROOF PLAN

- R1 - SEVERELY DETERIORATED ROOF DRAIN
- R2 - SEVERELY DETERIORATED DECKING
- R3 - SEVERELY DETERIORATED JOIST
- R4 - TERMITE DAMAGE THROUGHOUT
