Re: Bank of the Everglades - Foundation Assessment

On March 24, 2021, at your request, ORCO had the opportunity to visually inspect the foundation structural elements of Bank of the Everglades Building. The main purpose of the observation is to assess the current condition of these elements prior to finalizing purchase and any building renovations. This observation, conducted by Christopher Hagan PE and Christopher Eseppi PE, included a visual inspection of the complete interior and exterior of the building. Our team accessed the crawl space through an opening in the foundation wall.

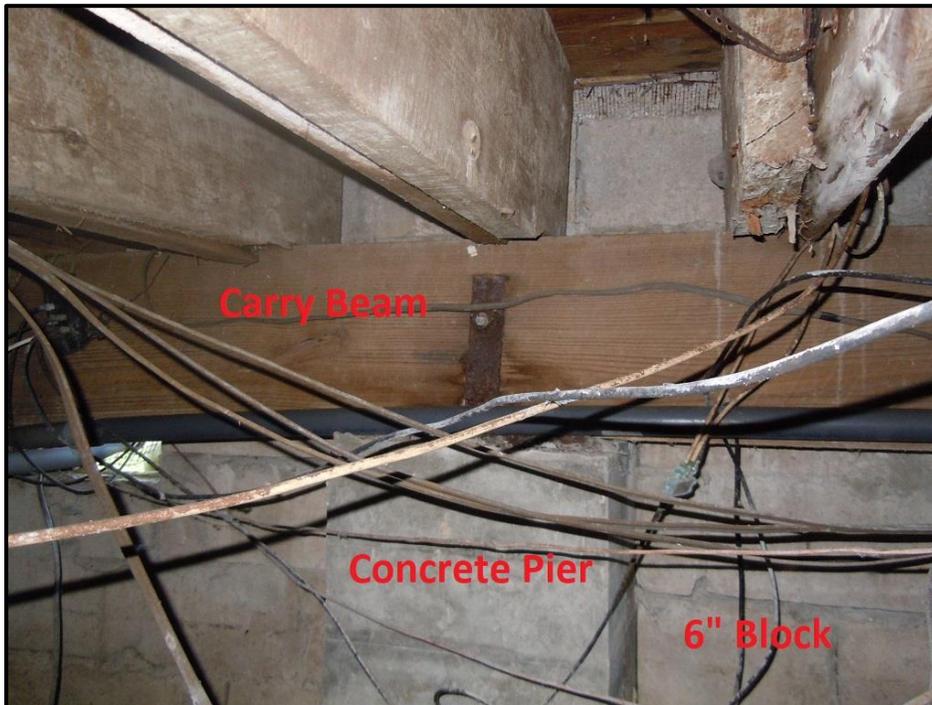
Based on our visual inspection, there appears to be three types of foundations. The original bank building foundation was constructed using 2' x 2' concrete piers along the building perimeter and the center carrying beam at approximately 6' on center. Without excavating and exposing a pier, we are unable to confirm the bottom of footing elevation. Wood carrying beams are used to support the building above the concrete piers which support a 2"x12" floor system.

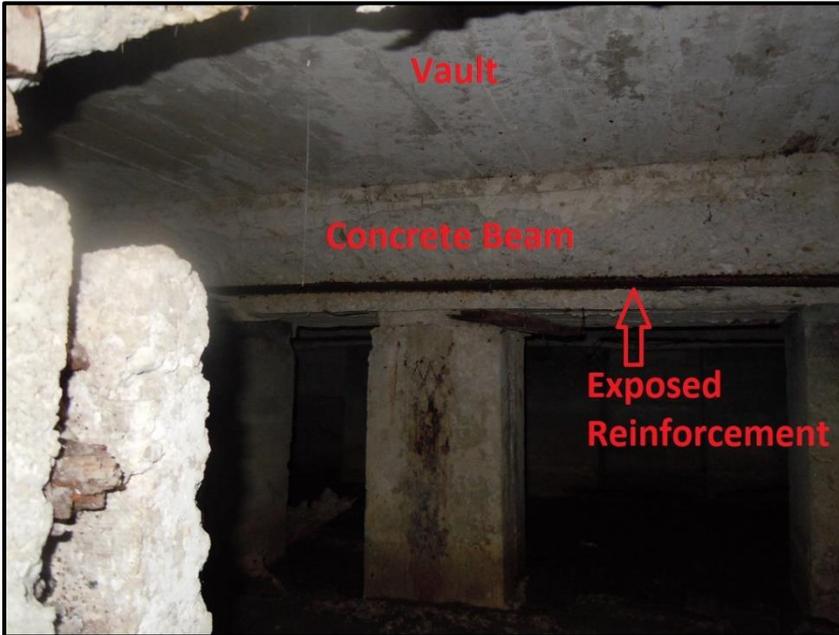
The bank building vault was constructed using wood piles encased in concrete and plaster supporting concrete beams and a concrete floor slab.

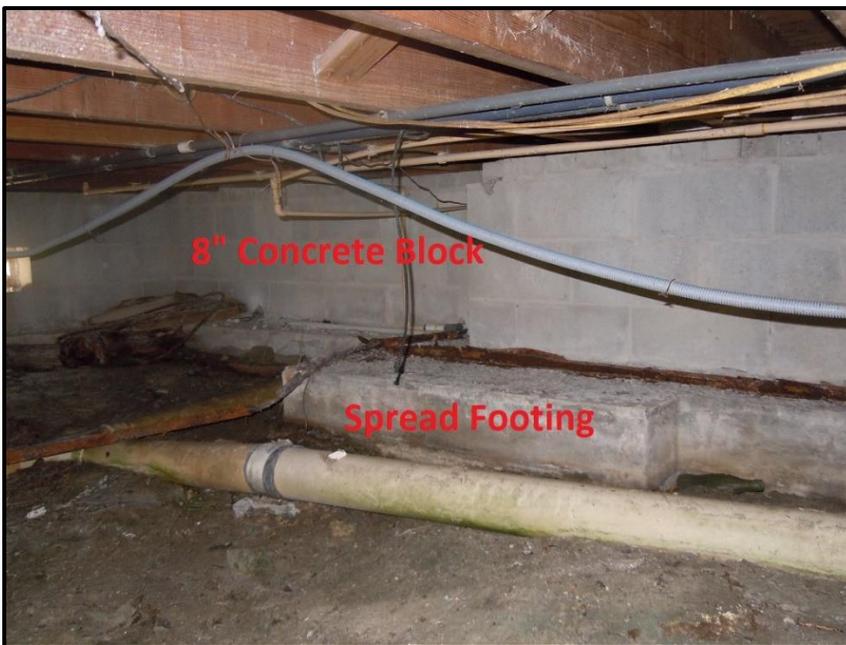
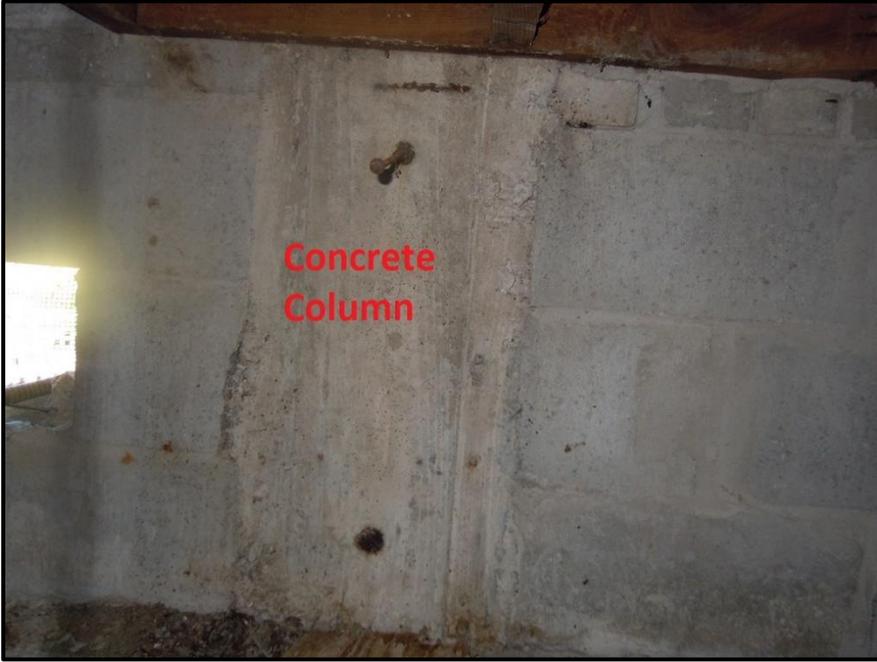
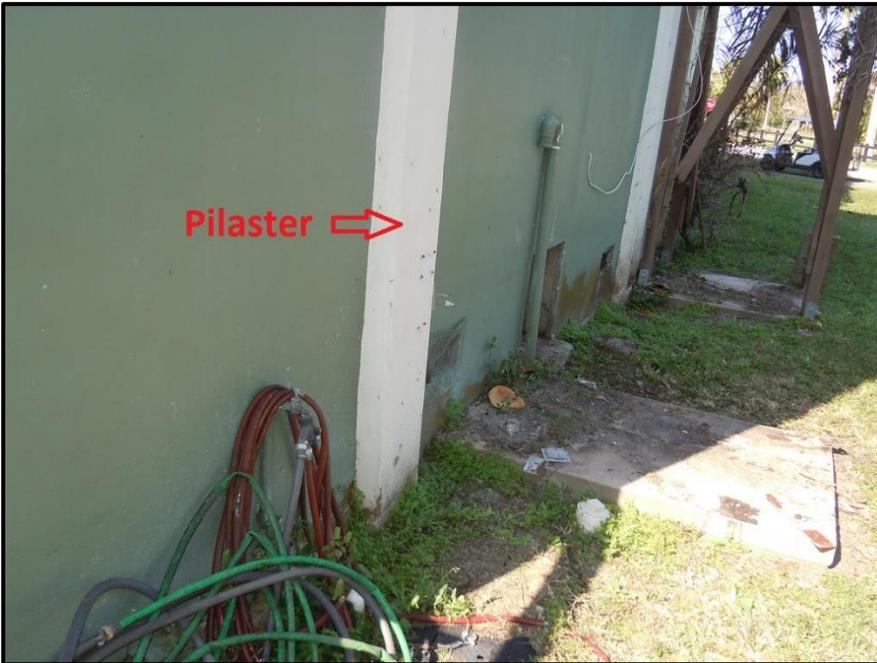
The 1950 addition was constructed using concrete spread footings and 8" block bearing walls. Concrete columns were incorporated into the foundation which correspond to the exterior pilasters at the building exterior walls. Without excavation, we are unable to determine if any piles were included in the original construction.

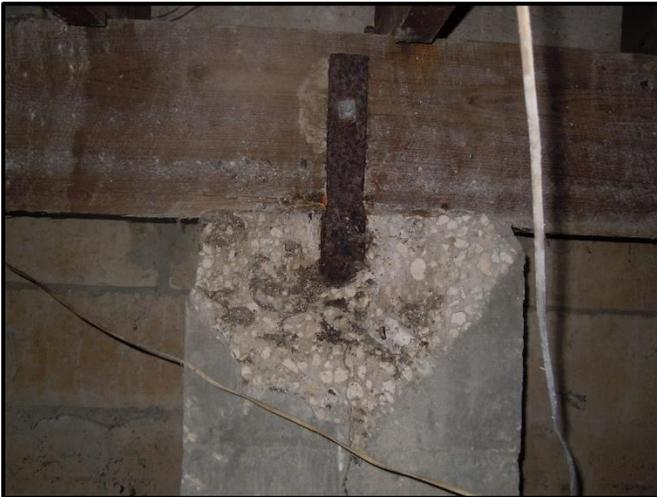
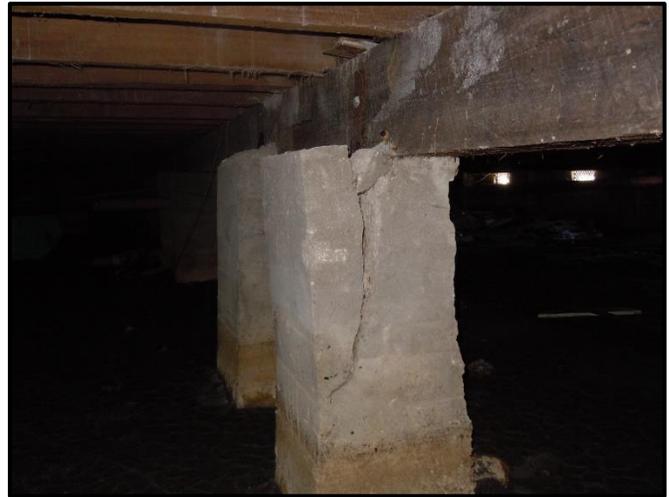
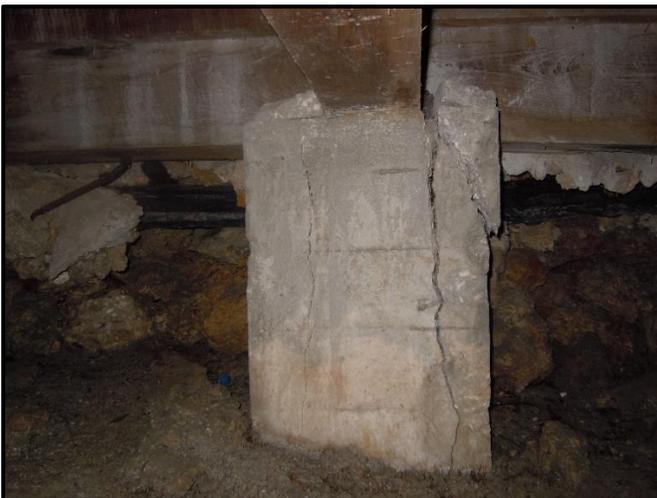
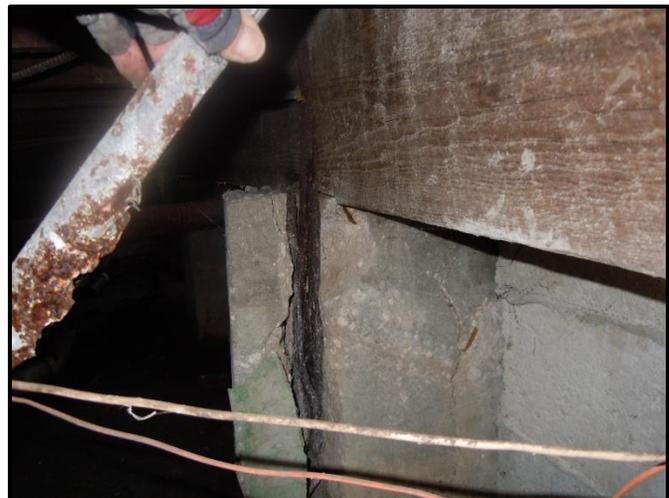
Over the past 95 years, to its credit, this building has been able to survive numerous hurricanes and periodic flooding. However, these events as well as the corrosive atmosphere of the ocean environment has taken its toll on the foundation integrity. The existing concrete piers are in poor condition. At least 30% of the concrete piers are cracked and deteriorating. Metal tie down anchors are highly corroded.

This building foundation is dire need of repair and replacement especially noting the future storm and flooding potential. Much of the original bank building piers are visibly crumbling and the anchorage is corroding. We also believe that there are additional areas of unseen failures. We do not recommend continuing with any renovations other than securing the building and patching any leaks without a full replacement of the 1920 building and vault foundation. The 1950 addition foundation should be repaired along with any column failures.

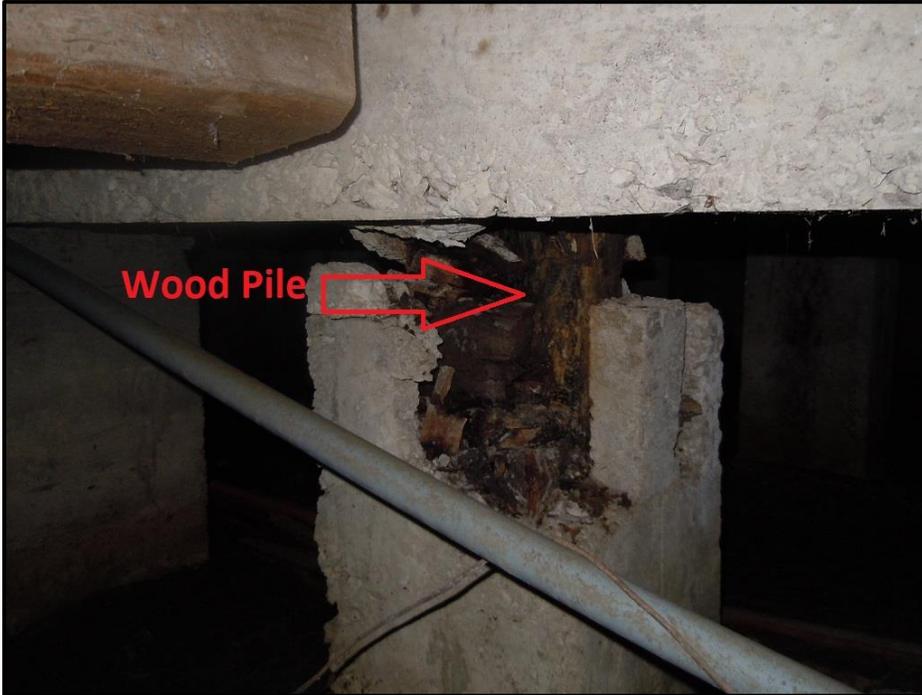
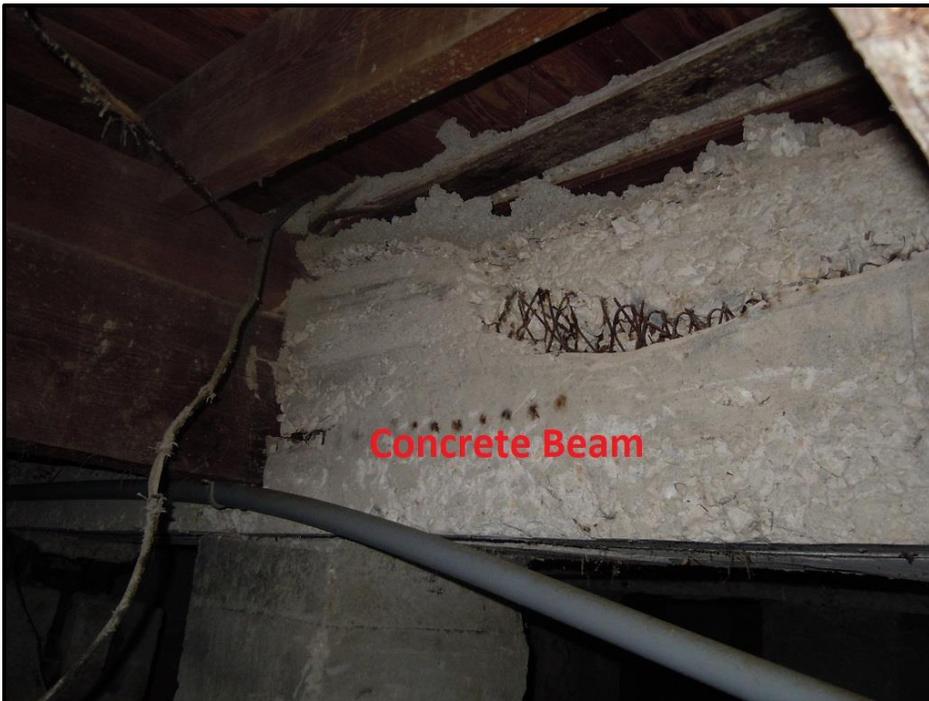
The vault support piles are in poor condition. The concrete encasement is cracked and deteriorated and the wood pile is exposed and deteriorated. The concrete support beam reinforcement is exposed and corroded.

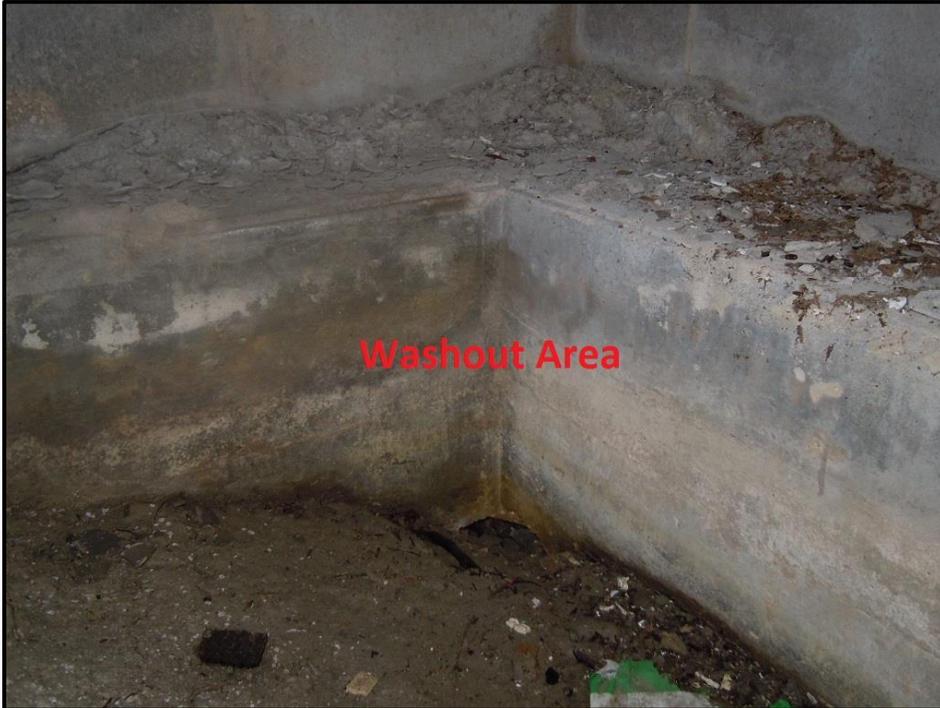
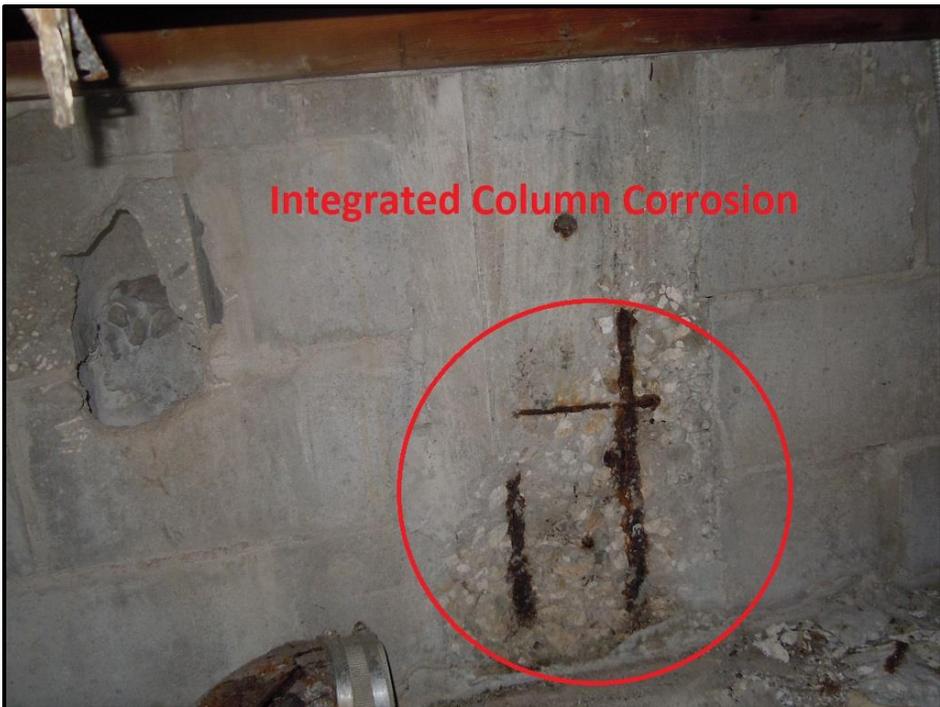
The 1950 addition foundation is in fair condition. The concrete is intact however, there is an area at the North East corner that appears to be washing out. The reinforcement of some of the concrete columns embedded in the masonry walls is exposed and corroded.

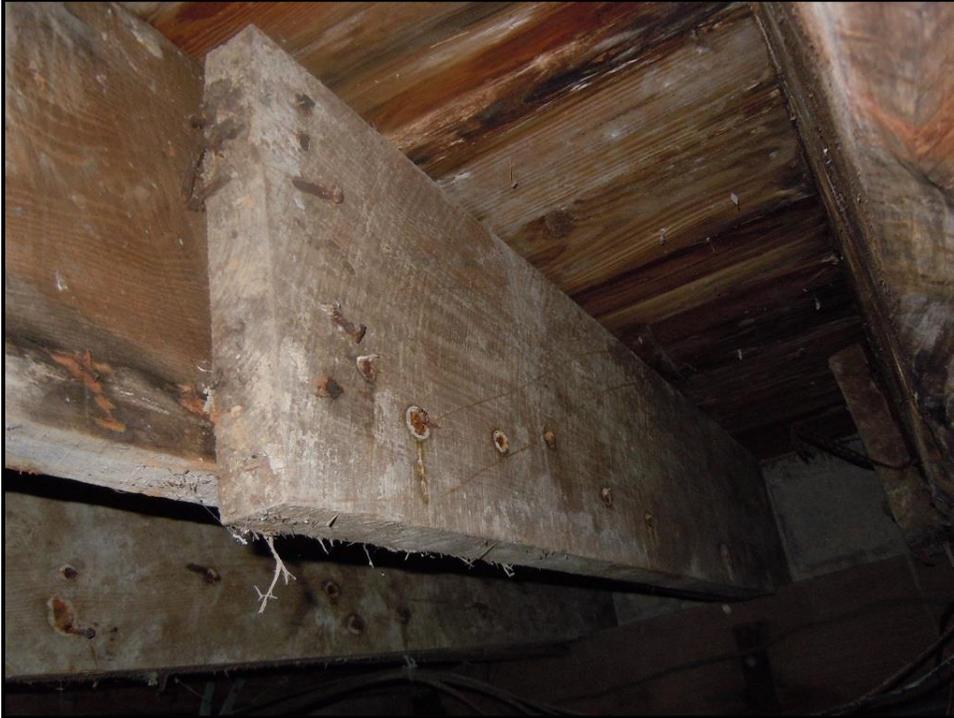
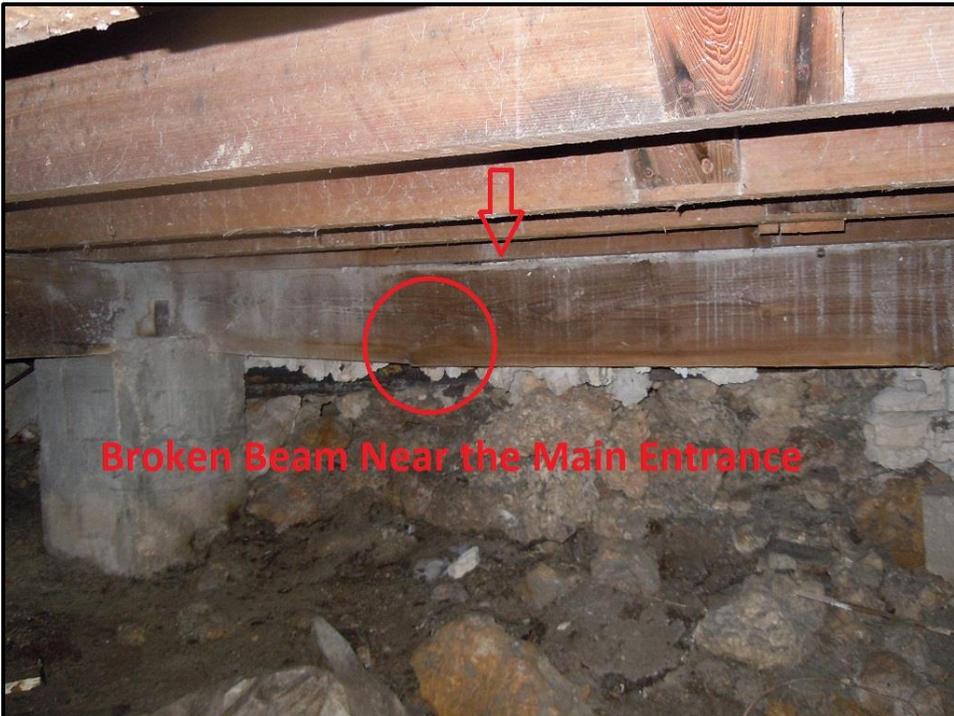
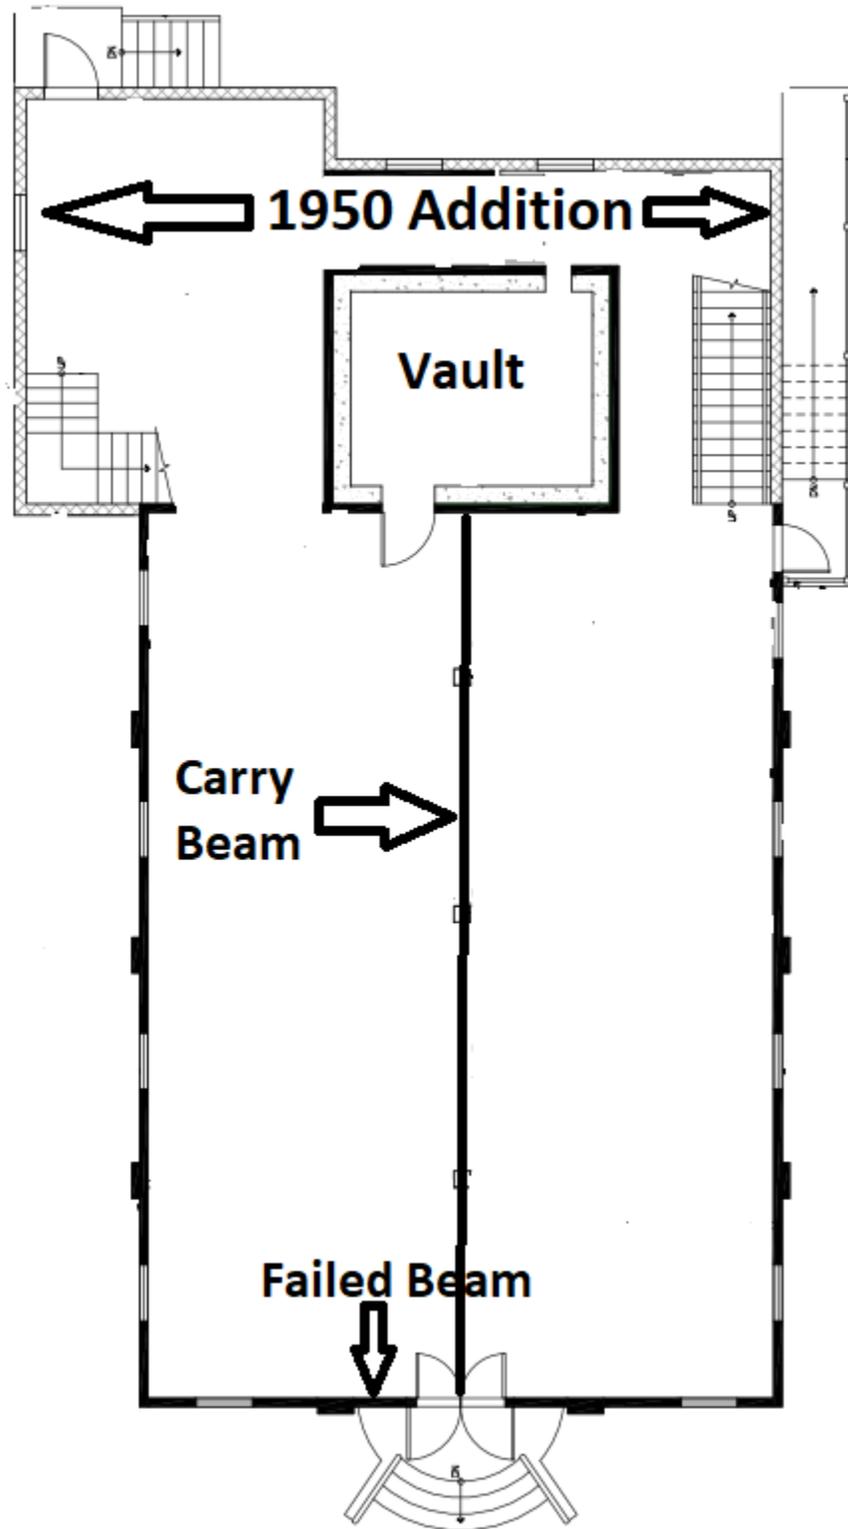
The structural wood support system is in fair condition. This wood construction has been exposed to a very moist environment which can reduce the ultimate strength of the system. There are signs of past splice repairs and a carry beam at the main entrance has failed.

As earlier stated, the ground floor deck system is in fair condition. If the foundation can be replaced with the ground floor intact, the failed beams and joist will require repair and reinforcement.
