# ECO MONTHLY ENVIRONMENTAL MONITORING REPORT

Virginia Photo Voltaic (PV) Solar Facility 1, 2 and 3,  
Matjhabeng, Lejweleputswa District Municipality within  
the jurisdiction of the Free State Province.

January 2025

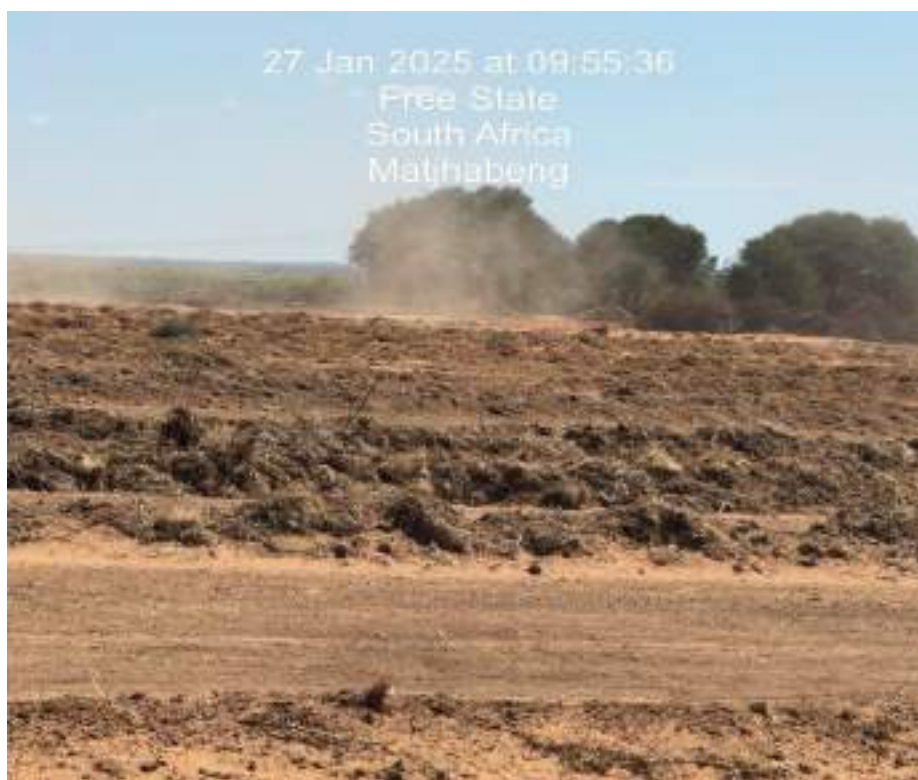
**Figure 1:** Excessive dust being generated.

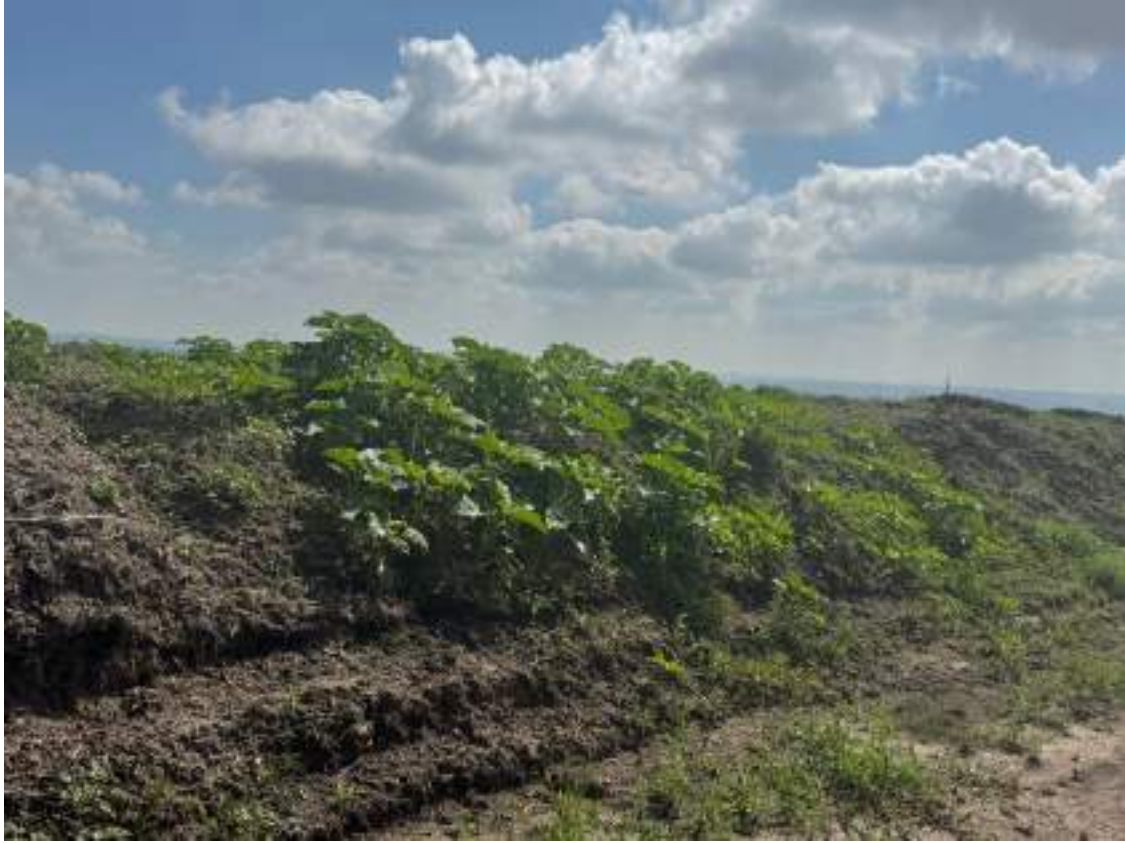
**Figure 1:** Alien Vegetation that must be cleared.

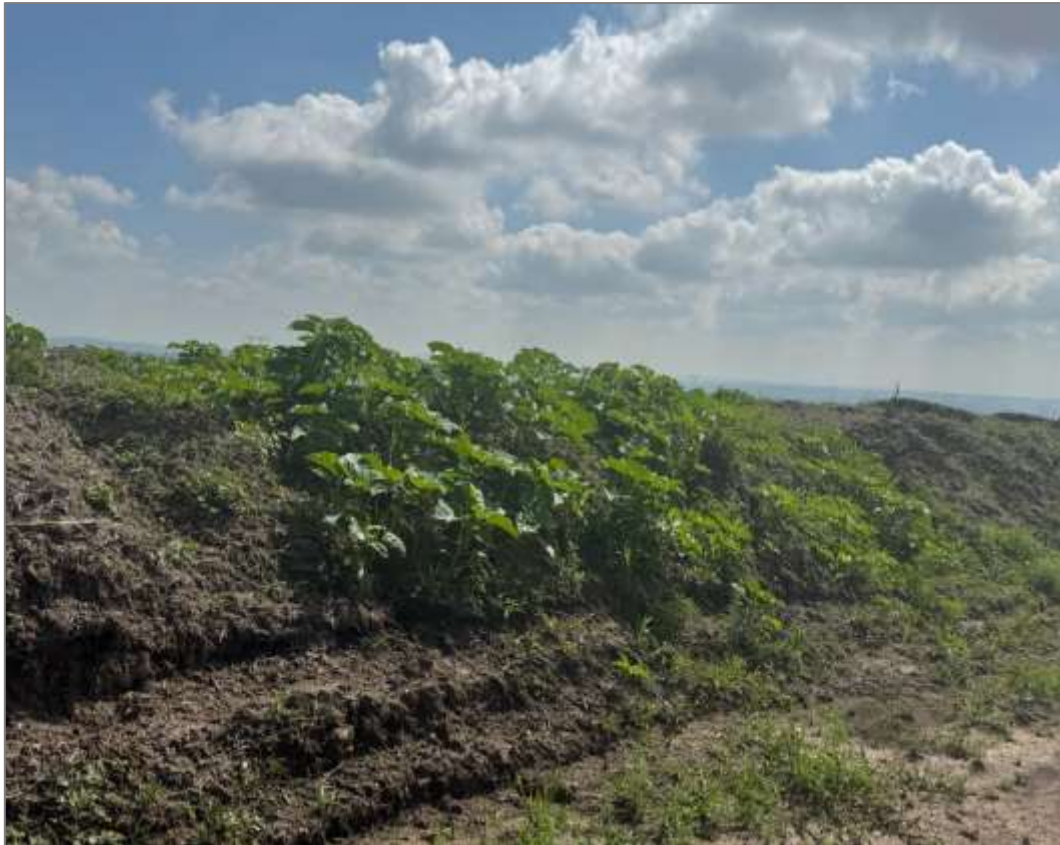
**Figure 1:** Alien Vegetation that must be cleared.

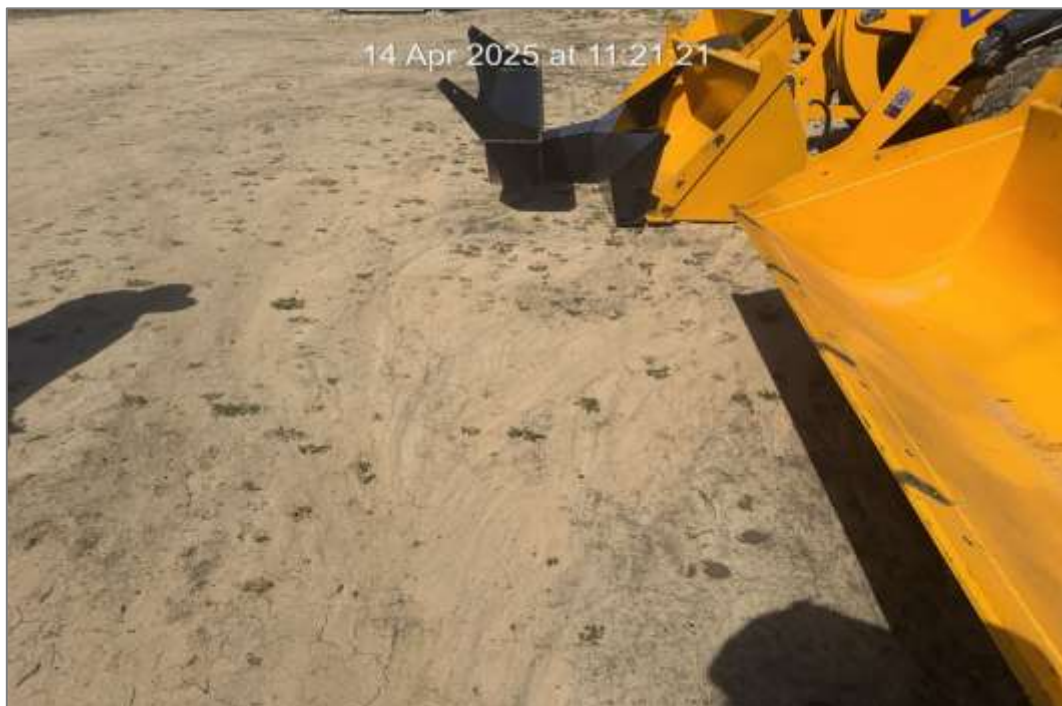
**Figure 6:** Erosion signs noted onsite.

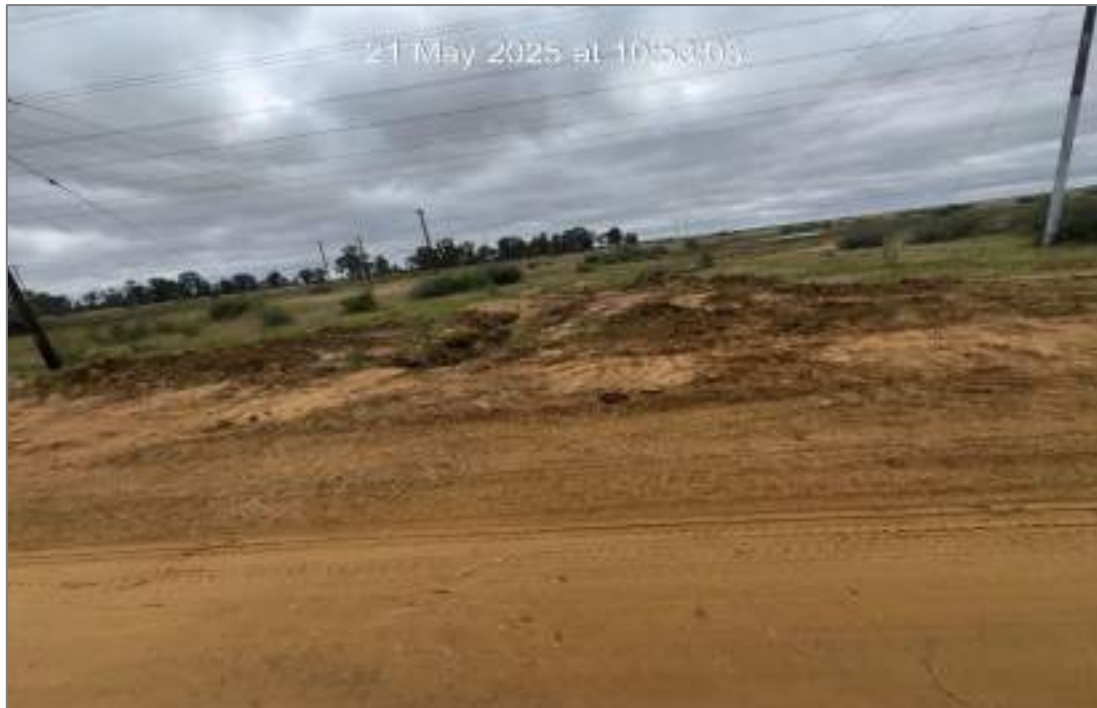
**Figure 1:** Erosion caused by pumped water.

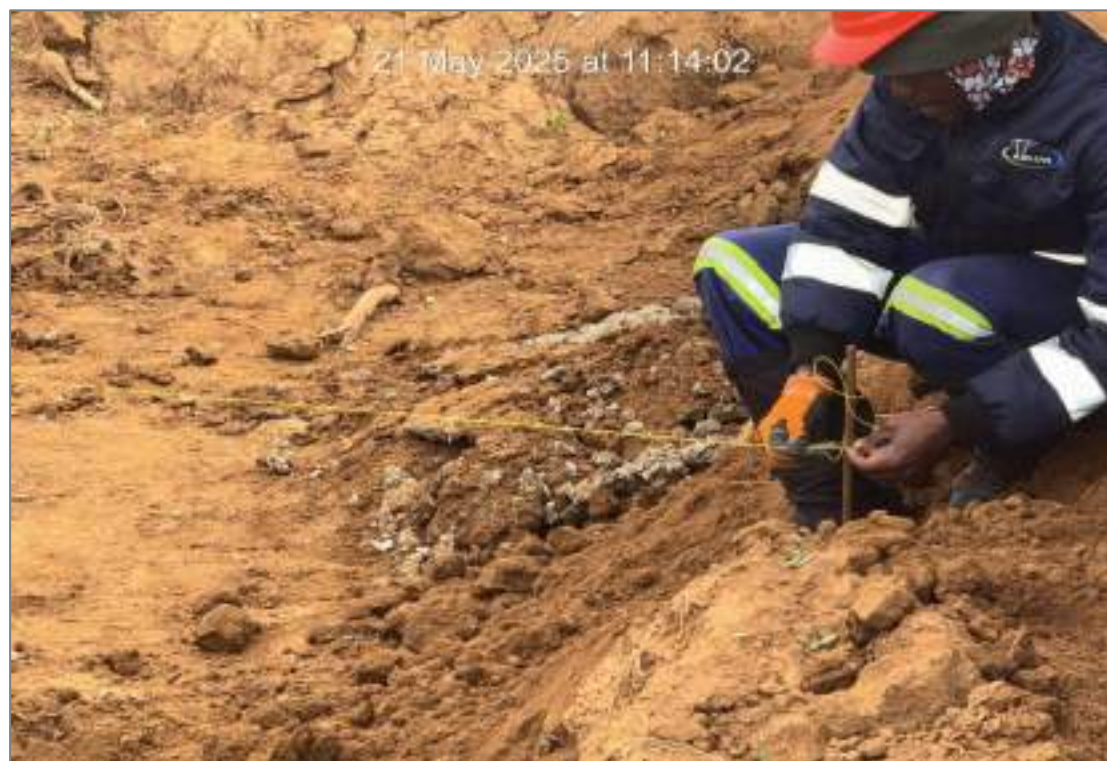
**Figure 2:** Concrete spillages that must be removed and not buried.

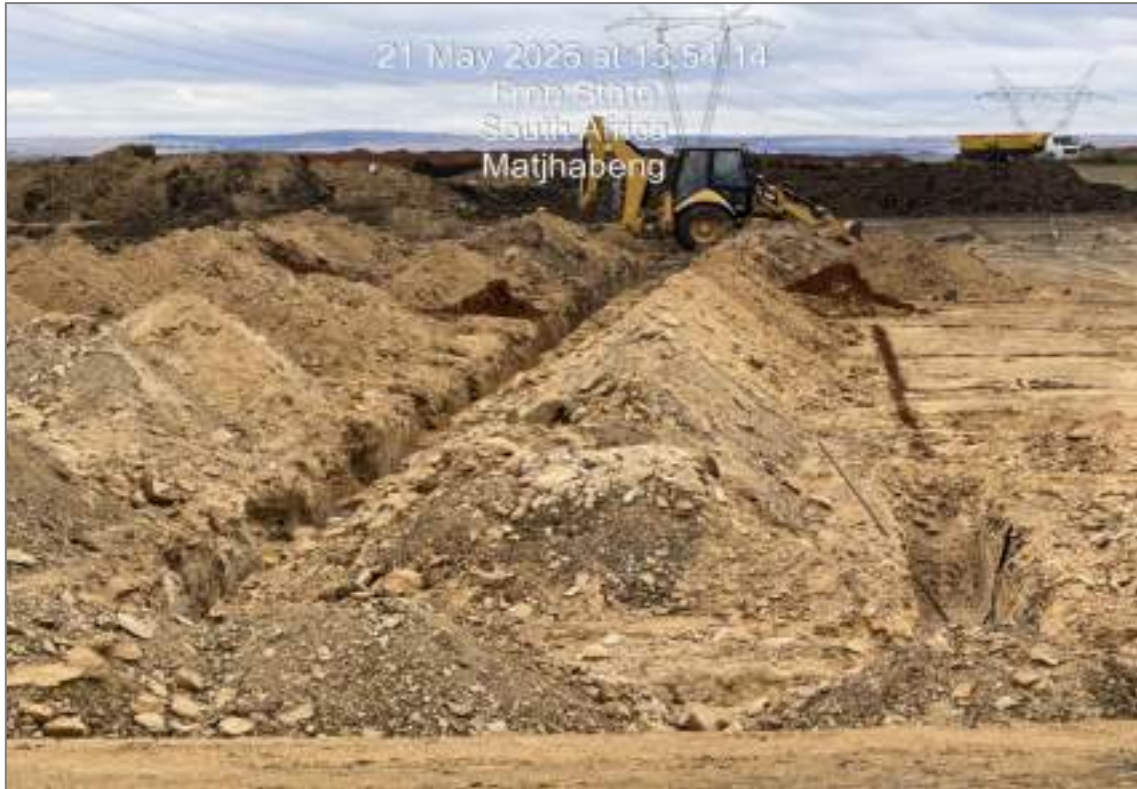
**Figure 5:** Excavation that must be barricaded.

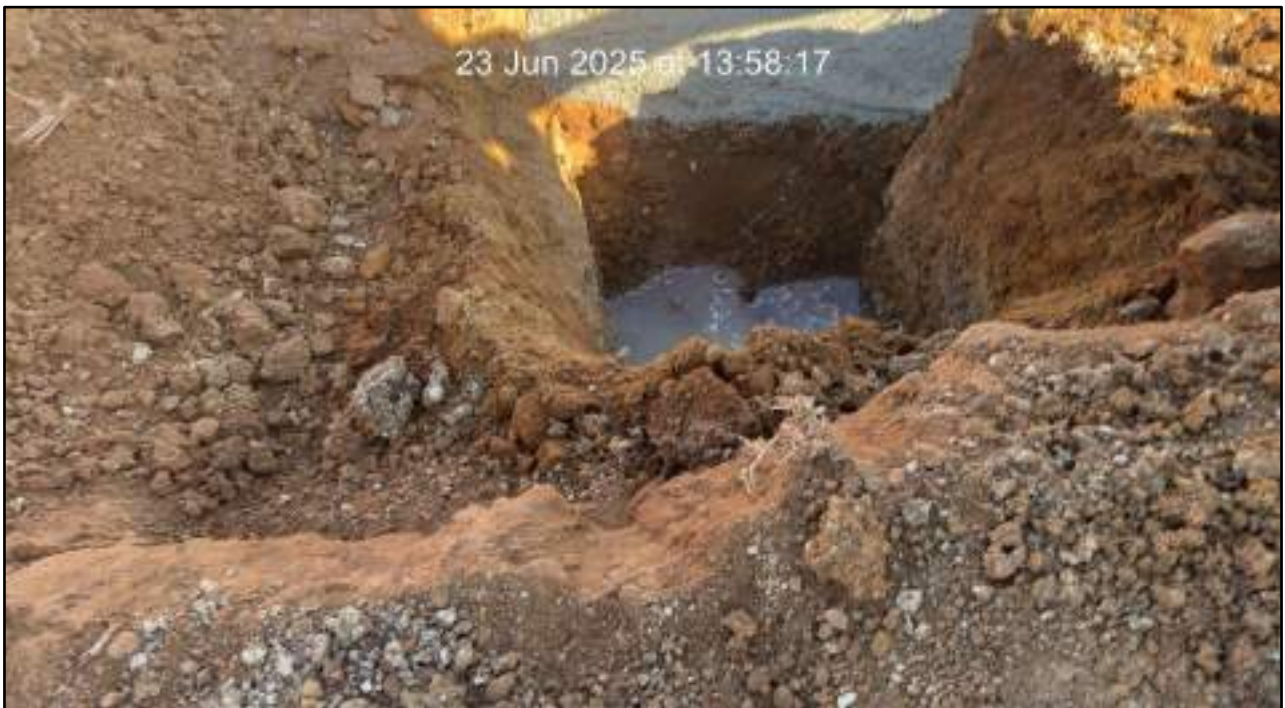
**Figure 6:** Groundwater that must be pumped out before concrete is poured.

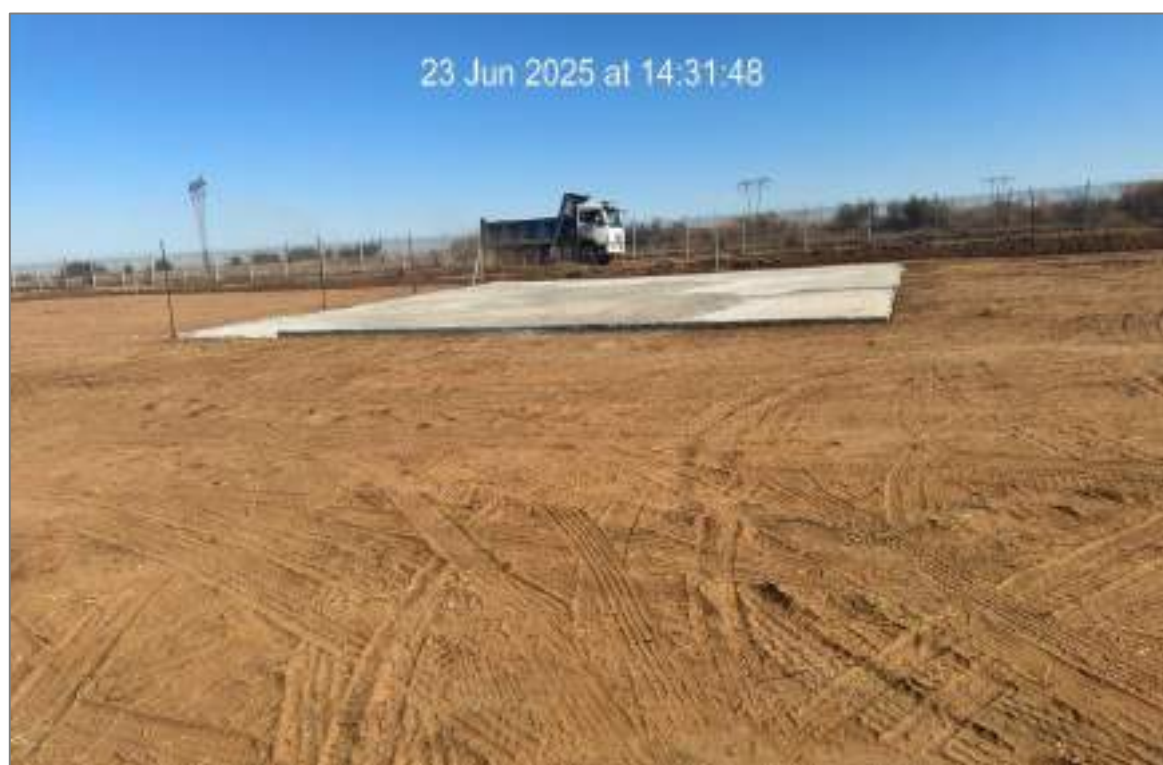
**Figure 6:** Incomplete concrete bund for the waste area

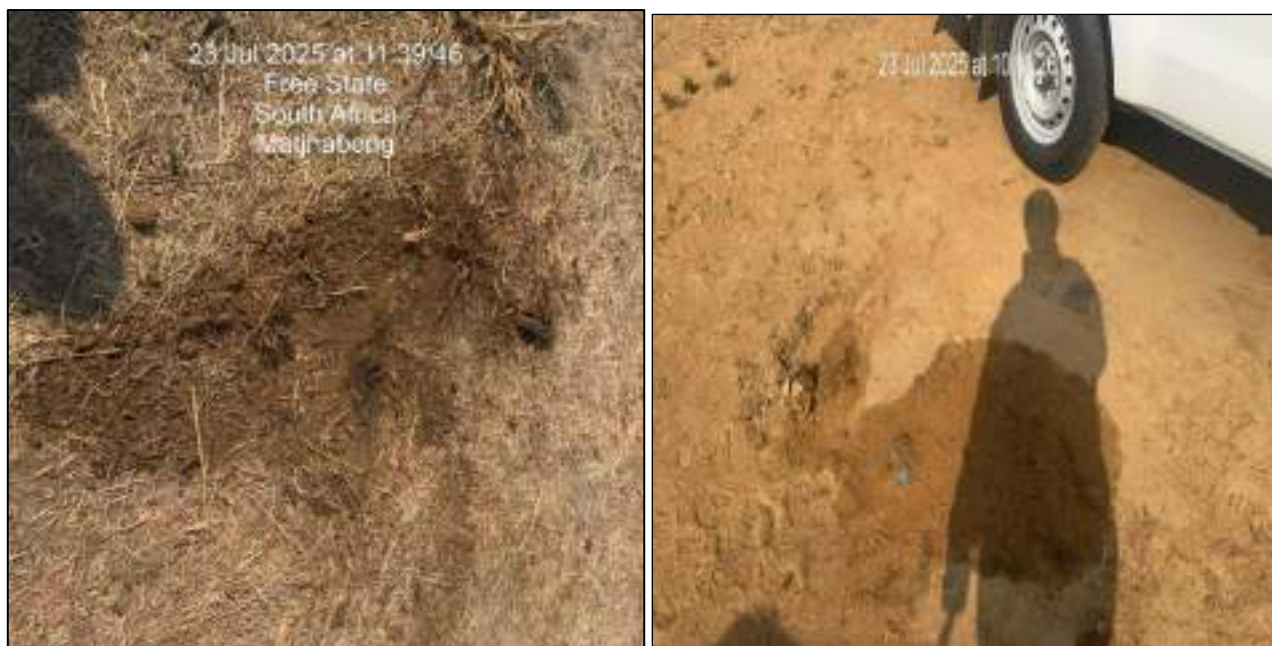
**Figure 1:** Oil spillages.

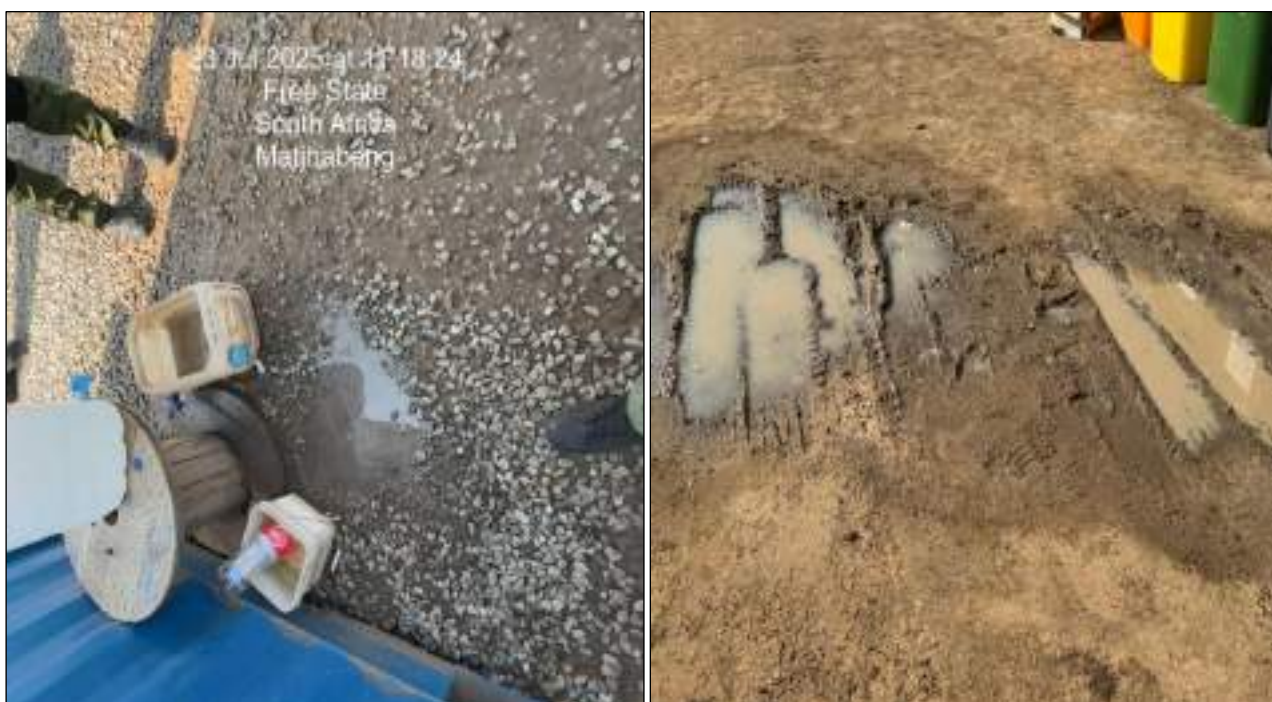
**Figure 2:** Nuisance due to water spillage

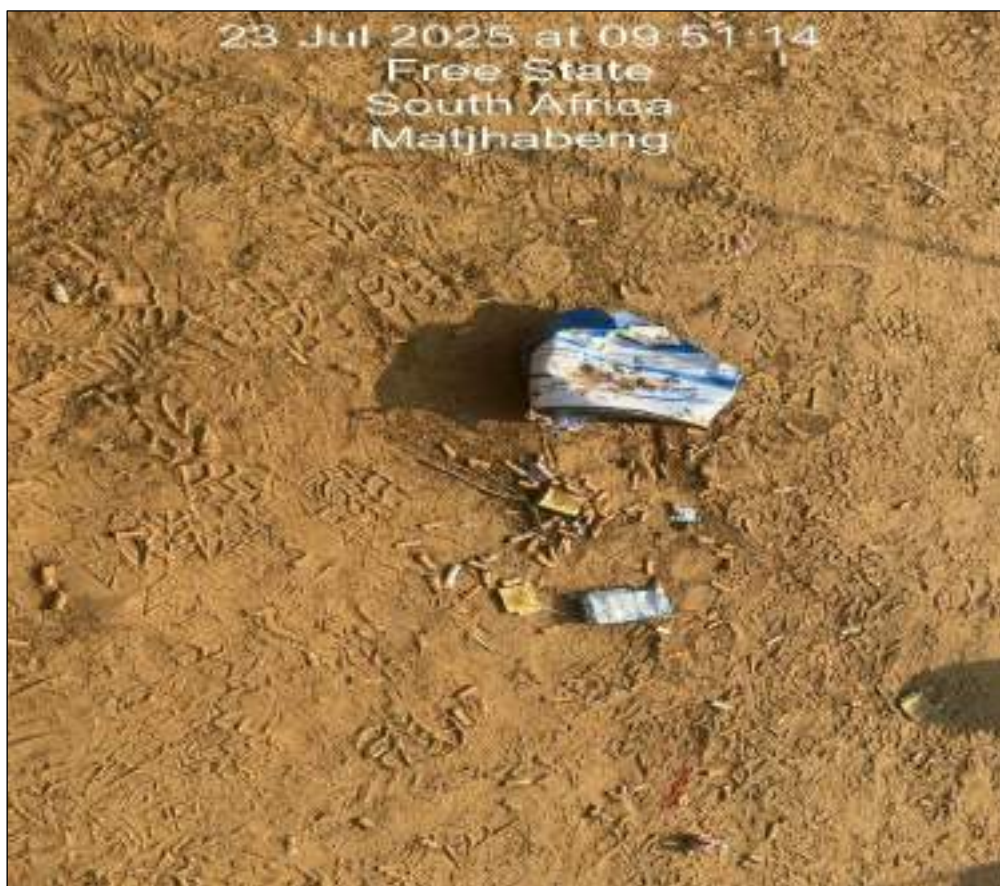
**Figure 4:** Cigarette buds found on the ground.

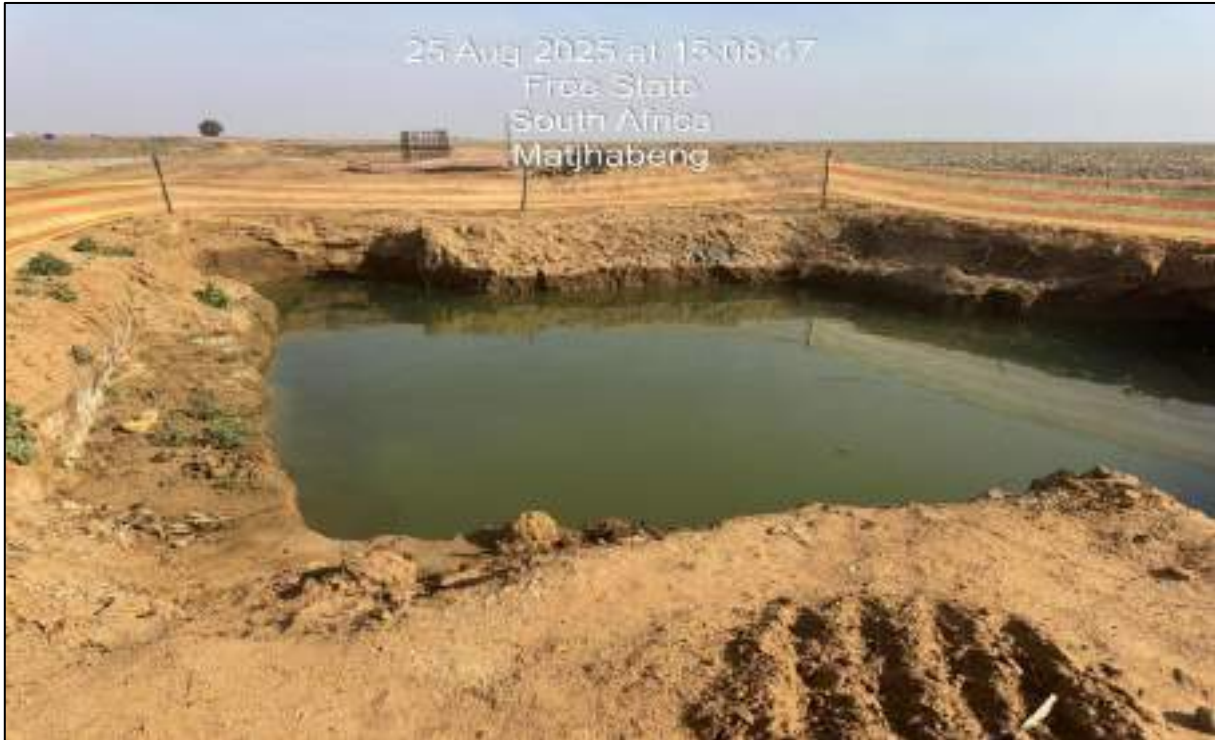
**Figure 1:** Groundwater encounter on some of the pits.

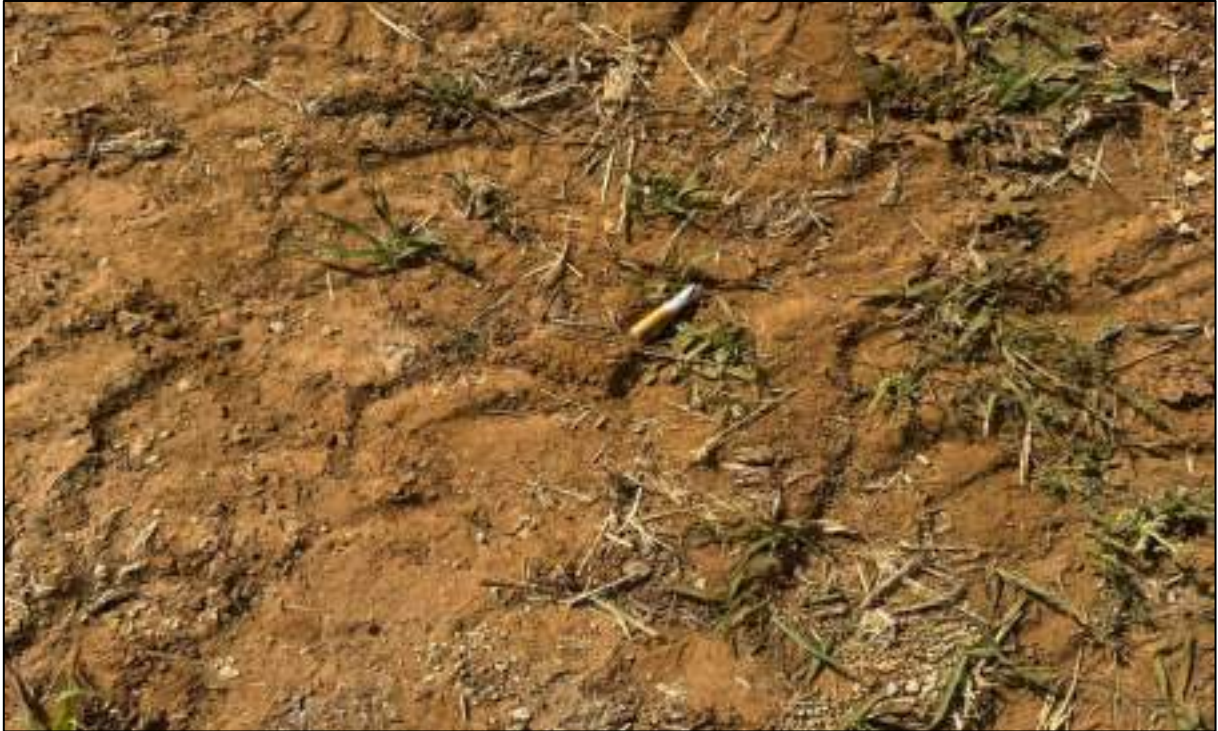
**Figure 3:** Cigarettes buds on the ground.

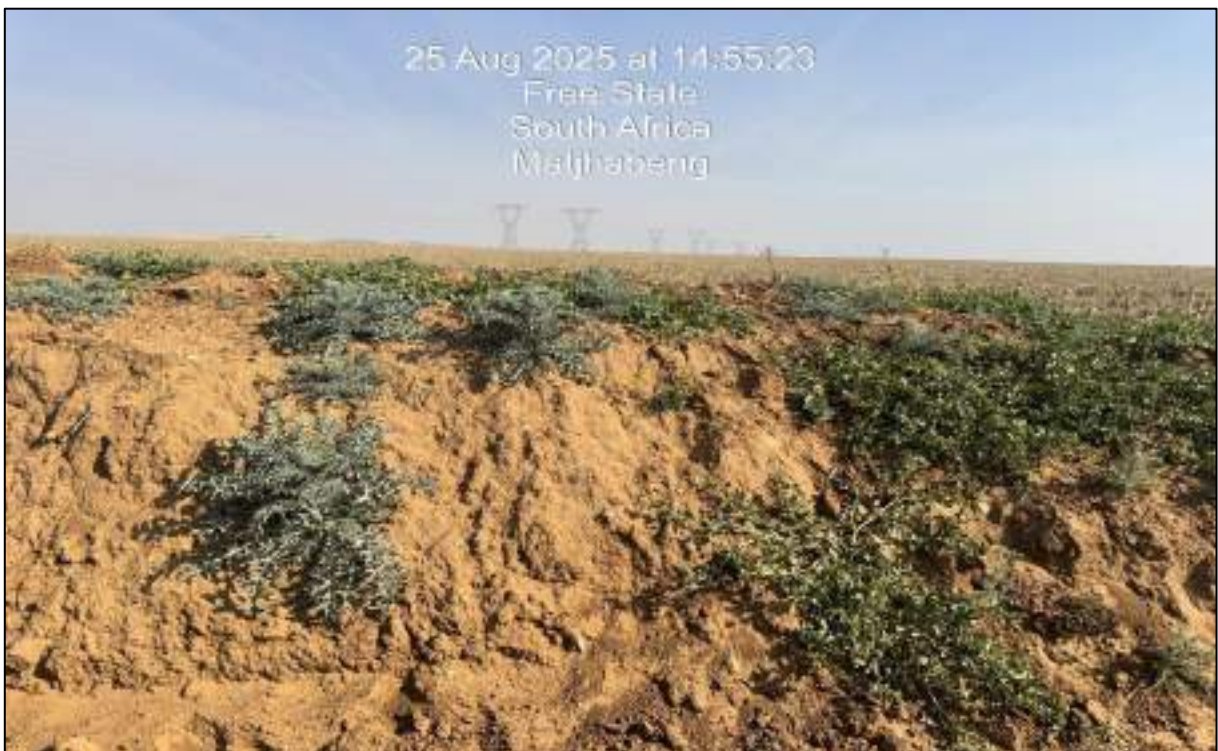
**Figure 4:** Alien vegetation on the topsoil stockpiles

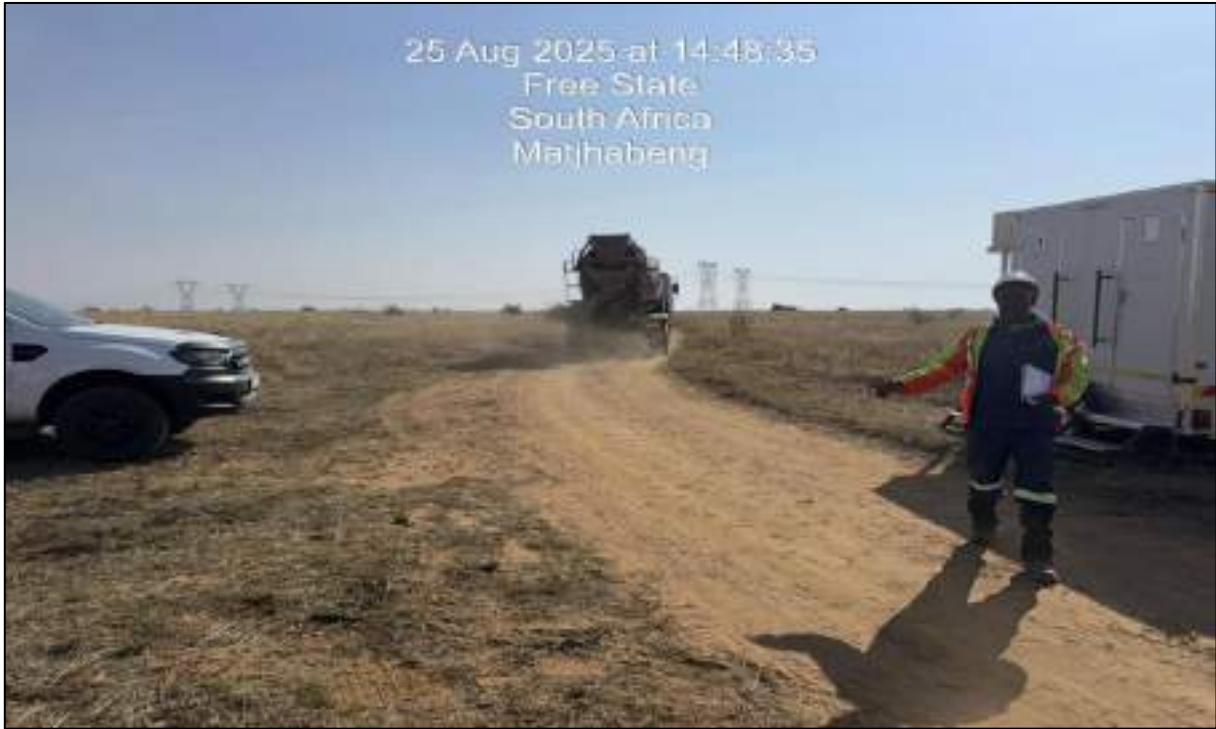
**Figure 5:** Dust observed on the access roads.

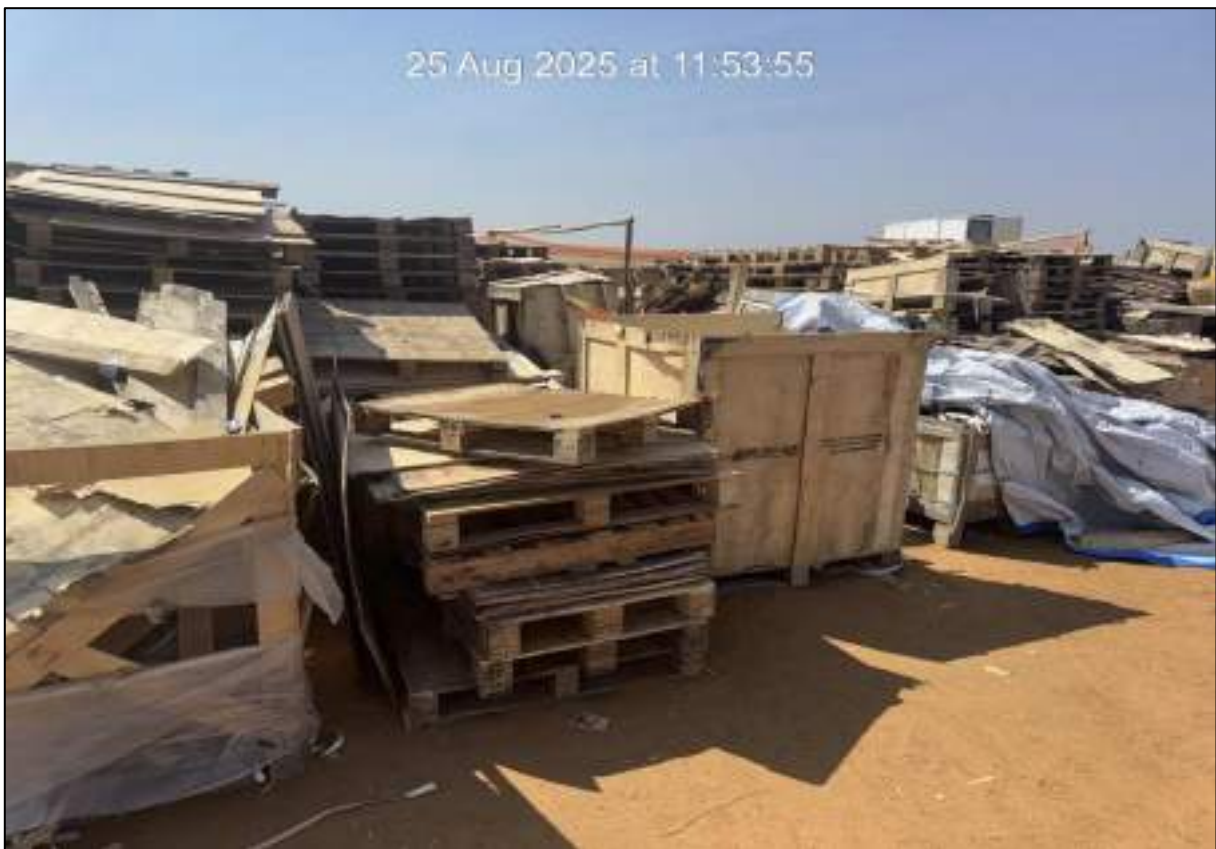
**Figure 6:** Large quantities of wood pallets

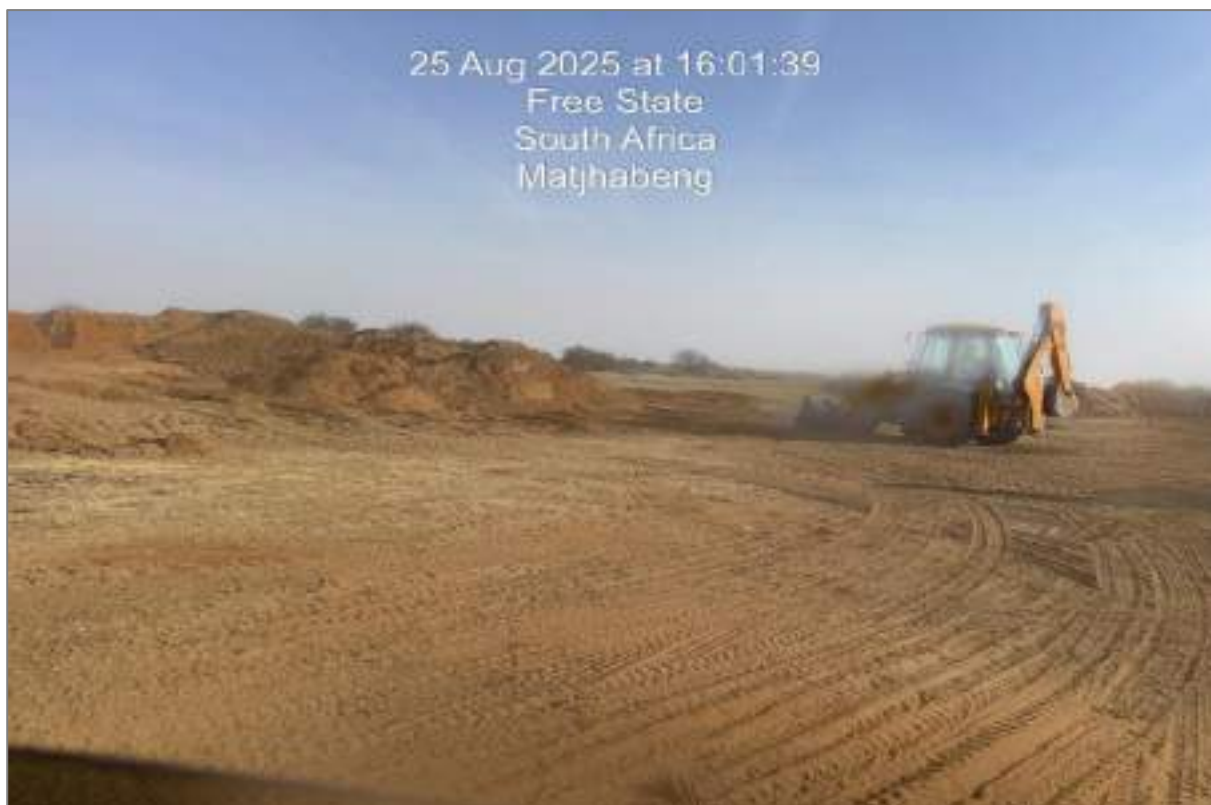
**Figure 1:** Compaction of topsoil.

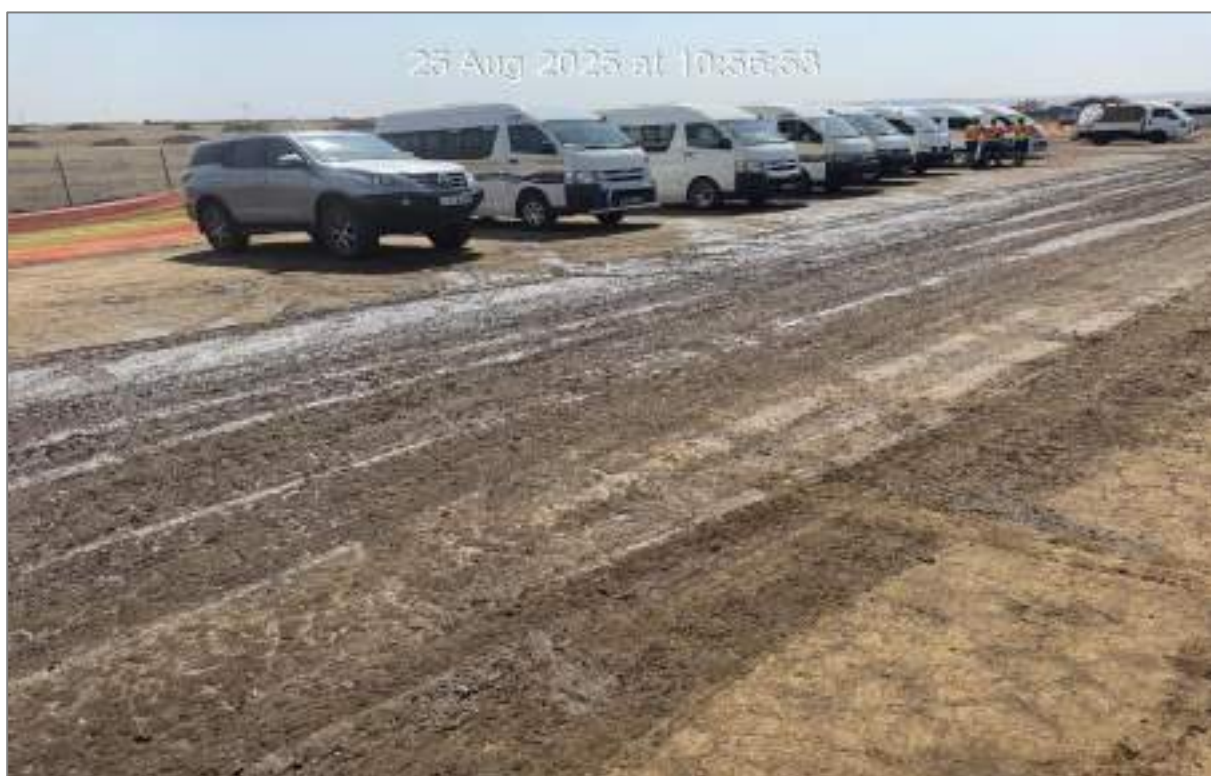
**Figure 2:** Nuisance due to water from the bowser

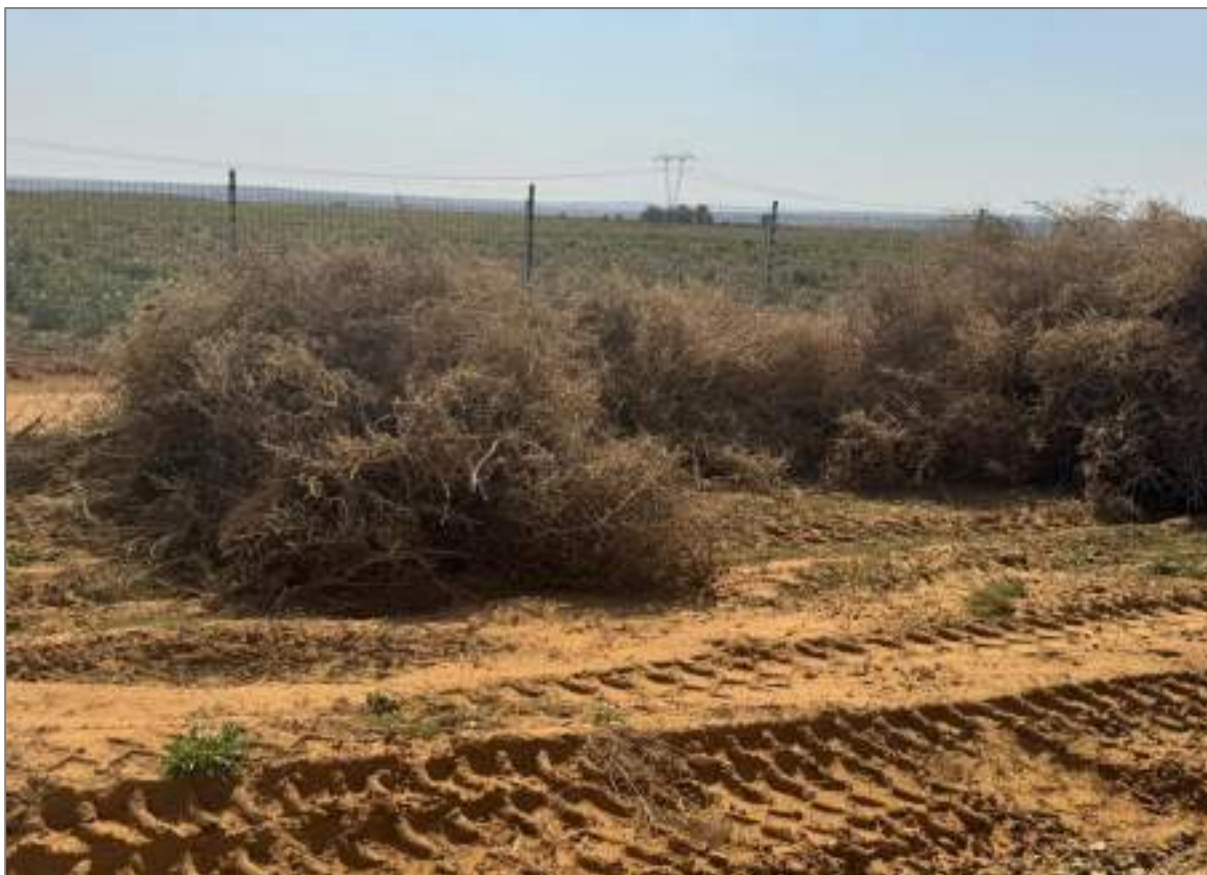
**Figure 3:** Cleared alien vegetation must be removed disposal.

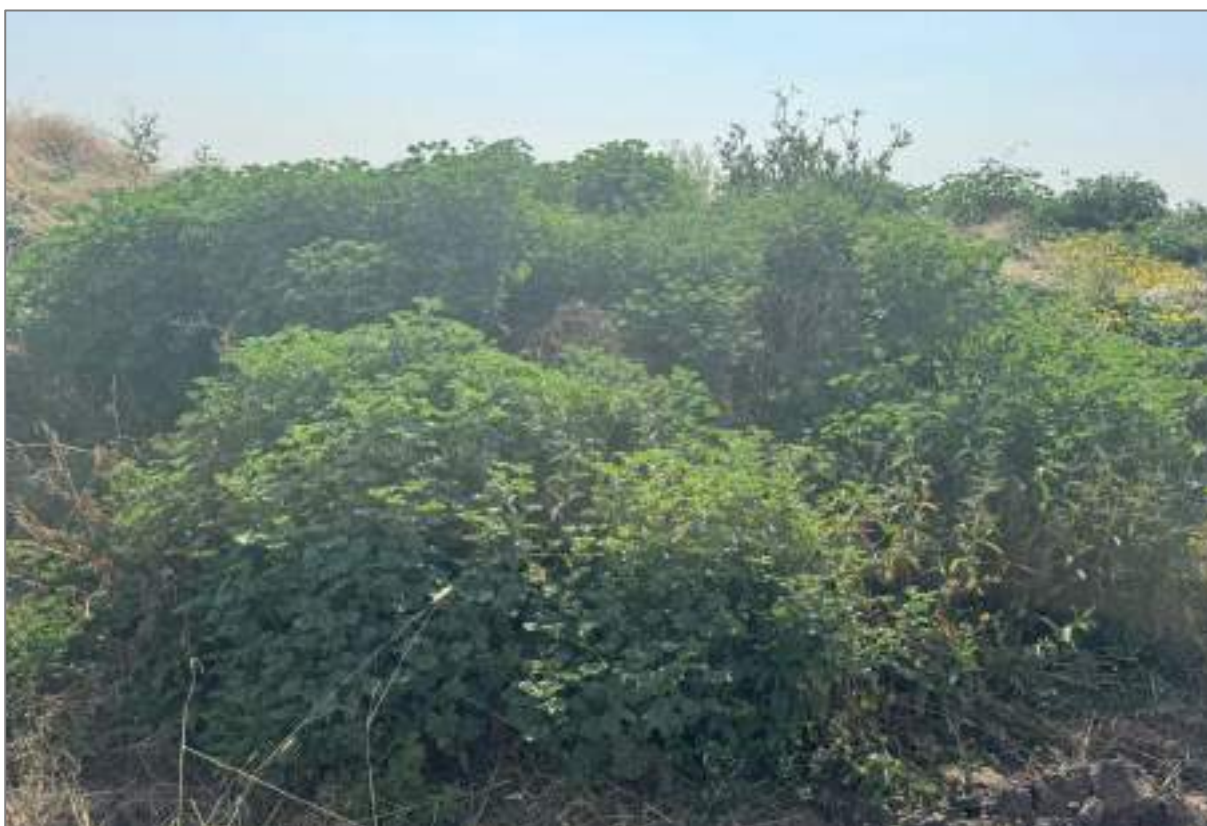
**Figure 4:** Alien vegetation.

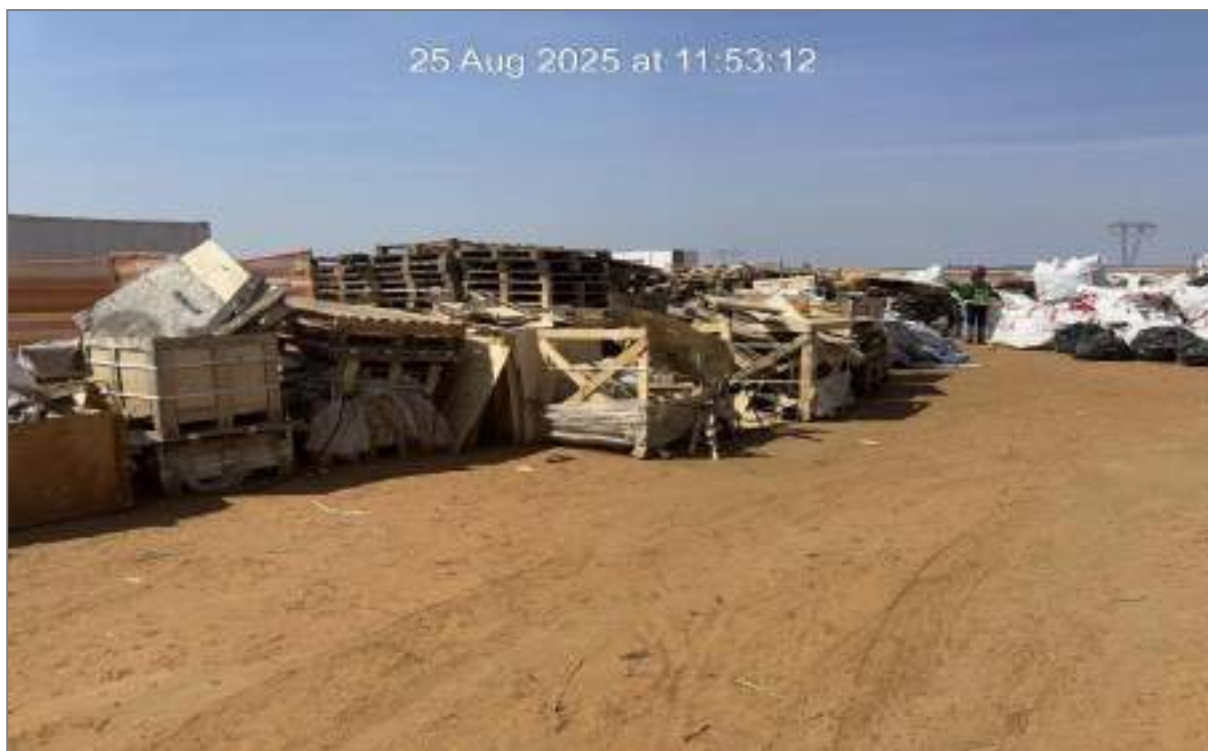
**Figure 5:** Large pile wood pallets.

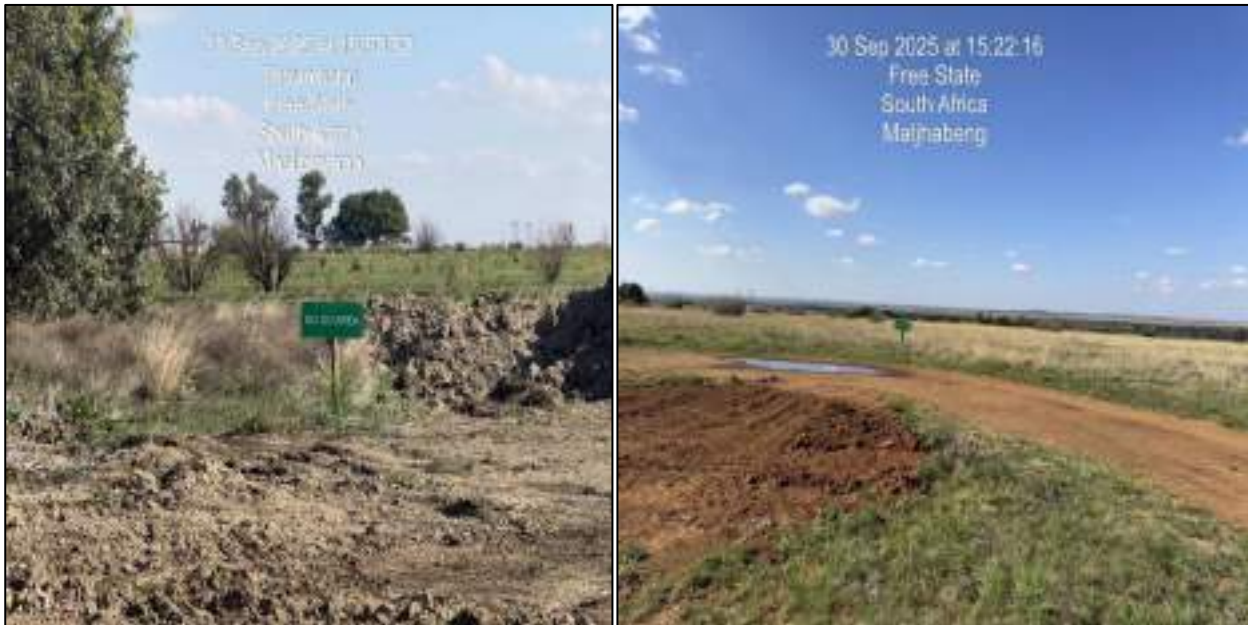
**Figure 1:** Sensitive areas that must be demarcated.

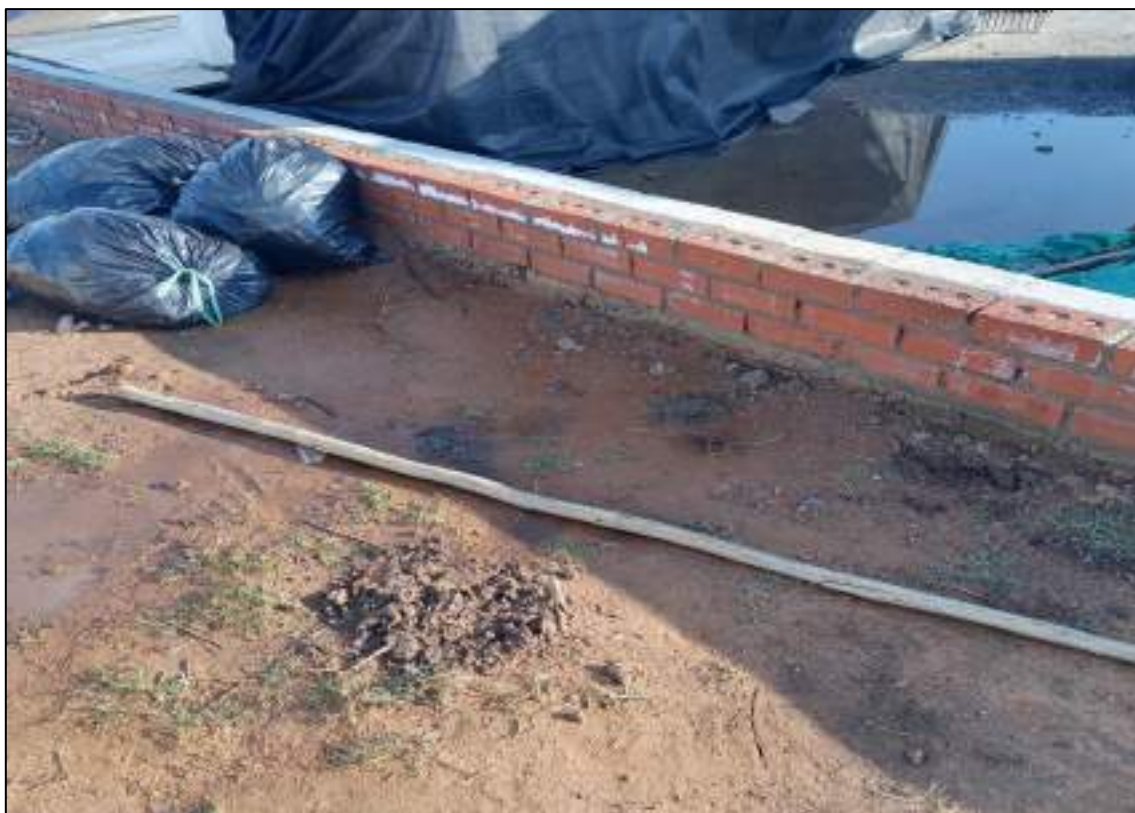
**Figure 10:** Leaking waste bund

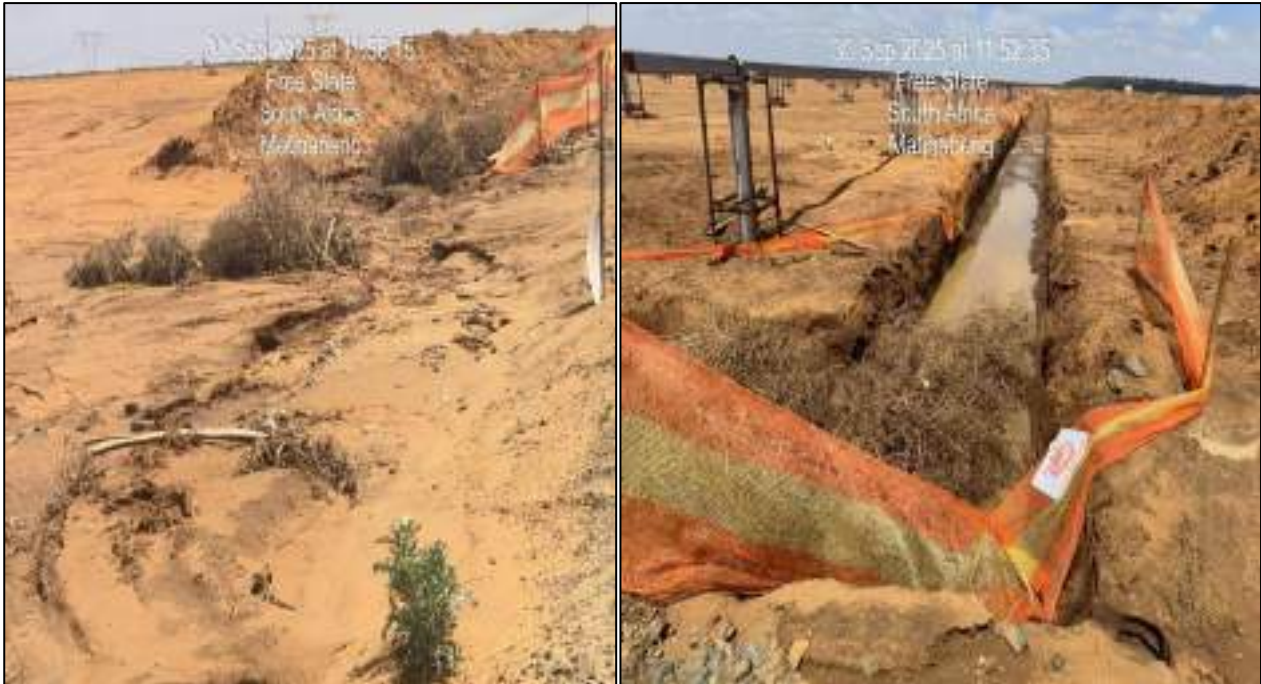
**Figure 1:** Cleared alien vegetation being moved by stormwater.
