# ECO MONTHLY ENVIRONMENTAL MONITORING REPORT

Virginia Photo Voltaic (PV) Solar Facility 1, 2 and 3,  
Matjhabeng, Lejweleputswa District Municipality within  
the jurisdiction of the Free State Province.

January 2025

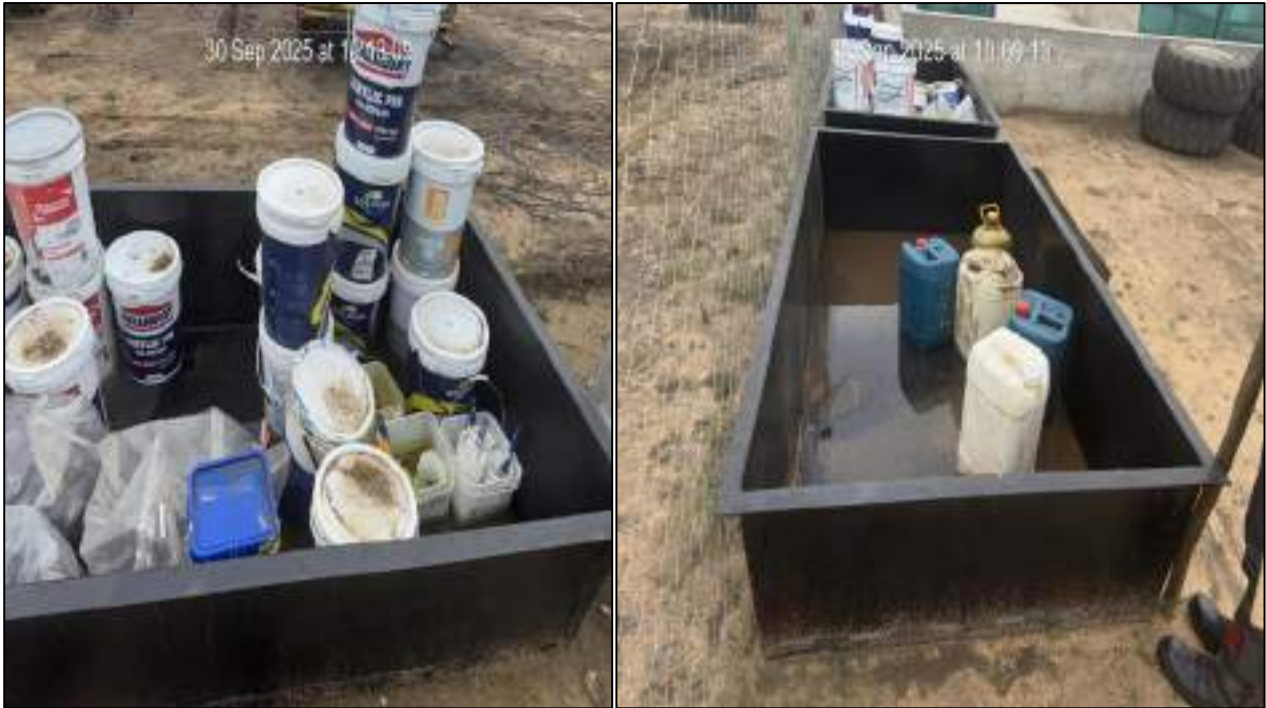
**Figure 7:** Chemical bund accumulating rainwater.

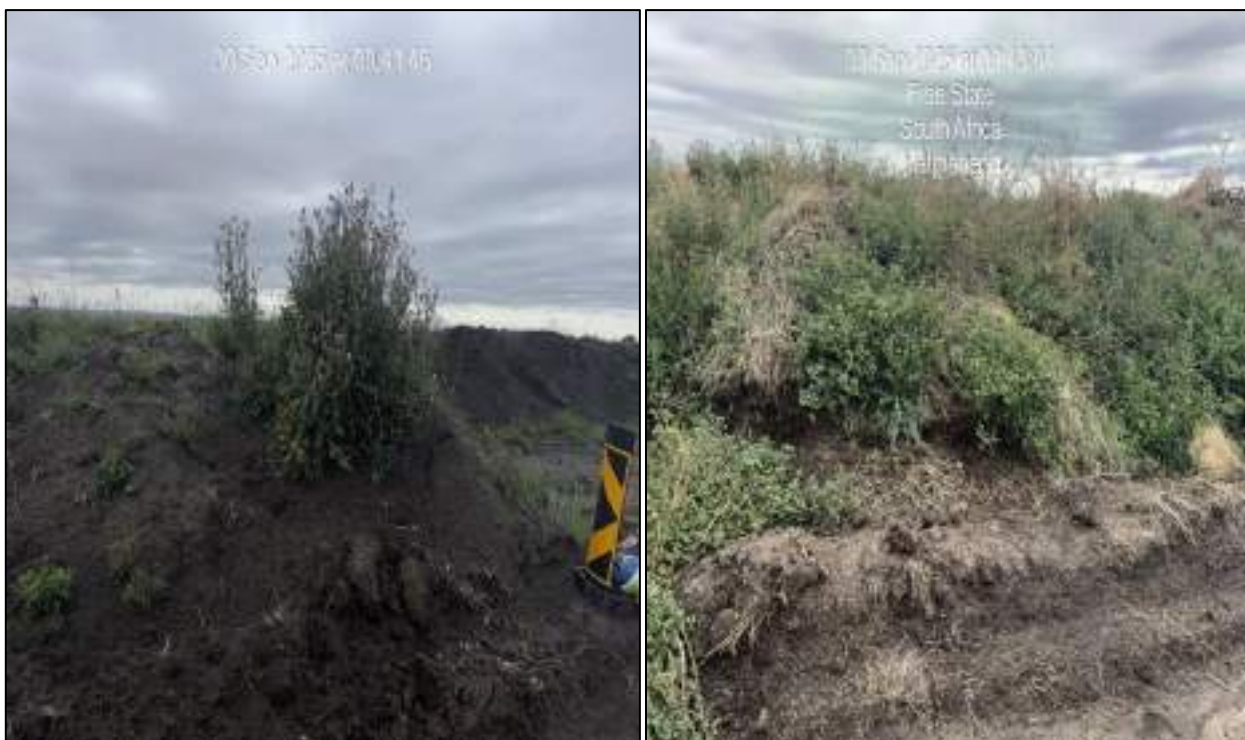
**Figure 9:** Alien vegetation site.

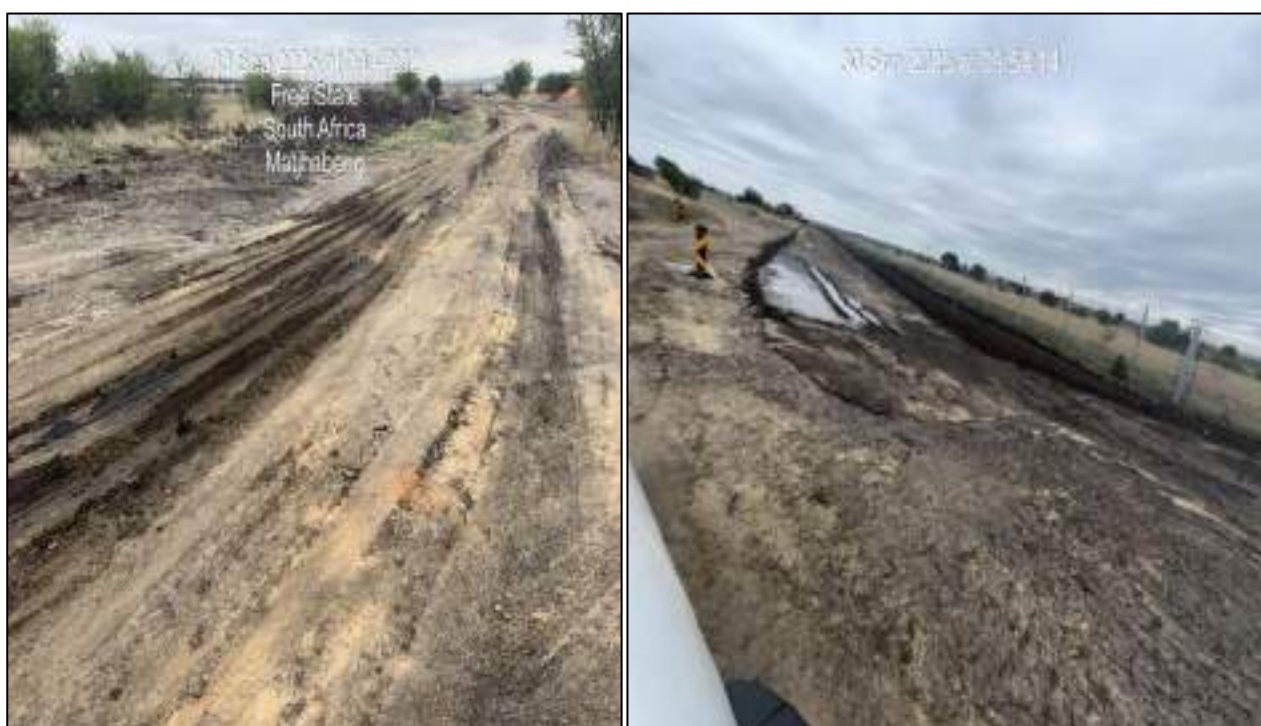
**Figure 10:** Condition of the access road.

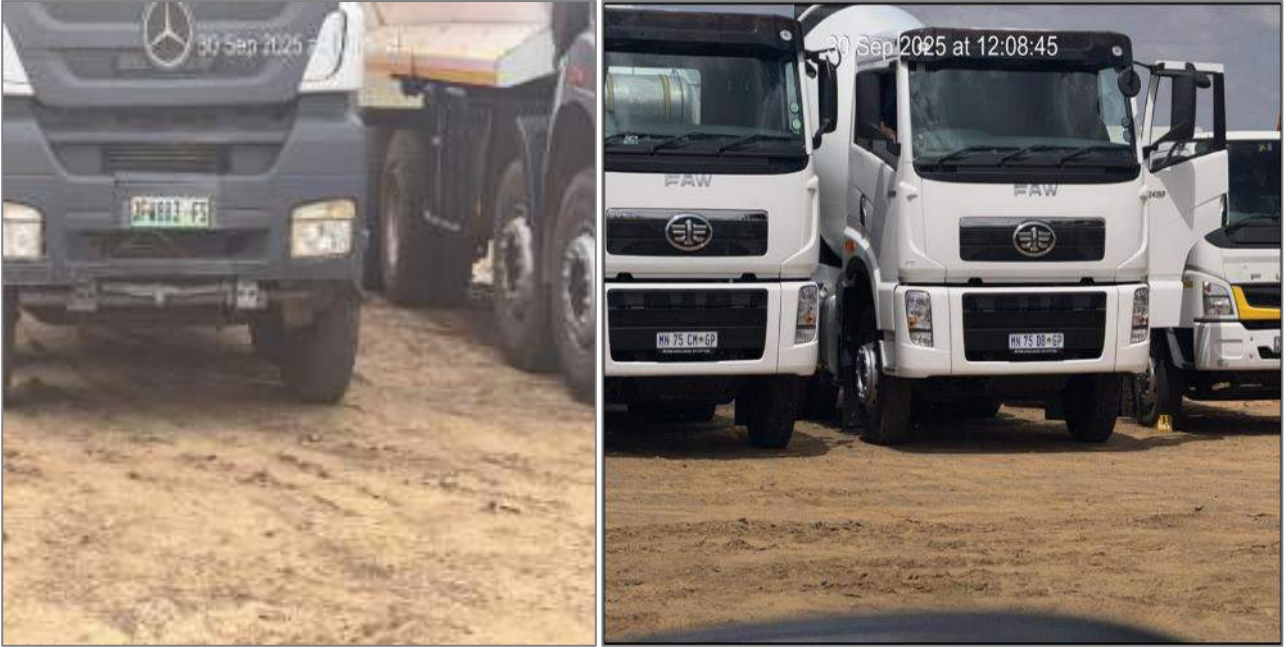
**Figure 11:** Equipment with on drip trays.

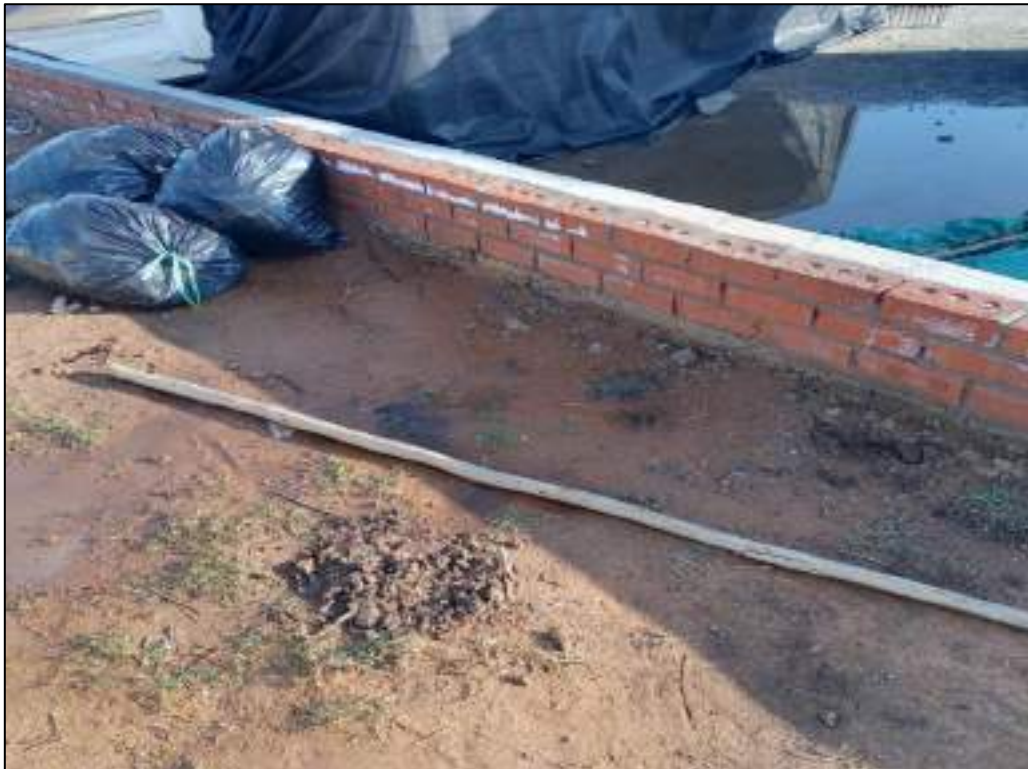
**Figure 12:** Leaking waste bund.

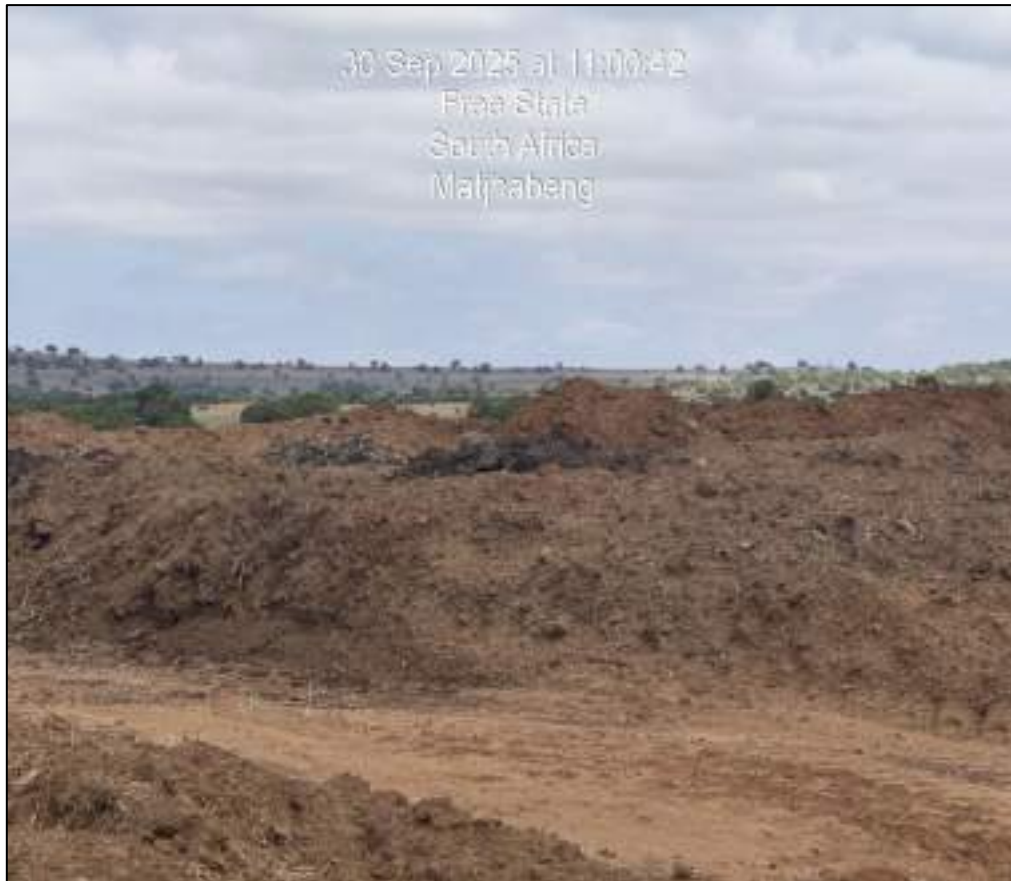
**Figure 13:** Topsoil mixed with spoil material.

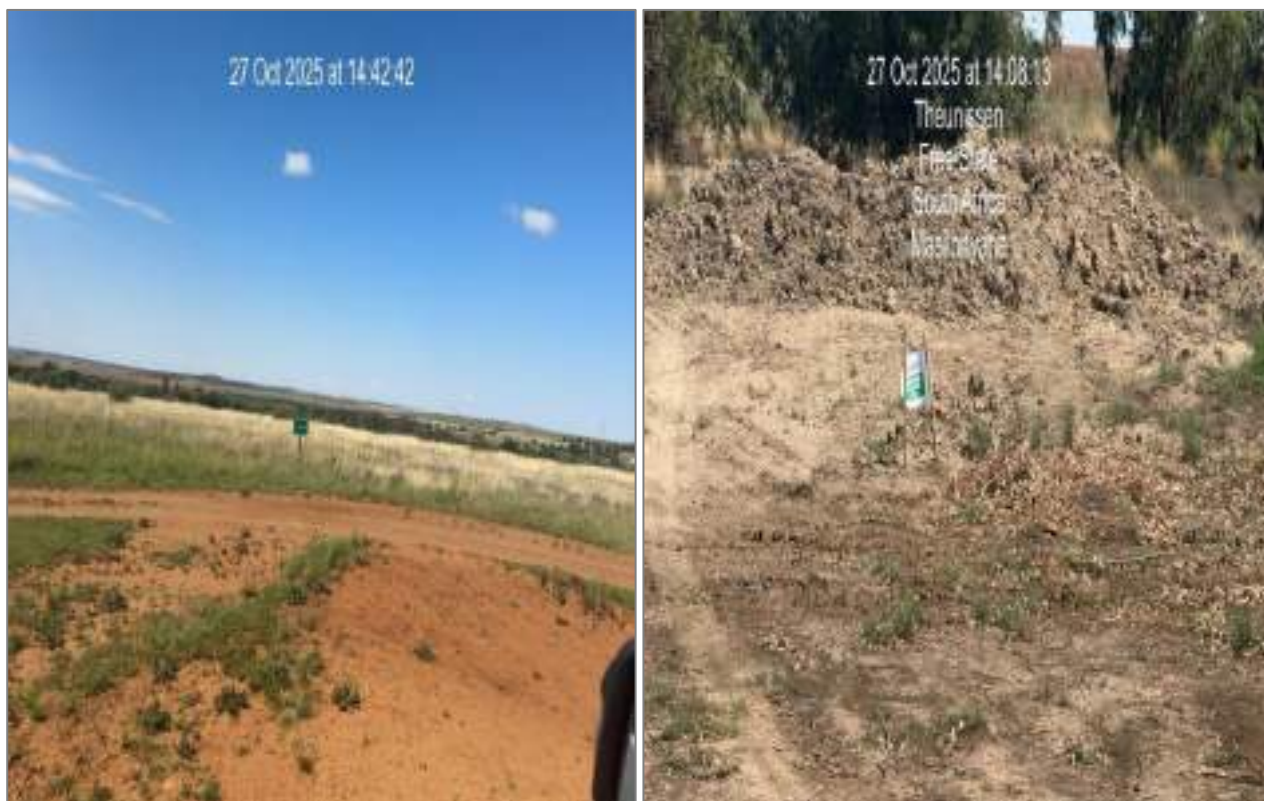
**Figure 1:** Sensitive/ no go areas must be demarcated.

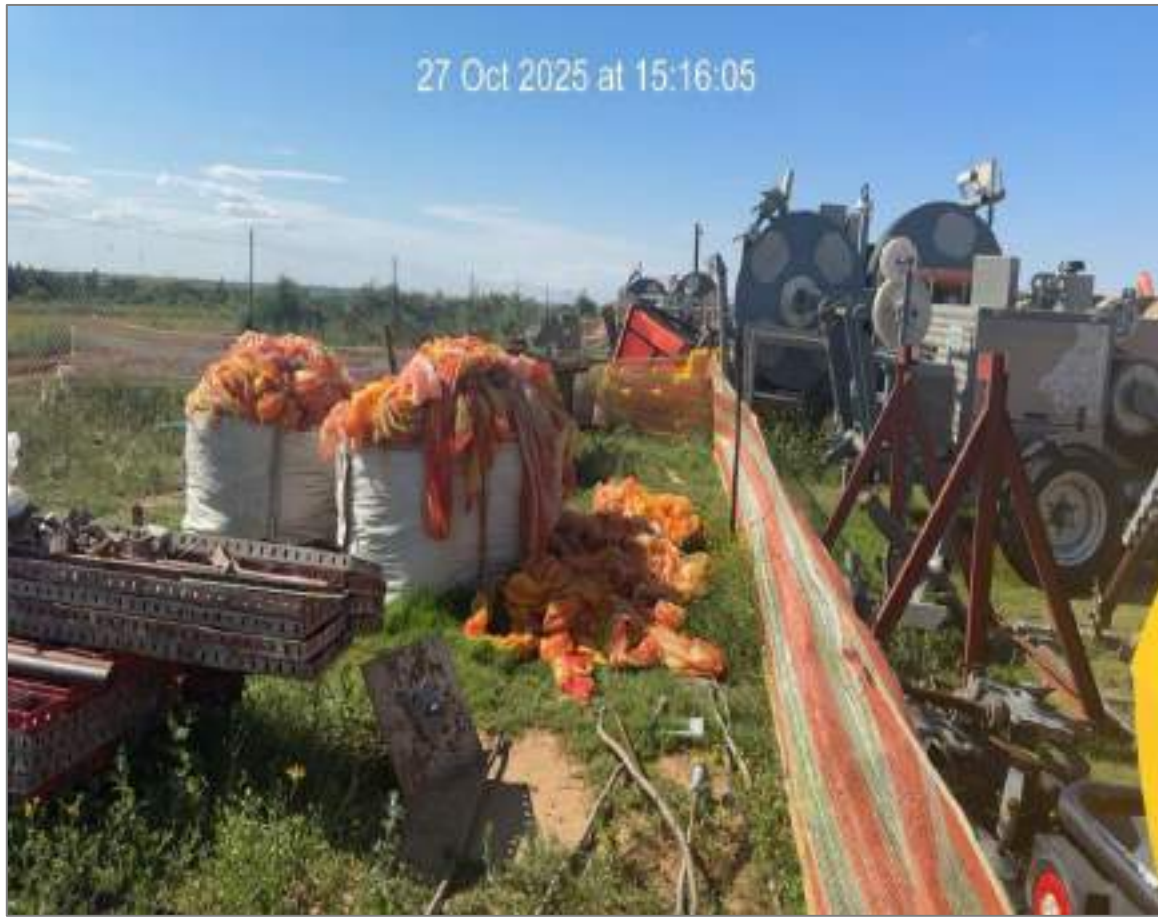
**Figure 3:** Torn barricade must be recycled.

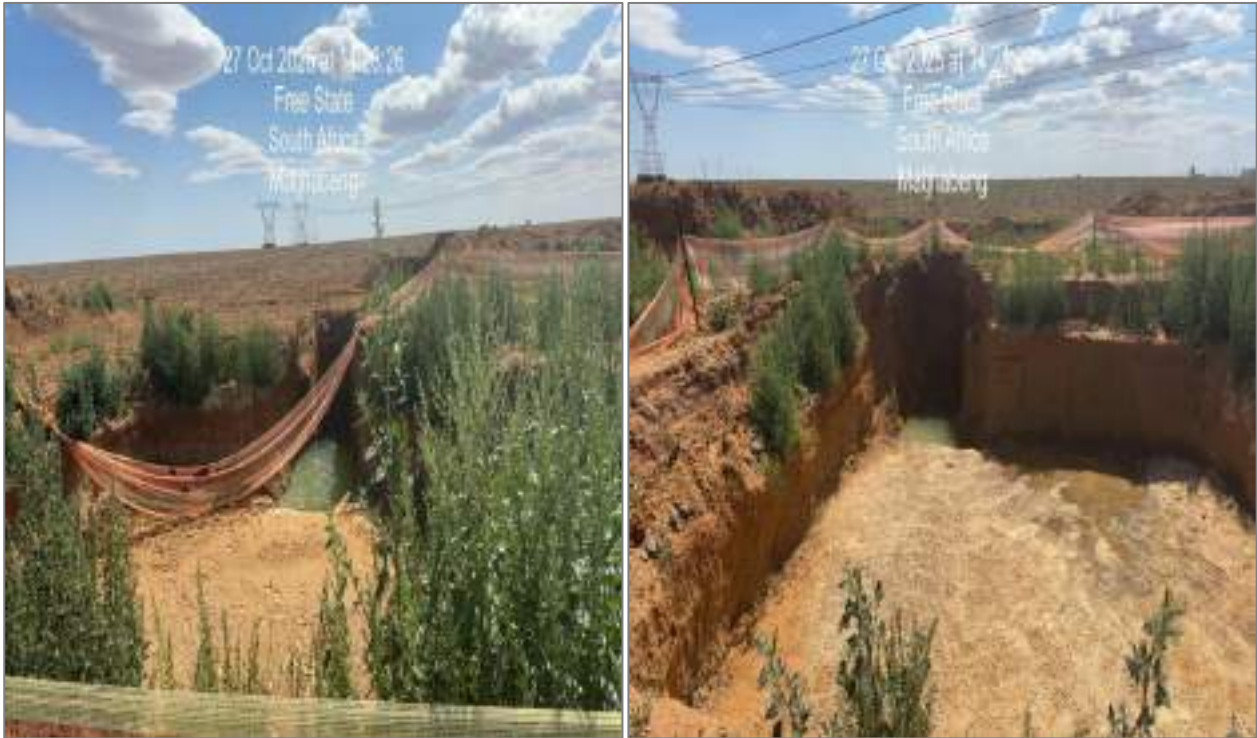
**Figure 7:** Groundwater encountered.

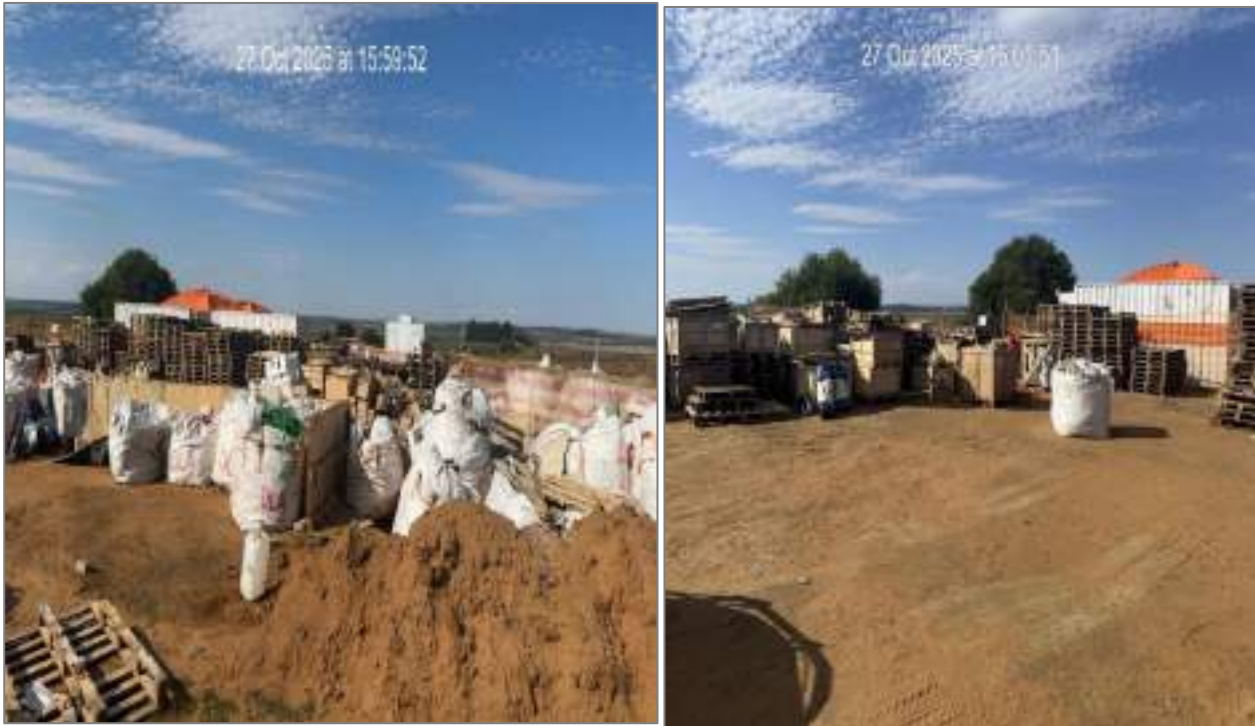
**Figure 11:** Large quantities of waste stored at the waste area.

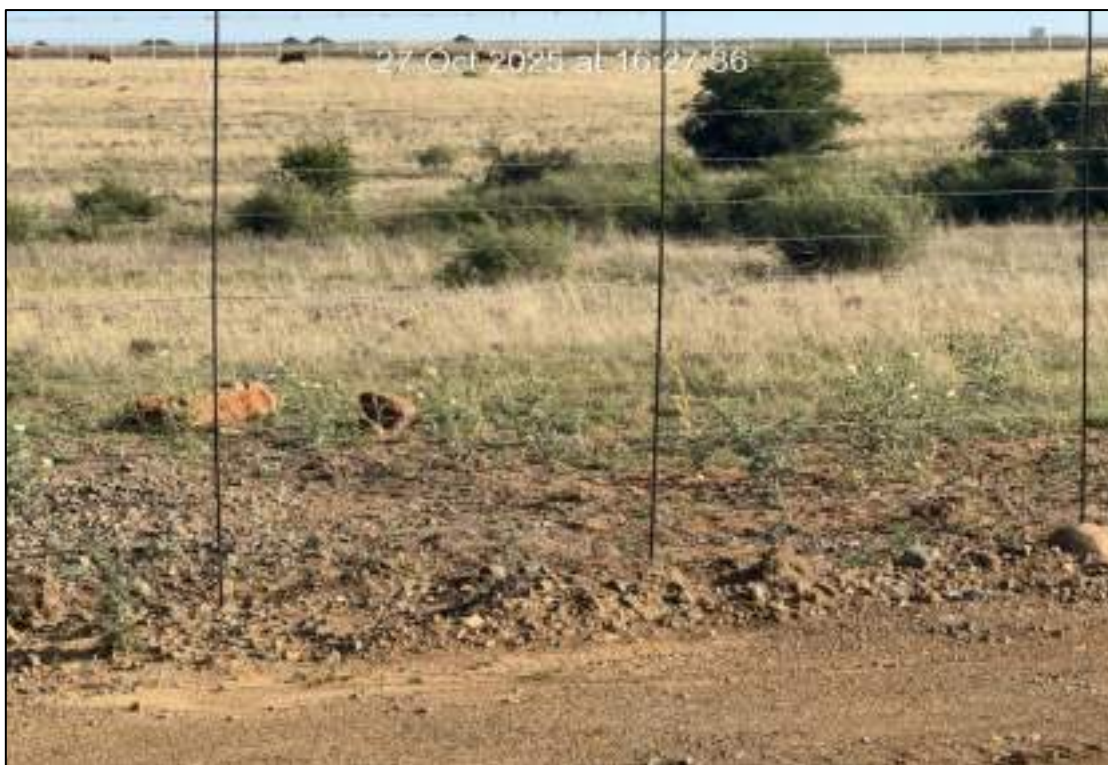
**Figure 1:** Alien vegetation in the no-go area.

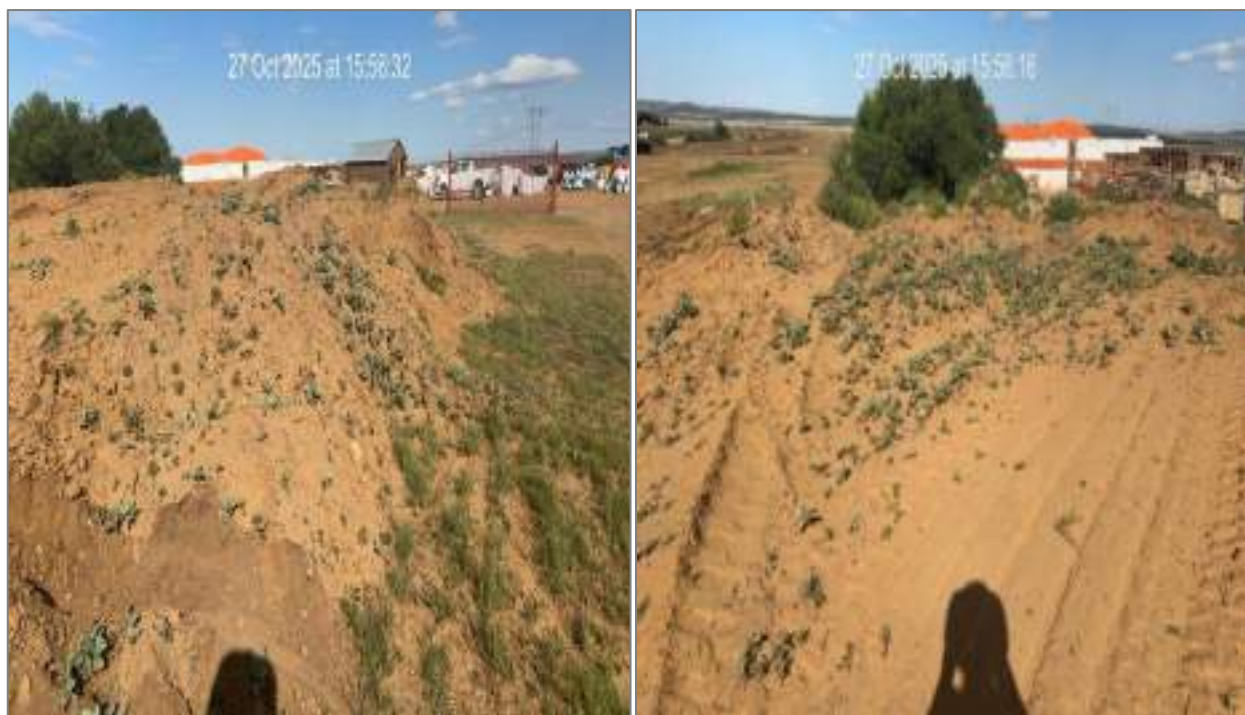
**Figure 3:** Alien Vegetation Establishing

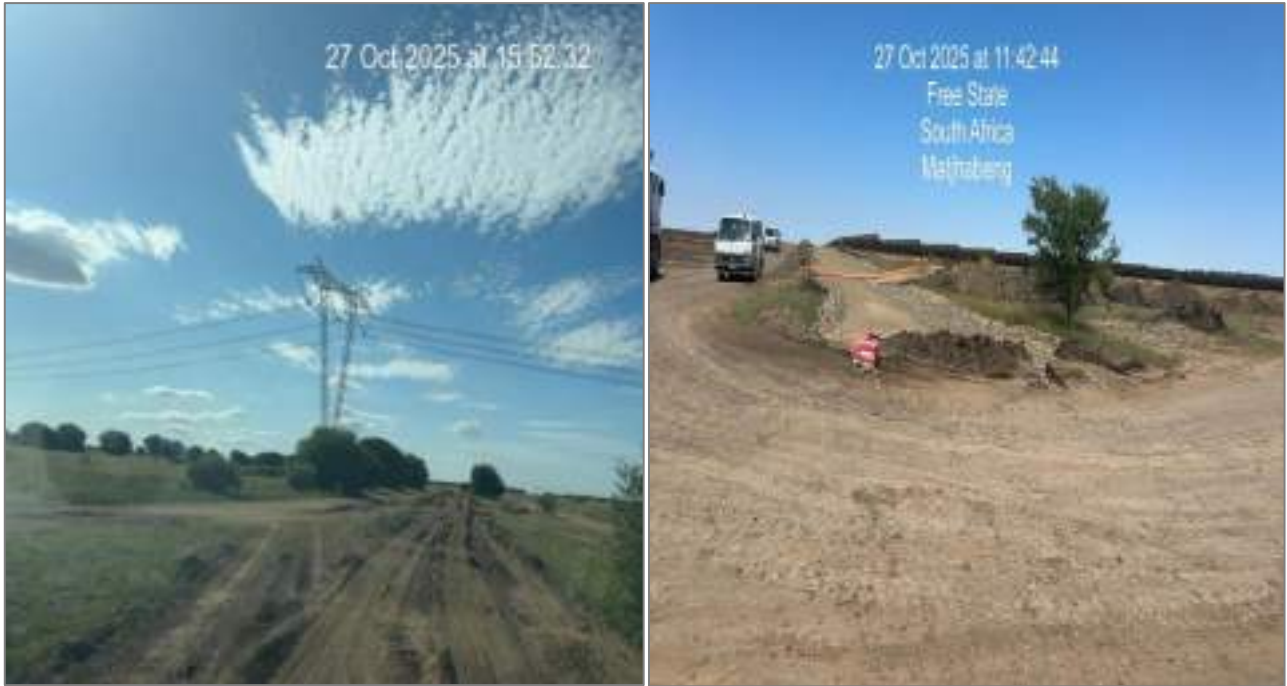
**Figure 7:** Poor condition of the access roads

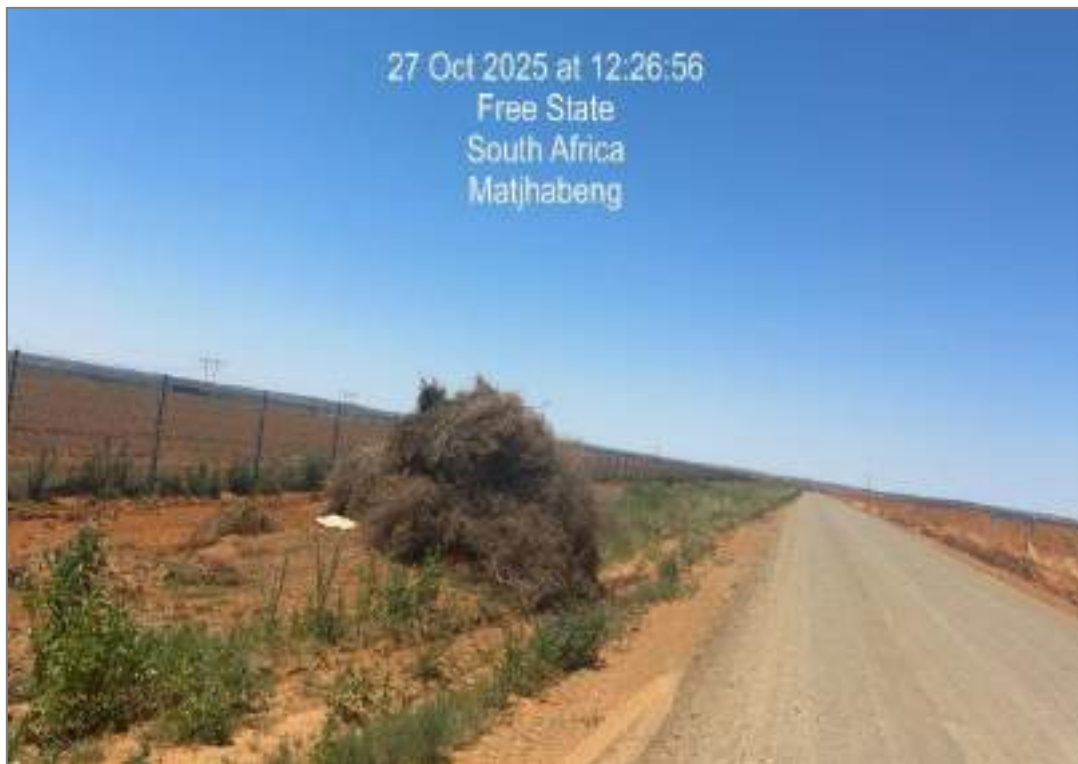
**Figure 8:** Cleared alien vegetation left onsite.

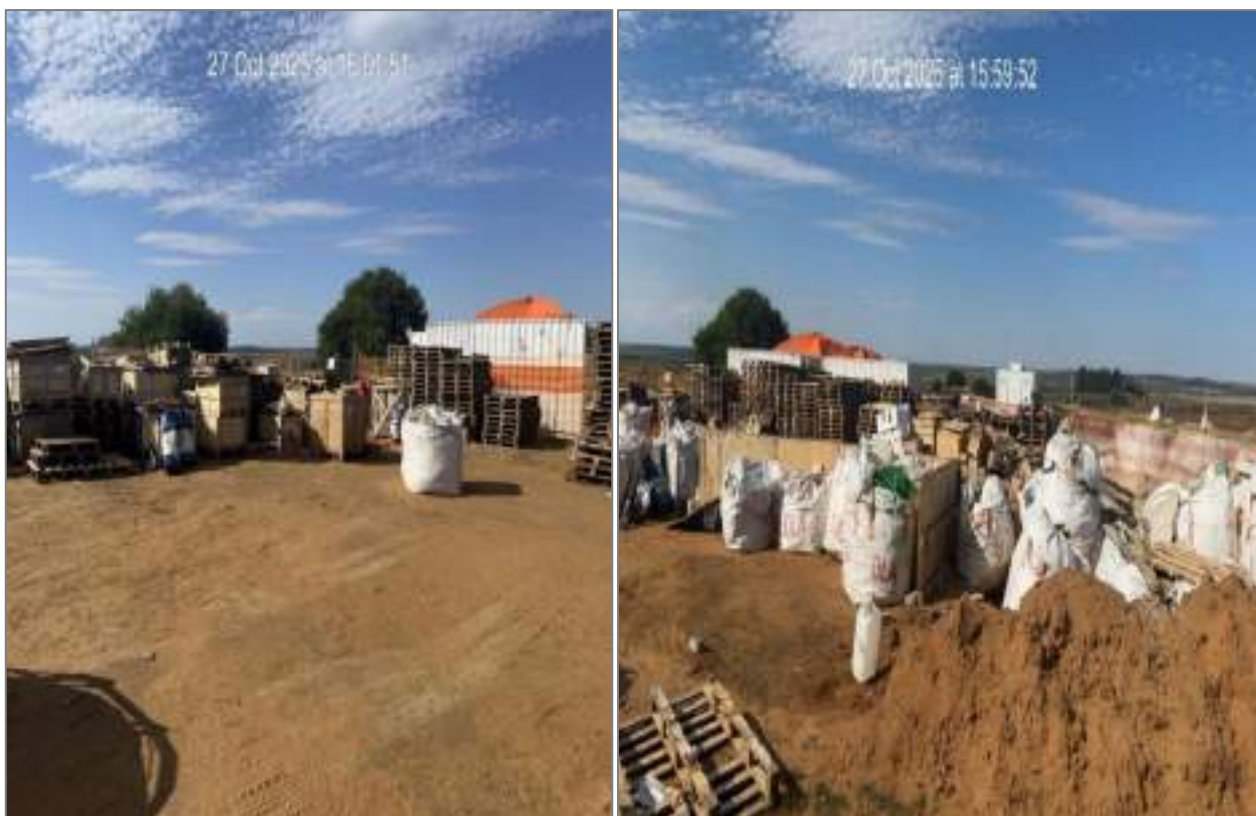
**Figure 11:** Large quantities of waste on the waste

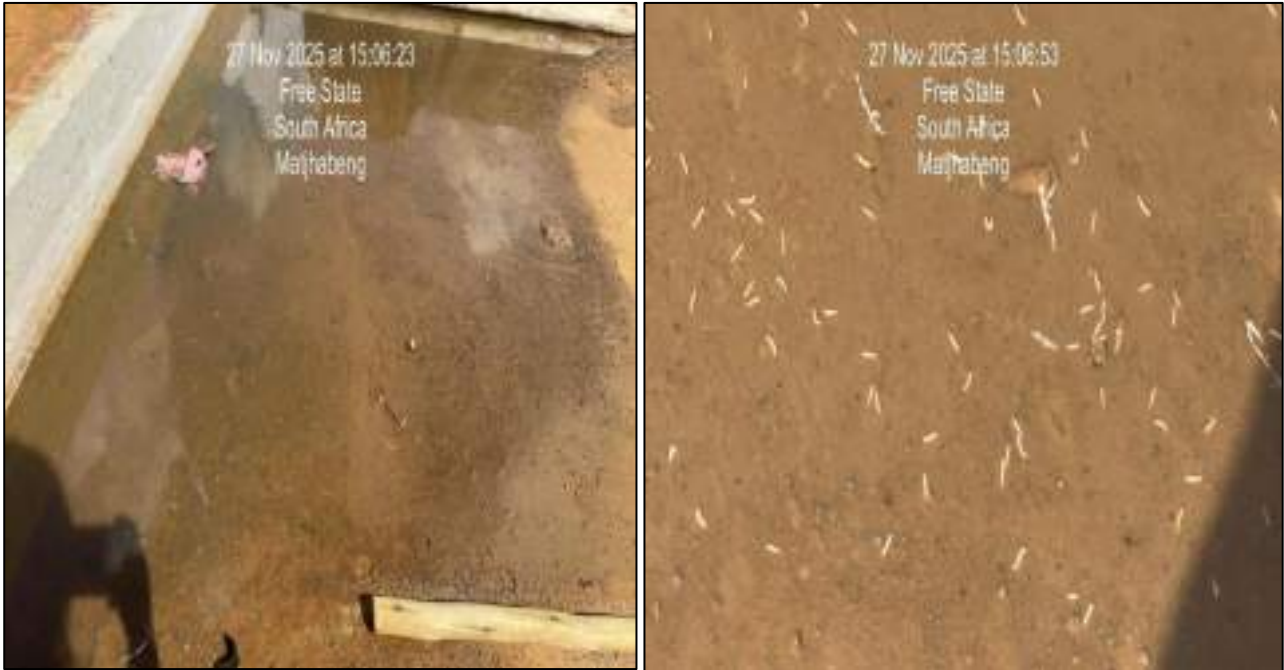
**Figure 1:** Standing water at the waste area with maggots.

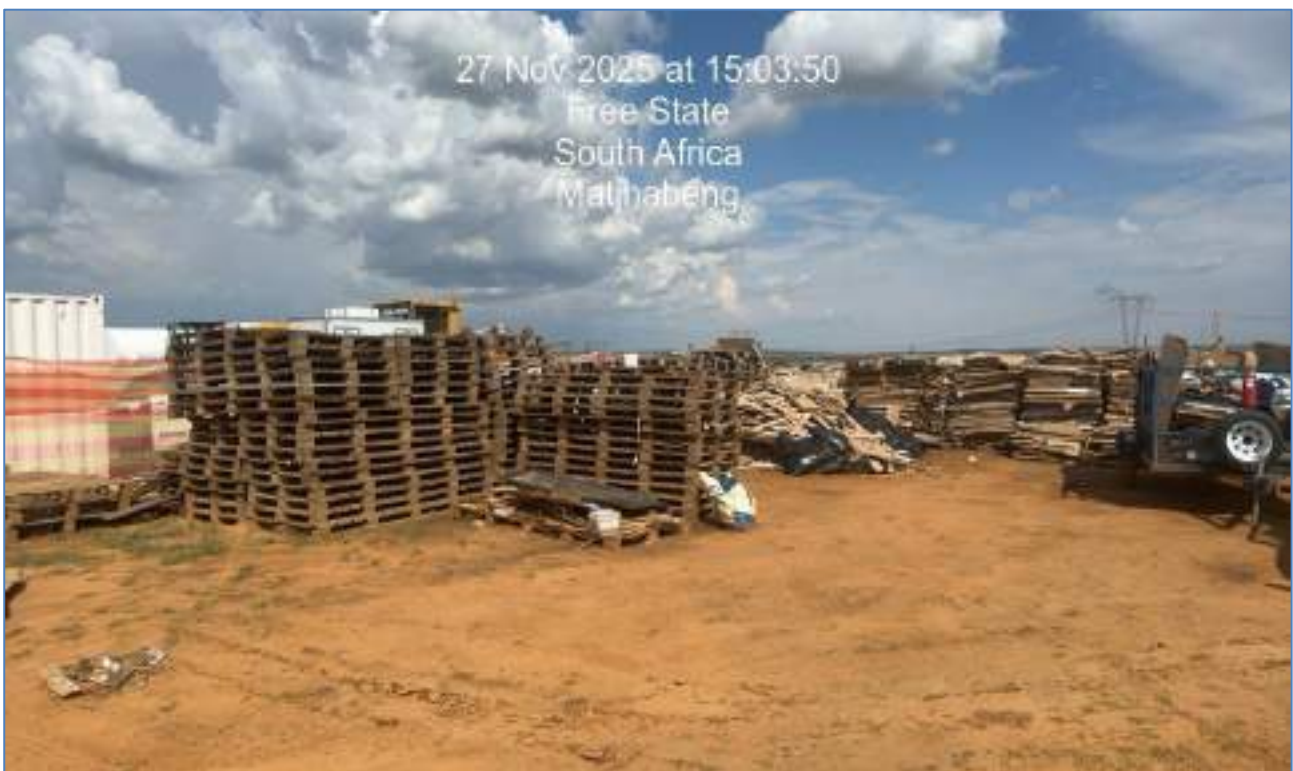
**Figure 2:** Large quantities of wood pats at the waste area

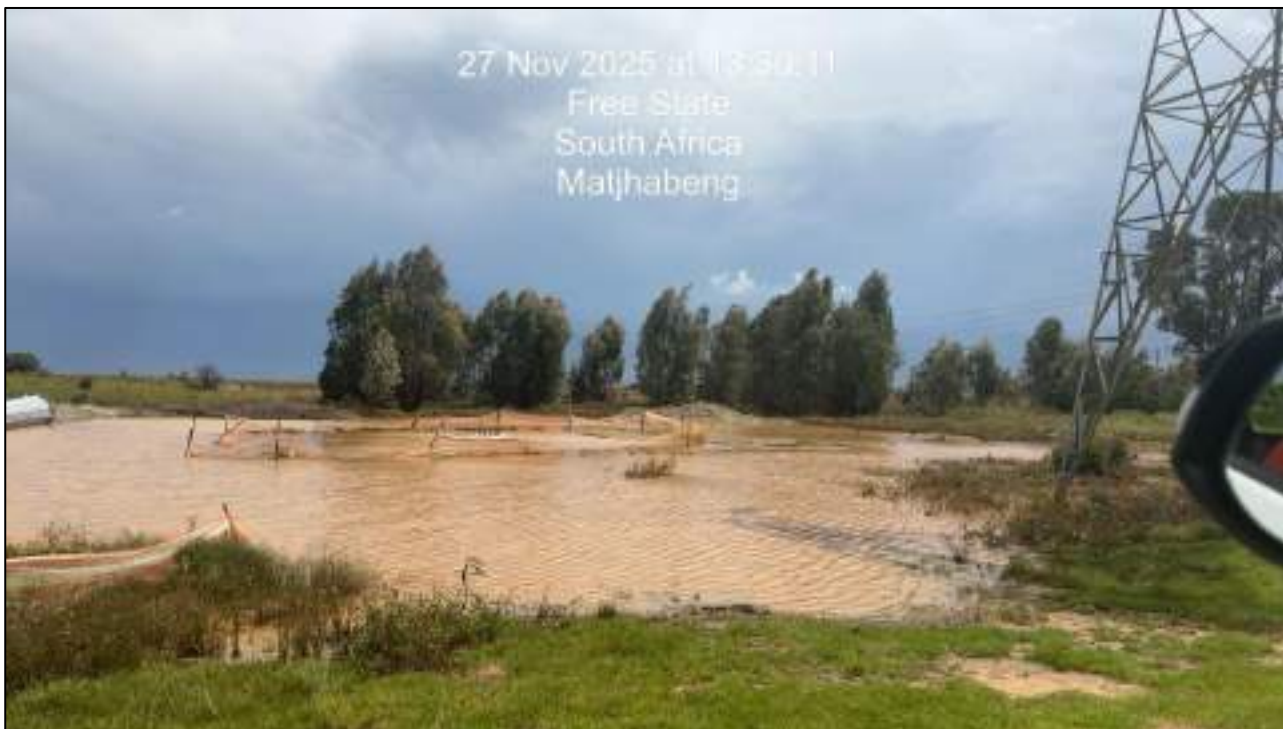
**Figure 3:** Rainwater accumulated at Tower No. 13

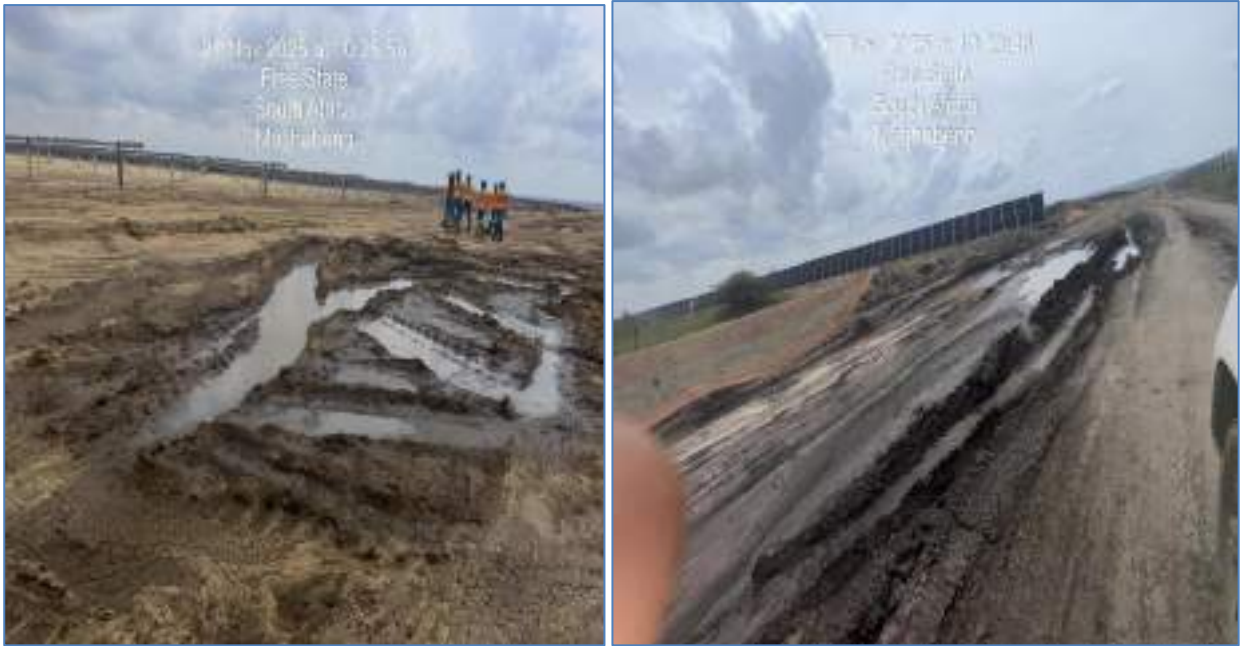
**Figure 1:** Condition of the access road

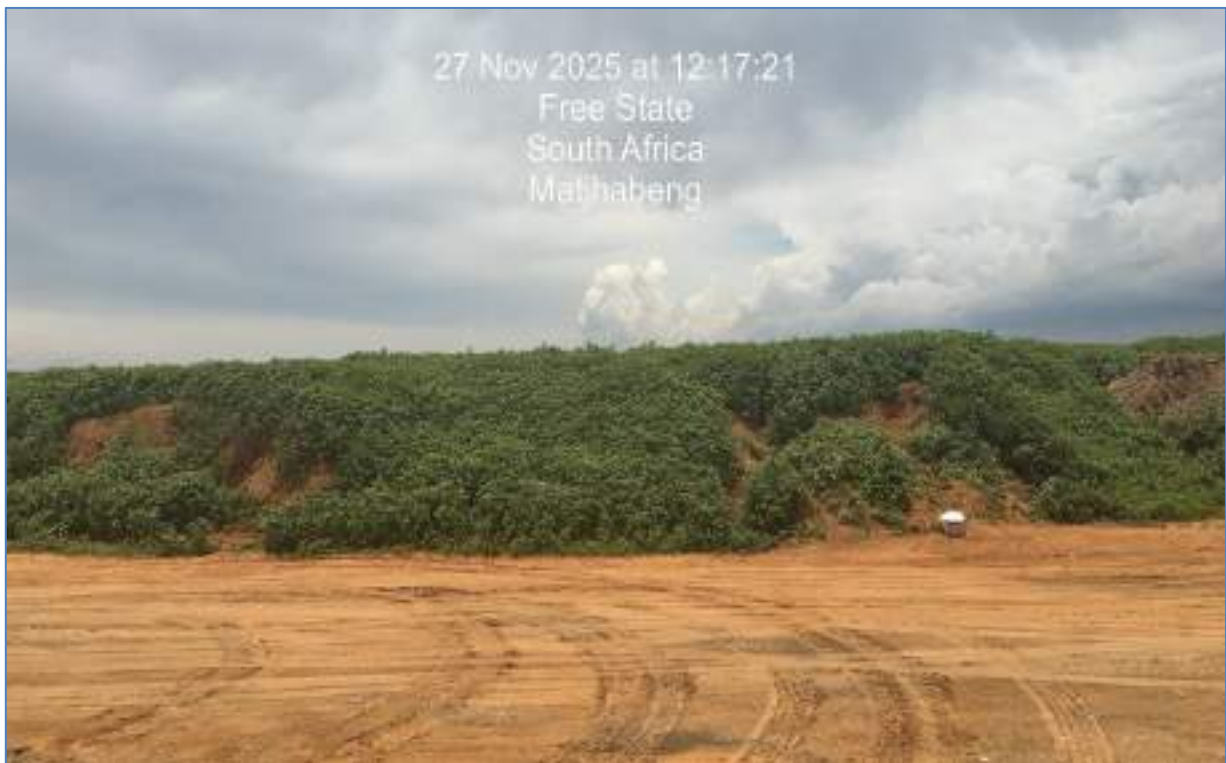
**Figure 2:** Alien Vegetation.

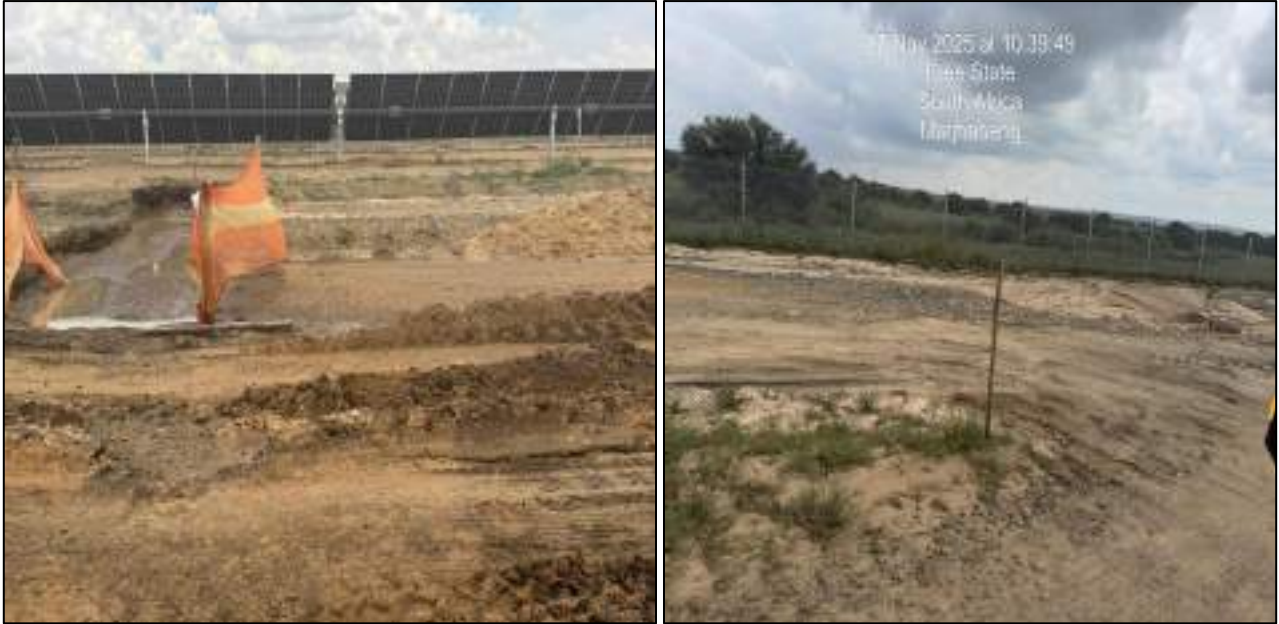
**Figure 7:** Damage caused rainwater

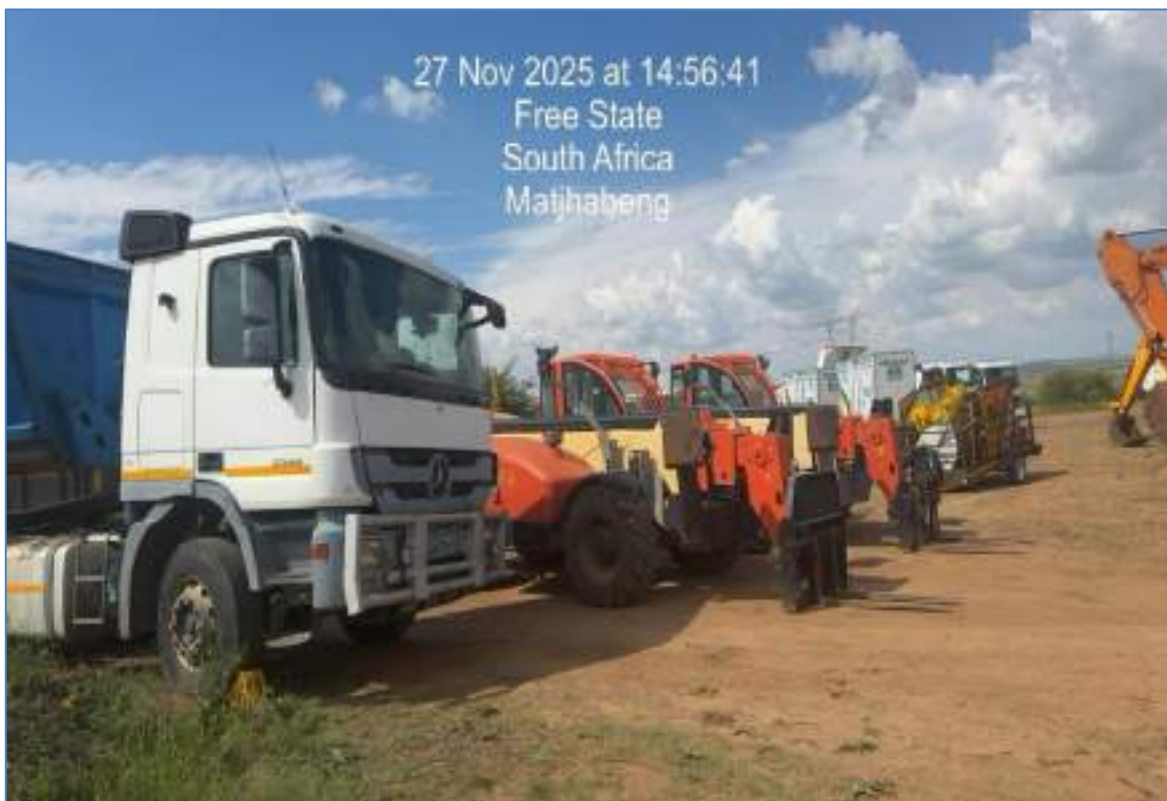
**Figure 8:** Machinery standing without drip trays

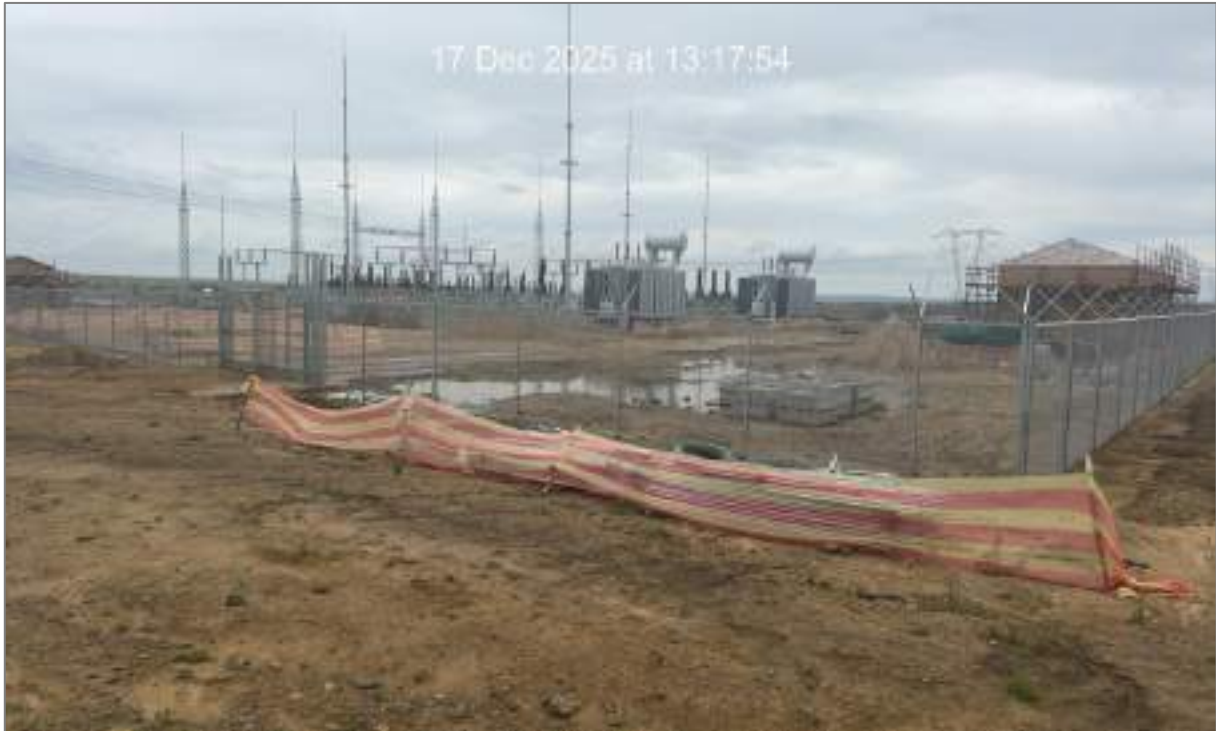
**Figure 1:** Water ponding at the substation area.

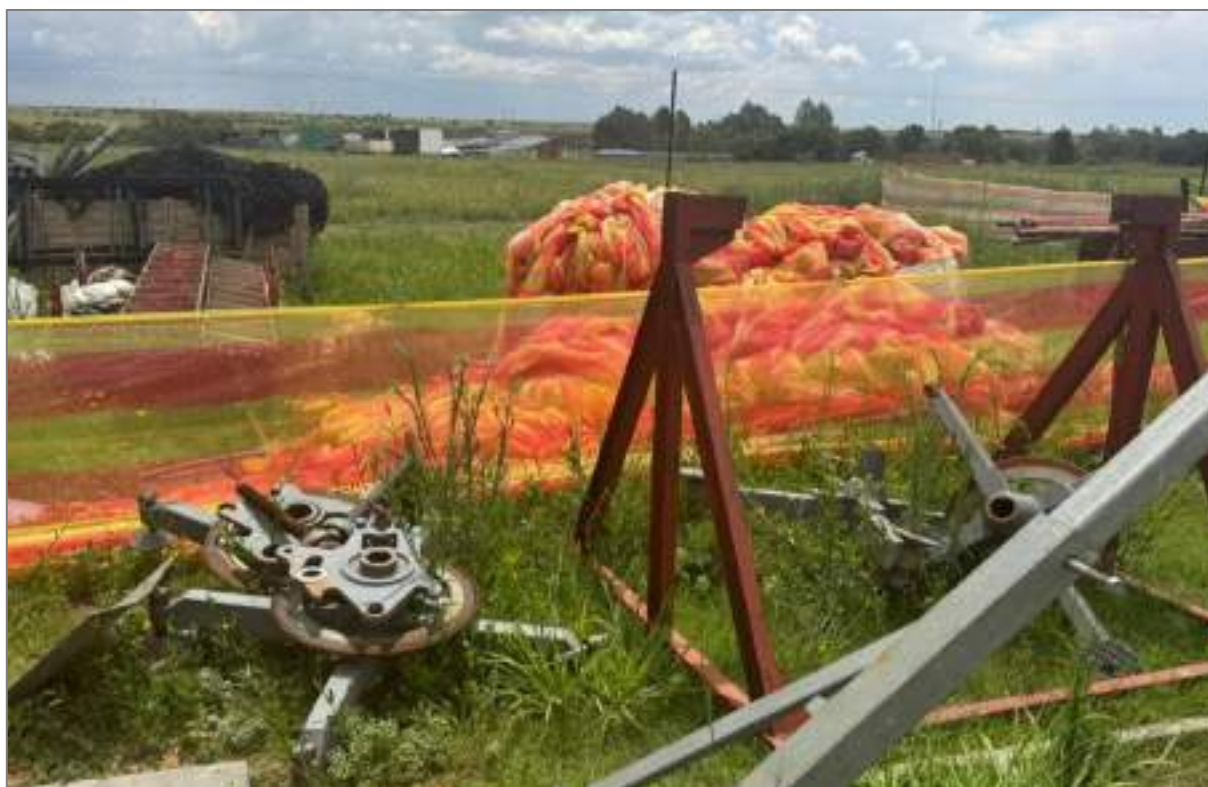
**Figure 7:** Torn barricading nets must be taken for recycling.

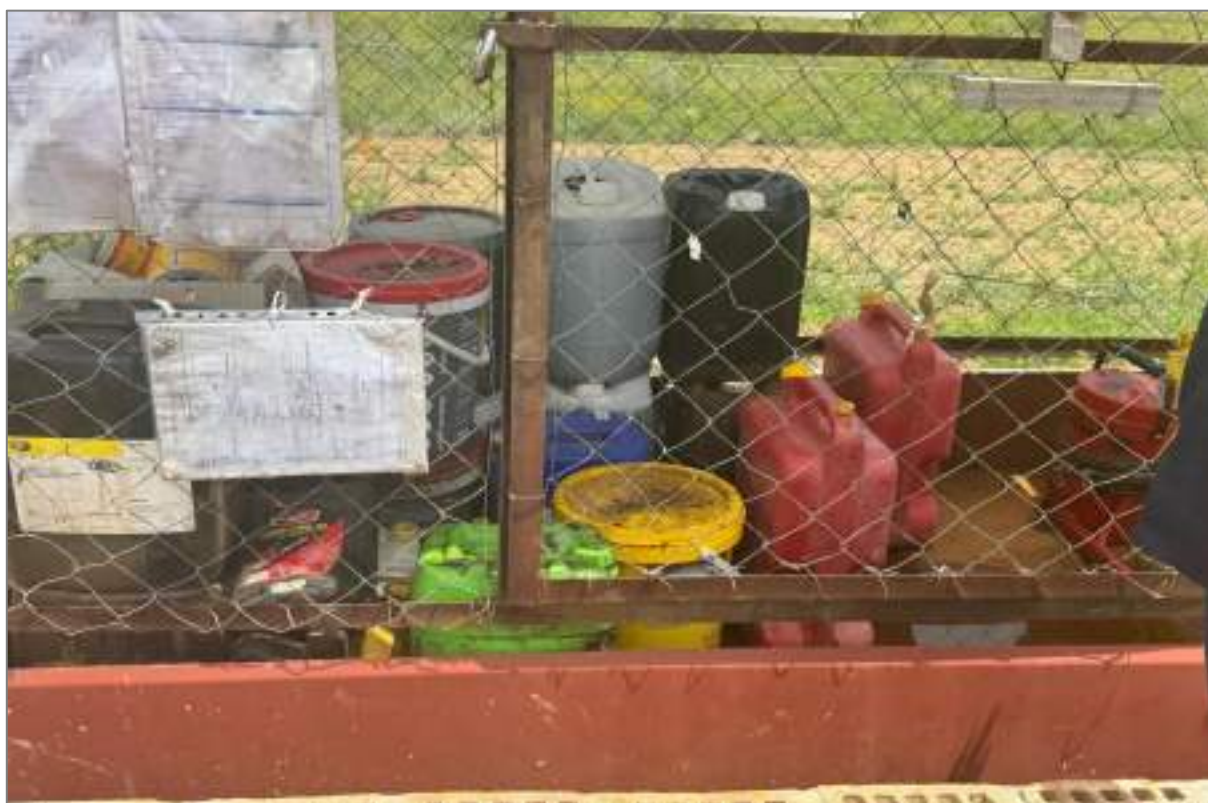
**Figure 8:** Crowded chemical bund
