# ECO MONTHLY ENVIRONMENTAL MONITORING REPORT

Virginia Photo Voltaic (PV) Solar Facility 1, 2 and 3,  
Matjhabeng, Lejweleputswa District Municipality within  
the jurisdiction of the Free State Province.

January 2025

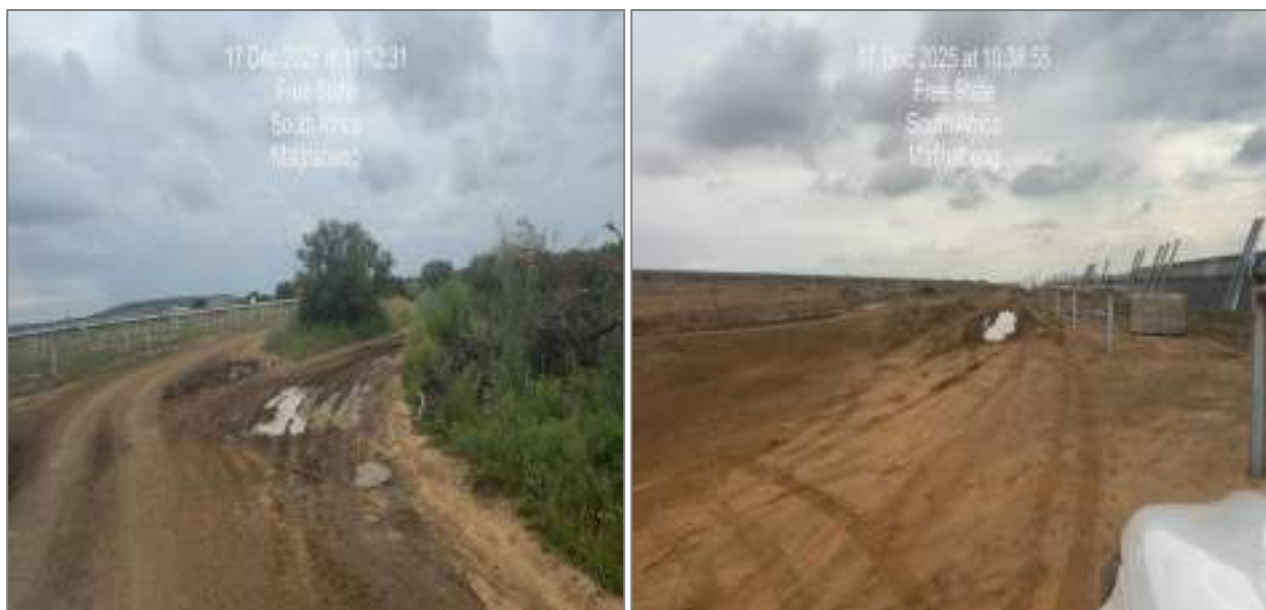
**Figure 1:** Condition of some portions of the access roads.

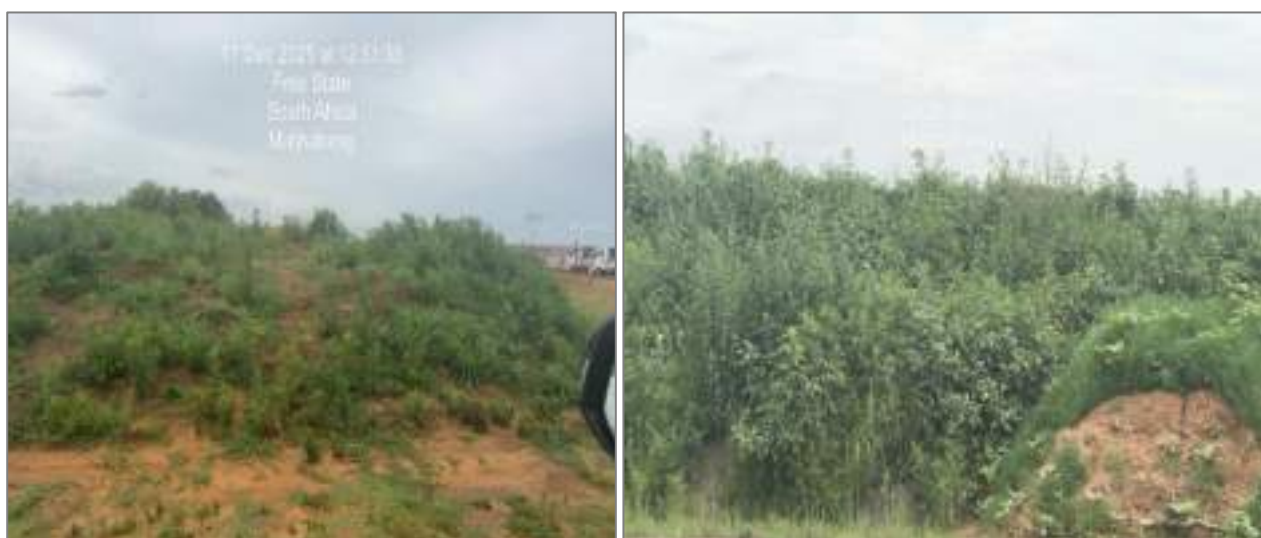
**Figure 2:** Alien Vegetation on stockpiles.

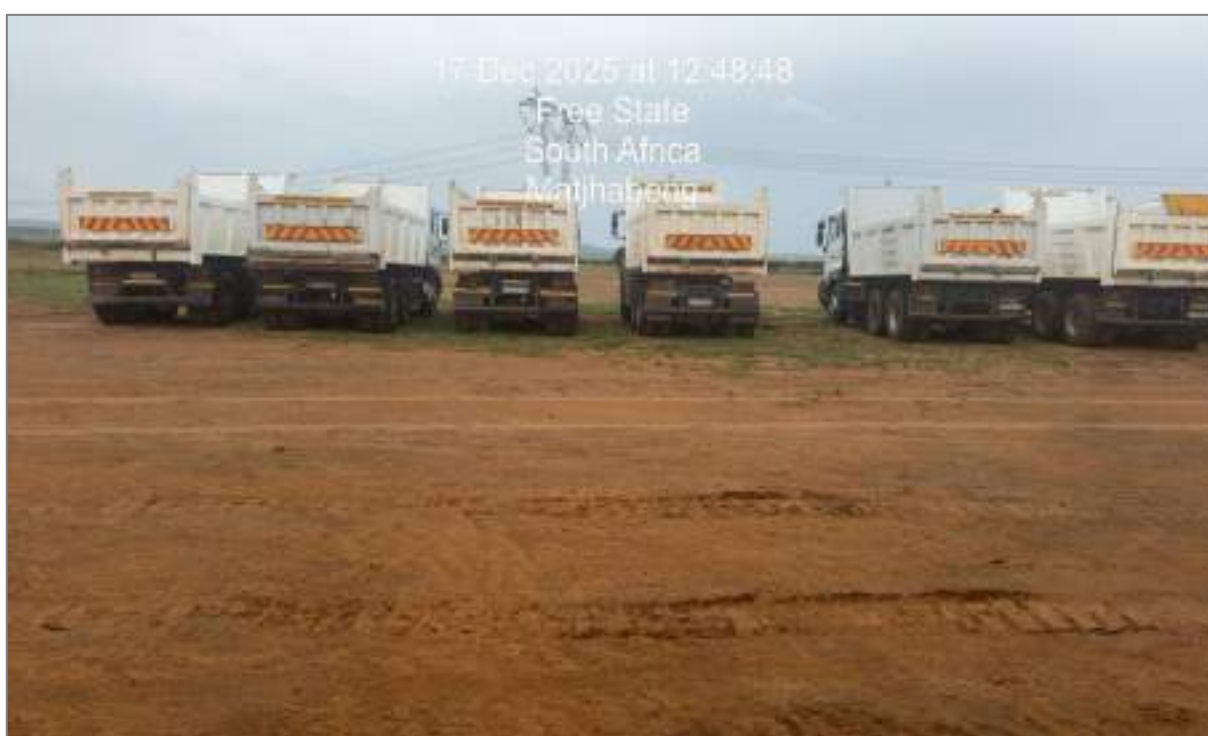
**Figure 6:** Machinery standing with no drip trays.

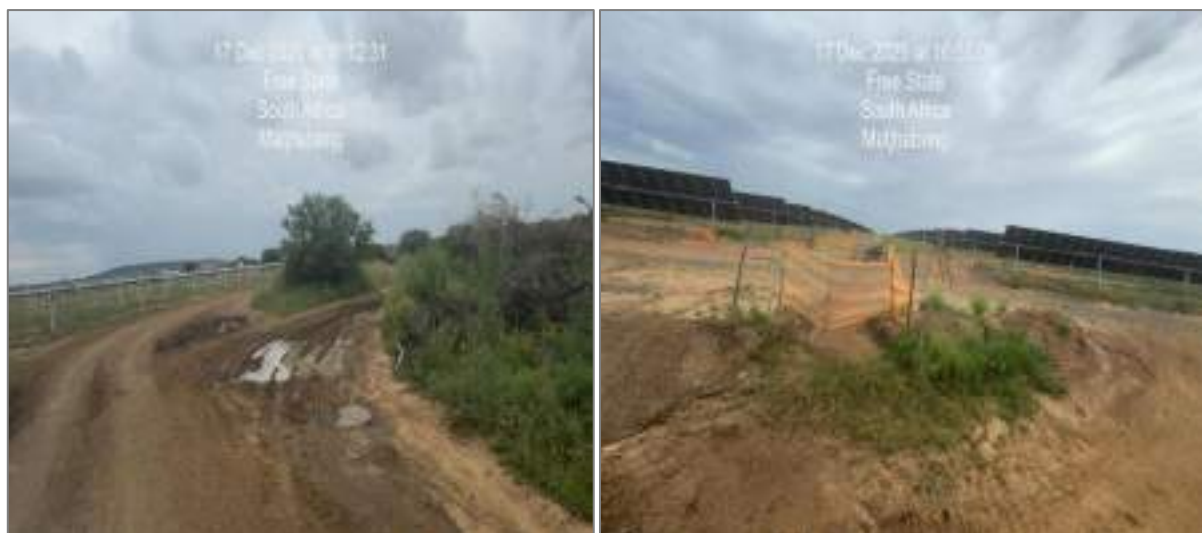
**Figure 7:** Damage to the road caused rainwater.

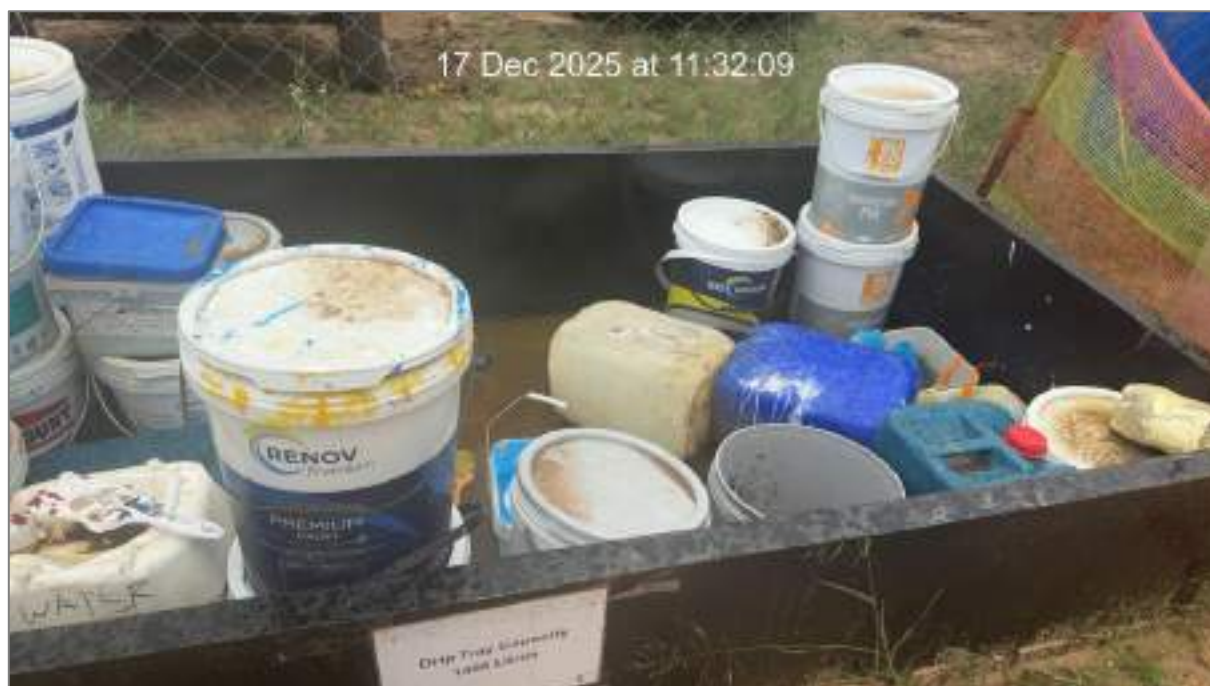
**Figure 8:** Rainwater that accumulated in the drip that must be disposed as hazardous waste.

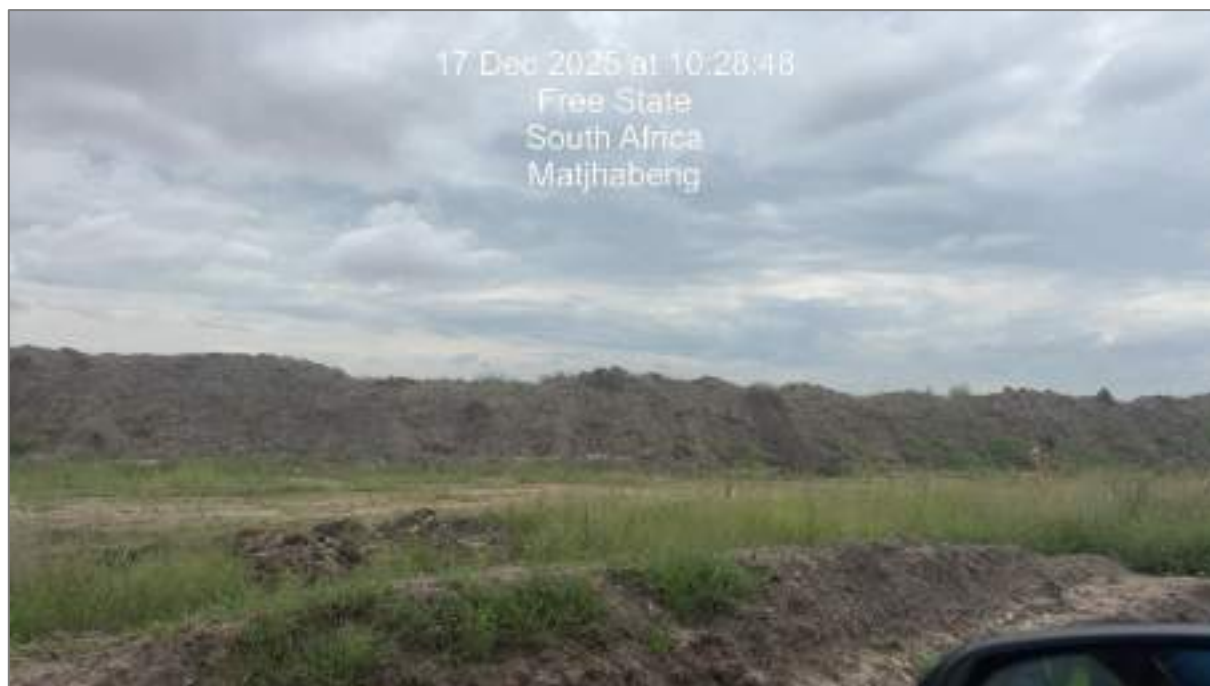
**Figure 9:** Stockpile height exceeding 2m.
