**JANUARY 2026**

# ECO MONTHLY ENVIRONMENTAL MONITORING REPORT

Virginia OPHL Line and Switching Station Matjhabeng,  
Lejweleputswa District Municipality within the jurisdiction  
of the Free State Province.

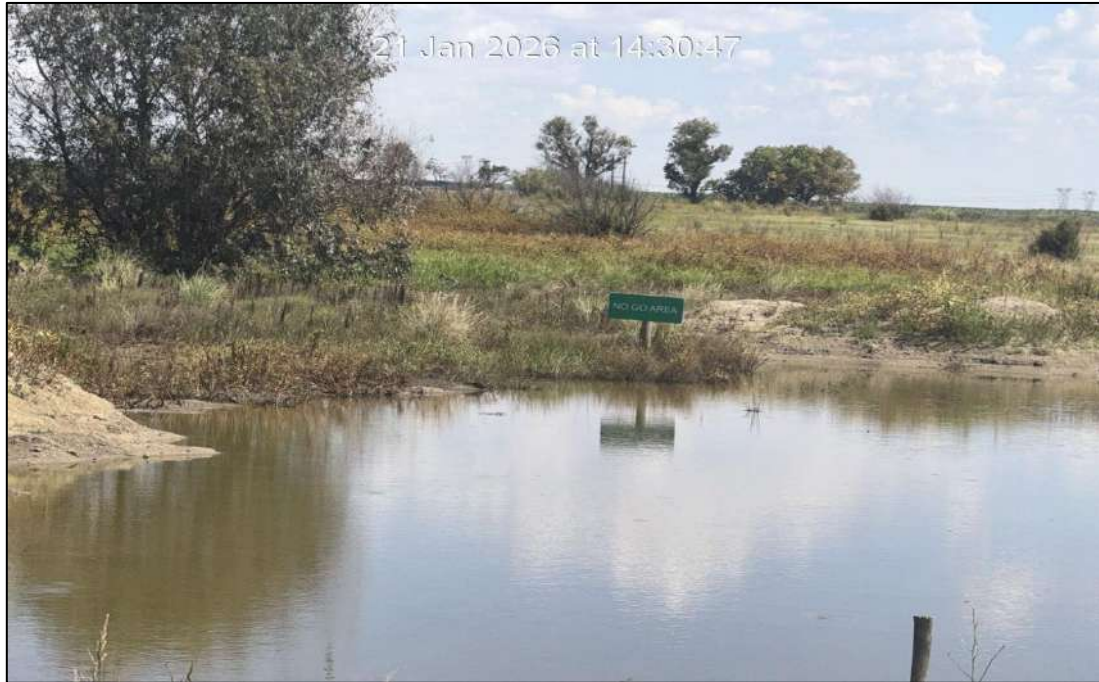
**Figure 1:** No-go area that must be demarcated

- Barricade the no-go area (wetland) at tower number 13 with a barricade net to demarcate the boundaries of the sensitive sites. Only a no-go sign has been placed.
- Alien vegetation clearance must continue onsite, and the contractor must monitor the cleared areas to prevent reestablishment of alien vegetation.
- All construction rubble must be removed timeously from construction areas.
- Roads must be maintained to correct the effects of erosion and water ponding.
- Stormwater measures must be implemented, measures to be implemented must align with the current conditions onsite.
- Drip trays must be used on all standing equipment including trucks waiting to be onboarded.
- Waste must be removed from the waste area more frequently to prevent overstocking the waste area.
- All torn nets must be removed for disposal.
- House keeping must be done at the laydown areas.

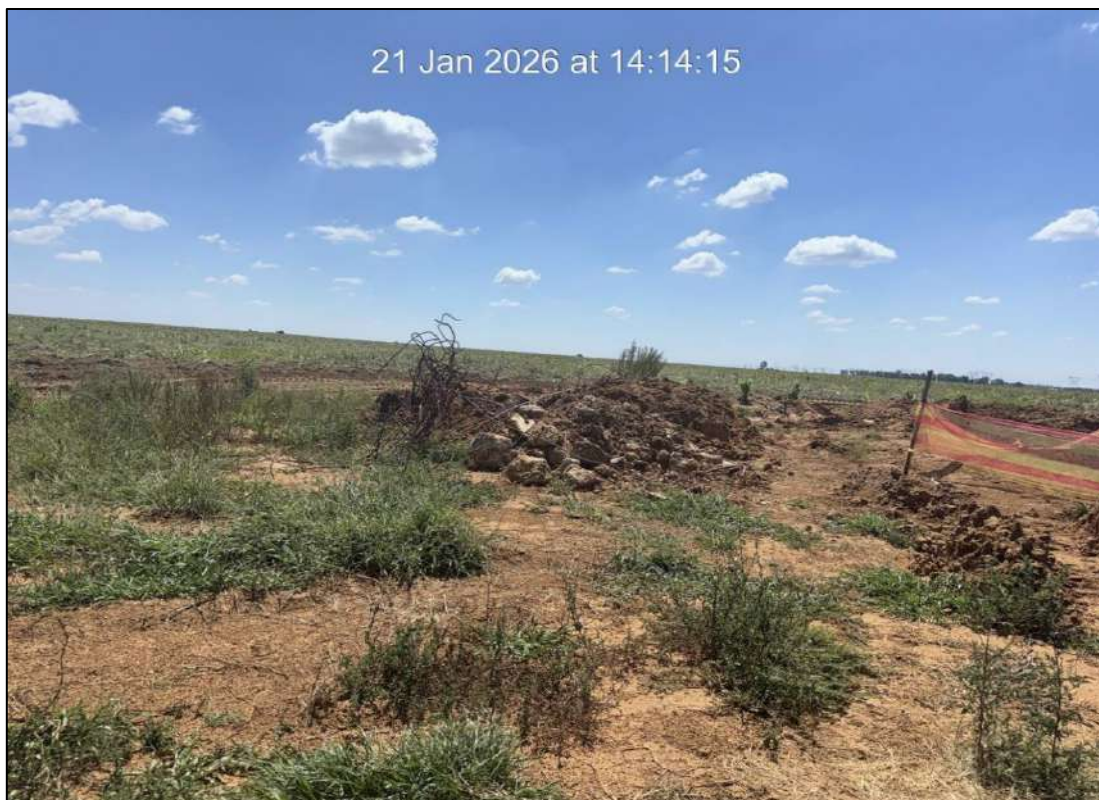
Several water damaged monopole concrete slabs had to be removed along the line; these generated a significant amount of rubble. The contractor must ensure this rubble is timely removed and disposed at a registered landfill site.

**Figure 2:** Rubble that must be removed from site.

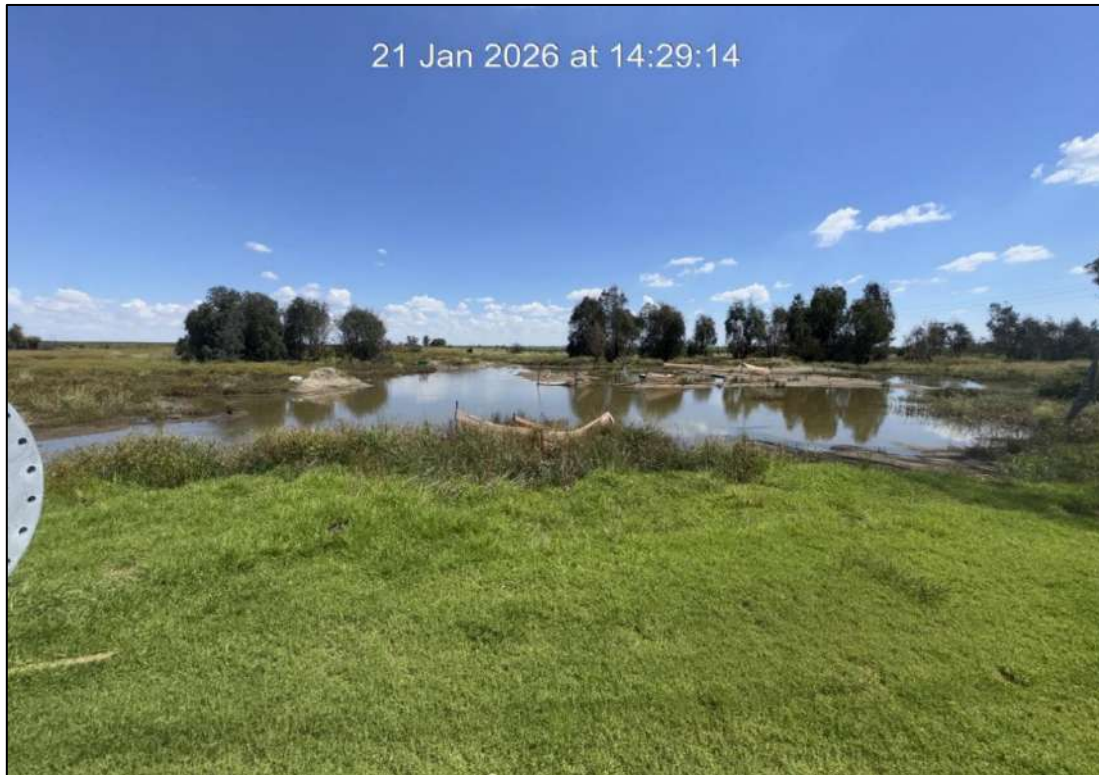
**Figure 3:** Rainwater accumulated at Tower No. 13.

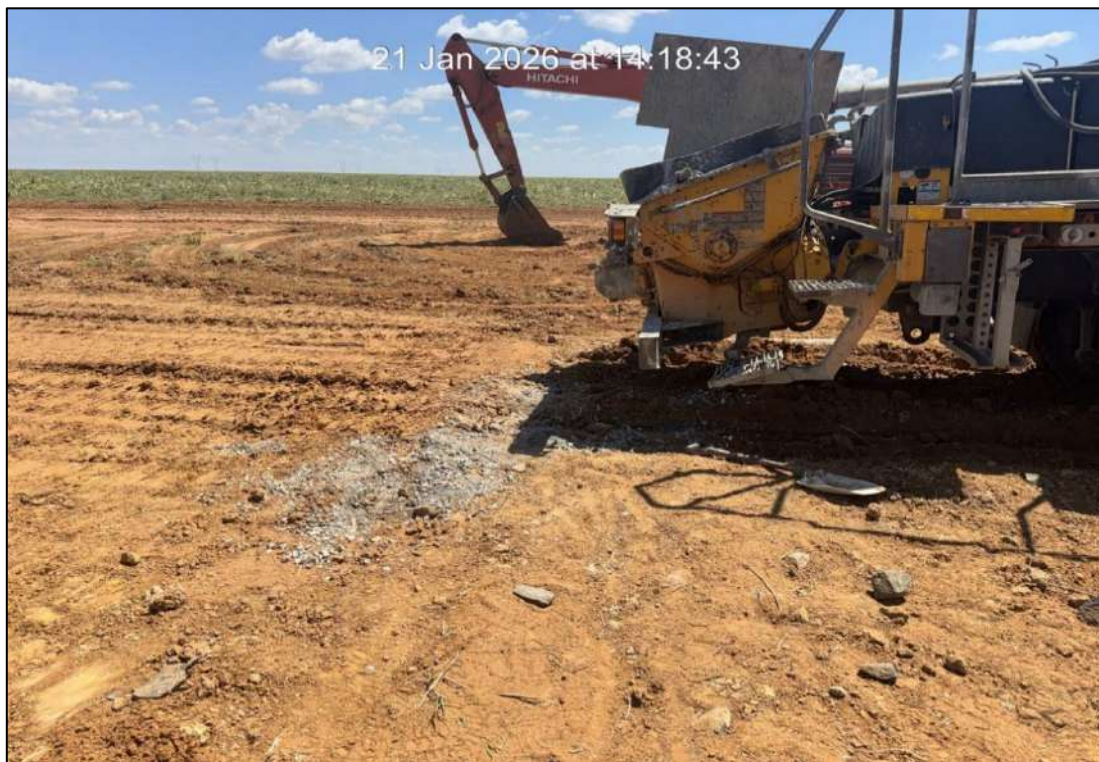
**Figure 4:** Spilled concrete must be removed before the end of the day.

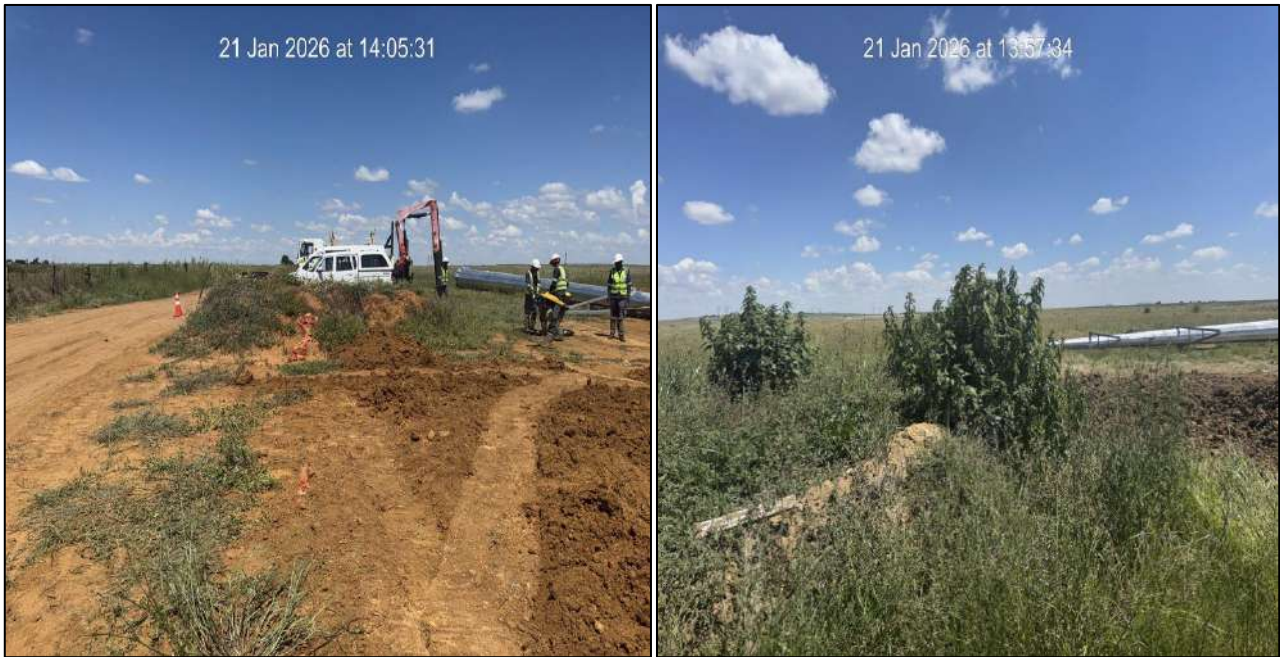
**Figure 5:** Alien Vegetation on the stockpiles.

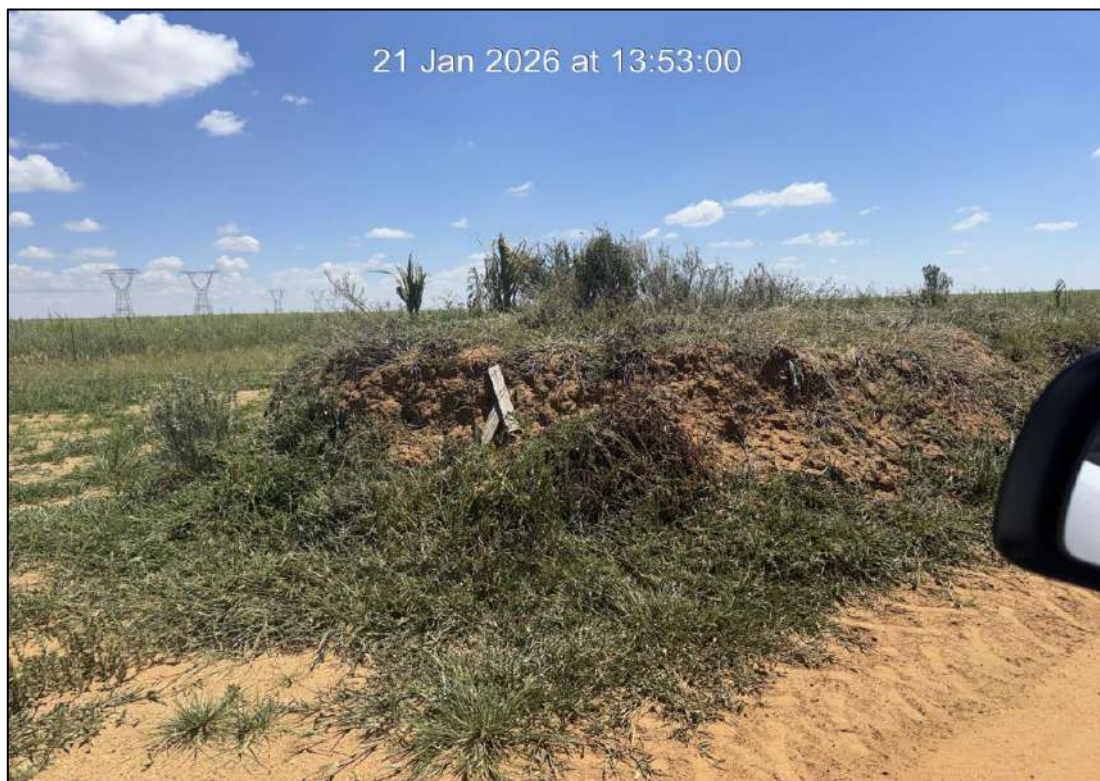
Cleared topsoil has been stockpiled along the OHPL line and the switching station. These must be protected from erosion and alien vegetation establishment. In some areas where the contractor has finished pouring concrete and the pits have closed. The contactor must ensure subsoil is used for infilling. Topsoil must only be spread after the structures have erected to prevent compaction. The contactor must replace all the missing/broken topsoil/subsoil signs on the stockpiles.

**Figure 6:** Topsoil stockpiles signs that must be replaced.

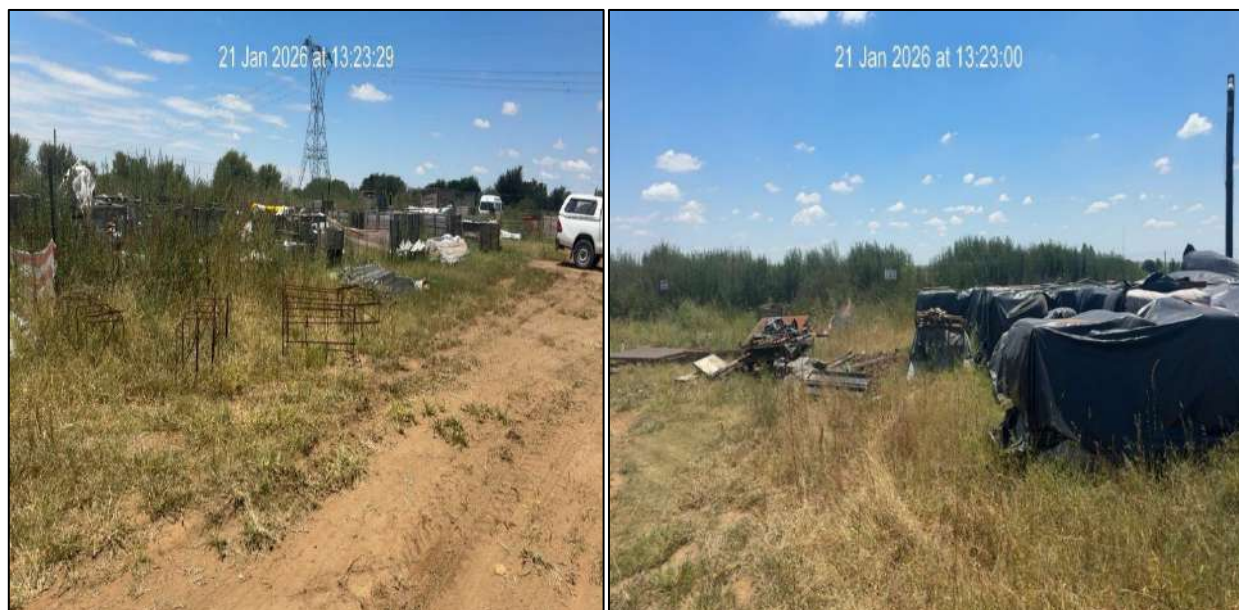
**Figure 7:** Housing must ne improved onsite.

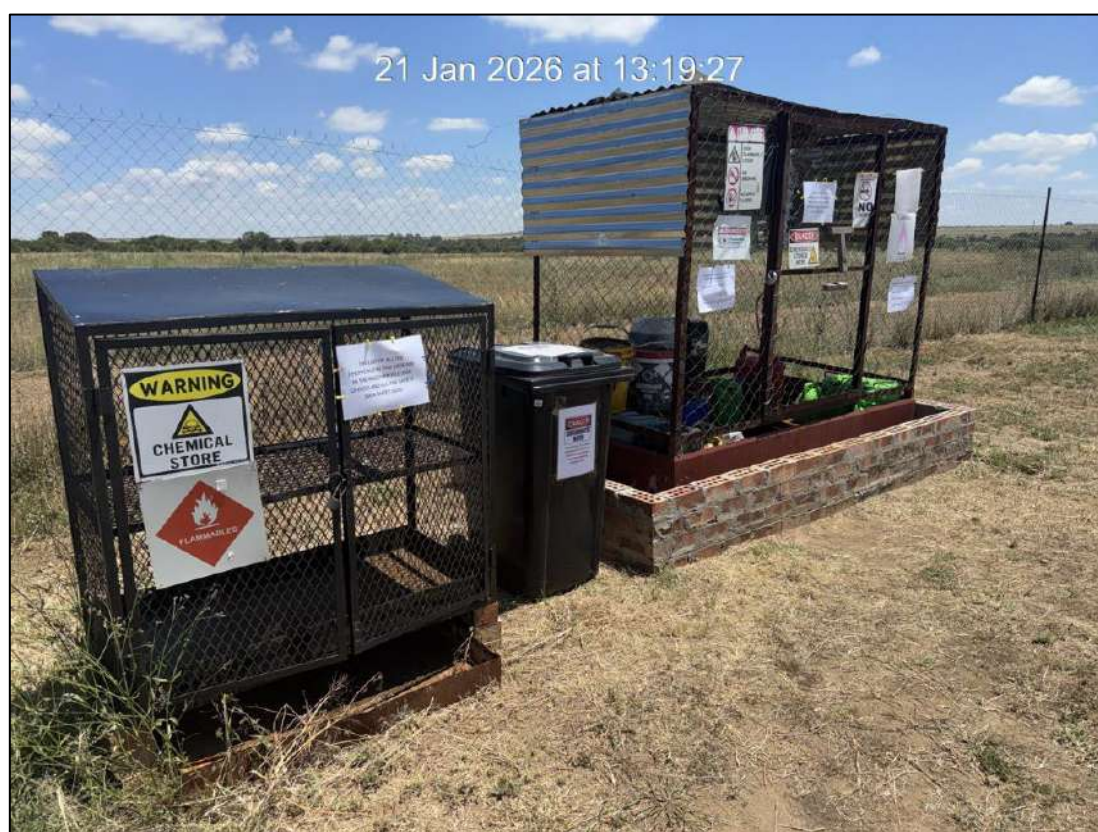
**Figure 8:** A new chemical bund.

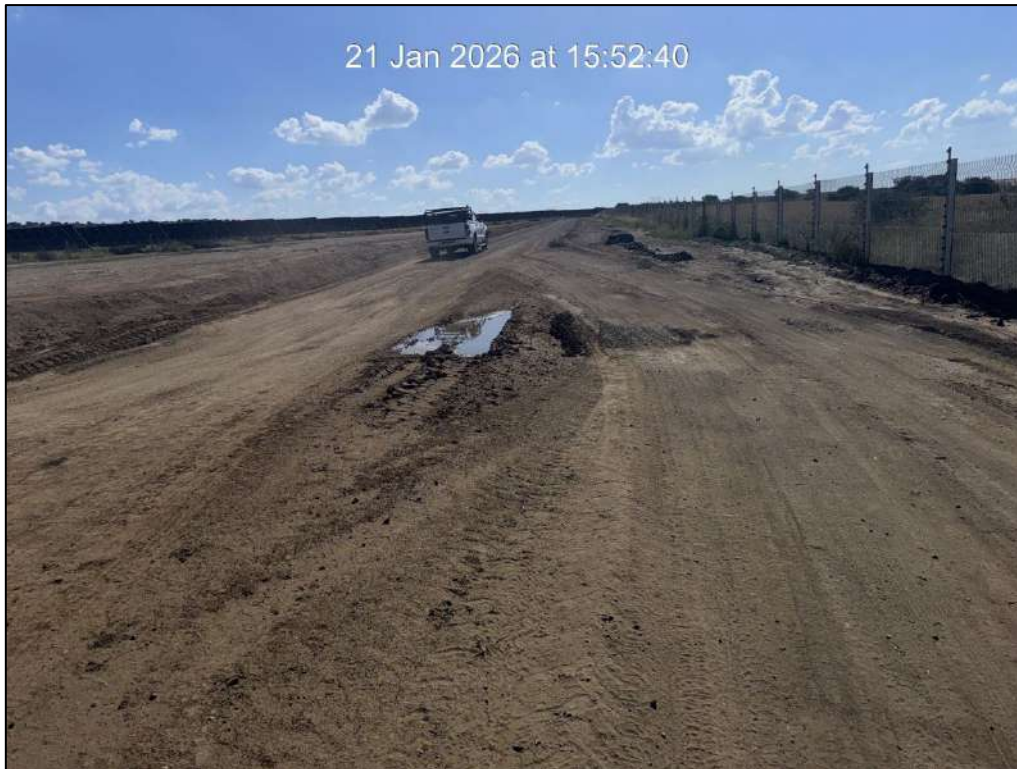
**Figure 1:** Condition of the access roads.

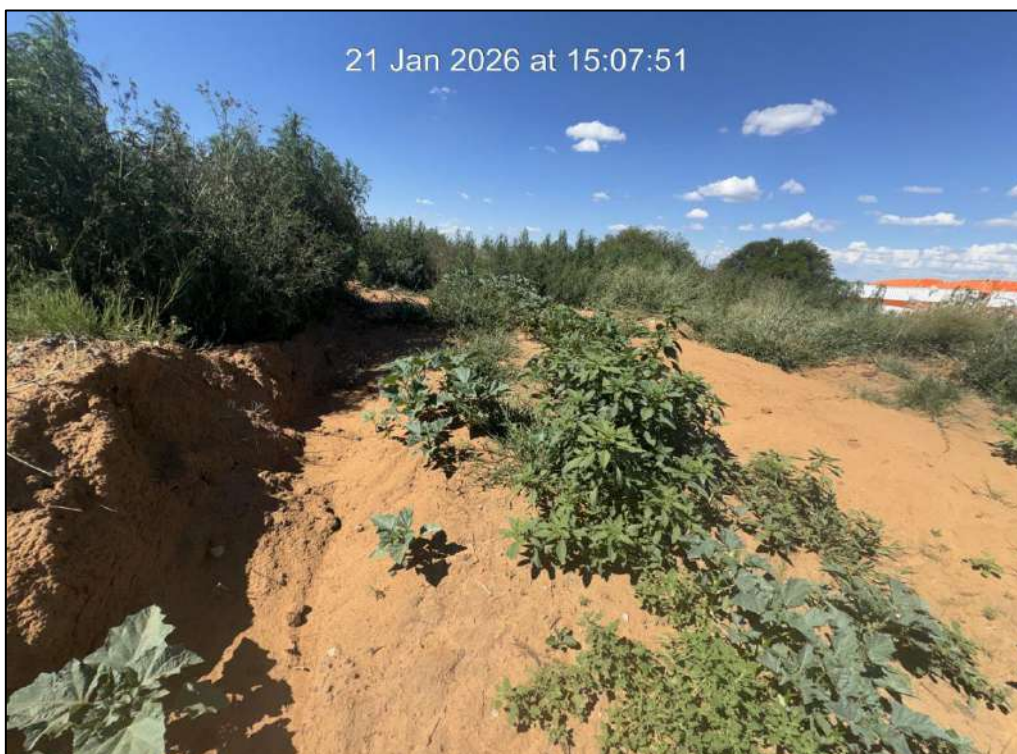
**Figure 2:** Alien vegetation on stockpiles.

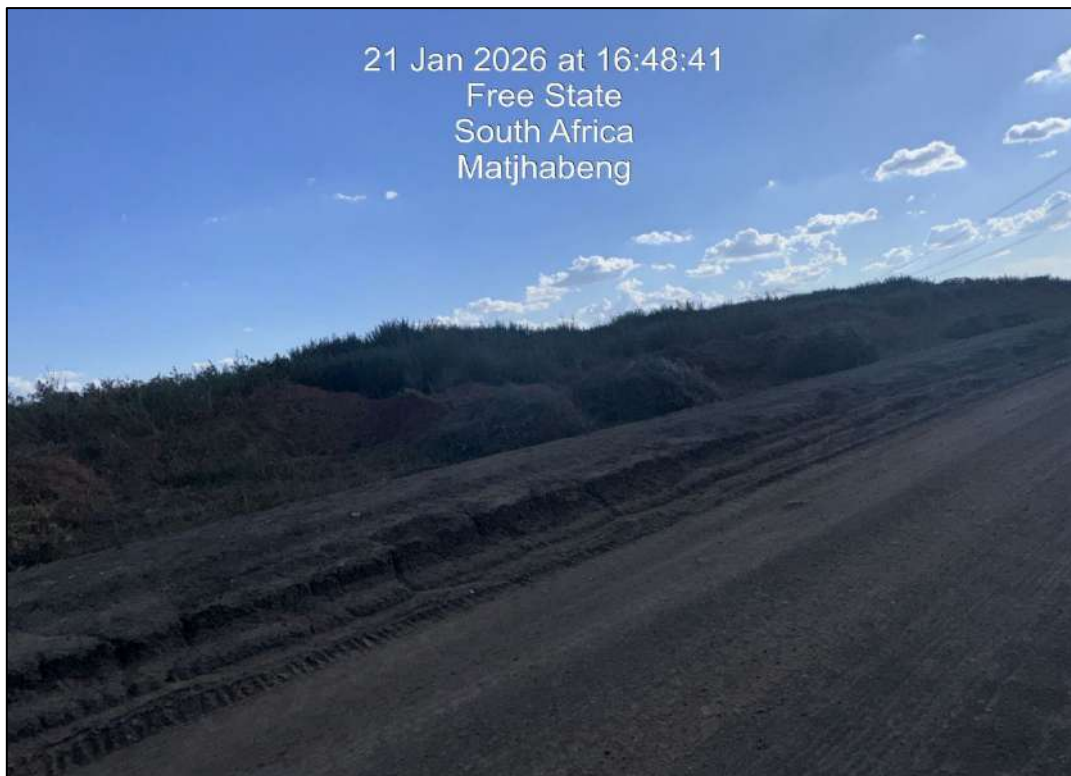
**Figure 3:** Cleared vegetation requiring to be disposed of.

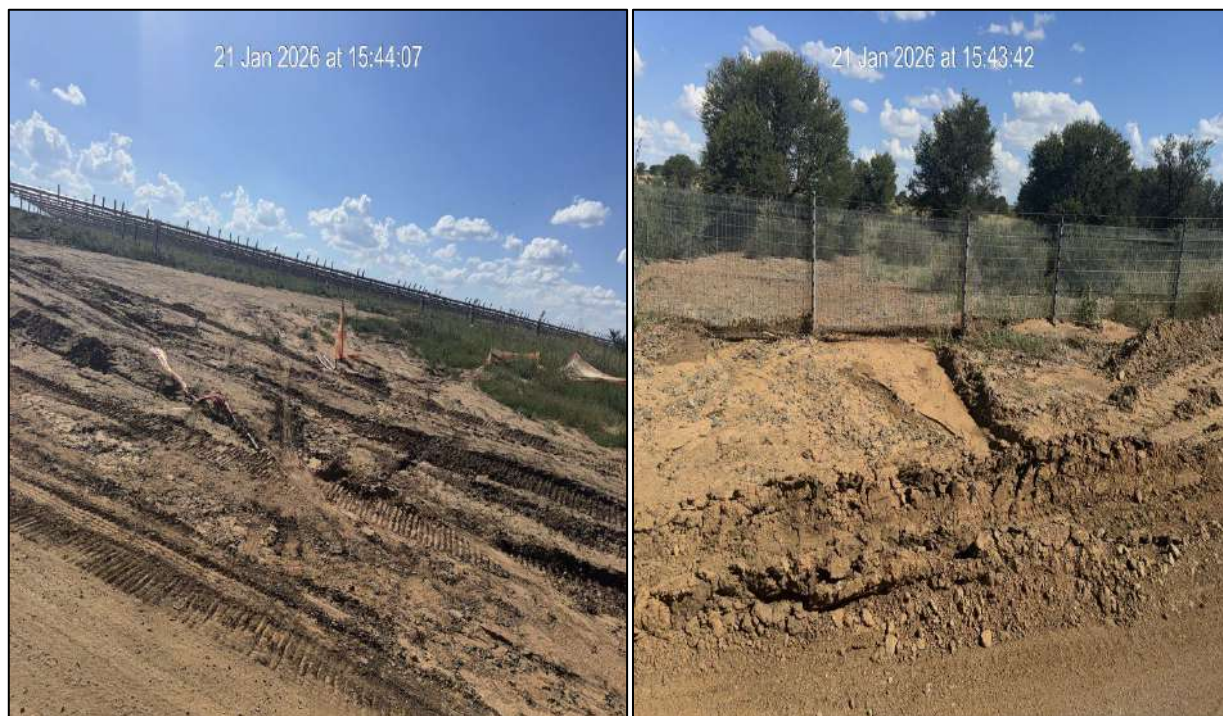
**Figure 4:** Erosion damage.

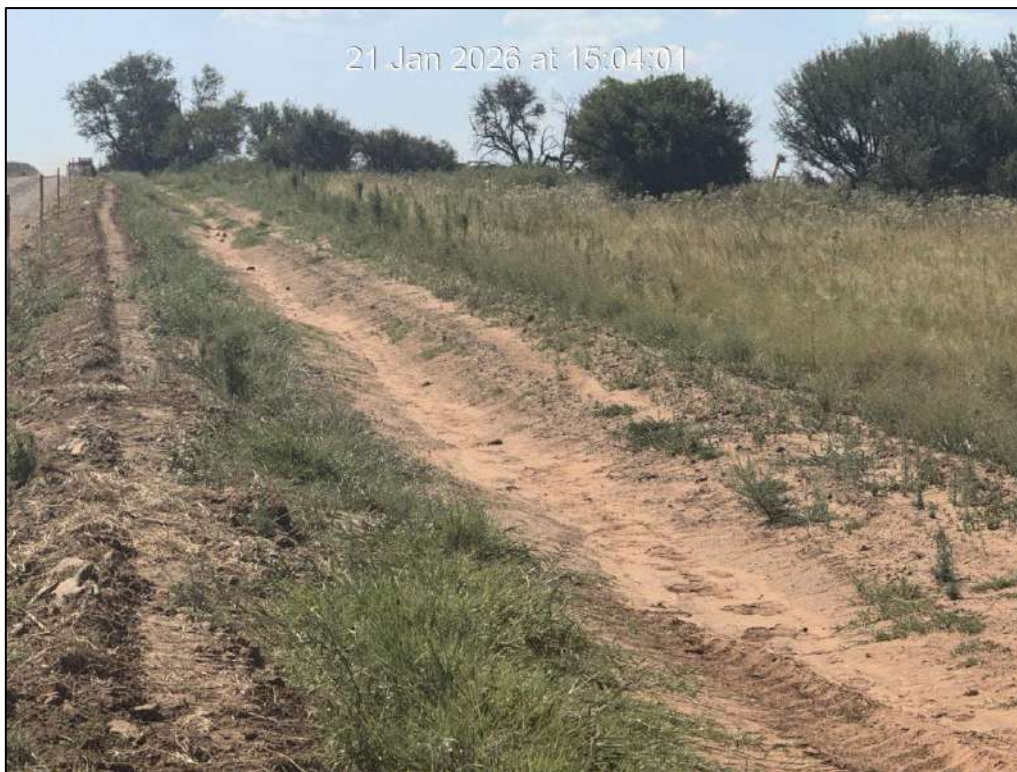
**Figure 5:** Constructed stormwater berms

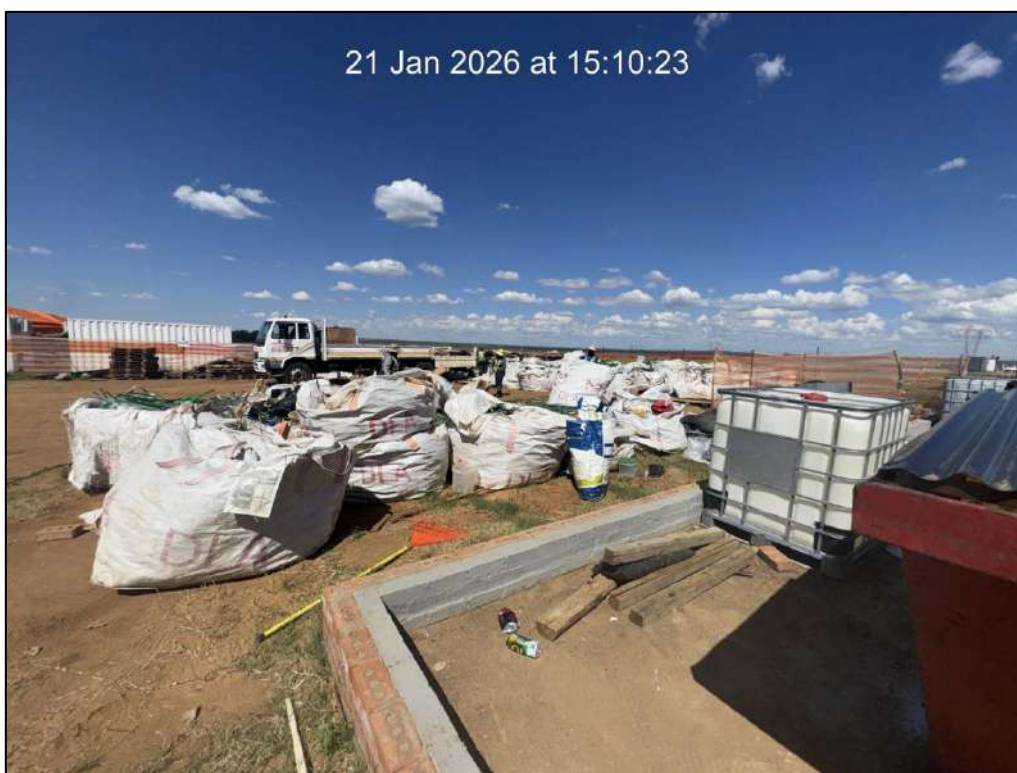
**Figure 6:** Waste area.

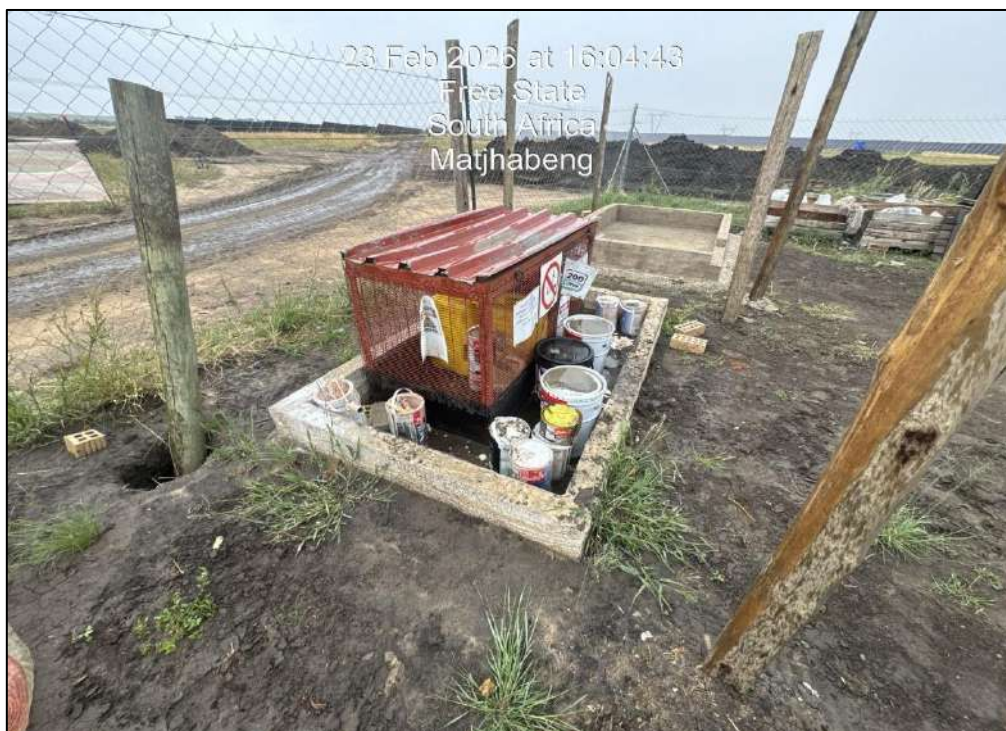
**Figure 1:** Chemical bund without a roof.

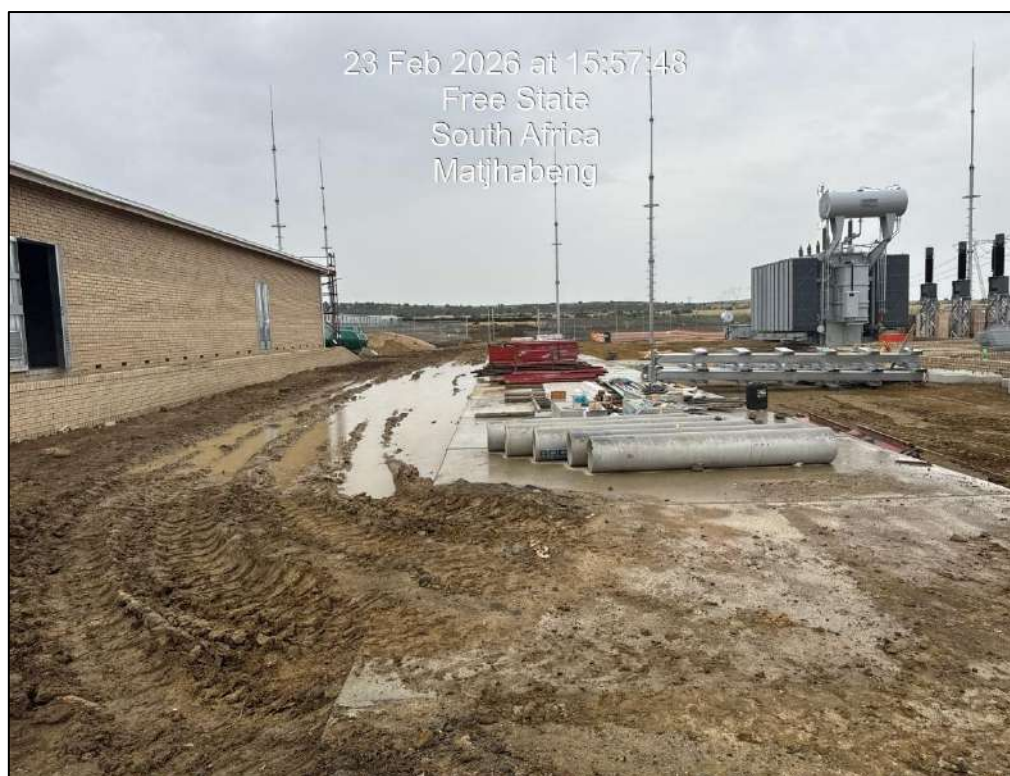
**Figure 2:** Water ponding and mud at the switching station

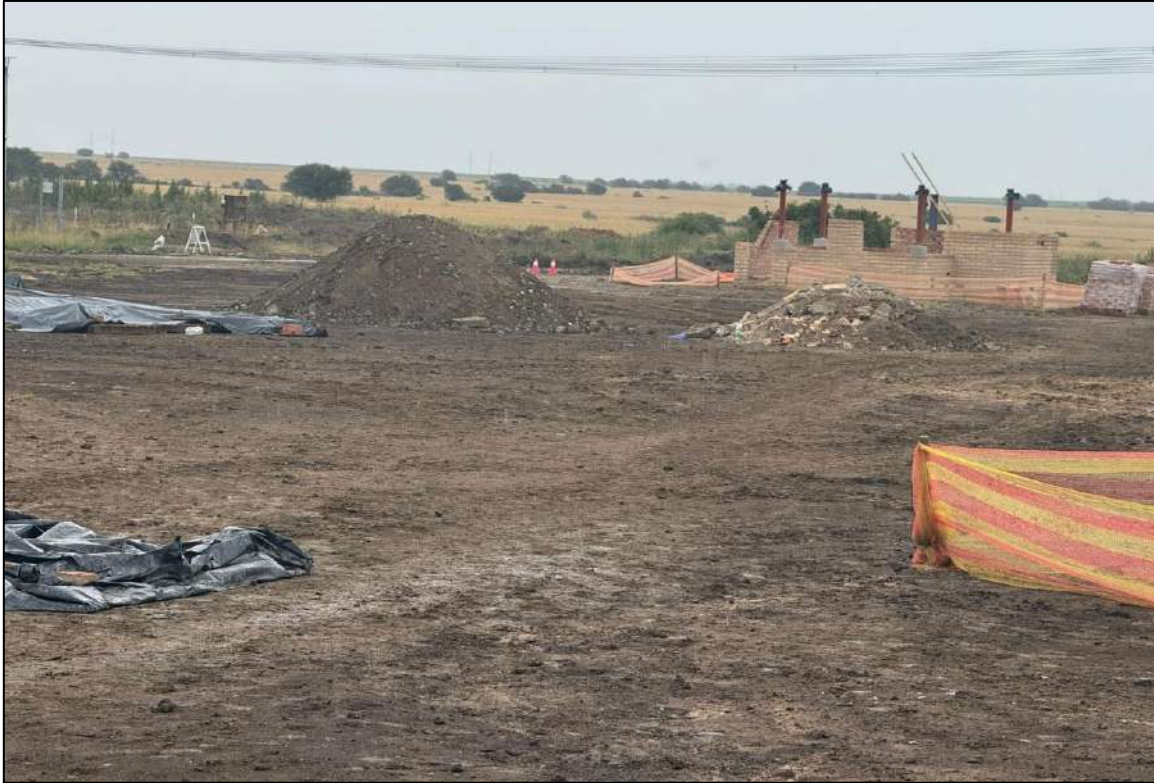
**Figure 3:** Construction Rubble at the switching station.

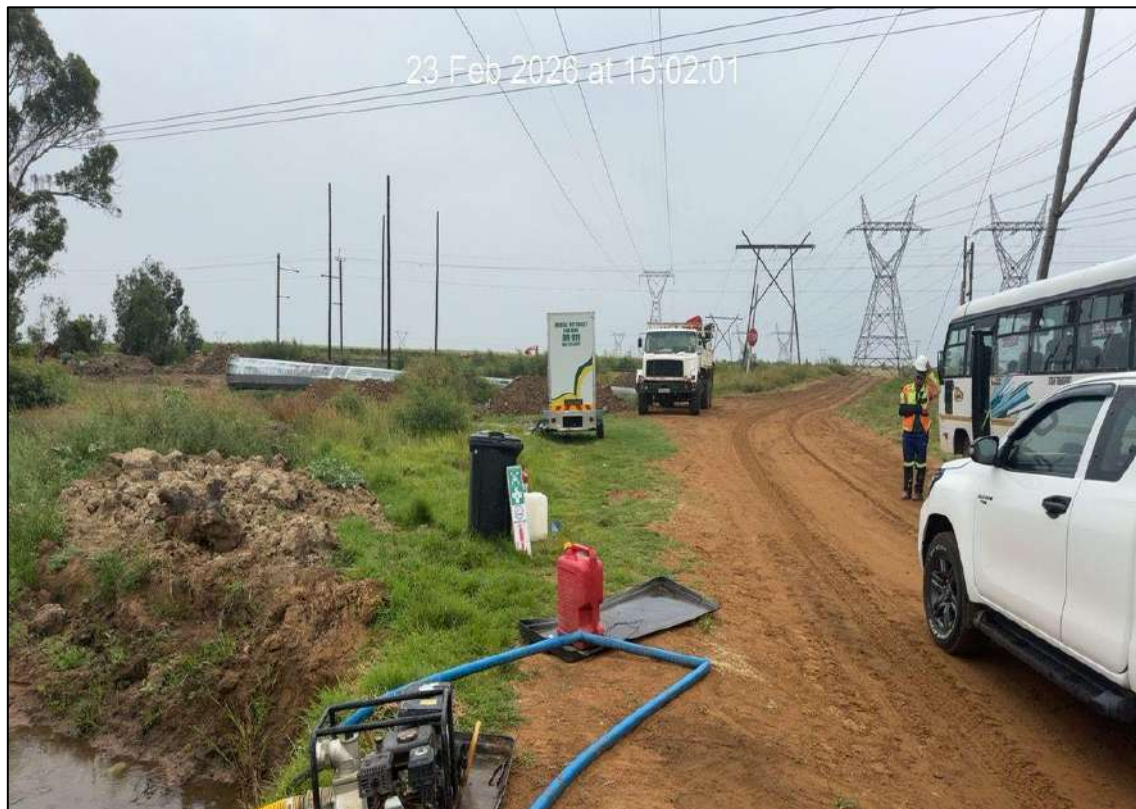
**Figure 4:** Toilet placed within 100 m of the wetland area.

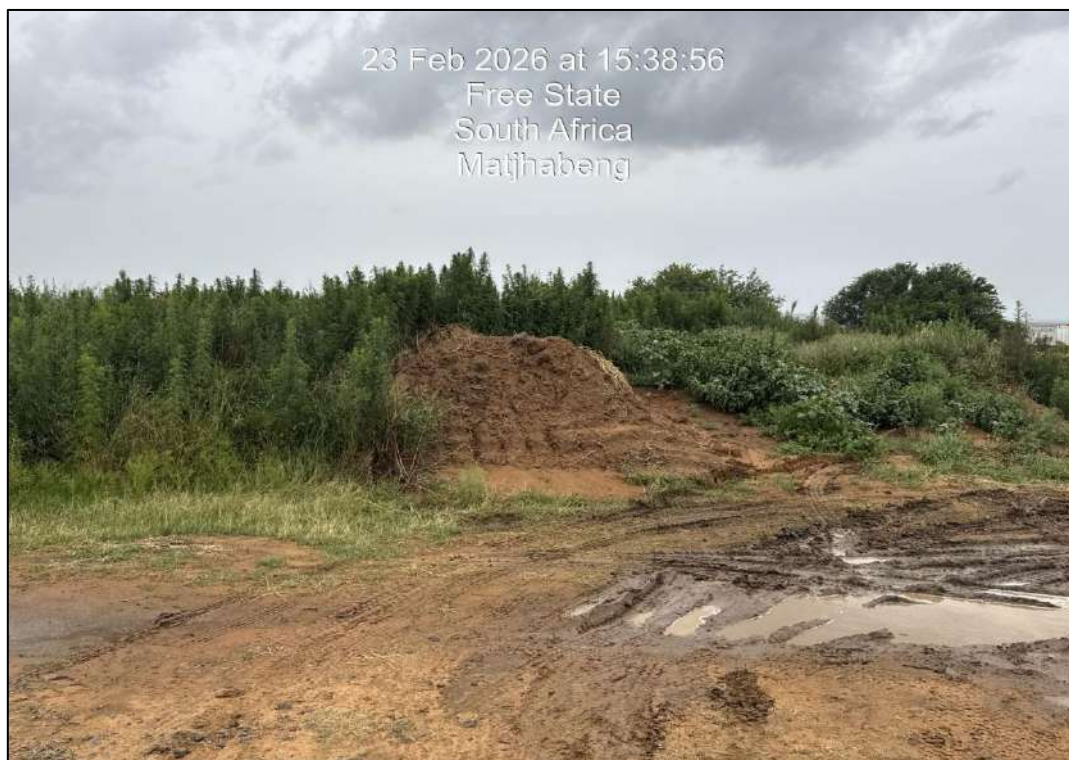
**Figure 5:** Alien Vegetation on the stockpiles.

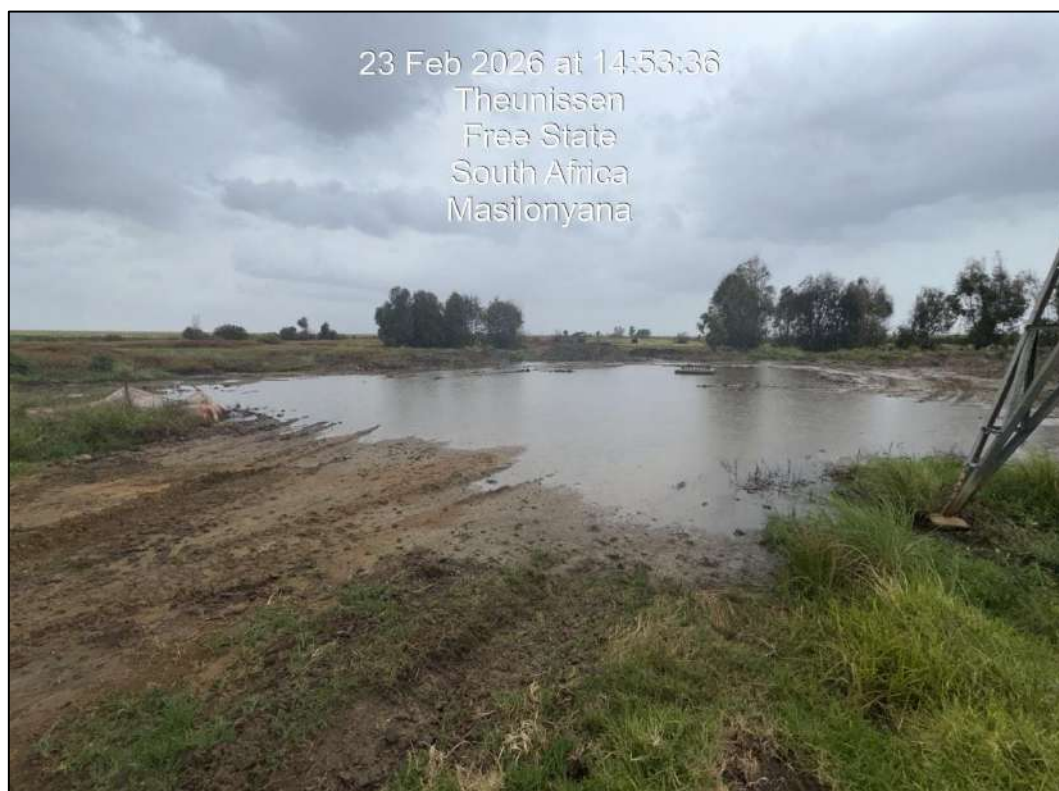
**Figure 6:** Trucks driving on the wetland area.

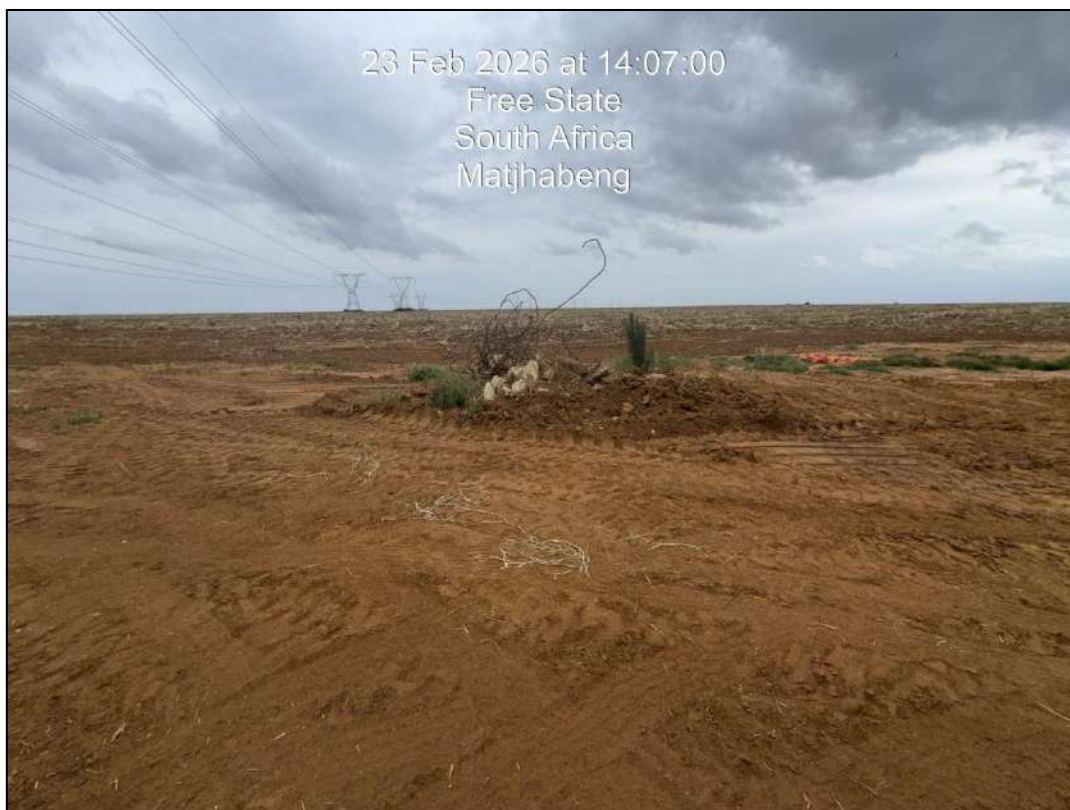
**Figure 7:** Rubble along the line.

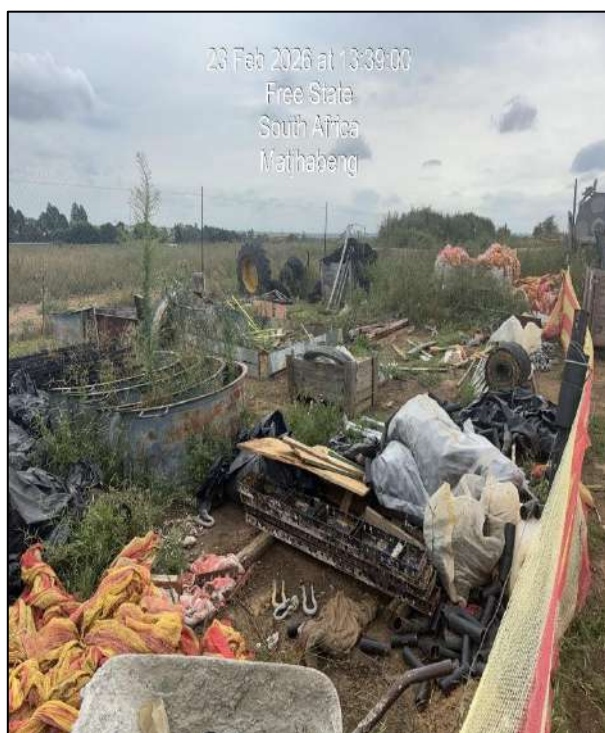
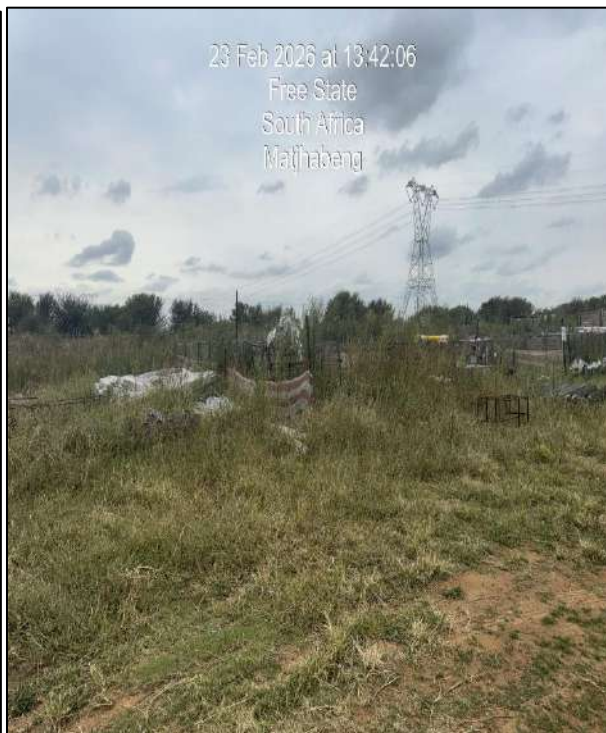
**Figure 8:** Housing keeping must be improved

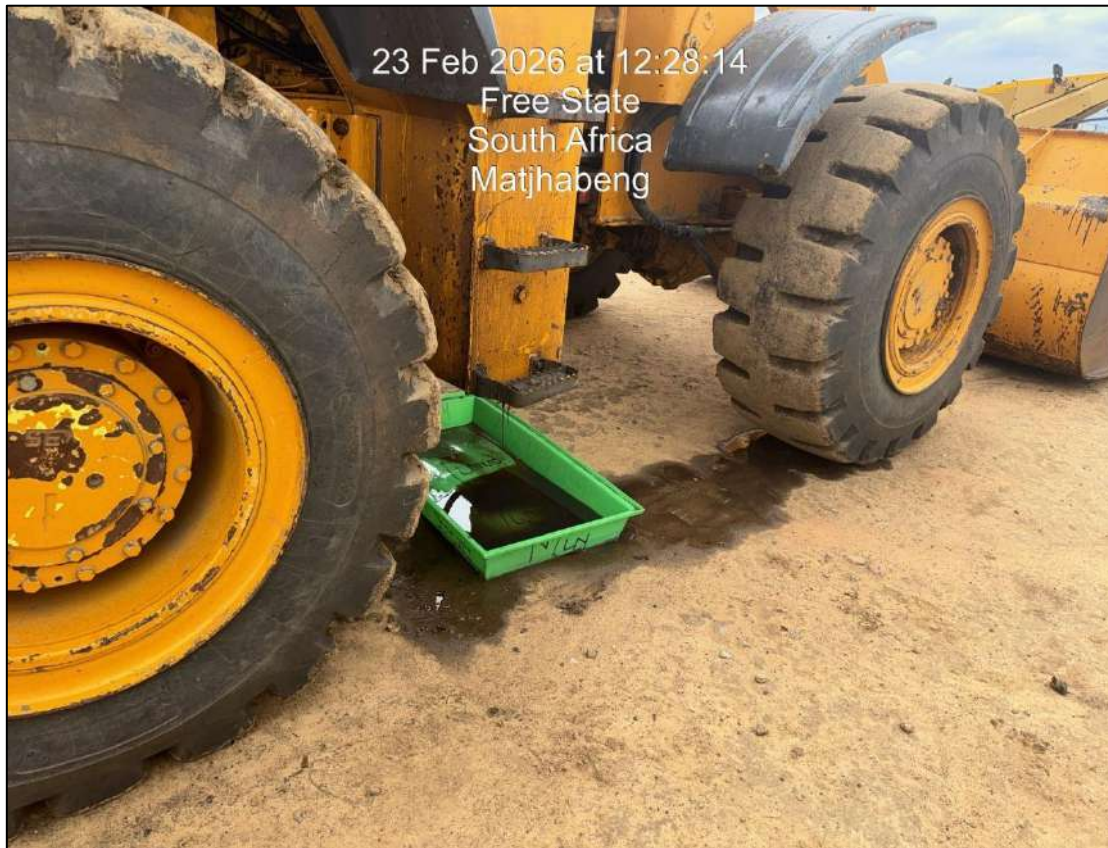
Figure 9: Leaking truck

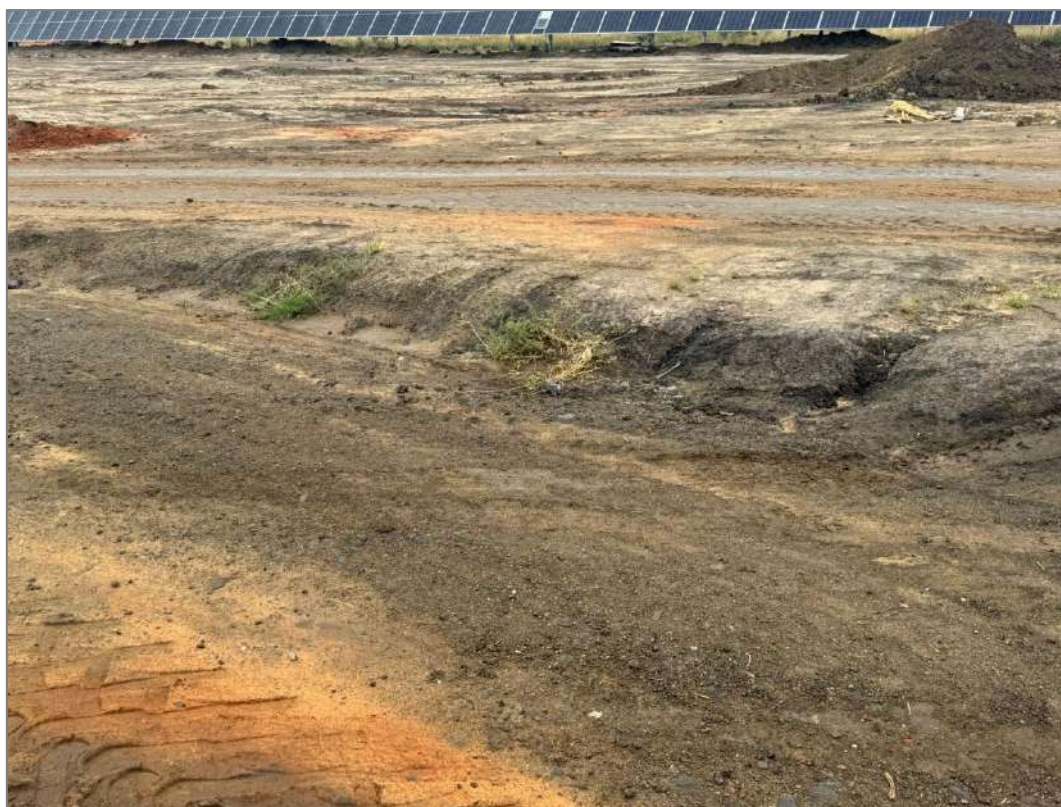
**Figure 1:** Condition of the access roads.

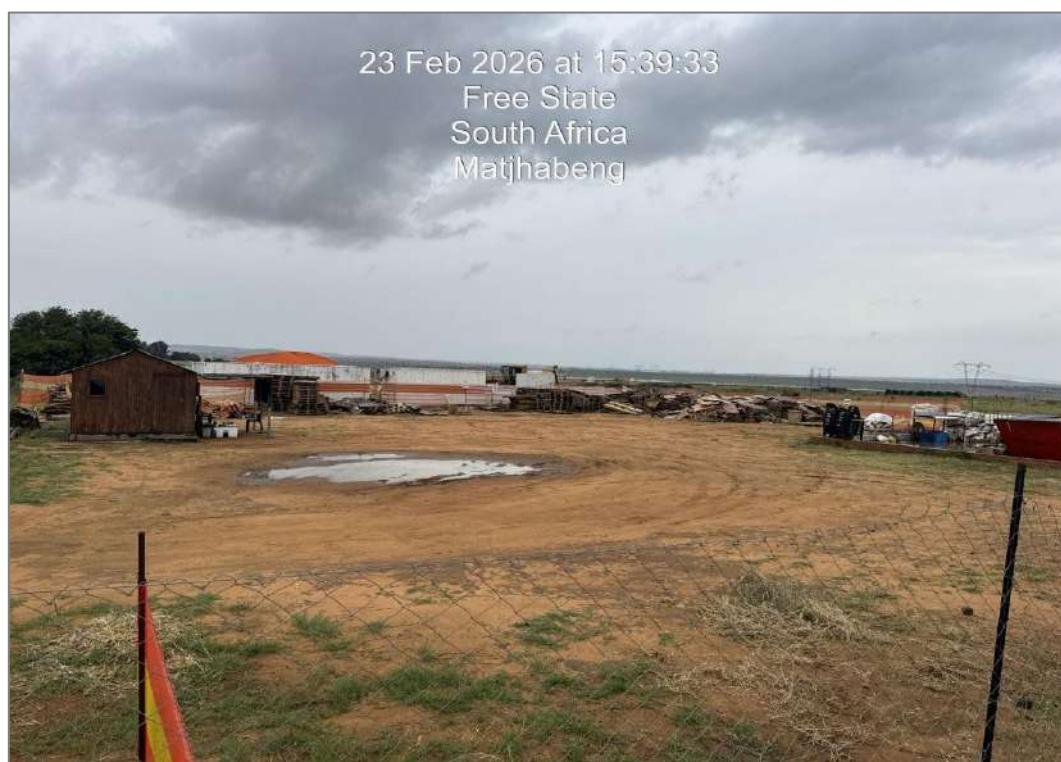
**Figure 2:** Water ponding at the waste area

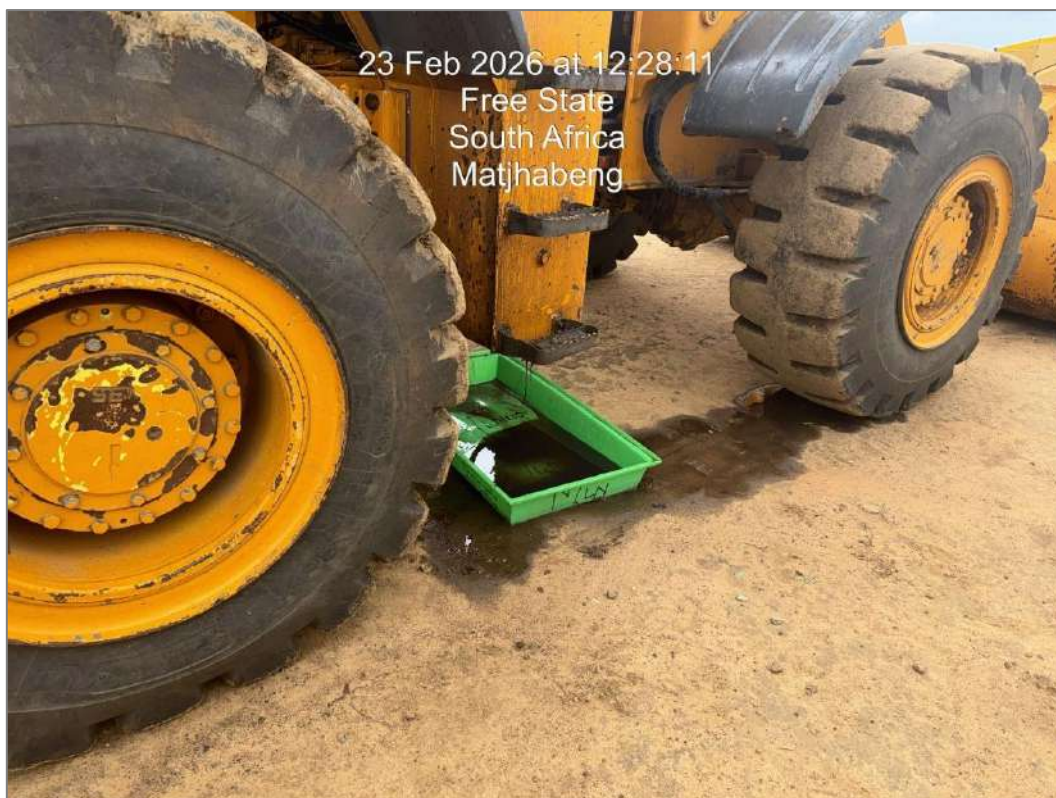
**Figure 3:** Leaking truck.
