**JANUARY 2026**

# ECO MONTHLY ENVIRONMENTAL MONITORING REPORT

Virginia OPHL Line and Switching Station Matjhabeng,  
Lejweleputswa District Municipality within the jurisdiction  
of the Free State Province.

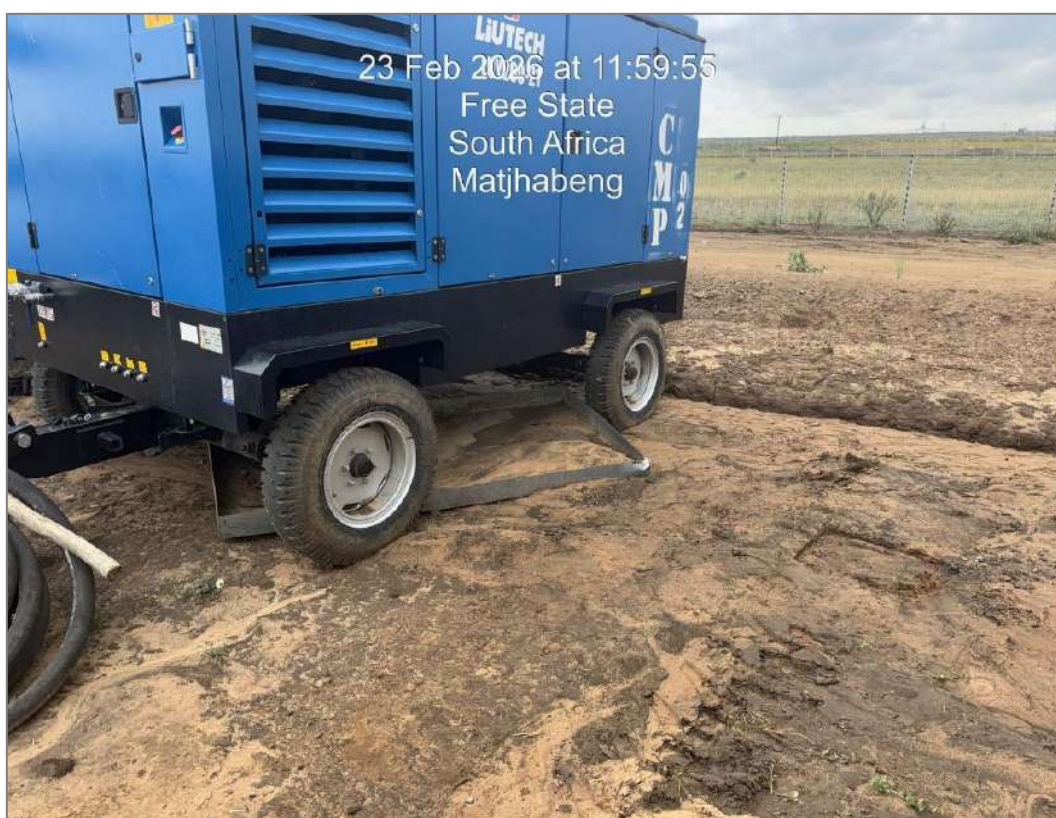
**Figure 4:** Equipment placed in the stormwater drains

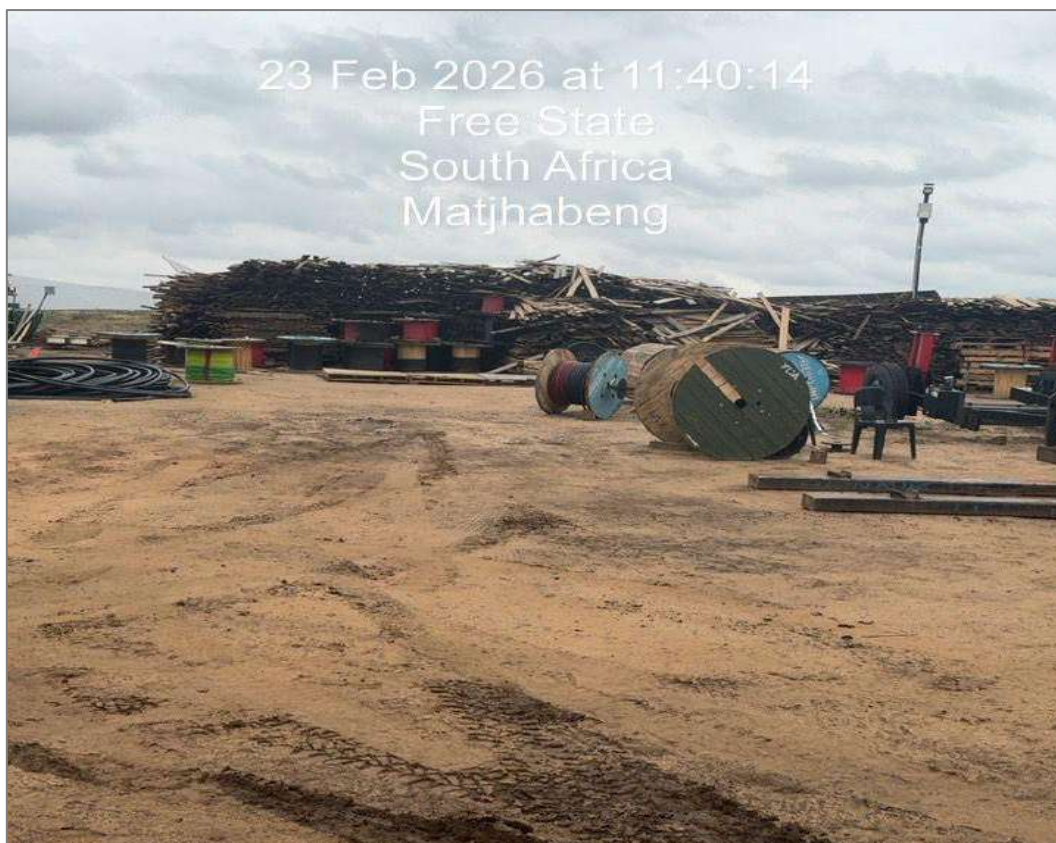
**Figure 5:** Large pile of wood that is a fire hazard

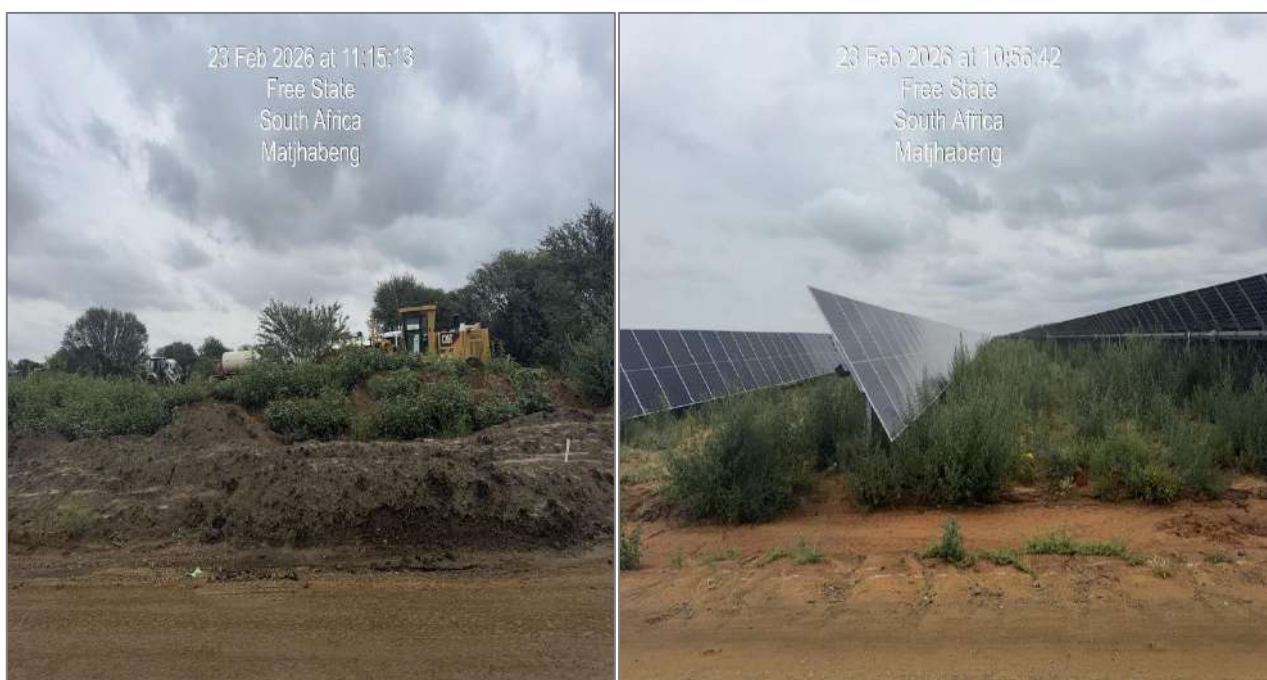
**Figure 6:** Alien Vegetation onsite

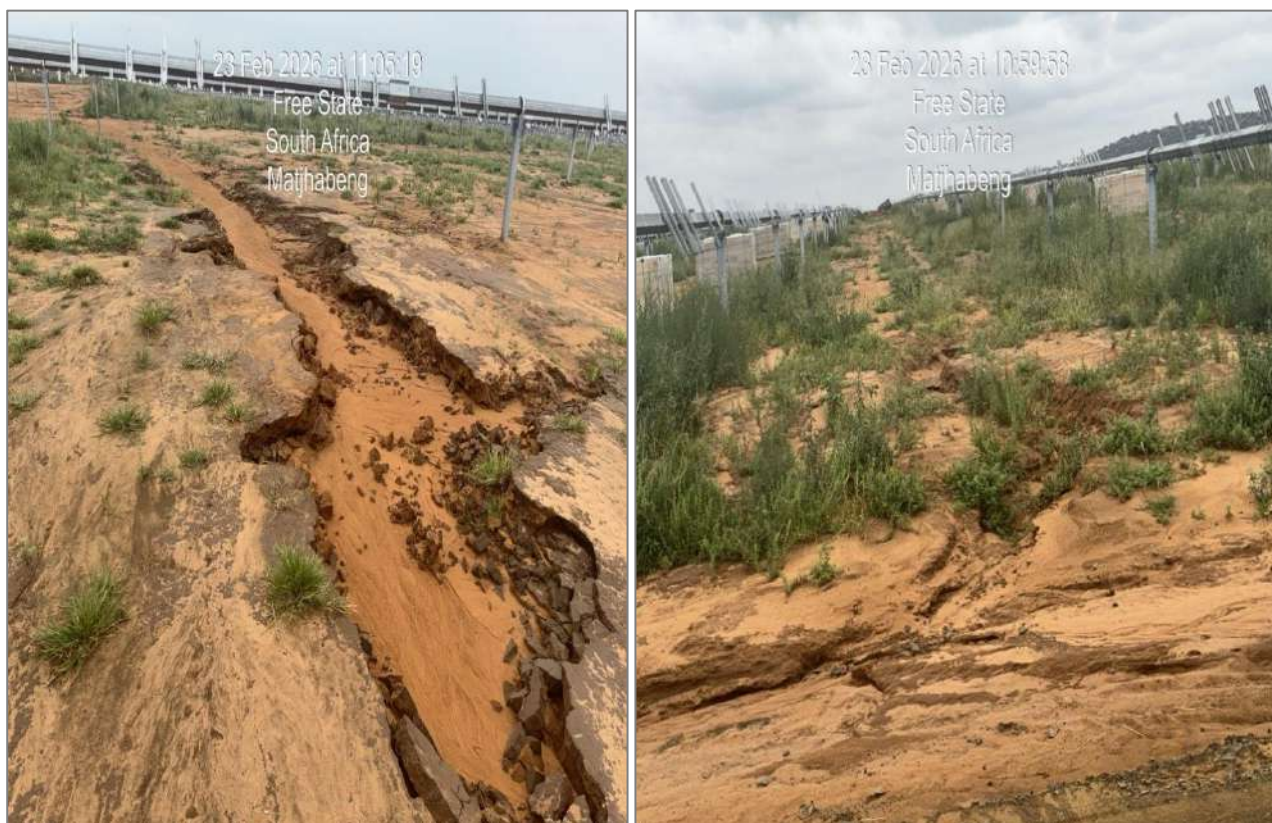
**Figure 7:** Erosion onsite

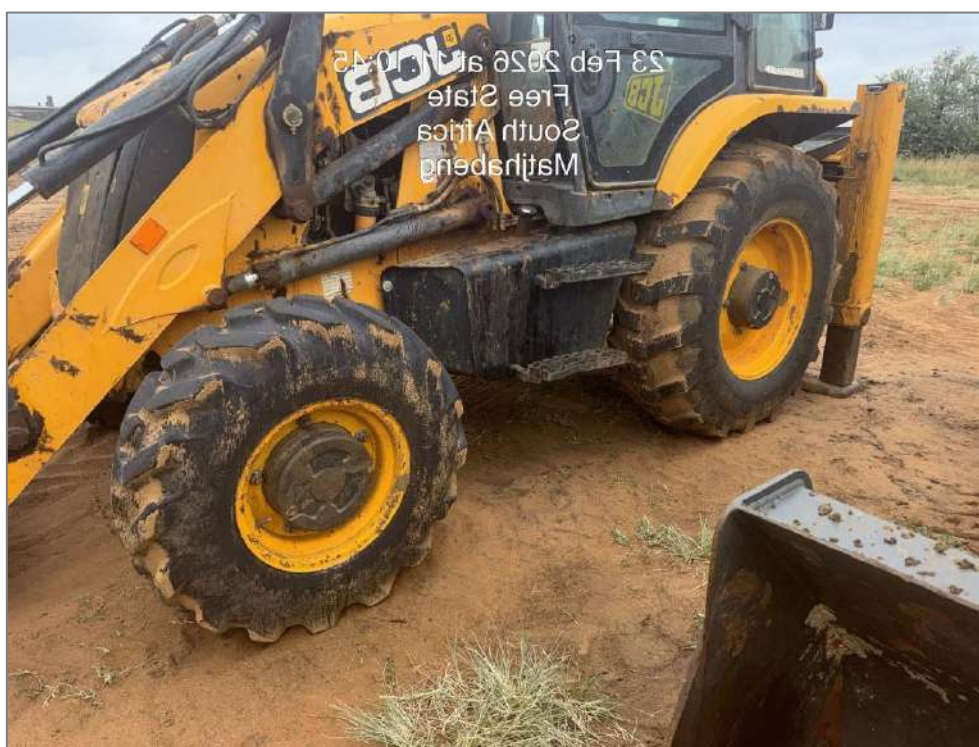
**Figure 8:** Equipment without Drip trays

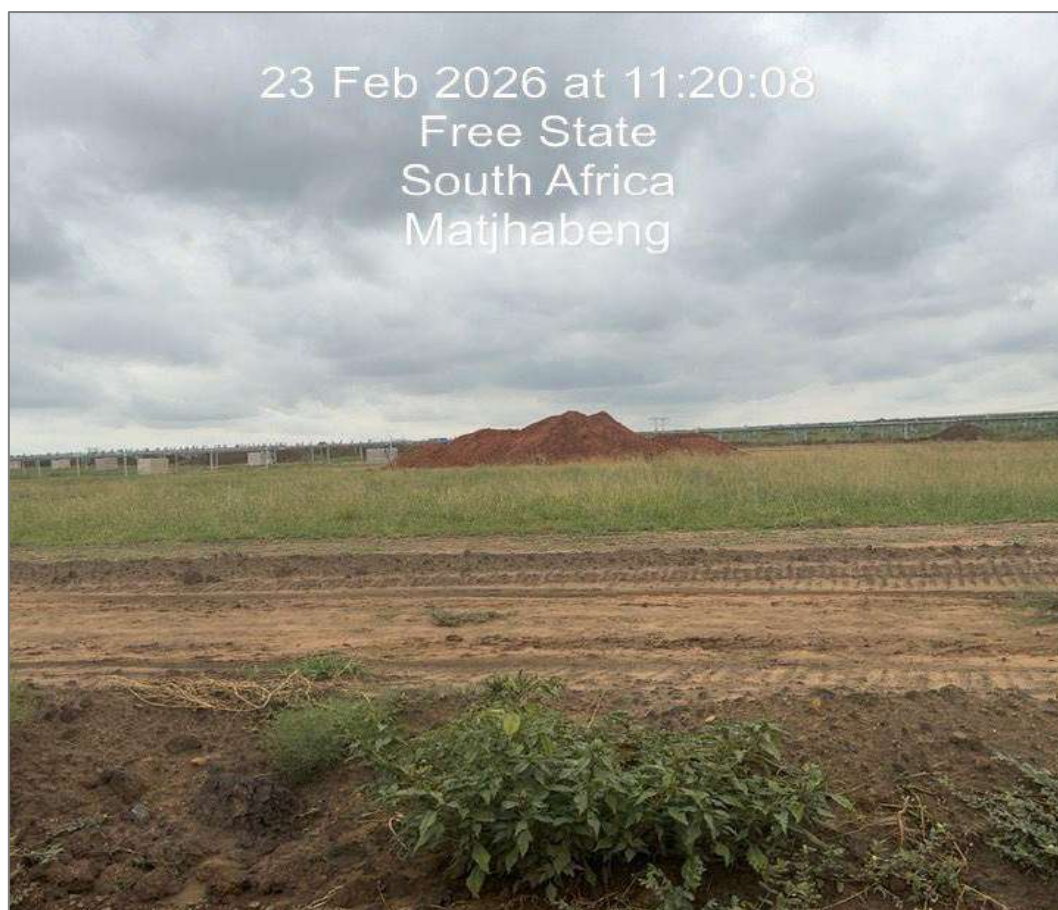
**Figure 9:** Stockpile height exceeding 2m

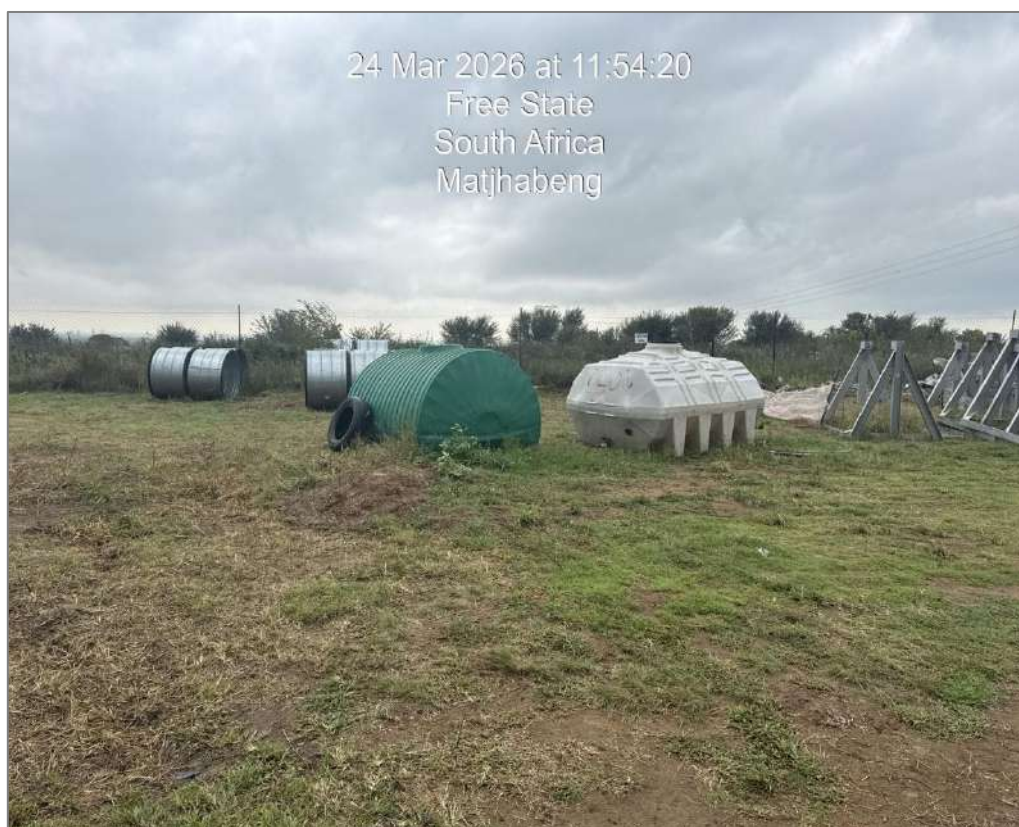
**Figure 1:** Cleaned section at the laydown area

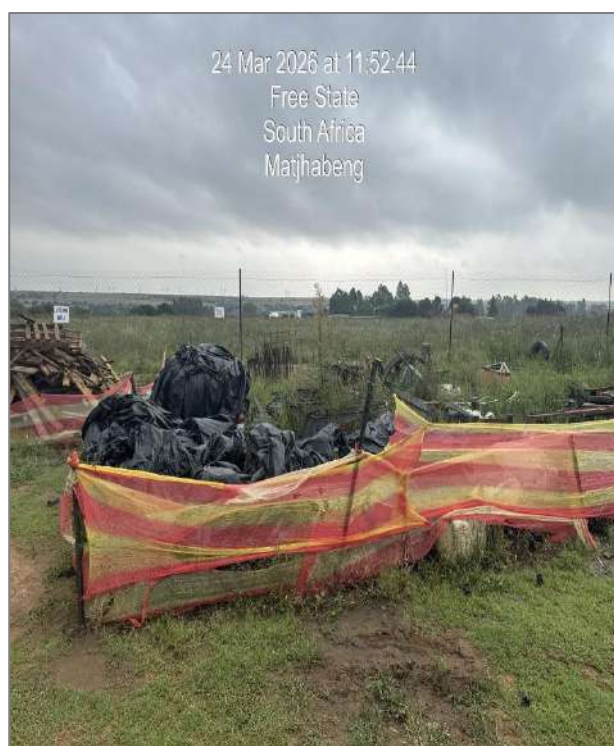
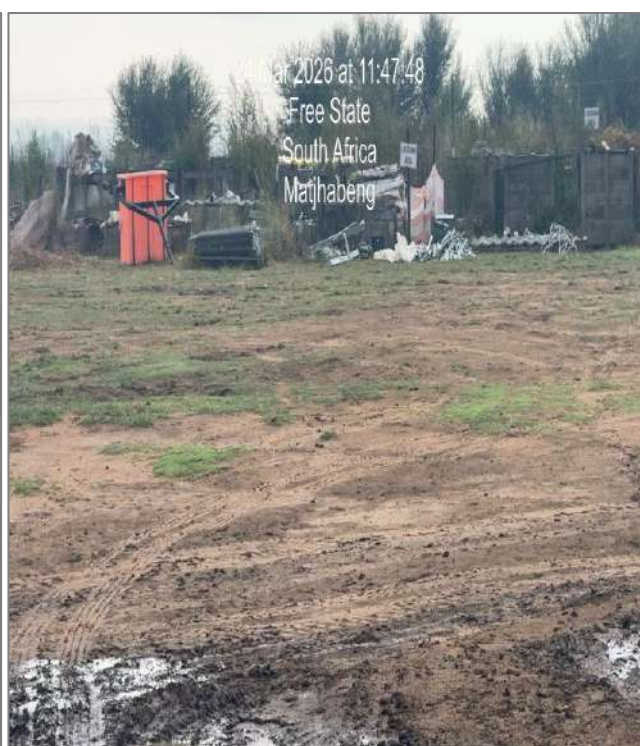
**Figure 2:** overgrown grass at the layout

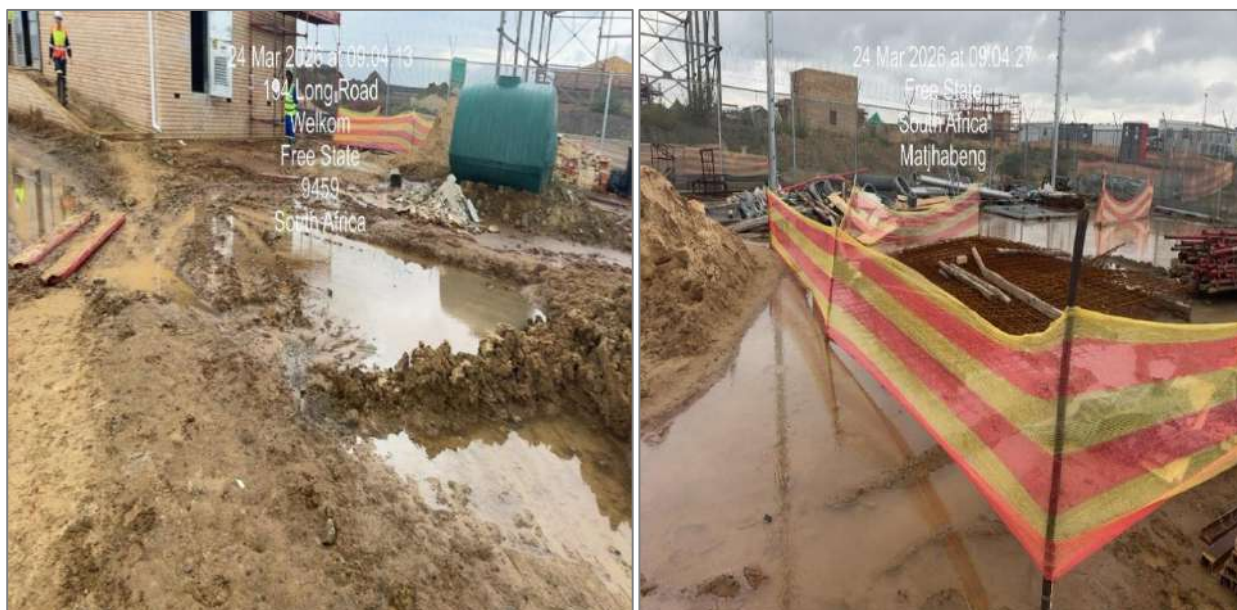
**Figure 3:** Water ponding and mud at the switching station

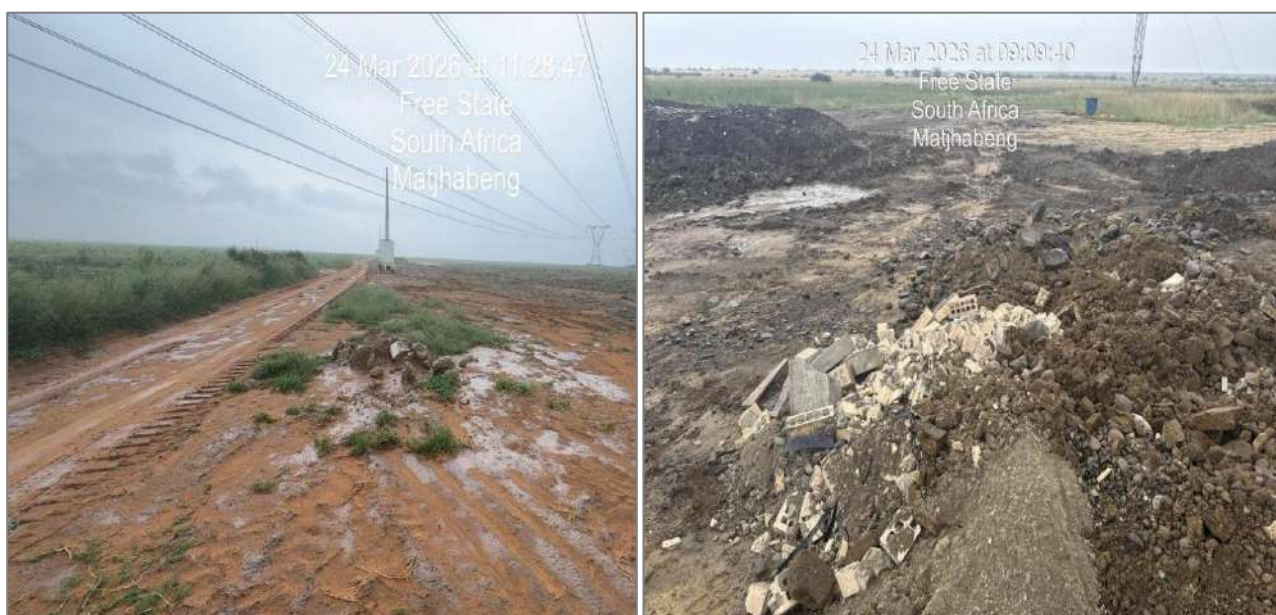
**Figure 4:** Construction Rubble on the line and switching station.

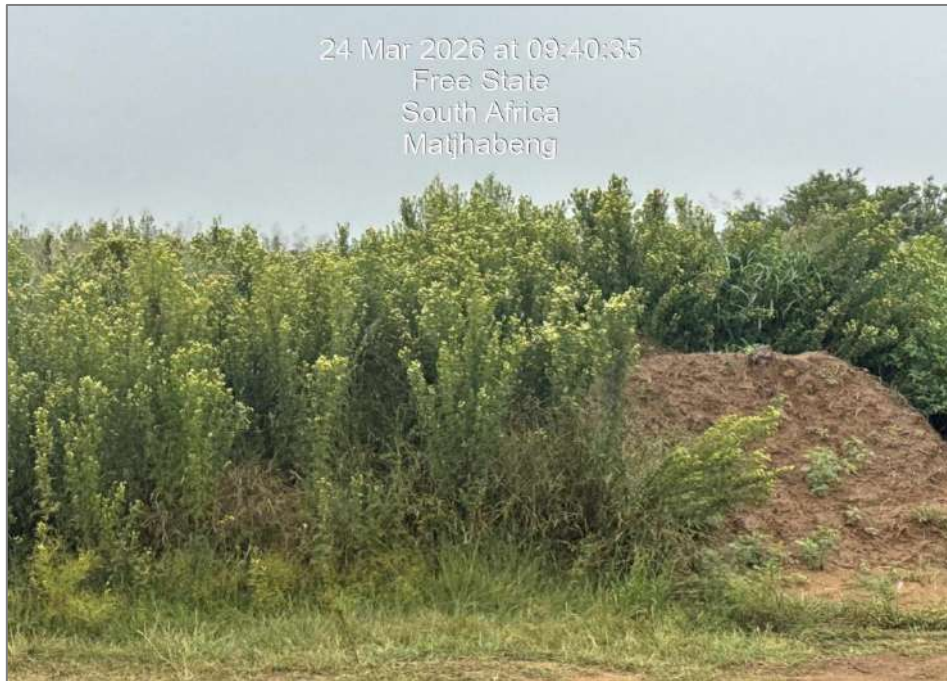
**Figure 5:** Alien Vegetation on the stockpiles.

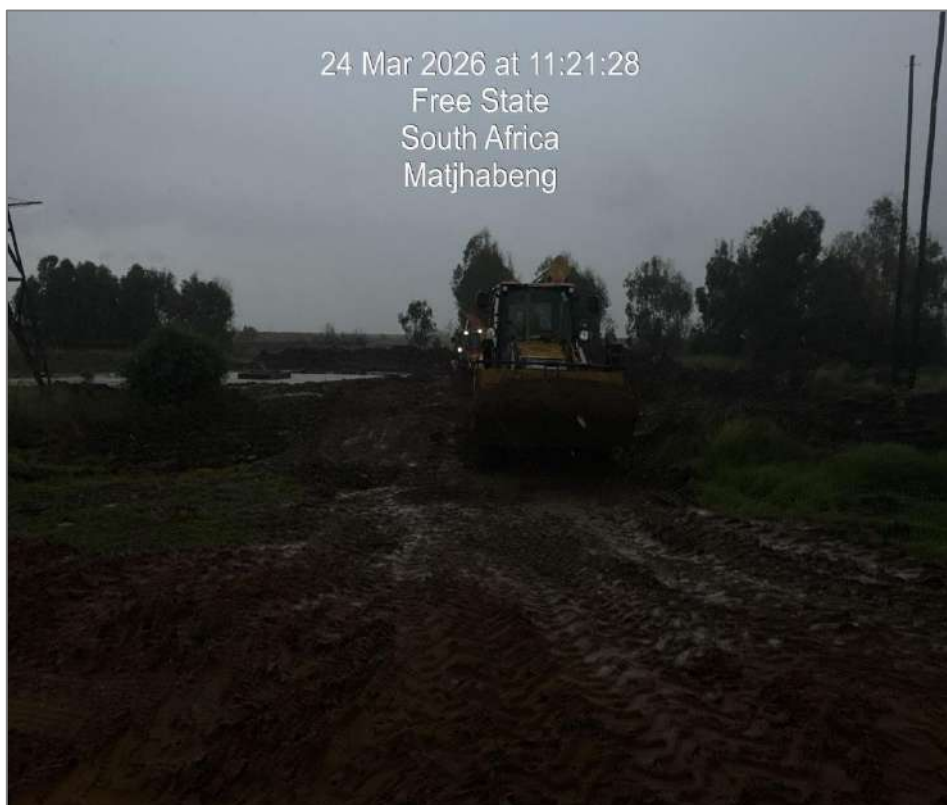
**Figure 6:** Significant transformation of the wetland area.

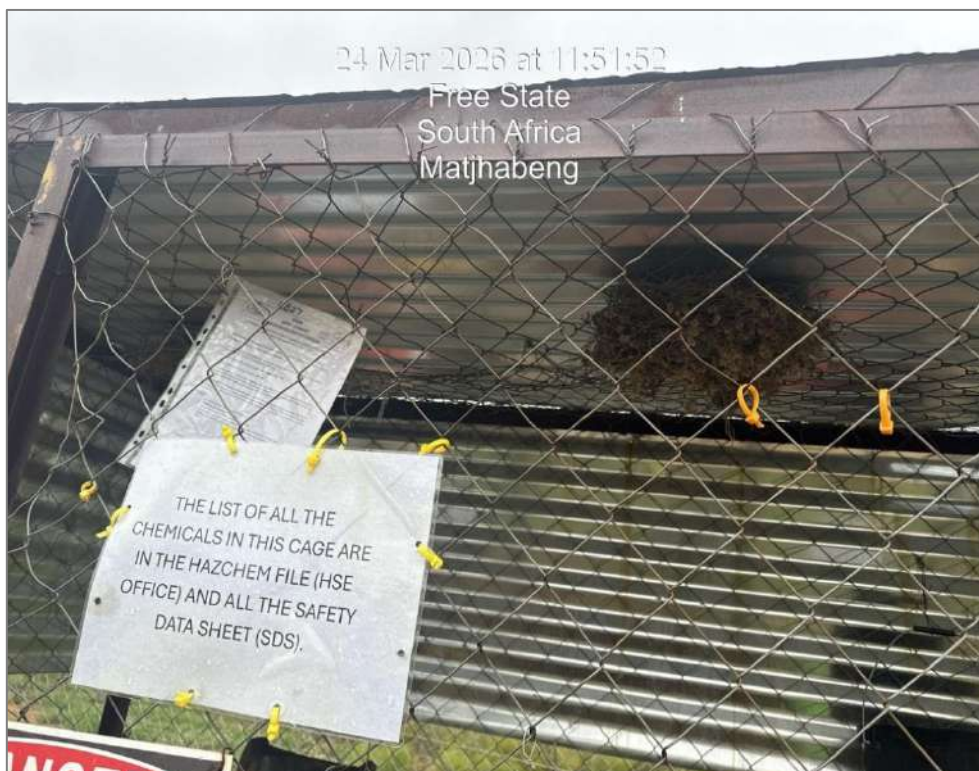
**Figure 7:** Nests in the chemical bund.

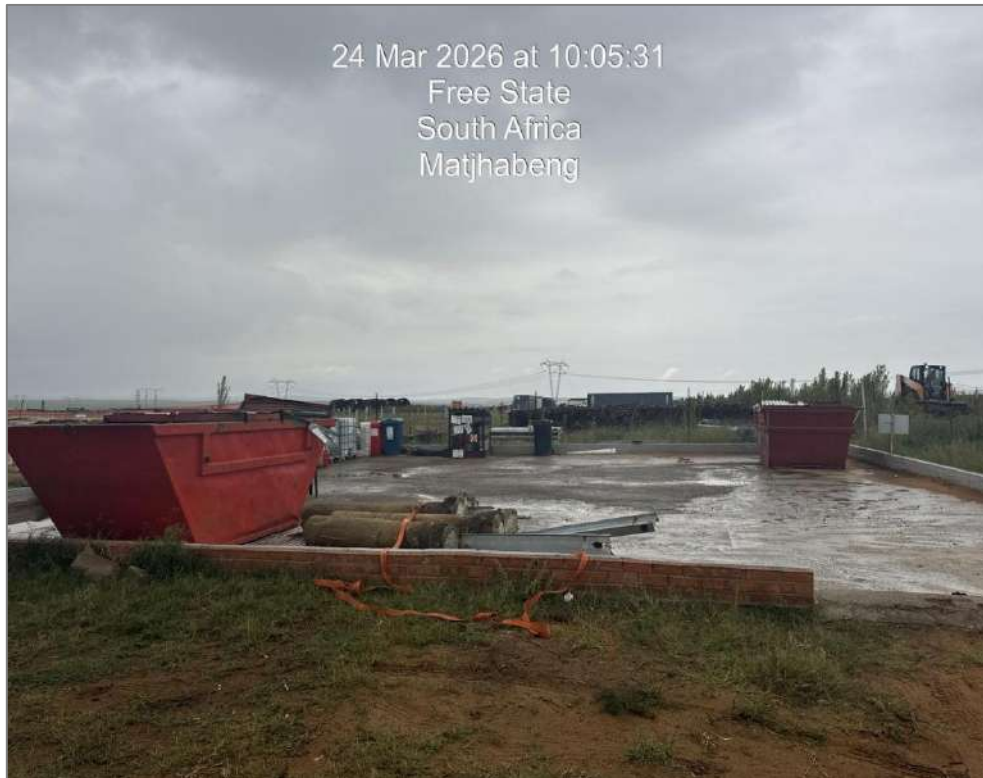
**Figure 9:** Clean waste area.

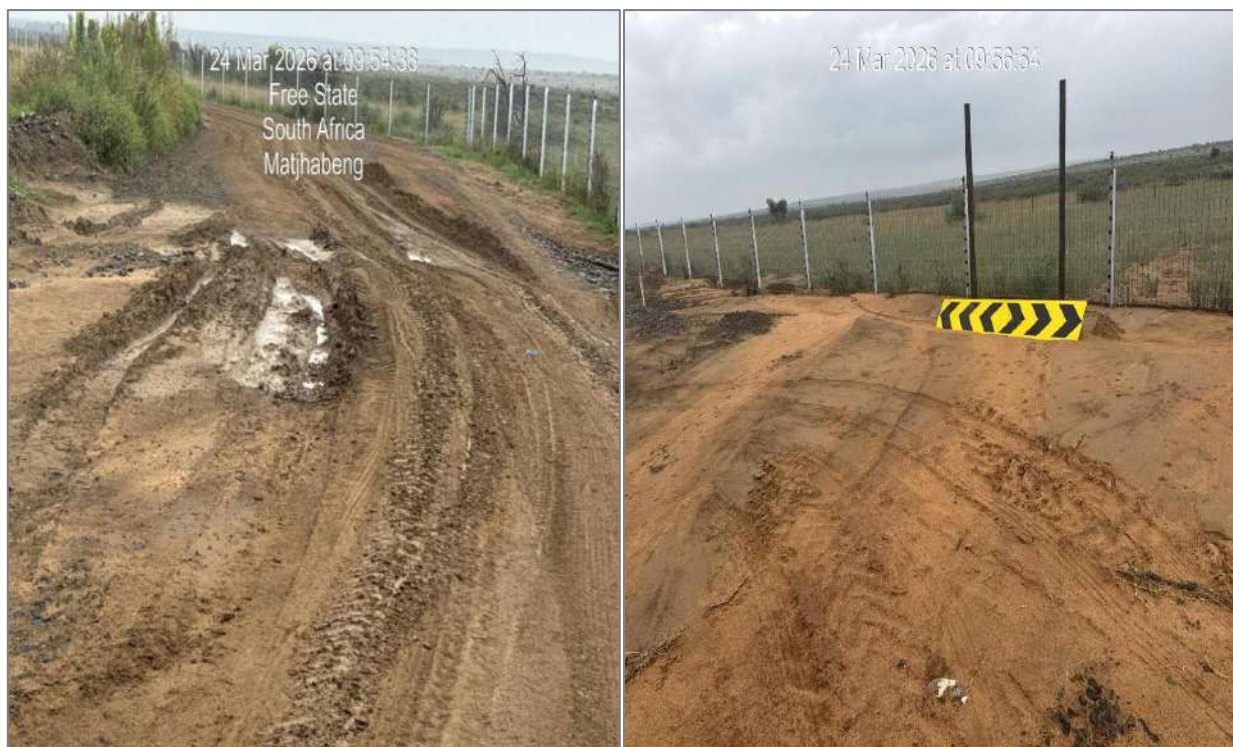
**Figure 1:** Condition of the access roads.

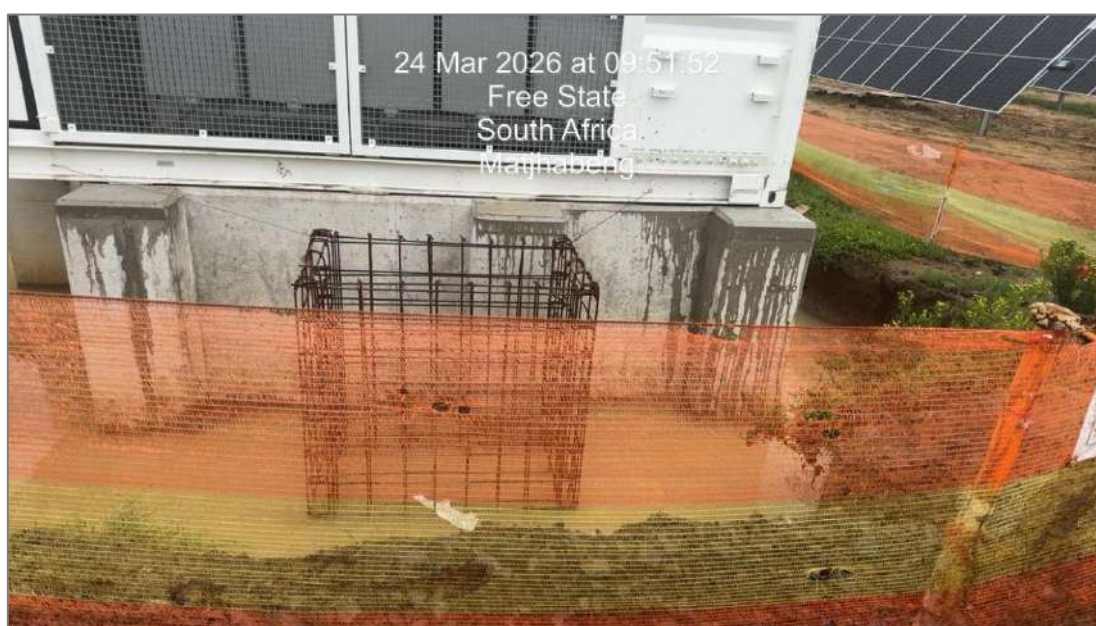
**Figure 2:** Water ponding

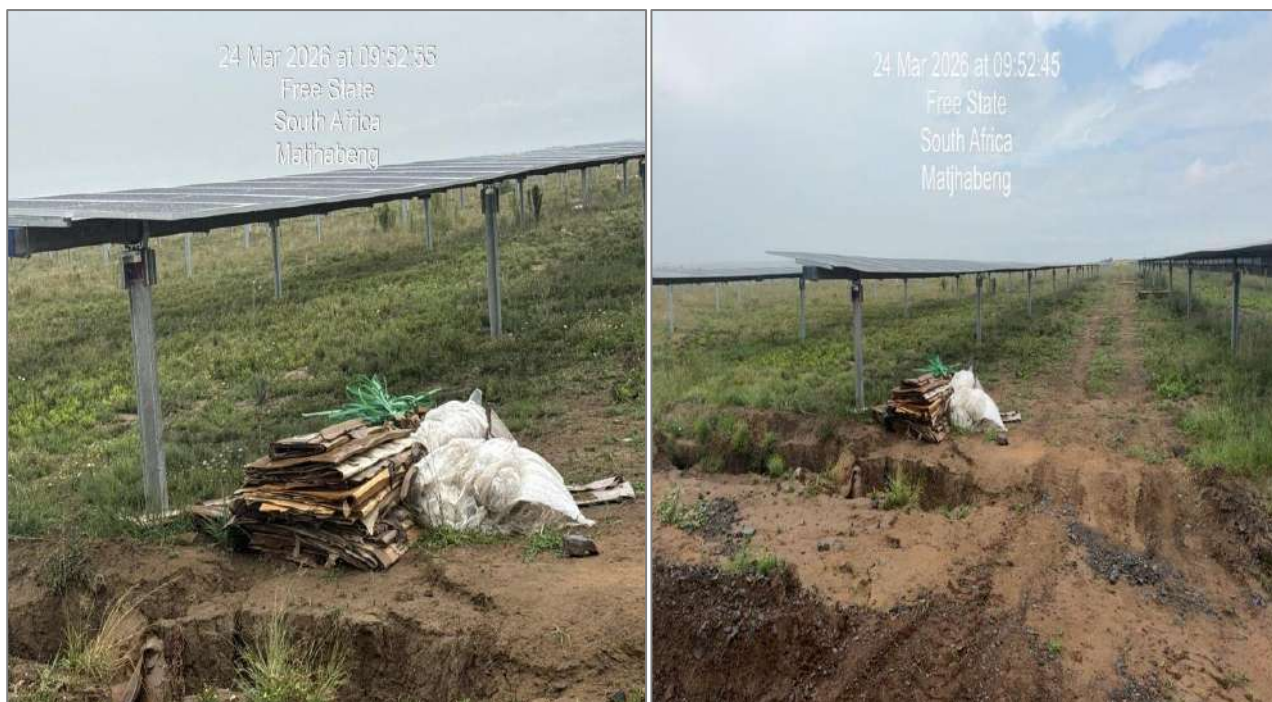
**Figure 3:** boxes on the solar field.

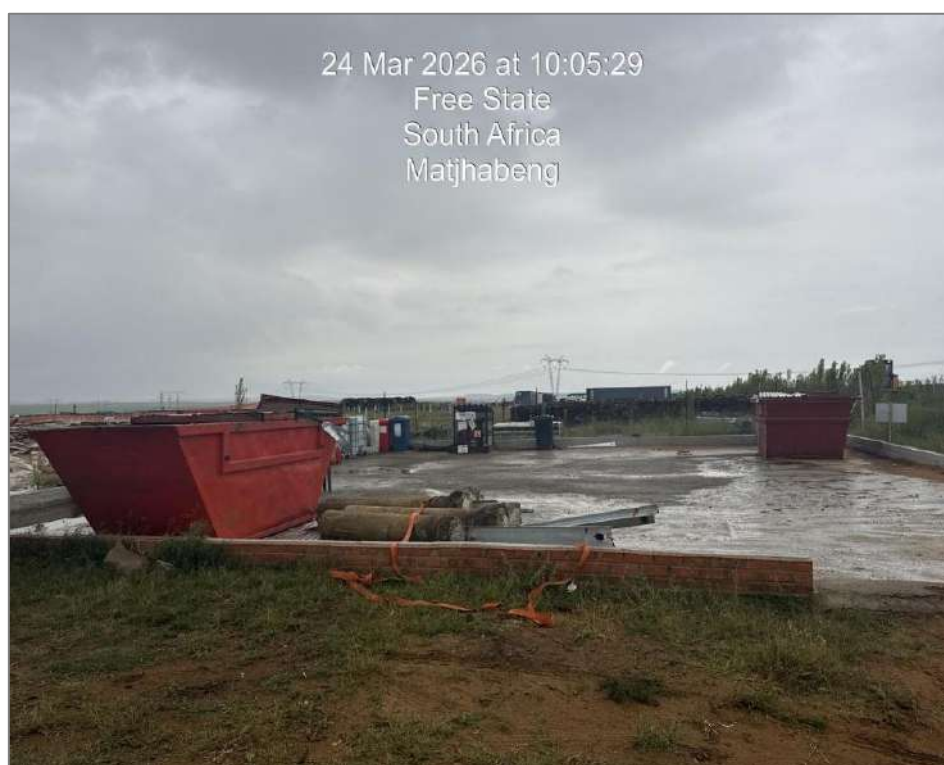
**Figure 4:** Clean waste area

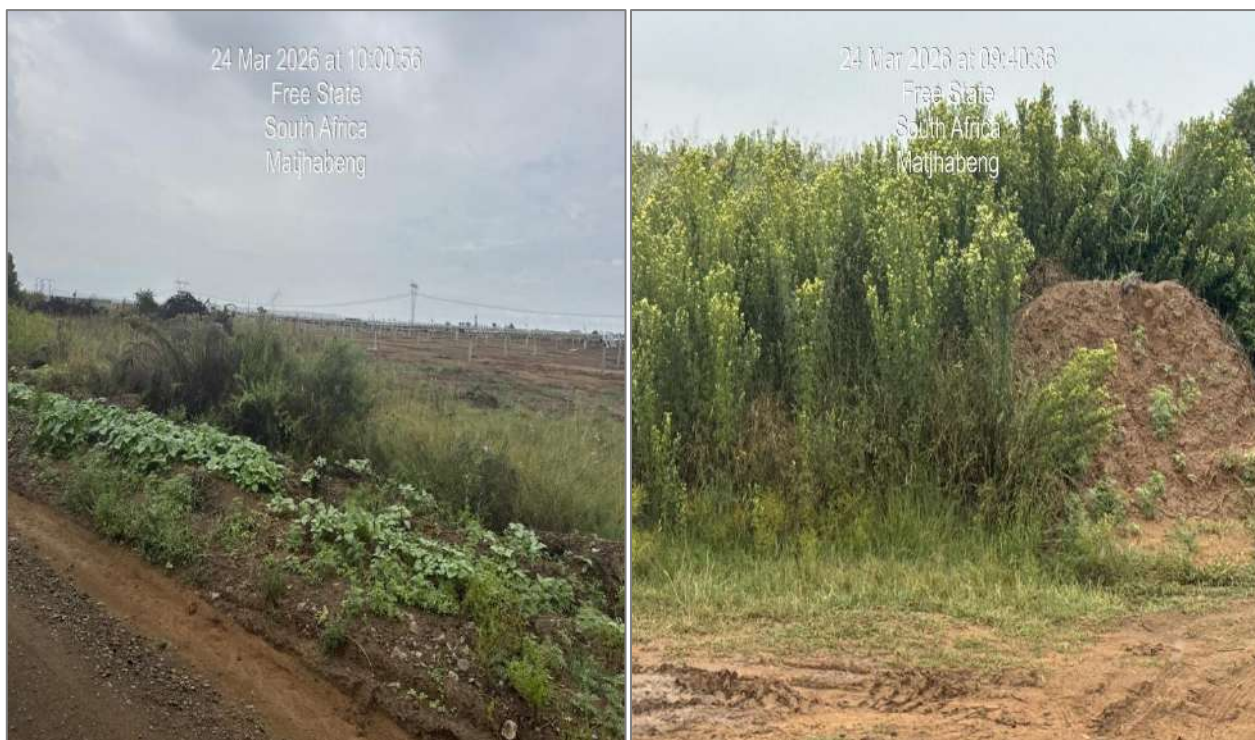
**Figure 5:** Alien vegetation

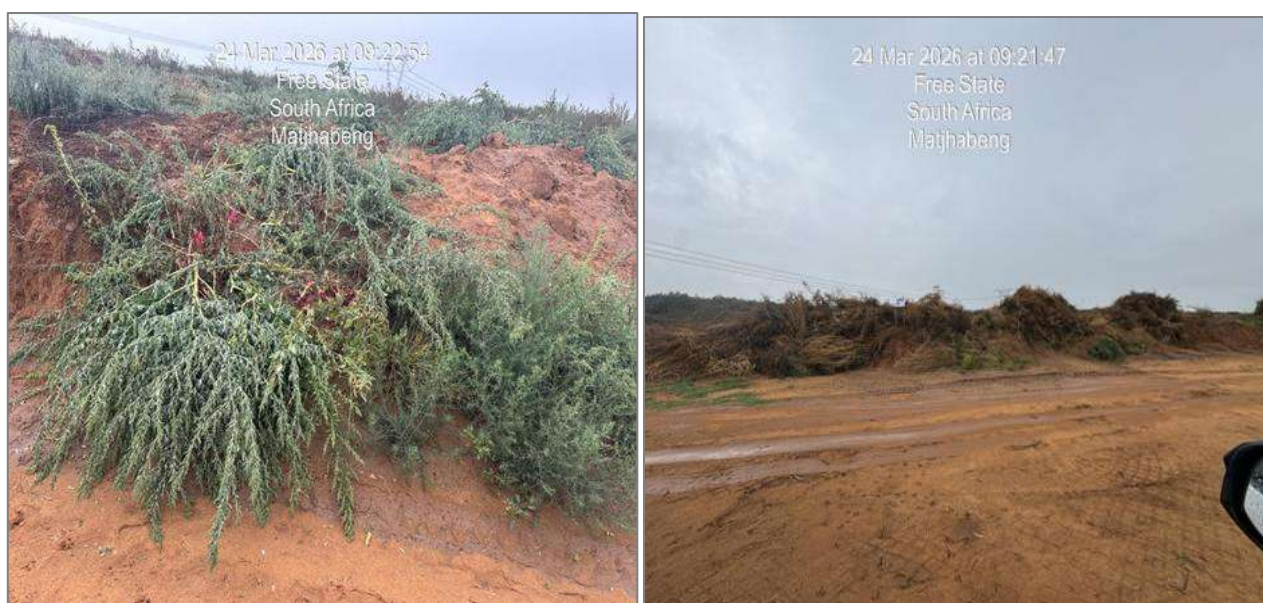
**Figure 6** Cleared Alien Vegetation

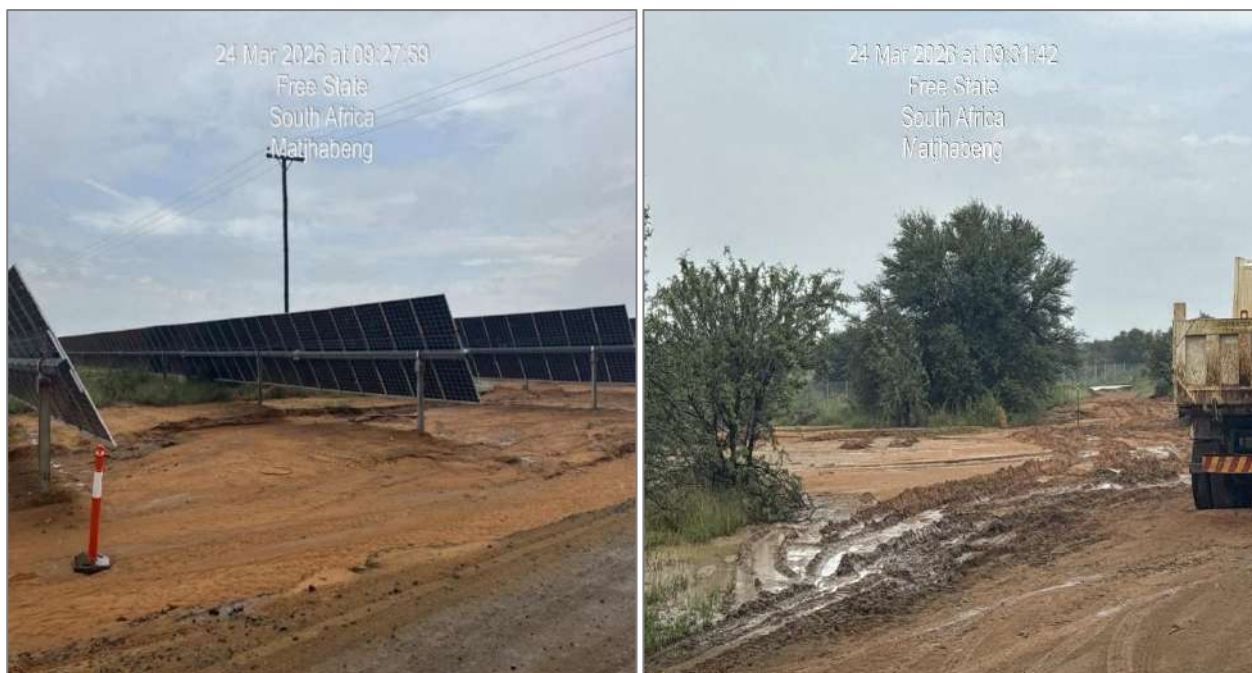
**Figure 7** Erosion onsite

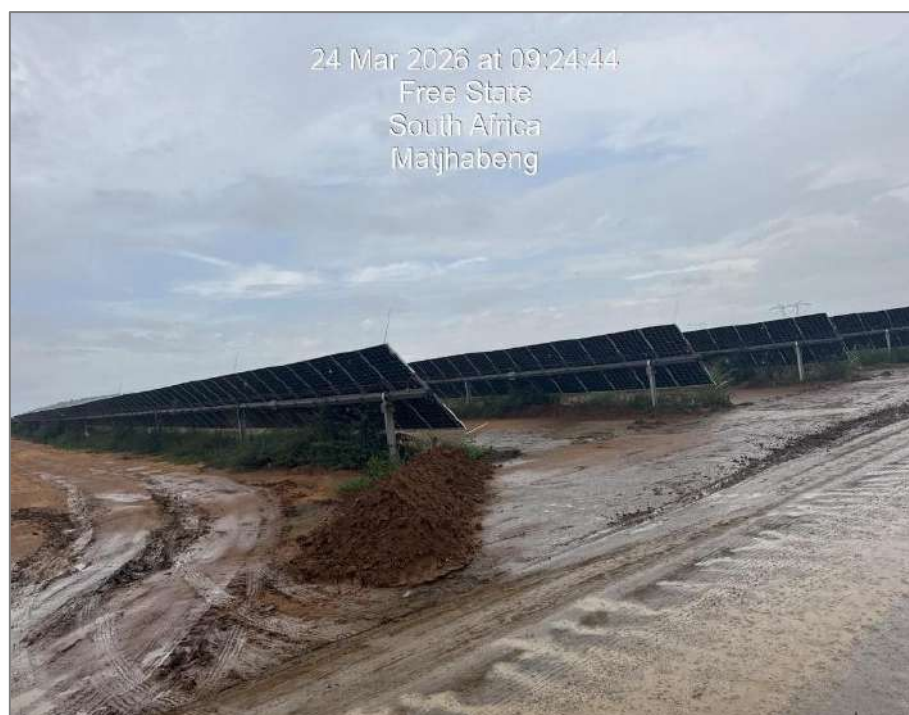
**Figure 8:** Erosion control measure

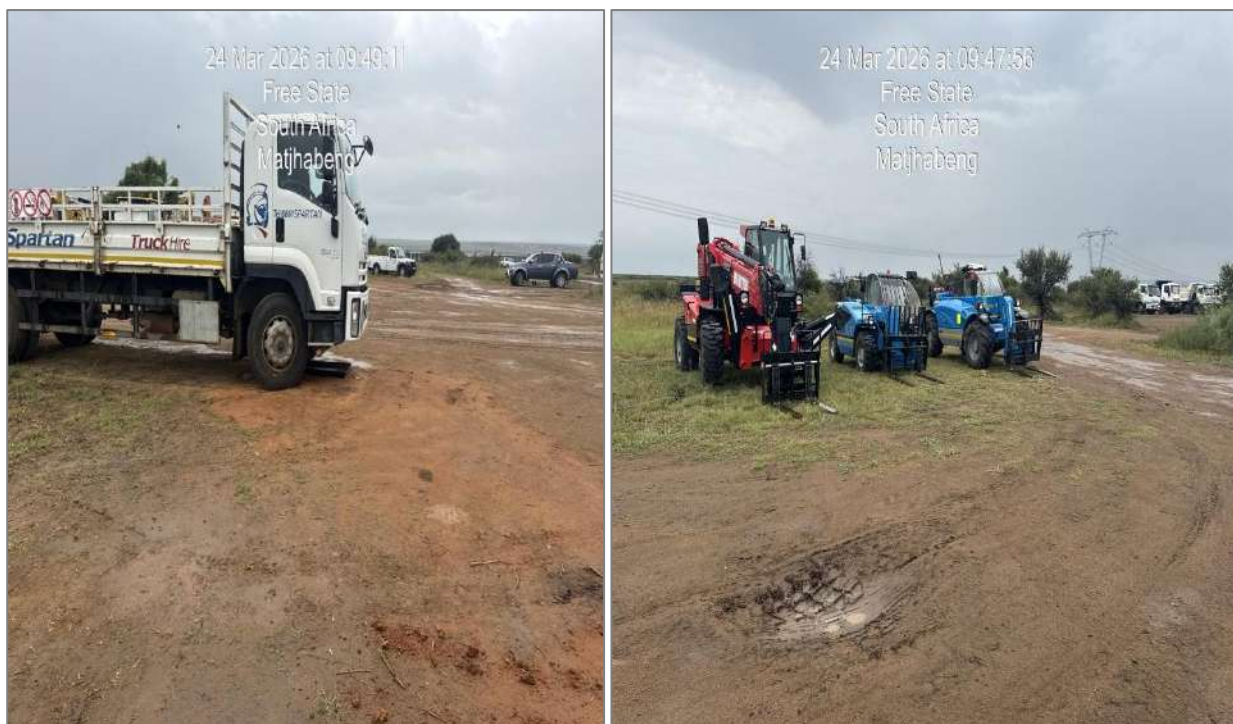
**Figure 9:** Equipment without Drip trays
