KRS
KENNY RELF SURVEYORS

Survey Report

123 The Street, Town, County AB45 6CD

Address of the Property 123 The Street, Town, County AB45 6CD
Name of the Client A Client
Report Reference 12345
Date of Inspection Monday 22 September 2025

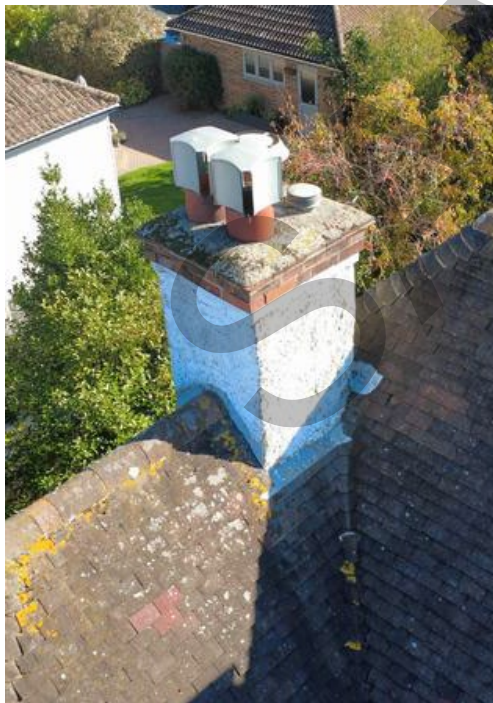
Left stack

The chimney stacks were found to be structurally stable, with no evidence of any unusual leaning, cracking or other failures, or of unusual wear of the bricks or mortar pointing between the bricks. The flashings (lead detailing at the base for the stacks) was noted to be in good condition. The pots were suitably cowled to prevent rainwater penetration.

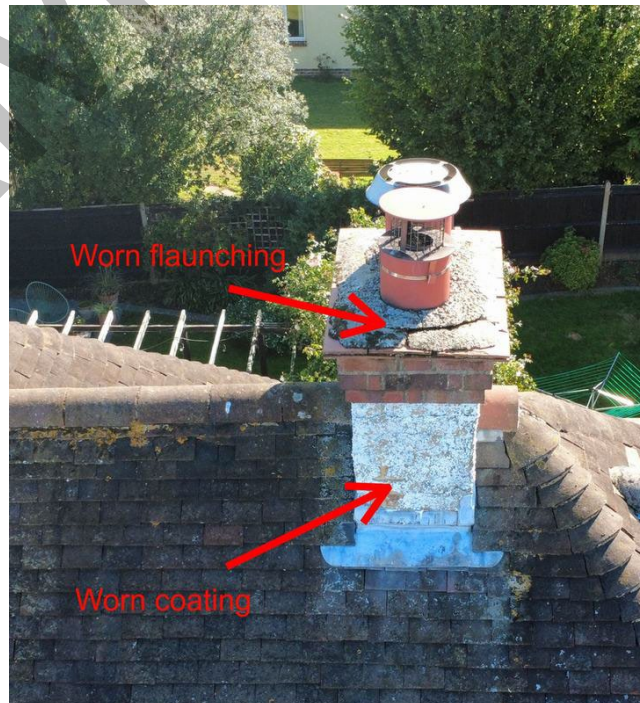
Right stack

This element has been assigned a Condition Rating 2 as repairs are required to the right stack.

The flashing of the right stack (cement layer on top) was noted to be damaged. The render or paint coating on the brickwork was very worn.

Normal maintenance and monitoring should be undertaken to prevent future defects. Flashings will need to

be periodically overhauled as part of your normal maintenance of the property as this area is particularly vulnerable to water penetration.

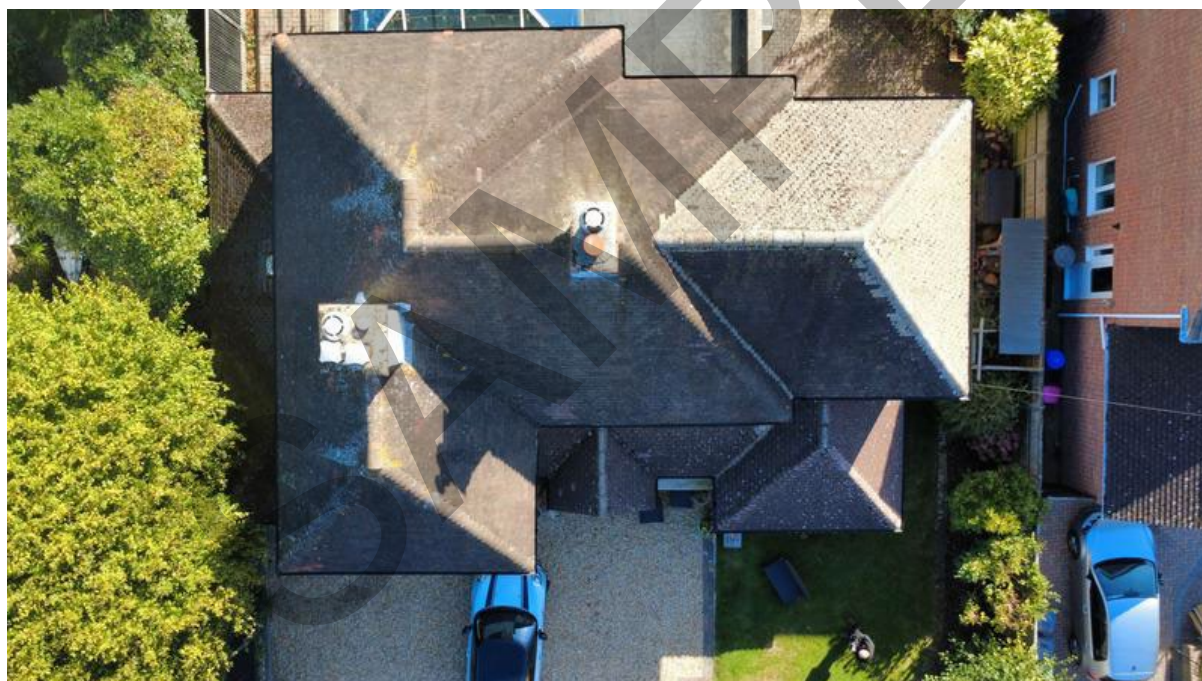
Roof overview

This element has been assigned a Condition Rating 2 due to the materials used and the standard of the repairs.

At the time of inspection, the main roof coverings were free from major defects such as deflection, damage, adjacent missing tiles. However, I have concerns regarding the quality of tiles used for the the earlier extension roof, and the quality of the repairs to the original roof.

No major repairs are currently required, however you should consider obtaining estimates for a complete overhaul of the main roof, either to budget for undertaking the work during your ownership, or so that you are prepared for the issue to be raised during a future survey should you decide to sell the property.

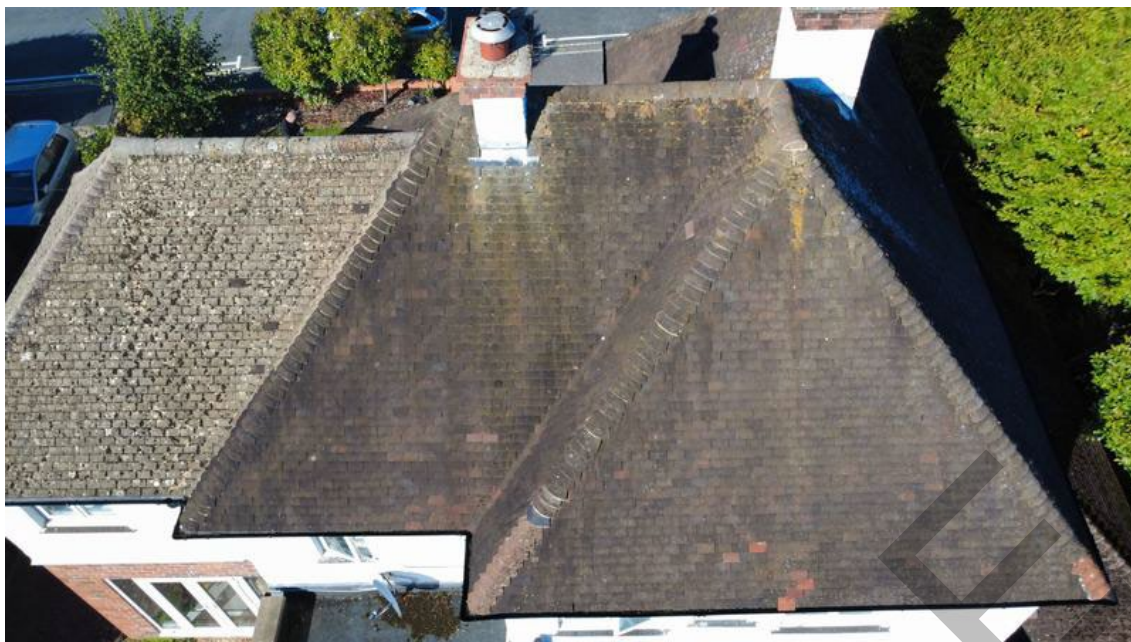
Original and extension roofs

Although weather tight at the moment, I am concerned that the roof will begin to fail during the next decade. There are timber sarking boards beneath the original tiles, indicating that they have not been

replaced since the property was built. There are isolated repairs and slipped tiles visible already, and it is likely that in the future, repairs will be required with increasing frequency. Also of concern is the apparently rapid wear of the extension tiles.

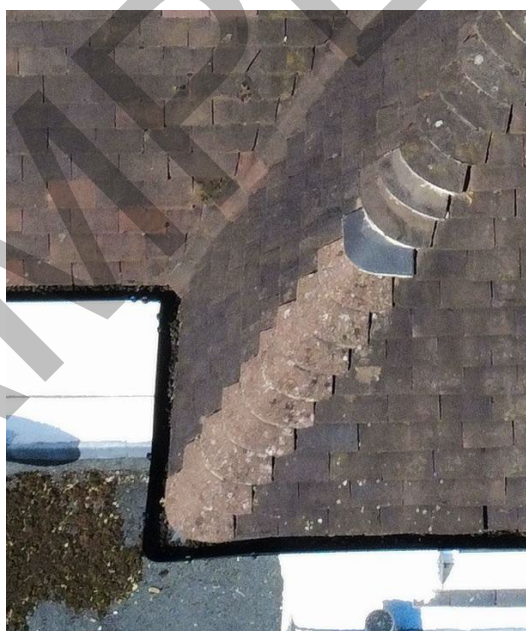
Repairs

There are repairs visible on the original roof hips that use a variety of materials.

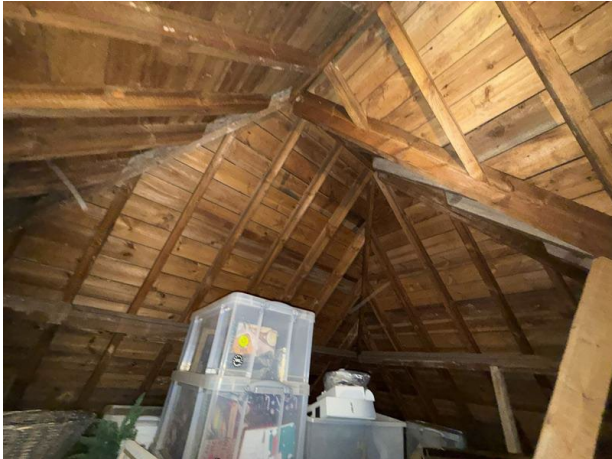
Roof Structure

The roof structure appeared to be free from significant defects.

The timbers are assumed to be of appropriate size and configuration to bear the dead and imposed loads as I noted no signs of deflection or movement.

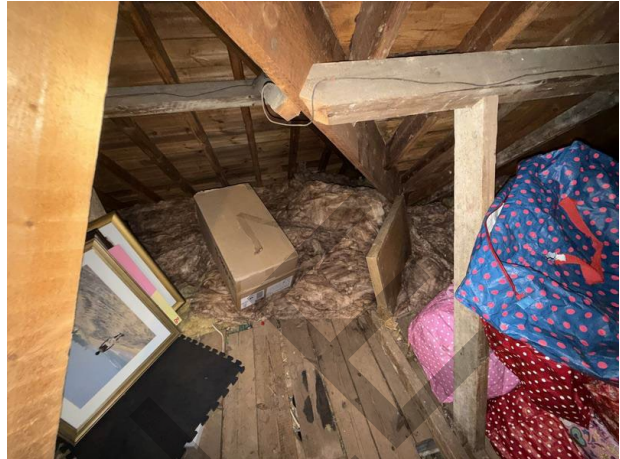
Insulation

The insulation within the roof space was seen to be in line with current regulations at a consistent depth of 270mm - 300mm. This should be maintained to at a consistent covering of the roof space as failure to do so can lead to cold bridge spots occurring which can cause condensation and mould growth to the ceilings below.

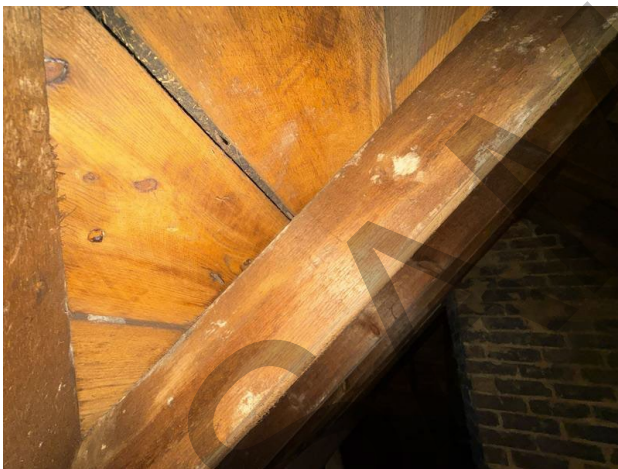
Sarking boards

A random selection of timbers were tested using a moisture conductivity meter (damp meter). I am pleased to say there was no higher than average readings obtained. Some dampness was noted to the sarking boards, however this is to be expected.

No repairs are currently required, however given the presence of timber sarking boards and limited ventilation, I recommend that you have the timber sprayed to prevent future infestations of woodworm and fungus.

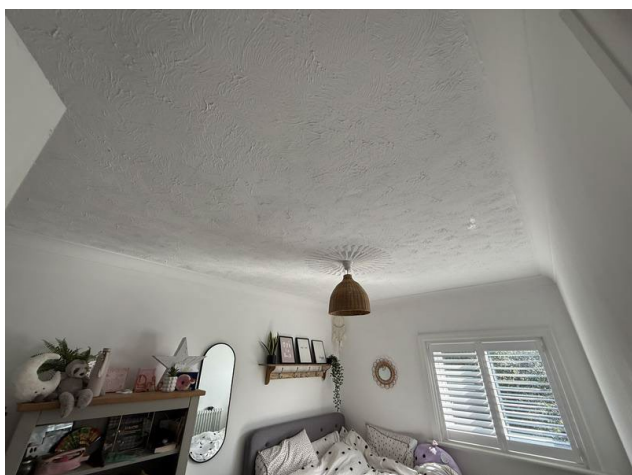
Textured ceiling

This element has been assigned a Condition Rating HS as the textured coatings may contain asbestos.

Prior to the year 2000, a common form of textured ceilings was Artex which may contain asbestos fibres. This presents a minimal risk whilst in situ and free from damage or deterioration. The ceilings should not be cut, sanded or drilled unless by a specialist contractor and then only in strict accordance with the latest HSE guidance. It would be wise to have a suitably qualified ARCA (Asbestos Removal Contractors Association) registered Asbestos contractor inspect the ceiling finish prior to carrying out any planned work or ongoing maintenance in order to advise on the safe management and/or removal and disposal of the hazardous material.

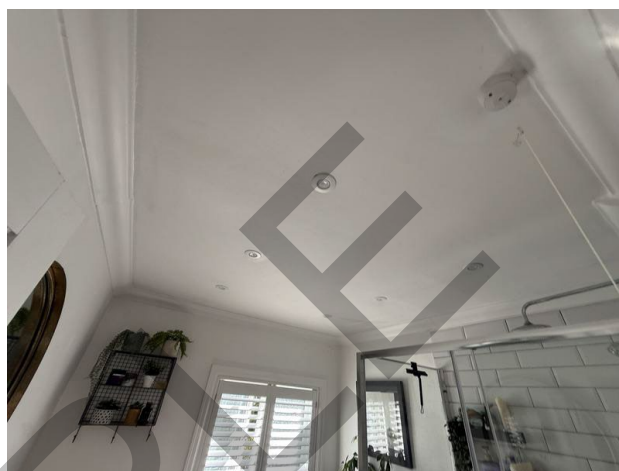
Plastered ceiling

Some minor cracks and blemishes were noted to the various ceilings, but these were not considered to be significant. Cosmetic repairs should be undertaken prior to redecoration. You have no doubt acquainted yourself of the overall standard of decoration and may wish to redecorate to your own taste in due course.
