# Damp Report

A Property

21393

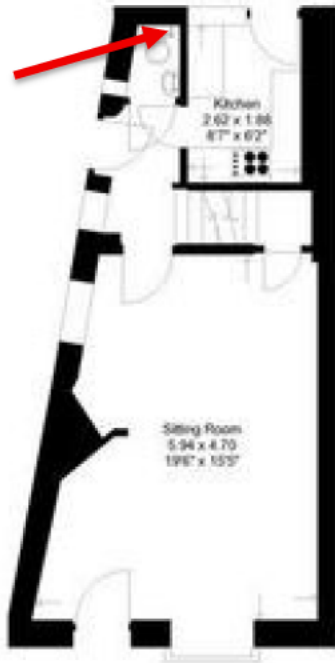
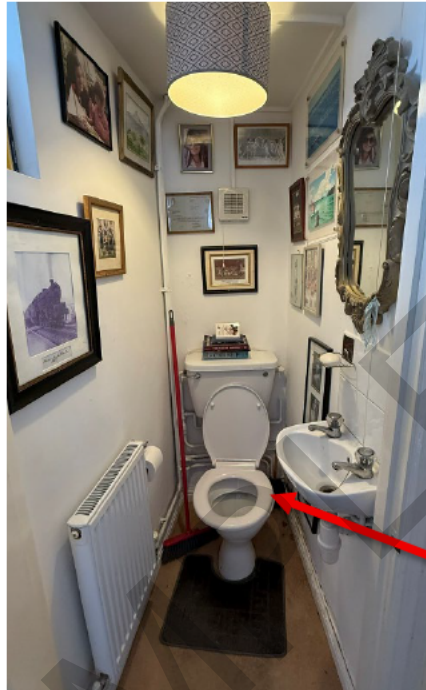
### Location 1 – Ground floor cloak room

The property was noted to be affected by damp in two locations:

**Location 1** - The dampness in the ground floor cloakroom appear to be caused by rainwater pooling in the courtyard and penetrating the base of the external wall.

In addition, the floor of the cloakroom should be stripped and replaced with laminate or vinyl, and the extractor fan should be replaced with a modern humidistat controlled model.

1. Install drainage strip along external wall, directed in to adjacent gulley
2. Remove carpet and replace with ceramic tiles, vinyl or laminate
3. Upgrade extractor fan

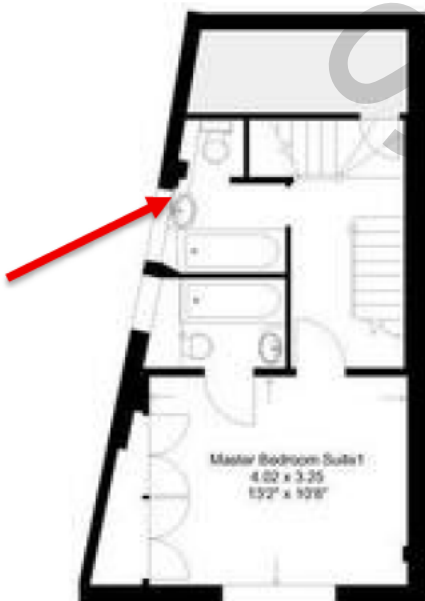
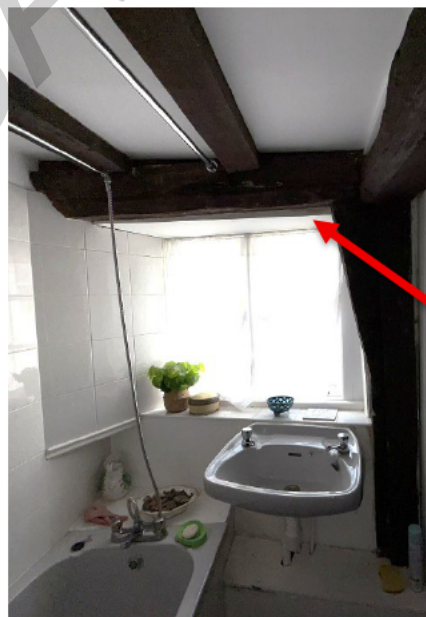
### Location 2 – First floor bathroom

**Location 2** – The brown staining suggests rainwater penetration; the most likely source is an overflowing gutter:

1. Reconfigure right section of gutter/downpipe to match left section
2. Ensure gutter is angled away from the window

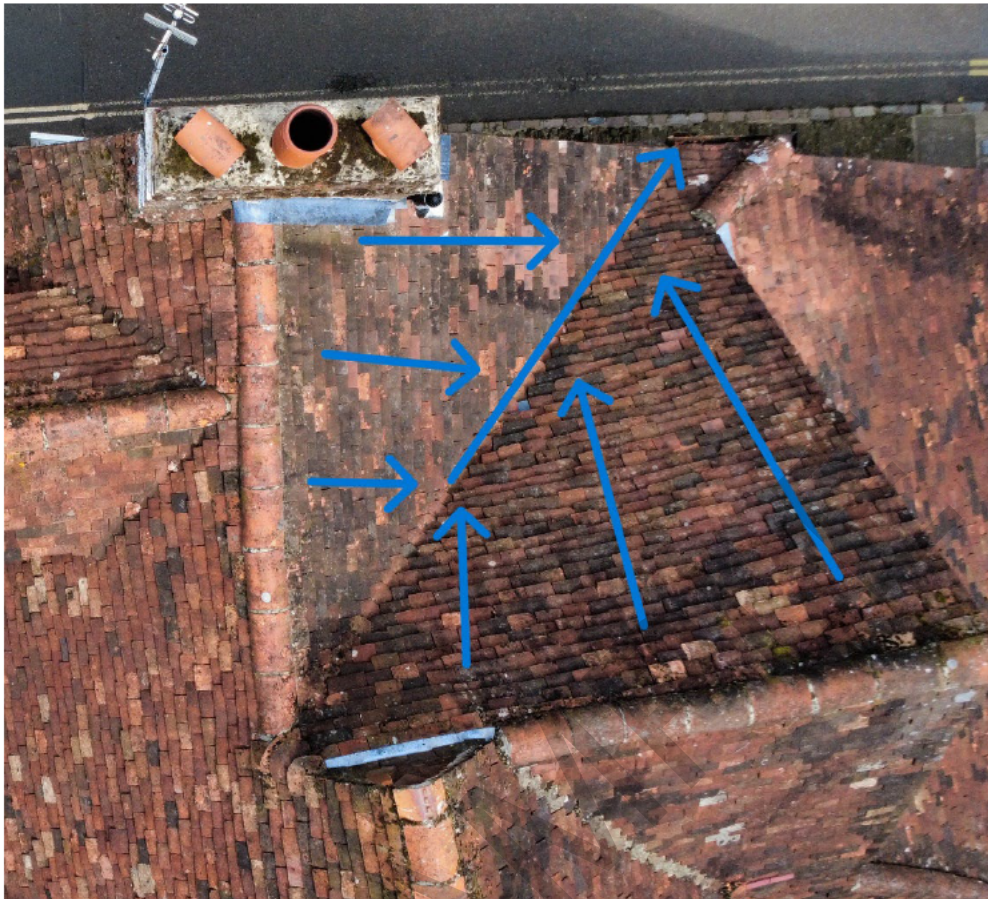
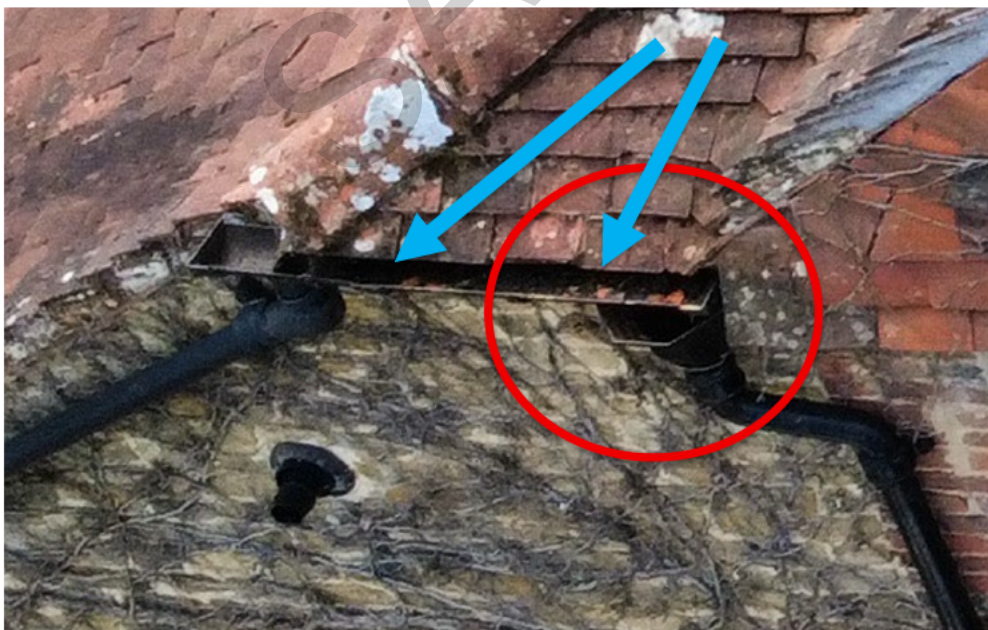
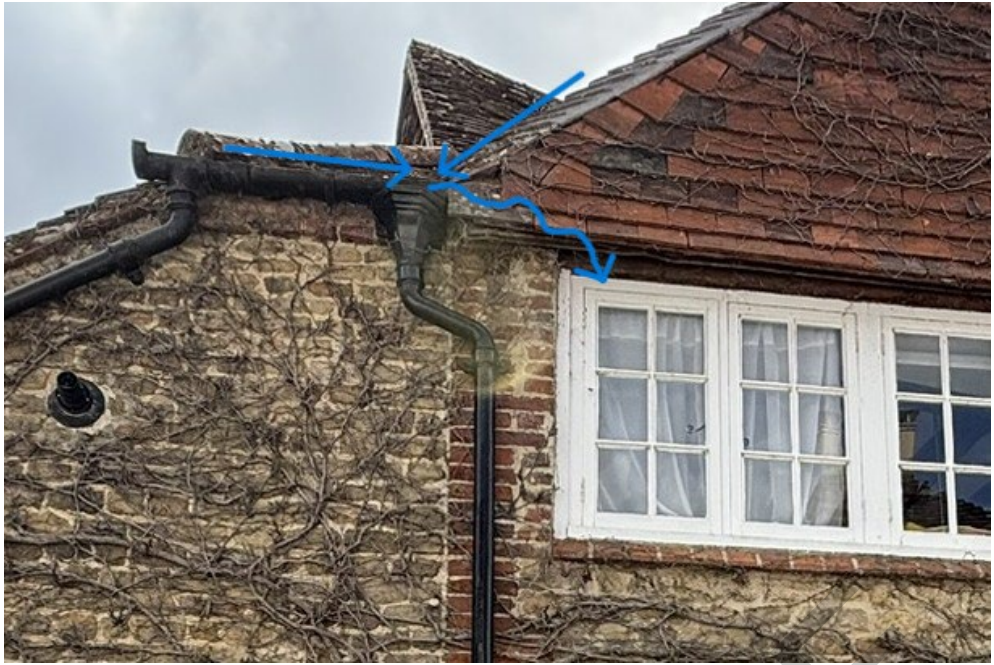
The rainfall from a large section of roof is being directed in to a short length of gutter. The left side has an elbow joint connected to a downpipe, however the right side appears to rely on overflow in to a hopper below.

I recommend the right side section is reconfigured as per the left side and that the left side of the gutter is lower than the right side to direct as much of the rainwater as possible in to the left downpipe
