KENNY RELF SURVEYORS

Sprayed Foam Installation Report

SAMPLE

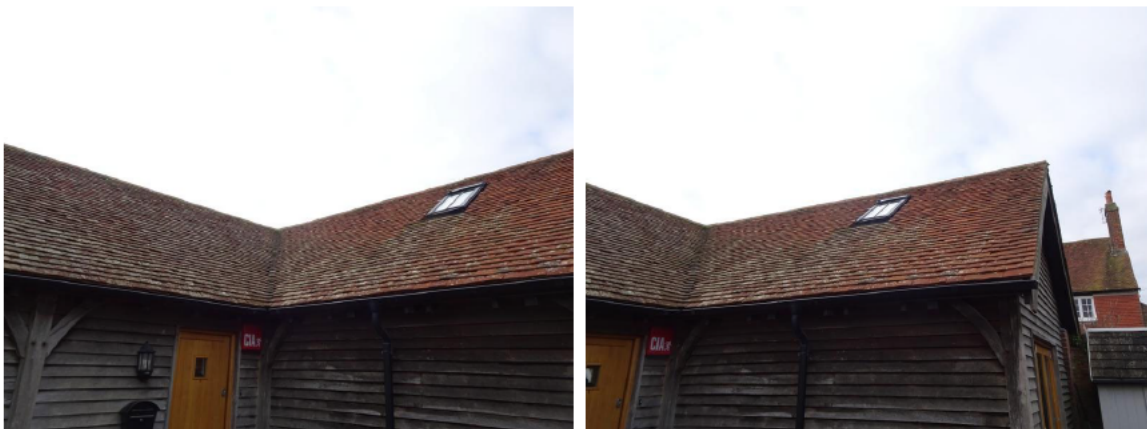
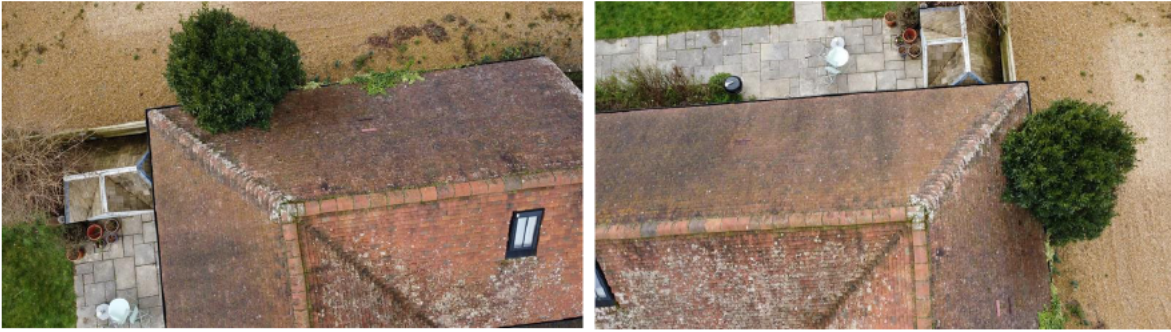
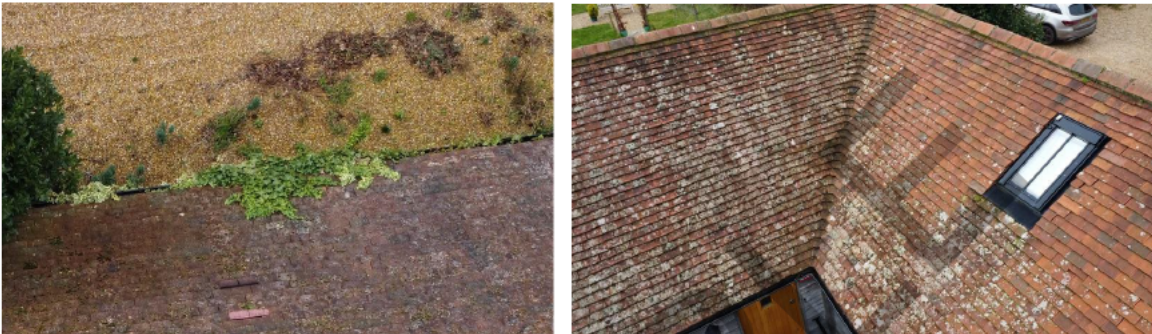
No significant defects were noted. No evidence was seen of unusual sagging or other movement which might indicate that the supporting structures are failing.

All tiles seen were in a serviceable condition with no evidence of any major failures or defects. The top line of ridge tiles was even with no evidence of any undue levels of flexing or bowing.

The mortar at the verges (side most run of tiles) was intact at the time of inspection with no evidence of any major weathering.

The rear gutters had been invaded by ivy.

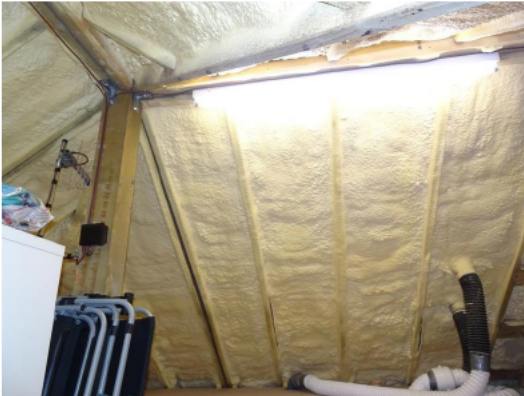
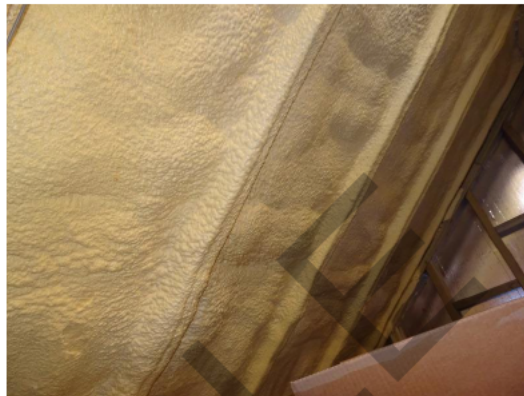
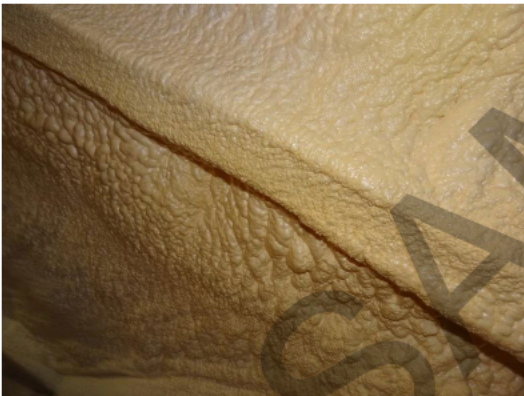
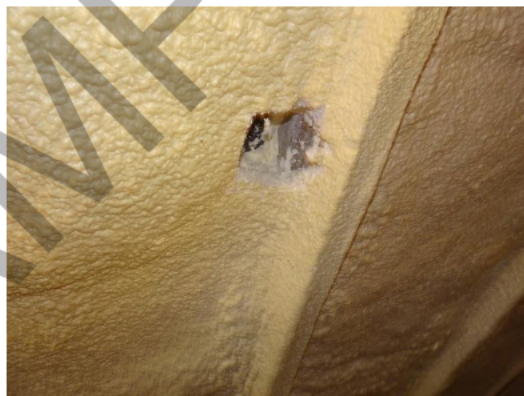
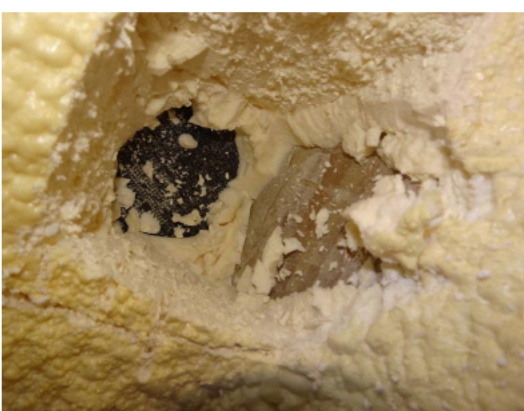
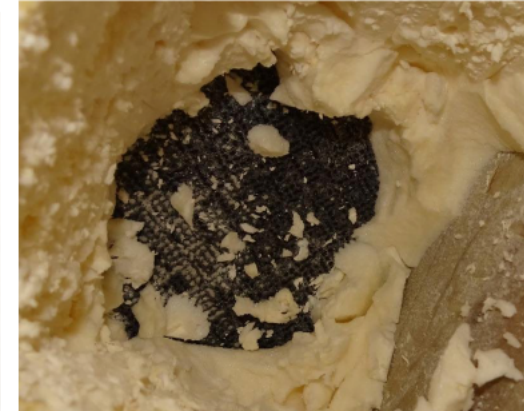
Closed cell foam was applied to the entire underside of the rafters and underfelt during the initial build. A section was removed to show a breathable underfelt and moder treated timbers. Moisture readings from the exposed timber were low. General humidity readings were low.

Although not urgent, the foam should be removed prior to marketing. Closed cell spray foam can only be removed by hand scraping, the cost for which is likely to exceed £5000.
