**Phase I Environmental Site Assessment**  
**of**  
**Lakeview Apartments**  
**1105 Edward Street**  
**Fort Valley, Georgia 31030**  
**Velocity Project #EA-25-0700**  
**Loan #506978850**

Conducted in accordance with a 06/09/25 Letter Agreement and the ASTM E 1527-21 Standard

*Inspection Date:* August 27, 2025

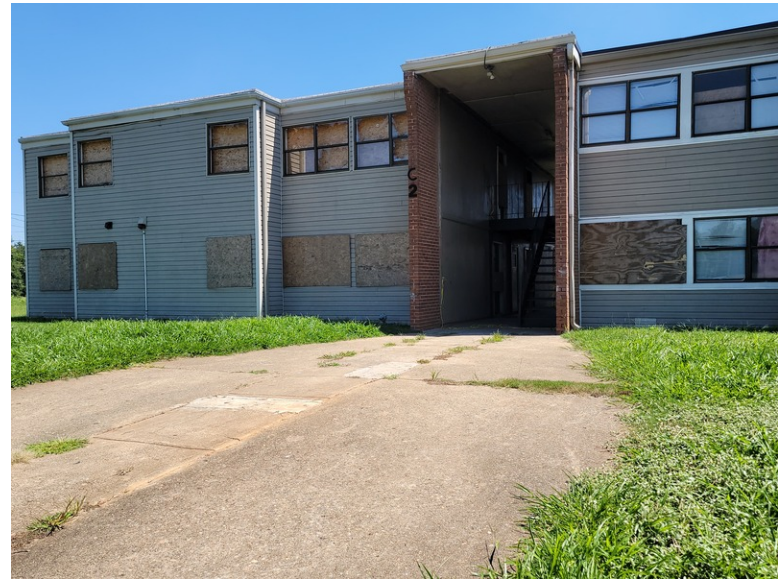
A fire occurred at the property in August 2024 that impacted the units at Building C2. Four of the units sustained extensive damage from the fire and the associated firefighting activities. These units will need to be completely demolished (none of the finishes have been removed). There is extensive mold and water damaged throughout these units.

Picture #6: Boarded up Bldg C2 due to fire damage

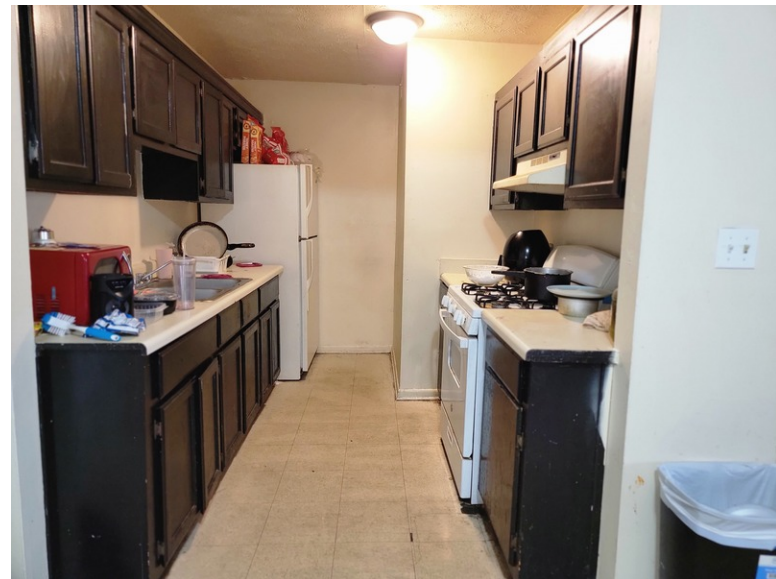
Picture #16: Non-friable vinyl floor tiles in an apartment

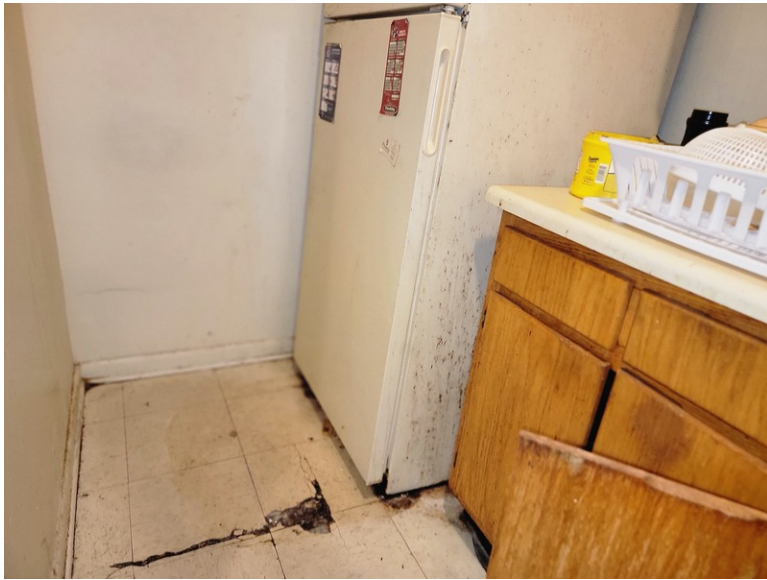
No friable suspect asbestos-containing (SAC) materials were observed in any of the areas inspected on-site. The following non-friable SAC materials were observed on-site: vinyl floor materials and mastic, plaster/drywall/joint compound, and roofing materials. The SAC materials ranged from good to poor condition. The SAC materials in the occupied units were generally in good to fair condition with some areas of localized damage. The SAC materials in the vacant and down units had many areas that were in poor condition.

Picture #17: Damaged SAC vinyl floor tiles in an occupied unit

Section 61.10(d) of the Freddie Mac Multifamily Seller/Service Guide states that non-friable SAC materials may remain in place. As per the Freddie Mac Multifamily 11/06/17 Bulletin, an Asbestos Operations and Maintenance (O&M) Program is required only if friable asbestos-containing materials remain present following the origination of a loan. Since no friable SAC materials were observed at the subject property, an Asbestos O&M Program is not required and has not been recommended.

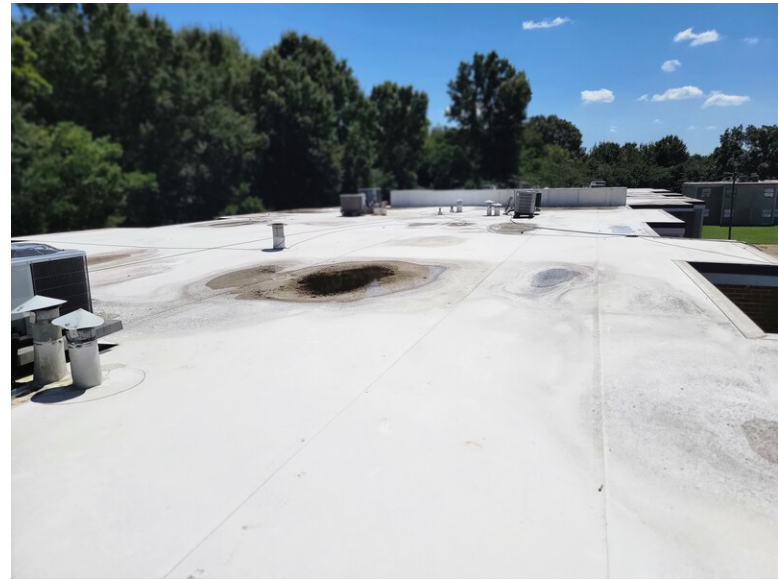
Picture #18: Non-friable SAC roofing materials

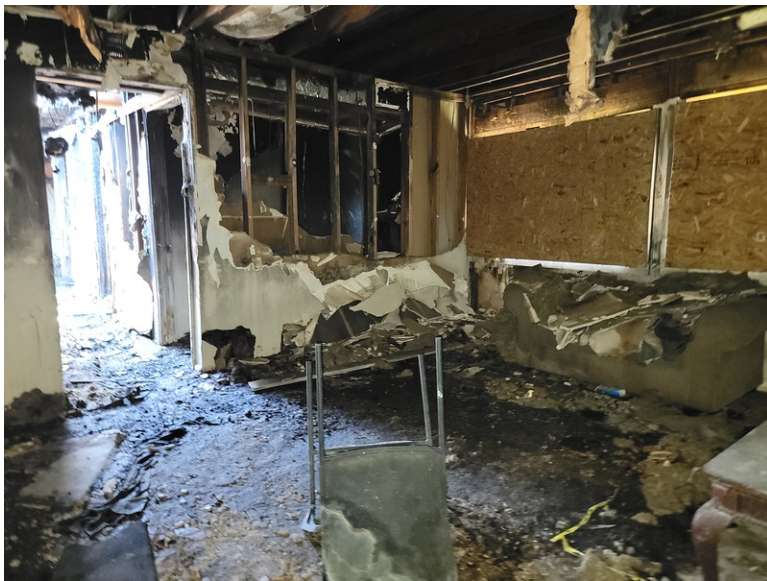
Painted surfaces throughout the inspected portions of the subject property ranged from good to poor condition. The painted surfaces in the occupied units were in good to fair condition with localized areas of damage. The damage in the occupied units is generally limited to areas of water damage or areas where the drywall has contact damage; no areas of significantly peeling paint were observed in the occupied areas. The painted surfaces in the down and vacant units ranged from good to poor condition with many areas of damaged paint from water, mold, fire, and contact damage.

Picture #19: Damaged painted surfaces in a down unit

paint from water, mold, fire, and contact damage. Given the construction date of the site improvements (1972) it is possible that subsurface layers of paint contain lead. Based on Section 61.11 of the Freddie Mac Multifamily Seller/Service Guide, the paint on-site is assumed to be lead-based paint. The areas with damaged paint in the down and vacant units will be addressed as part of the renovation activities to put these units back onto the rental market.

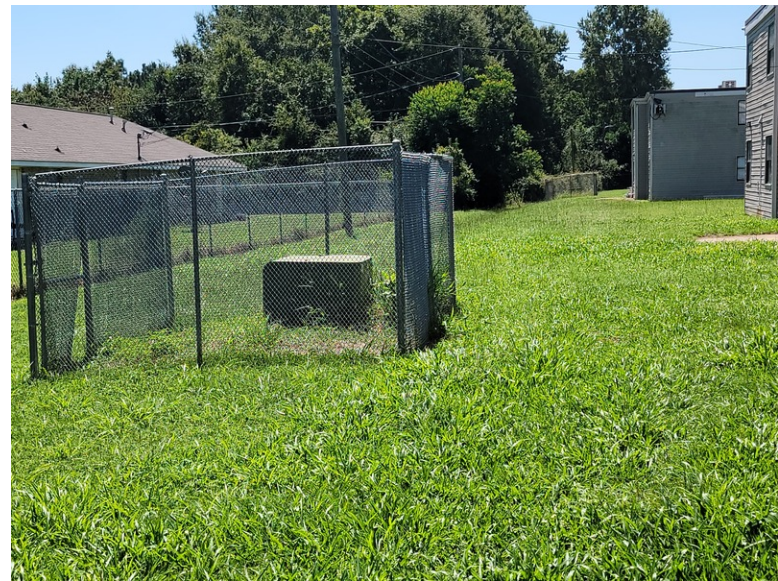
Pole-mounted transformers were observed along the property boundaries and a pad-mounted transformers were observed at the subject property. The transformers are free of visible leaks and staining. The transformers are owned and maintained by the local utility, Fort Valley Utility Commission. Typically, any maintenance, leaks or spills from the transformers are the responsibility of the utility.

Picture #20: Utility-owned transformer

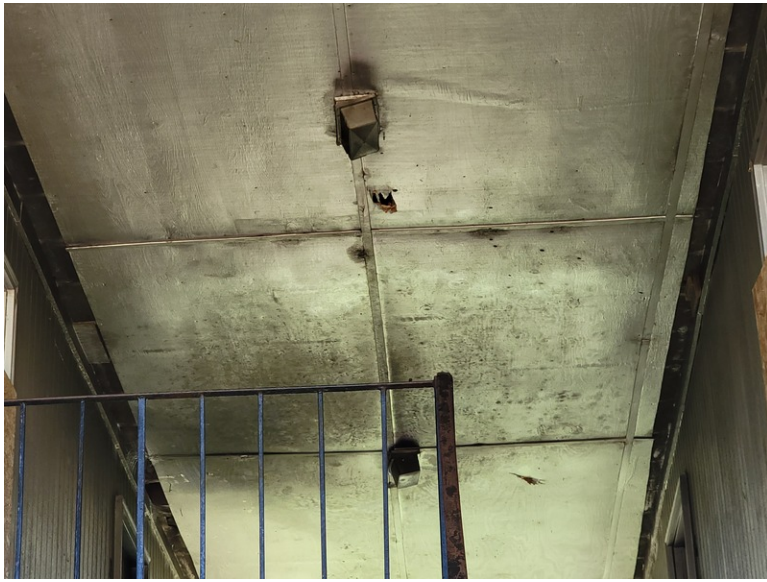
Picture #21: Mold on a breezeway soffit

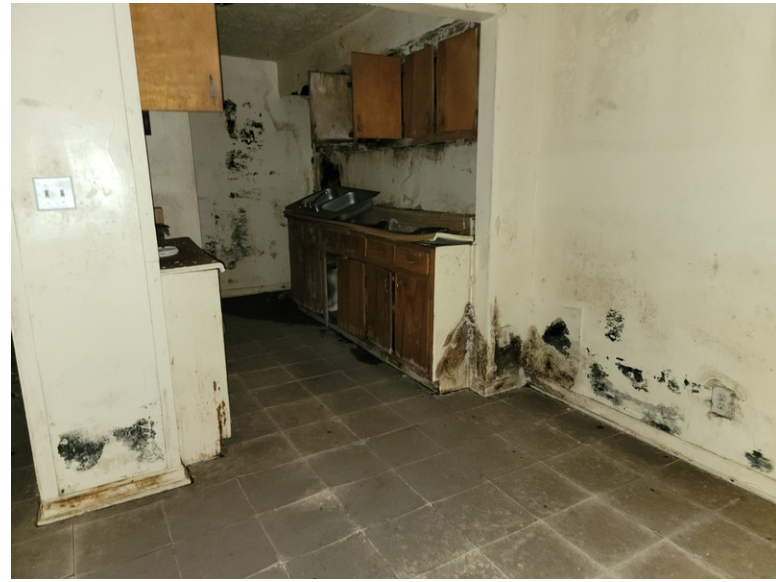
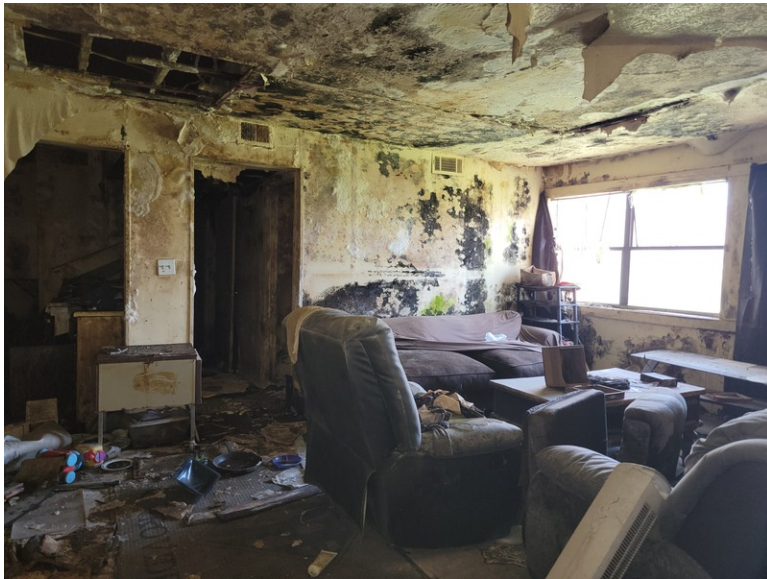
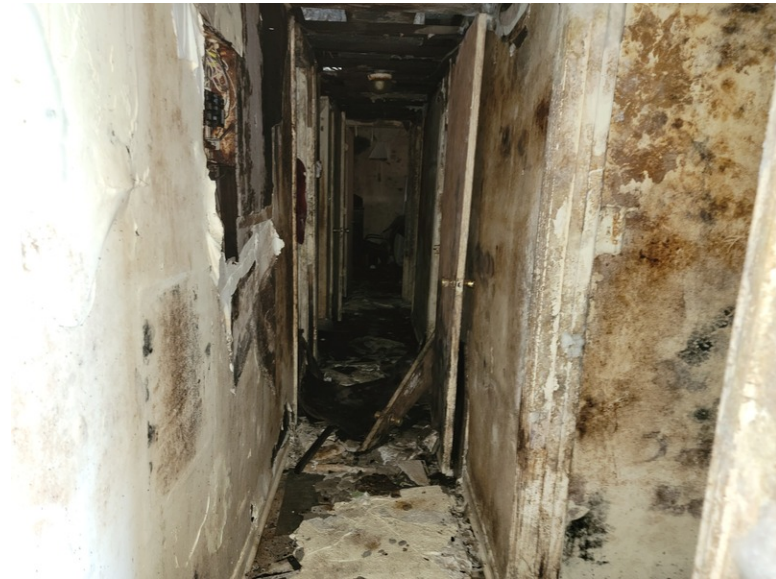
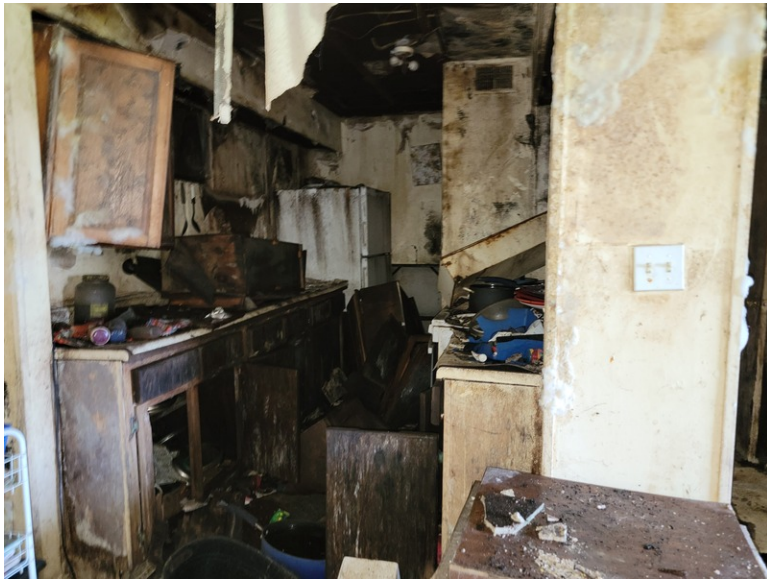
Areas of mold growth were observed in 13 of the apartments of the inspected apartments (see Section 4.9 for a list of the apartments with mold). The most extensive mold growth are in the vacant and down units, which also suffer from physical and/or fire damage. The source of the mold appears to include prior leaks, water damage, and unoccupied/humid conditions.

Picture #22: Mold growth in a down unit

Picture #23: Mold growth in a down unit

Picture #24: Mold growth in a down unit

Picture #25: Mold growth in a down unit

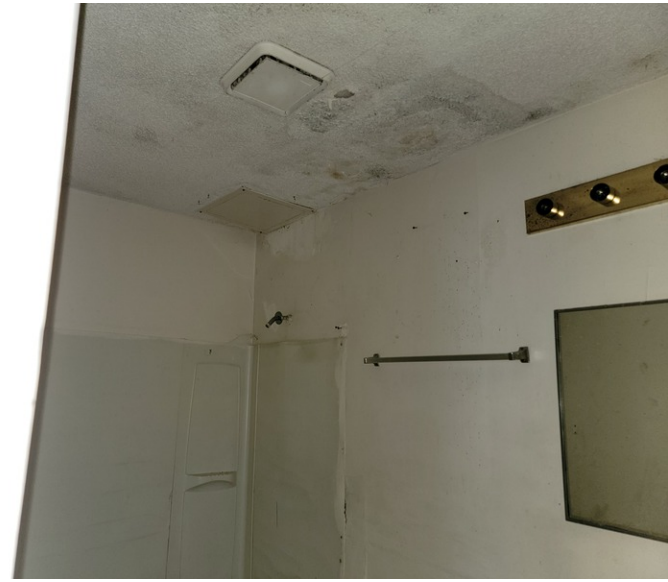
Picture #26: Mold growth in a vacant unit

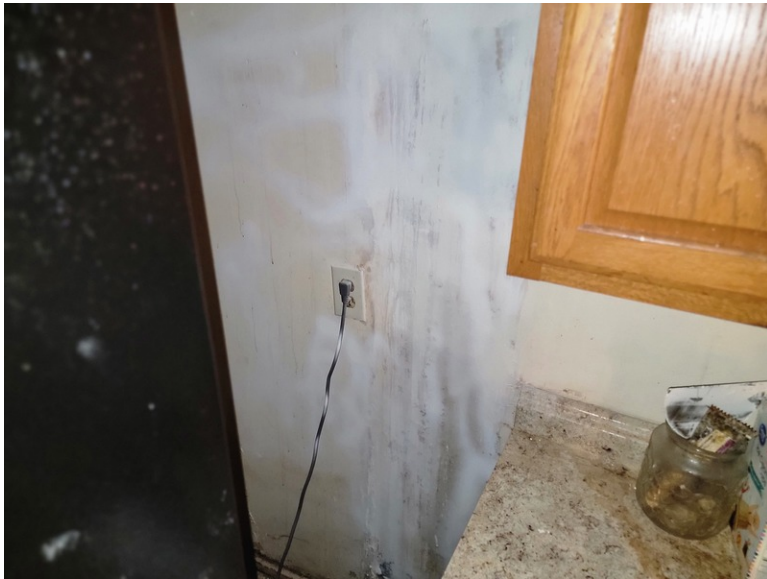
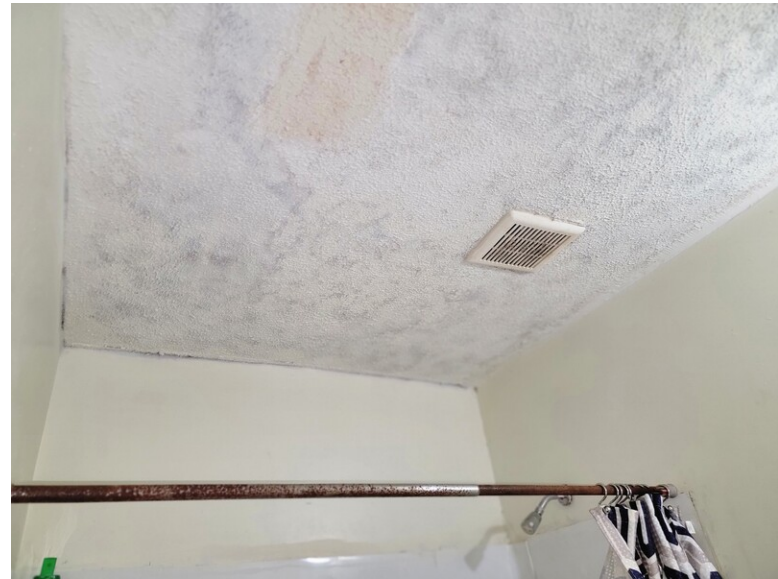
Picture #27: Mold growth in an occupied unit

Picture #28: Mold growth in an occupied unit

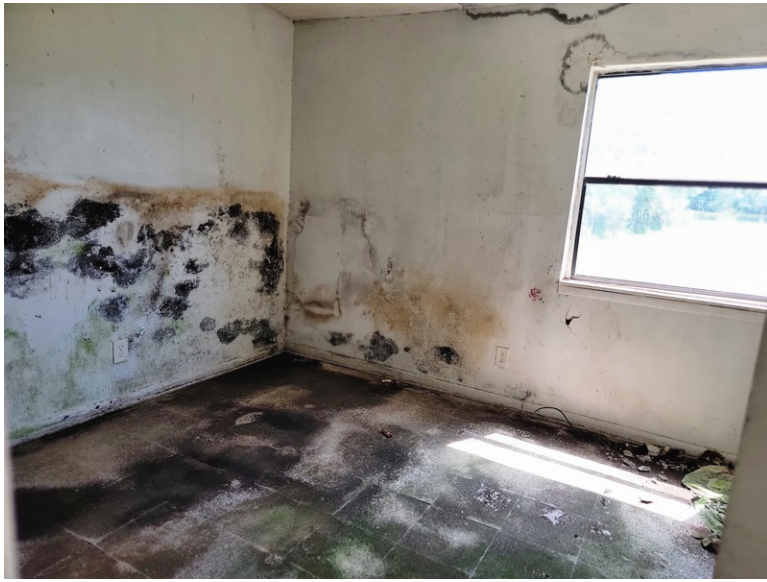
Picture #29: Mold growth in a down unit
