**Property Condition Report  
of  
Lakeview Apartments  
1105 Edward Street  
Fort Valley, Georgia 31030  
Velocity Project #PC-25-0701  
FHLMC Loan Number Loan #506978850**

*Inspection Date:* August 27, 2025  
*Draft Issue Date:* September 15, 2025  
*Final Issue Date:* September 19, 2025

**Lakeview Apartments**  
**1105 Edward Street**  
**Fort Valley, Georgia 31030**  
**Velocity Project # PC-25-0701**

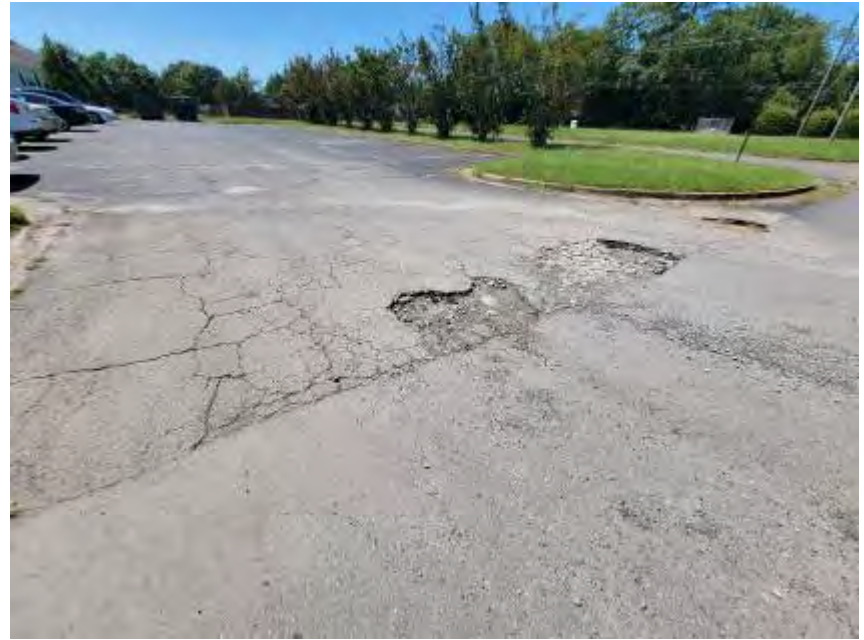
Picture #2: Potholes and damage on asphalt pavement

In any case, over the expected service life of the pavement, the cumulative costs for the spot-type repairs and re-surfacing will likely surpass or equal the cost of re-surfacing the entire lot had all paved areas been re-surfaced in their entirety at one time. If this approach is continued, patching and overlays can be expected as an annual, chronic operational condition. A new 1-½” to 2” (whatever is appropriate for the existing base and sub-base conditions) asphalt overlay is recommended to be laid over all of the paved surfaces. A two-coat emulsion slurry process is recommended after repaving and repairs have been completed on the remaining paved surfaces. This would extend the life of the paving provided that it is continued every 5 years or so. A properly applied slurry coat should prevent water from seeping through the asphalt surface to the base material, and future depressions and cracking would be minimized. Once repaved and slurry coated, the parking lots and drives should be restriped. Funds have been included in the Immediate Needs.

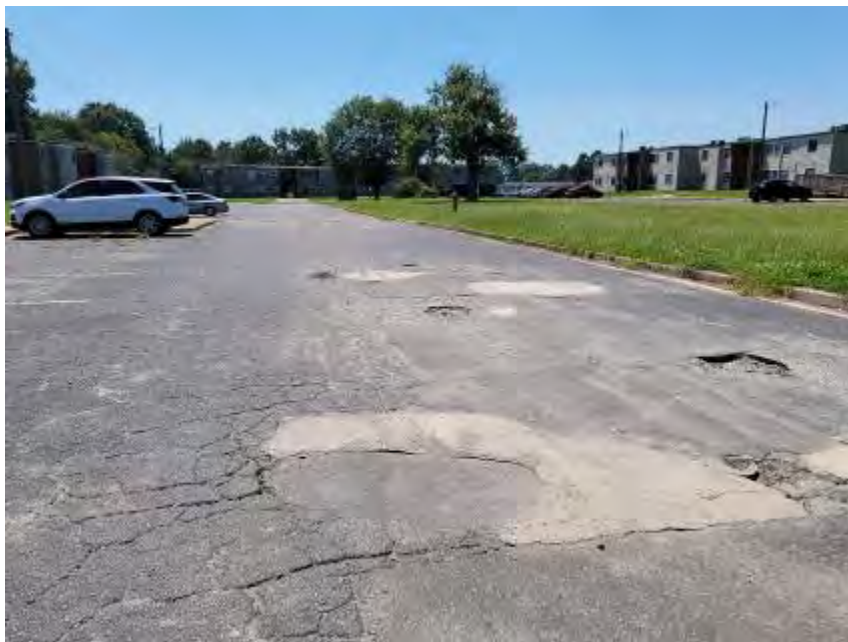
Picture #3: Potholes and damage on asphalt pavement

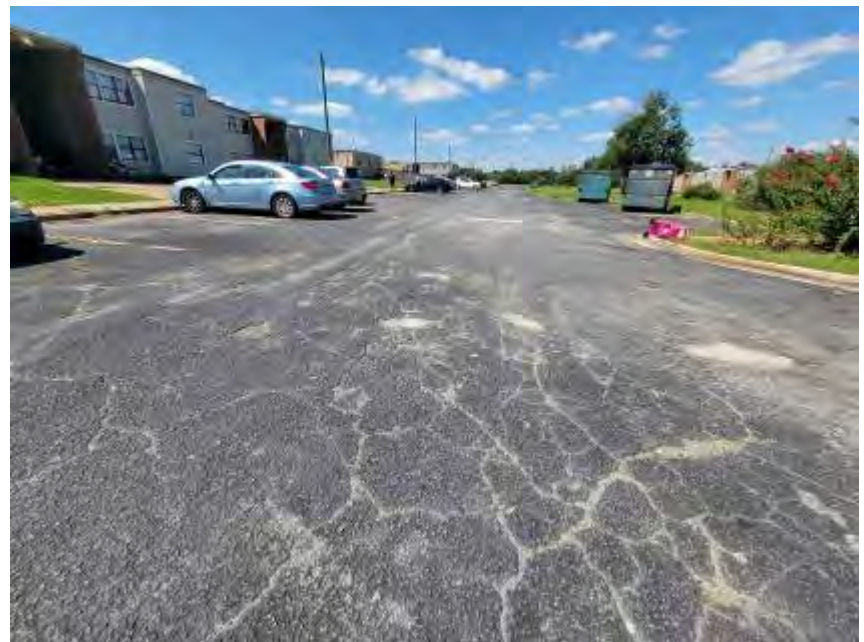
The dumpsters were observed to rest directly on the asphalt pavement. There is a concrete pad at the property; however, the dumpsters are not placed on the pad which helps to absorb damaging movement and loads. Since pavement damage commonly occurs from this condition, we recommend that management advise the waste contractor to place the dumpsters on the concrete pad. Trash including tires are placed adjacent to the dumpsters. The property should contact an appropriate waste hauler to remove the tires and other trash.

Picture #4: Asphalt-paved parking lot – note the trash dumpsters

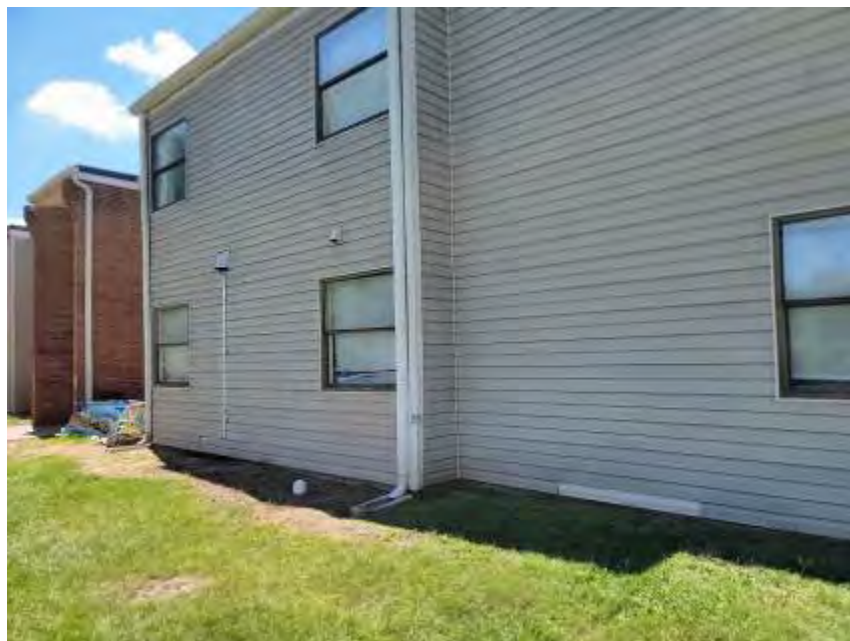
Sections of the gutters were noted to be damaged, sagging, leaking, and sections appear to overflow onto the sidewall surface. Excessive leakage onto sidewall surfaces has caused scouring. It was evident that this condition has been ongoing for an extended period of time.

Picture #11: A typical building façade and gutter and leaders

Repairs to the gutters and leaders should be completed and funds have been included Immediate Needs. We recommend bi-annual inspections and the inspections should ensure that the strainers are not clogged with debris or missing.

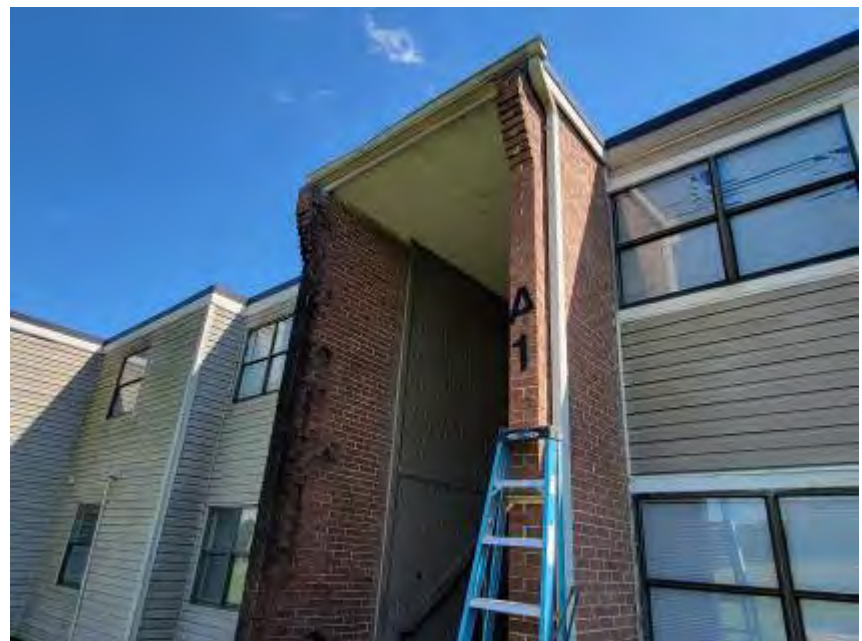
Picture #12: A typical breezeway entrance – note the staining on the walls (likely from leaking gutters)

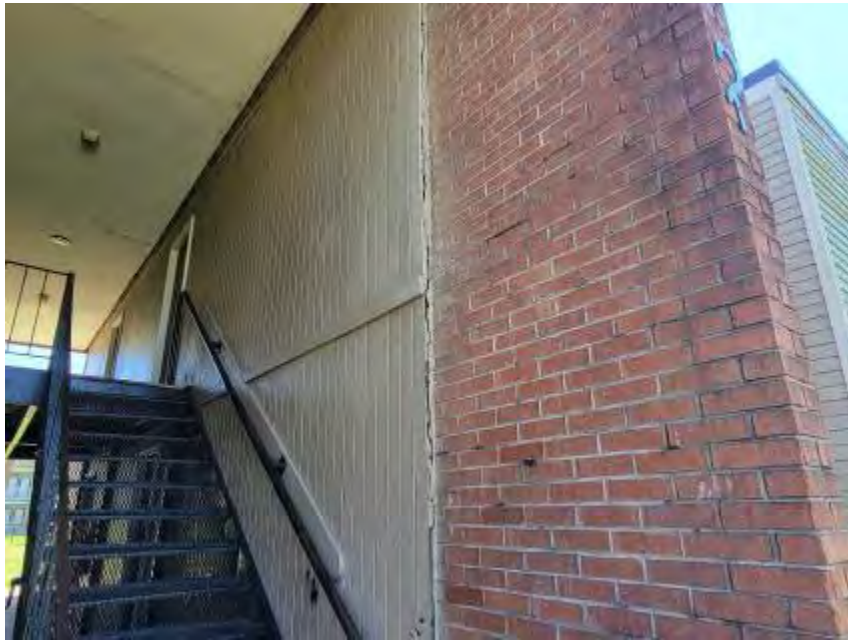
- Worn/damaged paint, cracks, damaged finishes, and water staining were noted throughout the breezeway decks.
- Damaged and worn paint on railings and handrails.
- Broken, spalled, and stained brick.
- Graffiti and staining on the walls.
- Loose and damaged siding including on the burned building.
- Open caulking joints including a section that appears to have been pulled away (Building A2).
- Damage and delamination (primarily along the base of the buildings) of the T1-11 siding.

Picture #13: Siding that has open joint

An allowance has been included in the Immediate Needs for the necessary repairs.

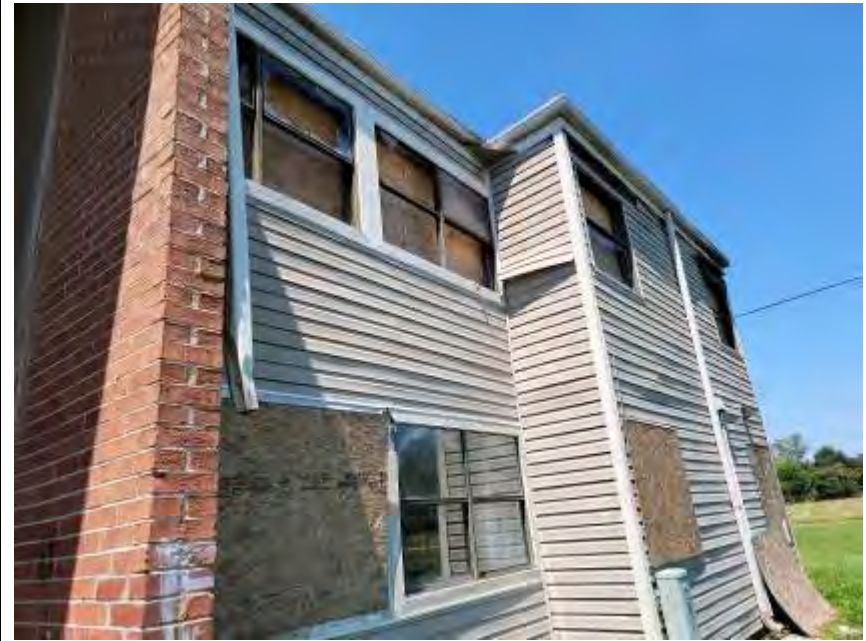
Picture #14: Fire damaged building

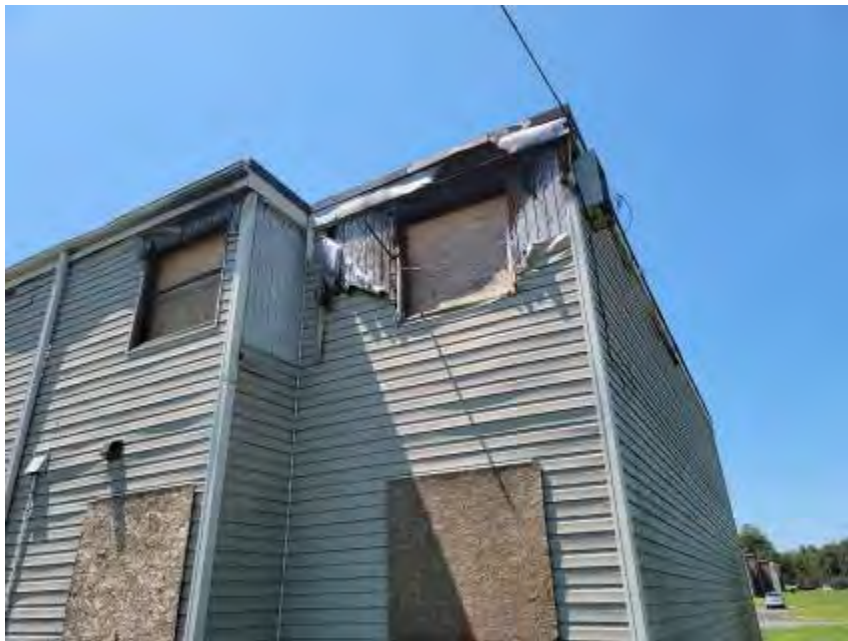
Picture #15: Damaged siding due to fire

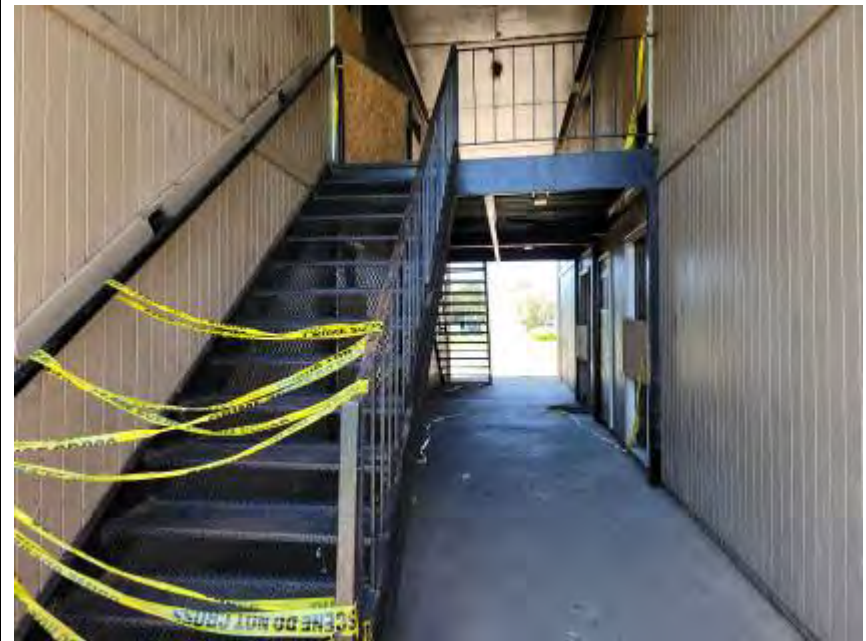
Picture #16: Breezeway and stairs (fire damaged building).

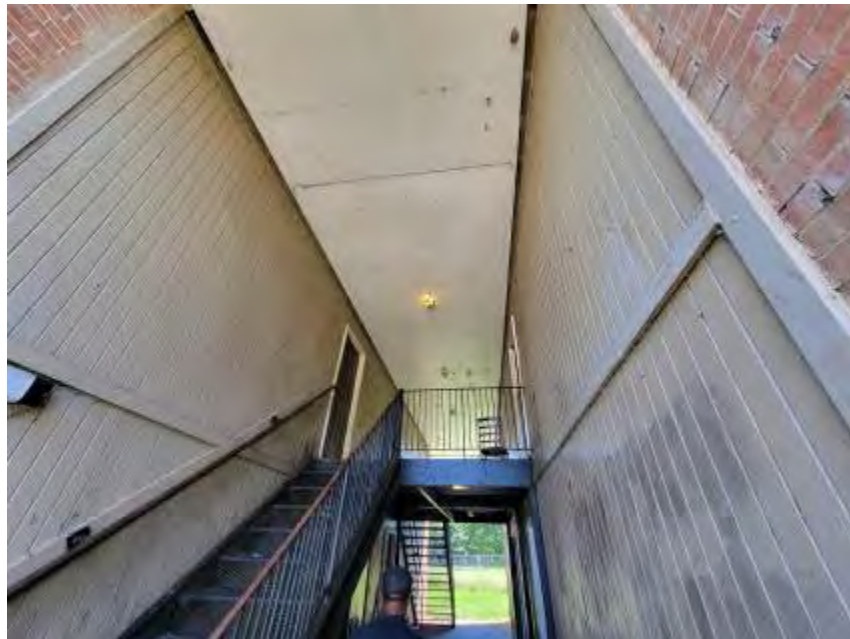
Picture #17: Graffiti that has not been properly removed – note the peeling paint on the railings

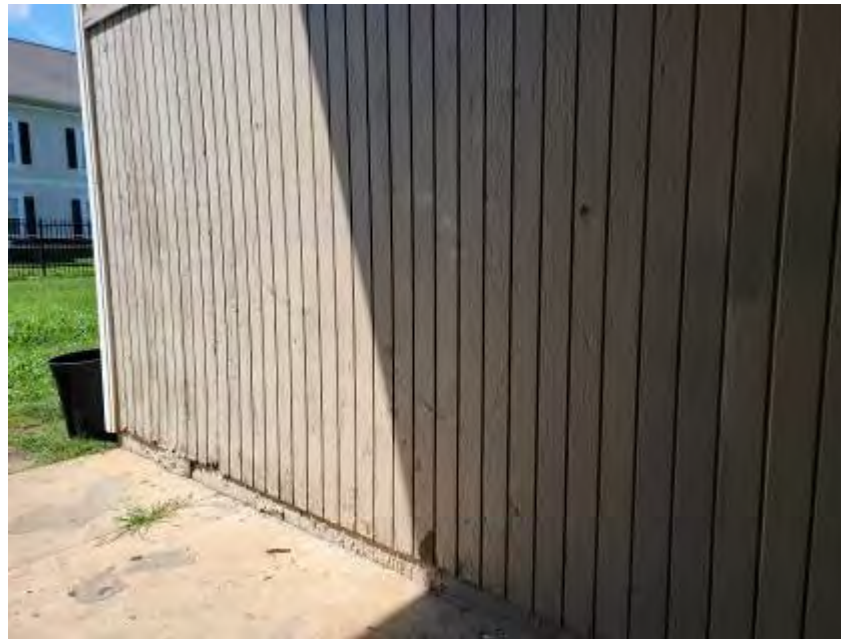
Picture #18: Damaged T1-11 siding

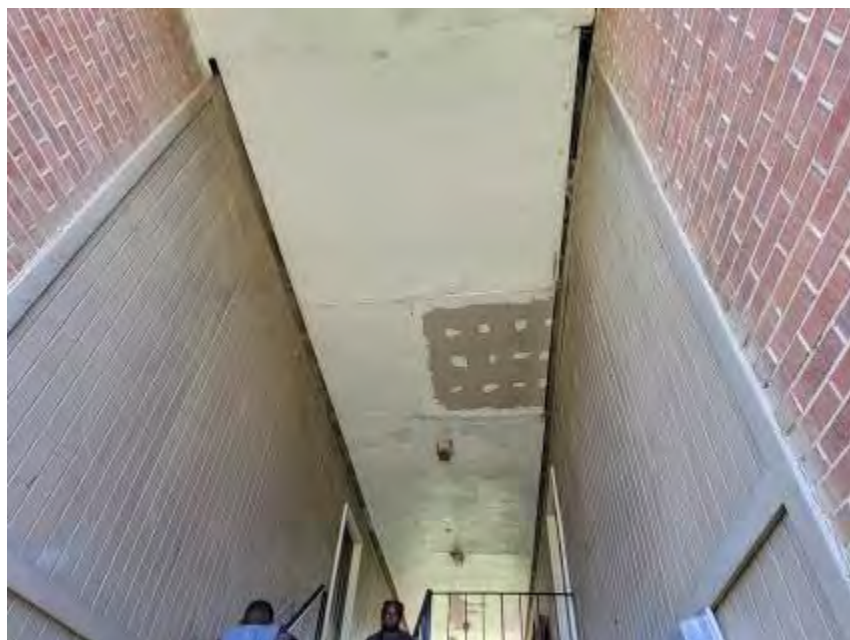
Picture #19: Patch repairs on soffits

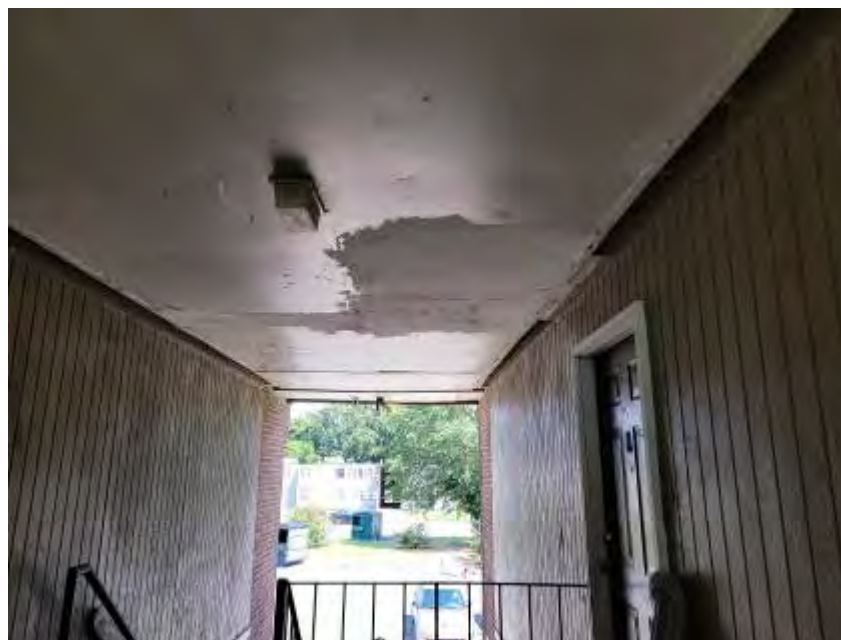
Picture #20: Damaged soffit in breezeways

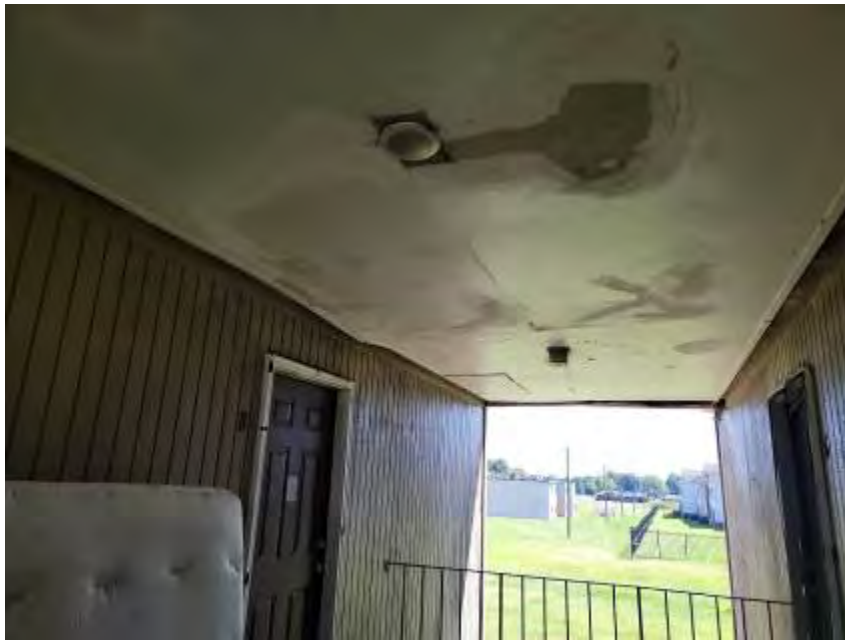
Picture #21: Damaged soffits in breezeways

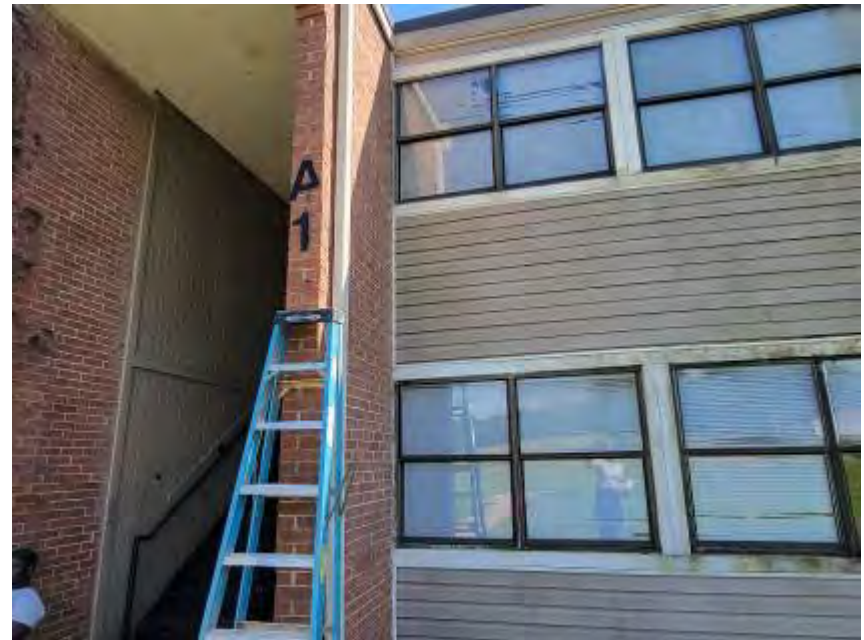
Picture #22: Mildew staining on the windows and facades

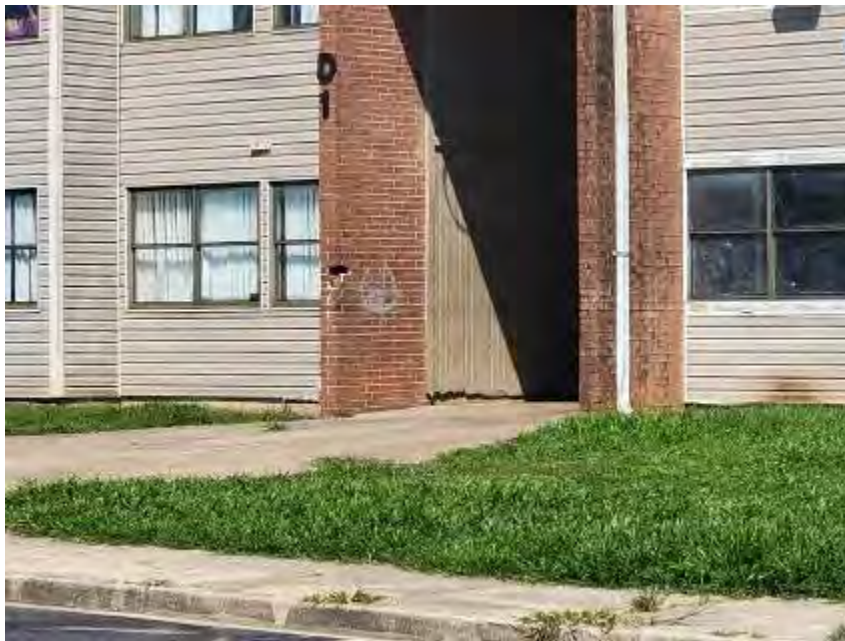
Picture #23: Damaged brick and graffiti – note the staining on the walls

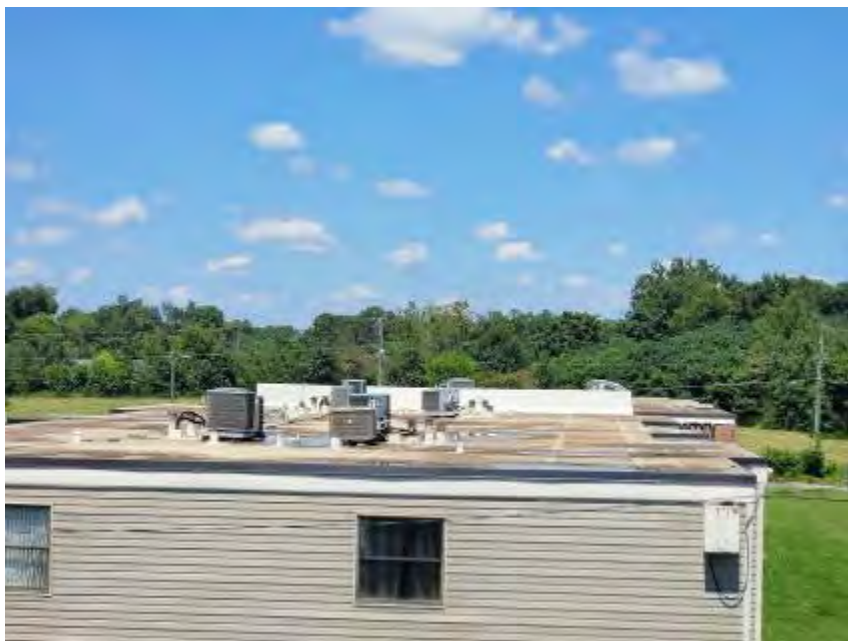
There are cannibalized condenser units and other debris noted on the roof surfaces. All debris should be removed and the roof surfaces cleaned. This can be completed in conjunction with the repairs discussed above.

Picture #27: A typical roof – note the condenser units

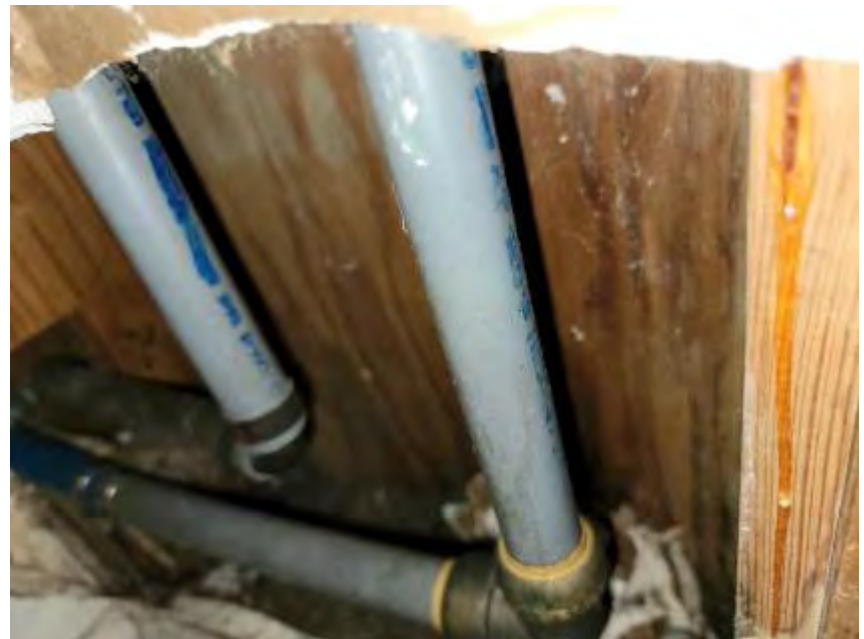
Picture #32: PB piping

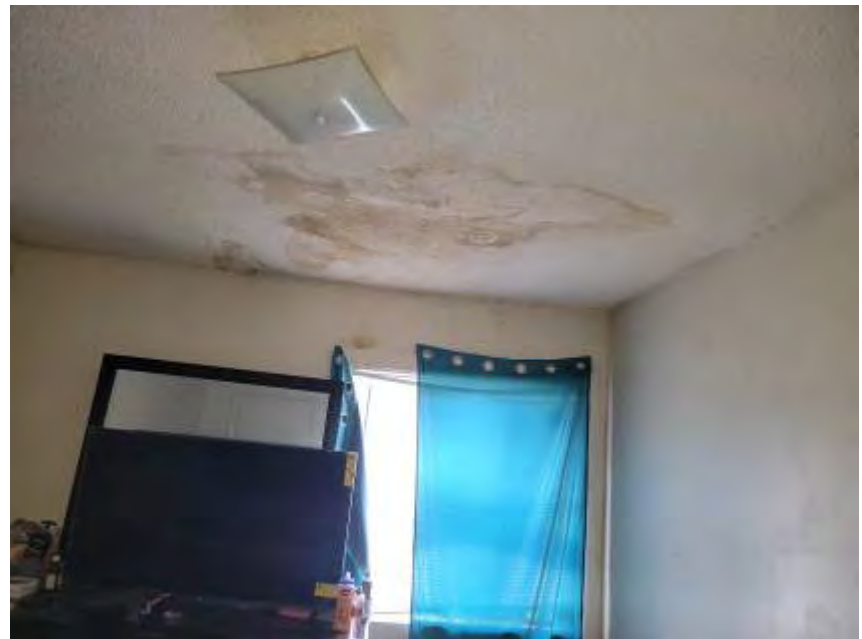
An active roof leak was observed at Unit F2-8 at the time of the site inspection. Refer above for further discussion.

Picture #52: Unit F2-8 – likley an active roof leak

Based on a review of online historical aerial photographs, the roofs were replaced between 2020 and 2022. Patch-type repairs were noted on several sections of the roofs. Mr. Azizuddin indicated that he has addressed several recent roof leaks, primarily around the roofing penetrations. An active roof leak was identified in Unit F2-8 at the time of the site inspection. Velocity recommends that all roofing penetrations and roofs be inspected to ensure that there are no open seams or avenues for potential leaks. An allowance has been included in the Immediate Needs to inspect all of the roofs, address any leaks, and properly flash the chimneys and penetrations.
