202501674
December 23, 2025

Property Condition Assessment (ASTM E 2018-24)

Motel 6
236 N Dixie Hwy
South Bend, Indiana 46637

Prepared By:
NV5
4580 Stephen Circle, Suite 300
Canton, Ohio 44718
800.787.8397

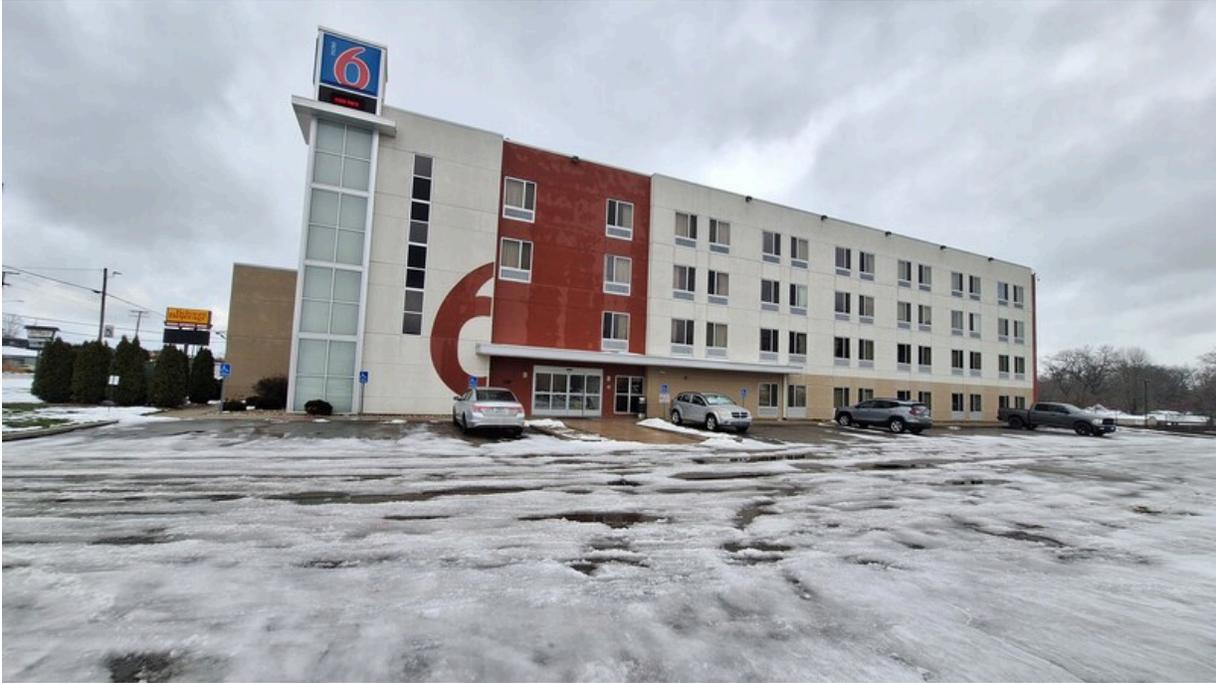
Asphalt areas

Asphalt parking areas typically have an EUL of 20 to 25 years depending on the level of maintenance, traffic and weather conditions. The EUL can be extended significantly with periodic sealing of these surfaces. NV5 has included an opinion of cost for periodic sealing and striping of the parking areas in the Replacement Reserve Schedule. In addition, an opinion of cost for milling/overlaying of **15% to 20%** of the most heavily worn or trafficked areas during the loan term are accounted for in the Replacement Reserve Schedule.

Cost Recommendation	EUL	EFF AGE	RUL	Year	Cost
Asphalt Pavement - crack seal, seal coat, restripe	-	-	-	2	\$25,200
				7	\$25,200
Asphalt pavement - mill/overlay	-	-	-	3	\$12,500
				8	\$12,500
Total					\$75,400

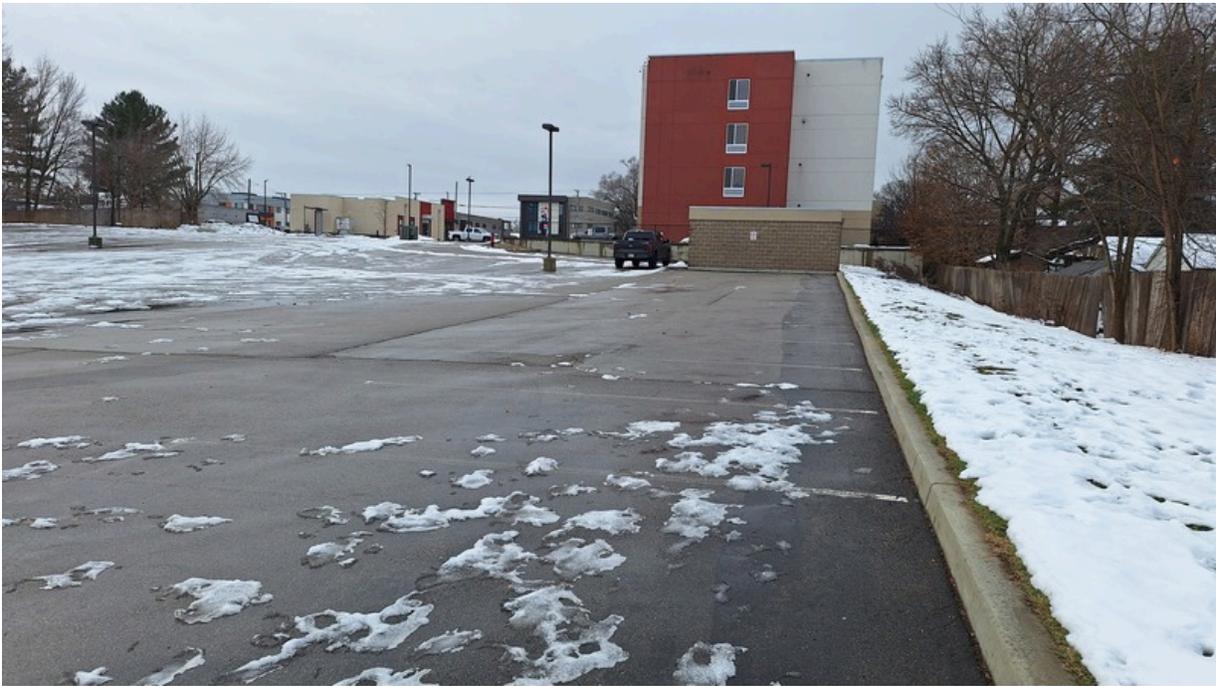
Asphalt areas

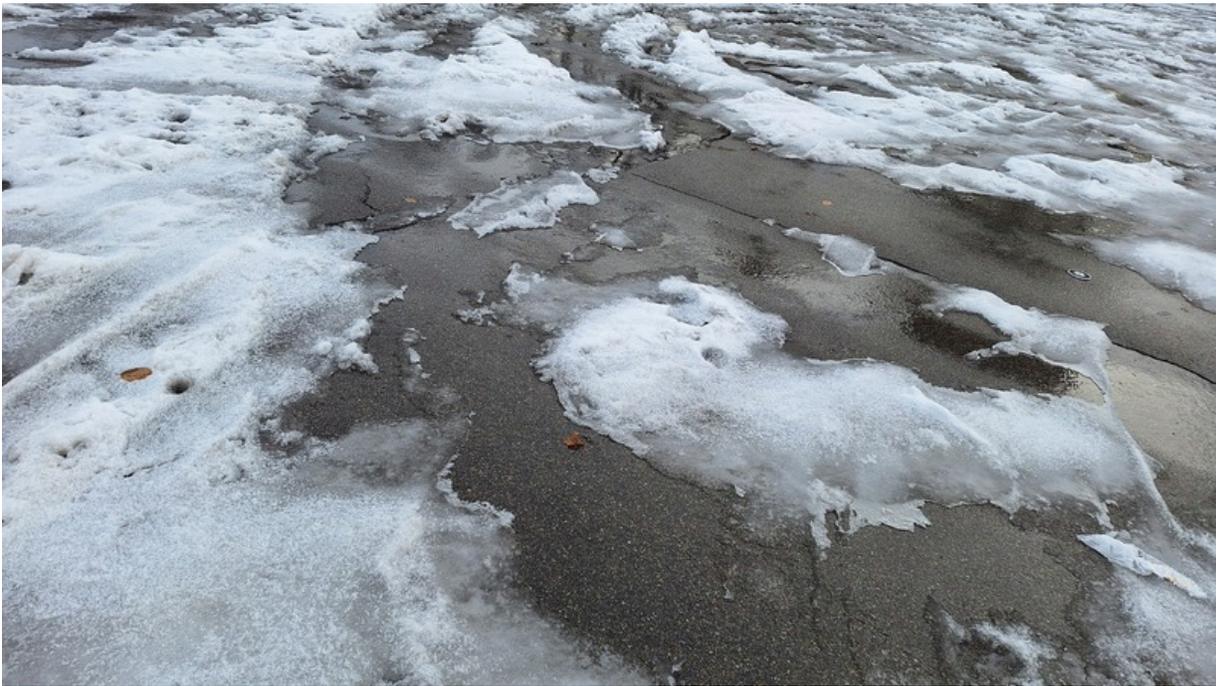
Asphalt areas

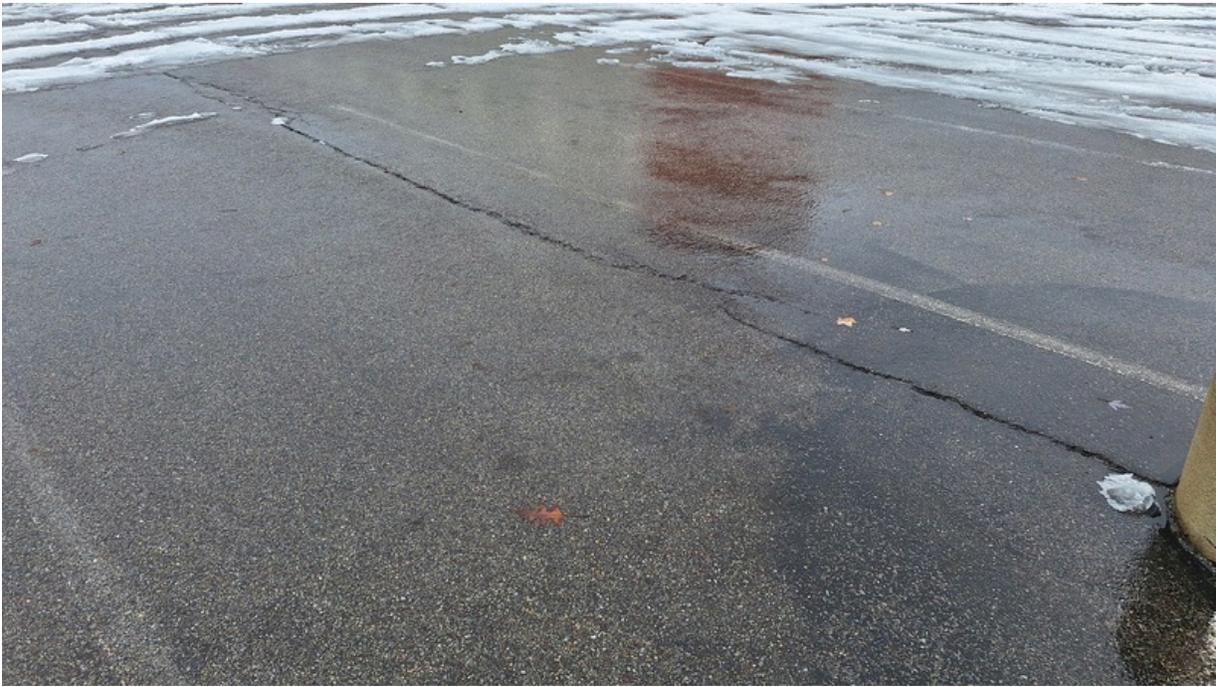
Asphalt areas

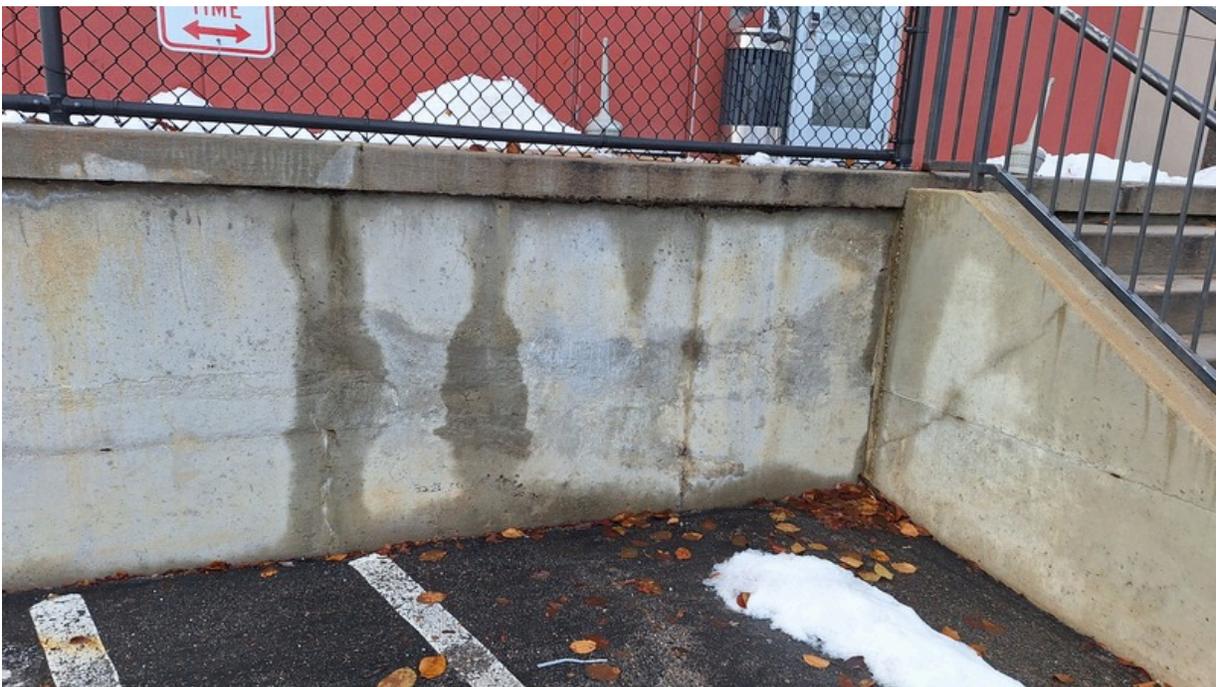
Retaining wall

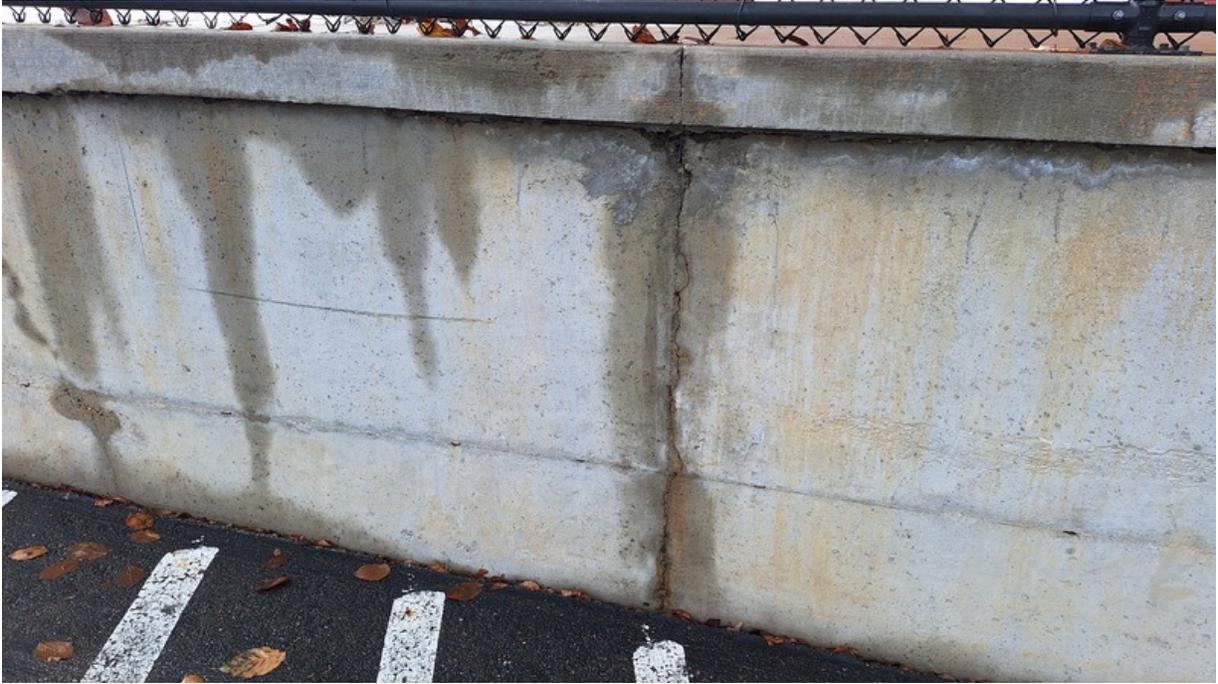
Overgrown or dead landscaping:	No significant areas of overgrown landscaping were noted.
Damaged fences/ retaining walls/signs:	No damaged walls, fences or signs were noted. However, several fissures were observed in the retaining wall.
Inadequate/broken property lighting:	No significant concerns relating to inadequate or non-functional property lighting were noted.
Other:	No other concerns were noted or reported.

Retaining wall - note fissures

The retaining wall should be repaired. NV5 has included an opinion of cost for retaining wall repairs in the short term.

Cost Recommendation	EUL	EFF AGE	RUL	Year	Cost
Locally Repair Concrete retaining wall	-	-	-	Short Term	\$2,000
Total					\$2,000

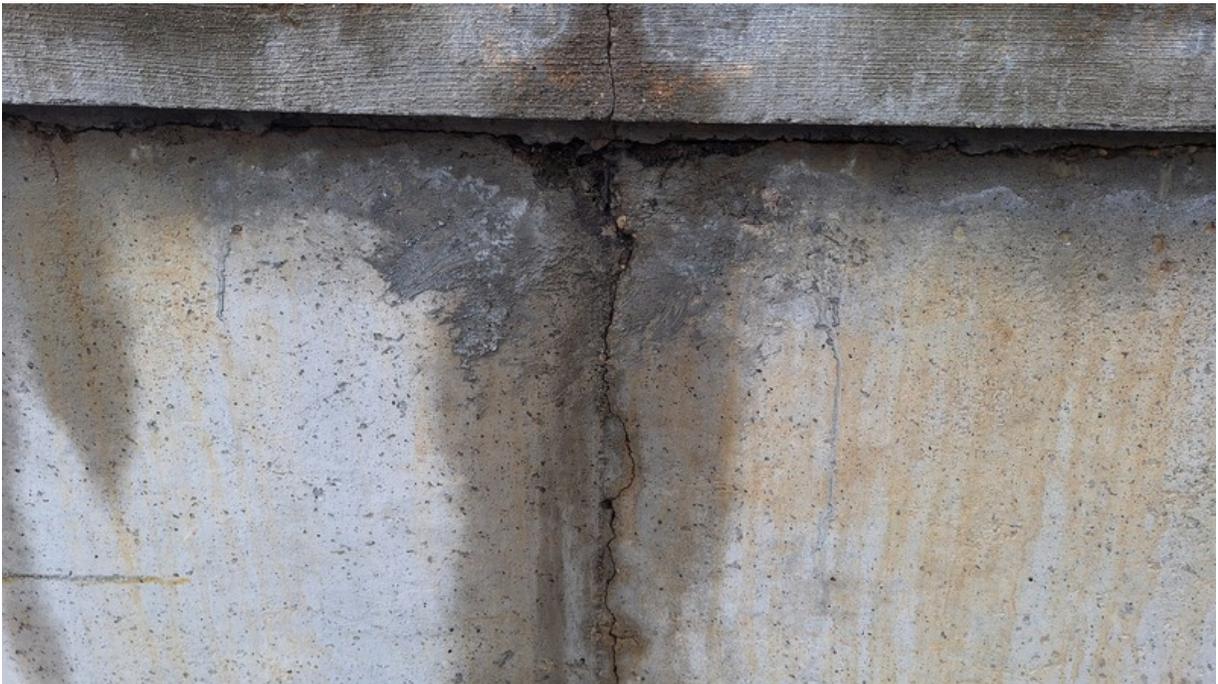
Retaining wall - note fissures

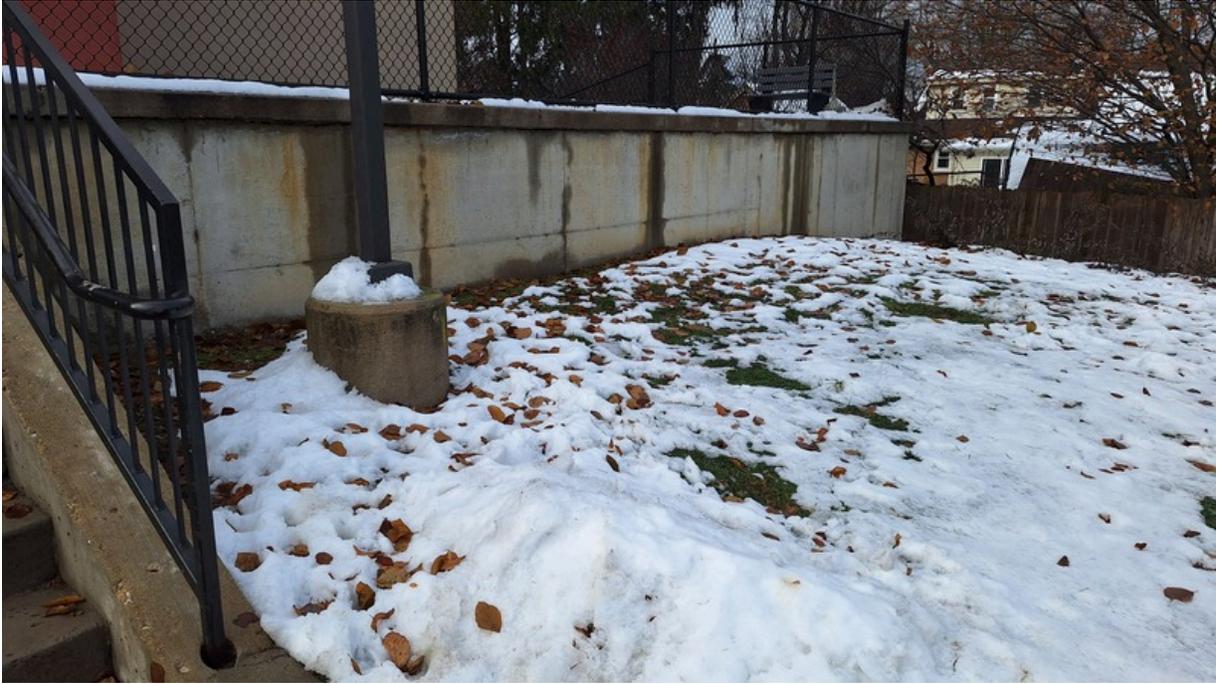
Retaining wall - note fissures

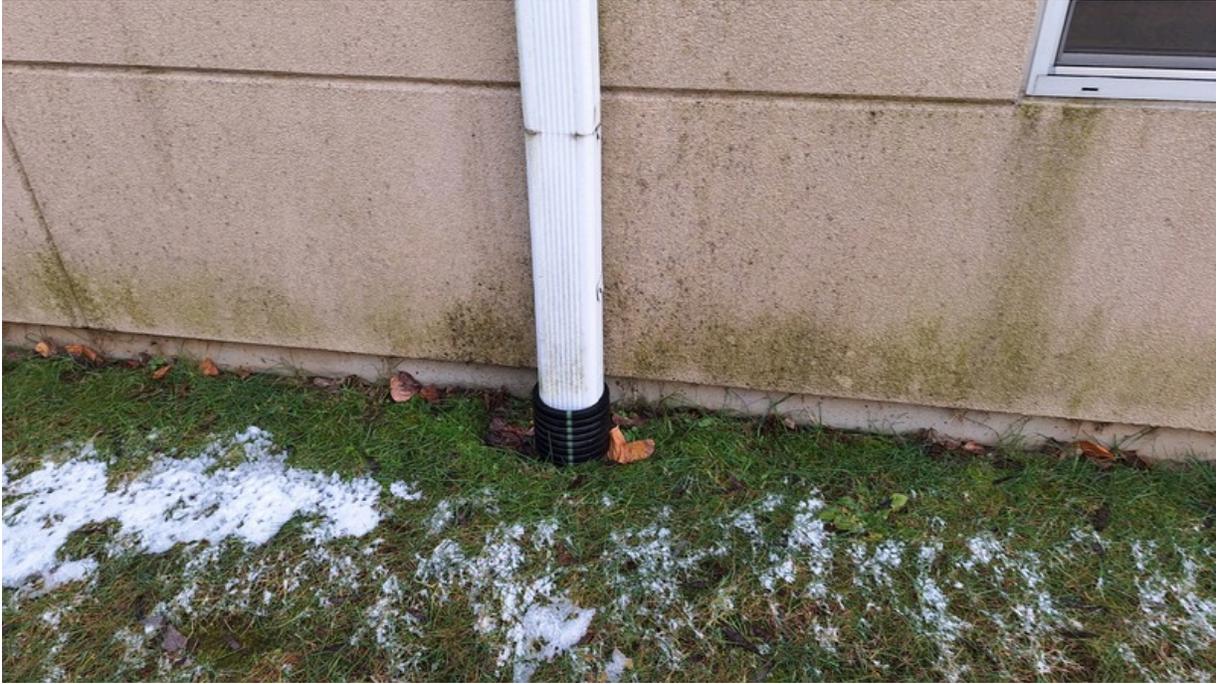
Roof drainage

Based on the age of the roofing system (10 years) and an EUL of 20 years, replacement of the roofing system is anticipated to be required during the term. An opinion of cost for the replacement has been included in the Replacement Reserve Schedule. In addition, activities including, but not limited to, keeping drains clear and repairing leaks promptly, should be done as part of routine maintenance.

Cost Recommendation	EUL	EFF AGE	RUL	Year	Cost
Roof membrane - Replace	20	10	10	10	\$50,000
Total					\$50,000

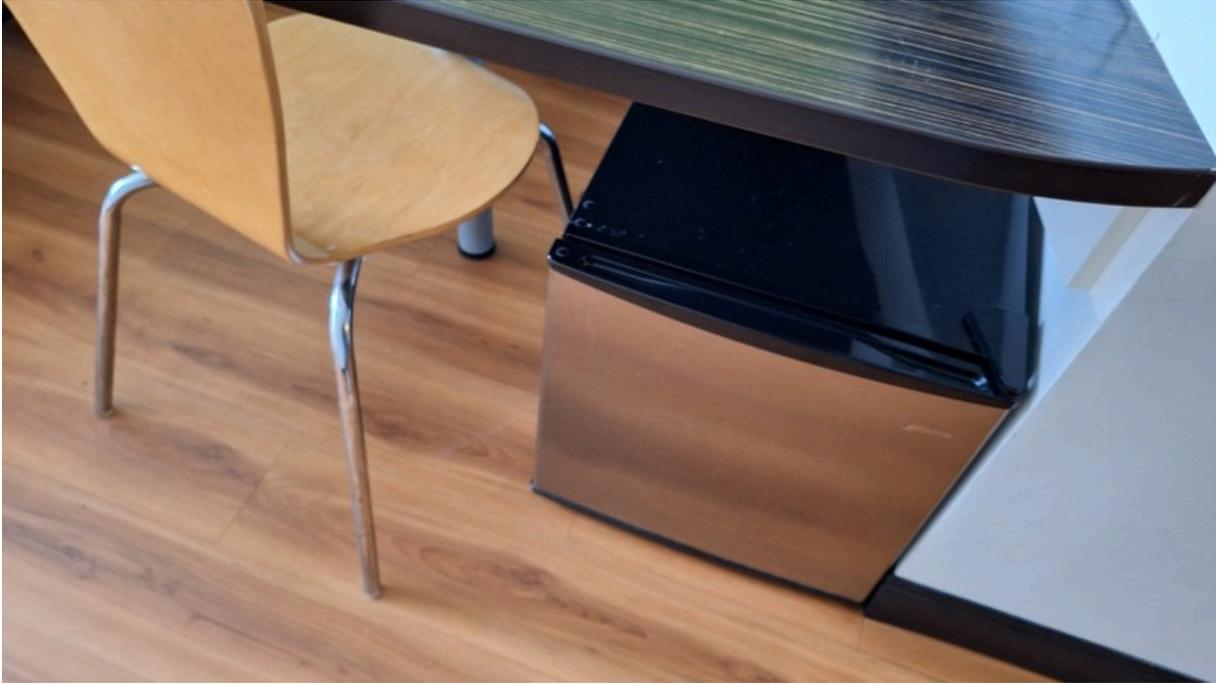
Mini fridge each room

Cost Recommendation	EUL	EFF AGE	RUL	Year	Cost
Mini-refrigerator	-	-	-	2	\$1,096
				4	\$1,093
				6	\$1,093
				8	\$1,093
Total					\$4,375

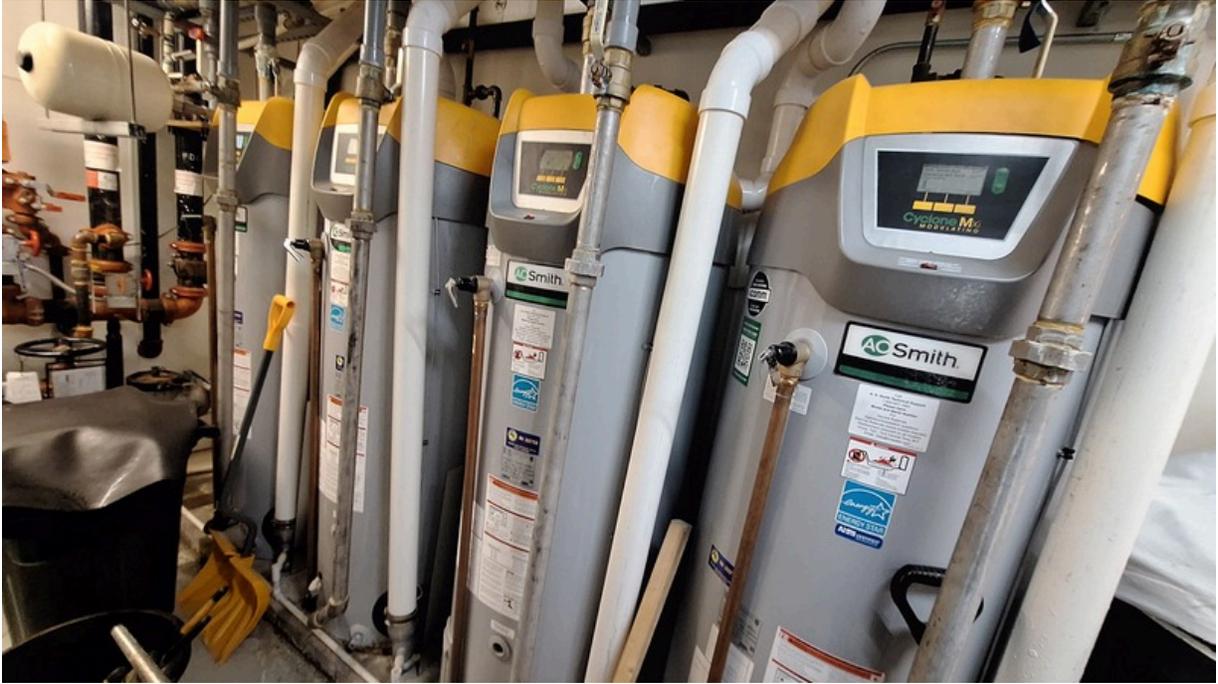
Water heaters

Cost Recommendation	EUL	EFF AGE	RUL	Year	Cost
Water heater tanks	15	10	5	5	\$12,000
				6	\$12,000
Total					\$24,000

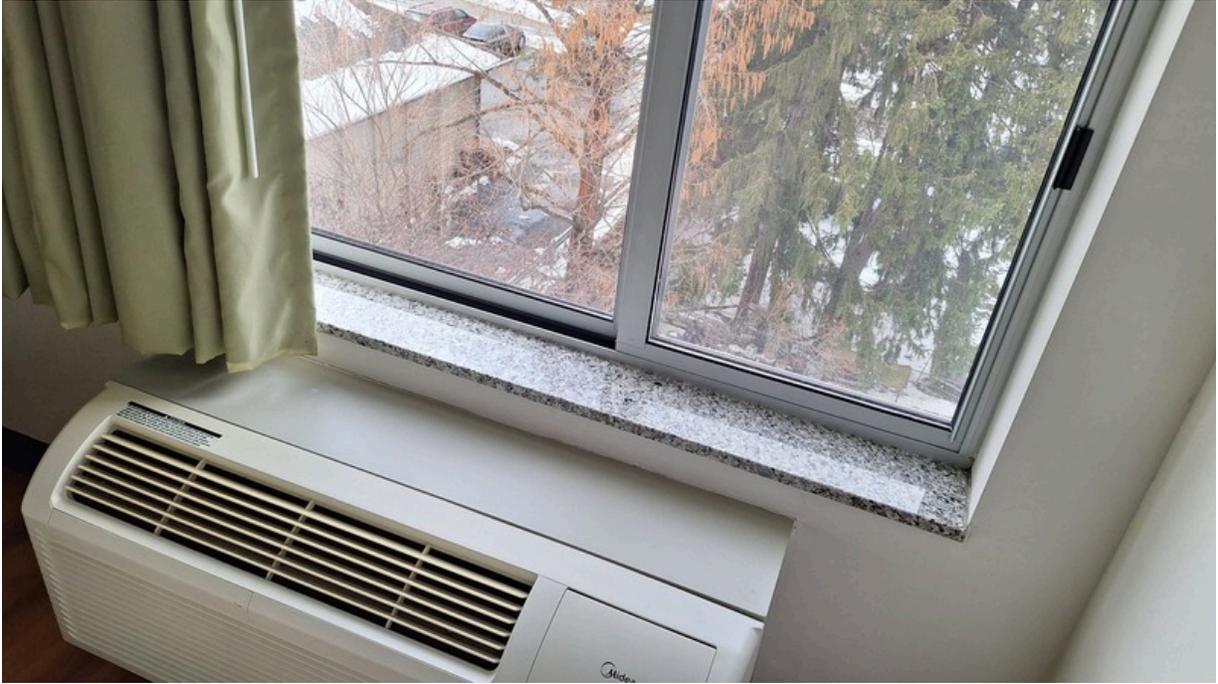
PTAC units

Cost Recommendation	EUL	EFF AGE	RUL	Year	Cost
Packaged terminal air conditioner (6,000 BTUH cooling and 8,800 BTU heat)	-	-	-	2	\$8,550
				4	\$8,550
				6	\$8,550
				8	\$8,550
				10	\$8,550
Condensers	-	-	-	5	\$10,500
				6	\$10,500
				7	\$10,500
				8	\$10,500
				9	\$10,500
Total					\$95,250

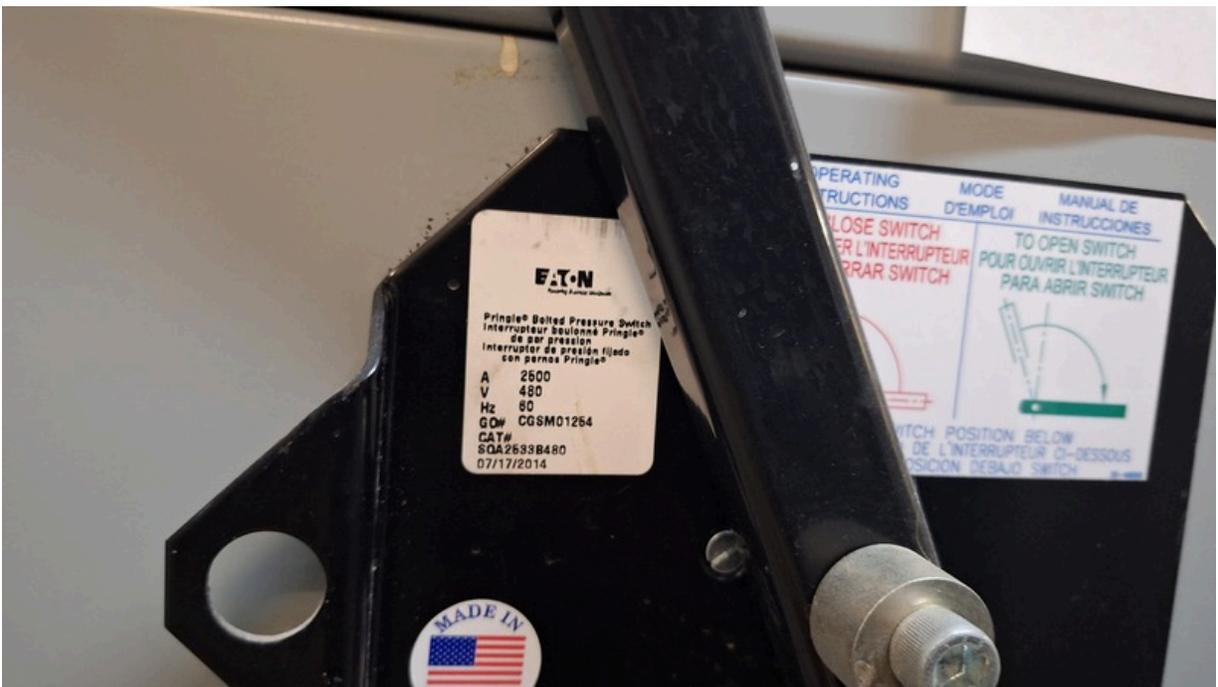
MAIN placard 2500amps

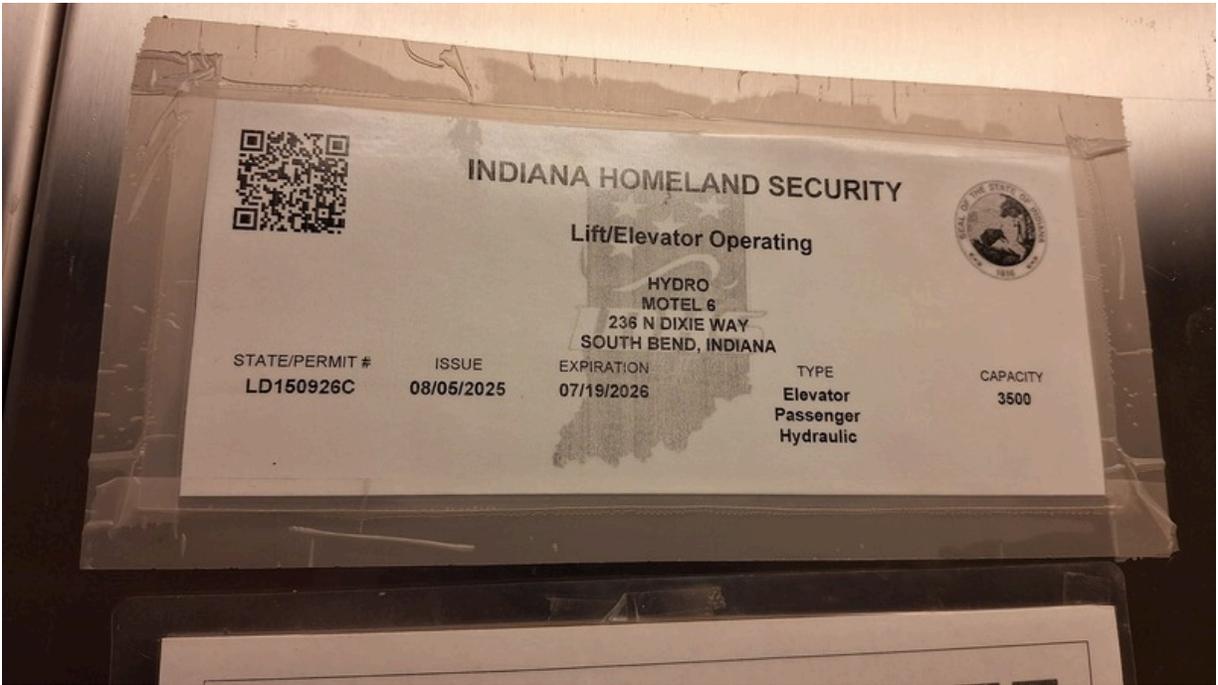
Elevator inspection tag

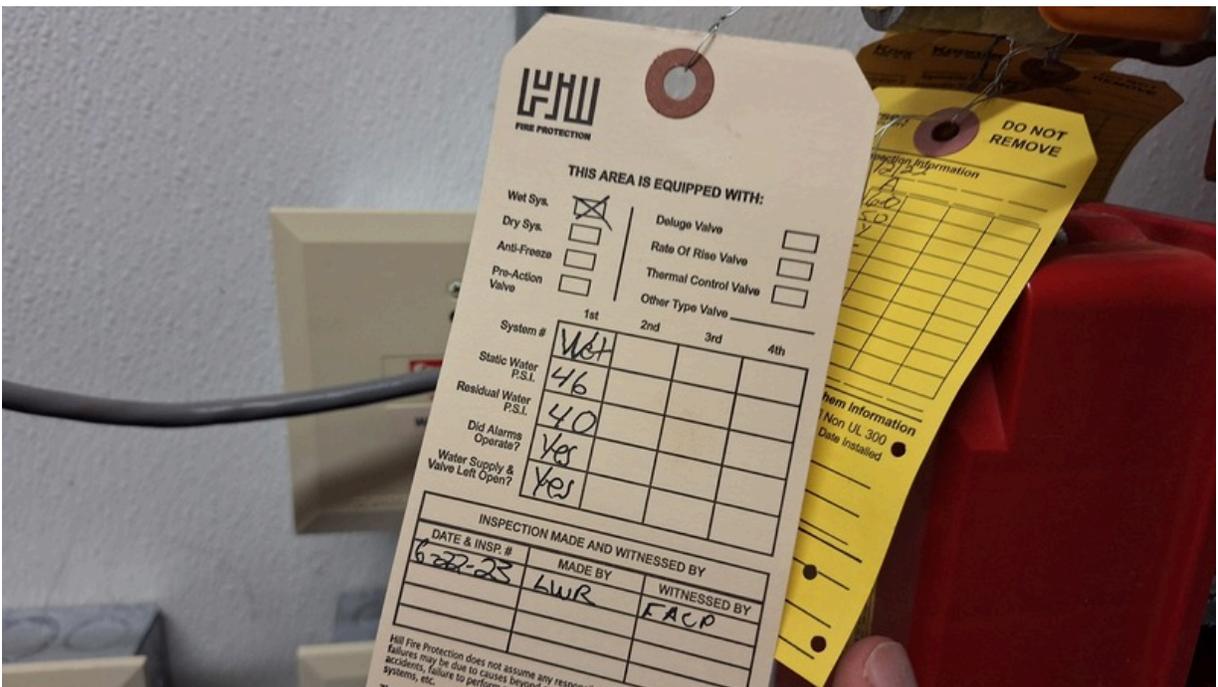
FIRE SUPPRESSION SYSTEM inspection tag - expired

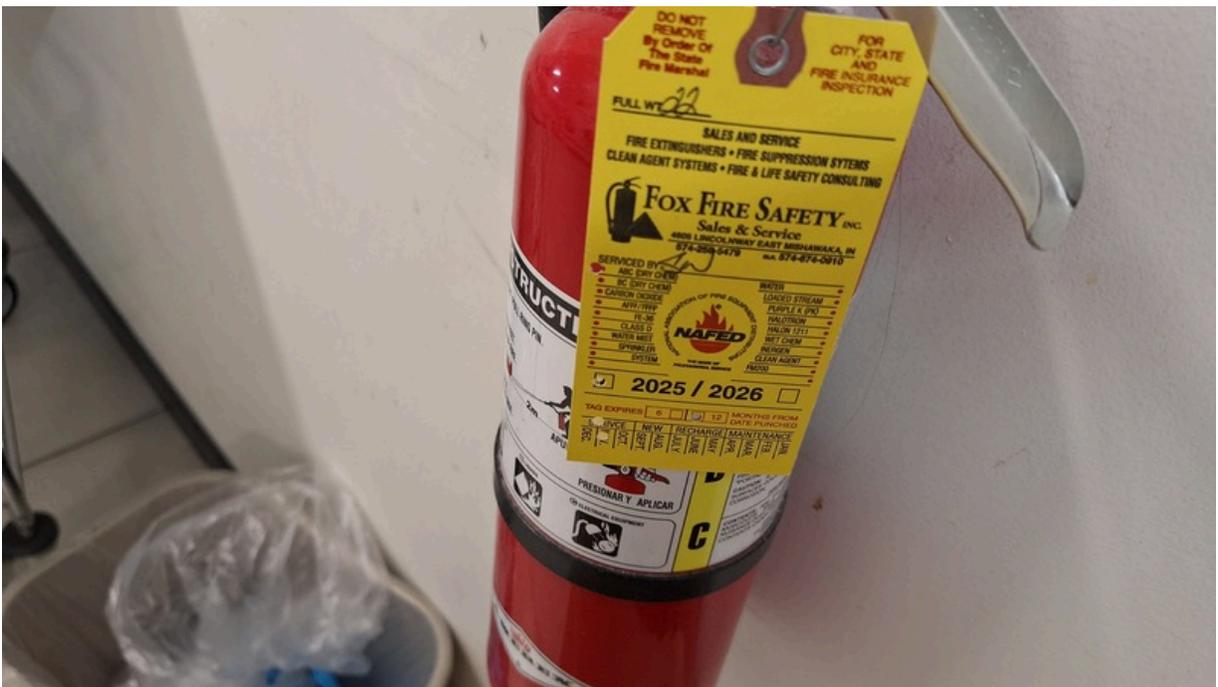
Fire extinguisher current tags
