Milestone Inspection – Phase 1

Anglers Cove Condominium Association

17450 Gulf Blvd. Redington Shores, FL 33708

February 21, 2024

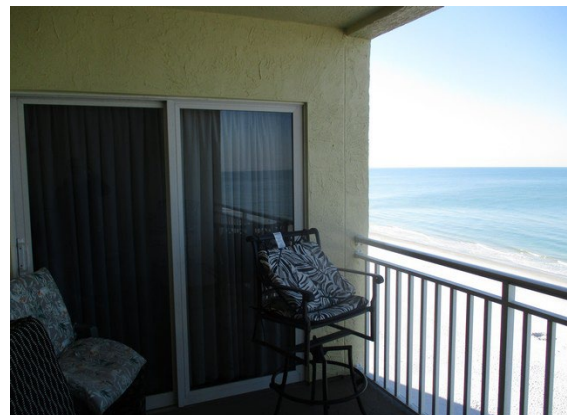
8 Unit #604 Balcony Overview

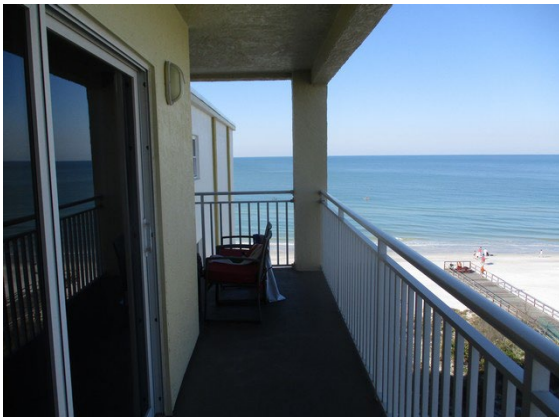
9 Unit #606 Balcony Overview

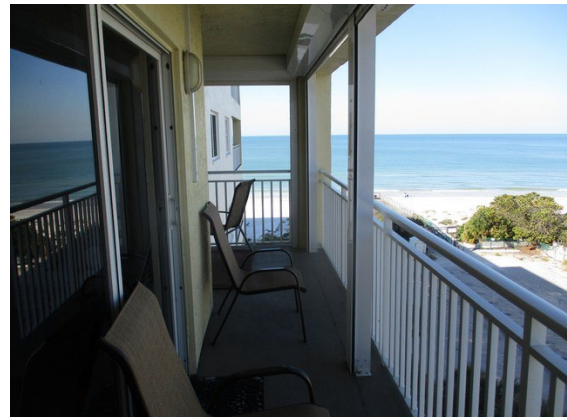
10 Unit #508 Balcony Overview

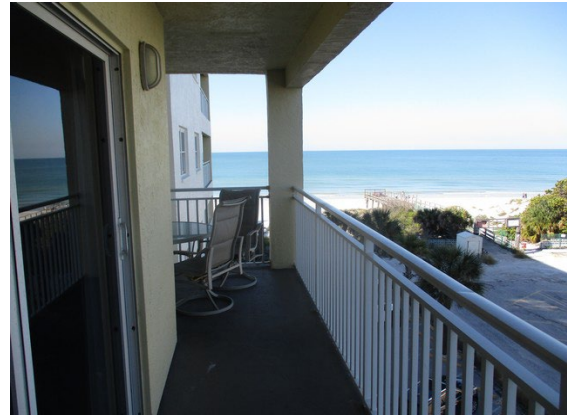
12 Unit #307 Balcony Overview
