Facility Assessment for

LEISTIKOW PARK OUTDOOR SWIMMING POOL

Grafton, North Dakota | August 6, 2025

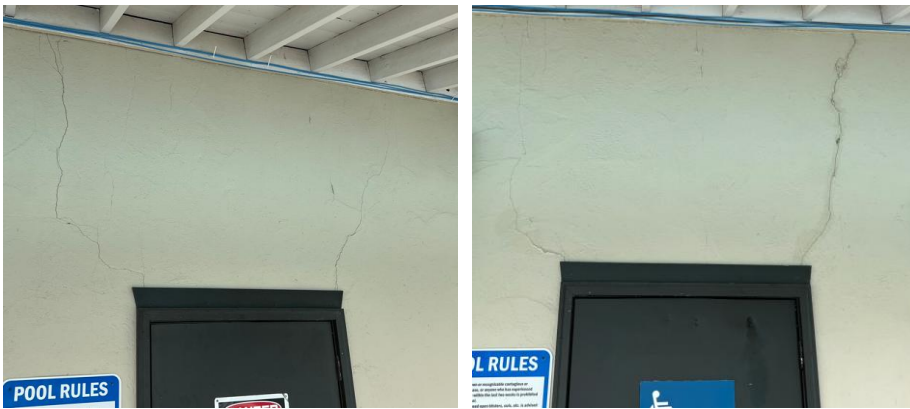
As mentioned above, there is some cracking in the CMU walls above door opening. These cracks appear to be mostly superficial and are not a structural concern.

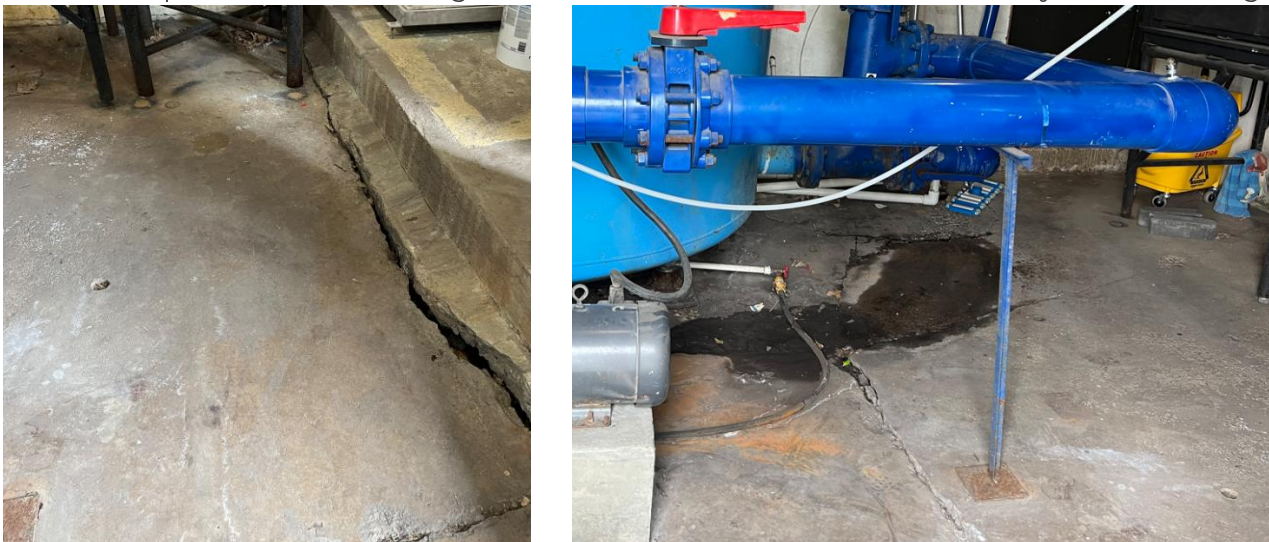
The exposed concrete floor in the lower portion of the pump room exhibits severe cracking and evidence of potential undermining. This is assumed to be associated with the years of flooding.

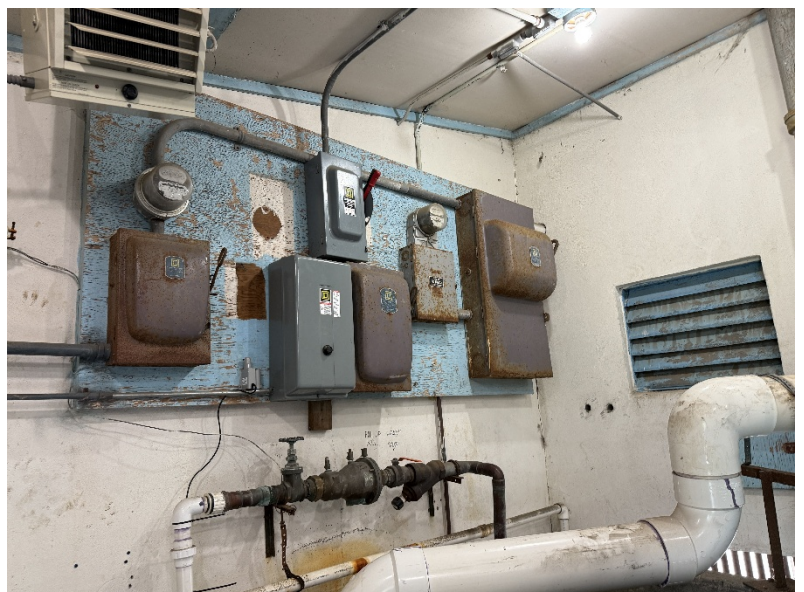
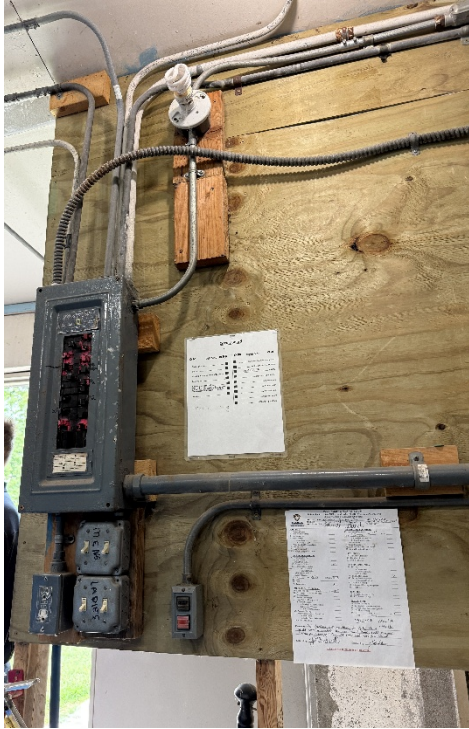
The 120/208 Volt electrical service disconnects and distribution equipment are located in the pool equipment room. There are multiple National Electric Code violations with this equipment.

- Dedicated working space violation.
- Not readily accessible.
- Operating apparatus mounted above maximum allowed height.
- Installed in a corrosive environment.

There is evidence that the branch circuit breaker panel in the pool equipment room has been submerged in flood water. It is unknown if the circuit breakers were replaced after they were underwater.

There are multiple other violations of current NEC codes specific to pools. These include GFCI protection, flexible cord length requirements, and corrosive environment wiring methods.

A new electrical distribution system needs to be installed in a location that provides proper access and working clearances. The pool water chlorination system cannot be in the same space as the electrical equipment. All existing wiring and devices in the pool equipment room that is not corrosion resistant compliant must be replaced.

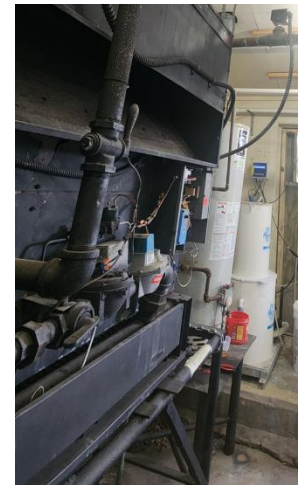
The pool boiler is a natural gas-fired Teledyne Laars Boiler. The boiler was manufactured in 2000 and is operating beyond its expected lifespan. The boiler is mounted on a tubular steel stand and is at risk of tipping over due to sloping floors. A chain bolted to the wall protects the boiler from tipping over.

The boiler stand should be stabilized as soon as possible. If the boiler should fall, it would likely rupture gas piping, potentially leading to an explosion.

The boiler itself is should be replaced as it is operating beyond its expected lifespan.

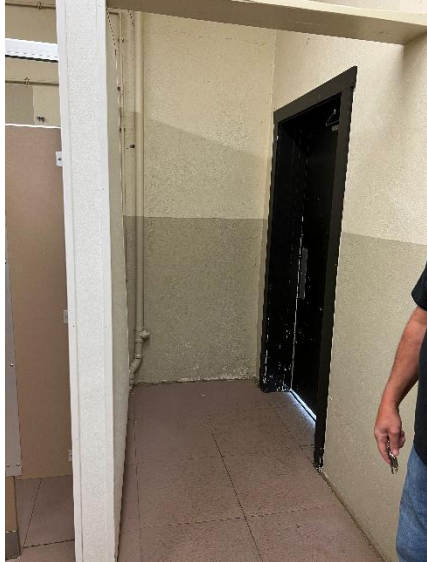
Entryways inside of shower/rest rooms do not meet ADA turning radius requirements.

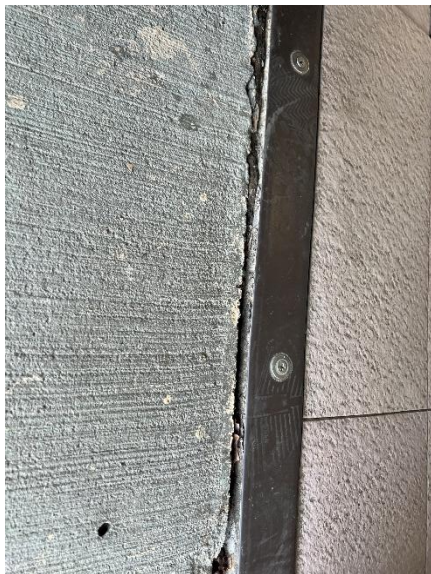
Door thresholds at shower/rest room entries do not meet ADA requirements.

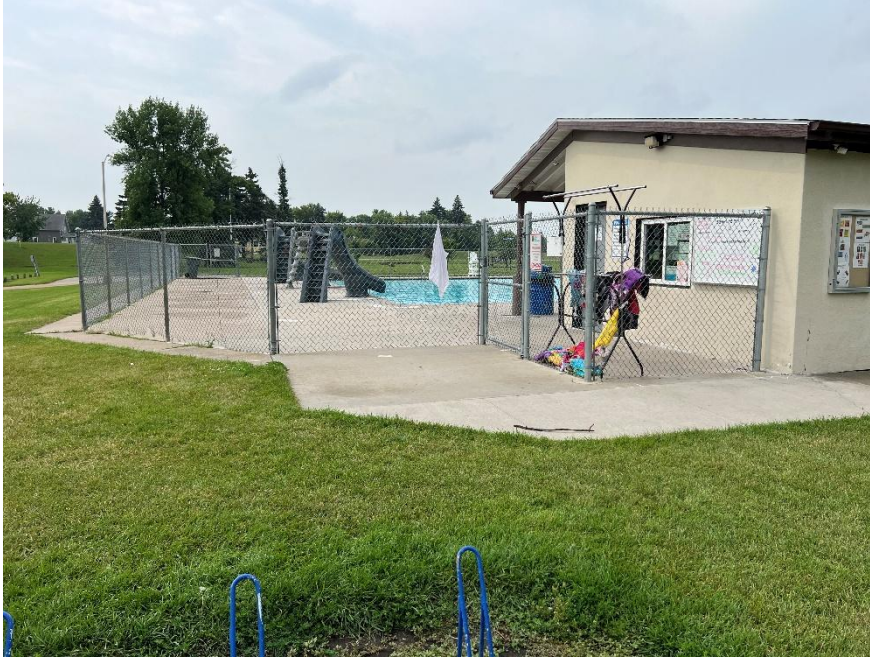
The entry path to the facility does not meet slope or width requirements per ADA.
