O-360-A4G
NN9757L

Engine Inspection
Camshaft Change

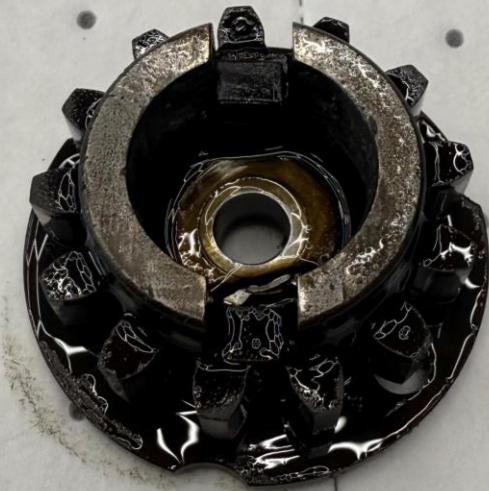
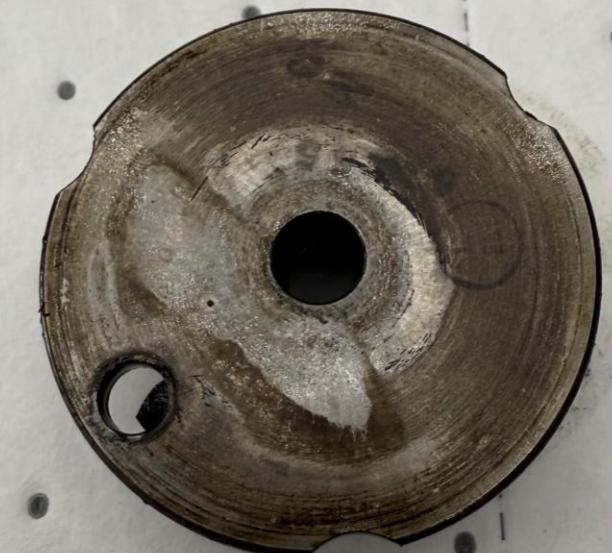
Crankshaft Gear
Rejected due to
not compliant
with Lycoming
MSB475

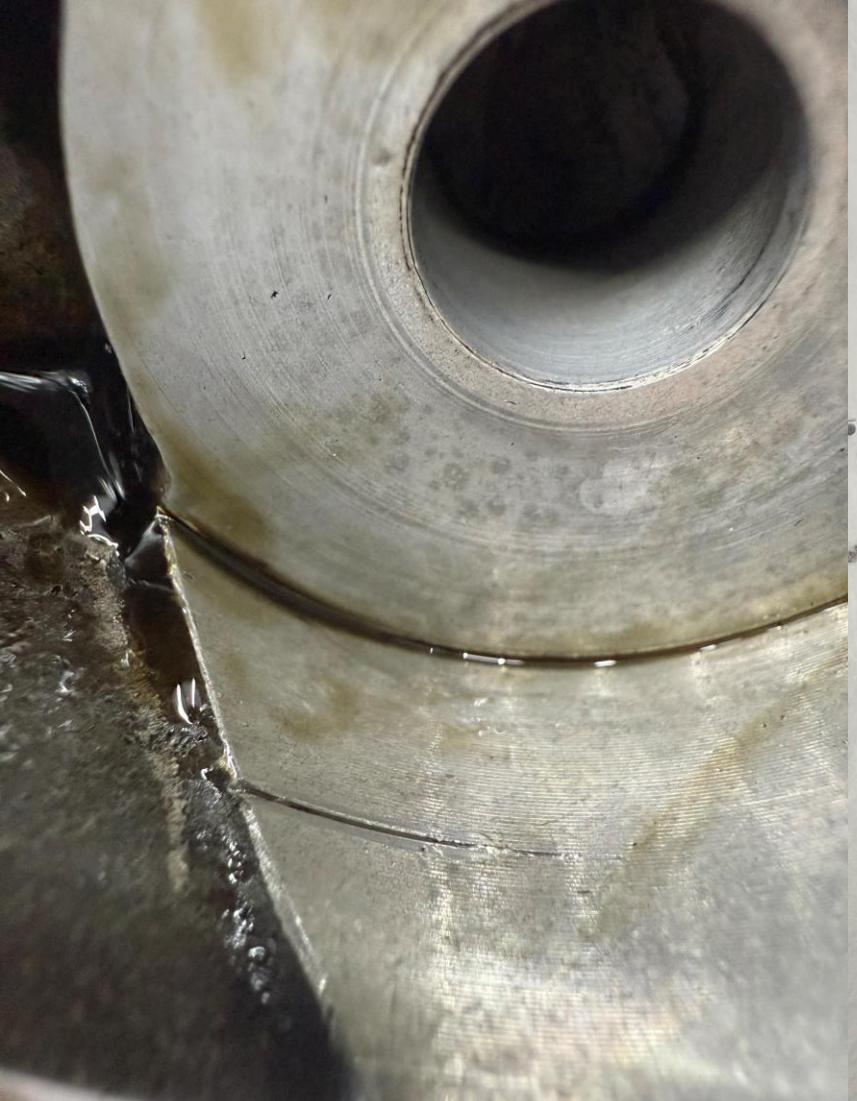
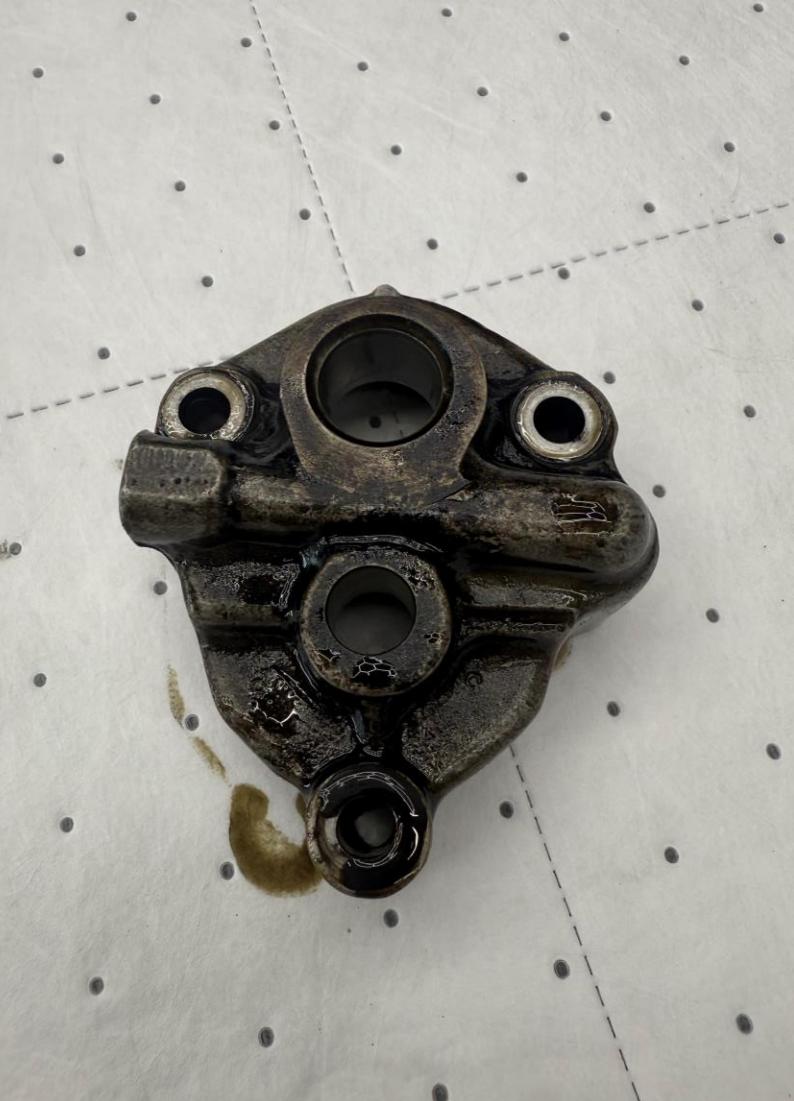
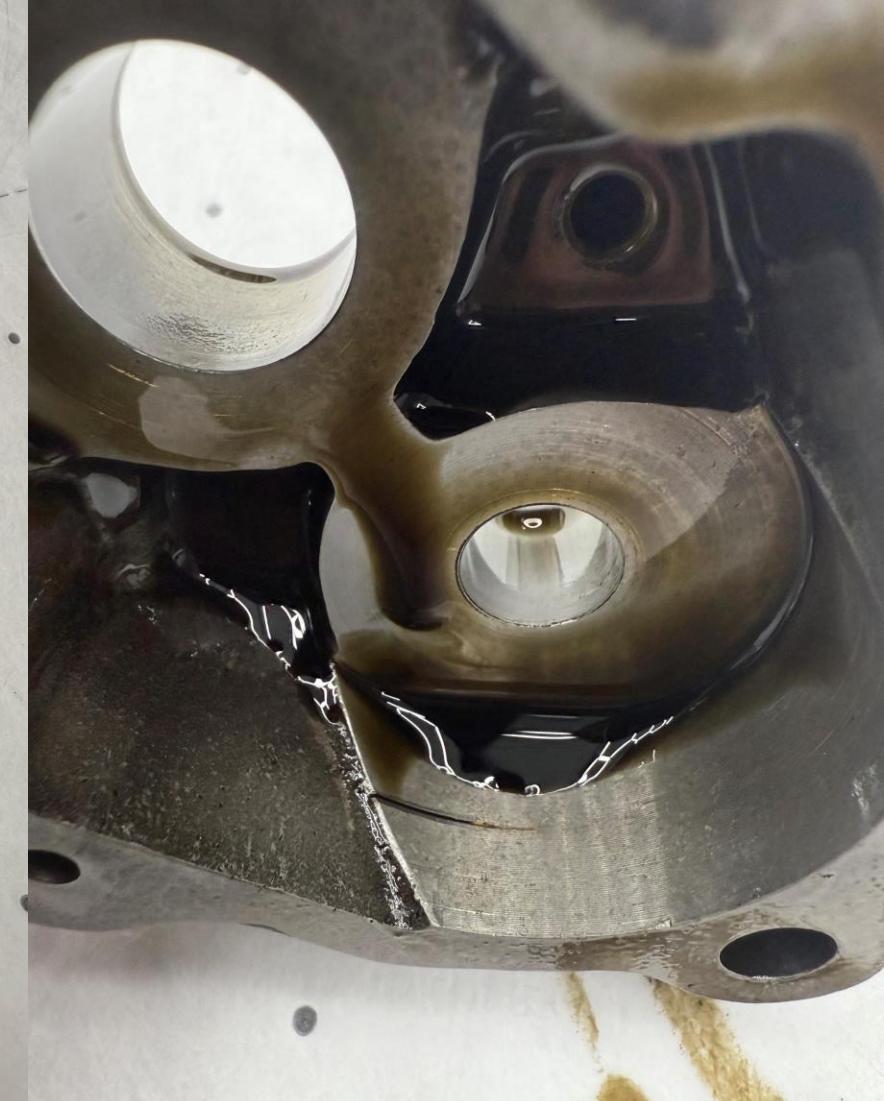
Oil Pump Body Rejected due to large scoring mark.

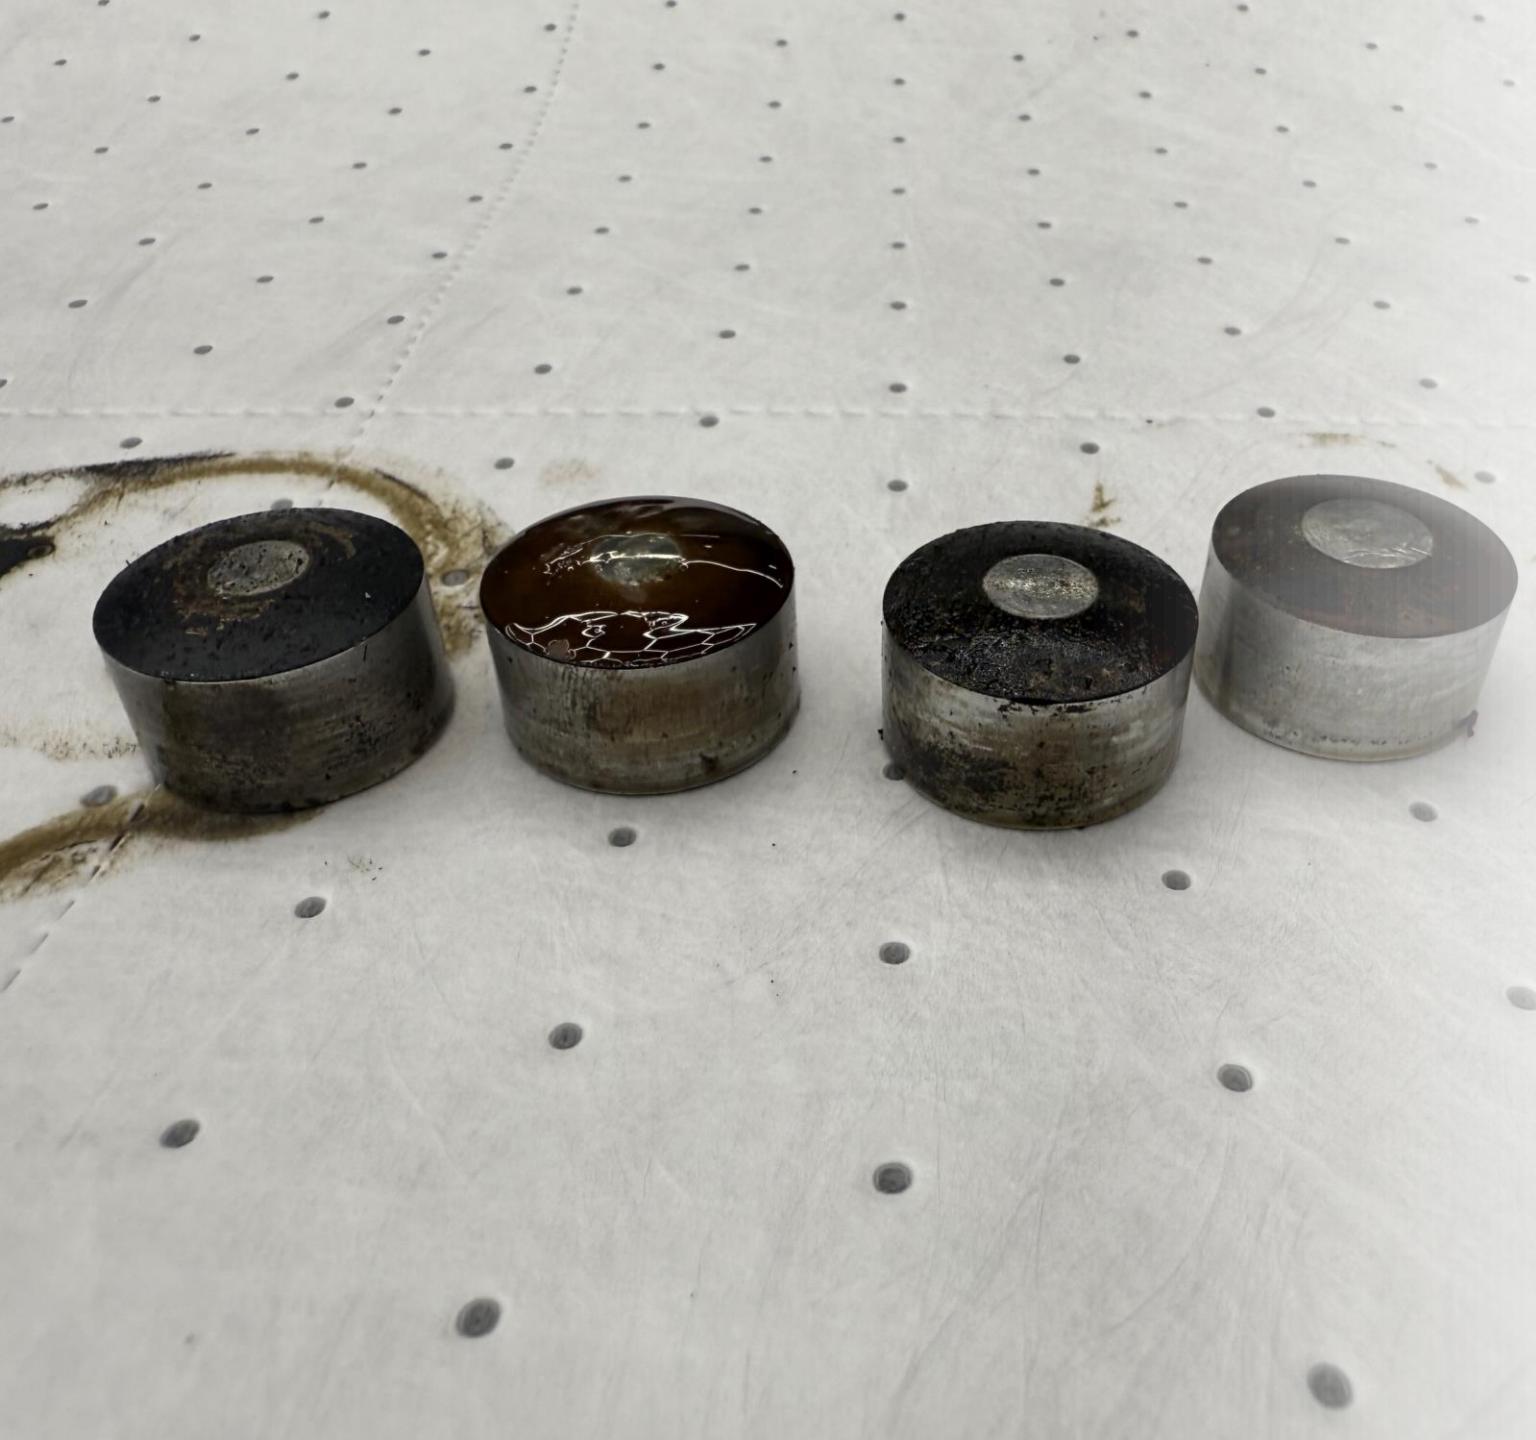
- **Piston Pin Caps Rejected**
These are the old aluminum style
an have an extremely high failure
rate.

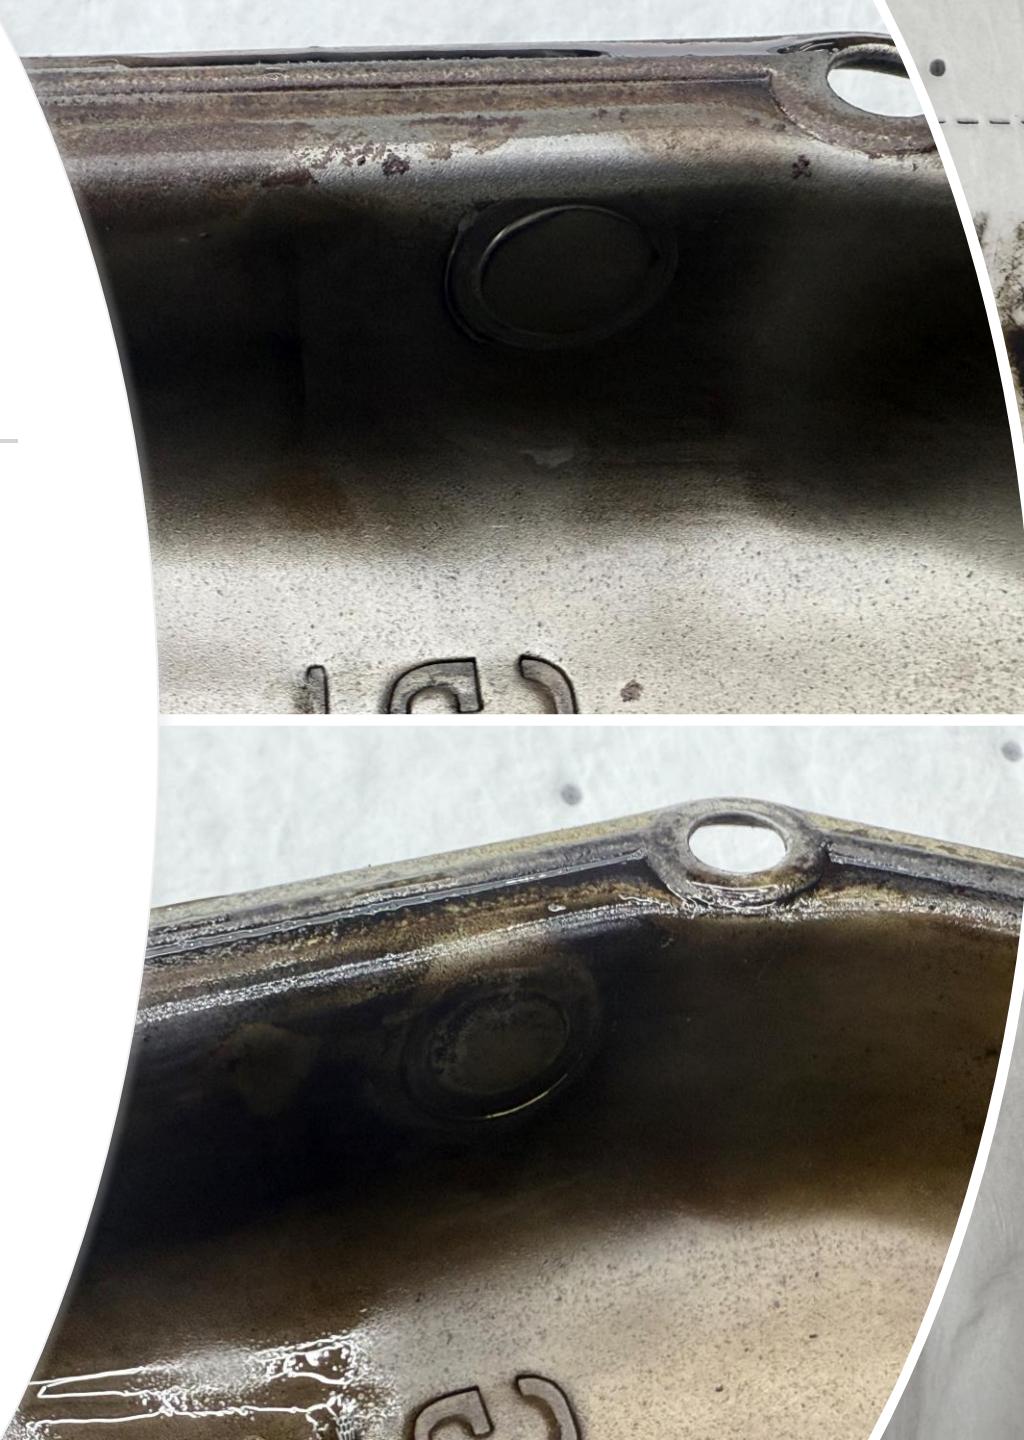
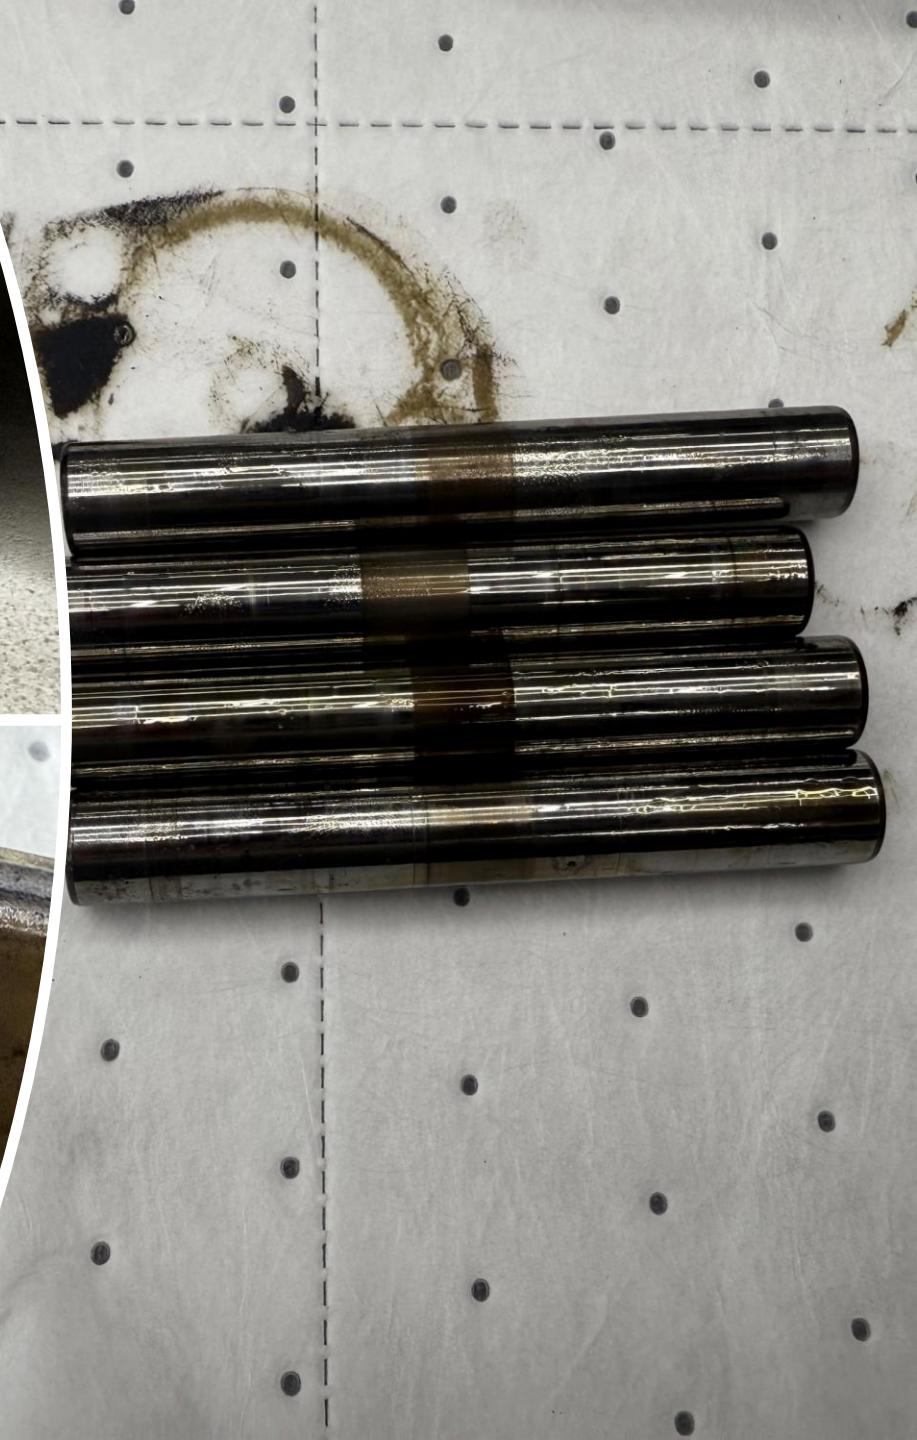
- Rockershafts Rejected due to being the old ones with no caps. These wear holes into the valve cover and will cause a oil leak.

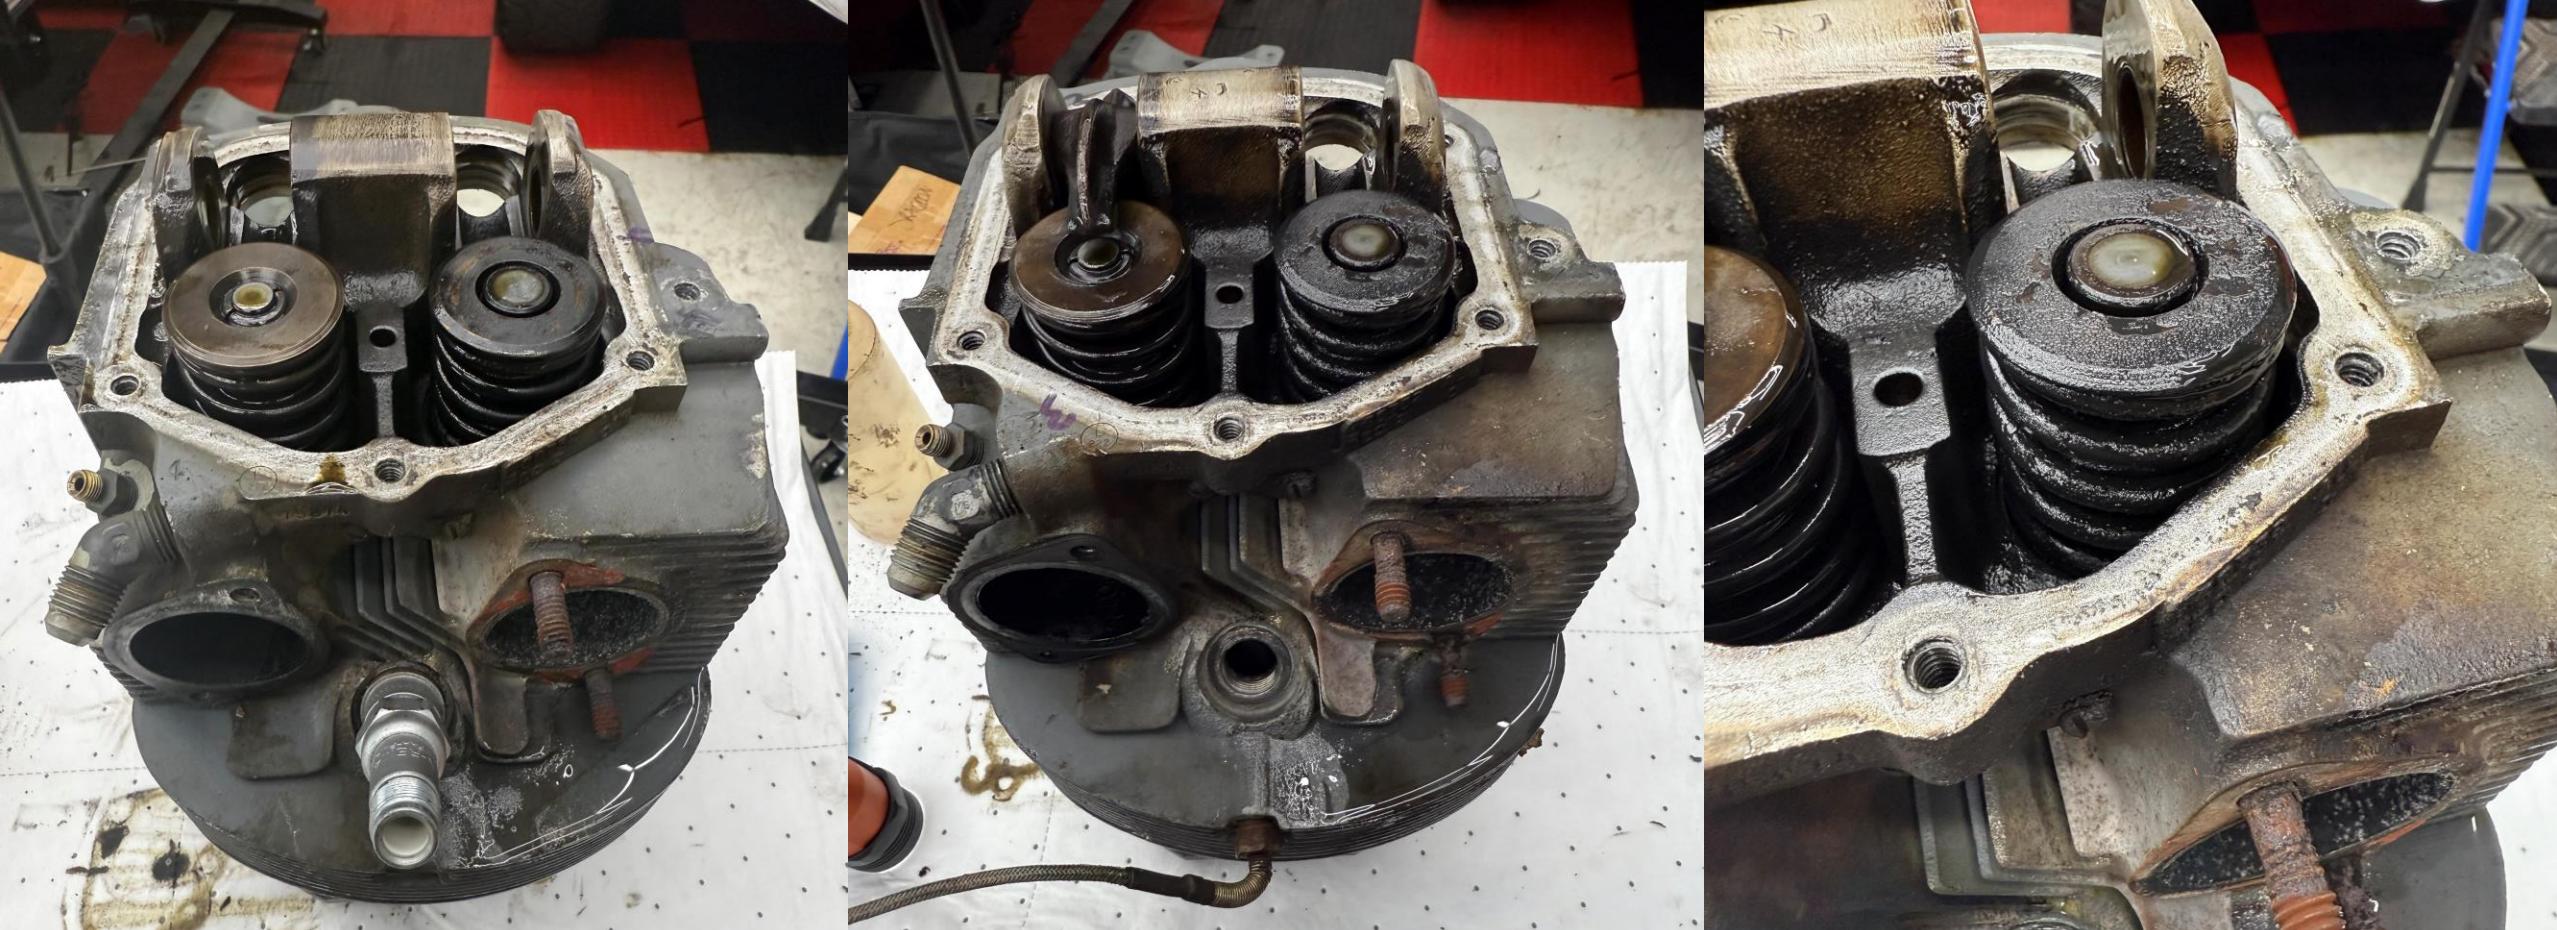
All Cylinder Rejected due to 3x cracked exhaust ports and 1 sparkplug hole damaged beyond repair.

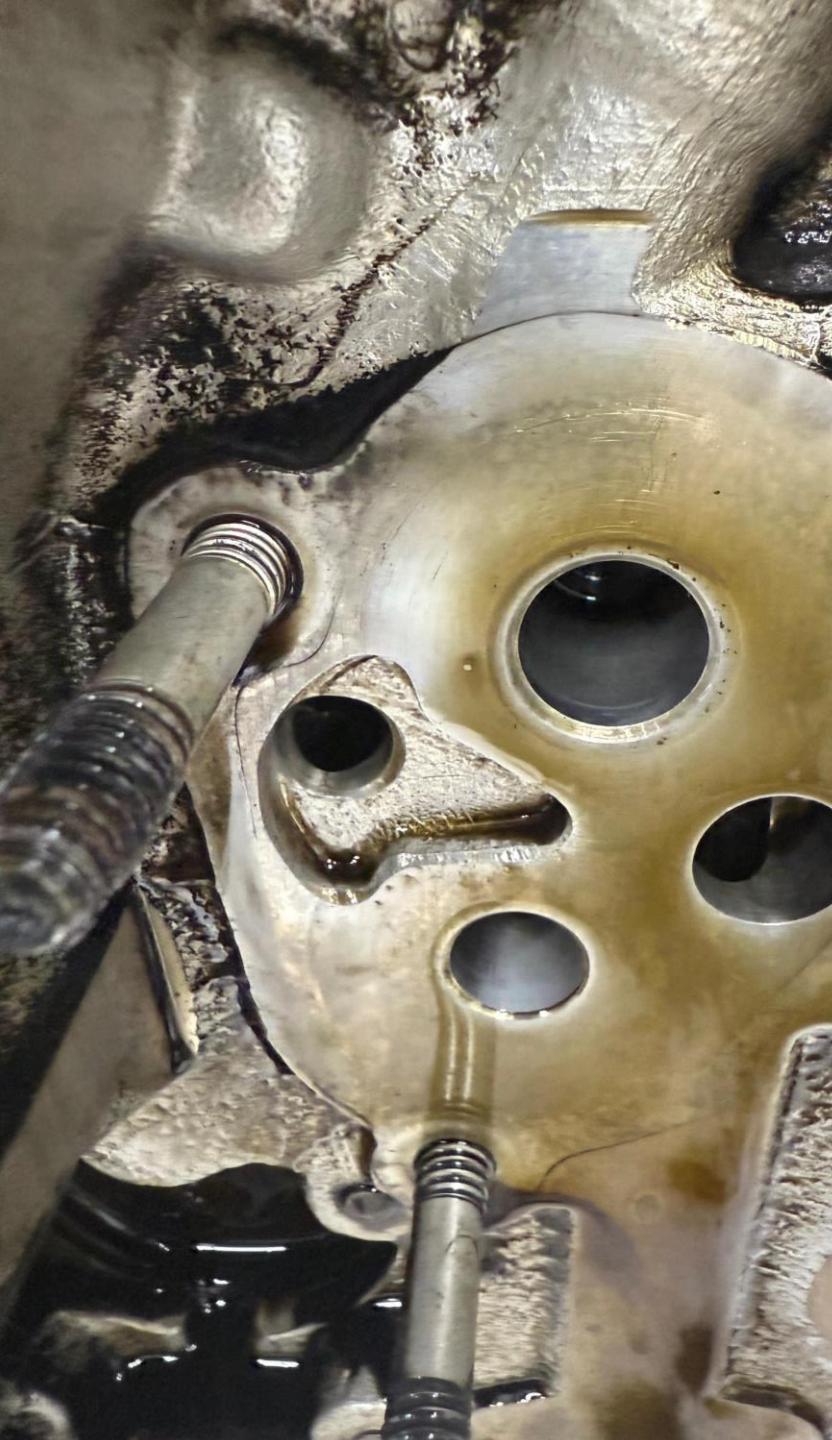
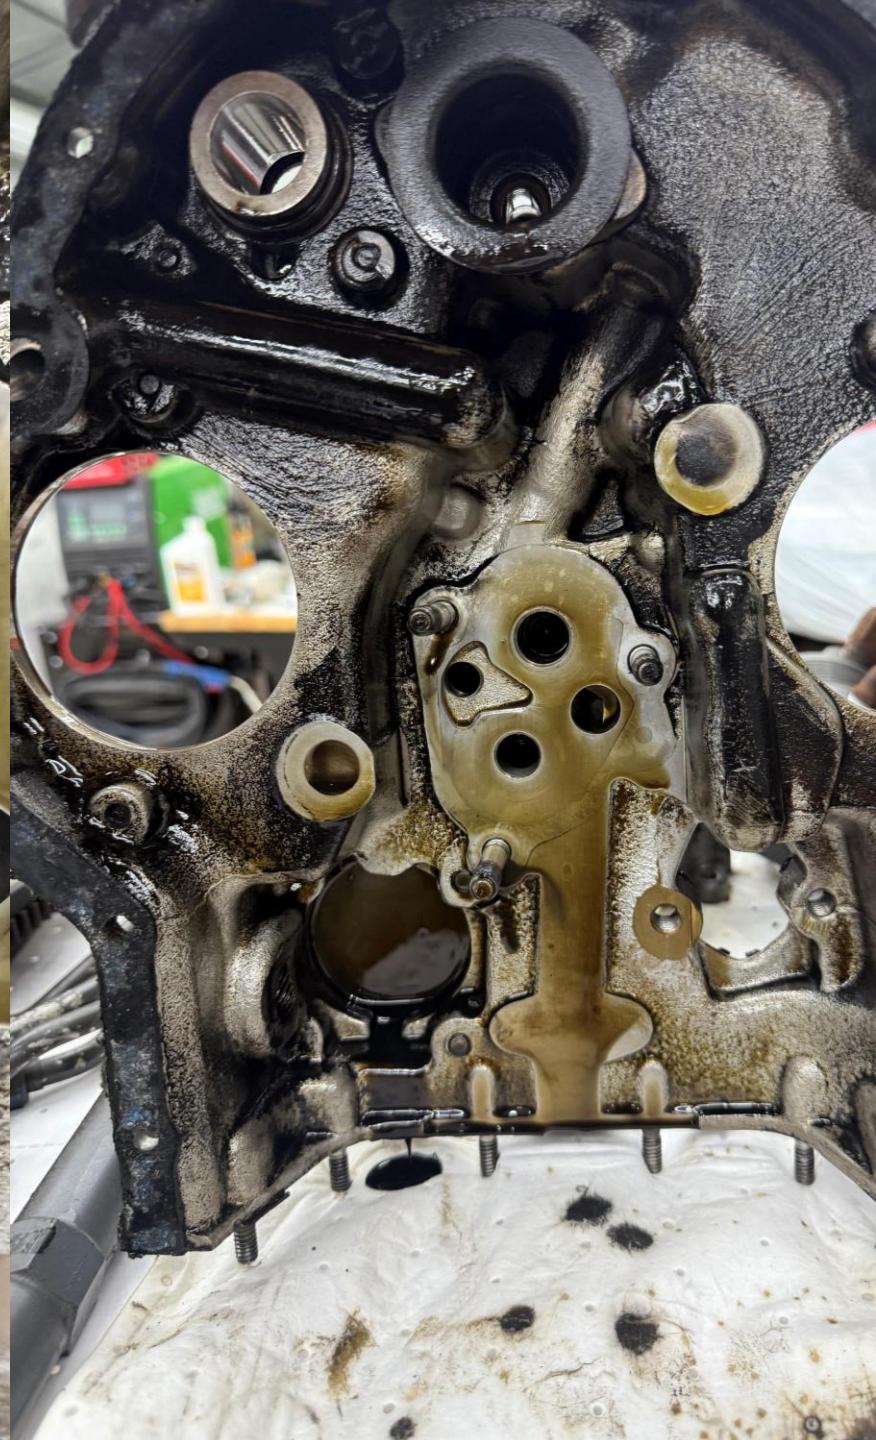
Accessory
Housing need to
be modified per
Lycoming SI 1341
for oil pump idler
shaft lubrication

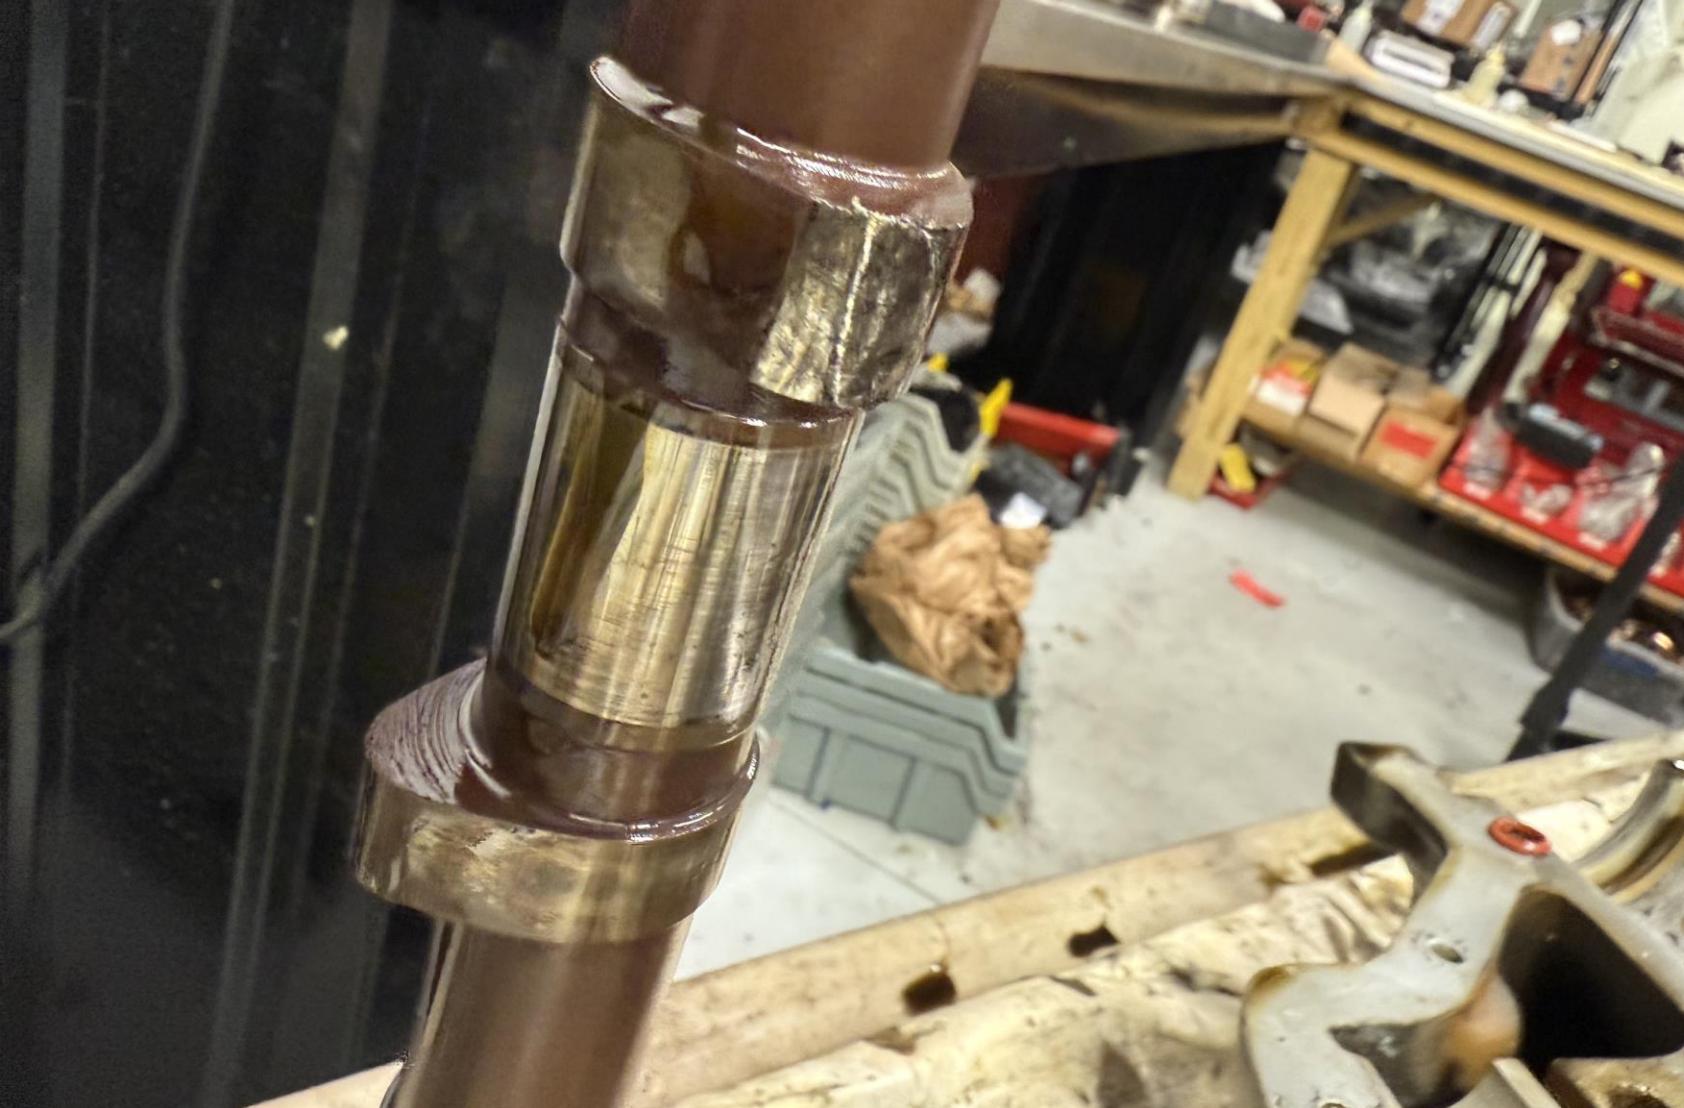
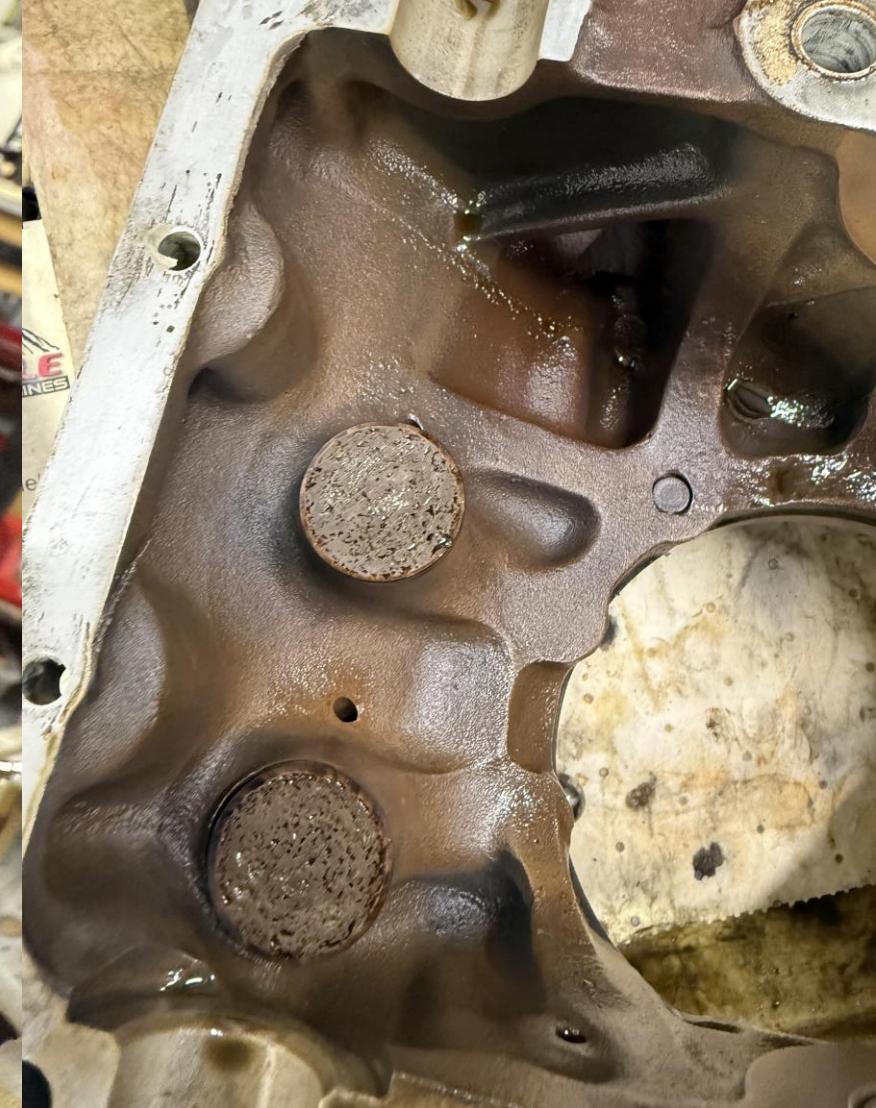
Camshaft and Lifters Rejected due to spalling
