**Re: Extension to Rasp Mine at Broken Hill – Zinc Lode
Affects to Road Reserve Infrastructure**

1.0 INTRODUCTION

The following report aims to provide further information to allow assessment of effects to surface infrastructure from proposed mining of the Zinc Lode ore body at the Rasp mine, South Road, Broken Hill NSW. It is understood this report will be included with the Environmental Assessment application for the mine extension.

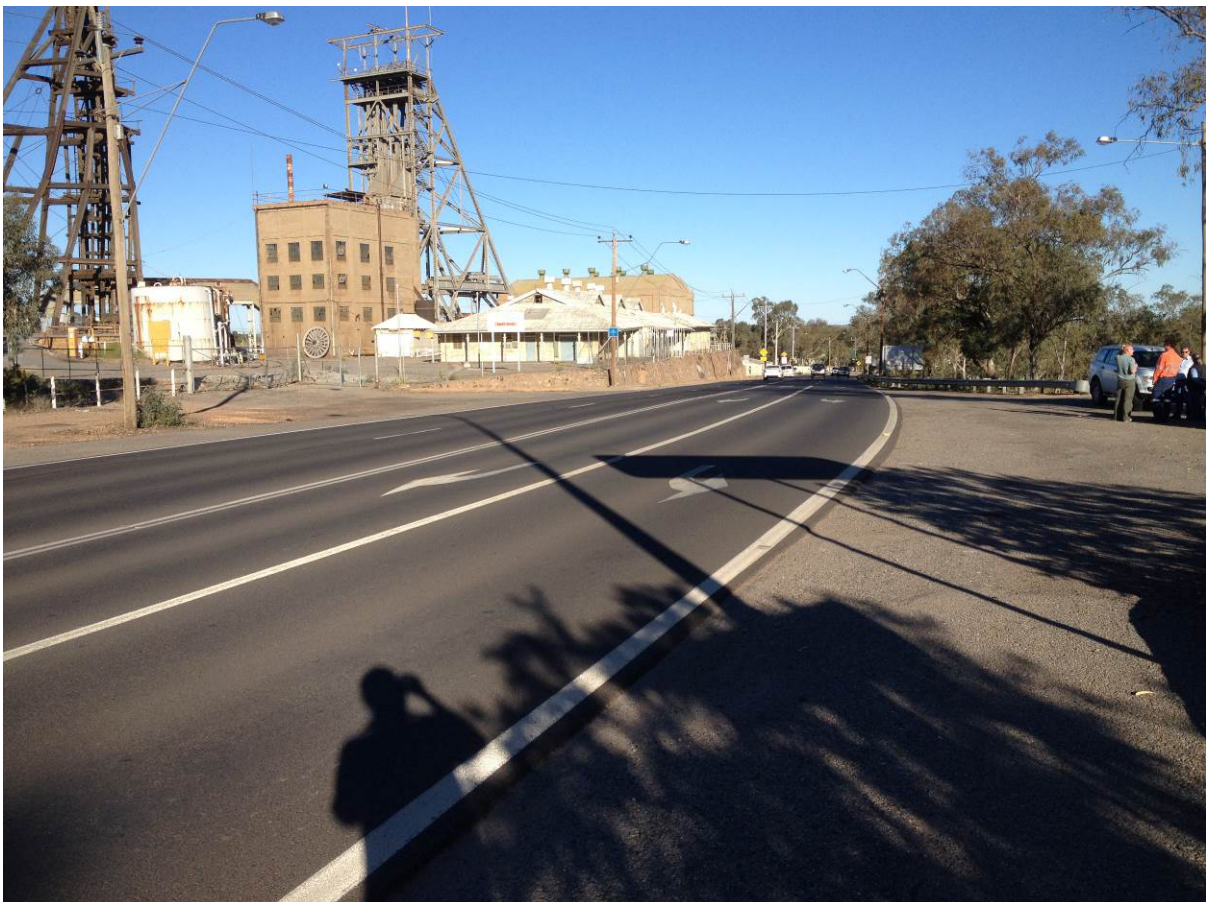
Photo No.1: South Road, looking east

The site was inspected by the writer on 9th October 2014. The road vertical alignment was noted to be at natural surface or shallow cut near the old mine entrance then falling to the east with substantial fill and a fill batter slope estimated to be 1V:2H. Rock outcrops could be seen on the mine site adjacent to the road at the top of the hill. See photo below.

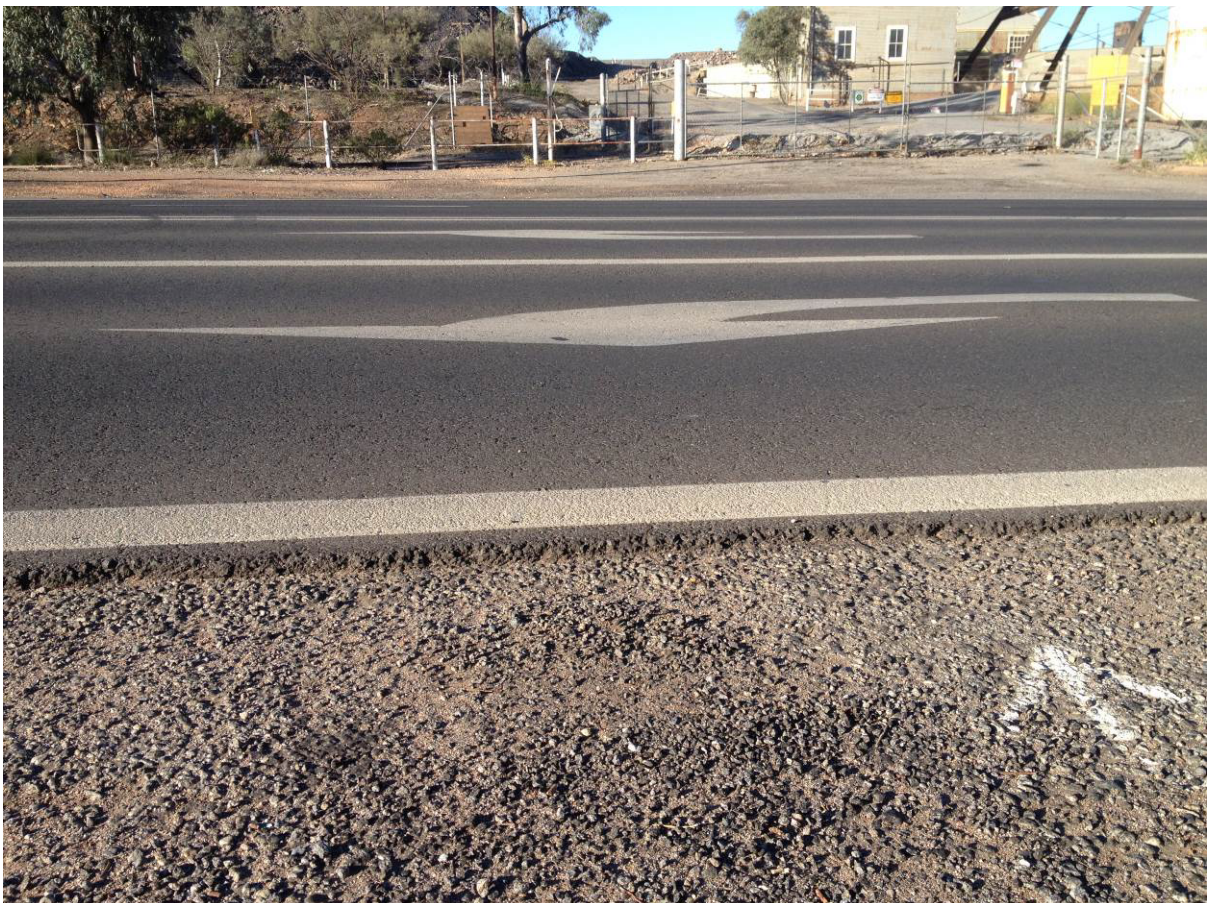
Photo no. 2: Current Asphalt seal

The road formation at the site varies from flexible pavement on shallow weathered rock cut to flexible road pavement on fill. The road surface is currently asphaltic concrete, which appears to be of recent construction (1-2 years old). The asphalt thickness was not determined, but from side profiles as per the photo below, appears to be 50-100mm thickness.

The road vertical alignment appears to be fairly uniform, which is probably due to the recent asphalt overlay. However this would also indicate that the fill compaction has performed adequately to date, with no major evidence of uneven settlement.
